**MONSANTO CHEMICAL COMPANY**

Date : June 26, 1959

Subject : Acetaldehyde Explosion in Pressure  
Cell No. 11

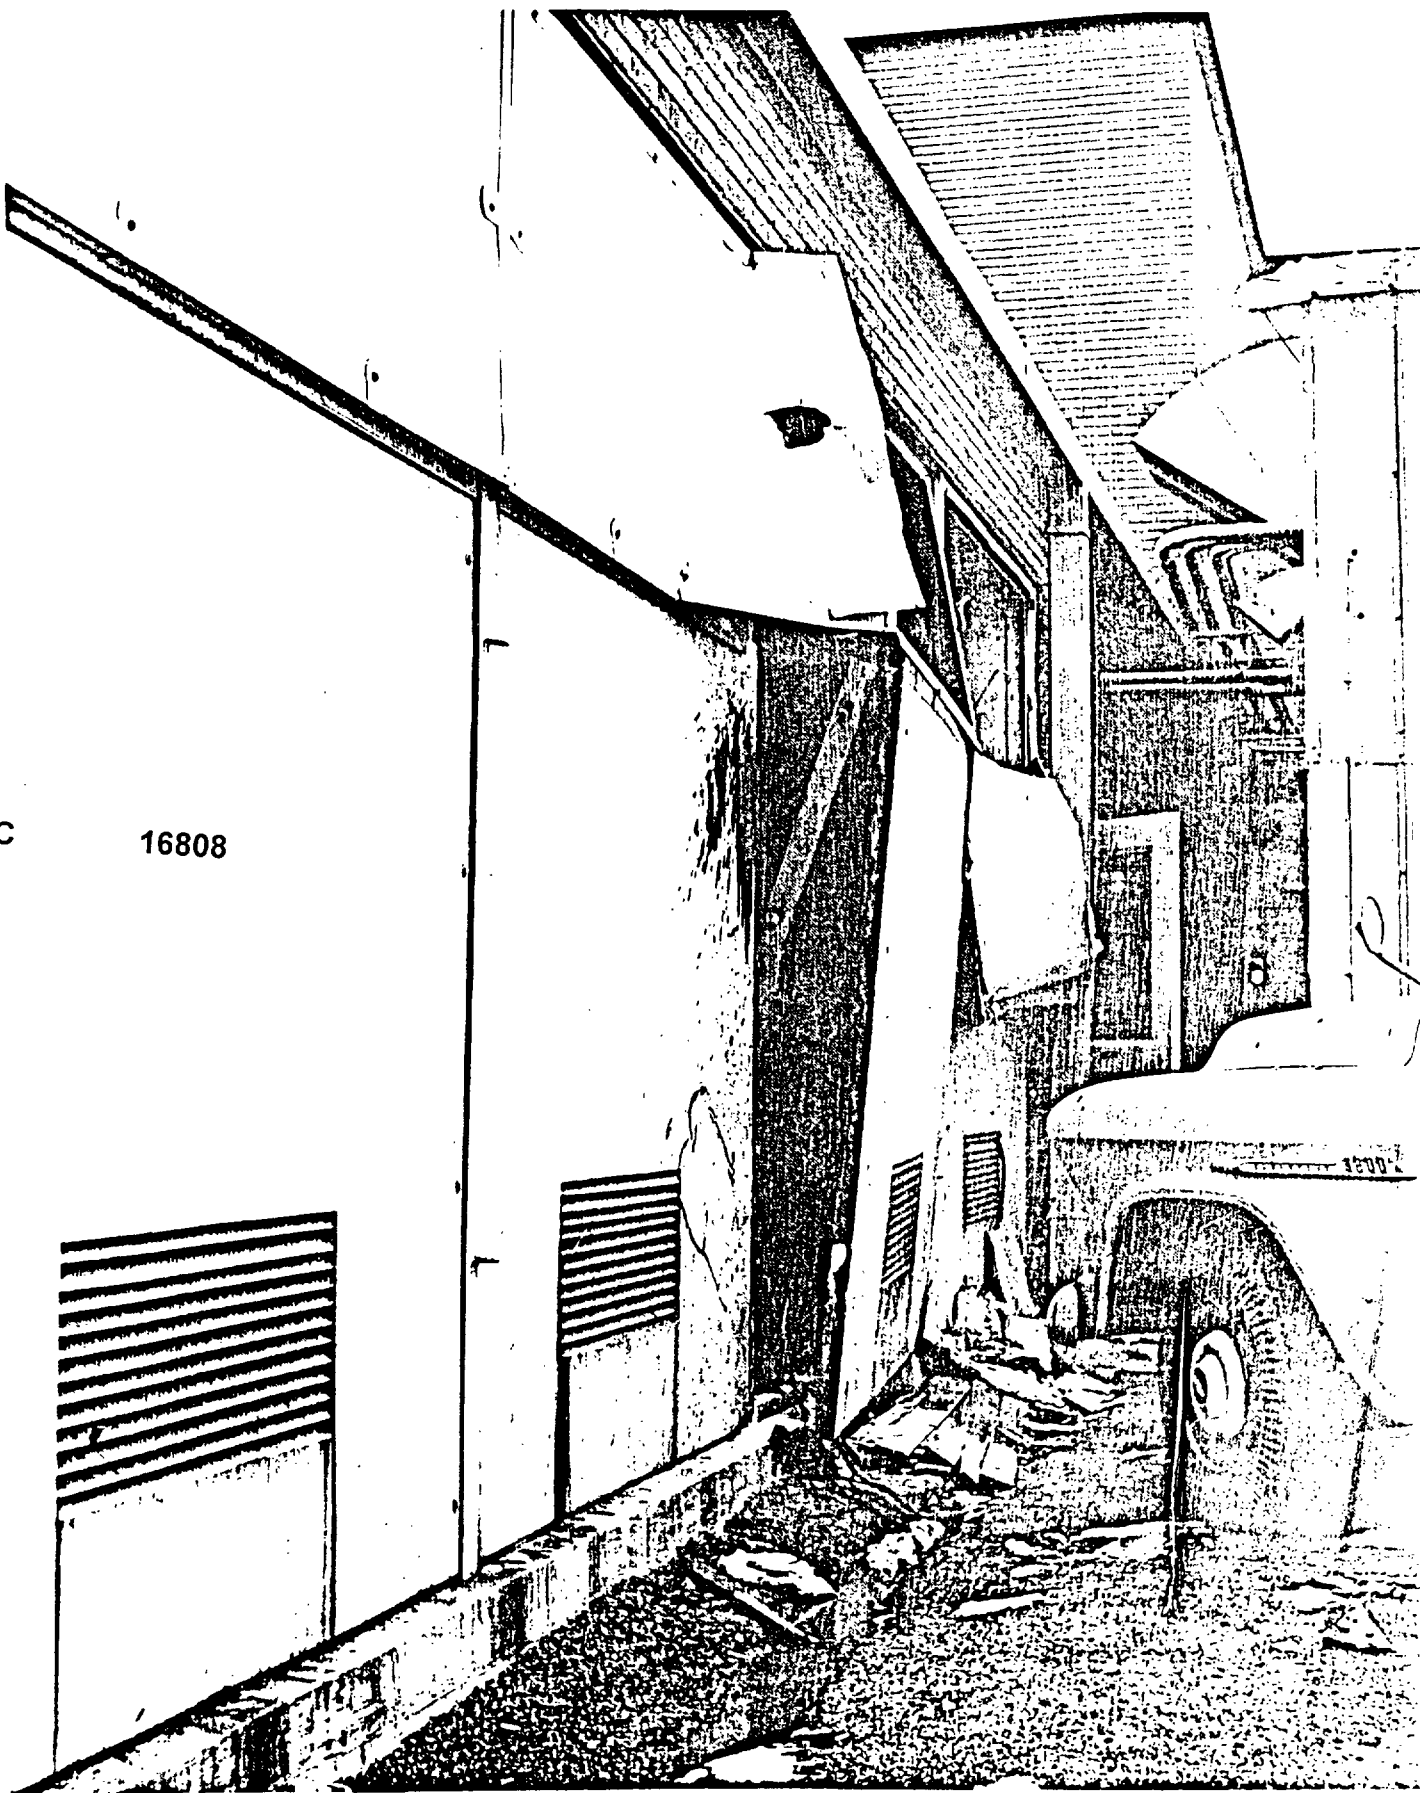
The cell walls, constructed of two 3/8" steel plates with an inner layer of 2" oak timbers, received major damage. Both side walls and the front wall were broken loose from their mountings and moved several inches. The entire back wall, of which 1/3 was the blowout panel, was blown completely loose except for one bolt which kept it from falling. The blowout panel, consisting of two sheets of thin aluminum enclosing glass wool insulation was completely blown out. The major portion of the panel was found upwind approximately 200' near the west side of the pilot plant. Small fragments of the aluminum panel and insulation were found scattered over the entire area between the pressure cell and the pilot plant. In addition, several small fragments of the pressure vessel were also found in the vicinity of the pilot plant. Instruments used in the experiment were knocked from their stand but the extent of damage has not been determined.

1. Outside view of the back wall and blowout panel.
2. Inside view from the cell doorway looking towards the back wall. Sections of the vessel are scattered on the floor. The white material in the pictures is from the dry chemical extinguishers.
3. Inside view from the back wall toward the corner of the front wall. Door out of picture to left. The bottom of the vessel was mounted 24" from the floor in the vicinity of the rope. Note the dark brown varnish like material on both walls. Walls were grey before the explosion.

- a. Replace the present blowout panels on the new cells with a thin light weight material.
- b. Block the utility trench between each cell.
- c. Cap all unused holes through the cell walls.

- d. Installation of a blowout retaining mat or wall.
  - e. Consider enlarging the blowout panels.
  - f. Use welded construction to tie all cell walls together. (While all welds held, practically all bolts pulled out or were sheared off.)

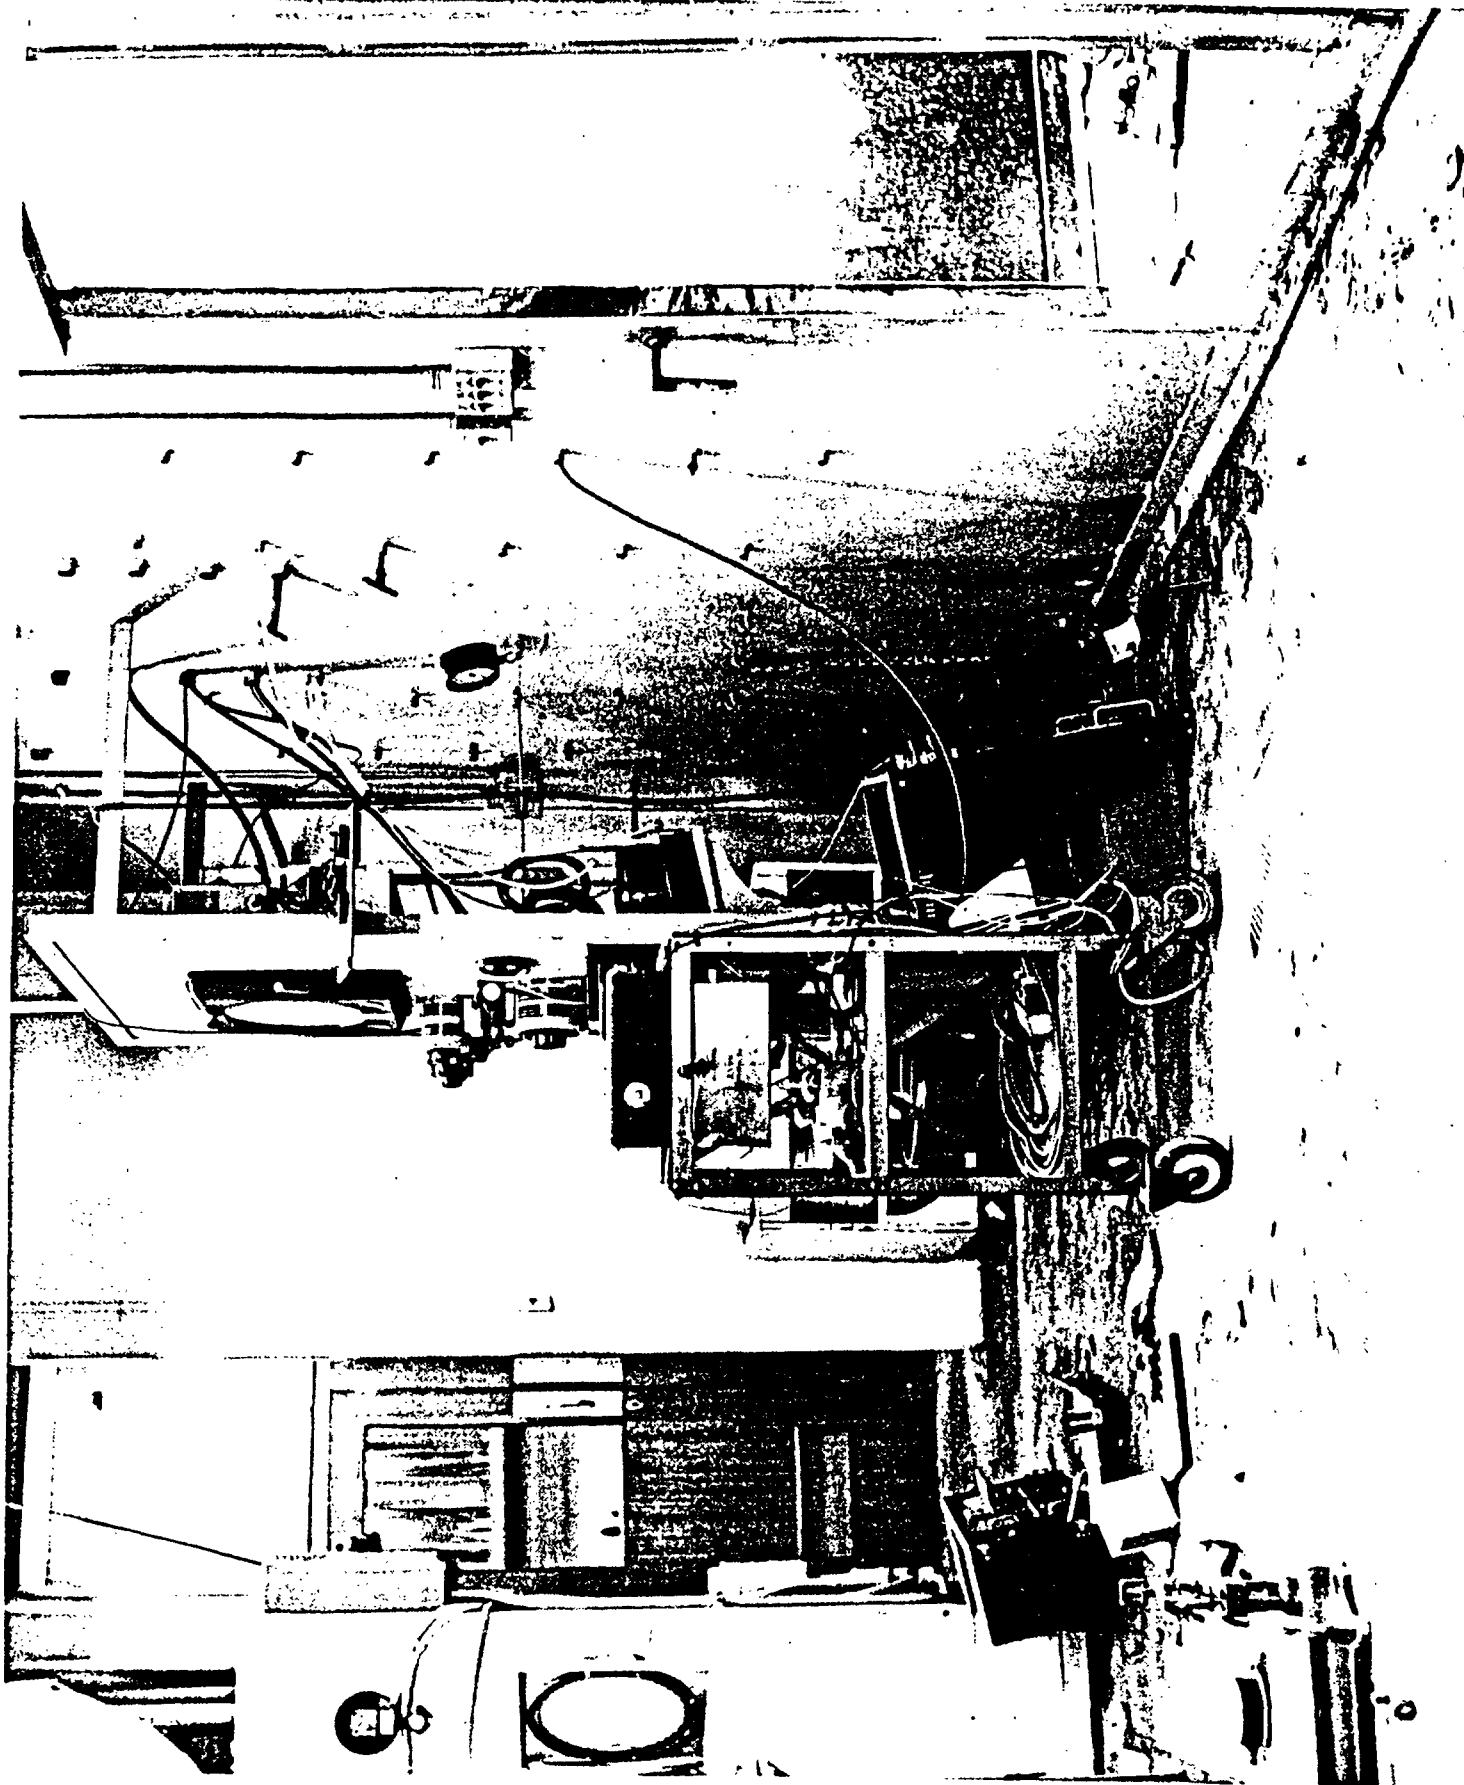
4. Inside view of the rear wall and concrete support pillar.
5. View of the control room. Cell doorway at right.

6. Pipes with threaded ends extend through the face of cell to provide for controls and reach rods. None of the unused holes in the new cells have been capped. This allowed gas and flame from the explosion to spew out into the control room.

10. The cylinders chained to the control room side of the cell wall were knocked down from the force of the explosion. Instruments mounted on a table 12" from the wall were knocked to the floor.
