## EPA Region 10 Enforcement Division

### INSPECTION REPORT

| Company Name | King County DOT Department of Local Services - Road Services Division | |

**APPENDIX 1: PHOTO LOG**

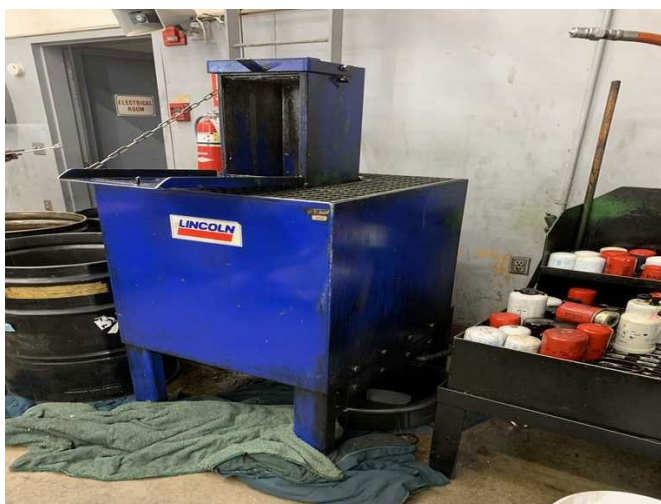
| [Title] | IMG_0015.jpg | |

| View of used oil drain pan beneath oil filter crusher that is not labeled with the words "Used Oil." | | |

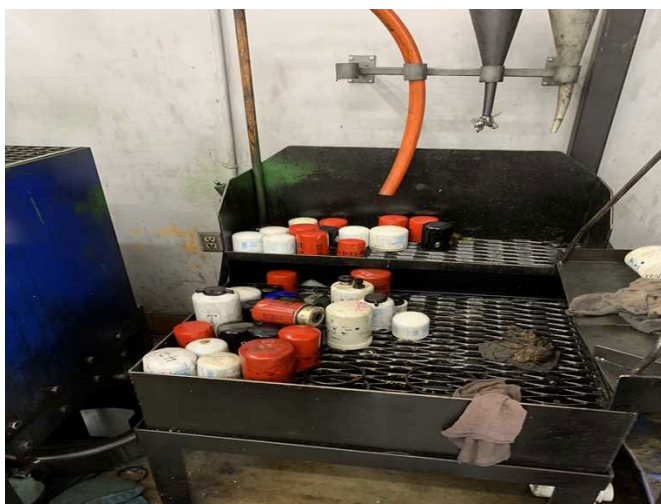
| [Title] | IMG_0017.jpg | |

| View of an elevated used oil drain pan, seen here with used oil filters draining into the pan. The drain pan is not labeled with the words "Used Oil." | | |

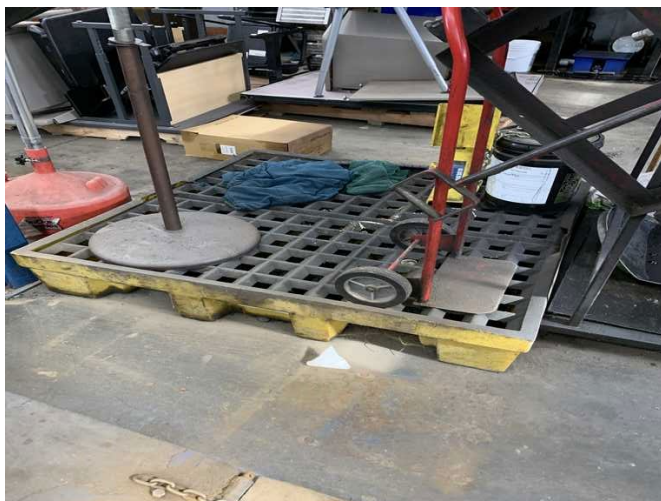
| [Title] | IMG_0021.jpg | |

| View of a spill pallet that contains used oil that has accumulated in the pallet. The spill pallet is not labeled with the words "Used Oil." | | |

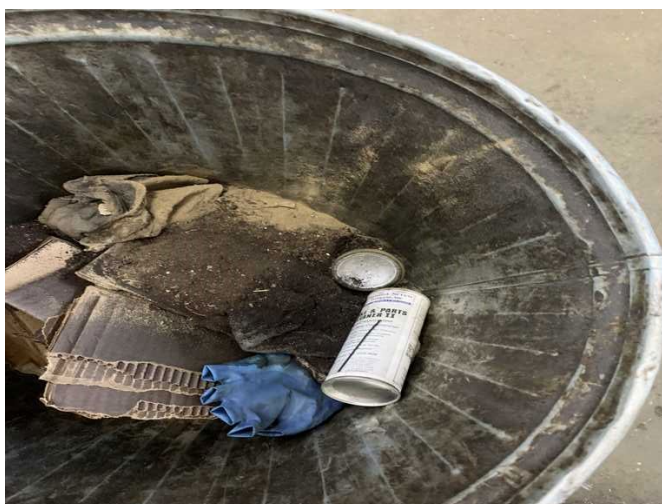
| [Title] | IMG_0019.jpg | |

While inspecting the interior of the building, I saw a waste aerosol can inside a trash receptacle. The aerosol was a can of marking paint, and the label identified the contents as extremely flammable liquid (D001) that were under pressure (D003). At the time of the inspection, the waste aerosol can was not being managed as a hazardous waste.

| View of a waste aerosol can inside a trash receptacle. | | |

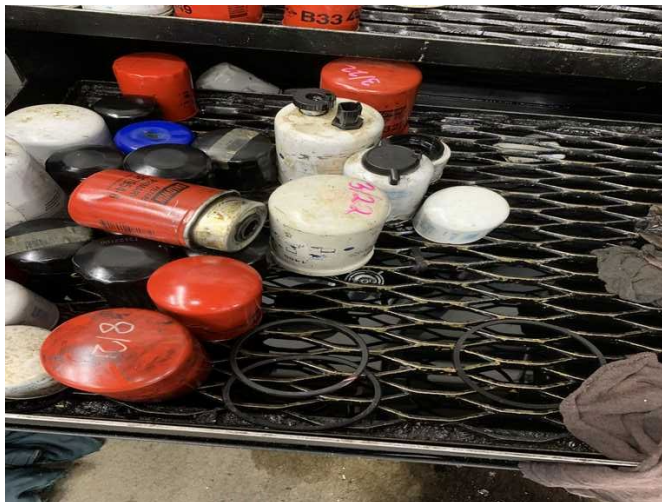
| [Title] | IMG_0018.jpg | |

| Close-up view of the elevated used oil drain pan that contains used oil and is not labeled with the words "Used Oil." | | |

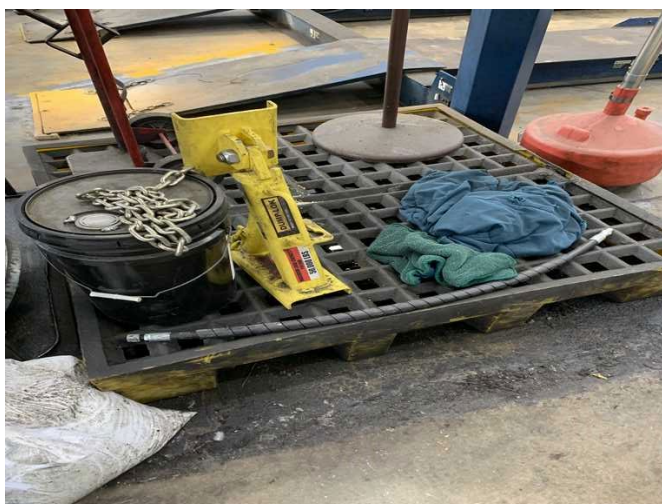
| [Title] | IMG_0022.jpg | |

| Another view of the same spill pallet that contains used oil and is not labeled with the words "Used Oil." | | |

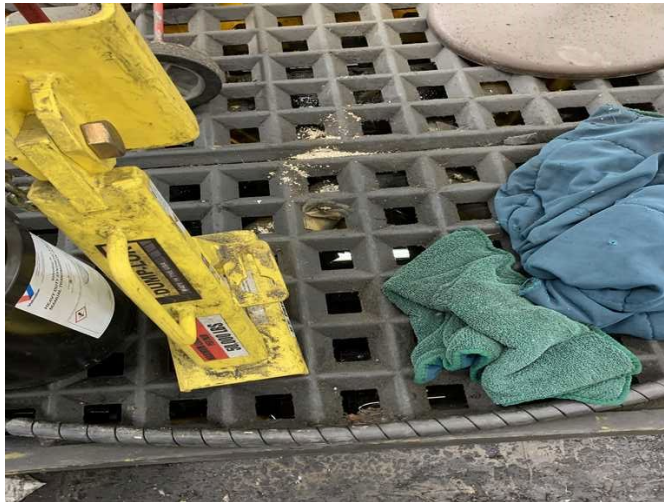
| [Title] | IMG_0023.jpg | |

| Close-up view of the same spill pallet showing that it contains used oil. | | |

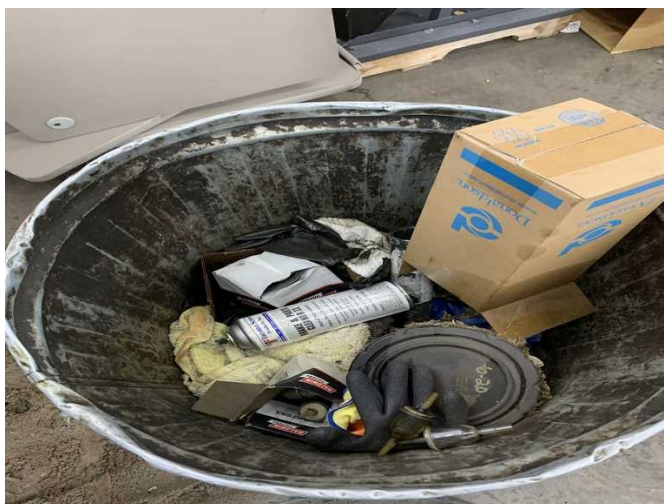
| [Title] | IMG_0024.jpg | |

| View of a waste aerosol can inside another trash receptacle. | | |

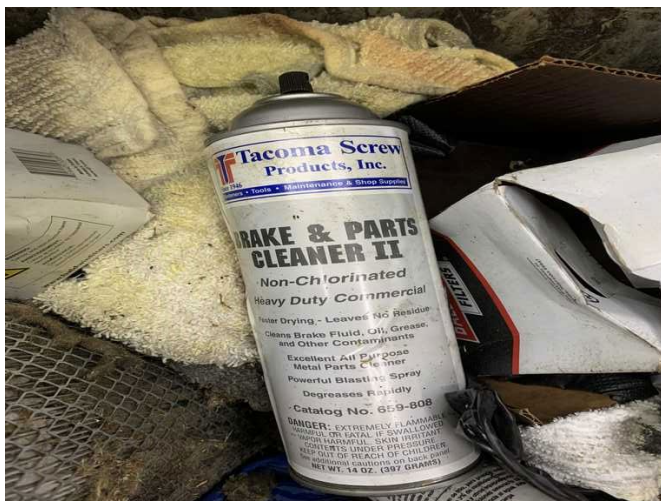
| [Title] | IMG_0025.jpg | |

| Close-up view of the same waste aerosol can in the trash receptacle. | | |

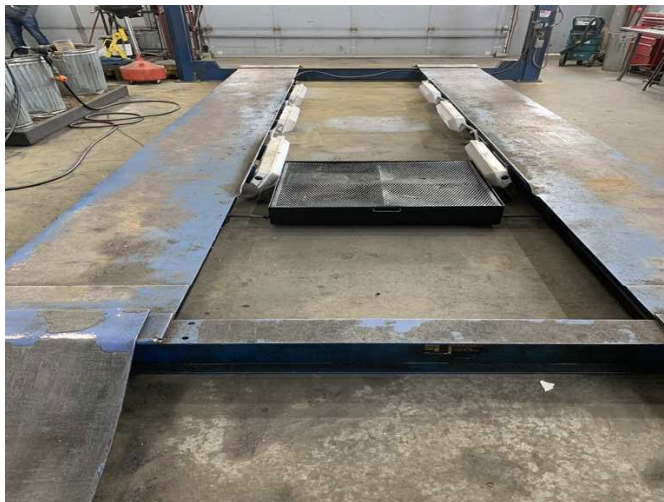
| [Title] | IMG_0027.jpg | |

| View of another used oil drain pan that is not labeled with the words "Used Oil." | | |

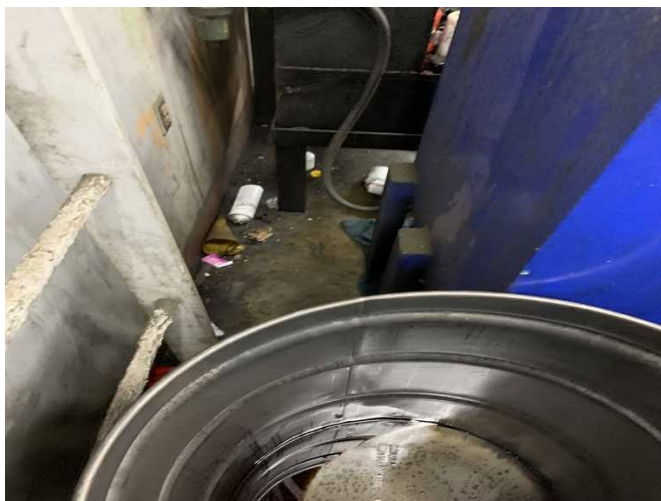
| [Title] | IMG_0034.jpg | |

| View of waste aerosol cans seen here on the floor behind the facility's oil filter crusher. | | |

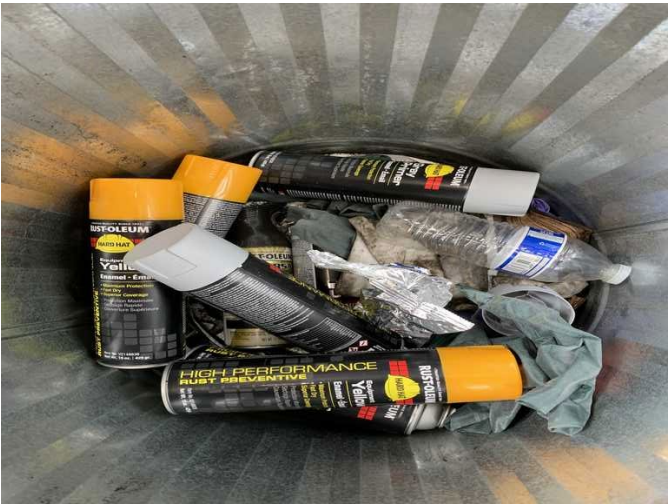
| [Title] | IMG_0032.jpg | |

| View of additional waste aerosol cans seen in another trash receptacle. | | |

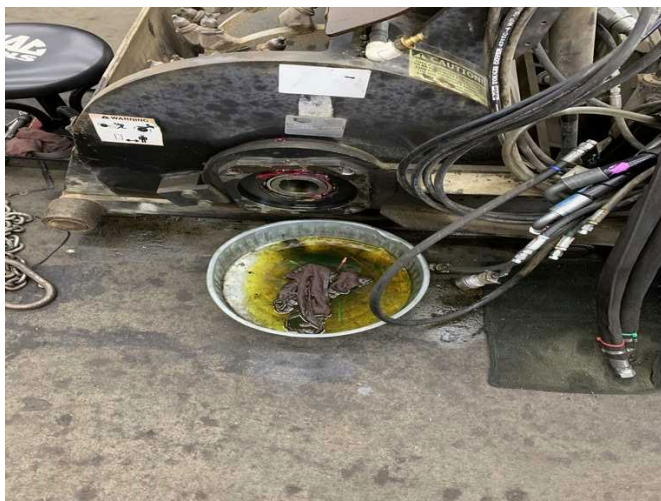
| [Title] | IMG_0006.jpg | |

| View of an oil drain pan that contains used oil and is not labeled with the words "Used Oil." | | |

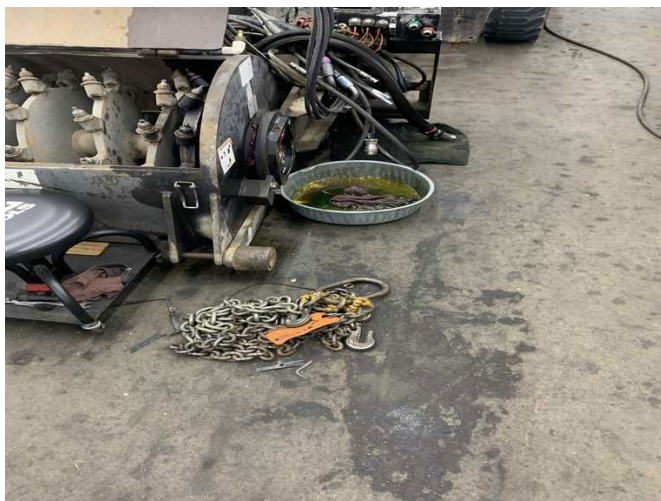
| [Title] | | IMG_0008.jpg | |

| Another view of the same unlabeled used oil drain pan seen in IMG_0006.jpg and IMG_0007.jpg | | | |

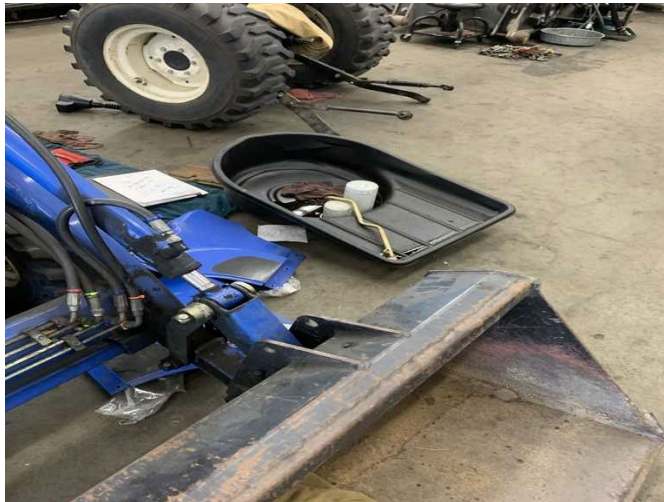
| [Title] | IMG_0010.jpg | |

| Another view of the same used oil drain pan seen in IMG_0009.jpg | | |

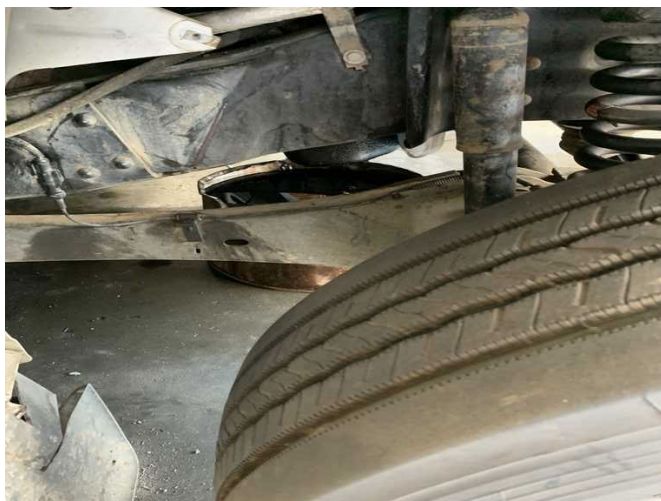
| [Title] | IMG_0011.jpg | |

| Another view of an unlabeled used oil drain pan. | | |

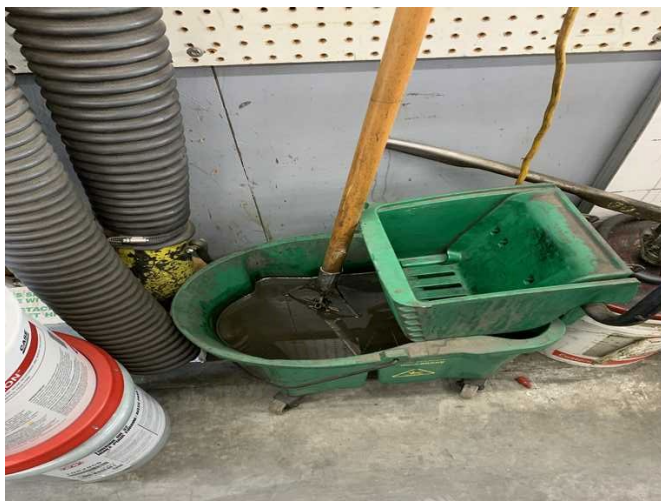
| [Title] | IMG_0014.jpg | |

| View of a bucket of mop water that is a dark color and was described as oily water, leading to questions of whether a dangerous waste designation needs to be made. | | |

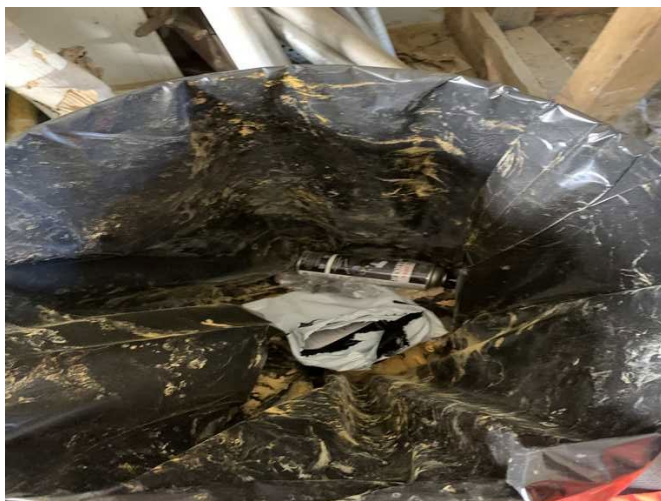
| [Title] | IMG_0060.jpg | |

| View of a waste aerosol can in a trash receptacle. | | |

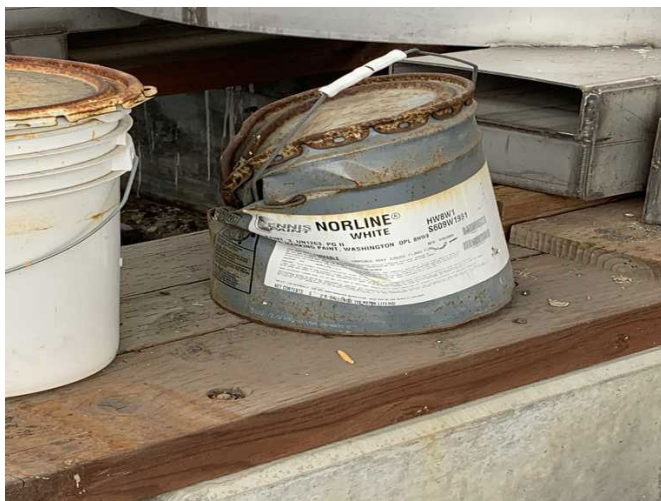
| [Title] | | IMG_0044.jpg | |

| View of damaged container of traffic paint that appears to need a waste determination. | | | |

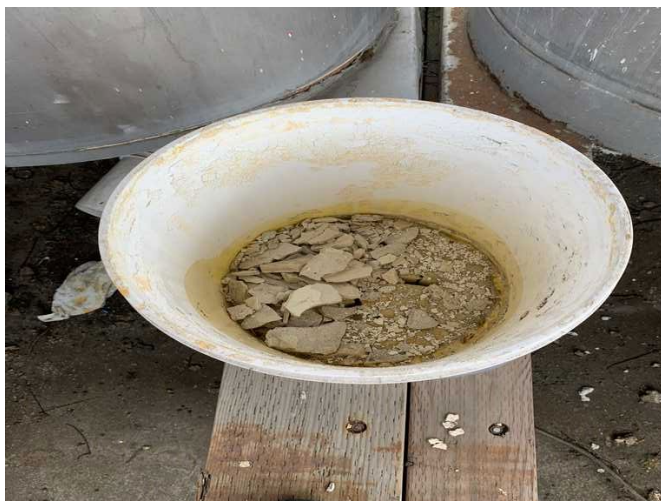
| [Title] | IMG_0041.jpg | |

| View of a 5-gallon container holding dried waste white traffic paint. | | |

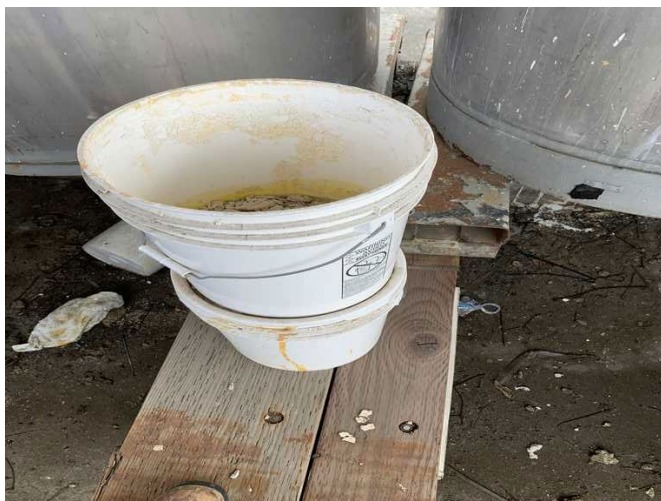
| [Title] | | IMG_0040.jpg | |

| View of another 5-gallon container that holds waste traffic paint that was allowed to dry out in the container. | | | |

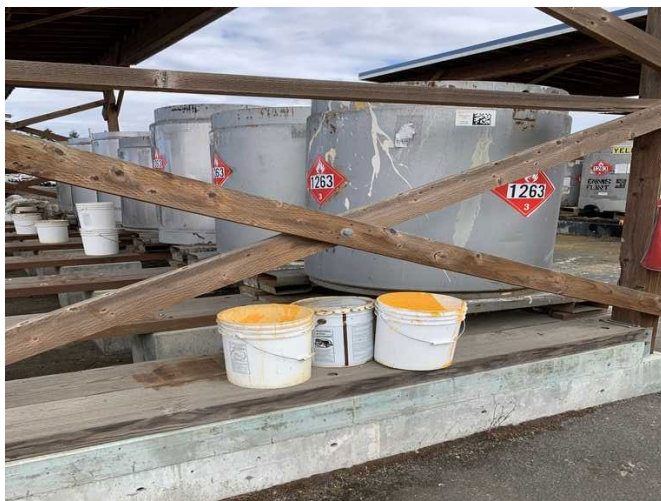
| [Title] | | IMG_0035.jpg | |

| View of three 5-gallon traffic paint containers that require a waste determination. Two of the three containers hold waste yellow traffic paint that had been allowed to dry out in the containers. | | | |

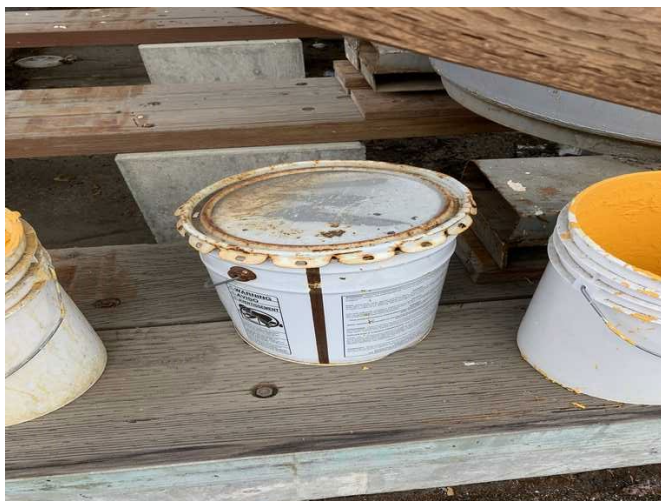
| [Title] | IMG_0038.jpg | |

| View of the closed container of traffic paint that requires a waste determination. | | |

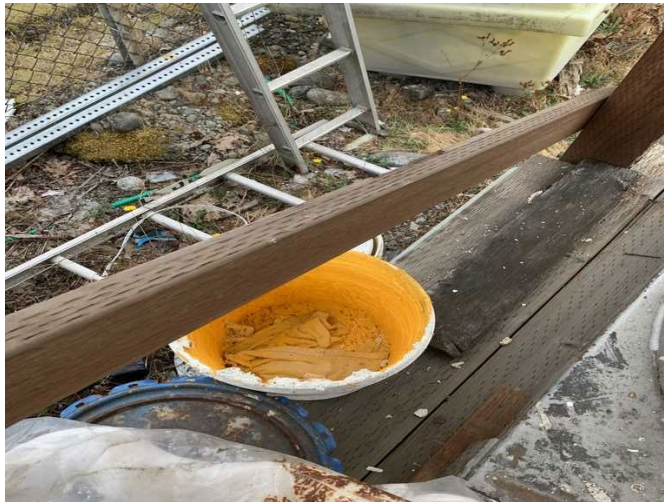
| [Title] | IMG_0042.jpg | |

| View of waste yellow traffic paint that had been allowed to dry out in the container. | | |

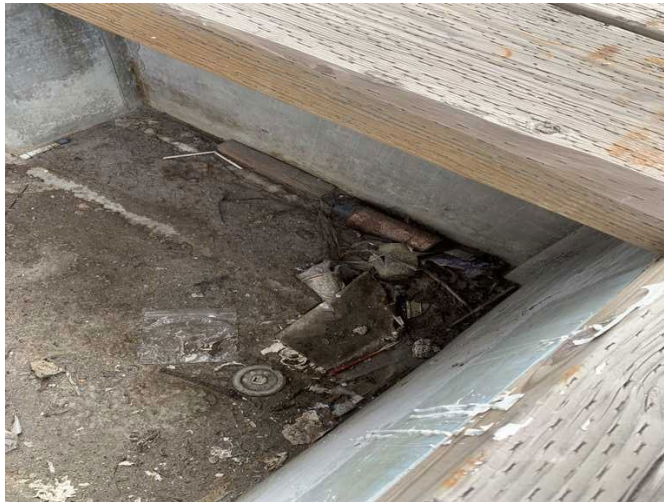
| [Title] | IMG_0045.jpg | |

| I saw five waste aerosol cans. Two of the five waste aerosol cans were in a pit, beneath some of the paint totes. The two waste aerosol cans were rusty and looked like had been discarded in the pit a long time before the inspection. The contents of the two waste aerosols were unknown due to missing labeling. | <b>Citations:</b> | <b>Sections:</b> |

| Another view of the waste aerosol can in the pit area beneath the traffic paint totes. | | |

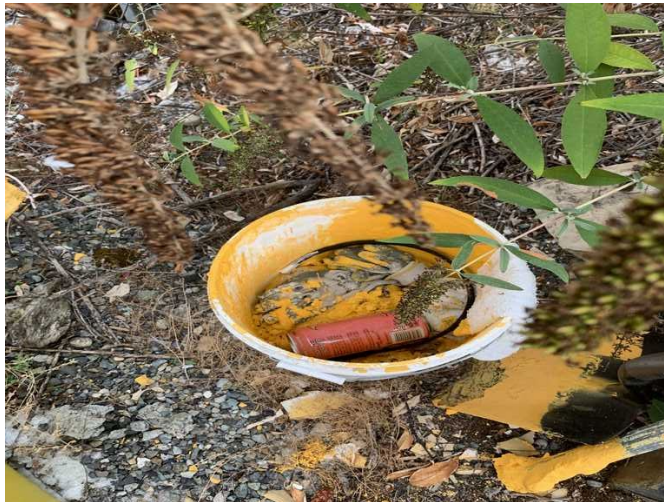
| [Title] | | IMG_0053.jpg | |

| View of another 5-gallon container of waste yellow traffic paint that had been allowed to dry out in the container. | | | |

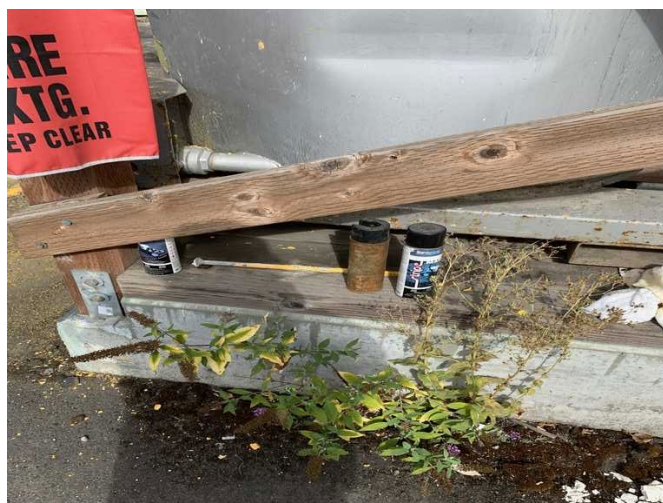
| [Title] | IMG_0058.jpg | |

| View of some additional aerosol cans that appeared to be waste-like and required a waste determination. | | |

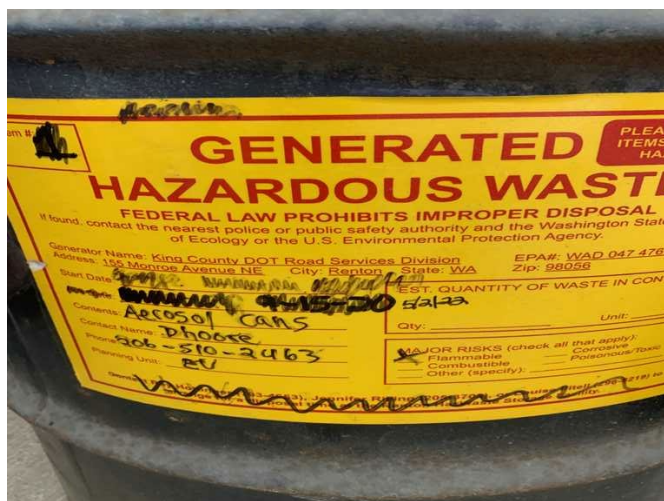
| [Title] | IMG_0091.jpg | |

Across from the pallets of orphaned waste, I saw a 55-gallon container that held 13 waste aerosol cans. The container was labeled with the words "Hazardous Waste" and marked with a hazard indicator; however, the container was not closed. The container lid was misshapen in a way that did not allow it to make a complete seal with the top of the container. The container was also marked with an ASD of 5/2/22. According to the ASD, the container had been in accumulation for greater than 90-days. At the time of the inspection, the container had been in accumulation for 150 days.

| View of the label on a container of waste aerosol cans, showing that the container has been in accumulation for more than 90 days. | | |

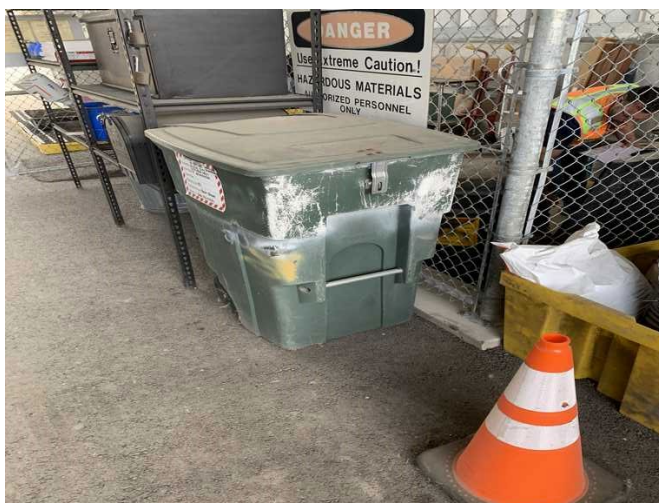
| [Title] | IMG_0064.jpg | |

We arrived at the facility's Hazardous Waste Shed (CAA) and prior to entering the gated CAA area, I saw a large, wheeled, trash receptacle with a hinged lid that was staged outside the fence. The trash receptacle had a capacity of 96 gallons and contained approximately 25 waste aerosol cans. At the time of the inspection, facility personnel stated that the container was being utilized as a satellite accumulation area (SAA) container. We explained that an SAA container could only accumulate up to a maximum of 55-gallons. During the inspection, I saw that the container was not labeled with the words "Hazardous Waste" and was not marked with a hazard indicator. Mr. Dhoore labeled the container with the words "Hazardous Waste" and a hazard indicator during the inspection.

| A trash receptacle outside the fenced CAA had a capacity of 96 gallons and contained approximately 25 waste aerosol cans. Facility personnel stated that the container was being utilized as a satellite accumulation area (SAA) container. The SAA container was not labeled with the words "Hazardous Waste" and was not marked with a hazard indicator.. Mr. Dhoore labeled the container with the words "Hazardous Waste" and a hazard indicator during the inspection. | <b>Citations:</b> | <b>Sections:</b> |

| View of a trash receptacle that is being used as a SAA container for the accumulation of waste aerosol cans. | | |

Following the inspection, I received an email from Mr. Dhoore on 10-5-22, that included photo documentation that showed the 96-gallon container, referenced above, had been replaced with a 55-gallon container.

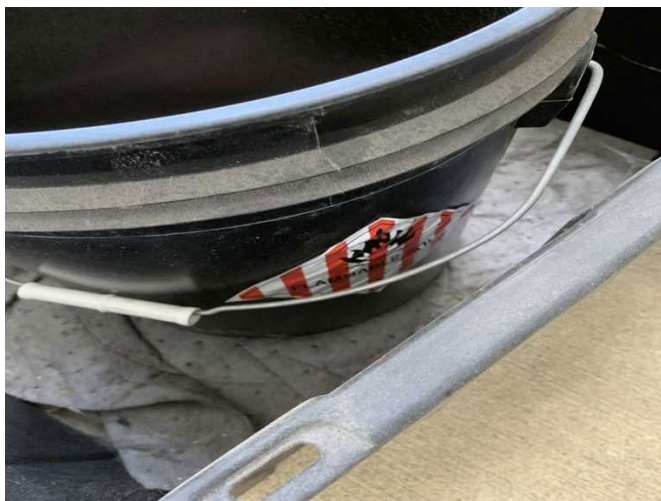
| [Title] | IMG_0077.jpg | |

While moving through the CAA, I saw a 5-gallon container that held waste flares. At the time of the inspection, the container was not labeled with the words "Hazardous Waste" and not marked with an ASD. The container was also not closed.

| View of the open container of waste flares seen in the CAA. | | |

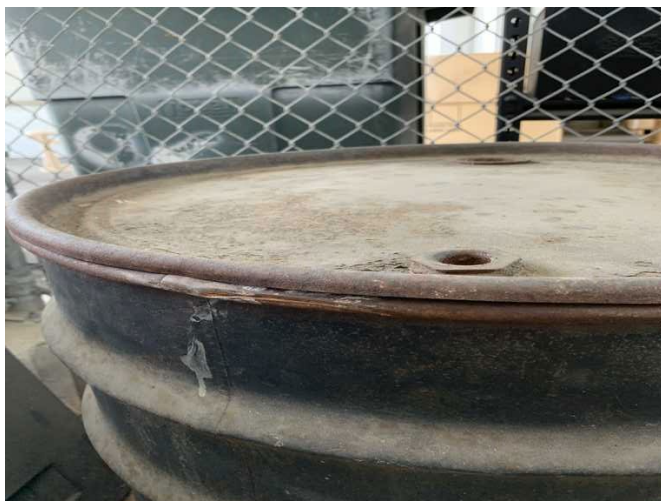
| [Title] | IMG_0092.jpg | |

| Close-up view of the lid on the waste aerosol can accumulation container that is greater than 90 days old. This view shows that the container is not closed. | | |
