**Region 6 - Enforcement & Compliance Assurance Division**  
**INSPECTION REPORT**

| Inspection Date(s): | 11/07/2019 | |
| Company Name: | <b>OKC West</b> | |
| Facility Name: | <b>OKC West Livestock Auction</b> | |

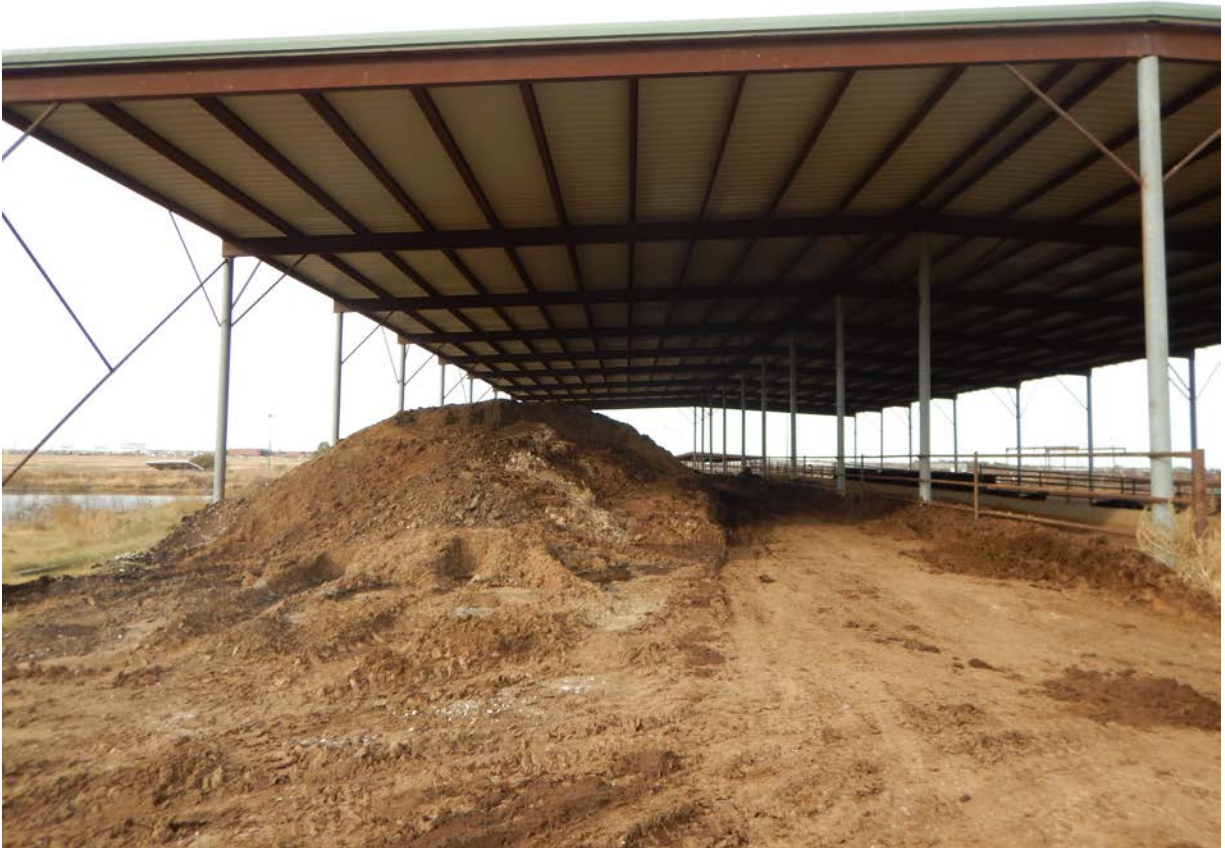
Photo No. 1

At the time of the inspection, I observed the lots to be well-kept and generally clean. I observed two manure/lot scraping storage piles; one pile was under cover (photo #1) and the other was not under cover. The covered pile appeared to be well-kept and was not exposed to rainfall. The uncovered pile was located just north of the truck washing station (approximately 35.506503°, -97.877682°) [AOC 1]. Mr. Haskell informed us that this was a temporary storage area; however, we observed vegetation growing on some of the piles which is an indicator of longer-term storage. This temporary storage area was bermed, but I observed a break in the berm in the northwest corner. We did not see any wastewater actively exiting this area.

Description: This photo was taken facing north across the facility's covered manure/lot scrapings storage area.

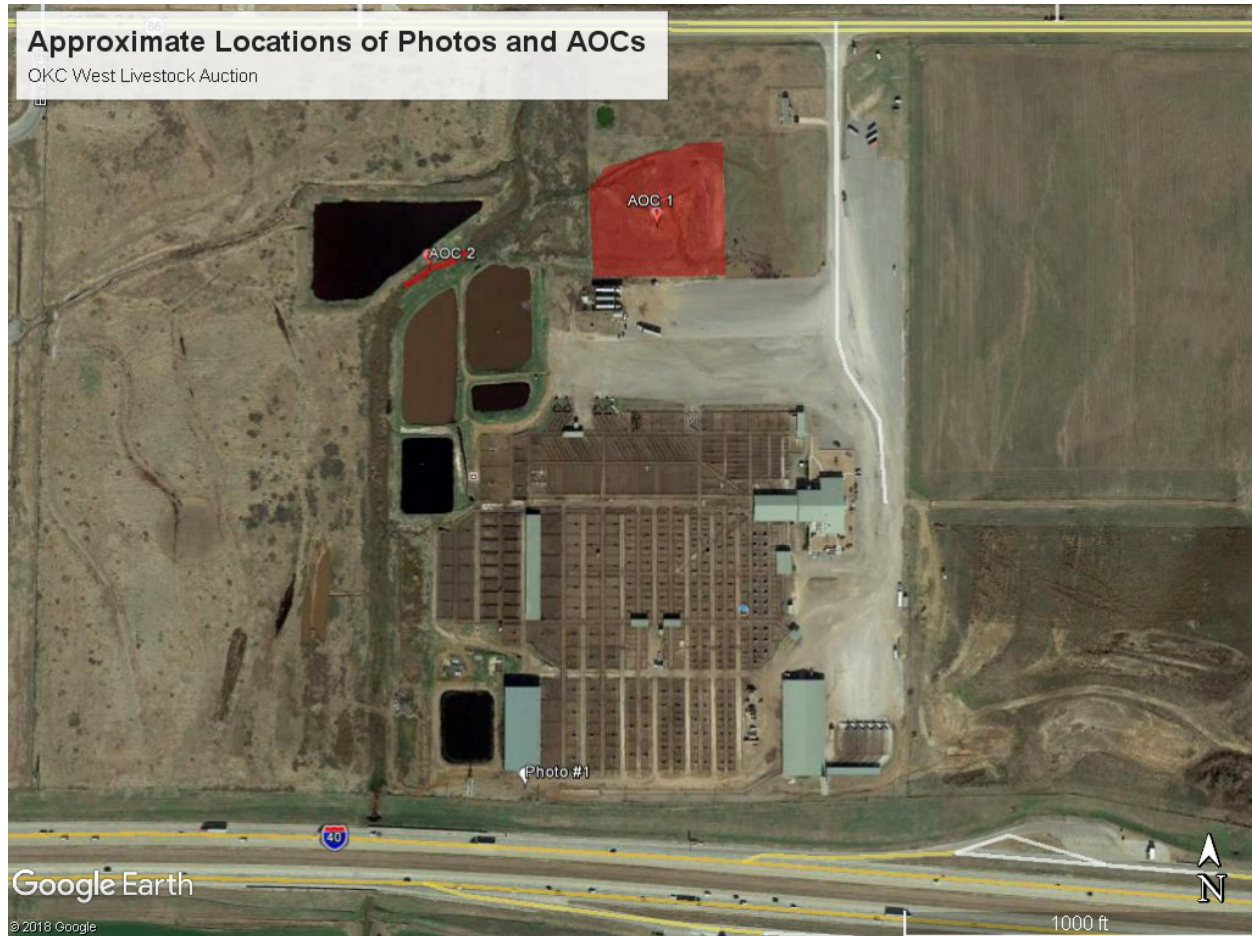
Photo No. 2

At the time of the inspection, the wastewater level in the five RCSs was satisfactory. We walked along the portion of Sixmile Creek which runs through the property and saw that the flow was brown and cloudy at approximately (35.505994°, -97.879988°) [AOC 2]. We walked along the remaining stream

segment upstream from this point and observed no cloudiness or brown color in the water. Due to the high grass and recent rainfall, we were unable to if a wastewater seep or leak was present.

1. The temporary manure/lot scraping storage area was not under cover. Any rainwater that comes into contact with the production area must be captured in an RCS.
2. Sixmile Creek showed evidence of a possible lagoon seep or wastewater irrigation line leak. Regular visual inspections must be conducted on all RCS berms and wastewater application equipment to ensure no leaks or seeps have developed.
