INSPECTION REPORT

| Type of Inspection | Compliance Evaluation Inspection (CEI) | | |
| Permittee Name | Oak Harbor WWTP | | |
| Facility/Site Physical Address | 355 East Water Street | | |

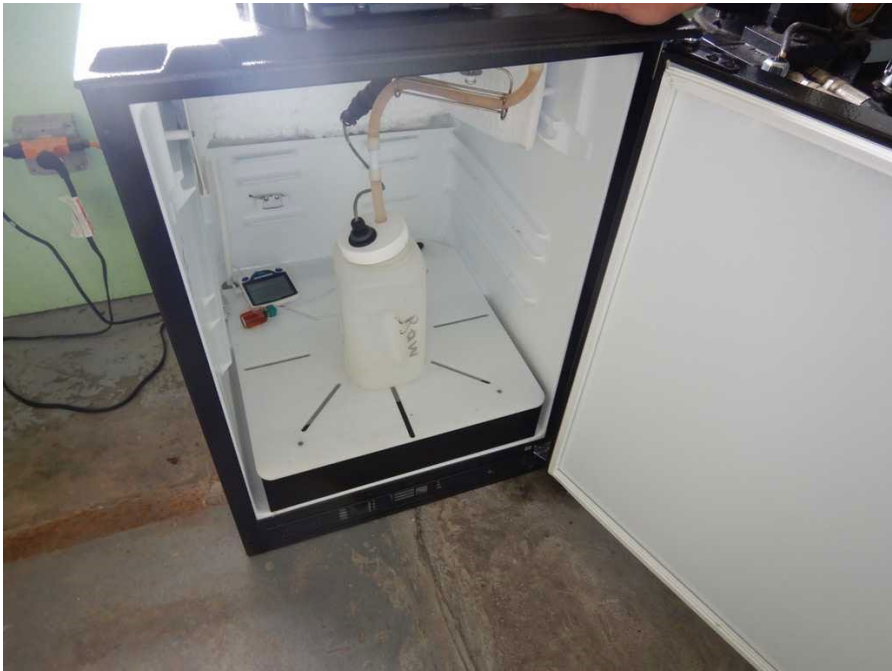
| Influent sample refrigerator | | | DSCN0583.JPG |

| OAK HARBOR WWTP | | |
|---|---|---|
| <p>The thermometer in the influent automatic sampler refrigerator was not operational at the time of the inspection.</p> | | |

| Influent sample refrigerator | | | |

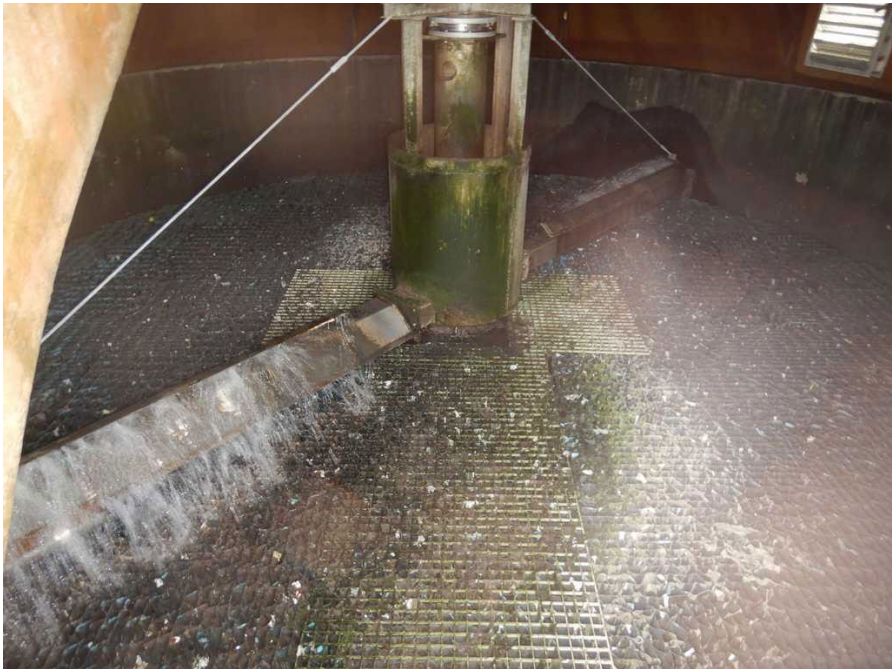
| East Trickling Filter | | | DSCN0594.JPG |

| OAK HARBOR WWTP | | |
|---|---|---|
| <p>The east trickling filter arm is not operational and has been out of operation at least since Ohio EPA conducted a facility inspection on October 20th, 2022. The operator of record stated that the reason for all of the facility's ammonia exceedances is that the east trickling filter arm is not operational, in addition to the media in both of the trickling filters being old. She also stated that there are currently no plans to repair or replace the filter arm. She stated that approximately 75% of the plant's flow is being directed to the west trickling filter, with the rest being directed to the east trickling filter.</p> | | |

| The east trickling filter arm is not operational and has been out of operation at least since Ohio EPA conducted a facility inspection on October 20th, 2022. The operator of record stated that the reason for all of the facility's ammonia exceedances is that the east trickling filter arm is not operational, in addition to the media in both of the trickling filters being old. She also stated that there are currently no plans to repair or replace the filter arm. She stated that approximately 75% of the plant's flow is being directed to the west trickling filter, with the rest being directed to the east trickling filter. |

| East trickling filter (rotating arm not operational) | | | |

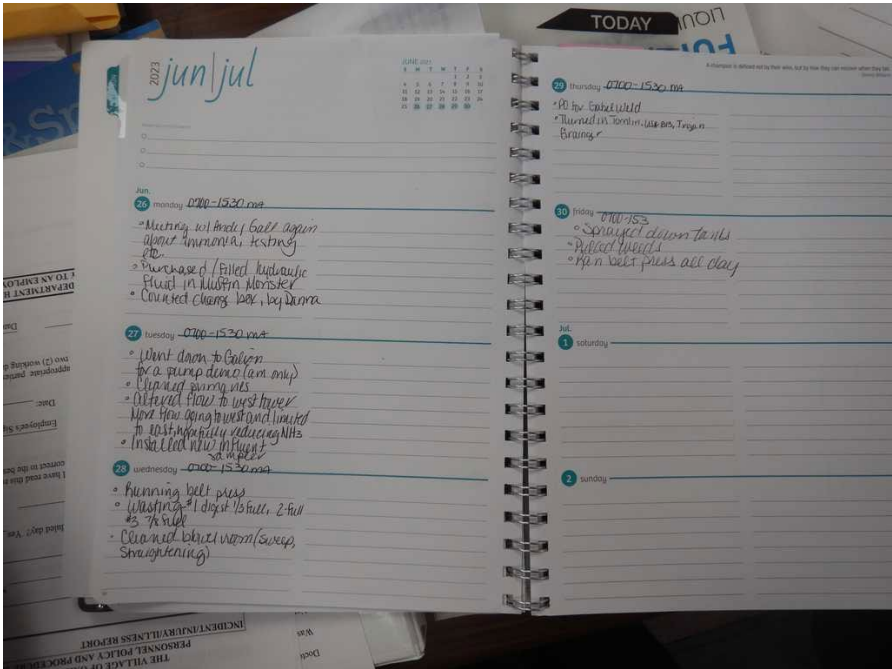
| Operator Log Book | | | DSCN0610.JPG |

| OAK HARBOR WWTP | | |
|---|---|---|
| <p>The operator stated that the facility's history of e. coli exceedances had been due to the UV treatment unit requiring repairs, which were completed the first week of June 2023. The facility's June 2023 Discharge Monitoring Report ("DMR") showed that the facility's e. coli effluent levels lowered to within permit limits in the third week of sampling for the month. They were also significantly lower in the final sampling week for the month, but slightly above permit limits. The operator stated this was due to a new employee cleaning/flushing the primary tanks on the first day of e. coli sampling. The operator's daily log book confirmed this information (photo DSCN0610.JPG).</p> | | |

| Operator log book | | | |

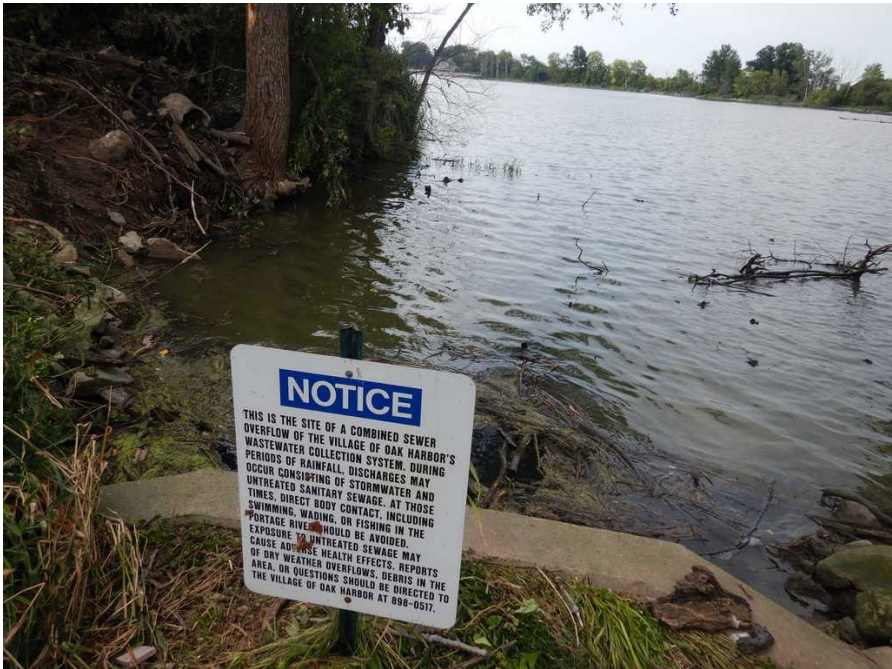
| Outfall 001 Signage | | | DSCN0640.JPG |

| OAK HARBOR WWTP | | |
|---|---|---|
| EPA observed that the final outfall signage was facing away from the receiving stream. The plant operator of record followed up with EPA in an email dated 8/31/2023 with photos of the outfall sign facing toward the receiving stream. | | |

| Outfall 001 signage | | | |
