**REPORT OF COMPLIANCE SAMPLING INSPECTION (CSI) &  
INDUSTRIAL STORMWATER  
COMPLIANCE EVALUATION INSPECTION (CEI)**

**Lehigh Cement Company, LLC  
700 25<sup>th</sup> Street NW  
Mason City, IA 50401**

NPDES NO: IA0001945  
STATE PERMIT NO: 1700100  
&  
NPDES NO: IA0072907  
STATE PERMIT NO: 1700113

**U. S. ENVIRONMENTAL PROTECTION AGENCY  
Region 7  
Enforcement and Compliance Assurance Division (ECAD)**

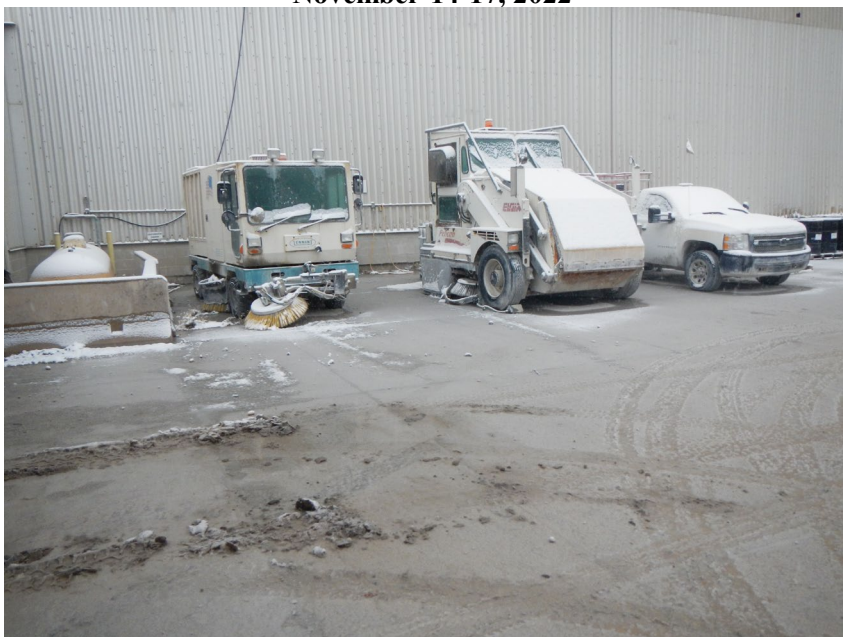
The facility's SWPPP also requires that good housekeeping is maintained. At the time of inspection, I observed multiple areas where CKD and other materials were mixed with storm water and not properly cleaned up (photos 1, 3-6, 11-12 & 21). Some of these areas were cleaned up at the time of inspection (attachment 12). This was noted as item #4 on the NOPF that was left on-site.

| Compliance<br>Evaluation<br>Inspection<br><br>Direction: S | DESCRIPTION | Facility's street sweepers to help keep material out of stormwater. The material on the ground is cement kiln dust (CKD). | 1 |

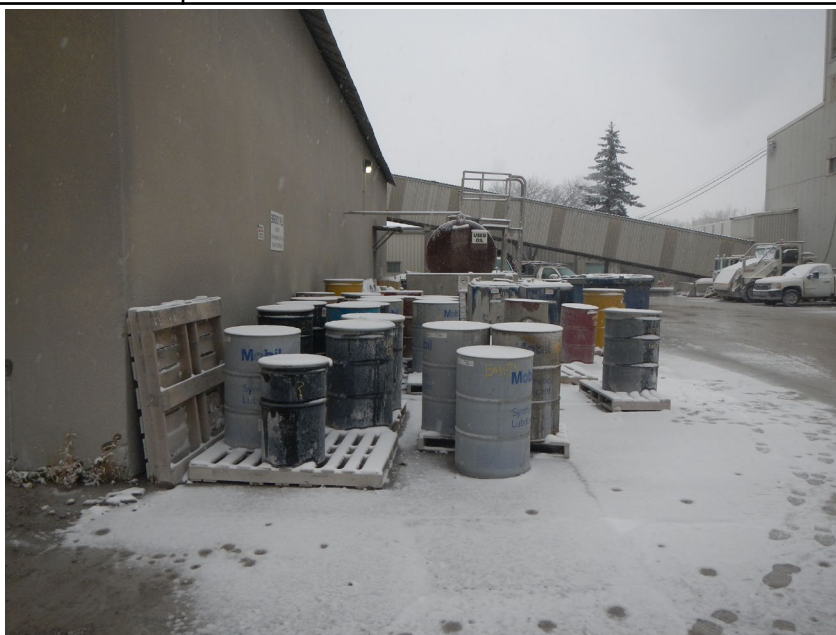
| Compliance<br>Evaluation<br>Inspection<br><br>Direction: N | DESCRIPTION | Outdoor drum storage. Some containers were full, some were empty. There was no evidence of any spills. | 2 |

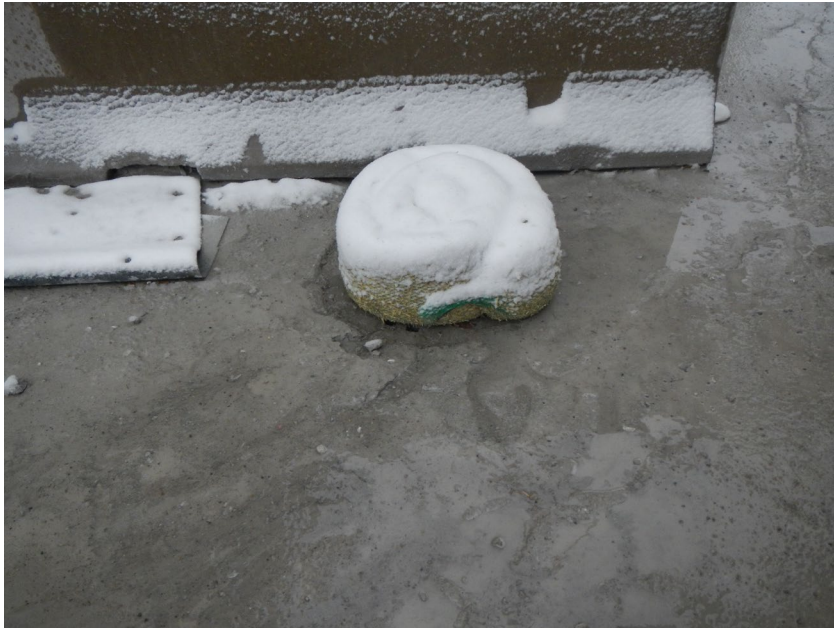
| Compliance<br>Evaluation<br>Inspection<br><br>Direction: D | DESCRIPTION | Stormwater waddle protecting a stormwater inlet. The material on the ground around is CKD. | 3 |

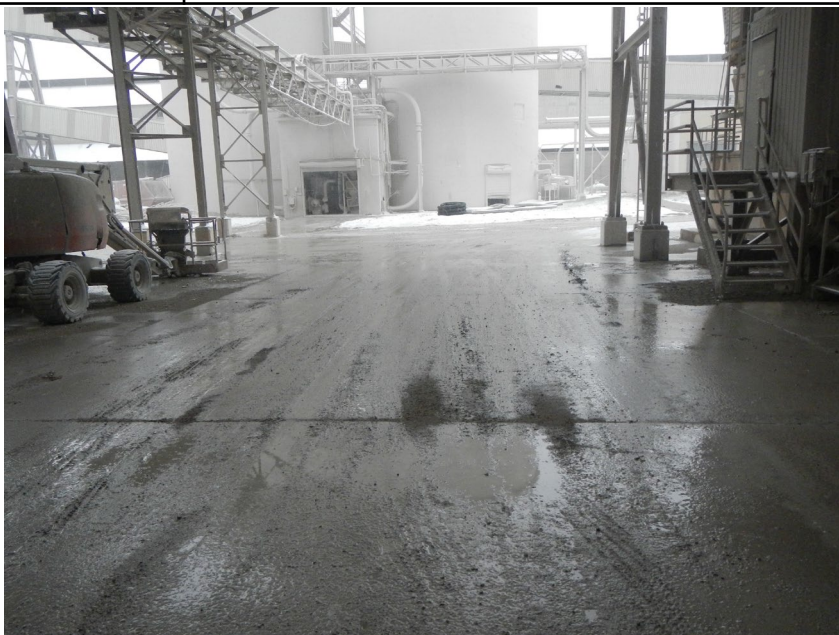
| Compliance<br>Evaluation<br>Inspection<br><br>Direction: N | DESCRIPTION | General photo of the facility. Material on the ground is CKD mixed with snow. | 4 |

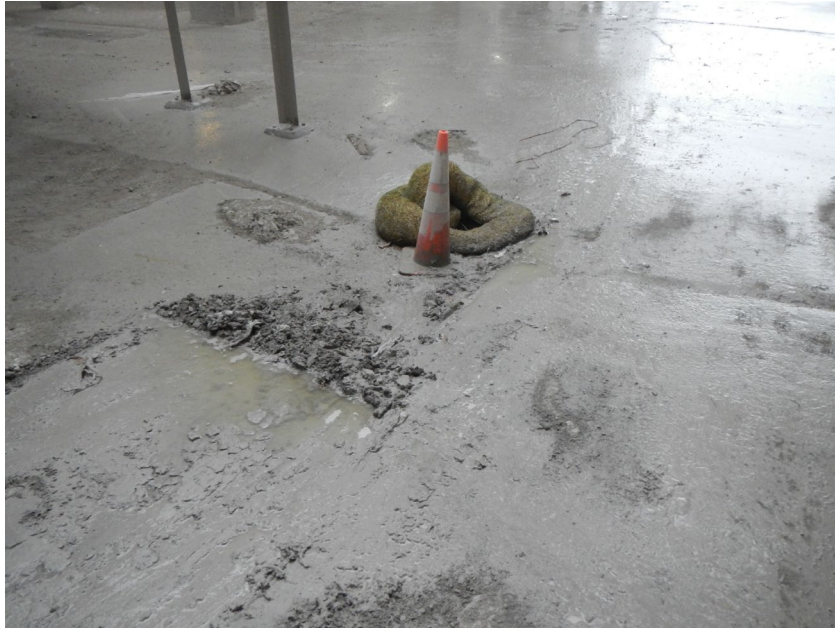
| Compliance<br>Evaluation<br>Inspection<br><br>Direction: D | DESCRIPTION | A stormwater waddle protecting the stormwater inlet. The material on the ground is CKD. | 5 |

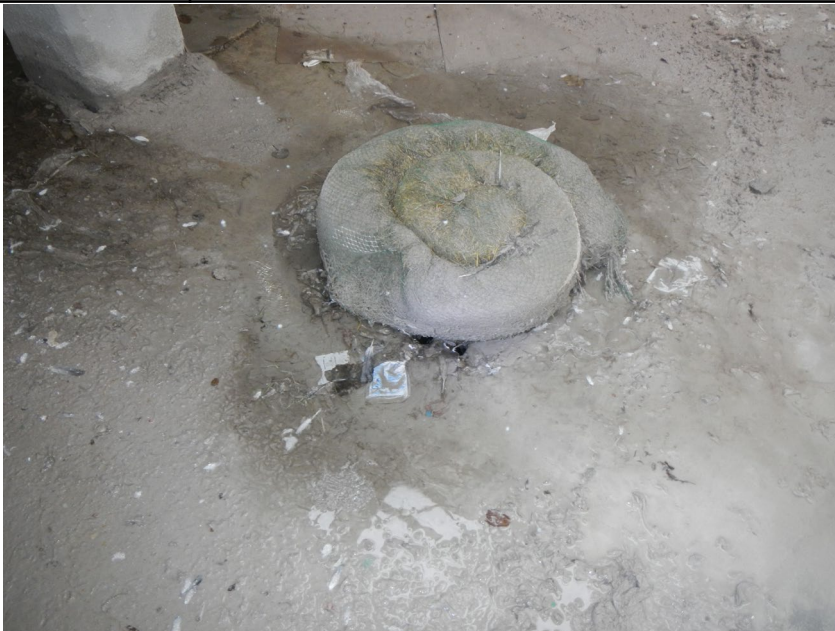
| Compliance<br>Evaluation<br>Inspection<br><br>Direction: D | DESCRIPTION | A stormwater waddle protecting the stormwater inlet. The material on the ground is CKD. | 6 |

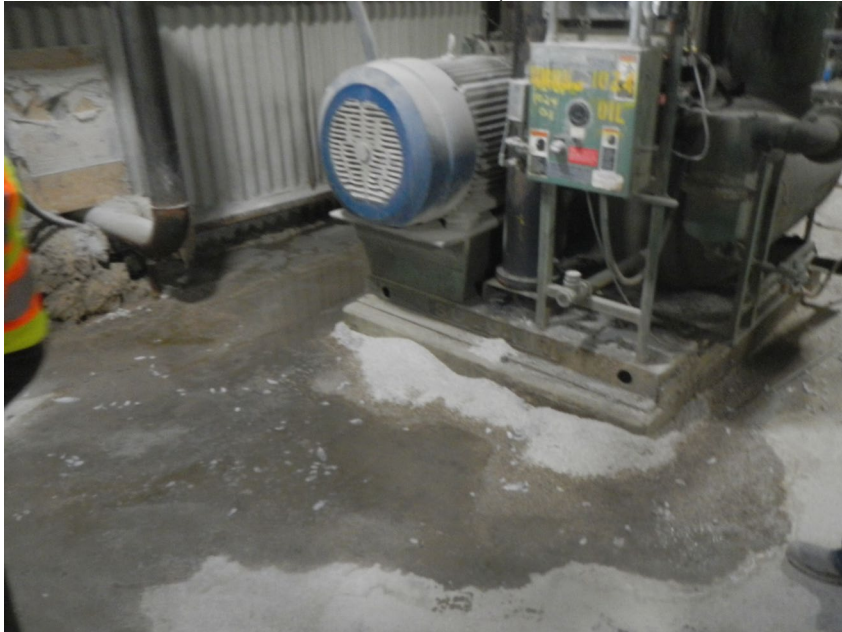
| Compliance<br>Evaluation<br>Inspection<br><br>Direction: D | DESCRIPTION | CKD and water | 11 |

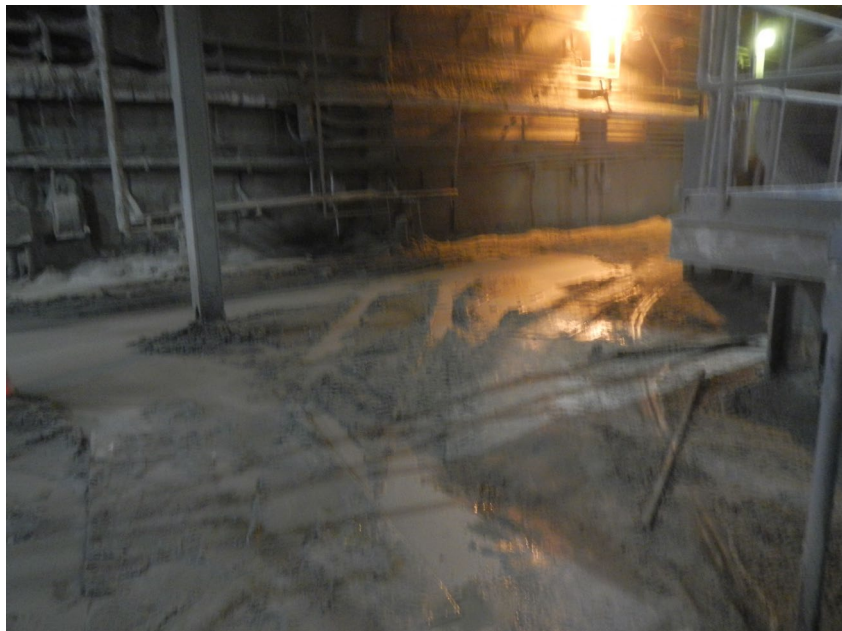
| Compliance<br>Evaluation<br>Inspection<br><br>Direction: Unk | DESCRIPTION | CKD on ground | 12 |

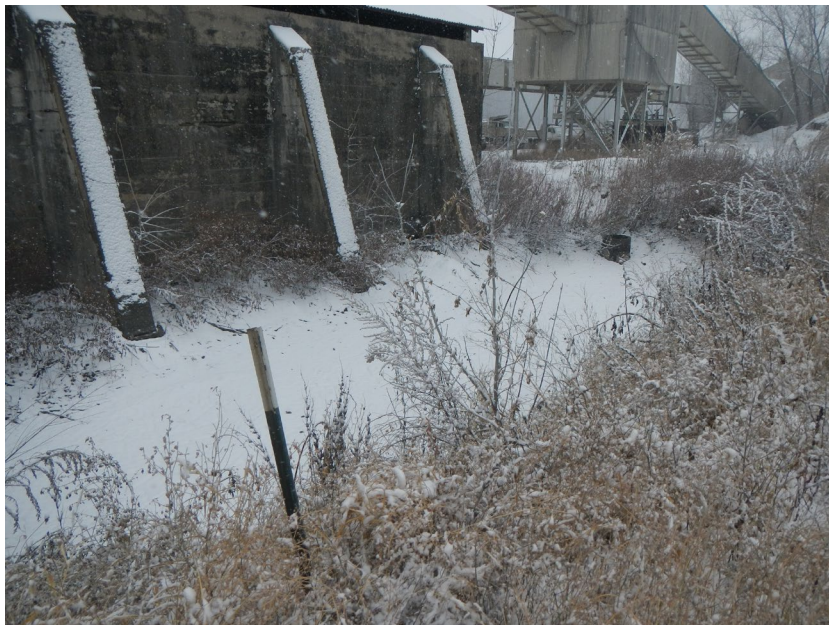
| Compliance<br>Evaluation<br>Inspection<br><br>Direction: SW | DESCRIPTION | Opposite direction of stormwater collection ditch in photo 19. Overflow pipe can be seen at the end of the ditch. | 20 |

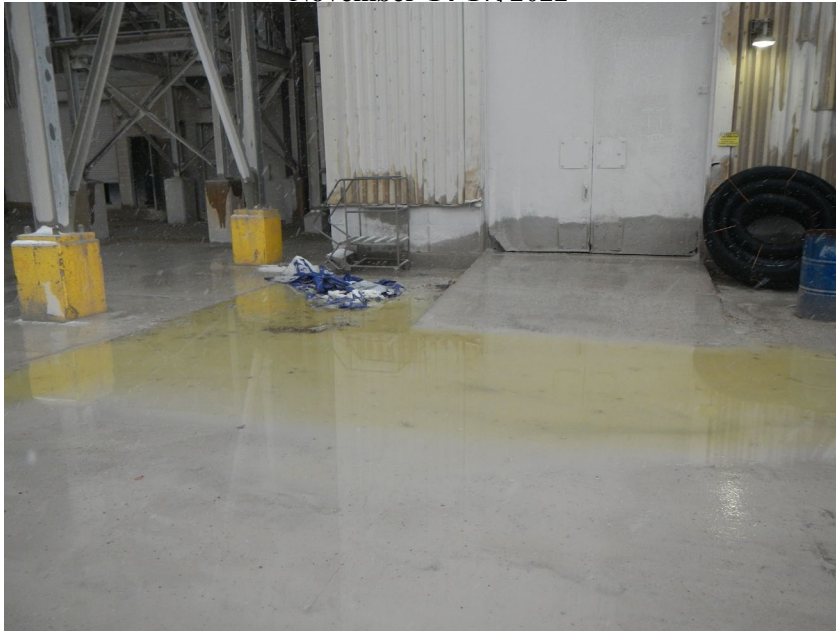
| Compliance<br>Evaluation<br>Inspection | DESCRIPTION | Discolored stormwater at the facility. Was later cleaned up by facility personnel. | 21 |

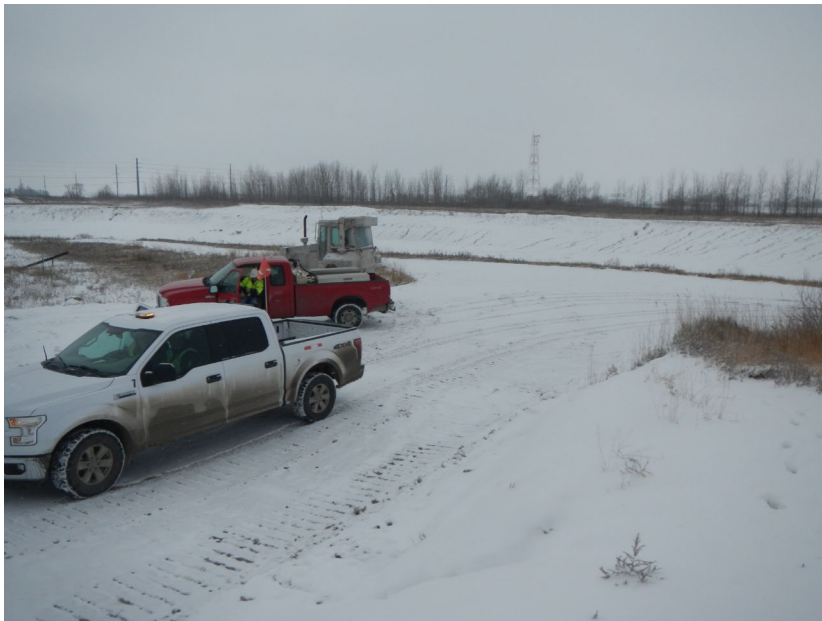
| Compliance<br>Evaluation<br>Inspection | DESCRIPTION | Area of run-on around the landfill | 22 |

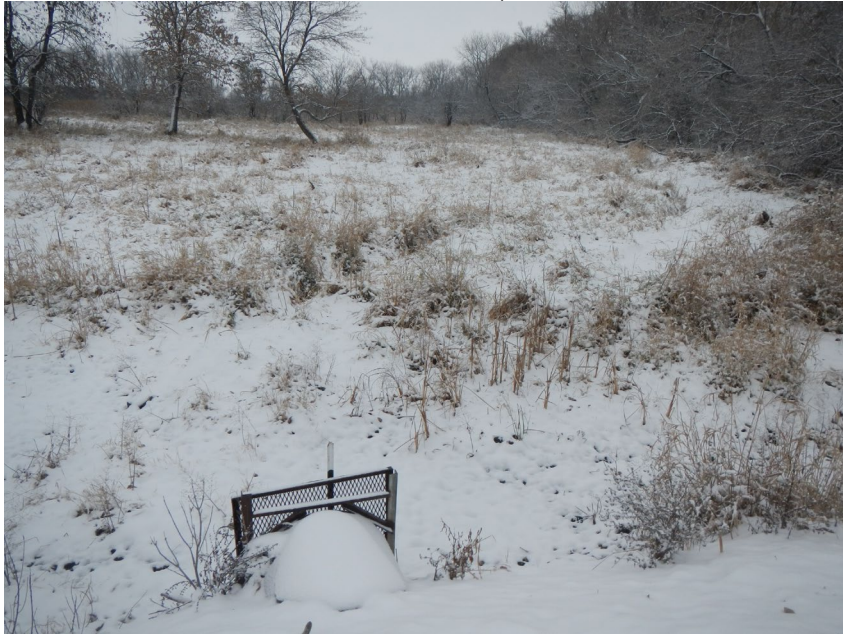
| Compliance<br>Evaluation<br>Inspection | DESCRIPTION | Drainage area from landfill (outfall 004) to the cooling pond. | 25 |

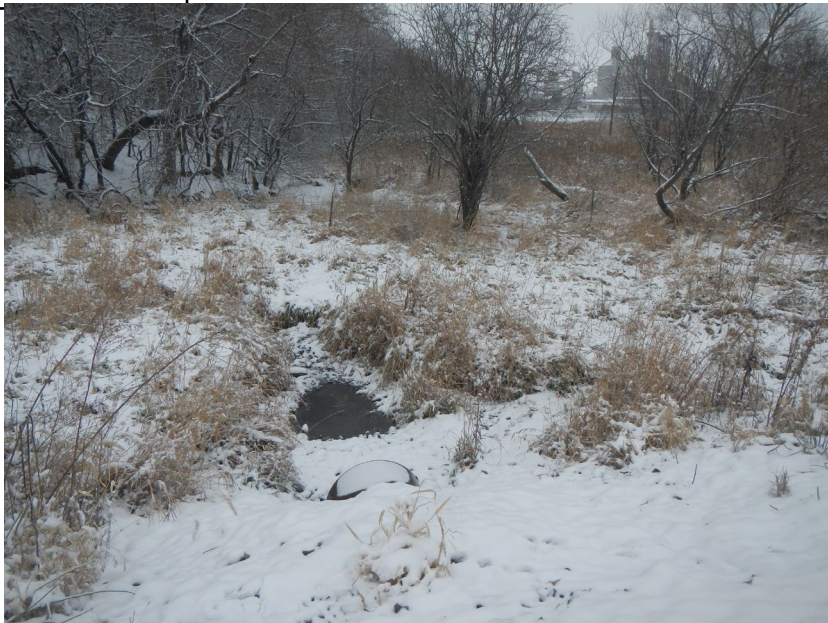
| Compliance<br>Evaluation<br>Inspection | DESCRIPTION | Opposite direction from photo 25 facing the plant. Discharge from outfall 004 flows to the cooling pond. | 26 |
