**Region 6 - Enforcement & Compliance Assurance Division**  
**INSPECTION REPORT**

| Company Name: | <b>Peabody Natural Resources Company</b> | |
| Facility Name: | <b>El Segundo Mine</b> | |
| Identification/Permit Number: | NM0030996 | |

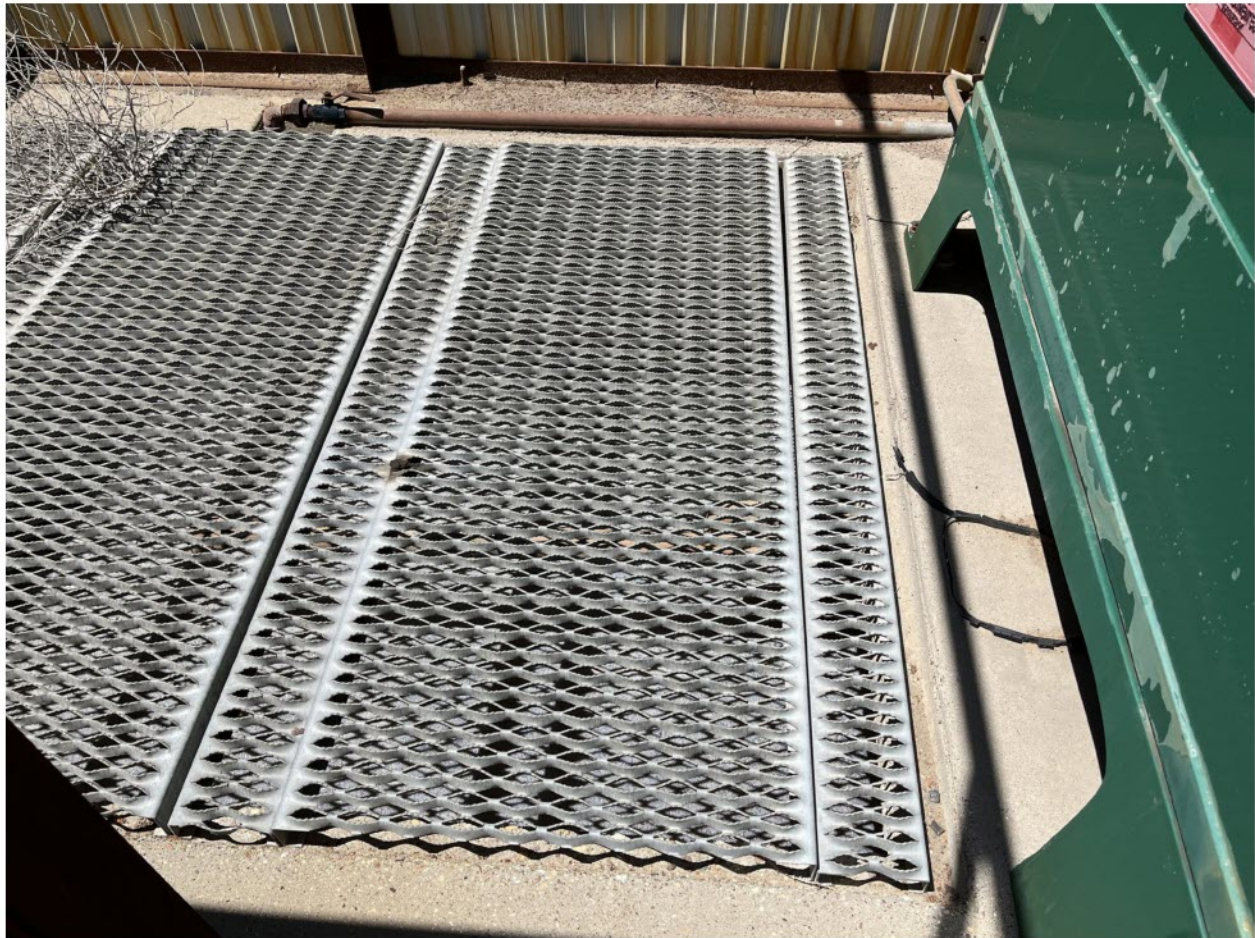
Photo No. 2

View of "diamond plate" steel grating covering the wastewater treatment headworks. (IMG\_0081).  
Photographed by D. Esparza

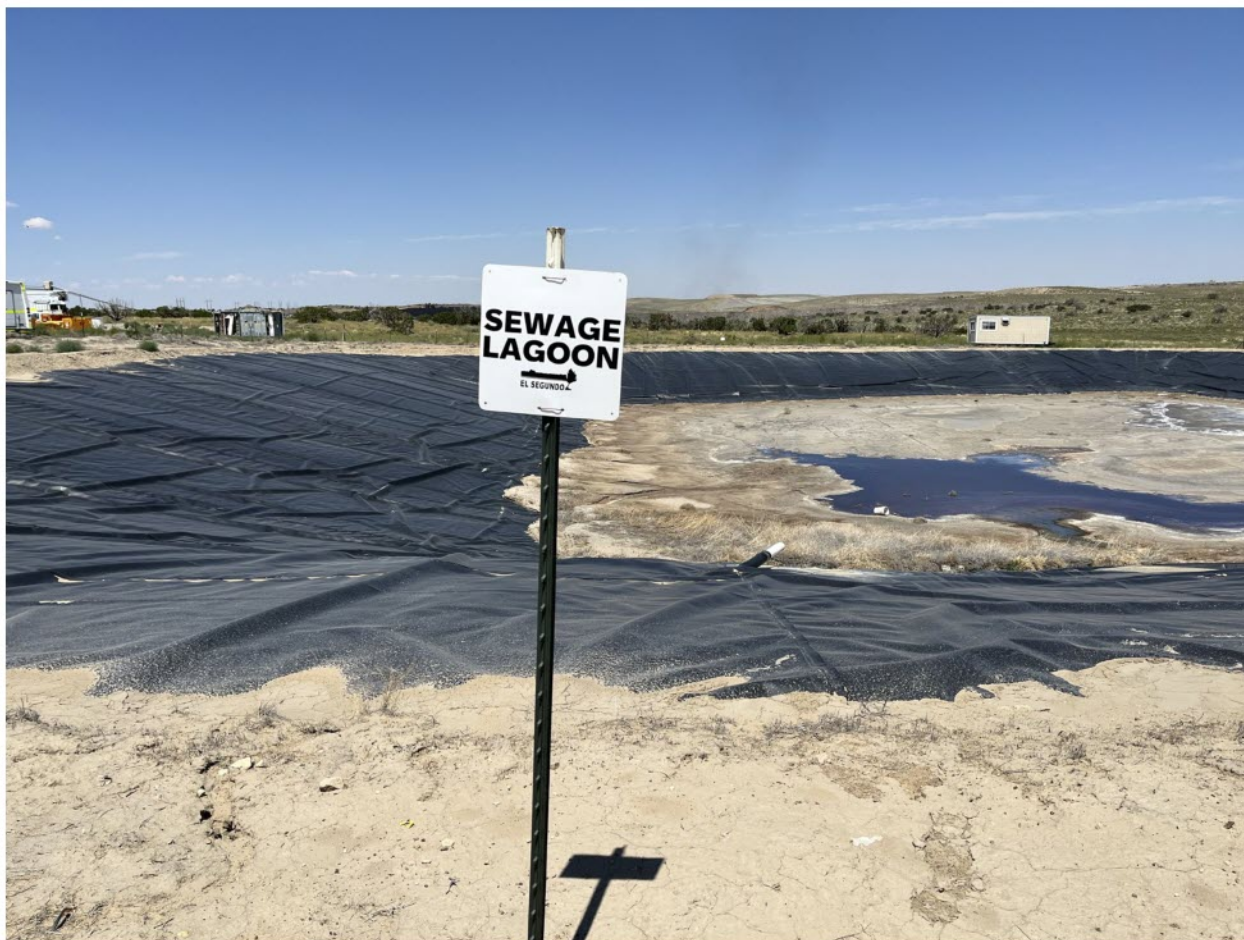
Photo No. 3

View of the existing sewage evaporative lagoon (pond) (listed as #018 on the El Segundo Outfall). **Note:** The integrity of the lagoon liner/fabric did not indicate visual signs of degradation or undermining by vagrant vegetation or vermin. (IMG\_0080). Photographed by D. Esparza
