**Region 2 Enforcement & Compliance Assurance Division**  
**Air Compliance Branch**  
**CAA Inspection Report**

**Facility Name:** 49 Gingerbread Castle Rd

**Facility Address:** 49 Gingerbread Castle Rd, Hamburg NJ

40 CFR Part 61 Subpart M – Asbestos NESHAPs

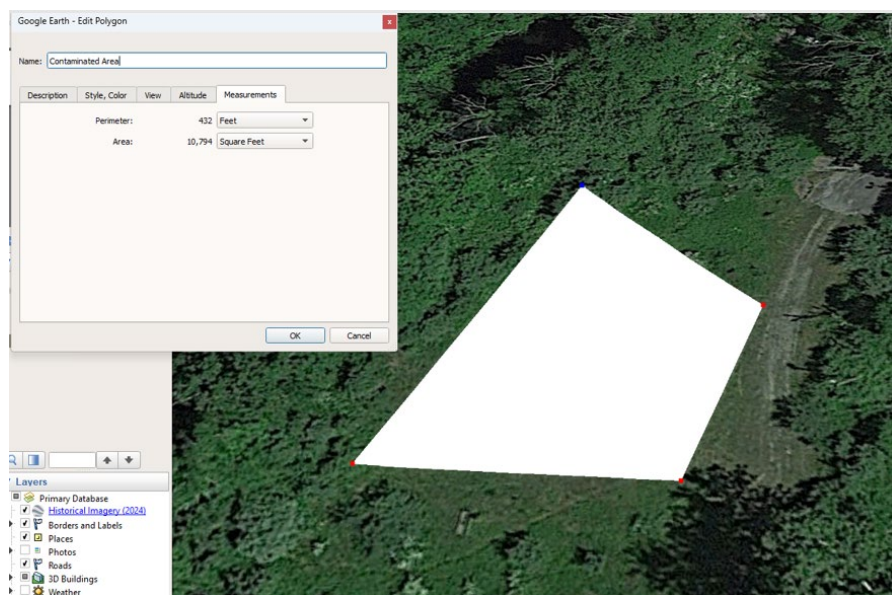
Fig 2, Perimeter and surface area of debris processing area

According to Mr. Sarkisen the debris depth is approximately 7 feet. Bella explained that when the material was moved from the original site, it was scraped from ground level and put into containers in order to transfer it to the current location. No excess soil under the debris was intentionally removed when they were moving the debris from the debris processing area to the storage area.

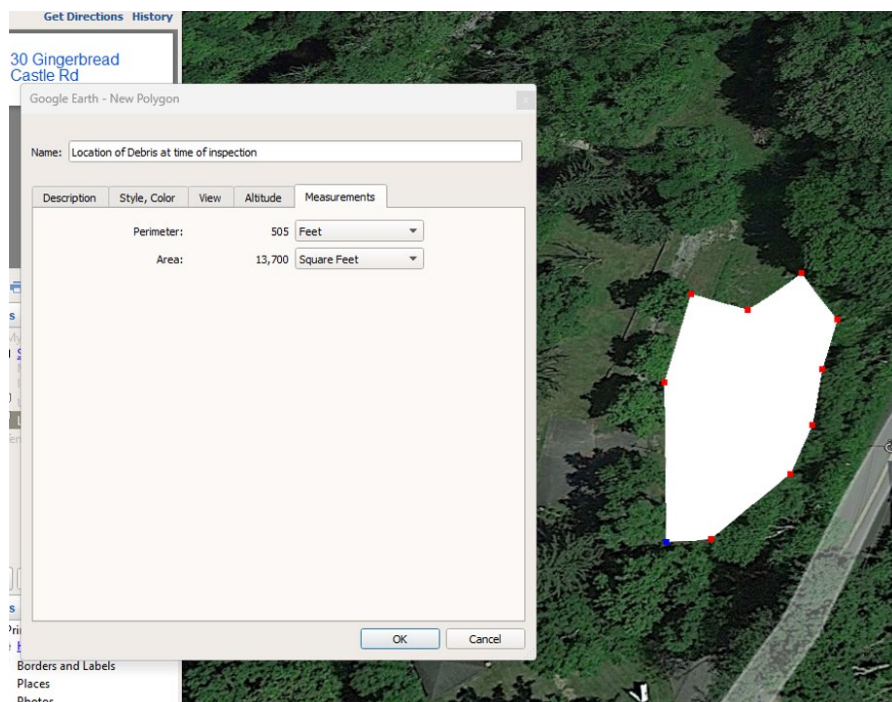
Fig 3, Perimeter and surface area of debris storage area

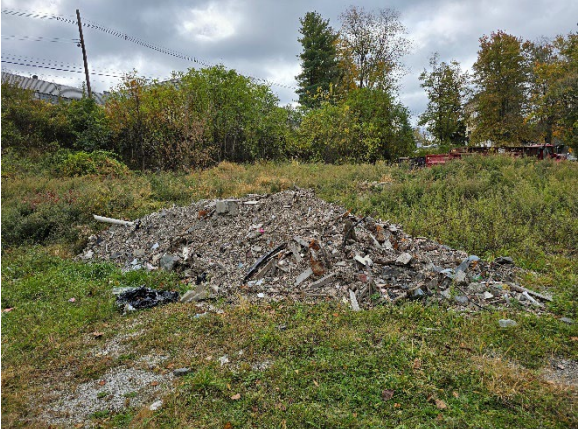
| 20241016_104303.jpg | Debris was said to be dumped by unknown parties in the debris storage area at the entrance of 30 Gingerbread castle road | |

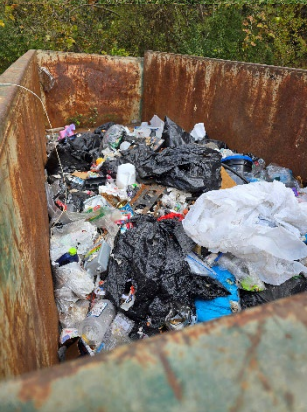
| 20241016_105130.jpg | Container full of household waste in the debris storage area at the entrance of 30 Gingerbread castle road | |

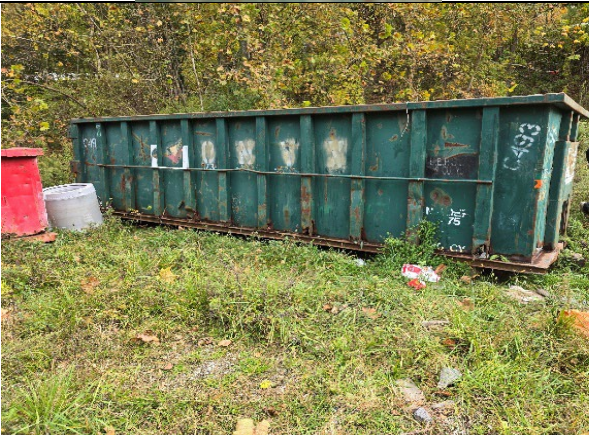
| 20241016_105140.jpg | Outside of Container from Photo 002 | |

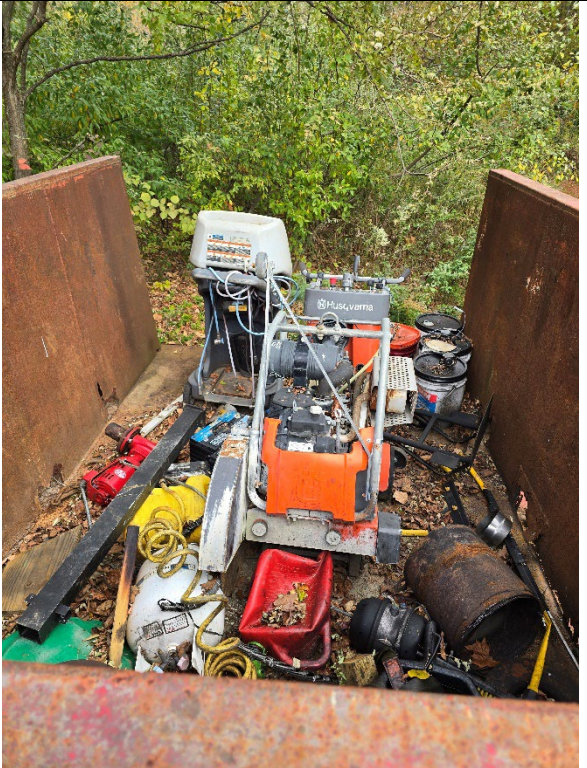
| 20241016_105211.jpg | Container with material and equipment from Bella in the debris storage area at the entrance of 30 Gingerbread castle road | |

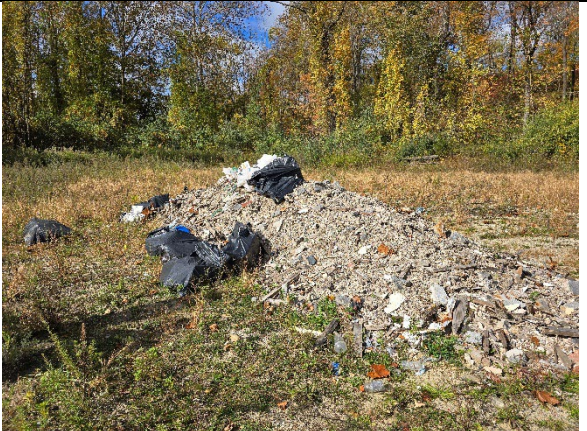
| 20241016_110903.jpg | Debris said to be dumped by unknown parties in the debris processing area. | |

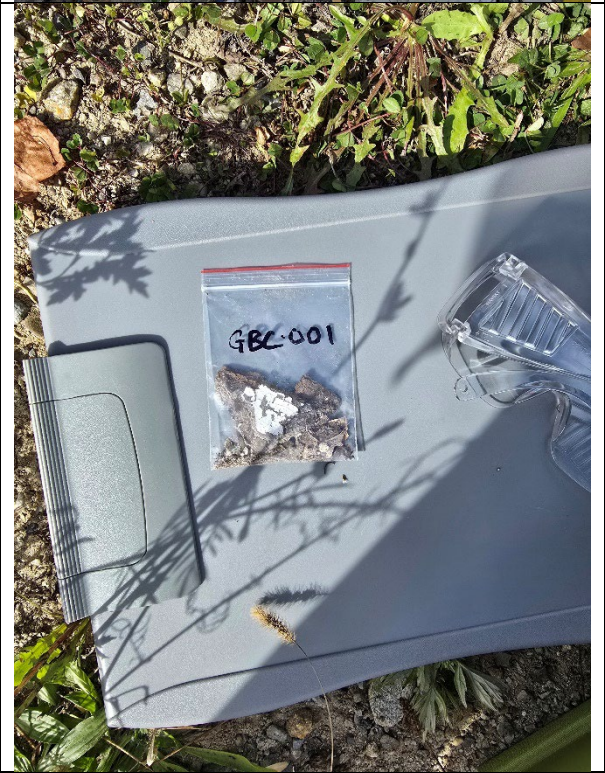
| <p>20241016_113536.jpg</p> | <p>Sample GBC001: White Material</p> | |
| <p>20241016_113753.jpg</p> | <p>Sample GBC001 (in bag)</p> | |

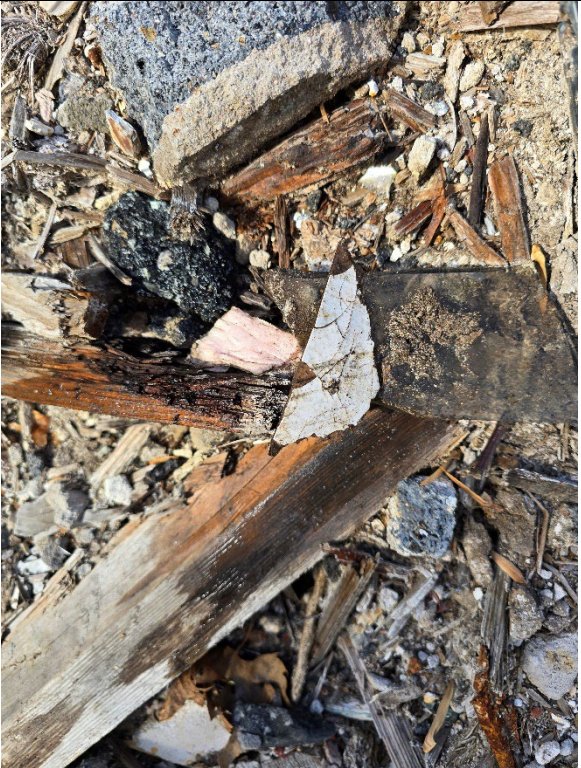
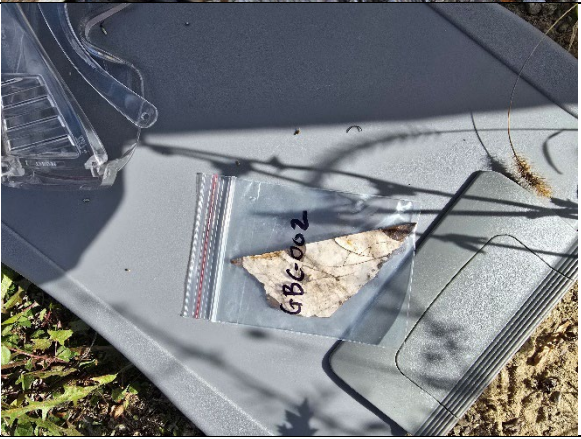
| 20241016_113912.jpg | Sample GBC002: White<br>Decorative Panel | |
| 20241016_114004.jpg | Sample GBC002 (in bag) | |

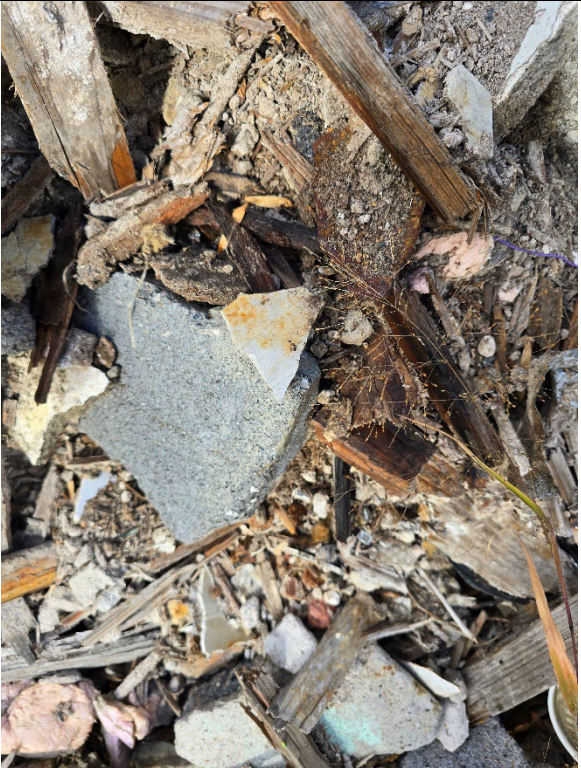
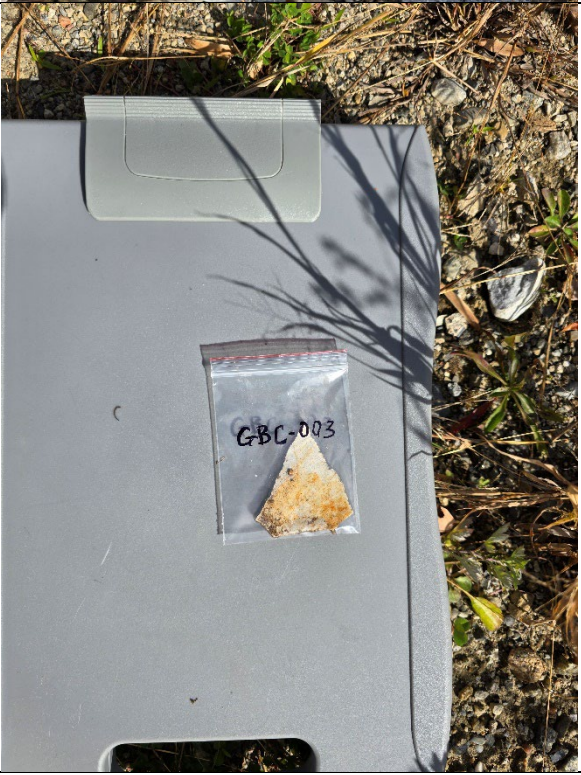
| <p>20241016_114120.jpg</p> | <p>Sample GBC003: Floor Tile</p> | |
| <p>20241016_114244.jpg</p> | <p>Sample GBC003 (in bag)</p> | |

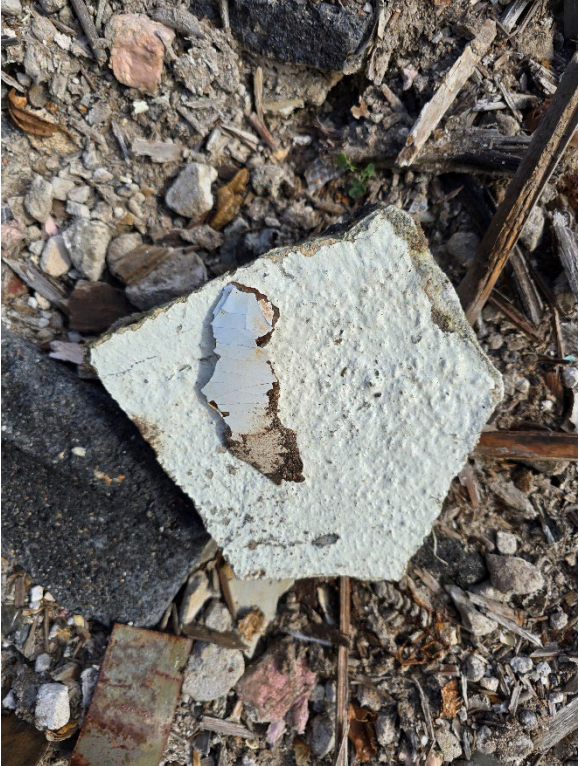
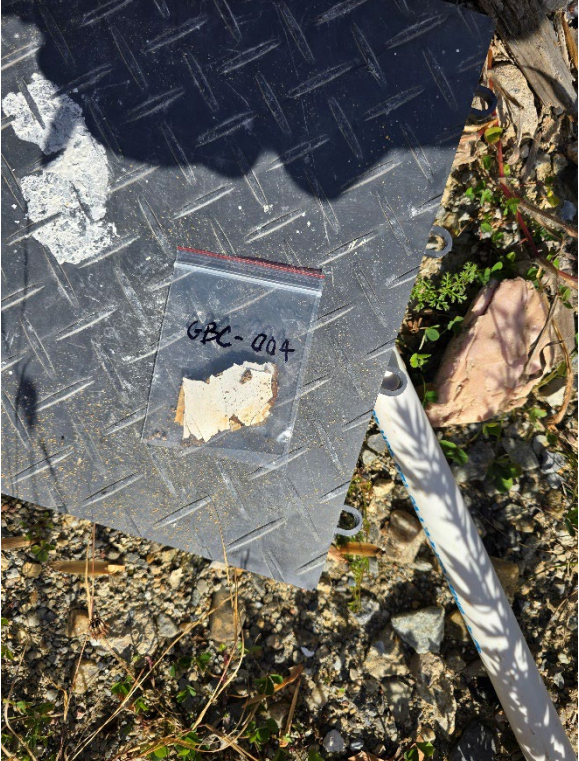
| 20241016_114632.jpg | Sample GBC004: White Material | |
| 20241016_114905.jpg | Sample GBC004 (in bag) | |

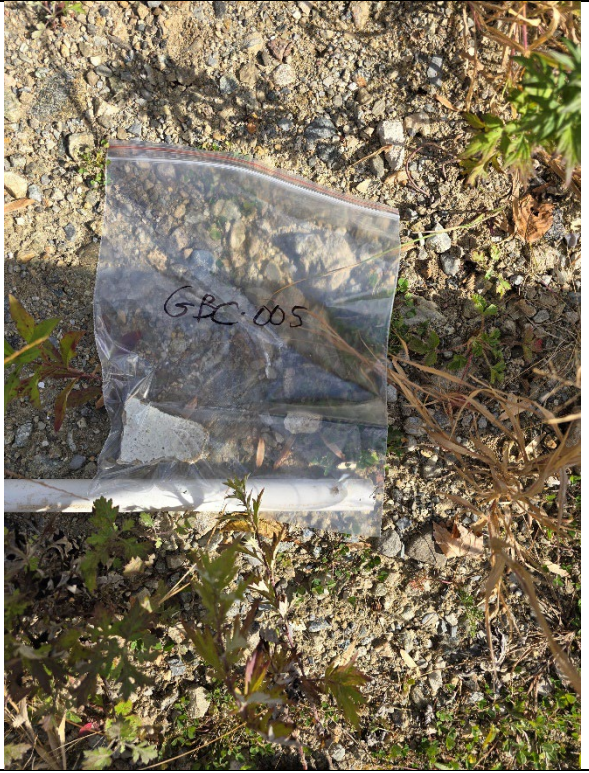
| 20241016_115127.jpg | Sample GBC005: Multiple Layered Troweled-On Material | |
| 20241016_115339.jpg | Sample GBC005 (in bag) | |

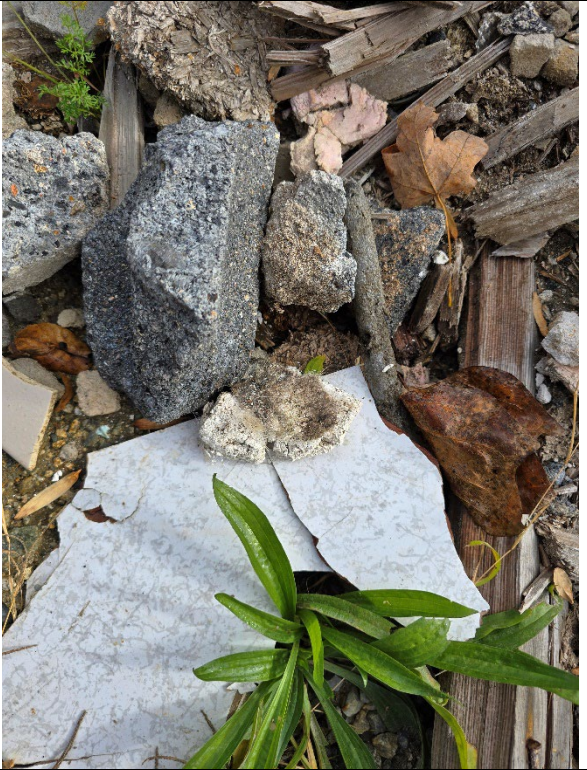
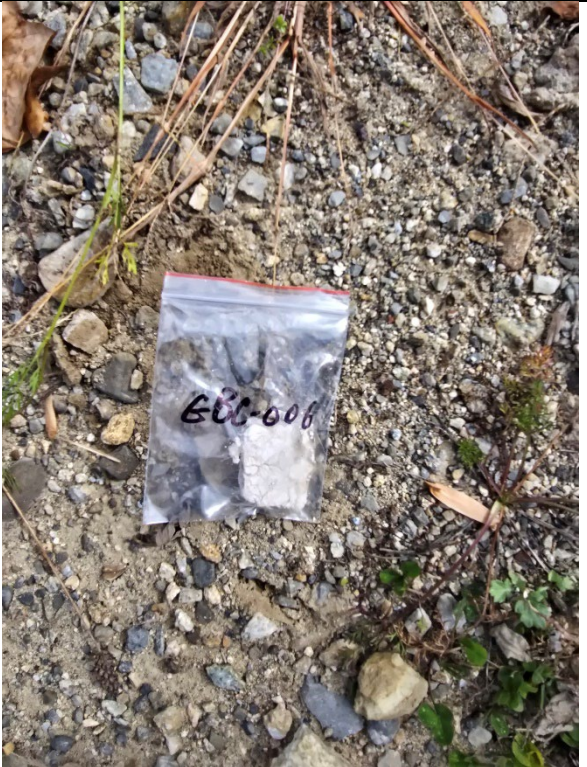
| 20241016_115601.jpg | Sample GBC006: Wall Board / Gypsum | |
| 20241016_115632.jpg | Sample GBC006 (in bag) | |

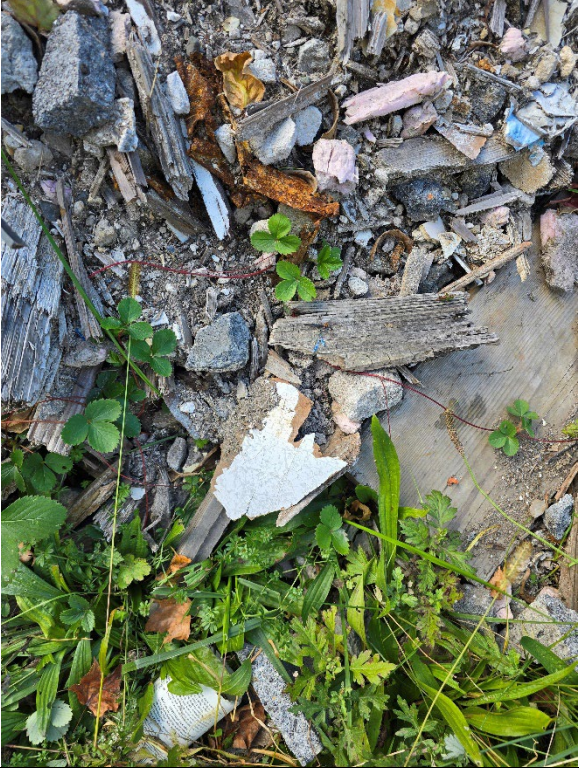
| 20241016_123649.jpg | <p>At approximately 12:30 PM, EPA inspectors start looking at the debris said to be dumped by unknown parties in the debris storage area at the entrance of 30 Gingerbread castle road. The material appears to have same consistency as material found in pile in the processing area.</p> | |

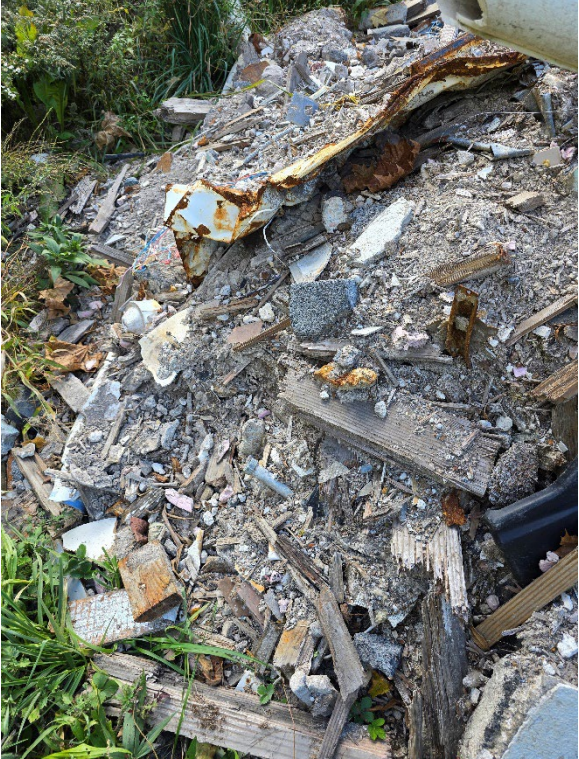
| 20241016_123655.jpg | <p>At approximately 12:30 PM, EPA inspectors start looking at the debris said to be dumped by unknown parties in the debris storage area at the entrance of 30 Gingerbread castle road. The material appears to have same consistency as material found in pile in the processing area, thus EPA inspectors decide to take only two samples from this pile. Sample 007 and 008 was taken.</p> | |

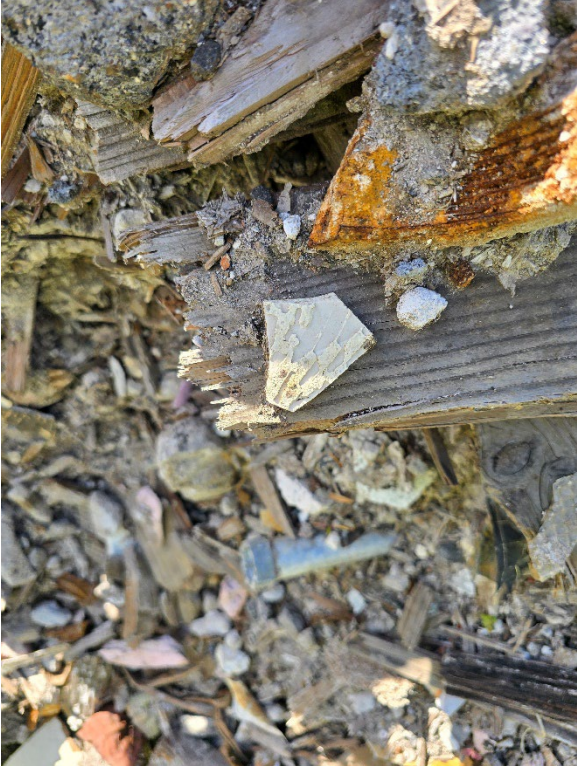
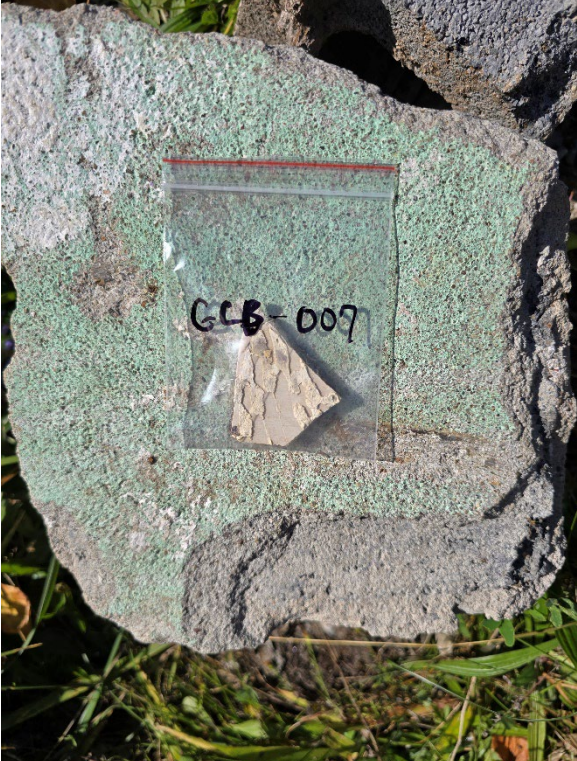
| 20241016_123904.jpg | Sample GBC007: Plaster from Tiles (ceramic) Mastic | |
| 20241016_123955.jpg | Sample GBC007 (in bag) | |

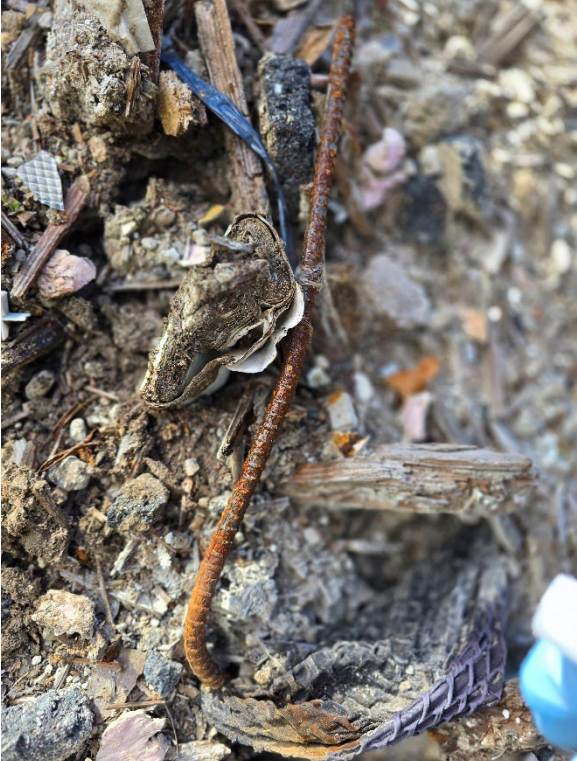
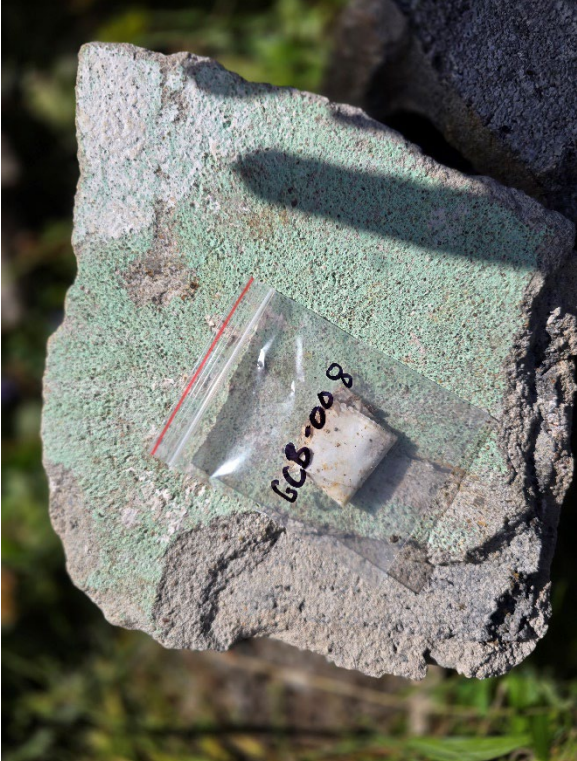
| 20241016_124117.jpg | Sample GBC008: Pipe<br>Insulation | |

| 20241016_124242.jpg | Sample GBC008 (in bag) | |

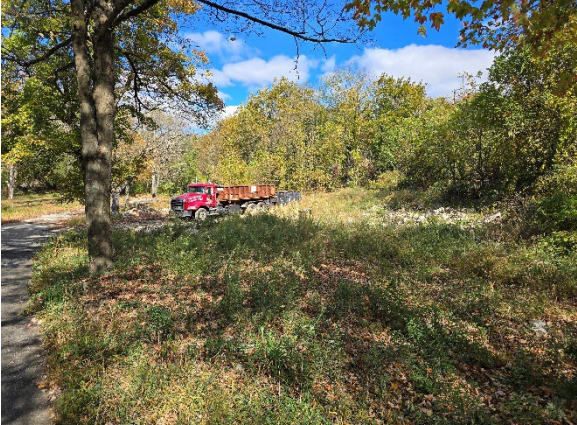
| 20241016_131416.jpg | Site where construction debris currently resides. | |
