## Region 6 Compliance Assurance and Enforcement Division

### INSPECTION REPORT

| Company Name: | <b>Southwestern Electric Power Company</b> | | |
| Facility Name: | <b>Arsenal Hill Power Plant</b> | | |

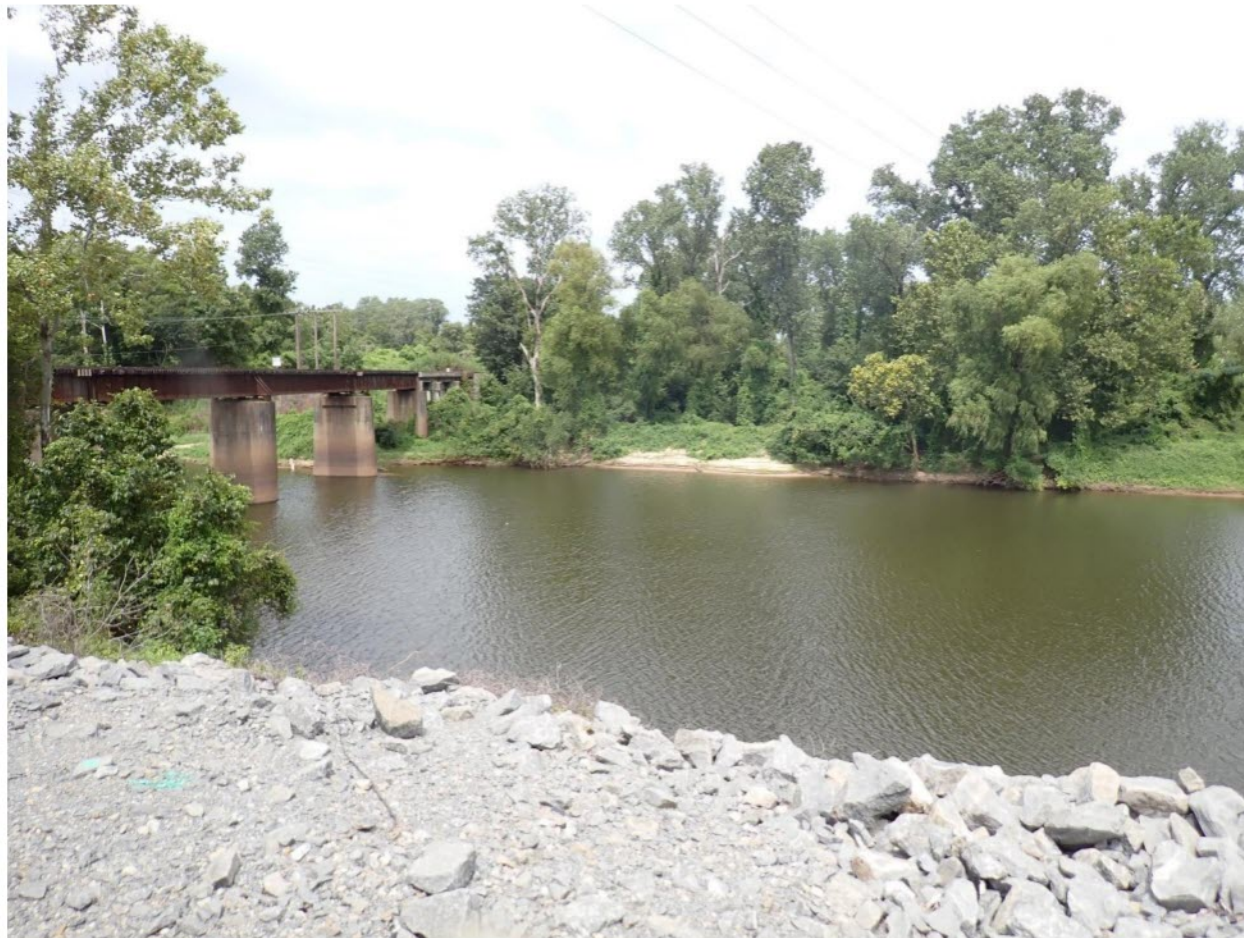
Photo No. 2

Description: This image shows the location of the submerged Johnson wedge wire T-27 screen and pipe system. The submerged Cooling Water Intake Structures (CWIS) is in Cross Bayou, adjacent to the facility.

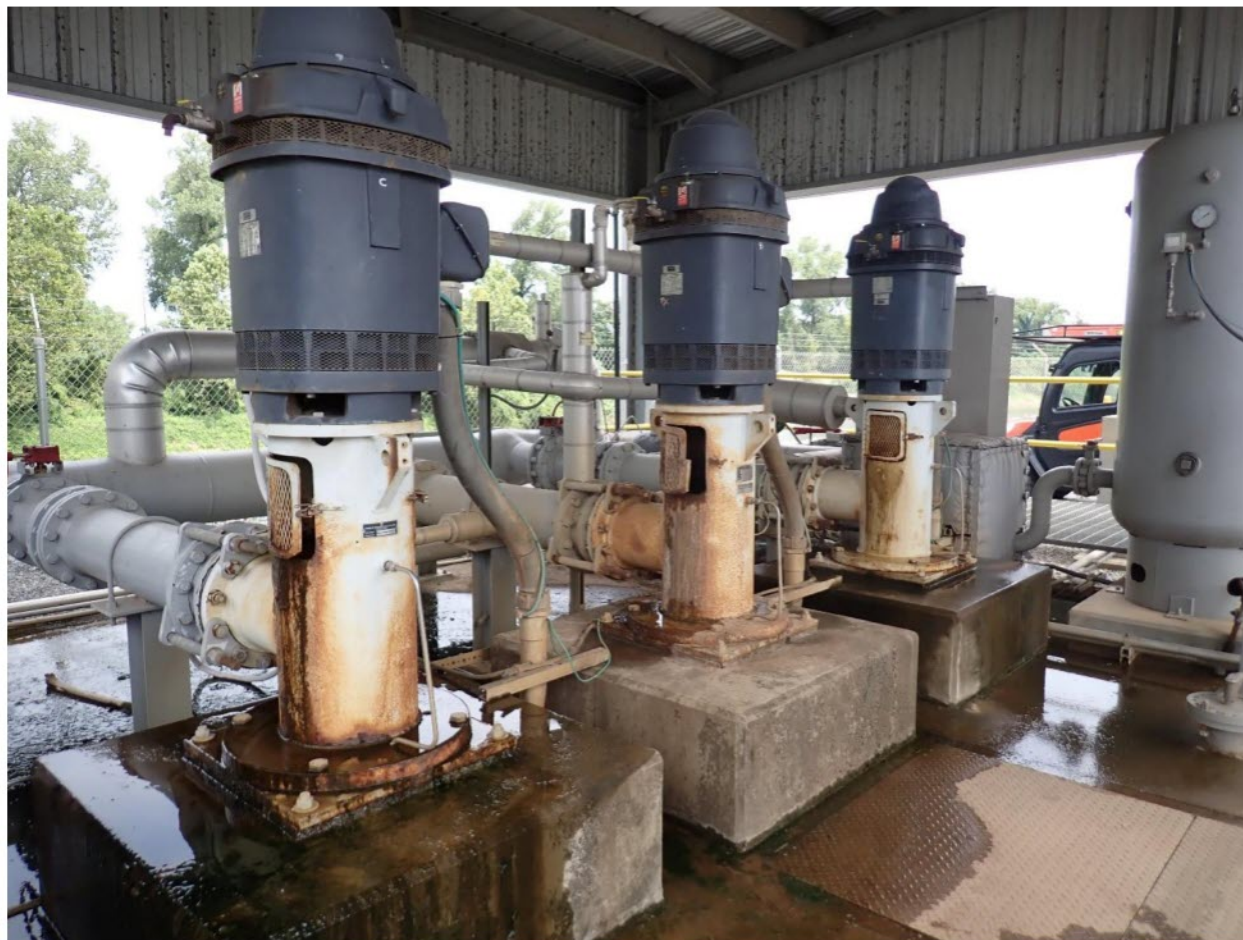
Photo No. 3

Description: This image shows three vertical shaft pumps each rated at 2,000 gallons per minute (GPM). The design capacity is 6,000 GPM or 8.6 million gallons per day (MGD). The pumps are connected to Cross Bayou, adjacent to cooling tower.

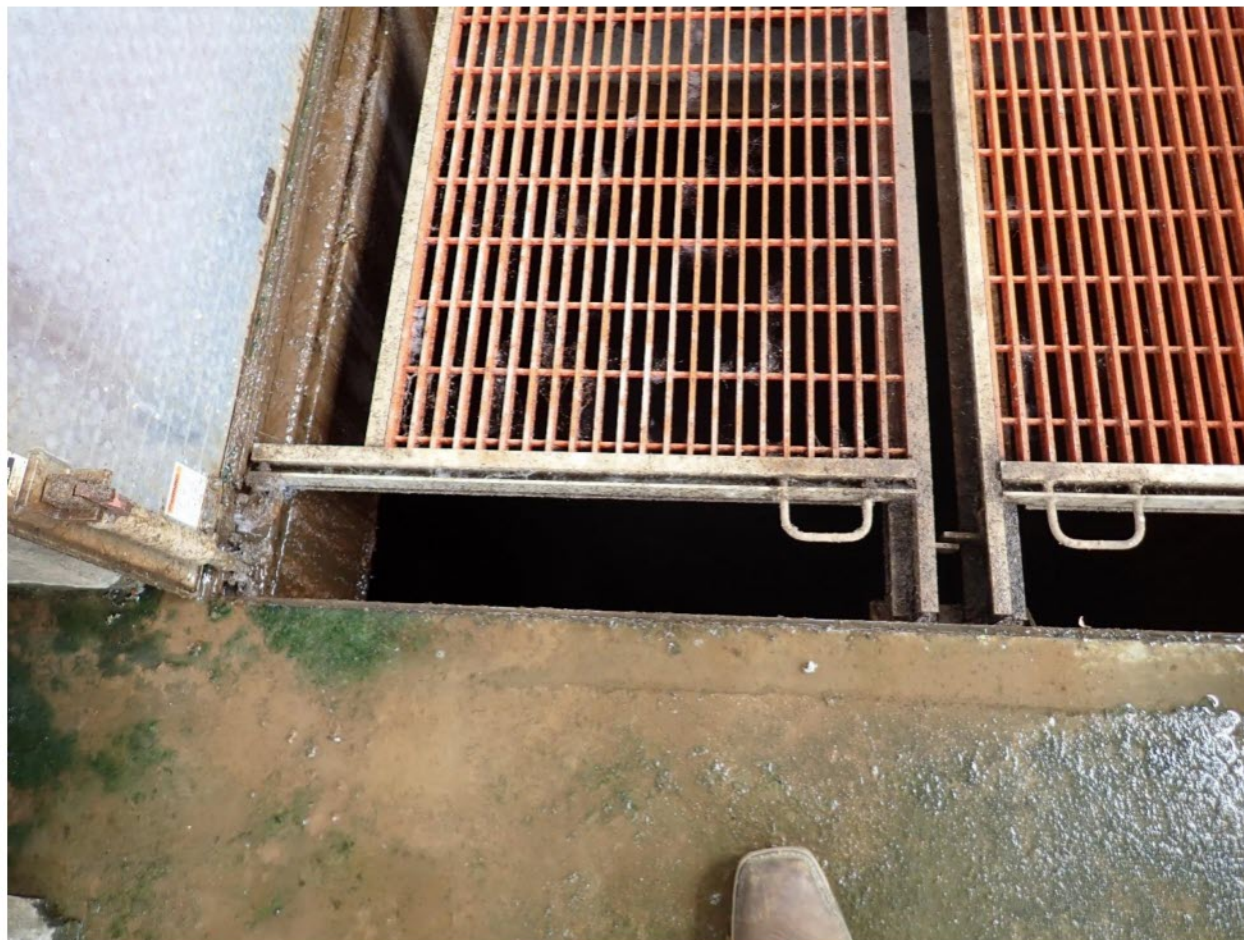
Photo No. 4

Description: This image shows the caisson that contained the Cooling Water Intake Structures (CWIS) connected to Cross Bayou, adjacent to cooling tower.

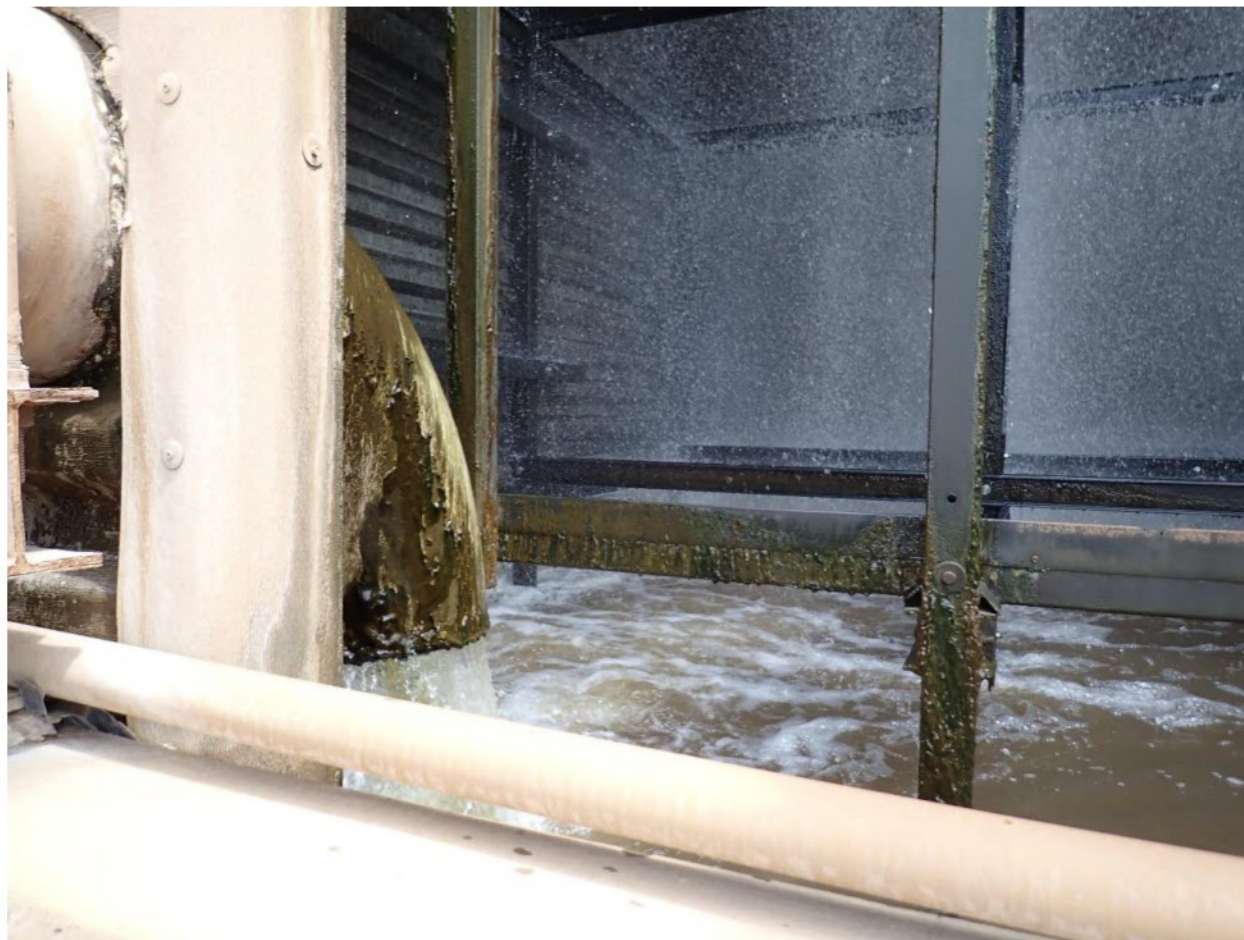
Photo No. 5

was not a problem or malfunctions on the cooling recirculating system. However, I observed an overflow of foam material potentially because of built up and low flow of material at the corner of the cooling water system. This foam material is near a stormwater drainage system (See Photo Nos. 5 - 7 in Appendix 1).

Description: This image shows the closed-cycle recirculating system cooling via a manmade cooling pond. Water is periodically diverted from the Cross Bayou, using a temporary pump rated at 1,900 GPM, to maintain water in the pond and cooling water system.

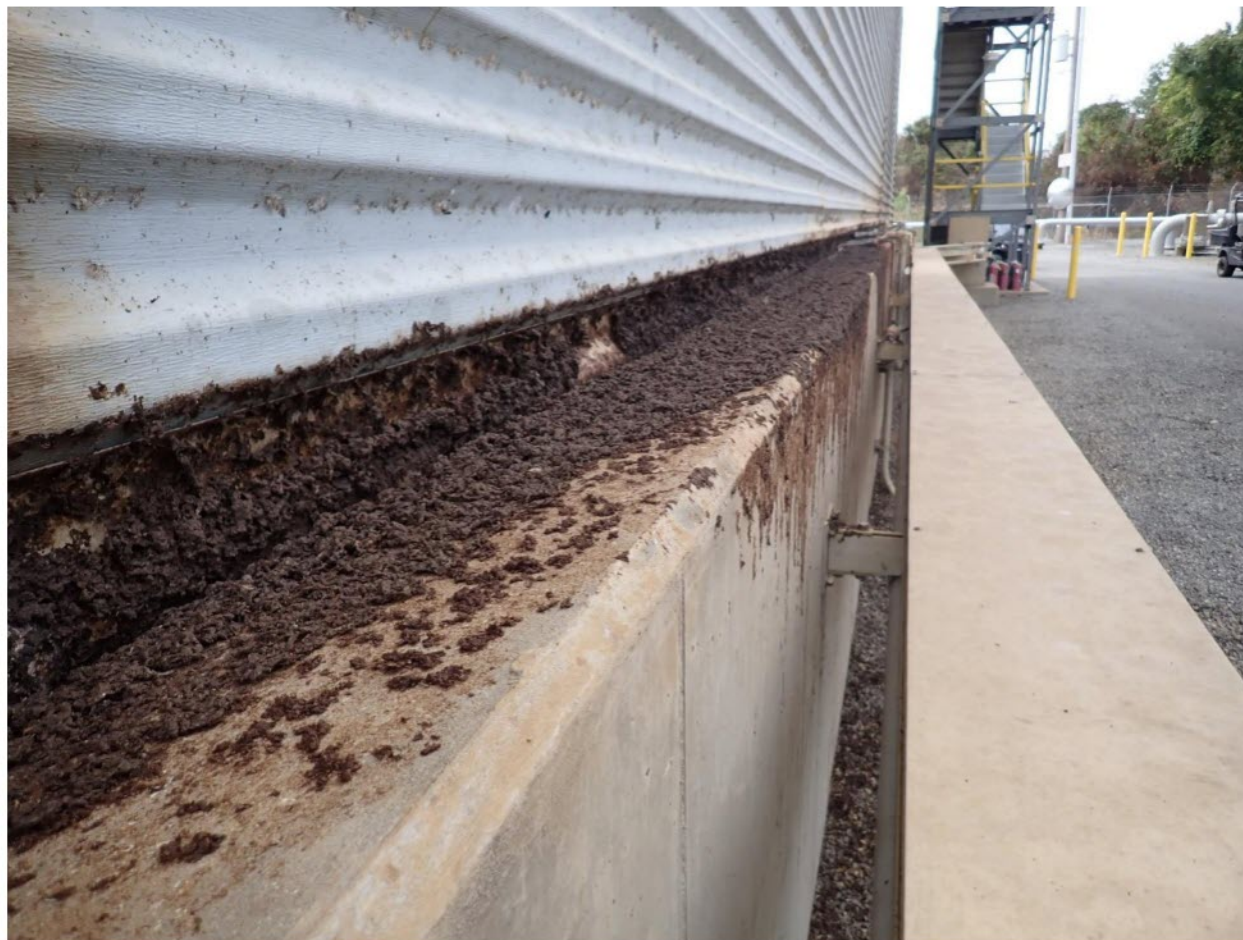
Photo No. 6

Description: This image shows an overflow of foam material due to the built up and low flow of material at the corner of the cooling water system.

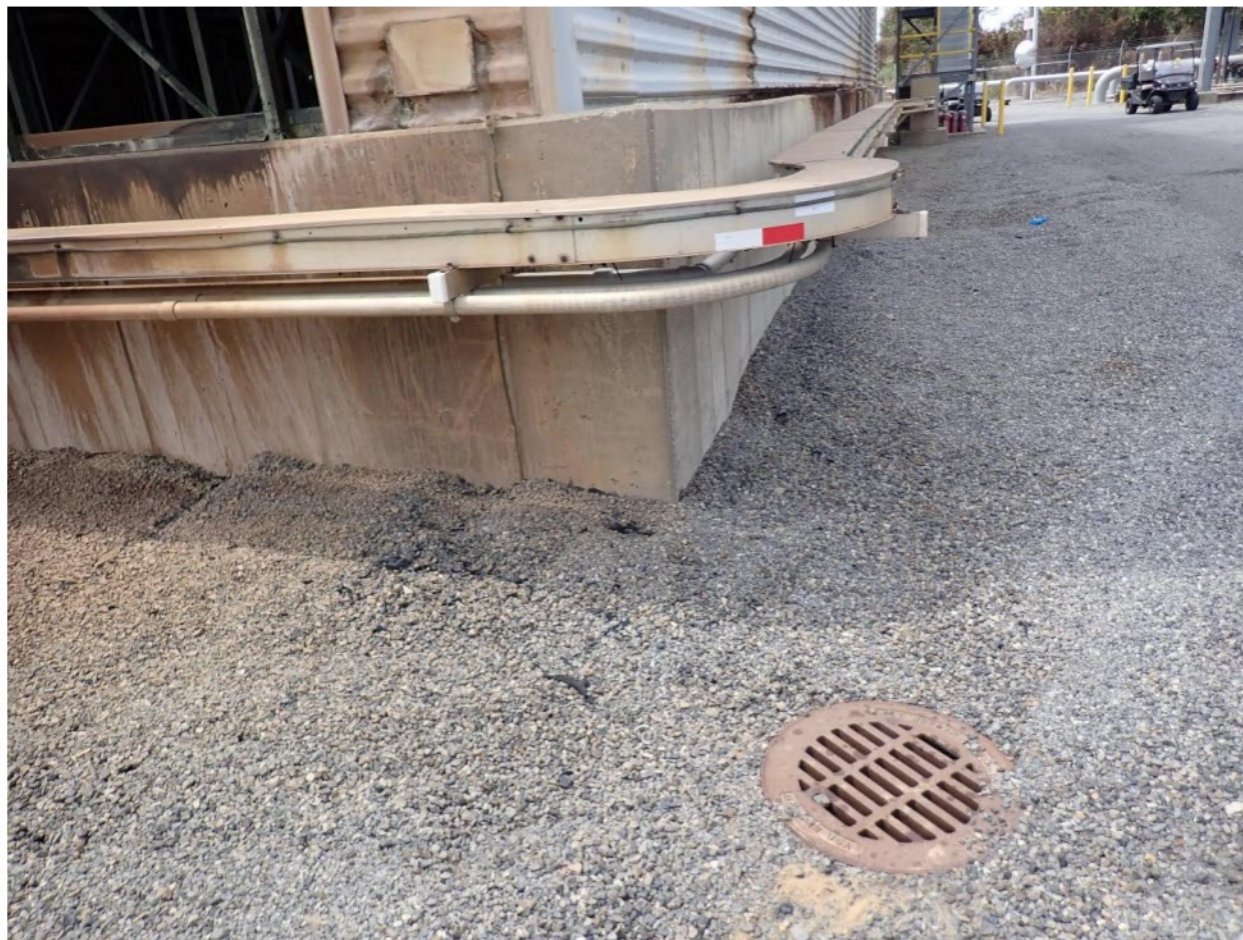
Photo No. 7

Photograph File Name: P8200017.JPG  
Date of Photograph: 08/20/2024  
Latitude and Longitud: 32.693941 -92.021102  
Orientation: NW  
Map Datum: WGS-84  
Time of Photo: 11:26 AM  
Photographer: Jack Arias  
Description: This image shows the stormwater drainage system. This system is near the overflow of the foam material.

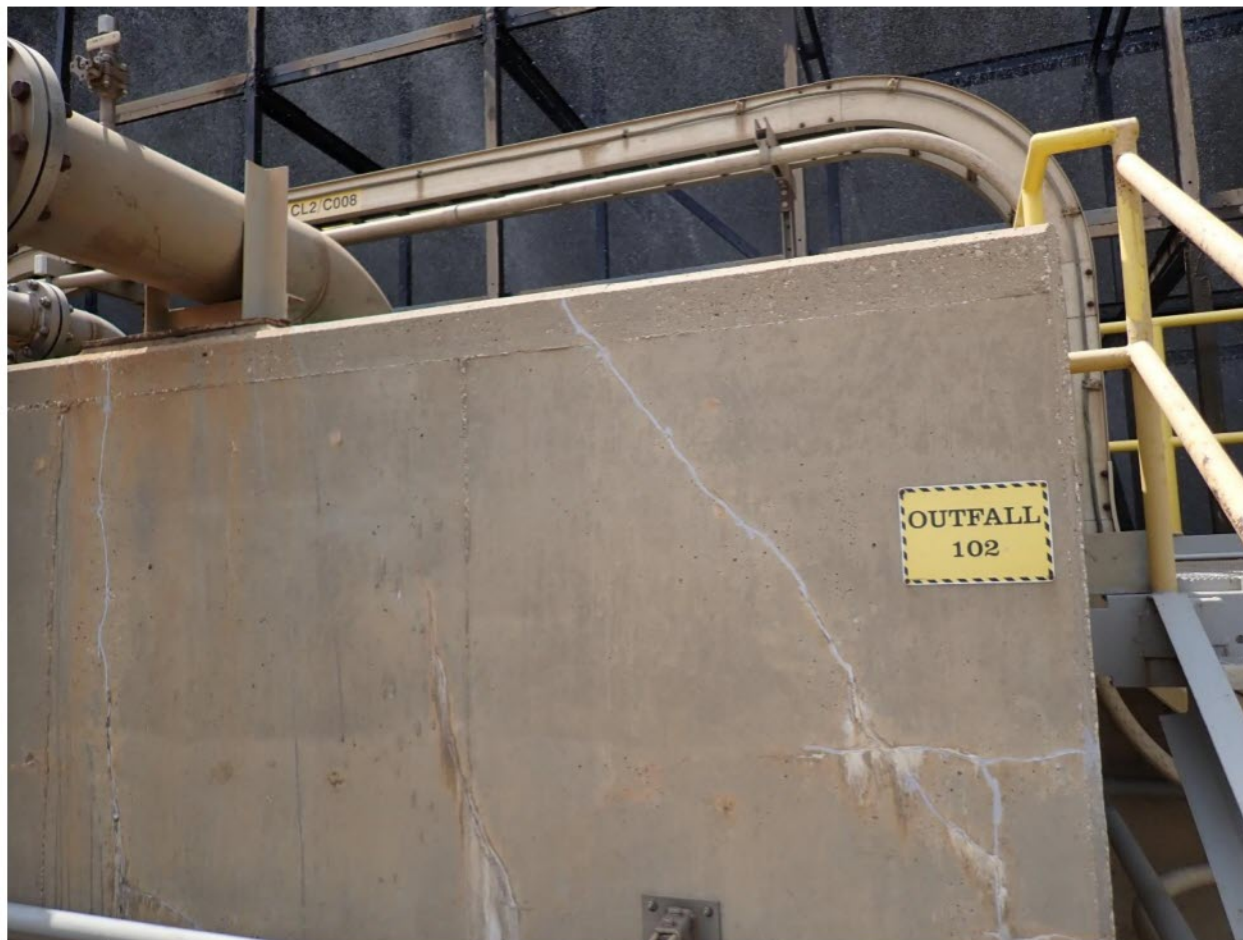
Photo No. 8

This outfall includes an intermittent discharge of low volume wastewater from the new units, including but not limited to, water treatment wastewaters; floor drains, condensate, and drainage from heat recovery steam generator (HRSG) blowdown. Outfall 102 discharges into the cooling tower basin, thence to outfall 002 and the Red River. There was flow and discharge at the time of the inspection and the water was clear (See Photo Nos. 8 - 9 in Appendix 1).

Photograph File Name: P8200023.JPG  
Date of Photograph: 08/20/2024  
Latitude and Longitude: 32.5204096 -93.7621763  
Orientation: NE  
Map Datum: WGS-84  
Time of Photo: 11:33 AM  
Photographer: Jack Arias  
Description: This image shows outfall 102 that includes an intermittent discharge of low volume wastewater from the new units, water treatment wastewaters; floor drains, condensate, and drainage from heat recovery steam generator (HRSG) blowdown. Outfall 102 discharges into the cooling tower basin, thence to outfall 002 and Red River.

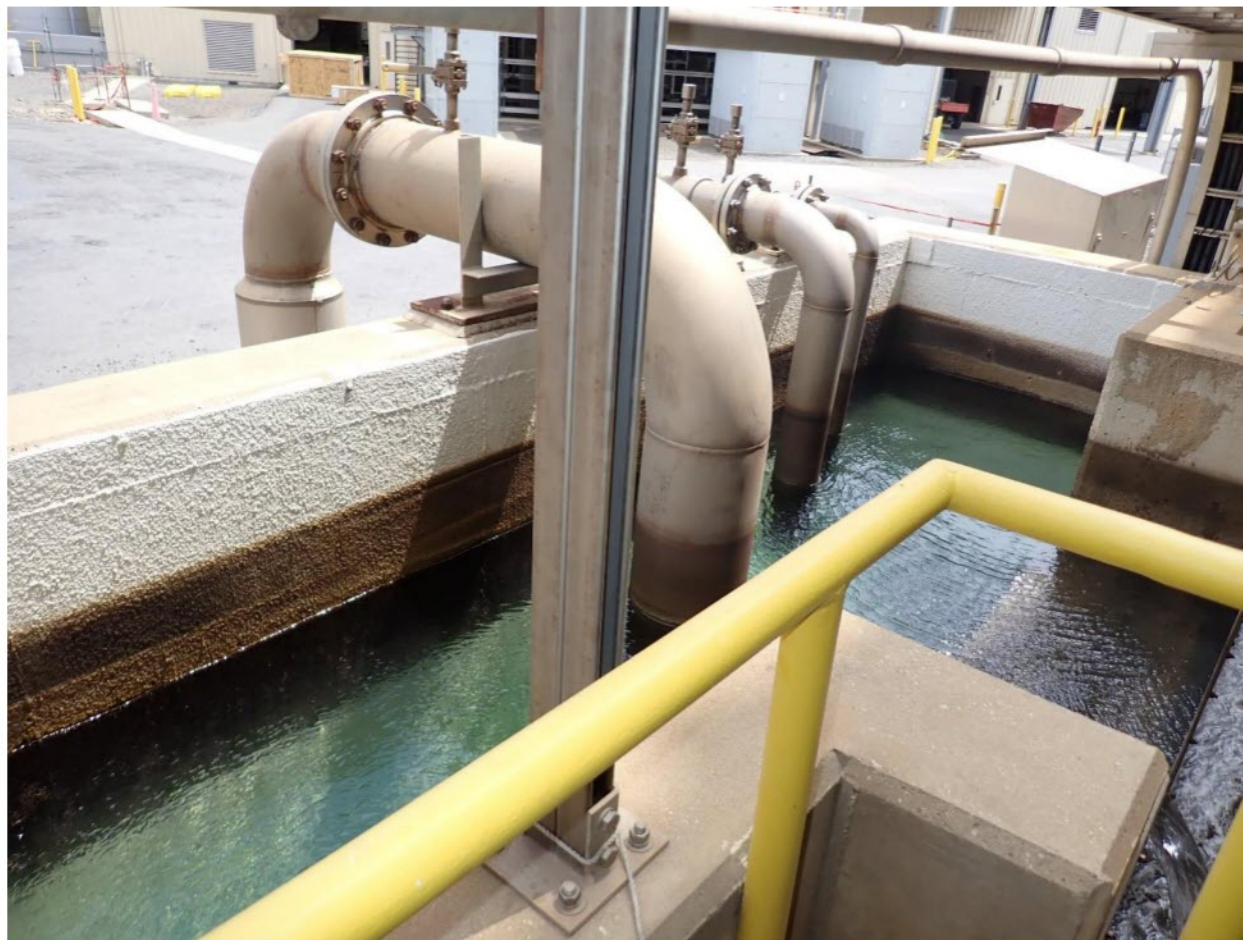
Photo No. 9

Photograph File Name: P8200021.JPG  
Date of Photograph: 08/20/2024  
Latitude and Longitude: 32.5204096 -93.7621763  
Orientation: NE  
Map Datum: WGS-84  
Time of Photo: 11:30 AM  
Photographer: Jack Arias  
Description: This image shows outfall 102 and intermittent discharge of low volume wastewater from the new units, water treatment wastewaters; floor drains, condensate, and drainage from heat recovery steam generator (HRSG) blowdown.

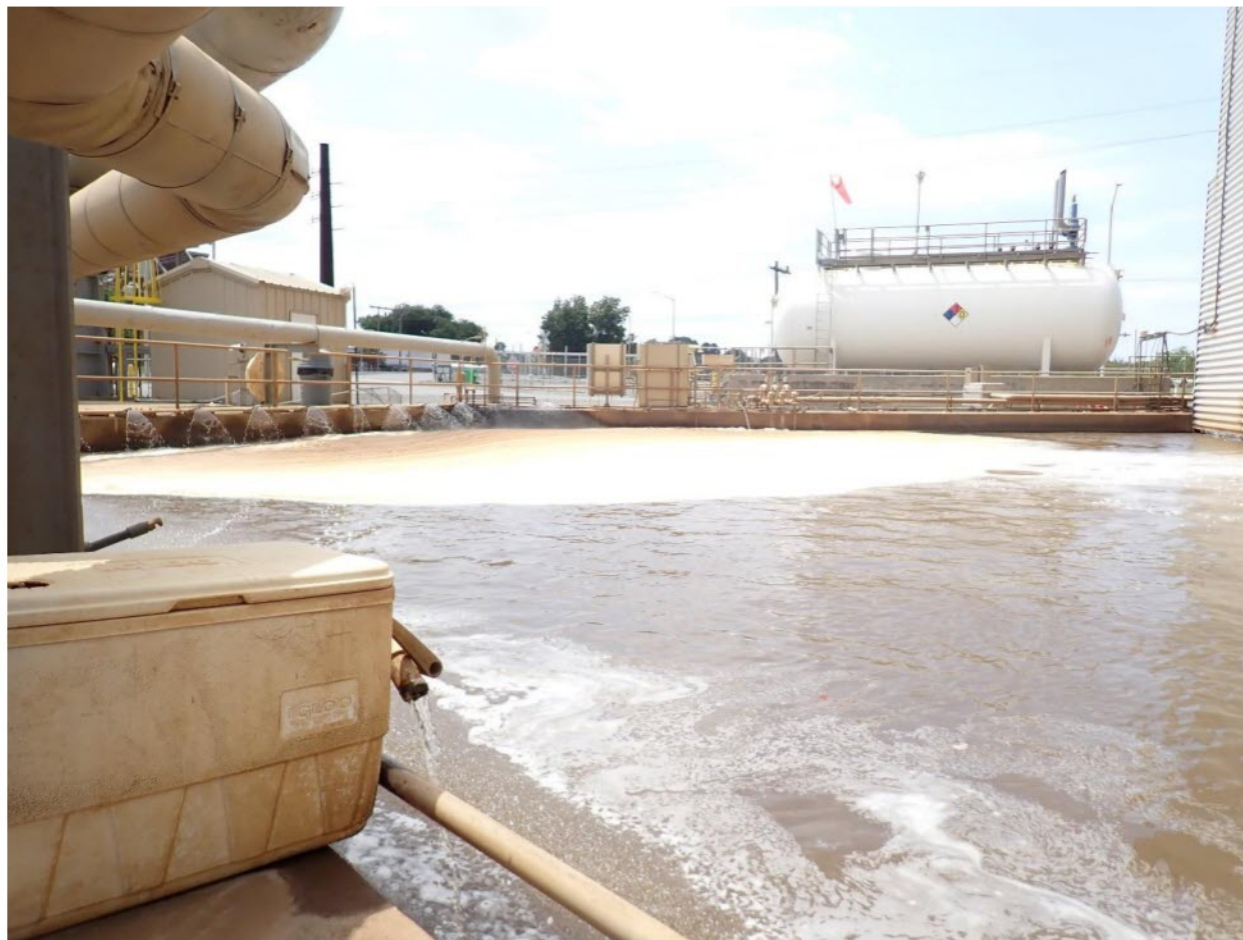
This outfall includes an intermittent discharge of the water from the cooling pond consisting of commingled once-through cooling water, non-process area stormwater runoff, and previously monitored low volume wastewater from internal Outfall 101. Outfall 202 discharges into the cooling tower basin, thence to outfall 002 and the Red River. There was flow and discharge at the time of the inspection and the water was brown in tint (See Photo No. 10 in Appendix 1).

This image shows the continuous discharge of cooling tower blowdown; previously monitored low volume wastewater from internal Outfall 102; and previously monitored effluent from internal Outfall 202.

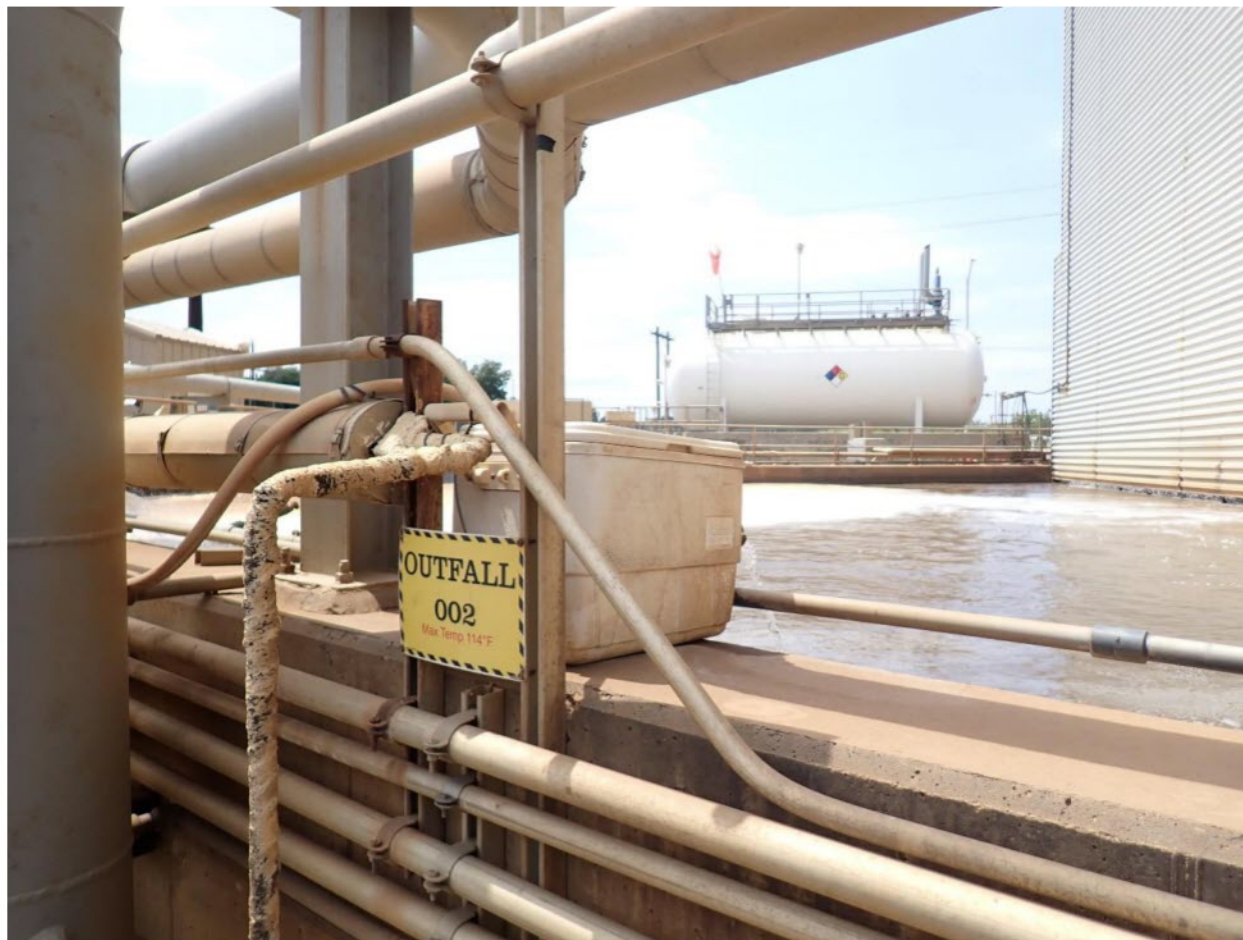
Photo No. 11

This outfall includes a continuous discharge of cooling tower blowdown; previously monitored low volume wastewater from internal Outfall 102; and monitored effluent from internal Outfall 202 and 002. Both outfalls monitored wastewater prior to the discharge into Red River. There was flow and discharge at the time of the inspection and the water was brown tint (See Photo Nos. 10 - 13 in Appendix 1).

This image shows the continuous discharge of cooling tower blowdown and monitored effluent on internal Outfall 202 and 002. Both outfalls monitored wastewater prior to the discharge into Red River.

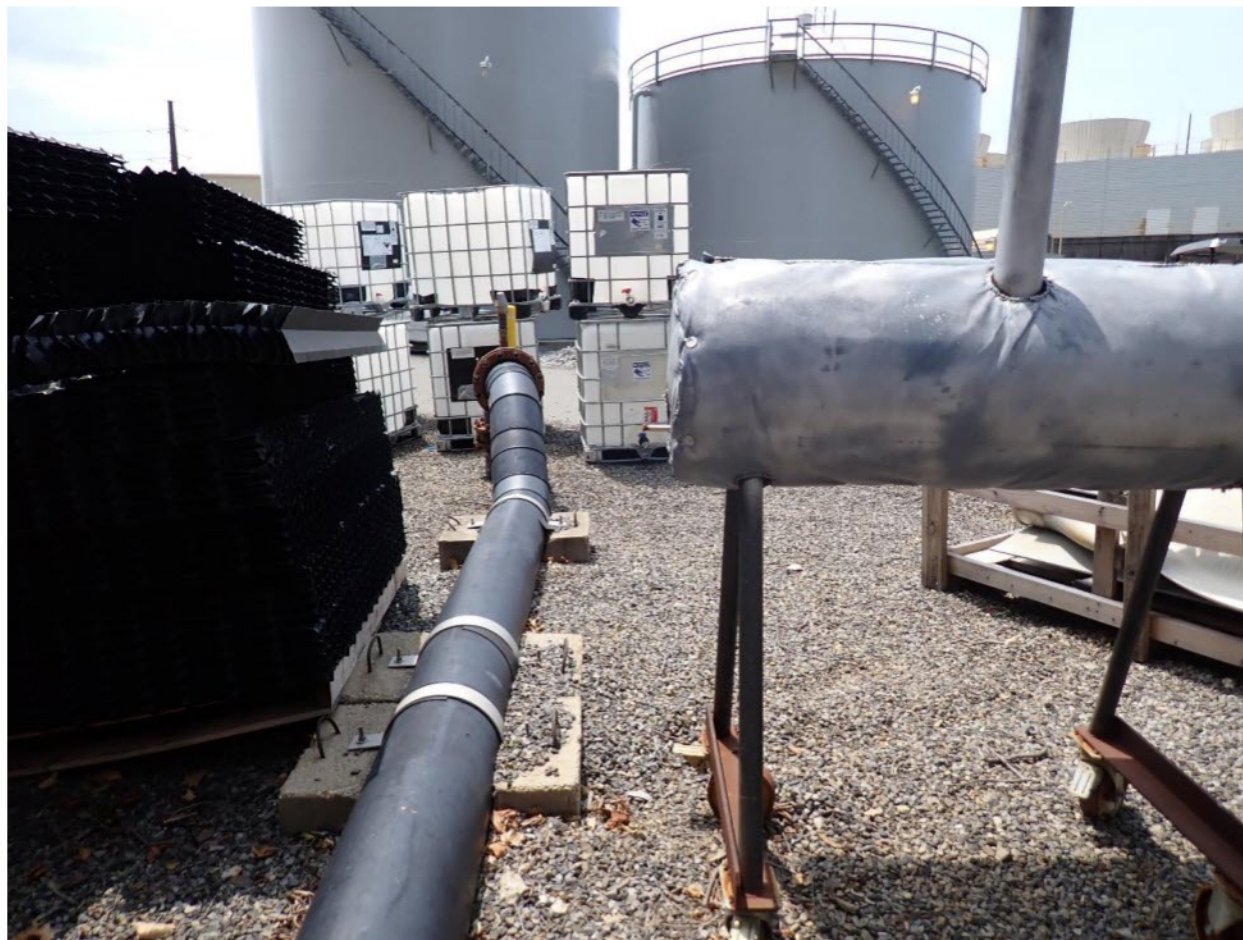
Photo No. 12

Photograph File Name: P8200029.JPG  
Date of Photograph: 08/20/2024  
Latitude and Longitude: 32.521141 -93.761594  
Orientation: NE  
Map Datum: WGS-84  
Time of Photo: 11:46 PM  
Photographer: Jack Arias  
Description: This image shows monitored wastewater prior to the discharge into Red River.

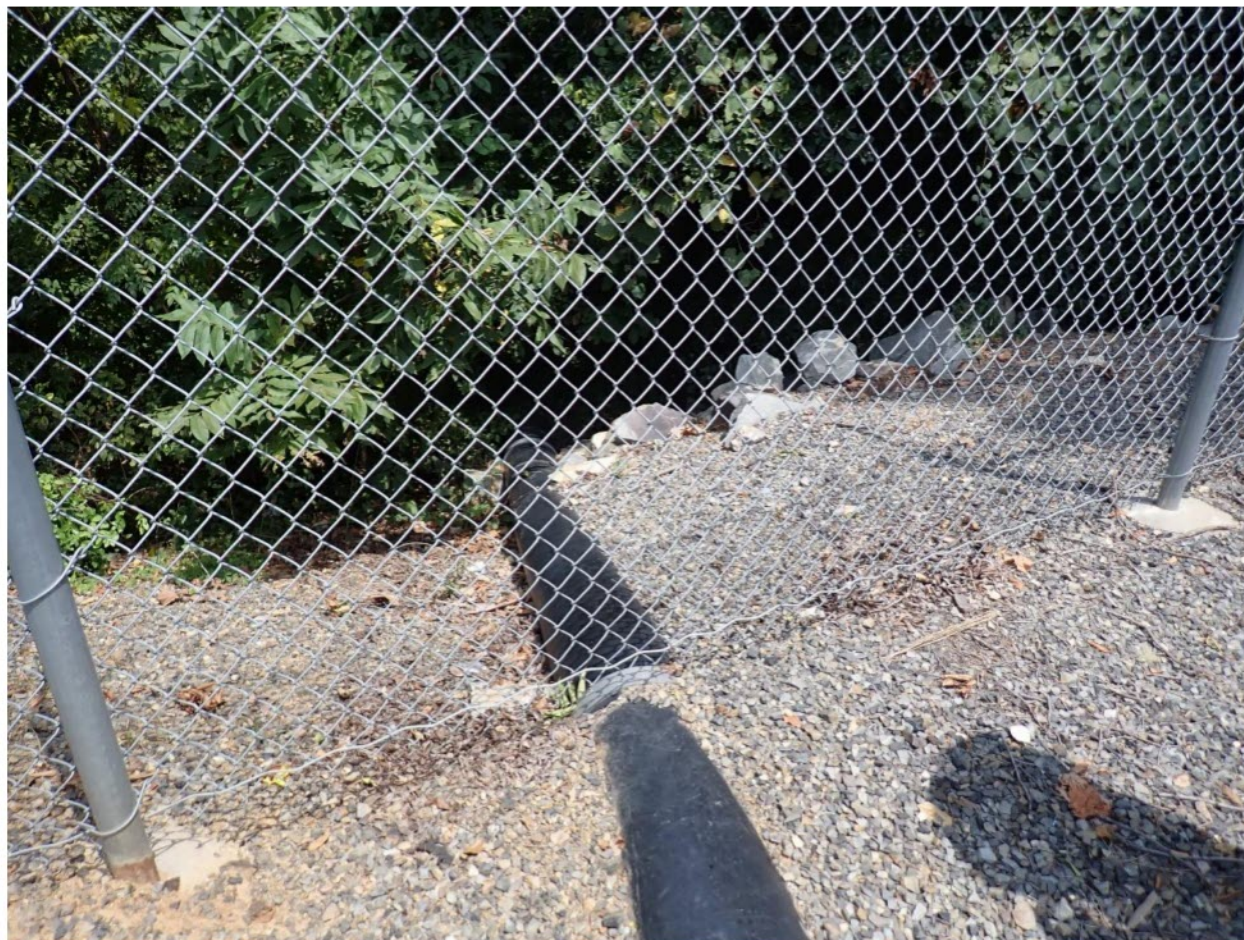
Photo No. 13

Photograph File Name: P8200030.JPG  
Date of Photograph: 08/20/2024  
Latitude and Longitude: 32.521141 -93.761594  
Orientation: NE  
Map Datum: WGS-84  
Time of Photo: 11:46 AM  
Photographer: Jack Arias  
Description: This image shows monitored wastewater prior to the discharge into Red River.

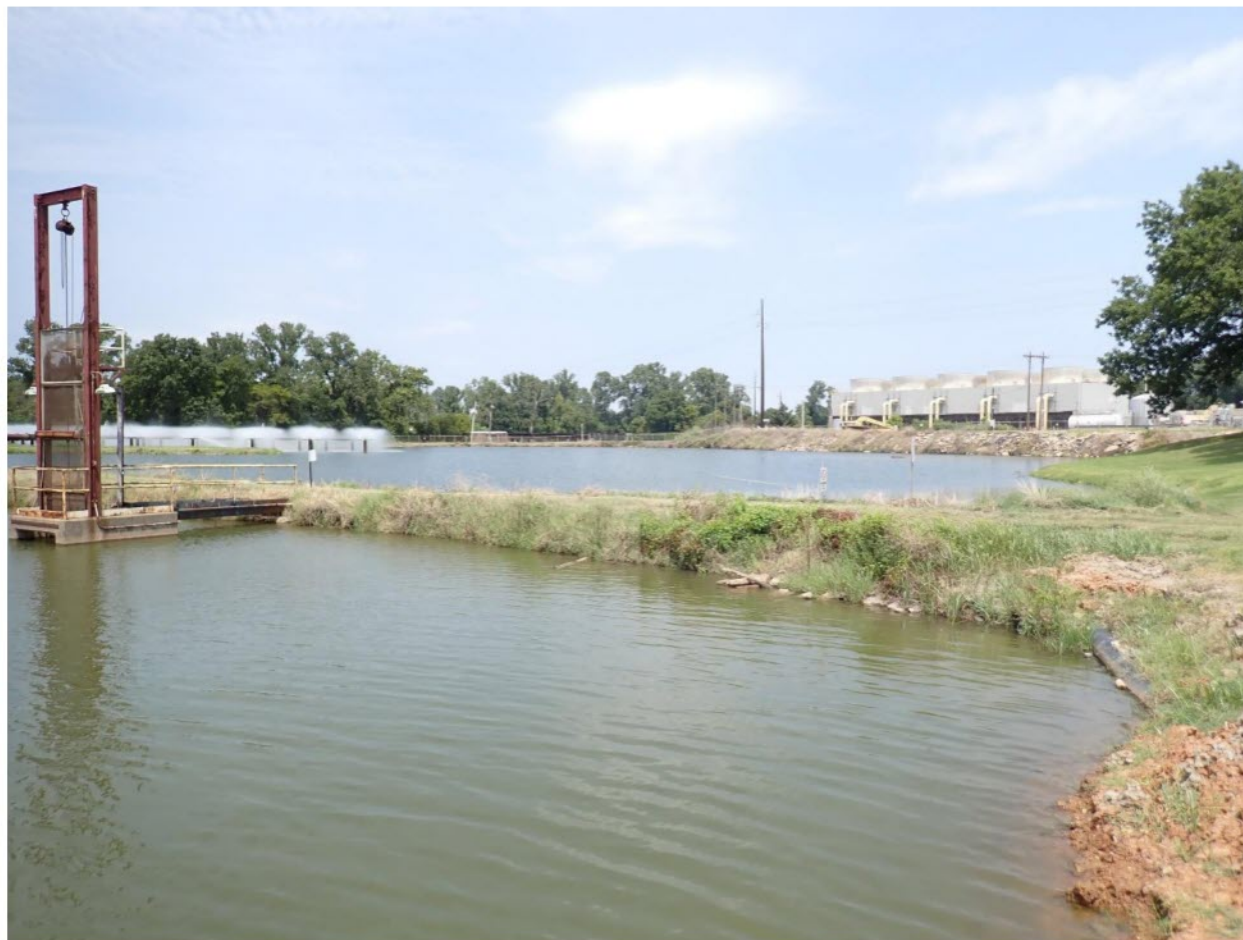
Photo No. 14

Cooling water is returned to the cooling pond where a portion of the flow is sent through a spray system to aid in heat dissipation. Water in the cooling pond is used primarily for condenser cooling with smaller amounts used to support electric generation (See Photo Nos. 14 - 15 in Appendix 1).

Description: This image shows the cooling pond where a portion of the flow is sent through a spray system to aid in heat dissipation.

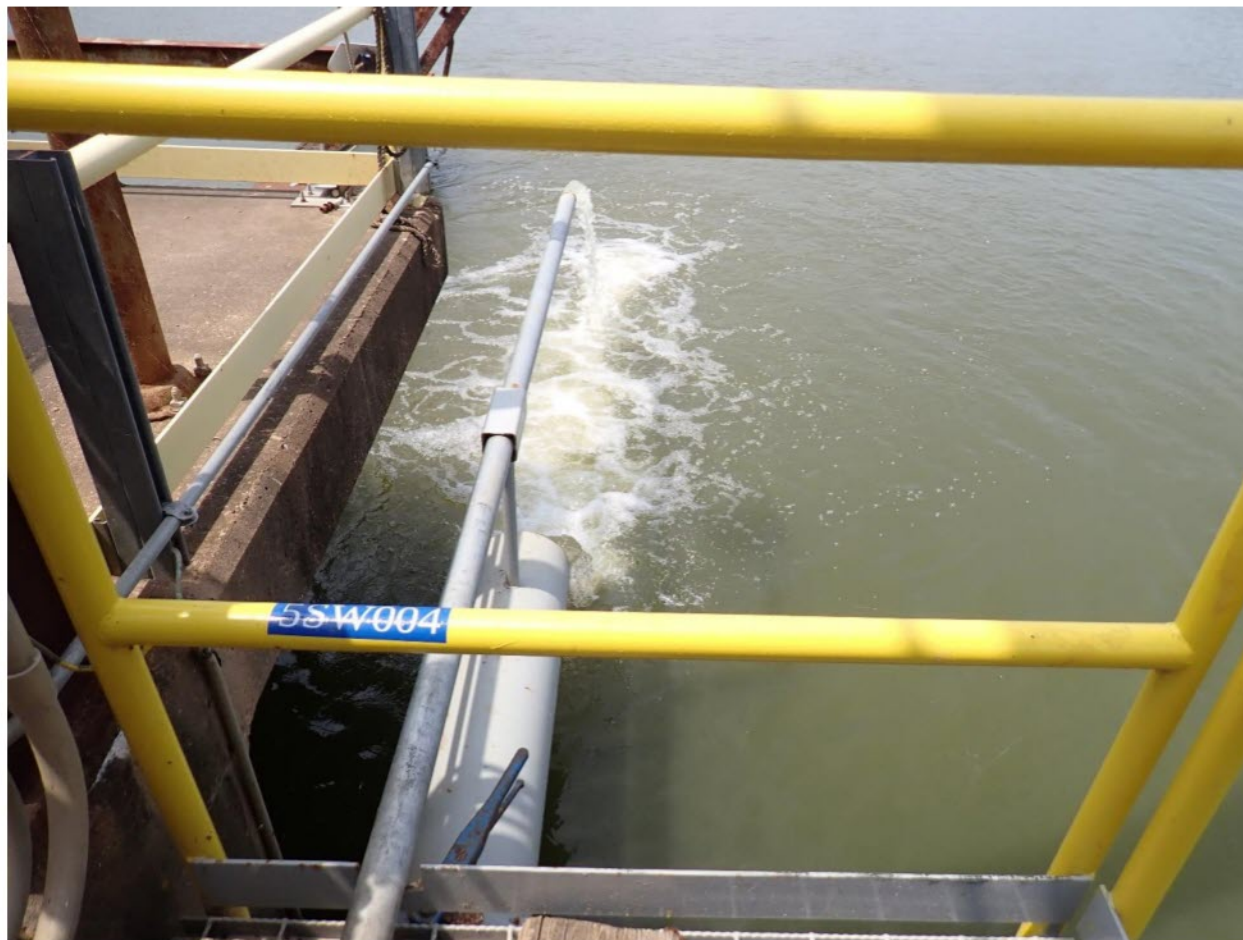
Photo No. 15

Photograph File Name: P8200035.JPG  
Date of Photograph: 08/20/2024  
Latitude and Longitude: 32.517723 -93.763206  
Orientation: SW  
Map Datum: WGS-84  
Time of Photo: 12:01 PM  
Photographer: Jack Arias  
Description: This image shows the cooling pond where a portion of the flow is sent through a pipe system to the cooling pond.

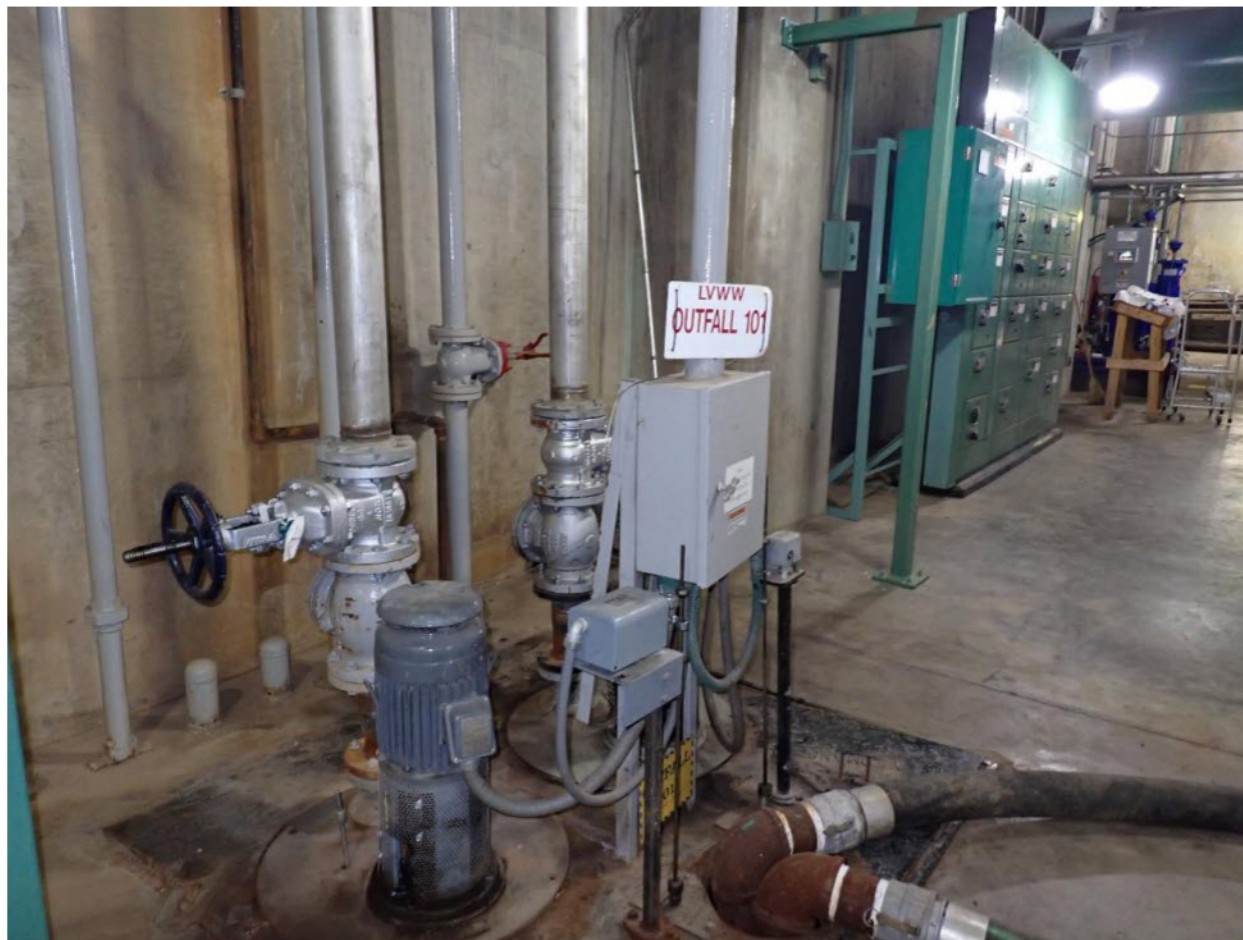
Photo No. 16

This outfall includes an intermittent discharge of low volume wastewater, including but not limited to, boiler blowdown, miscellaneous cooling water, water treatment wastewaters, and floor drains from unit 5. Internal Outfall 101 is monitored prior to the discharge into outfall 001 and thence Twelve Mile Bayou. There was flow and discharge at the time of the inspection and the water was brown in tint (See Photo Nos. 16 - 19 in Appendix 1).

This image shows the internal sump system connected to outfall 101. This outfall includes a intermittent discharge of low volume wastewater from unit 5.

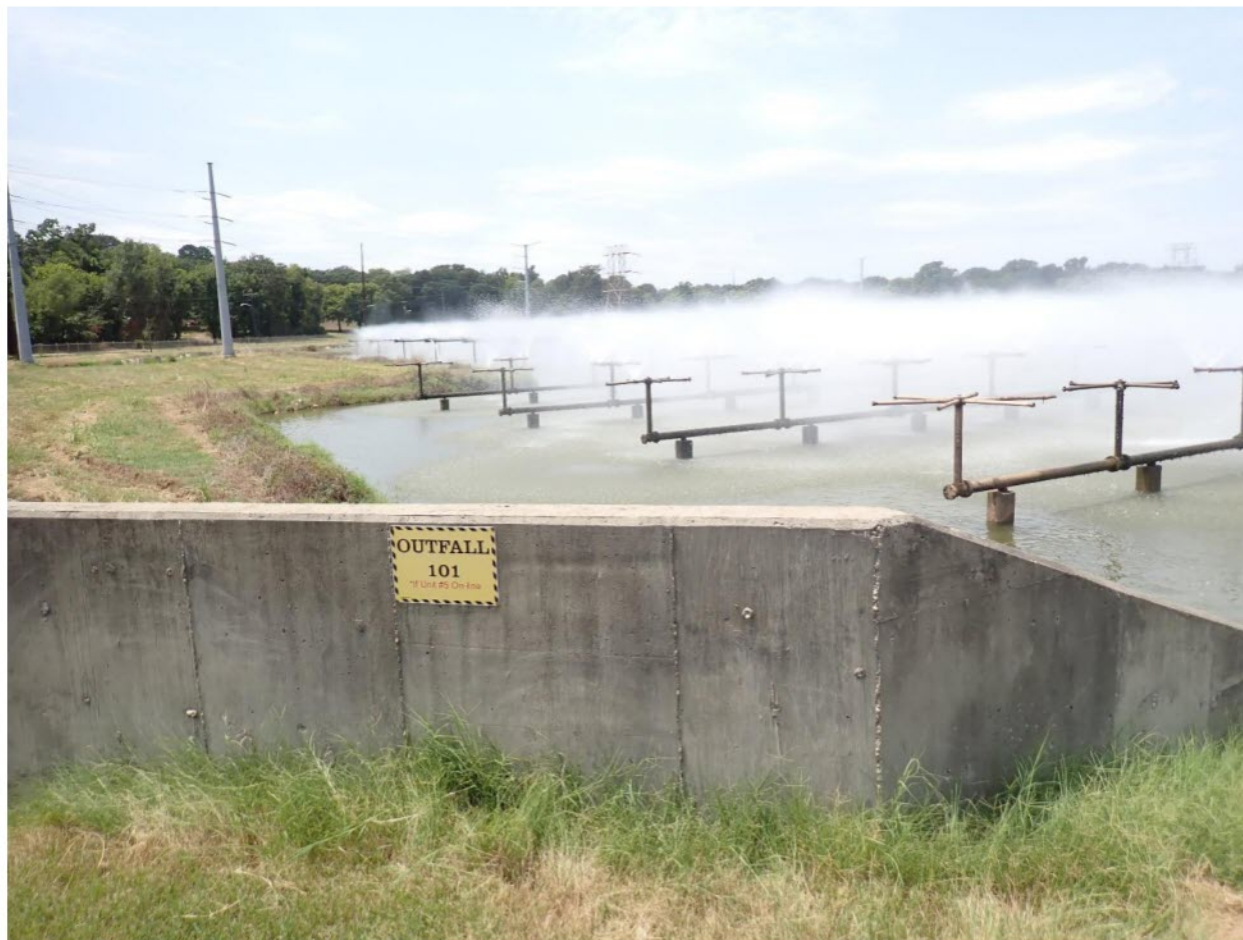
This image shows outfall 101 with an intermittent discharge of low volume wastewater, boiler blowdown, miscellaneous cooling water, water treatment wastewaters, and floor drains from unit 5. Internal Outfall 101 is monitored prior to the discharge into outfall 001 and thence Twelve Mile Bayou.

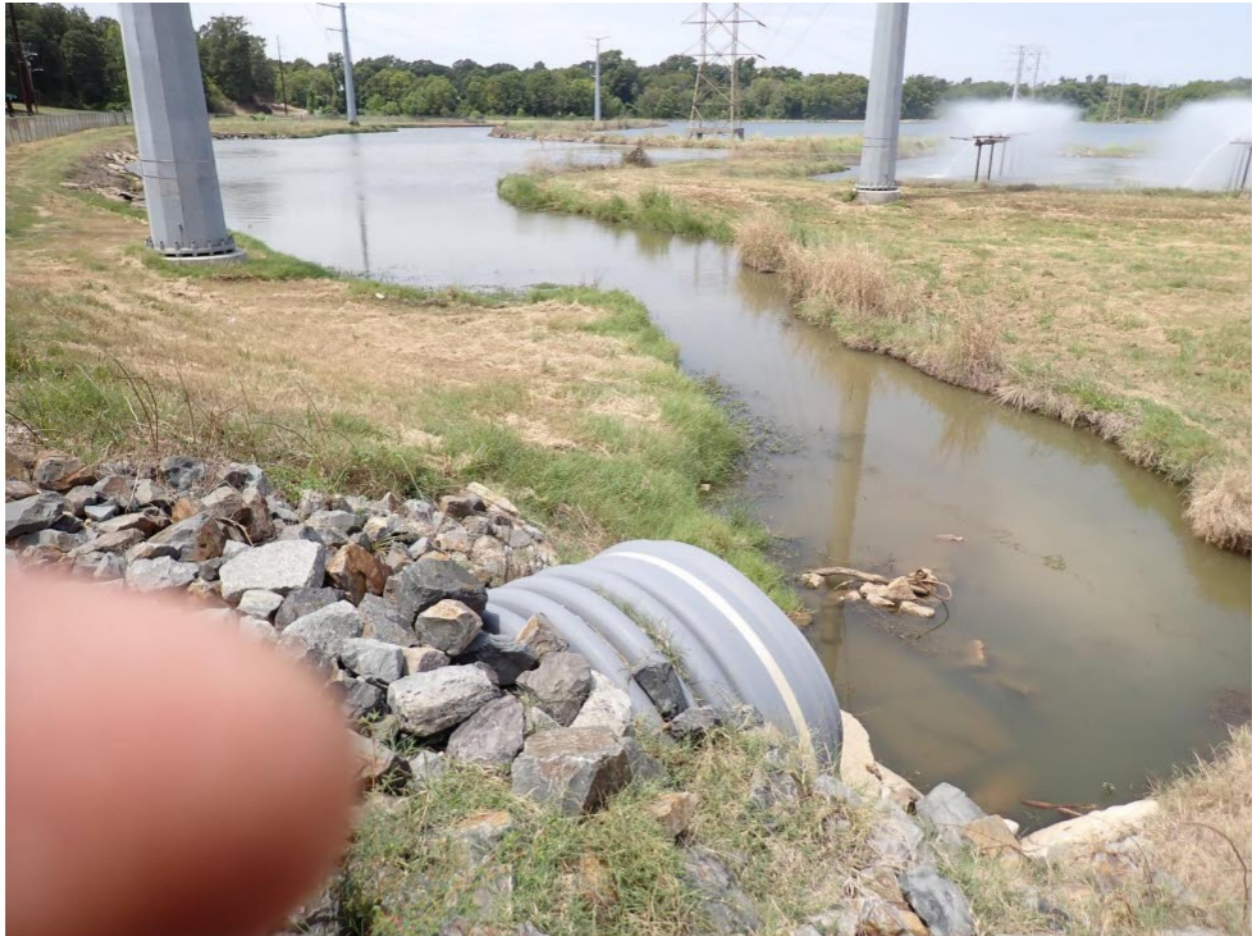
Photograph File Name: P8200041.JPG  
Date of Photograph: 08/20/2024  
Latitude and Longitud: 32.515956 -93.763297  
Orientation: SW  
Map Datum: WGS-84  
Time of Photo: 12:16 PM  
Photographer: Jack Arias  
Description: This image shows the cooling pond connected to the stormwater discharge system.
