## Region 6 Compliance Assurance and Enforcement Division

### INSPECTION REPORT

| Company Name: | <b>Southwestern Electric Power Company</b> | | |
| Facility Name: | <b>Arsenal Hill Power Plant</b> | | |

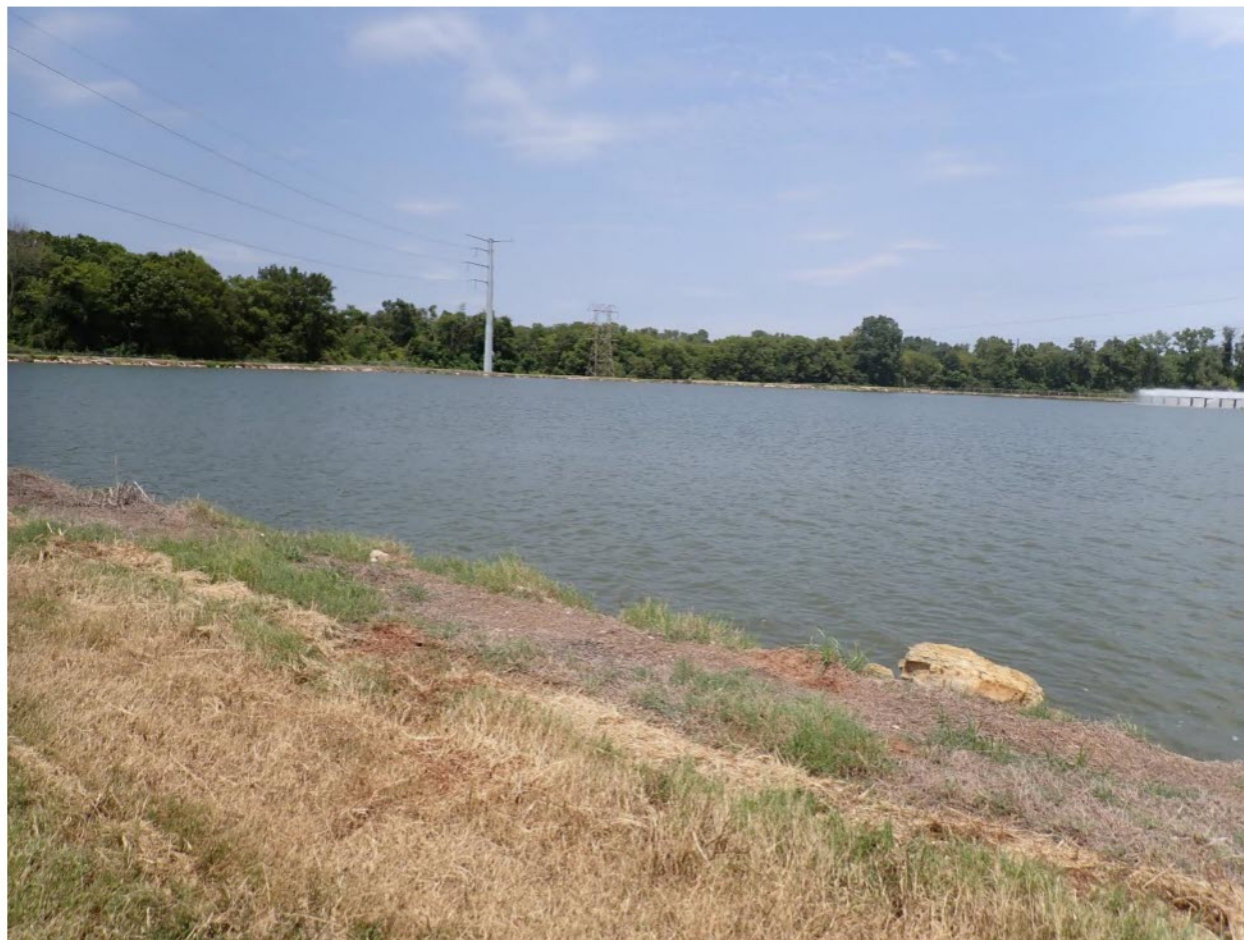
This outfall includes an intermittent discharge of low volume wastewater, including but not limited to, boiler blowdown, miscellaneous cooling water, water treatment wastewaters, and floor drains from unit 5. Internal Outfall 101 is monitored prior to the discharge into outfall 001 and thence Twelve Mile Bayou. There was flow and discharge at the time of the inspection and the water was brown in tint (See Photo Nos. 16 - 19 in Appendix 1).

Photograph File Name: P8200045.JPG  
Date of Photograph: 08/20/2024  
Latitude and Longitud: 32.519225 -93.766315  
Orientation: NW  
Map Datum: WGS-84  
Time of Photo: 12:20 PM  
Photographer: Jack Arias  
Description: This image shows the cooling pond system.

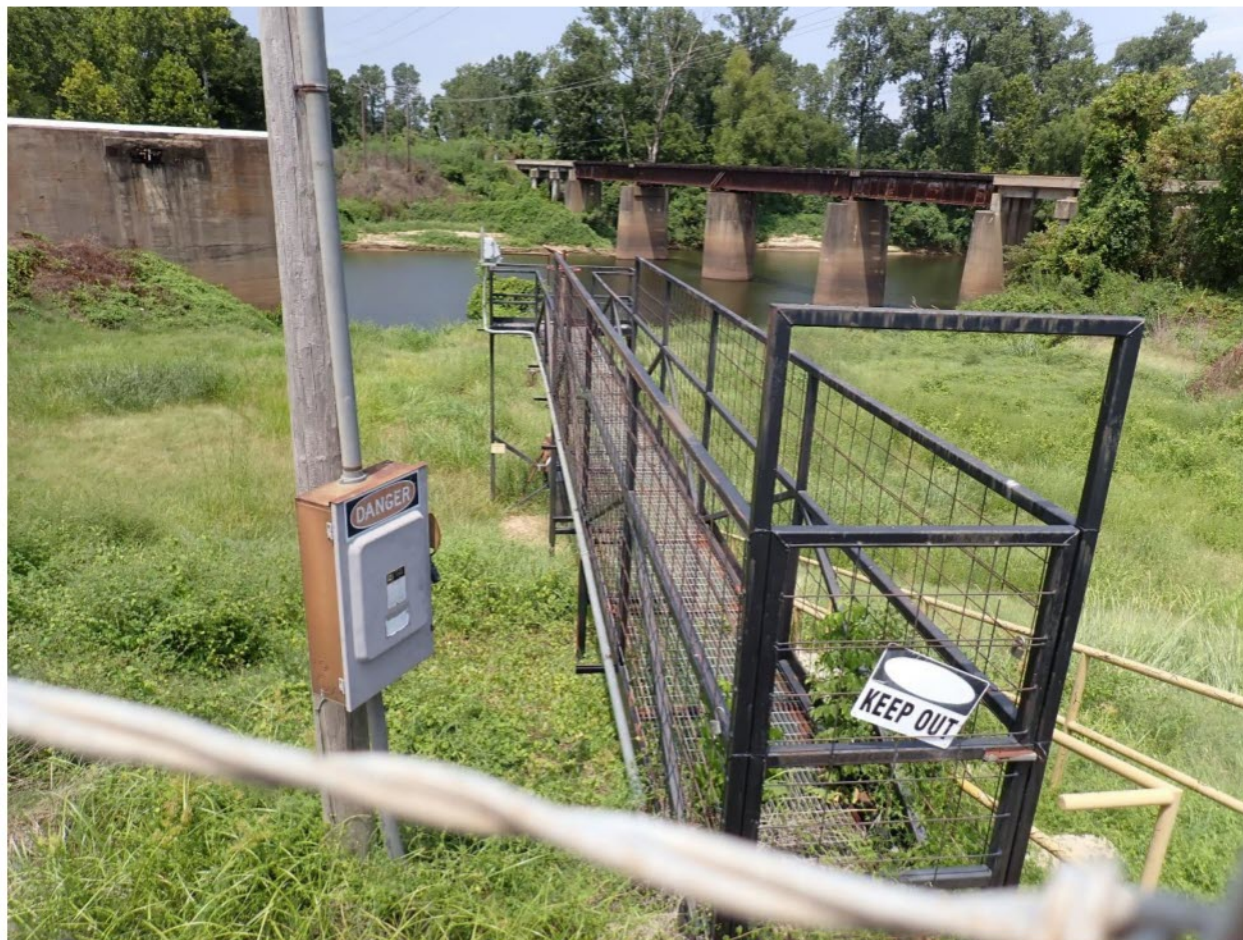
This outfall includes intermittent discharge of once-through cooling water, non-process area stormwater runoff, and previously monitored low volume wastewater from internal Outfall 101. Outfall discharge into Twelve Mile Bayou. There was not flow and discharge at the time of the inspection (See Photo No. 20 in Appendix 1).

This image shows the outfall 101 that includes intermittent discharge of once-through cooling water, non-process area stormwater runoff, and previously monitored low volume wastewater from internal Outfall 101. Outfall discharge into Twelve Mile Bayou.
