**Region 6 Compliance Assurance and Enforcement Division**  
**INSPECTION REPORT**

| Inspection Date(s): | 10/19/2017 | | |
| Regulatory Program(s) | NPDES | | |
| Facility Name: | [REDACTED] | | |

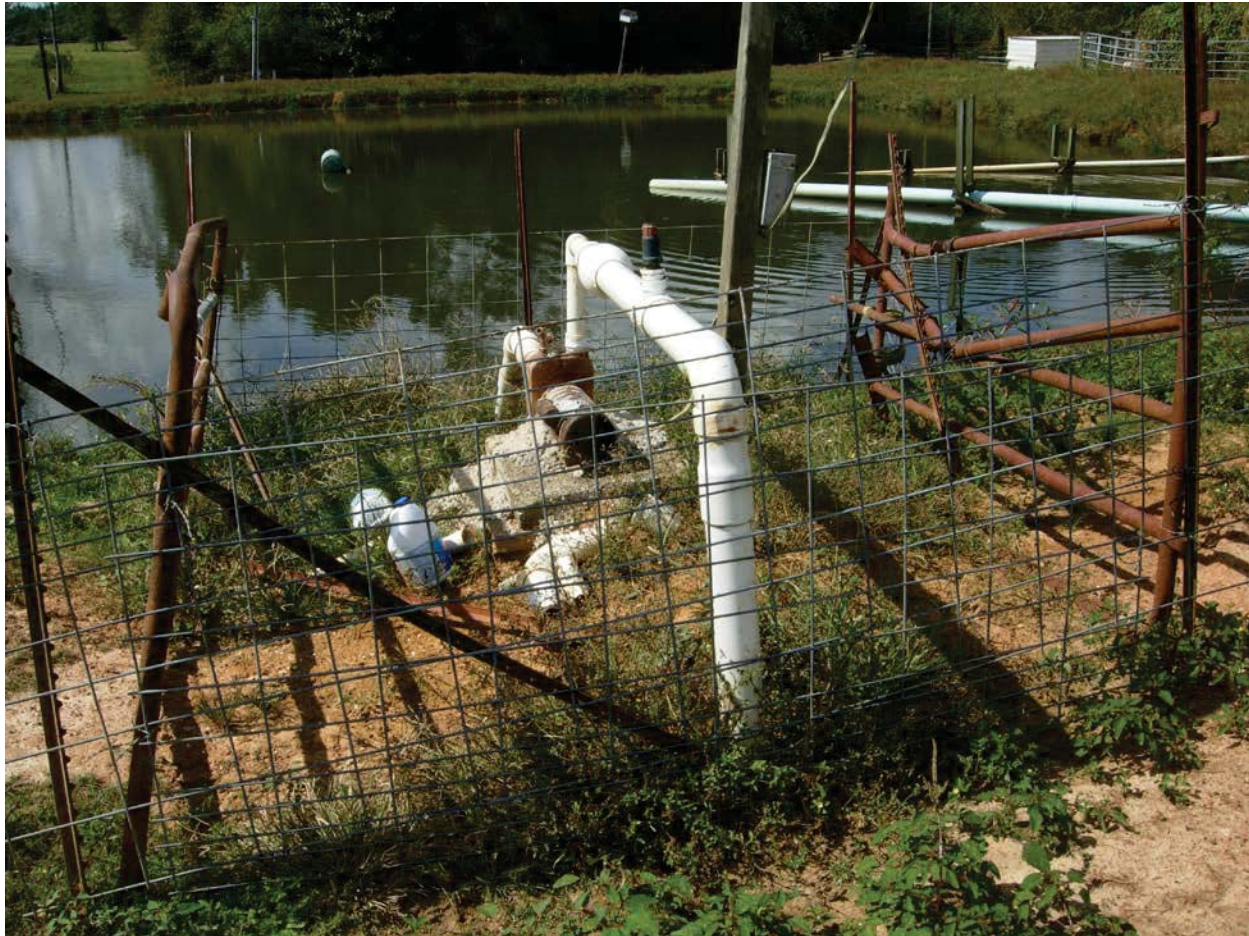
Photo No. 1

At the time of the inspection, [REDACTED] had a functioning electric pump capable of dewatering the RCS. [REDACTED] informed us that he pumps out the RCS about once every six weeks or as needed.

Description: Photo taken facing west toward dewatering equipment.

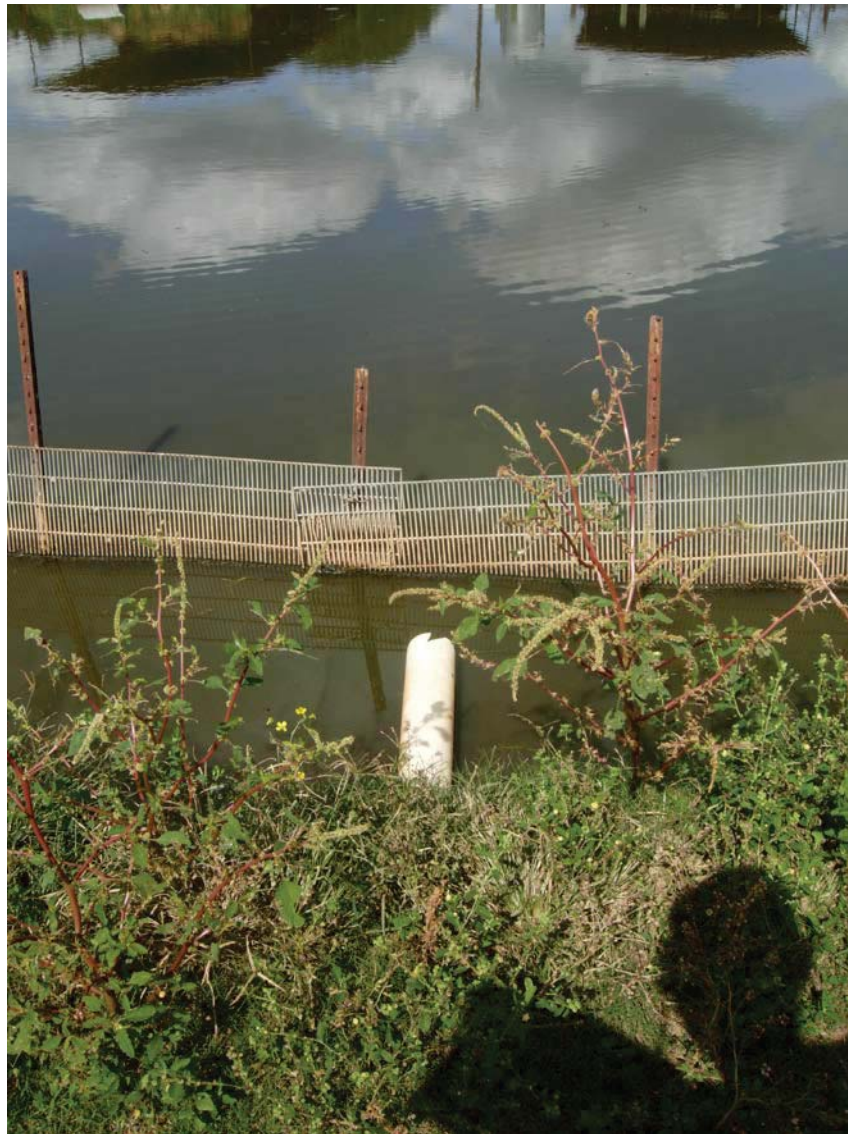
Photo No. 2

We observed the RCS to be in good condition and free from any evidence of discharge.

Description: Photo taken facing north towards pipe which would receive a discharge if wastewater levels reached high enough.
