# TAILINGS DAMS RISK OF DANGEROUS OCCURRENCES

*Lessons learnt from practical experiences*

Bulletin 121

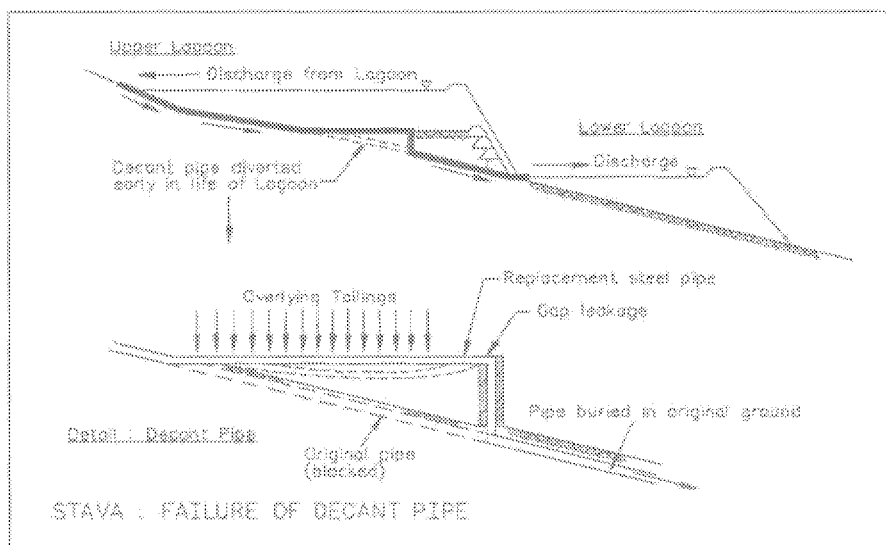
Figure 16. Failure of the decant pipe at Stava.
