## **RCRA Inspection Report**

Jaxon Energy LLC/Ashland Inc  
455 Industrial Drive  
Jackson, Mississippi 39206  
Hinds County  
EPA ID: MSR000106666/MSD000829150

February 13, 2024, at 9:20 a.m. CST

**COMPLIANCE EVALUATION INSPECTION PHOTOGRAPHS**

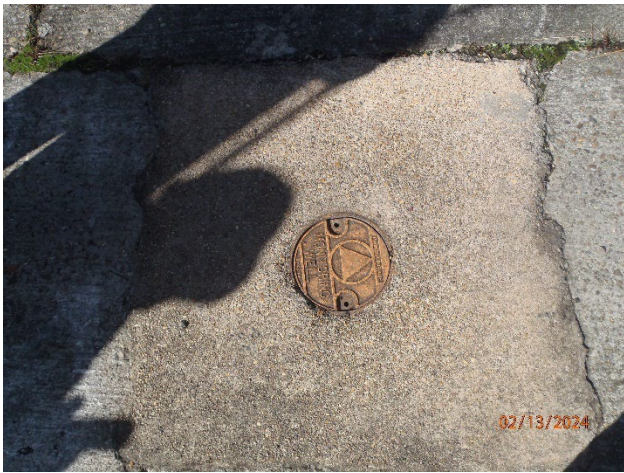
During the tour, the inspectors consulted the Figure 3 Arcadis Groundwater Monitoring Report map for the facility to locate the 31 monitoring wells on site. At that time of the inspection, the inspectors were only able to identify three monitoring wells (MW 13, MW18 and MW23) near the hydrogen gas plant (Pictures 1-3). The inspectors believe that at least one well may be located underneath the spent SMR catalyst drums along the fence line.

Picture 1 – Monitoring Well 13

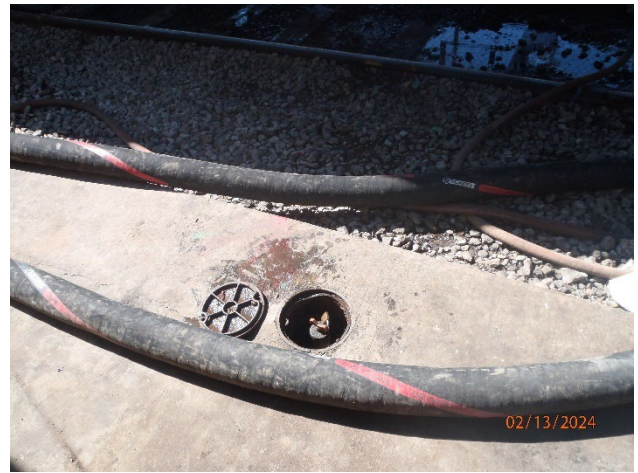
Mr. Olier and Mr. Ellison restarted the tour by identifying the groundwater monitoring wells within the facility. MW7 and MW16 were along the internal railway (AOC C), MW13, MW18, and MW23 (originally identified during the first tour with Mr. Scott), MW3 near Laydown Area in SWMU 4A, and MW19R in a flooded corner of the property along the fence line (Pictures 4-10). This well is buried under equipment and water. No other wells were identified in the main areas of the facility. The wells that were observed were not secured and the vault lid bolts were missing.

Picture 4 – Monitoring Well 7 in AOC C

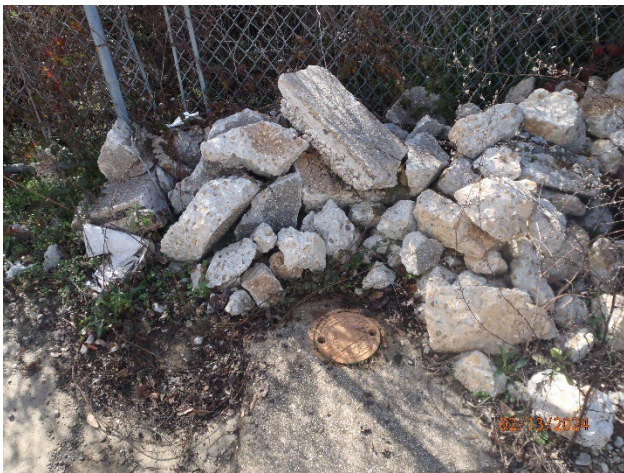
Picture 2 – Monitoring Well 18

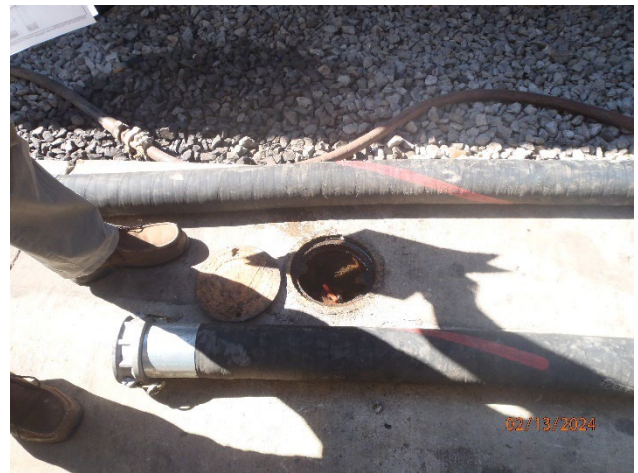
Picture 5 – Monitoring Well 16 in AOC C

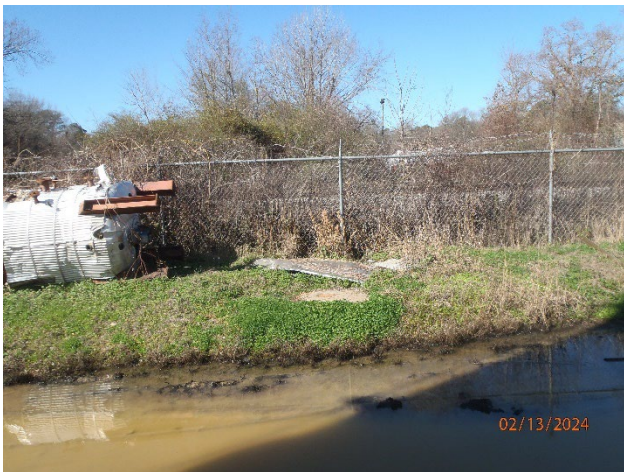
Picture 3 – Monitoring Well 23

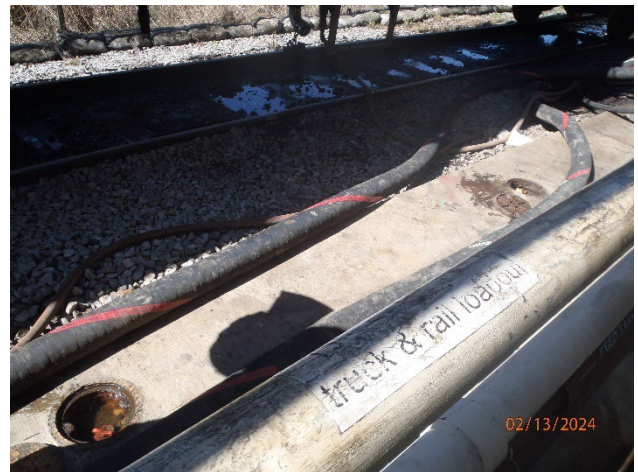
Picture 6 – Monitoring Wells 7 and 16 in AOC C

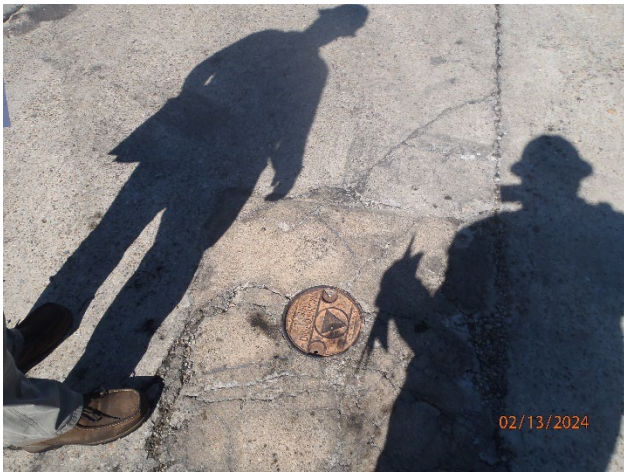
Picture 7 – Monitoring Well 3 near Laydown Area – SWMU 4A

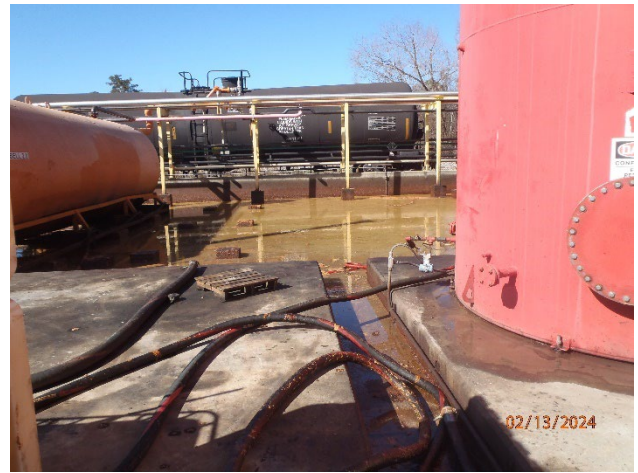
Picture 10 – Day Tank Farm containment flooding

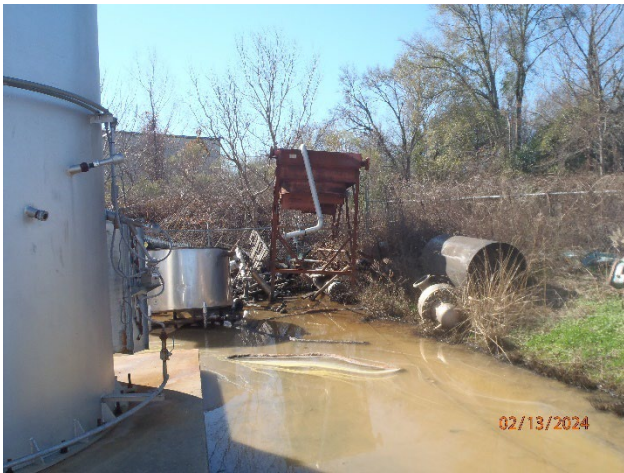
Picture 8 – Flooding near Monitoring Well 19R

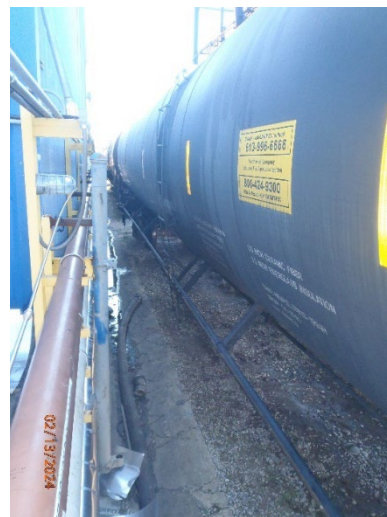
Next the inspectors were taken to the location of the 2020 diesel spill (Pictures 11-12). Mr. Ellison provided this information concerning the release: *An estimated 6,000-gallon spill of renewable diesel occurred due to overfilling a railcar tanker at the railcar unloading area. The diesel flowed into two ditches (one onsite concrete ditch and one offsite ditch associated with the adjoining railroad), which both discharge to a larger offsite west-east-oriented drainage ditch directly north of the facility. This west-east-oriented drainage ditch flows eastward until reaching Town Creek (approximately 520 feet). At this confluence, Town Creek continues to flow southward. The spilled diesel reached to the Shop Street bridge, which crosses Town Creek. Therefore, the spilled diesel travel approximately 0.5 miles downstream.* Mr. Olier and Mr. Ellison explained that Jaxon Energy LLC remediated the area to prevent further releases by installing a railway discharge to an oil water separator and sump collection basin (Pictures 13-21). This area is located between the corn oil unloading area and its secondary containment (Picture 21) and the second tank farm and its secondary containment.

Picture 11 – Internal Railway – area of 2020 Diesel Release

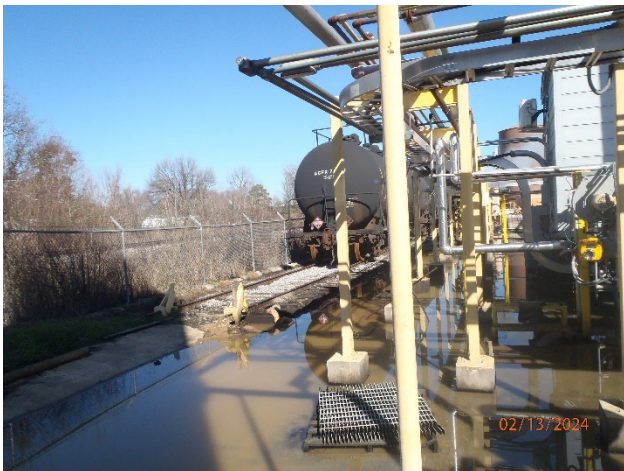
Picture 9 – Flooding along the railway

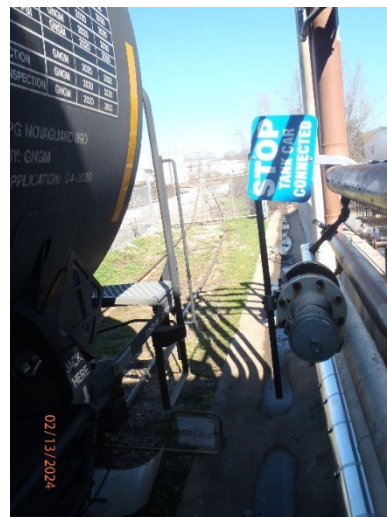
Picture 12 – Internal Railway – area of 2020 Diesel Release

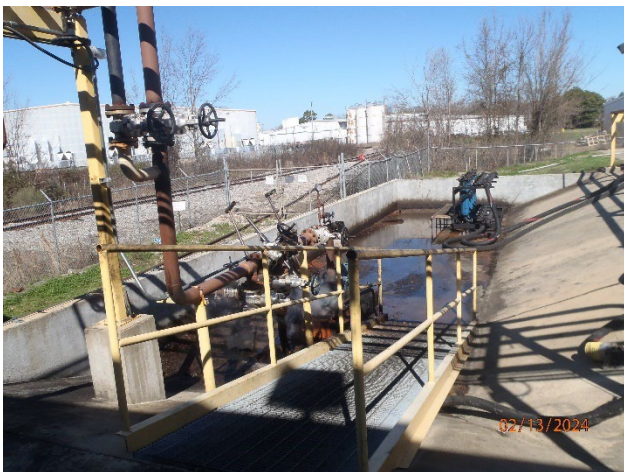
Picture 21 – Corn Oil unloading area and secondary containment

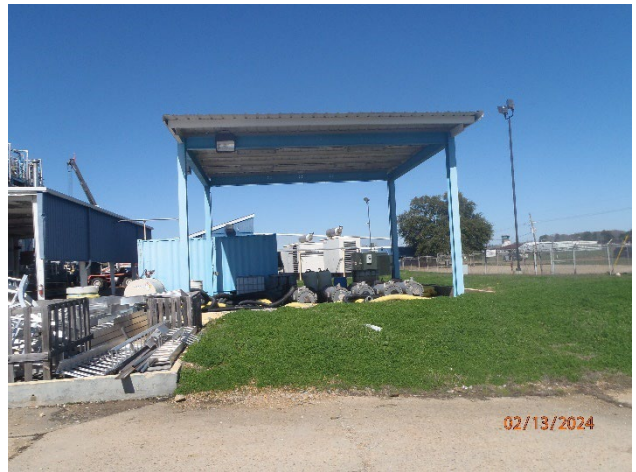
The inspectors explained to Mr. Olier and Mr. Ellison that the facility has an EPA ID Number and that a hazardous waste inspection of the facility was being conducted. In addition, since the facility is under corrective action the EPA inspector was requested to review the groundwater monitoring well maintenance and conditions, the vapor intrusion system and ancillary piping, the area of the 2020 diesel spill and the locations of Solid Waste Management Unit (SWMU) 4A and Areas of Concern (AOC) A, C and E. Mr. Olier provided the inspectors with the point of contact for Ashland Inc., Trey Richardson and for Arcadis, Brian Burke. Using the Figure 3 Arcadis Groundwater Monitoring Report map, Mr. Olier, Mr. Ellison, and the inspectors identified the SWMU and AOCs against the current plant layout. The group determined that SWMU 4A was the current laydown area (Picture 22), AOC C was the circular tower/air cooler tower and AOC E was the day tanks.

Picture 22 – Laydown Area – SWMU 4A

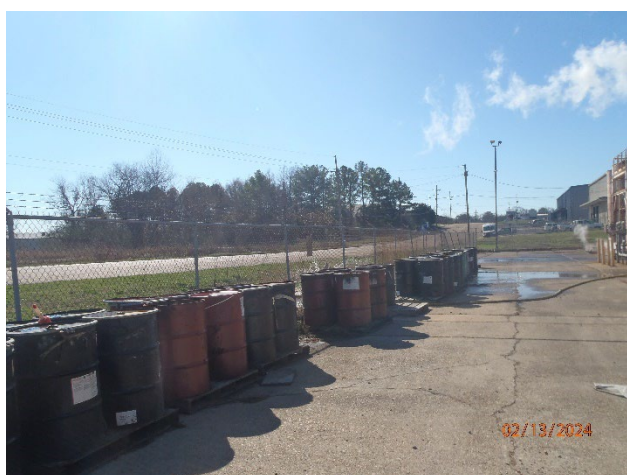
The second catalyst generated on site is a platinum catalyst from the R-25 Unit. This Steam Methane Reformer (SMR) catalyst is sent to Evonik Catalyst Recovery of Louisiana, LLC in Lafayette, Louisiana for regeneration and then returned to Jaxon Energy LLC. When the catalyst can no longer be regenerated it is placed in 55-gallon drums and stored along the fence near the hydrogen gas plant (Pictures 32-33). This spent catalyst has not been analyzed and needs a waste disposal profile.

Picture 32 – SMR Spent Catalyst Drums

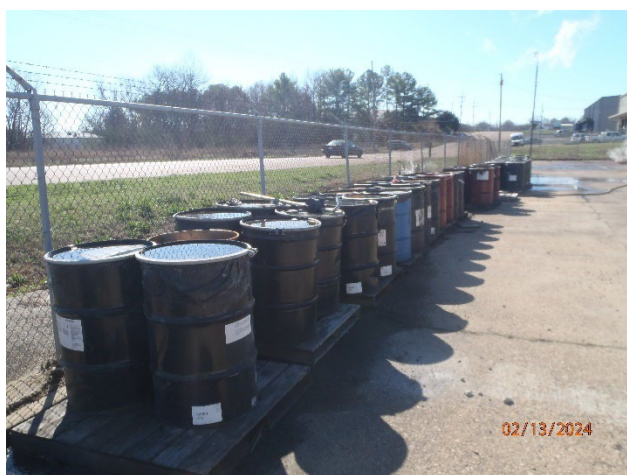
Picture 33 – SMR Spent Catalyst Drums
