**UNITED STATES ENVIRONMENTAL PROTECTION AGENCY, REGION 2  
CARIBBEAN ENVIRONMENTAL PROTECTION DIVISION  
MULTIMEDIA PERMITS AND COMPLIANCE BRANCH**

**Industrial Site  
NPDES Stormwater Reconnaissance Inspection**

**CHITOLIE TRUCKING SERVICE, LLC**

Inspection Date: November 2, 2022

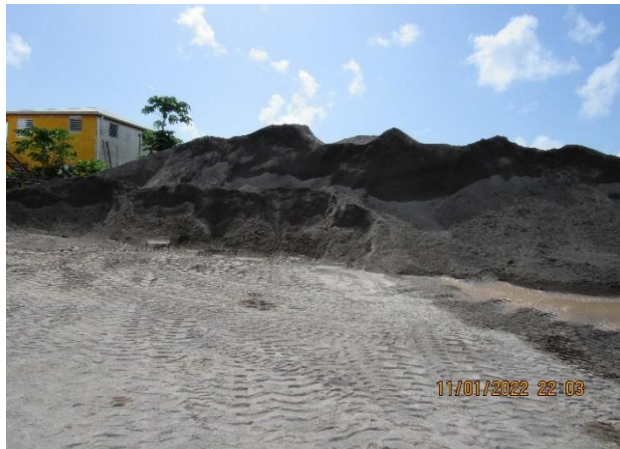
- a. Potential for release of Aggregate (sand and gravels) out of the Facility – Observed that the aggregate cells are situated in the stormwater runoff flow path, and thus an increased chance being washed-off and discharged off-site by stormwater that comes into contact with the materials. See **IMGs 760 and 762 of CHITOLIE’S November 2, 2022 NPDES SWI Photo Album, ATTACHMENT 1**, of the 2022 Inspection Report.

**IMG 760**-Storage cell with sand situated about mid-way along the eastern border of the Facility. Cell is exposed to rain and stormwater runoff flow.

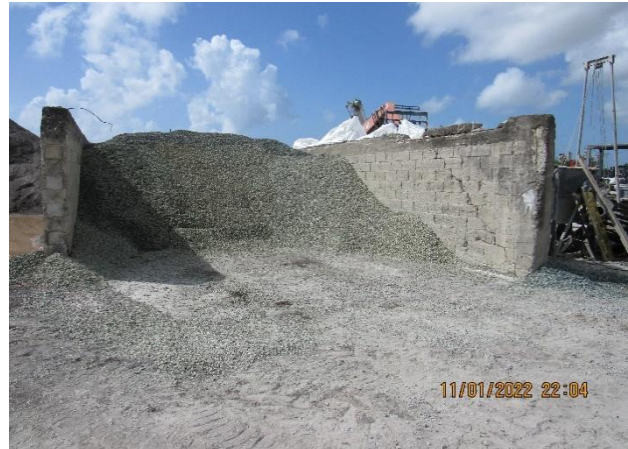
**IMG 762**-Storage cell with gravel situated next to sand storage. Storage area exposed to stormwater runoff flow, leading to wash-off of material.

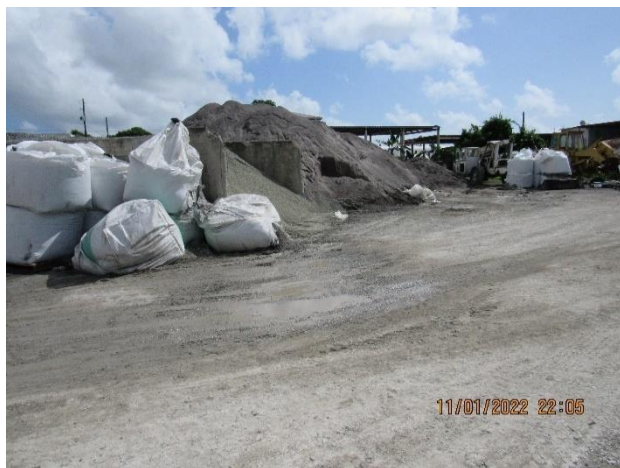
- b. Failure to minimize discharge of Pollutants from the Facility – Observed that some bags of cement in the materials storage area were ripped and their content spilled onto the ground. The spilled cement was observed in the stormwater runoff flow path and would readily be washed-off by stormwater that comes into contact with the material and will be discharged off-site. See **IMGs 765, 767 and 768 of CHITOLIE’S November 2, 2022 NPDES SWI Photo Album, ATTACHMENT 1**, of the 2022 Inspection Report.

**IMG 767**-Bags of cement stored immediately next to aggregate (sand & gravel) cells. Some bags were ripped, with cement spilled onto ground.

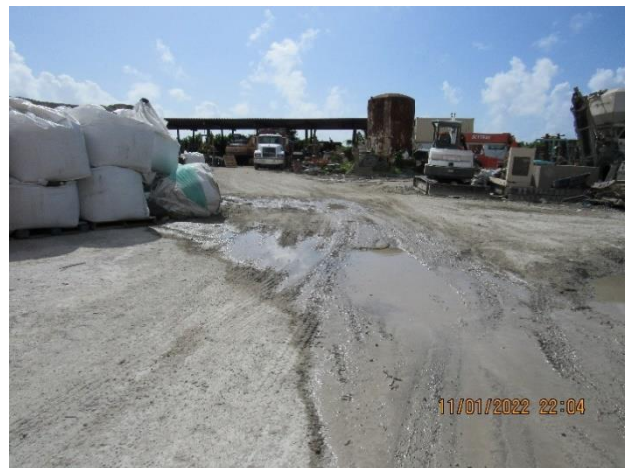
**IMG 768**-Observed that the cement bags and spilled cement sits in the stormwater flow path. Cement spilled will be washed-off by stormwater runoff.

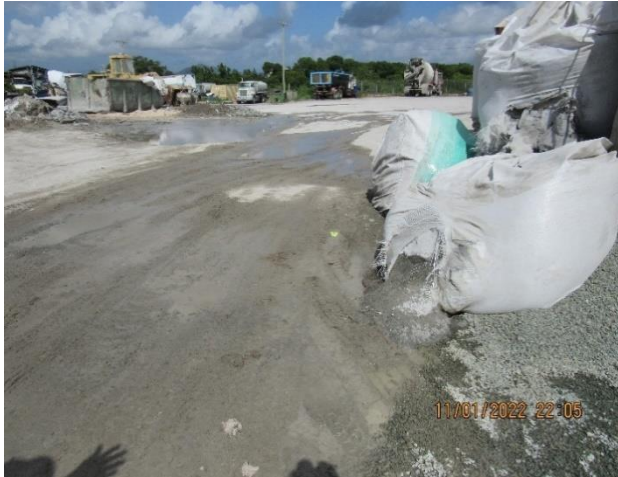
**IMG 765**-Close-up of cement and gravel in the path of stormwater flow that drains toward the retention

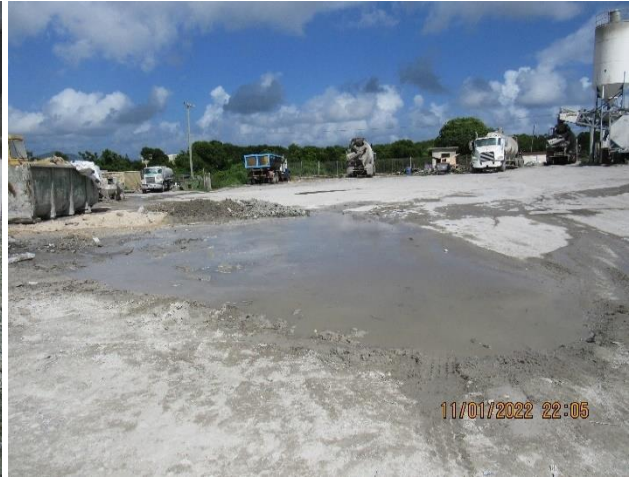
**IMG 766**-Close-up retention pond, and deposited spent concrete used to form a berm.

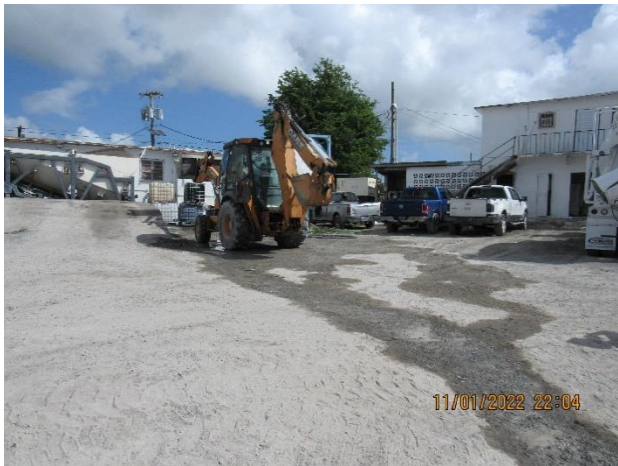
- a. Failure to segregate process wastewater from stormwater runoff – Observed a dry-weather flow stream from around the concrete batch plant that drained towards a shallow depression in the ground situated in the middle of the Facility. According to Uriah Chitolie, the observed shallow depression serves as a “retention area” for stormwater runoff and waste streams generated onsite, which in turn drains along the ground and out of the Facility into the public road. See **IMGs 785, 783, 763 and 764 of CHITOLIE’S November 2, 2022 NPDES SWI Photo Album, ATTACHMENT 1**, of the 2022 Inspection Report.

**IMG 763**-Observed dry-weather flow coming from the ready-mix concrete plant and drained towards the pond.

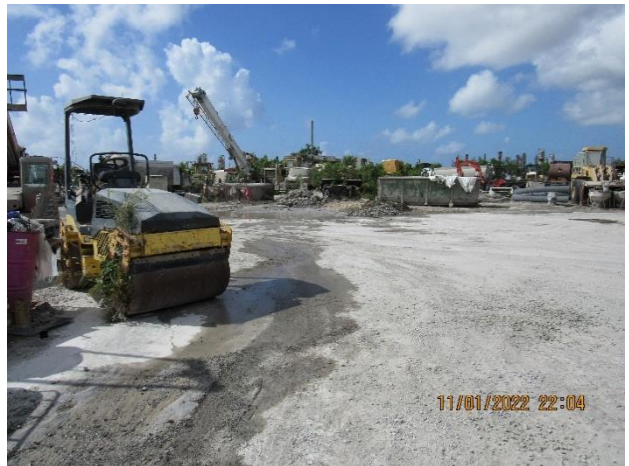
**IMG 764**-Path of dry-weather flow from the ready-mix concrete plant running across the yard towards the retention pond.

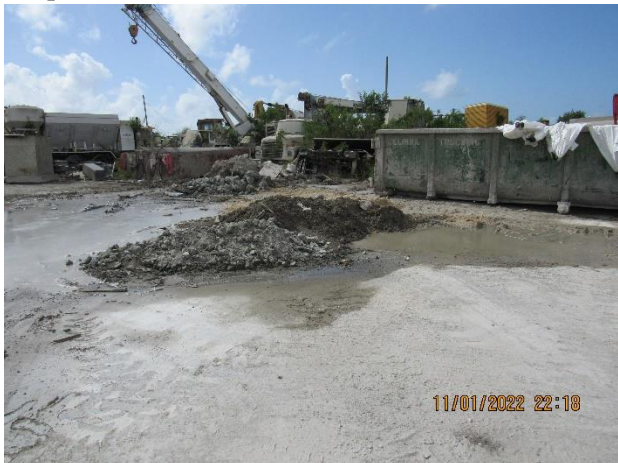
- a. Potential for Discharge of spent ready-mixed concrete out of the Facility – Observed that spent ready-mixed concrete was used to form a containment berm around part of the Facility’s stormwater retention pond. See **IMG 773 of CHITOLIE’S November 2, 2022 NPDES SWI Photo Album, ATTACHMENT 1**, of the 2022 Inspection Report.
- b. Wet-weather flow discharged out of the Facility – Observed that a dry-weather flow event of wastewater from the retention pond was occurring at the time of the walkthrough, which flowed out of the Facility, and into the public road. See **IMGs 774 and 775, 777 and 778 of CHITOLIE’S November 2, 2022 NPDES Stormwater SWI Photo Album, ATTACHMENT 1**, of the 2022 Inspection Report.

Evidence revealed that the spent ready-mixed concrete forming the berm will readily be washed-out by stormwater runoff flow, and eventually discharged out of the Facility.

**IMG 773**-Edge of the pond where spent concrete to a berm. The berm ineffective because a dry-weather flow drained from the pond. and out of the Facility. wastewater).

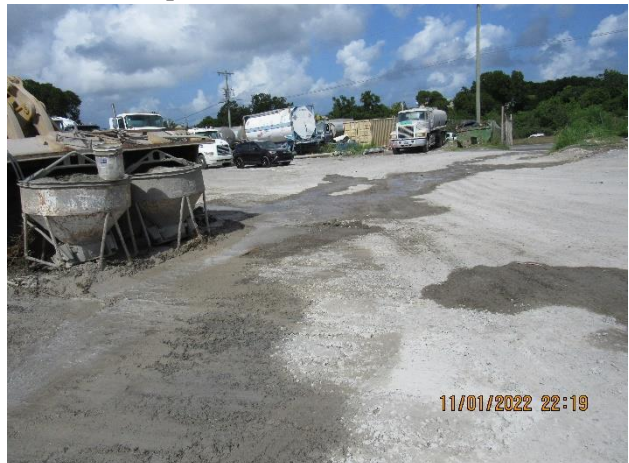
**IMG 774**-Dry-weather flow the pond drains away from the pond across the yard towards the lower entrance/exit, transporting pollutants (e.g., industrial wastewater).

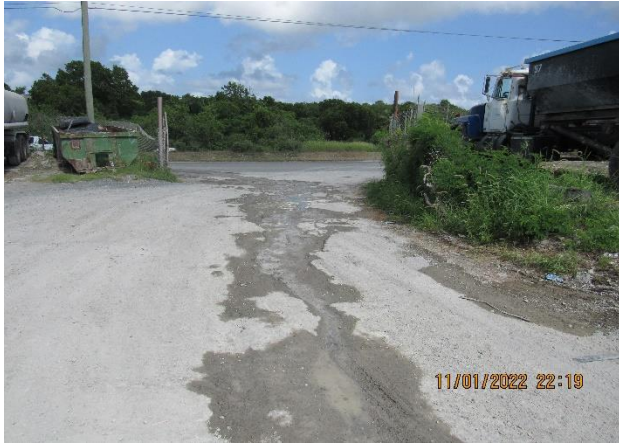
**IMG 775**-Dry-weather flow being discharged from Facility through the lower entrance/exit.

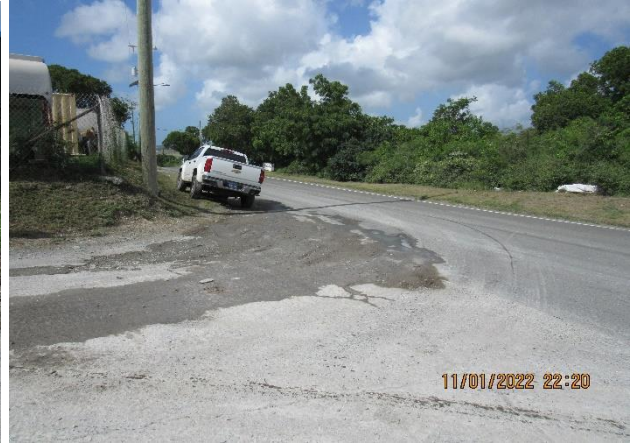
**IMG 777**-Dry-weather flow leaving the Facility and out into the public road.

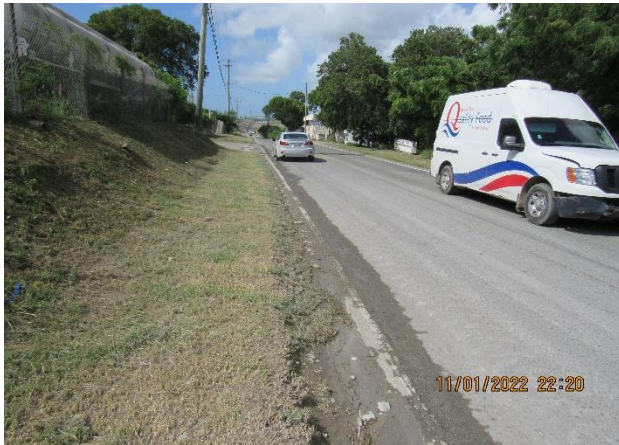
**IMG 778**-View of dry-weather flow event occurring and running along left side of the road downhill in the stormwater flow path along the road.

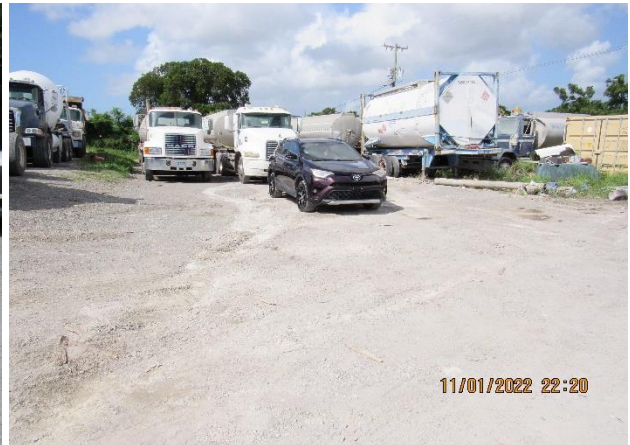
**IMG 776**-Evidence of stormwater flow path from a staging area for fuel-tanker trucks, dump trucks other heavy equipments before draining off-site.

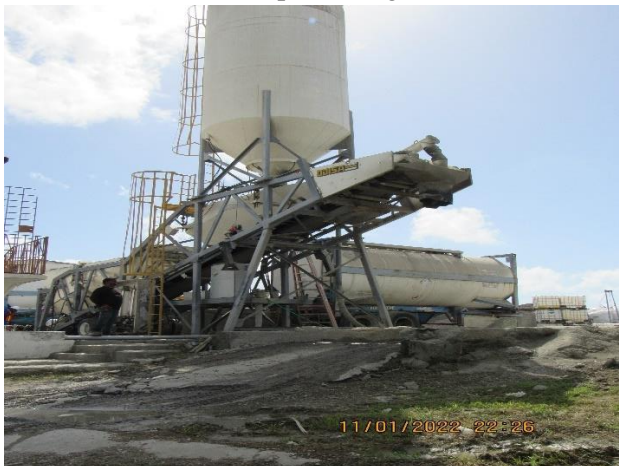
- c. Potential for discharge of Pollutants from the Ready-mixed Concrete Loading Bay – Observed that the product loading bay is situated in a location and oriented in a manner, that spilled residues of ready-mix concrete or wastewater generated from washing of residues off the exterior of concrete trucks within the general loading bay, will drain-off into the nearby road. See **IMGs 786, 780 and 781 of CHITOLIE’S November 2, 2022 NPDES SWI Photo Album, ATTACHMENT 1**, of the 2022 Inspection Report.

**IMG 786**-View of ready-mixed concrete loading bay, the wider ready-mixed manufacturing plant, situated adjacent to the Admin Office.

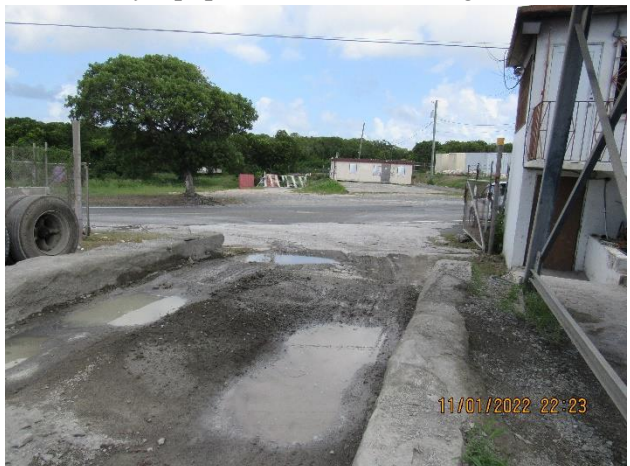
**IMG 780**-Close-up of the ready-mixed concrete loading bay, inclined down towards the public road.

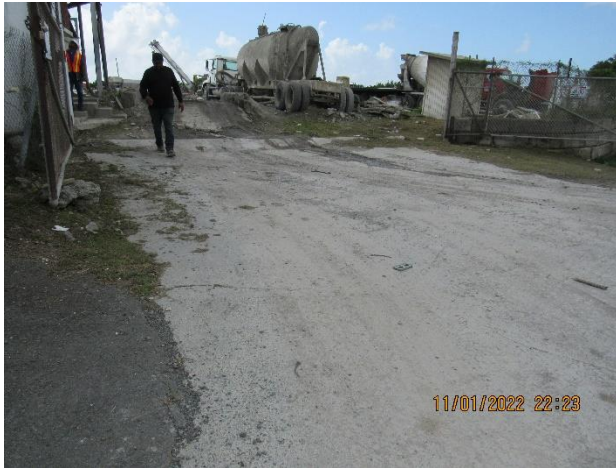
**IMG 781**-View of the ready-mix loading bay, upper entrance/exit and stormwater flow path out of the Facility and into the public road.

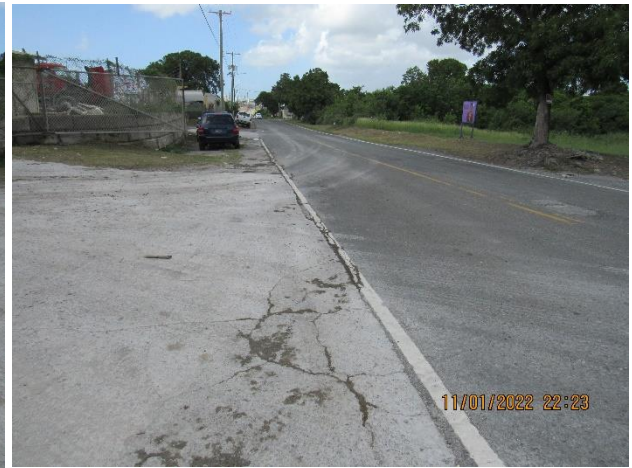
**IMG 782**-Evidence of track-out of pollutants from Facility and into the public road. Path of stormwater runoff leaving the Facility from upper entrance/exit.

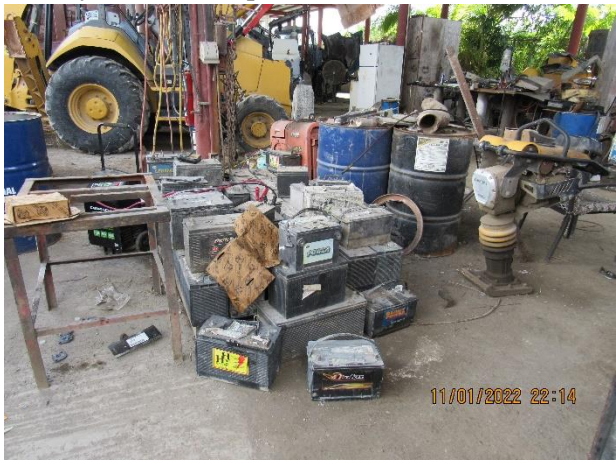
- a. Improper management of regulated hazardous wastes – The EPA Inspector observed many spent automobile batteries staged on the floor of the mechanical maintenance shed where the Facility's vehicle fleet and heavy equipments are serviced. The spent batteries were situated in very close proximity to operational machinery used during mechanical repair work and metal drums with materials. See **IMG 771 of CHITOLIE'S November 2, 2022 NPDES Stormwater SWI Photo Album, ATTACHMENT 1**, of the 2022 Inspection Report.

**IMG 771**-Accumulation of spent auto batteries situated on floor of maintenance shed in potentially managed under incompatible conditions.

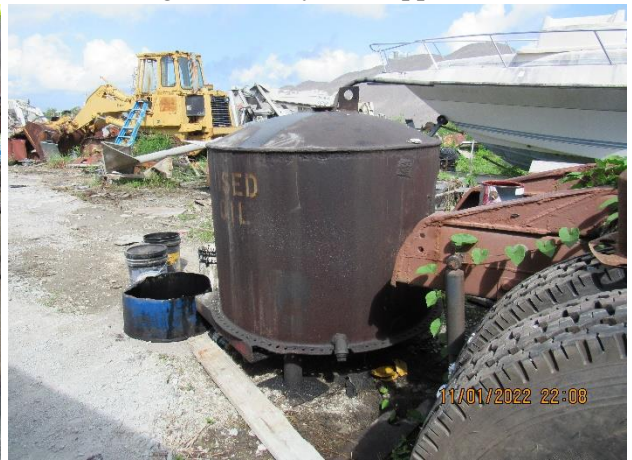
- a. Failure to Minimize the Potential for Release of Improperly Stored Used-oil – Observed a large metal tank in which Chitolie stores used oil generated from servicing its fleet of trucks, other vehicles, and heavy equipments. The used oil storage tank was not within a containment to capture leaks and accidental spills that may occur during management of the waste. The EPA Inspector also observed several smaller containers (5-gallons plastic buckets and cut-metal drums with used oil residues) staged immediately around the larger storage tank and not within a containment for prevention of additional releases of the pollutant in the event of accidental spills from the smaller vessels.

- b. Improper housekeeping practices at Facility's Used Oil Management Station – The EPA Inspector observed that the surface of the storage vessel was wet with oil residue, and the ground surface beneath it appeared saturated from spilled used oil. The storage tank was exposed to all environmental conditions. Stormwater runoff that comes in contact with the oil-saturated soil will readily transport the pollutant from and out of the Facility.

**IMG 769**-Container in which the Facility's used oil is collected and stored on-site. Improper housekeeping conditions observed and documented.

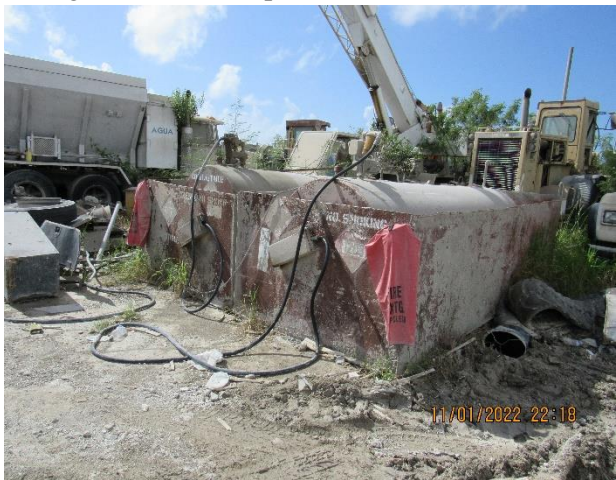
- a. Potential for release of petroleum product during operation of the fueling terminal – The EPA Inspector did not observe containment around the area where vehicles are positioned to be serviced at the fueling terminal. In the event of fuel releases caused by accidental spilled or leaks during fueling operation, petroleum products will fall immediately onto the ground area in front of the metal containment within which the fuel storage tanks sit. The fueling terminal is exposed to all environmental conditions. Stormwater runoff flow will readily come into contact with the petroleum product saturated soil and will be transported off-site. See **IMGs 772 of CHITOLIE'S November 2, 2022 NPDES SWI Photo Album, ATTACHMENT 1** of the 2022 Inspection Report.

**IMG 772**-Facility's fueling terminal situated in path of stormwater flow. No containment in area where vehicles are staged for fueling service.

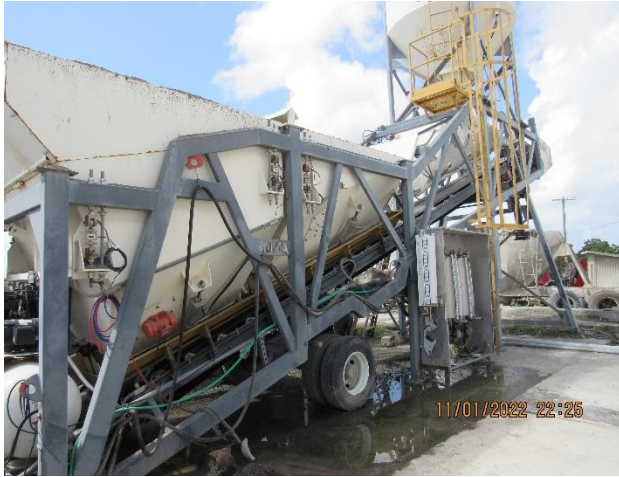
**IMG 785**-Accumulation of water beneath ready-mix Ed concrete batch plant related to operations of the system. Source of a dry-weather flow observed.

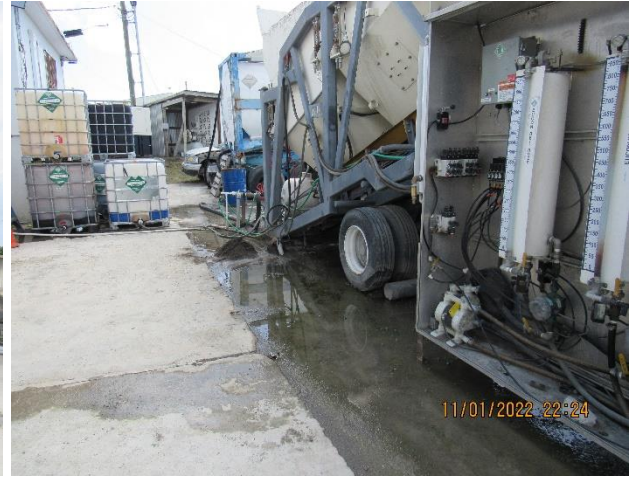
**IMG 783**-Close-up of accumulated water beneath the batch plant, and point where dry-weather flow observed began.

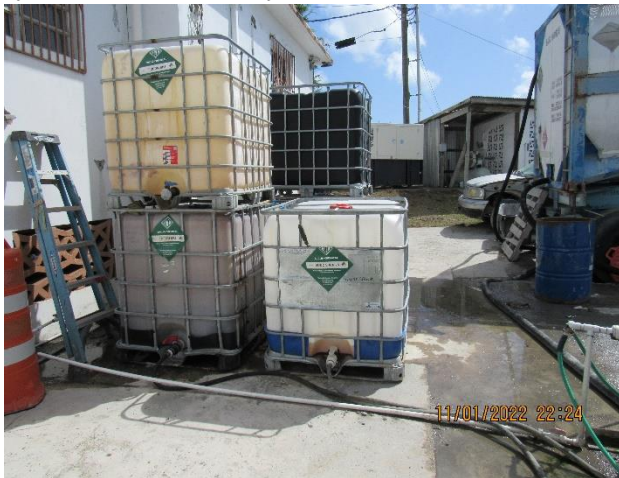
- b. Failure to minimize potential release of pollutants – Observed that the chemical application system (totes and application hoses) for the ready-mix concrete manufacturing process was not situated in a containment through which leaks, and accidental spills of the chemical additives would be captured, minimizing the chances of releases of the pollutants exposed to stormwater runoff flow from the area in question. See **IMGs 783 and 784 of CHITOLIE’S November 2, 2022 NPDES SWI Photo Album, ATTACHMENT 1**, of the 2022 Inspection Report.

**IMG 784**-Observed totes of chemical additives with connective application hoses by stormwater into the ready-mix concrete manufacturing process.

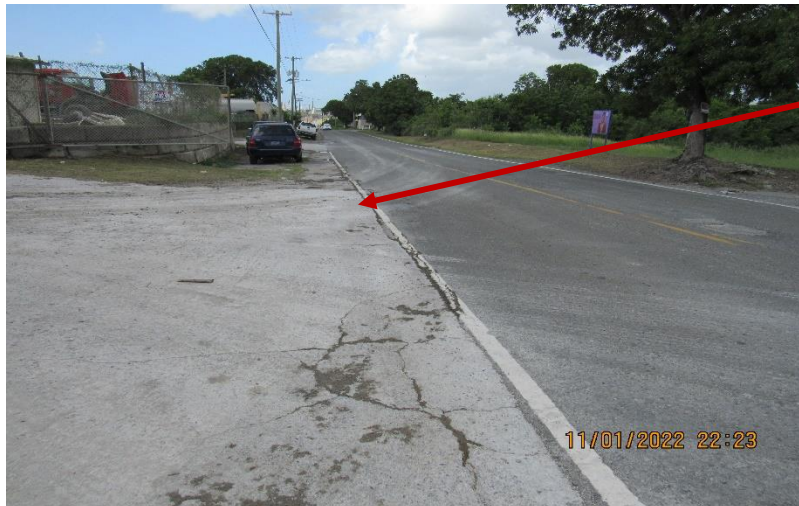
- o **Outfall 1** – Stormwater runoff flow from through the area around the administrative office building and the upper entrance/exit used to access the ready-mixed concrete loading bay. Outfall 1 is featured in **IMG 782 in Part B of CHITOLIE’S November 2, 2022 NPDES Stormwater SWI Photo Album, ATTACHMENT 1**, of the 2022 Inspection Report.
- o **Outfall 2** – Stormwater runoff flow through the lower entrance/exit through which the dry-weather discharge flow was observed flowing out of the Facility during the 2022 Inspection. Outfall 2 is featured in **IMG 777 in Part B of CHITOLIE’S November 2, 2022 NPDES Stormwater SWI Photo Album,**

**Outfall 1** – Discharge of stormwater flow from the upper driveway into area stormwater drainage system, then into Cane Garden Bay

**IMG 782**-Discharge point where stormwater runoff flow from around the Ready-Mixed Concrete Plant loading bay and vicinity of the Administrative Building are combined and discharged into the public road through the upper entrance/exit. Stormwater flow drains into Fig Tree Ghut, and Cane Garden Bay downstream.

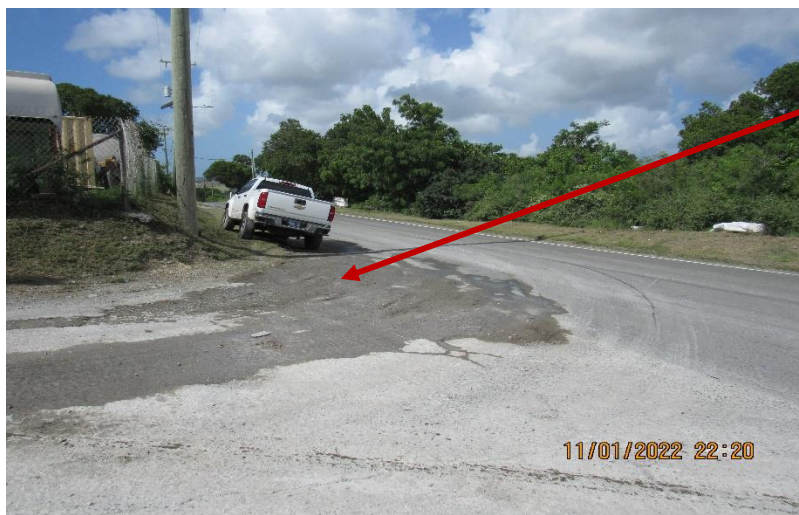
**Outfall 2** – Discharge of stormwater flow from the lower driveway into the area stormwater drainage system, then into the Cane Garden Bay

**IMG 777**- Discharge point where stormwater runoff flow from the central area (shallow retention pond) combined with flow from the northwestern (truck parking area) of the Facility and discharged into the public road through the lower entrance/exit. Stormwater flow drains into Fig Tree Ghut, and Cane Garden Bay downstream.
