**Report Title:** Clean Air Act Inspection of Dynax America Corporation  
**Inspection Date(s):** 1/28/2025  
**Regulatory Program(s):** Title V, MACT, NSPS, NESHAP, SIP

**Company Name:** Same as below  
**Facility Name:** Dynax America Corporation  
**Facility Location:** 568 East Park Drive  
Roanoke, VA 24019

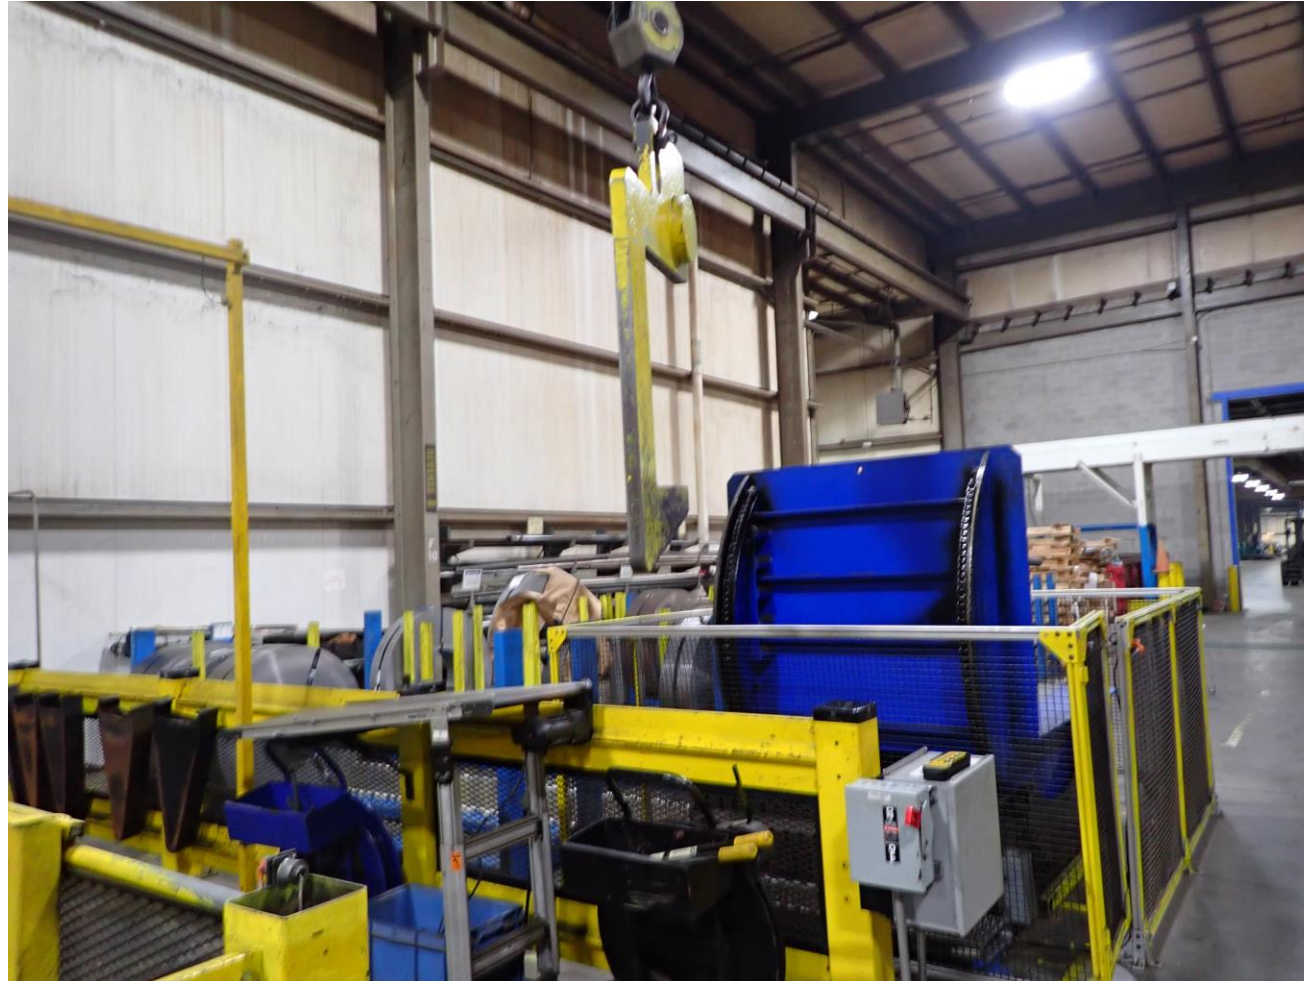
Photo Number: 001

Photo Description: Raw Material Receiving

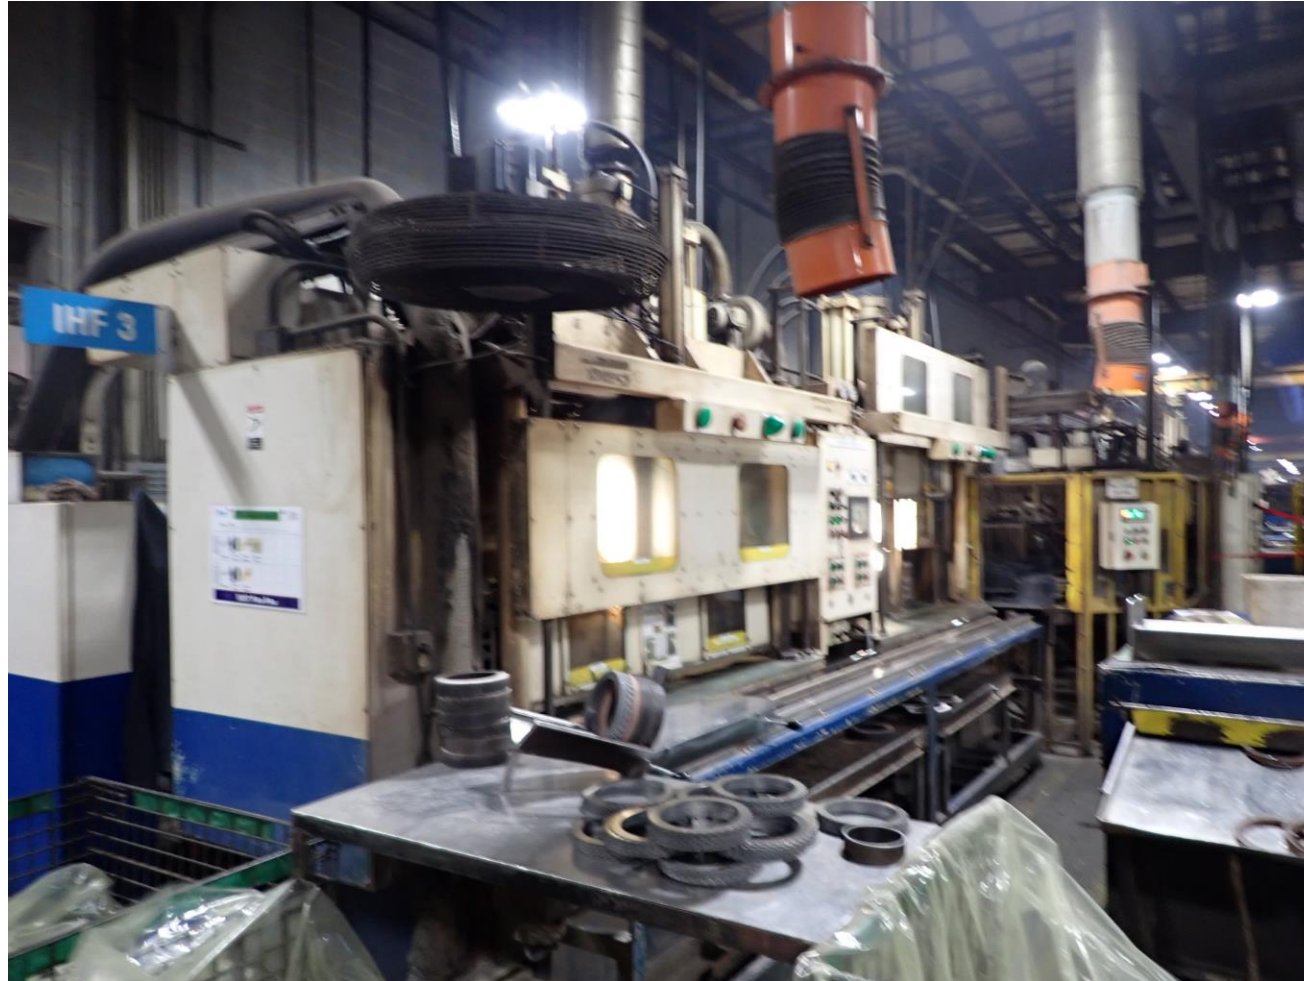
Photo Number: 002

Photo Description: Induction Heat Unit #3

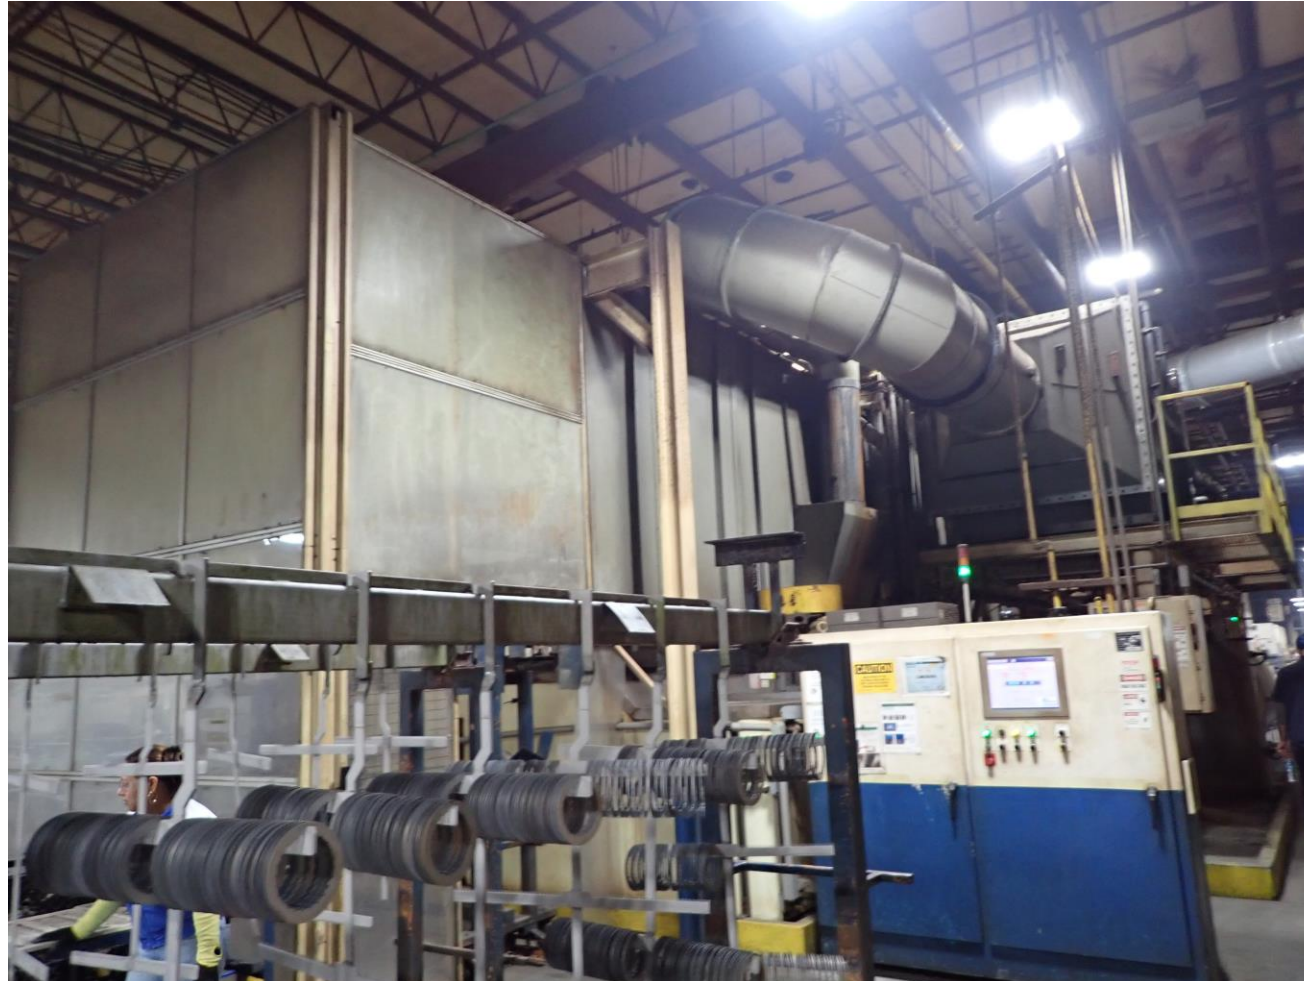
Photo Number: 003

Photo Description: Acid Etch Unit #3 (Surface Treatment Line 3, ST3)

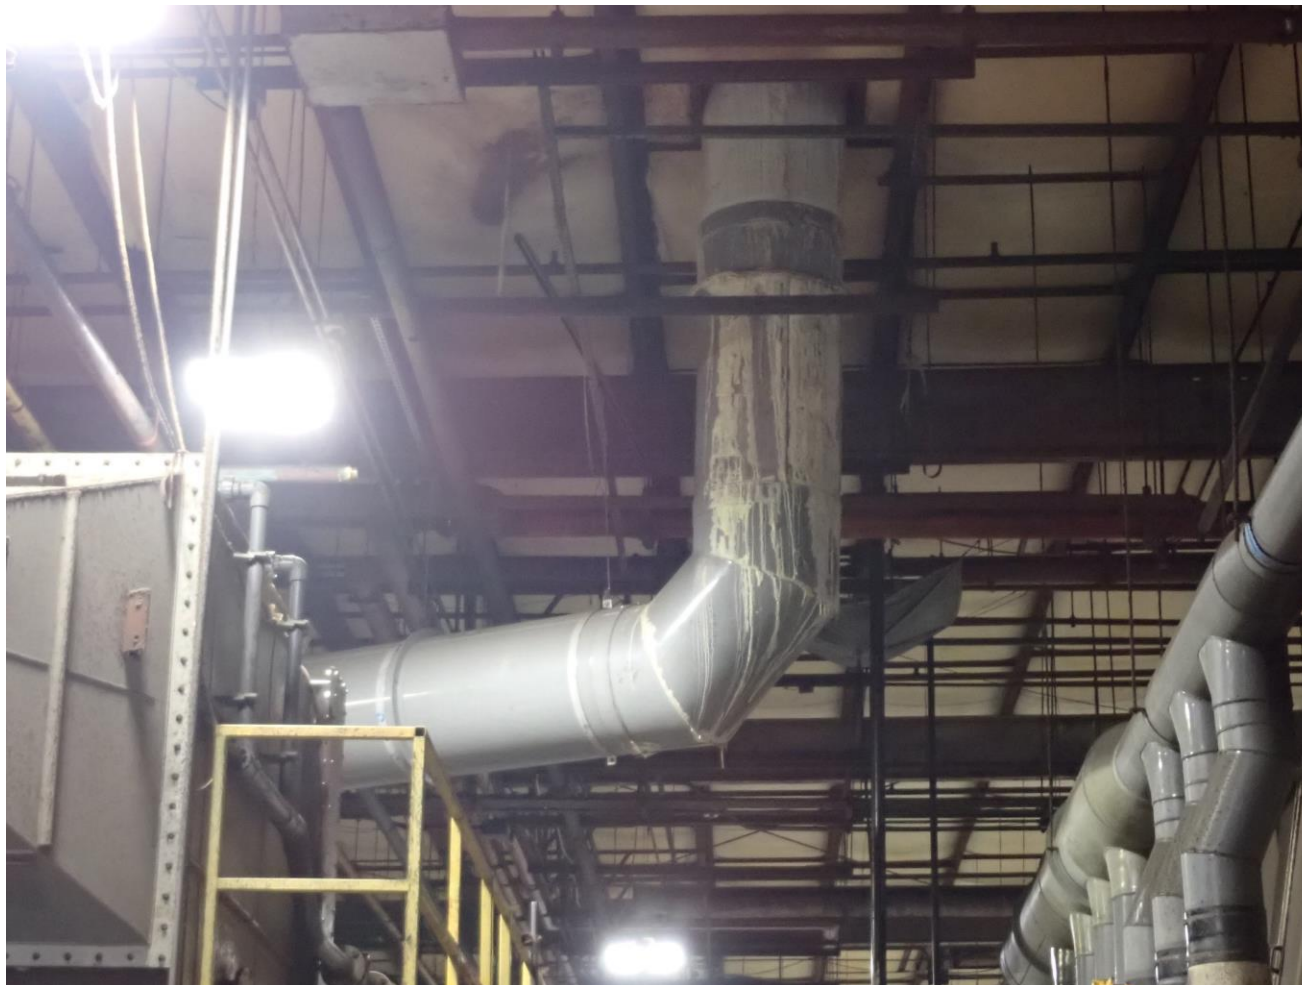
Photo Number: 004

Photo Description: Acid Etch Unit #3 Scrubber Exhaust

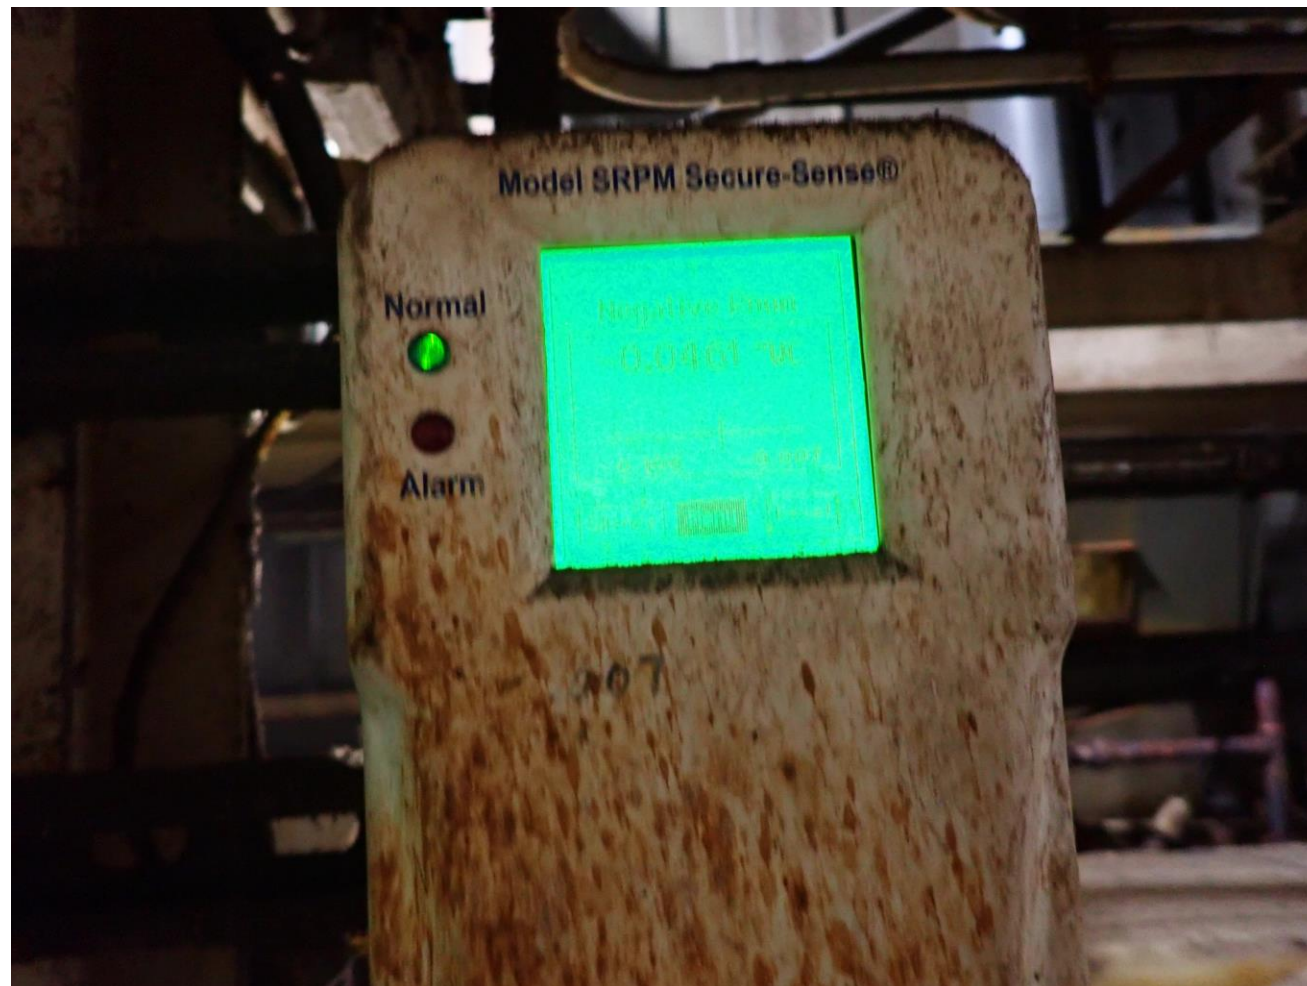
Photo Number: 006

Photo Description: Acid Etch Unit #3 Negative Pressure Enclosure Reading

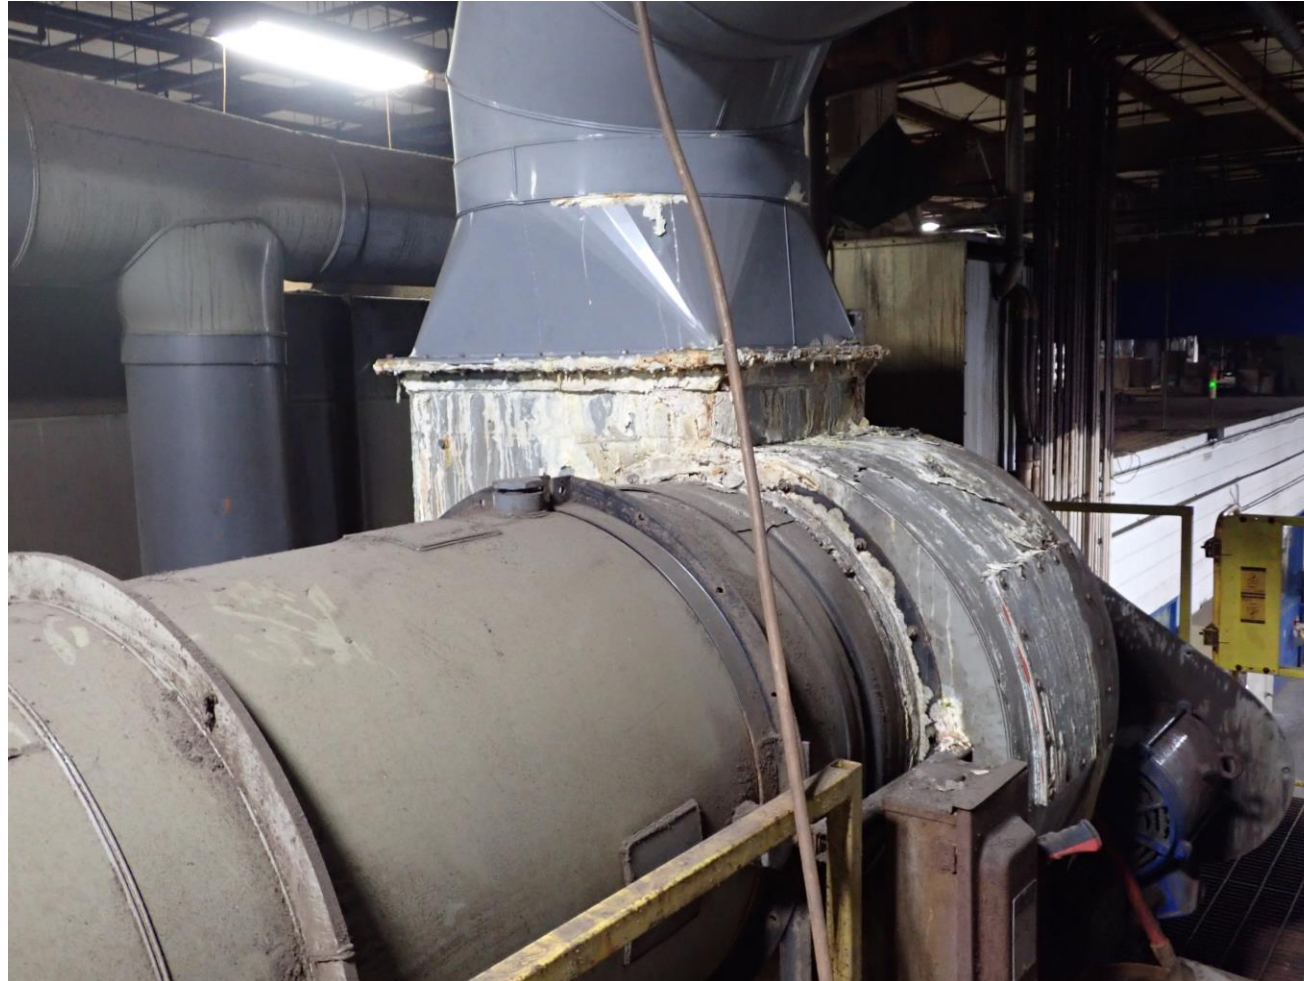
Photo Number: 007

Photo Description: Acid Etch Unit #3 Scrubber Intake

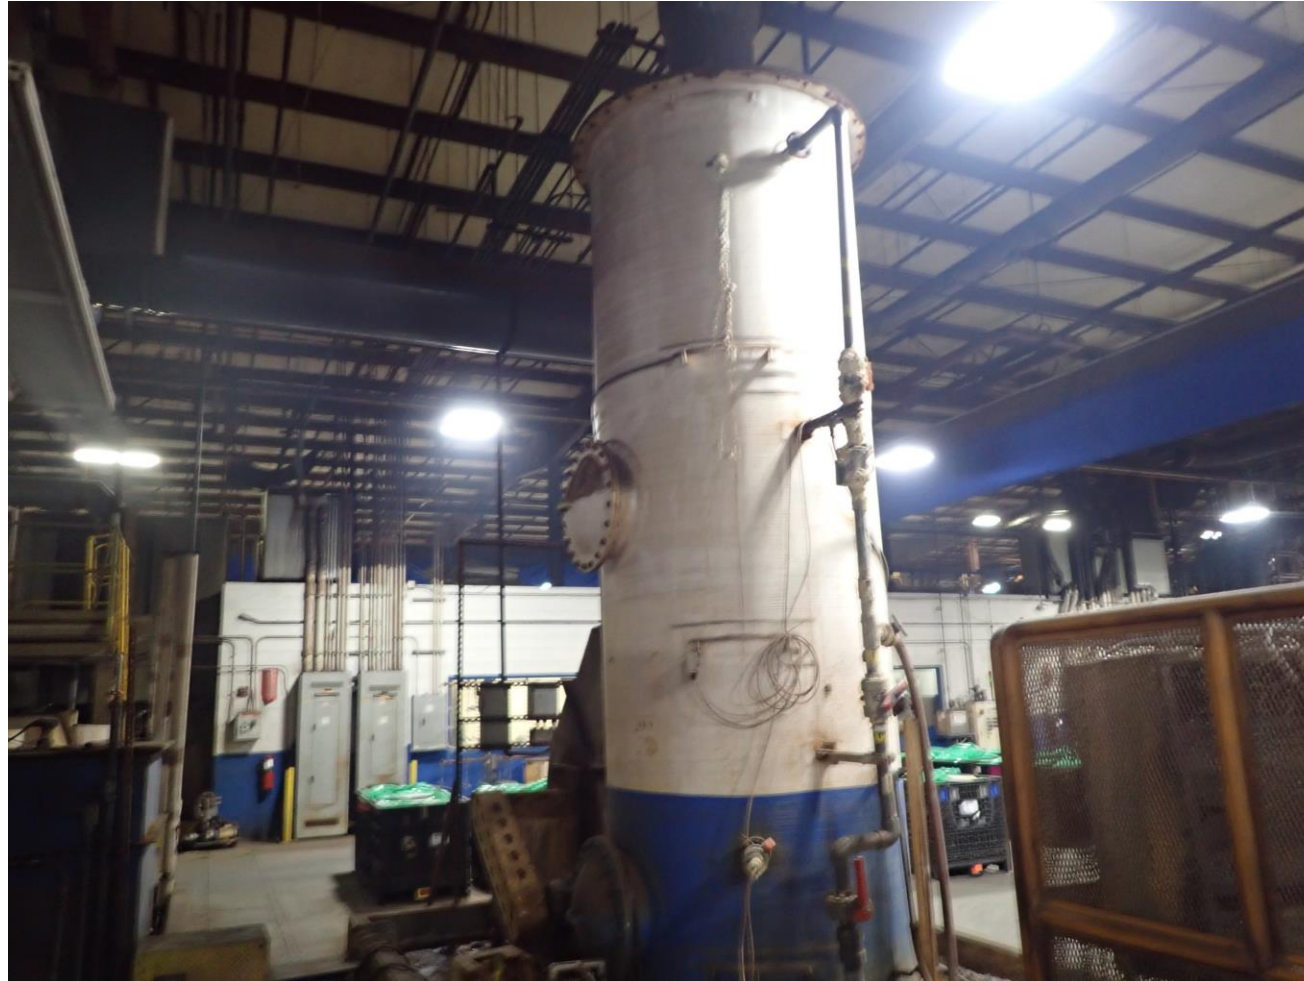
Photo Number: 008

Photo Description: Scrubber Unit #2

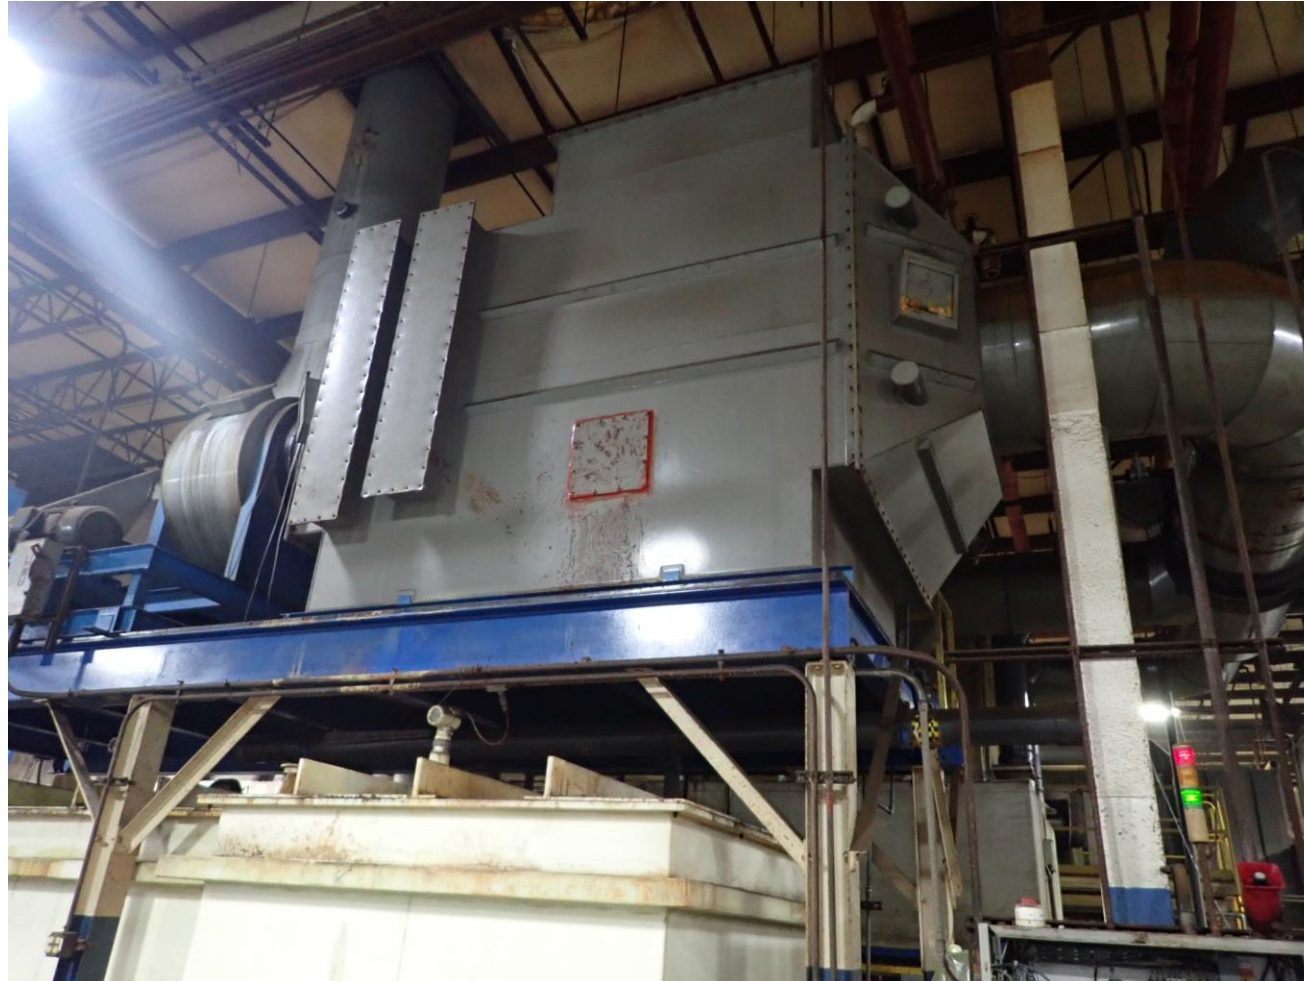
Photo Number: 009

Photo Description: Scrubber Unit #4

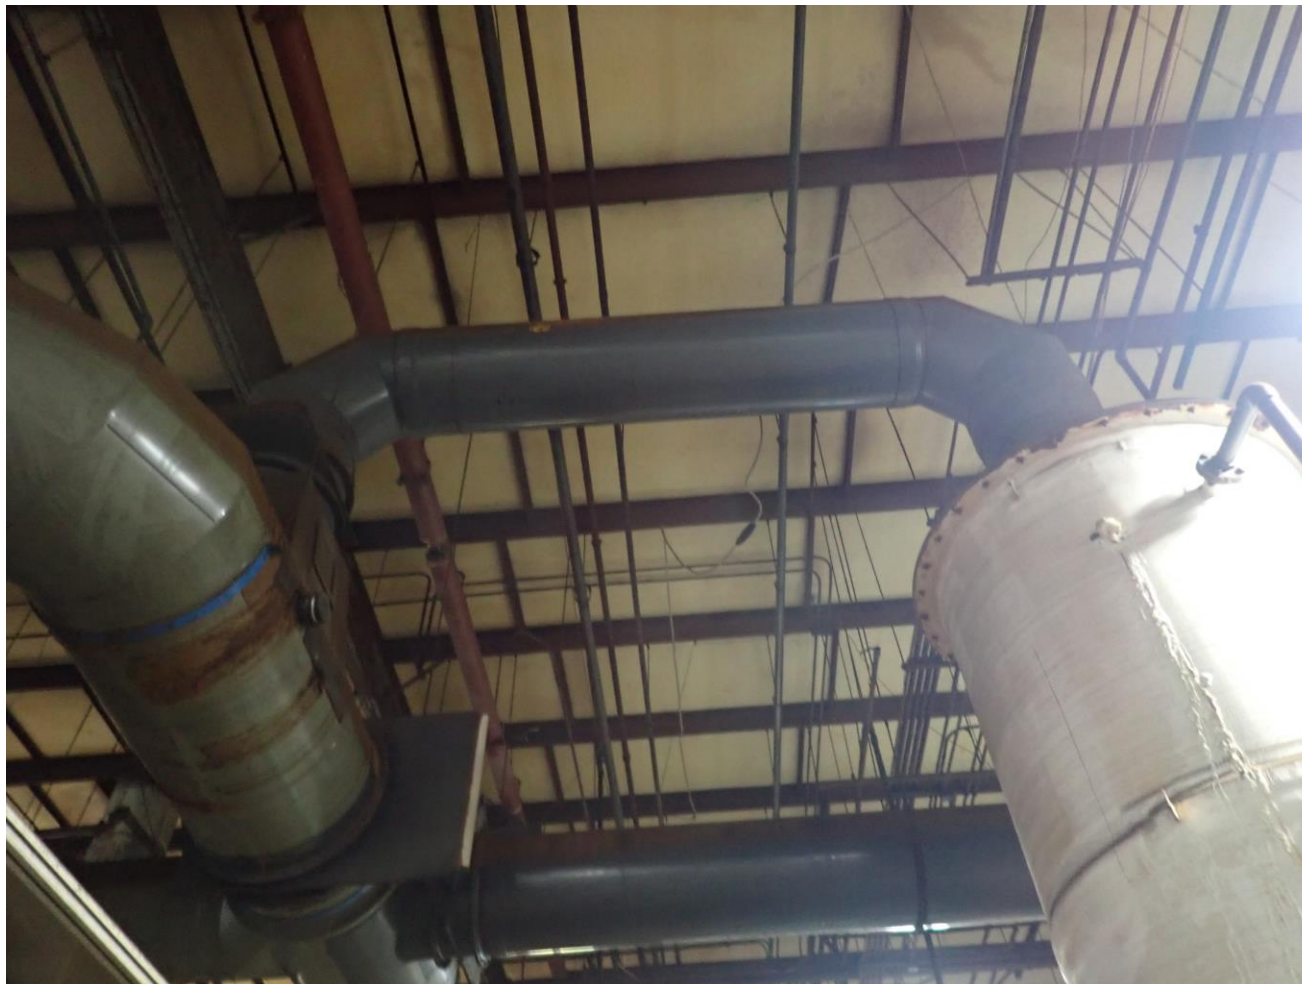
Photo Number: 010

Photo Description: Connection Between Scrubber Unit #2 and Scrubber Unit #4

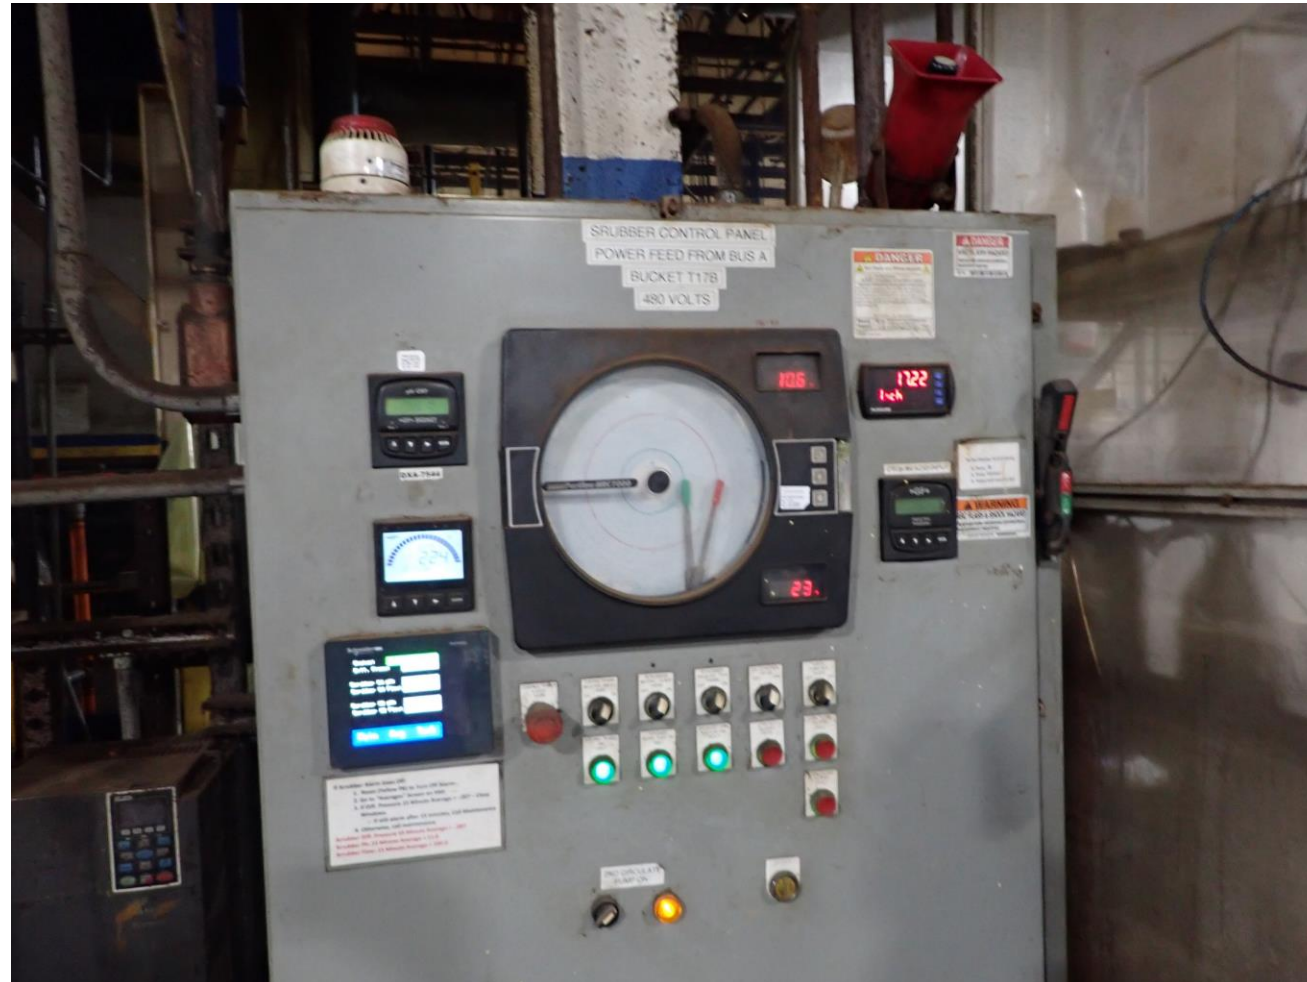
Photo Number: 011

ST4 followed a very similar process, but the parts were on a conveyor which did not need to be manually placed into the enclosure and there were two in line scrubbers (PCD8 and PCD6 (also called scrubber 4)) designed to control HCl. The process was completely enclosed except for the door for the conveyor. When the inspection team arrived, ST4 was temporarily not in operation. At this time, Facility representatives discussed the testing history concerning ST4 with the inspection team. Facility representatives stated: the PCD6 scrubber failed to meet the destruction efficiency requirement in approximately 2017; then the PCD8 vertical scrubber was added as a second scrubber for the same process line; PCD6 failed a retest in 2019; PCD6 failed a retest in 2020; VADEQ and Dynax signed a consent agreement requiring Dynax to install a new scrubber by November 2025, with a stack test to follow the installation; the new scrubber must go where the current vertical scrubber is located; and the new scrubber will be designed to control particles down to one micron using a candle filter and a vertical venturi throat. By this time this discussion ceased, ST4 had restarted operation. During the inspection, the PCD6 scrubber showed a differential pressure of -0.023" H<sub>2</sub>O, a flow rate of 219 gallons/minute of water, a pH of 10.6.

Photo Description: Acid Etch Unit #4 Control Panel

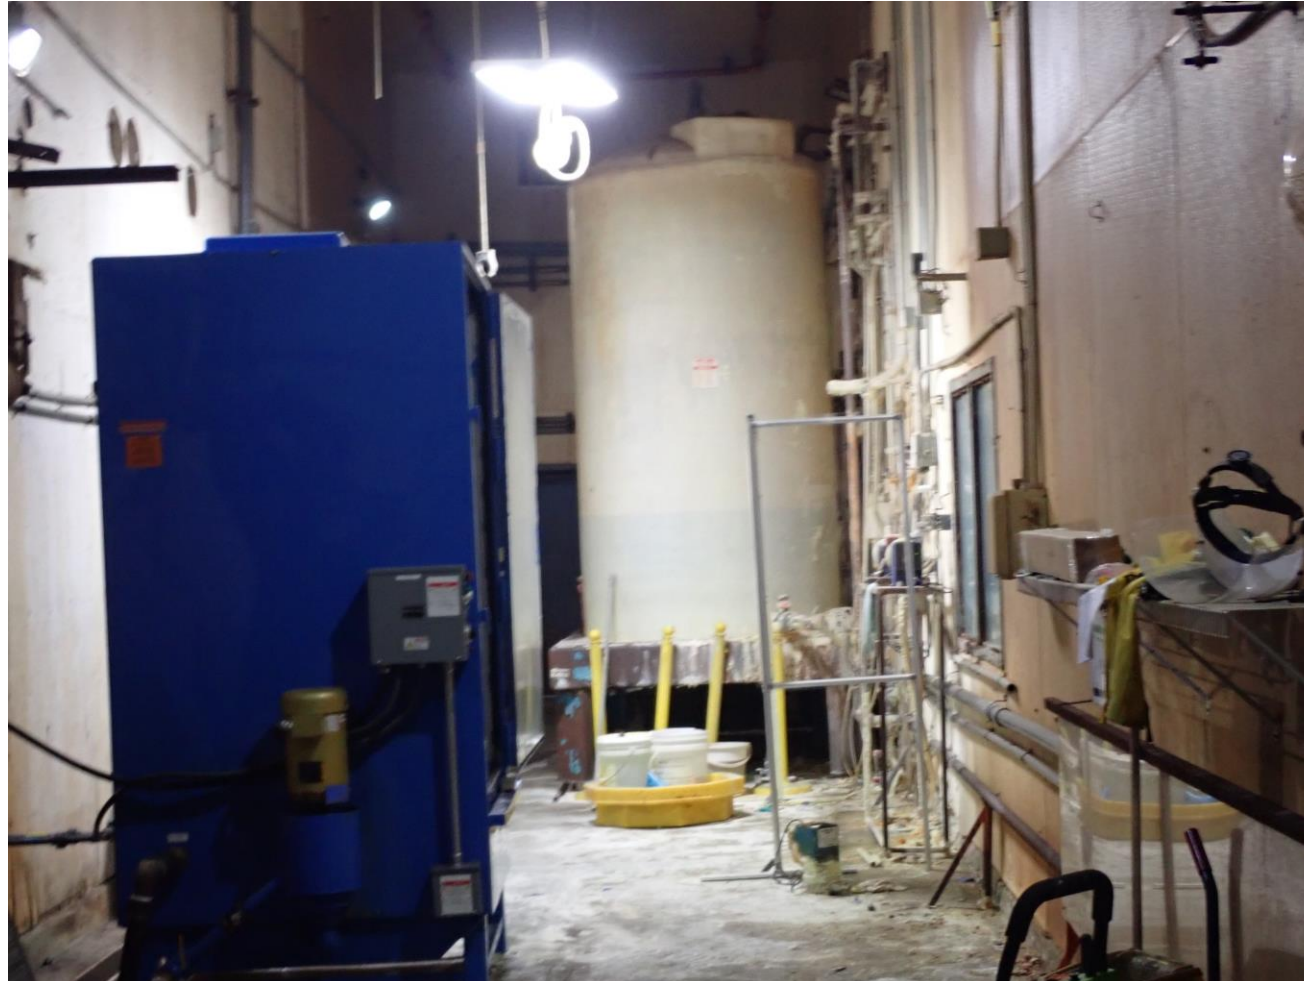
Photo Number: 012

Following the surface treatment lines, the inspection team observed some smaller emitting processes and locations: a 10,000-gallon caustic tank in an enclosed room with some previous spillage noted; the roll coating process with an oven temperature of 135°C; the induction banding process whose ovens were not operating but Facility representative stated they typically operate at about 400°C; the enclosed paper grinding process which essentially sand smaller strips of paper on conveyor belts at multiple smaller machines; and an industrial laser cutter. The paper grinding process collects dust to the building's main baghouse. Facility representatives stated this unit was tested once around 2015, but it does not have any requirements to be tested. The industrial laser cutter is a smaller volume process which is only used for the aftermarket parts. This laser cuts pieces to the required sizes and vents to a small baghouse which exhausts inside the building.

Photo Description: 10,000 Gallon Caustic Tank

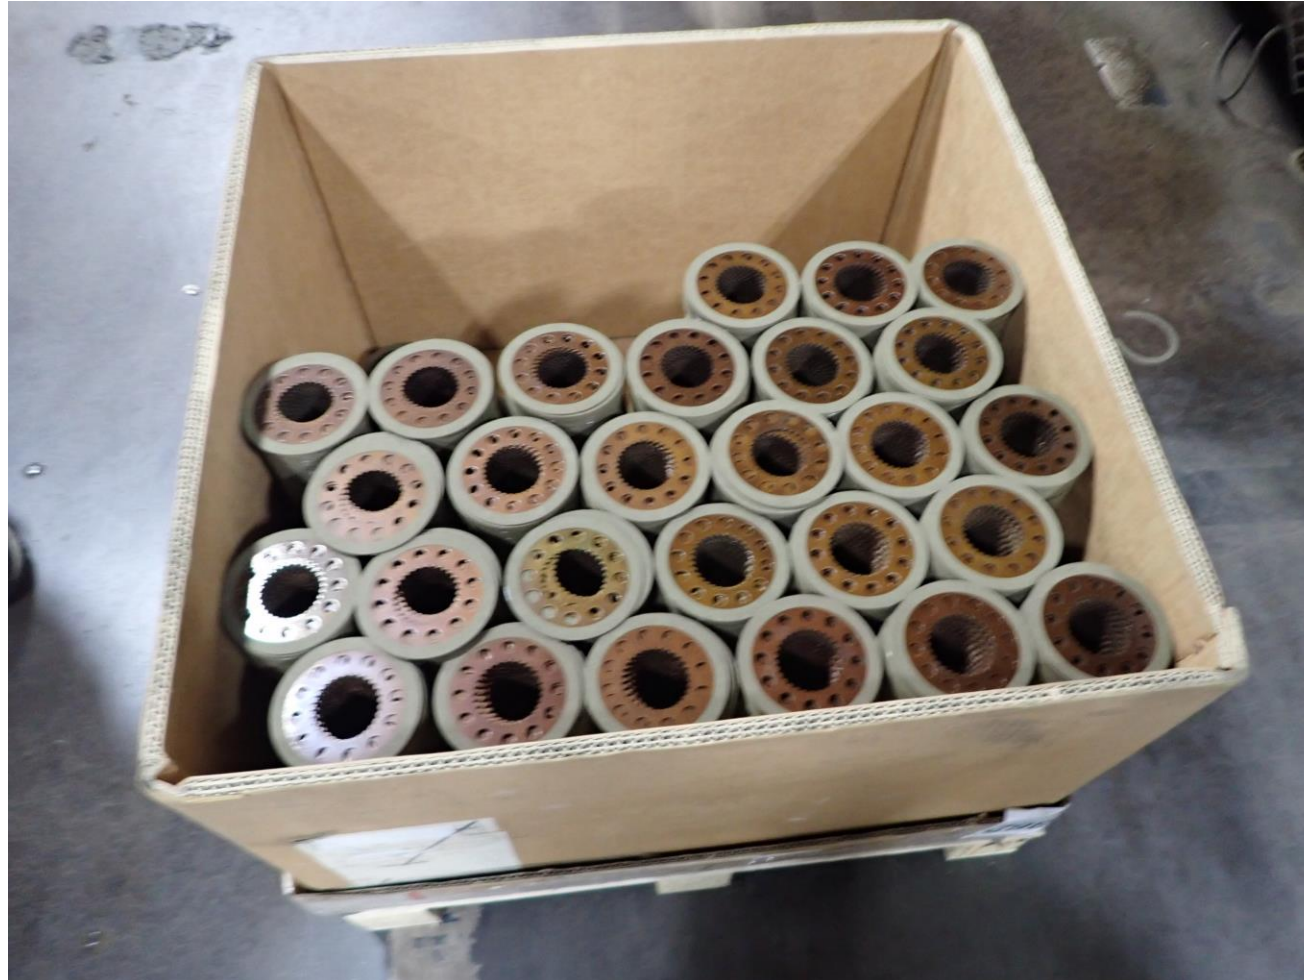
Photo Number: 013

Photo Description: Example Final Product Being Packaged

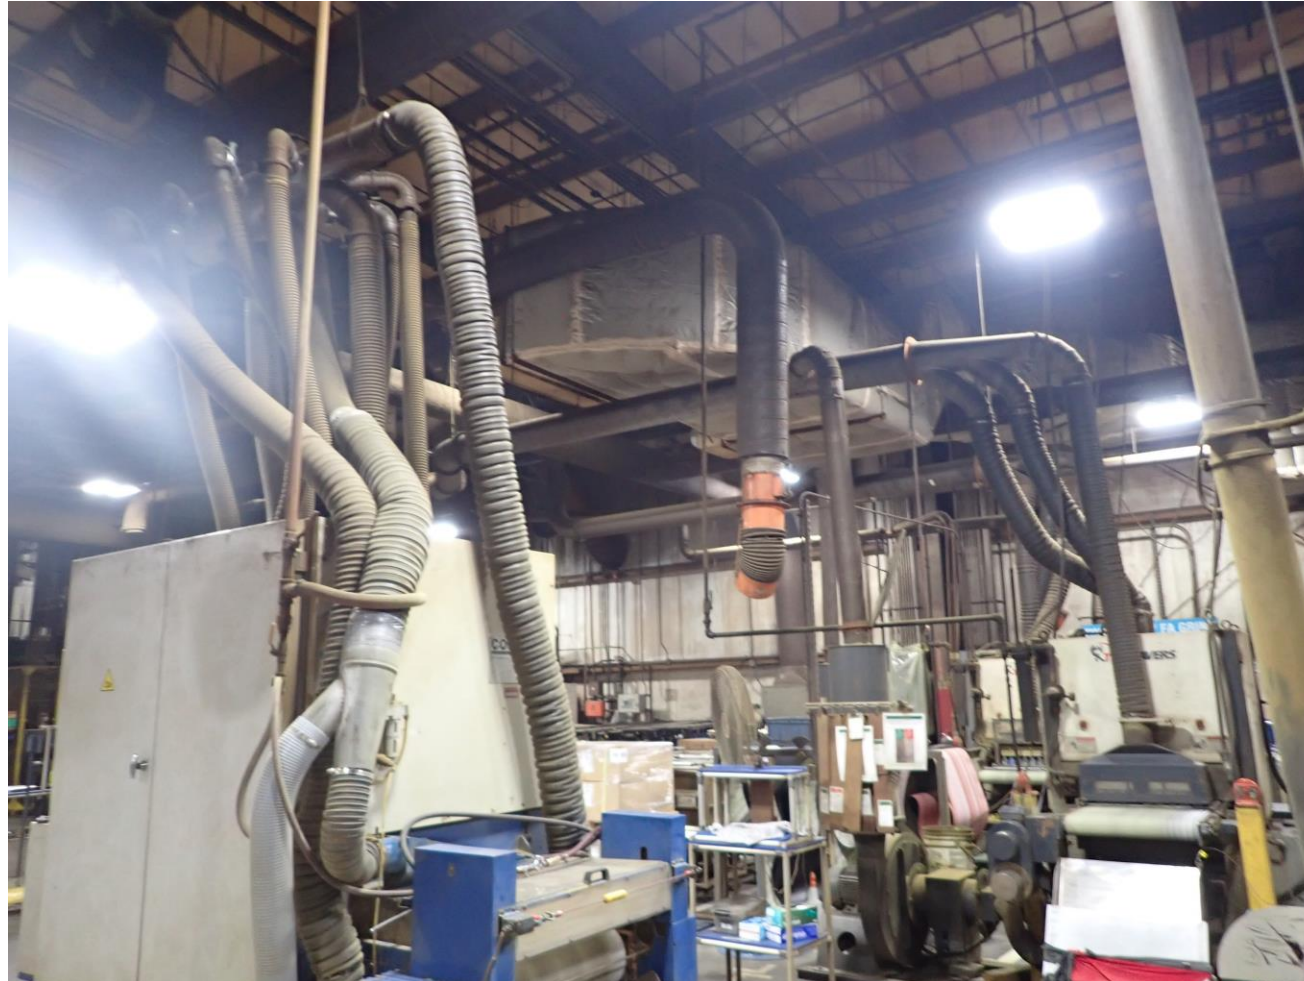
Photo Number: 014

Photo Description: Grinding and Jet Blowing Process Units

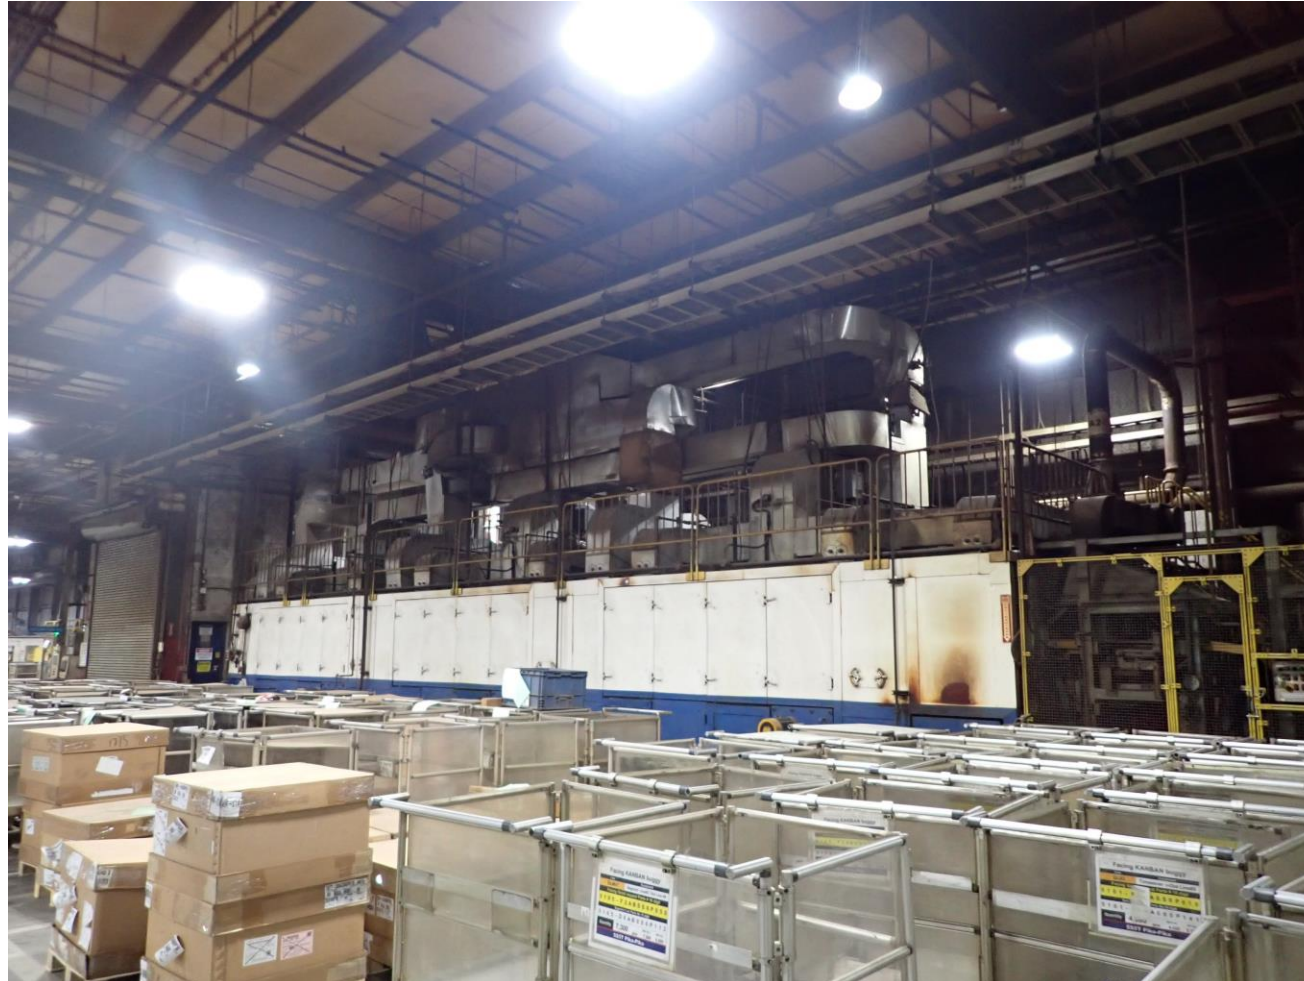
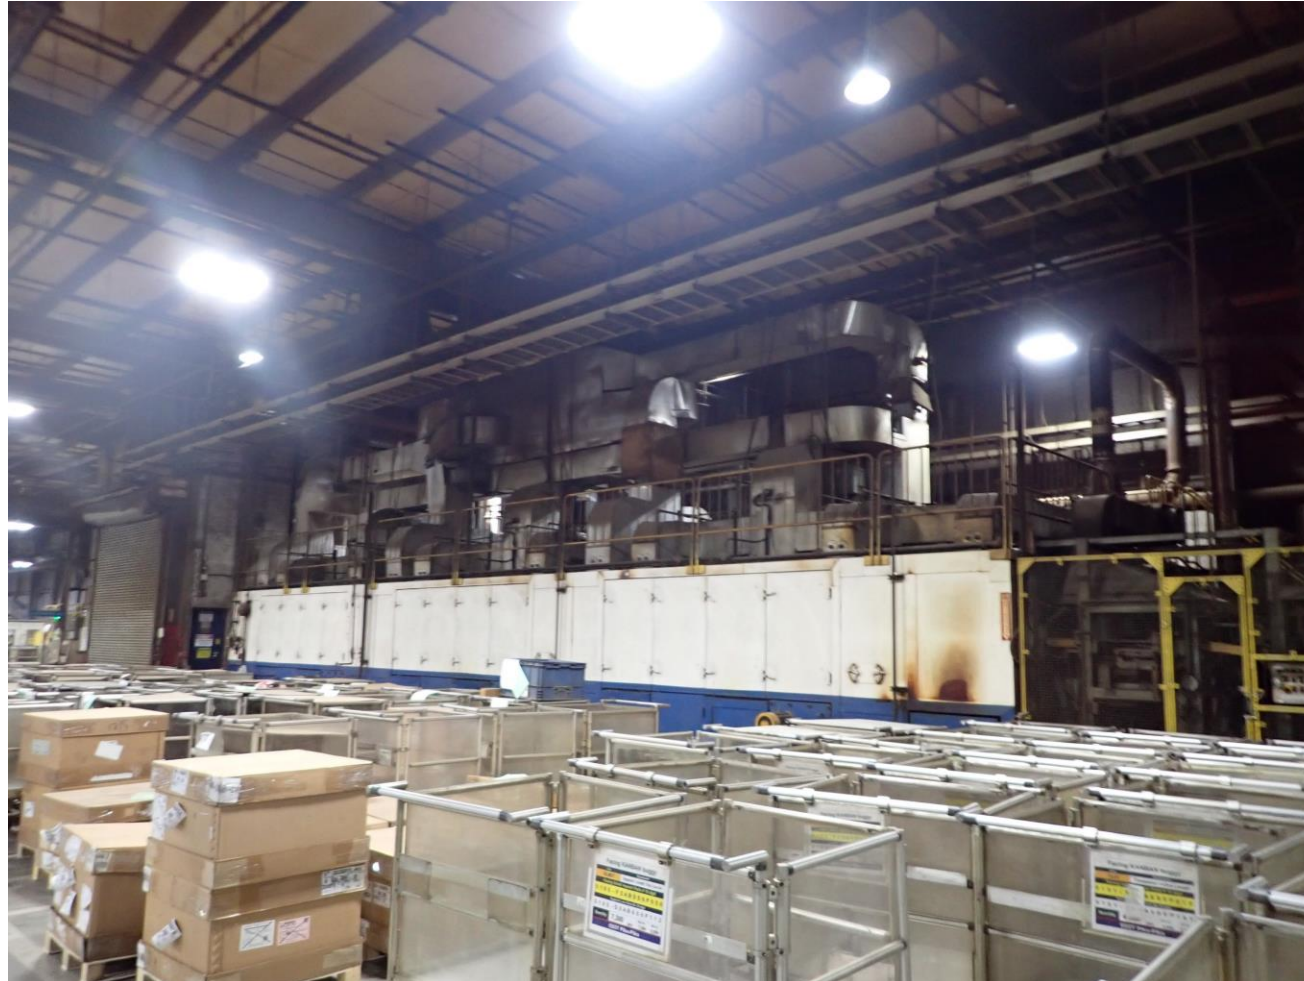
Photo Description: Saturation Unit

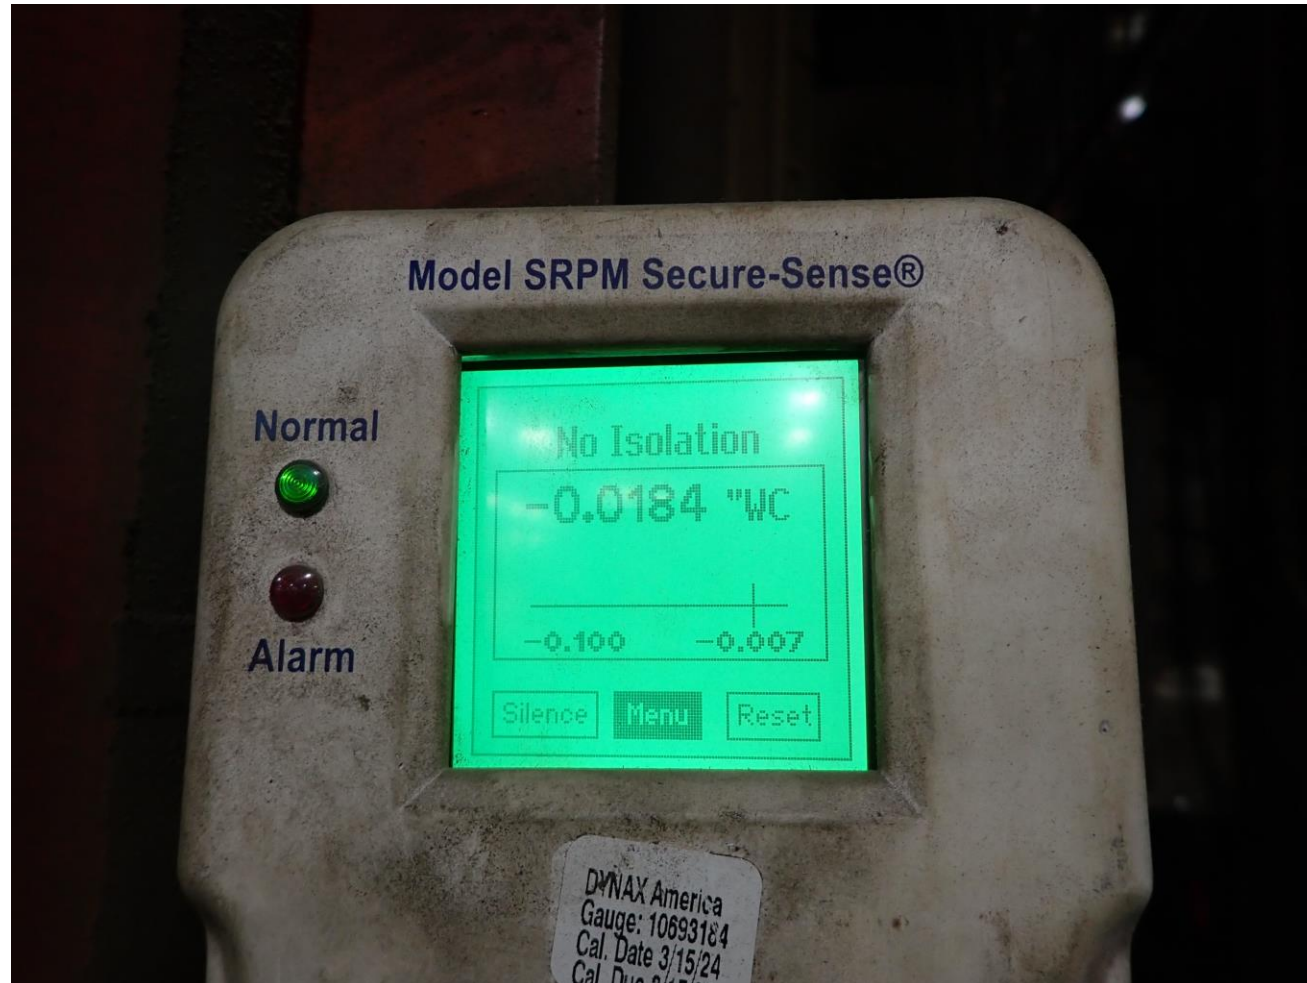
Photo Number: 017

The inspection team first went to the saturation process and its phenolic resin baths. Facility representatives stated they use two resins (Resin A and Resin B) in this process. The enclosure surrounding the resin bath was observed to have a differential pressure of  $-0.0185'' \text{ H}_2\text{O}$ . The inspection team observed the back of the enclosure also from within the resin room and did not observe any noteworthy openings. At the time of the inspection, the oxidizer was operating at  $1253^\circ\text{F}$  and the three drying ovens were operating at  $303^\circ\text{F}$ ,  $439^\circ\text{F}$ , and  $447^\circ\text{F}$ . Facility representatives stated the oxidizer operational information gets continuously recorded into their SCADA (Supervisory Control And Data Acquisition) system.

Photo Description: Saturation Unit Resin Bath Negative Pressure Enclosure Reading

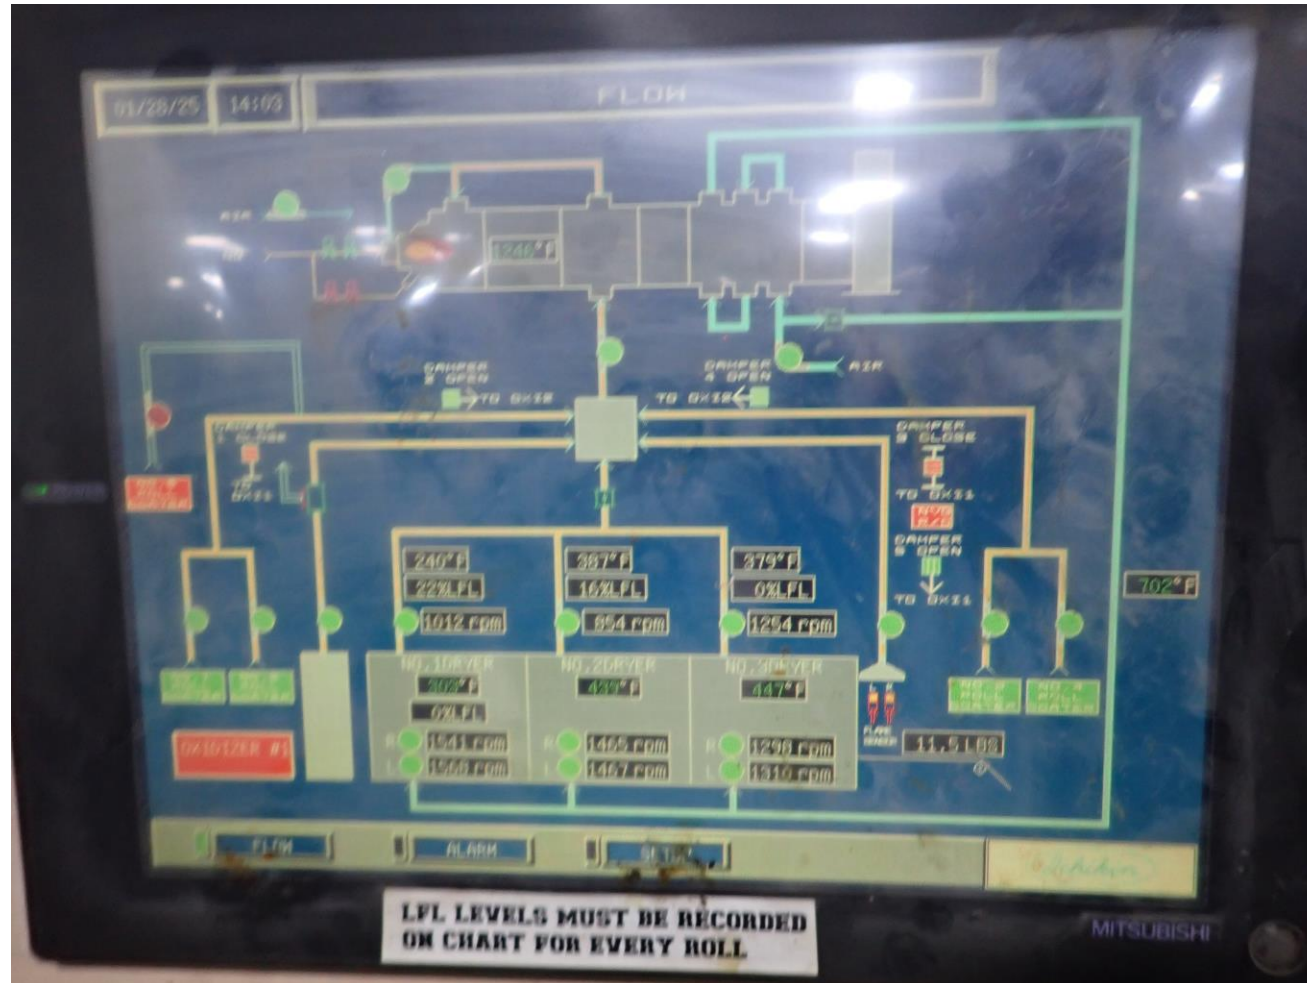
Photo Number: 018

Photo Description: Saturation Unit Control Panel
