**Report Title:** Clean Air Act Inspection of Dynax America Corporation  
**Inspection Date(s):** 1/28/2025  
**Regulatory Program(s):** Title V, MACT, NSPS, NESHAP, SIP

**Company Name:** Same as below  
**Facility Name:** Dynax America Corporation  
**Facility Location:** 568 East Park Drive  
Roanoke, VA 24019

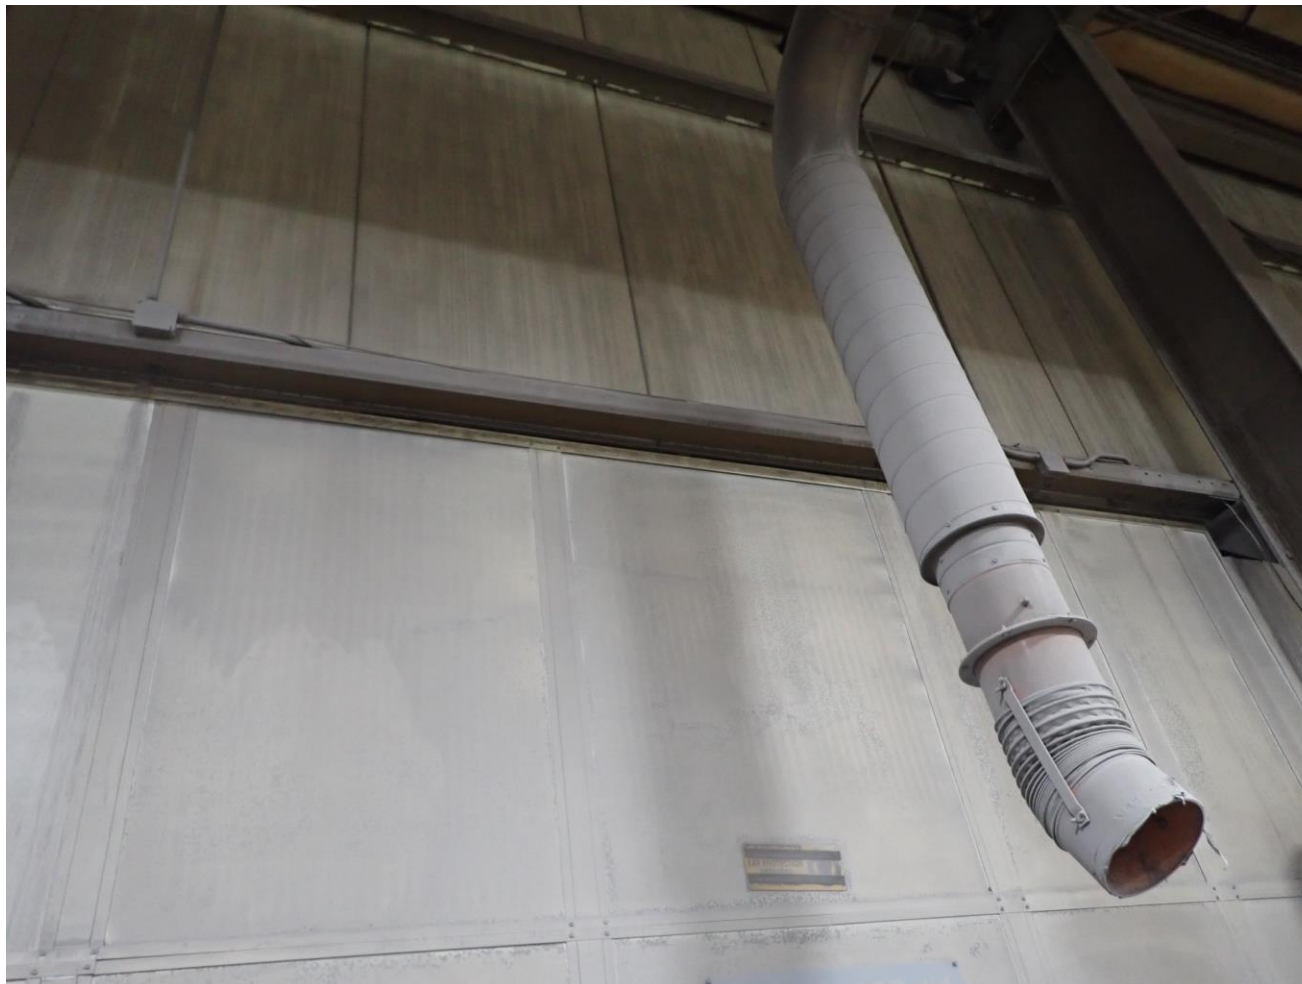
Photo Number: 019

Dynax has a shotblasting room with its own baghouse. This baghouse is located inside the shotblasting area and exhausts within that same room. The inspection team did not enter the shotblasting room, but did observe dust on the walls outside of the room.

Photo Description: Dust Covered Walls in Shot Blaster Area

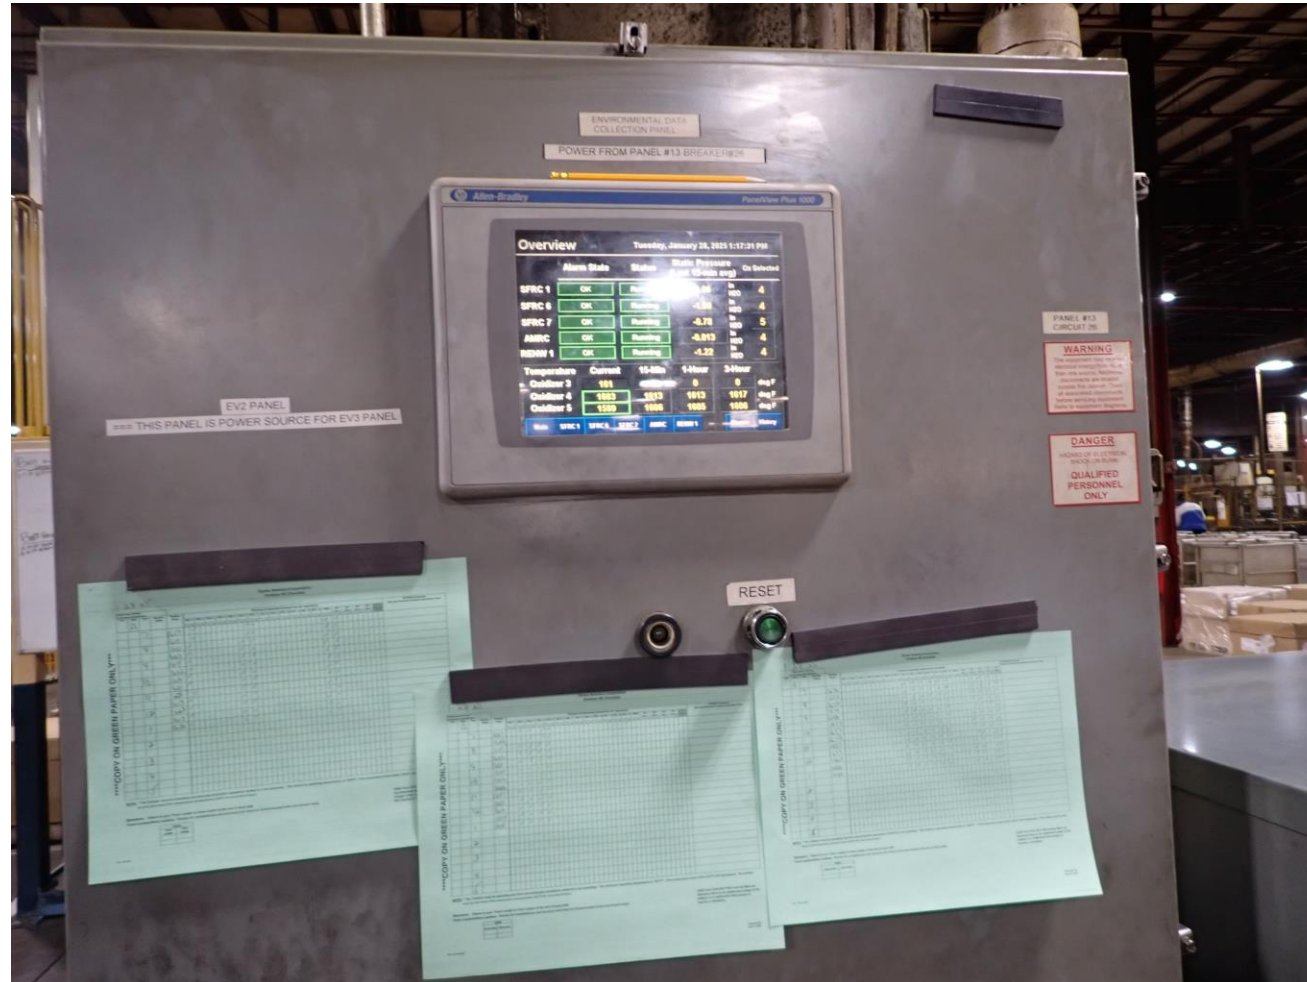
Photo Number: 020

Dynax has an engineering control panel (ECP) which displays information from multiple oxidizers. Dynax again confirmed that the SCADA system was the primary location to get information, but green sheets are also secondarily maintained at the ECP for workers to use if there is an issue with the SCADA system. At the ECP, the inspection team observed that oxidizer #4 was operating at  $1625^\circ\text{F}$ . Facility representatives stated the oxidizers have alarms which are set approximately  $25^\circ\text{F} - 50^\circ\text{F}$  above the permit limit for each oxidizer. After leaving the ECP, Facility representatives showed the inspection team that oxidizer #3 was locked out and tagged out.

Photo Description: SCADA Floor Controls and Green Sheets

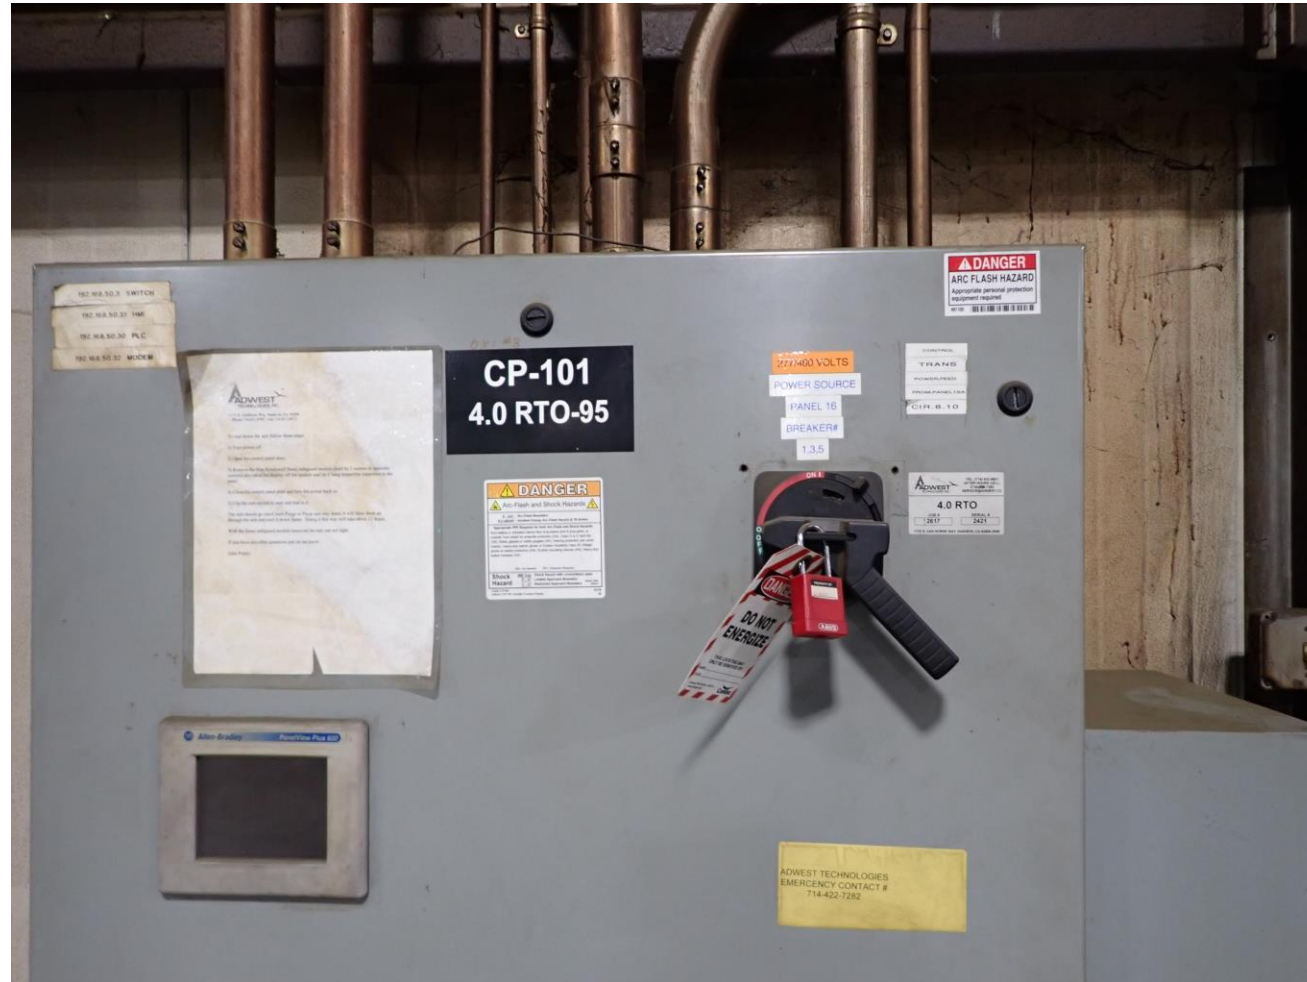
Photo Number: 021

2019-2023. This unit was tested in 2023 and failed its stack test. Following the failure, this unit was locked out. Vendors have been selected to refurbish Oxidizer 3 and a retest will follow this refurbishment. If it fails another stack test, Facility representatives stated the unit would be decommissioned.

Photo Description: Lockout/Tagout of Oxidizer Unit #3

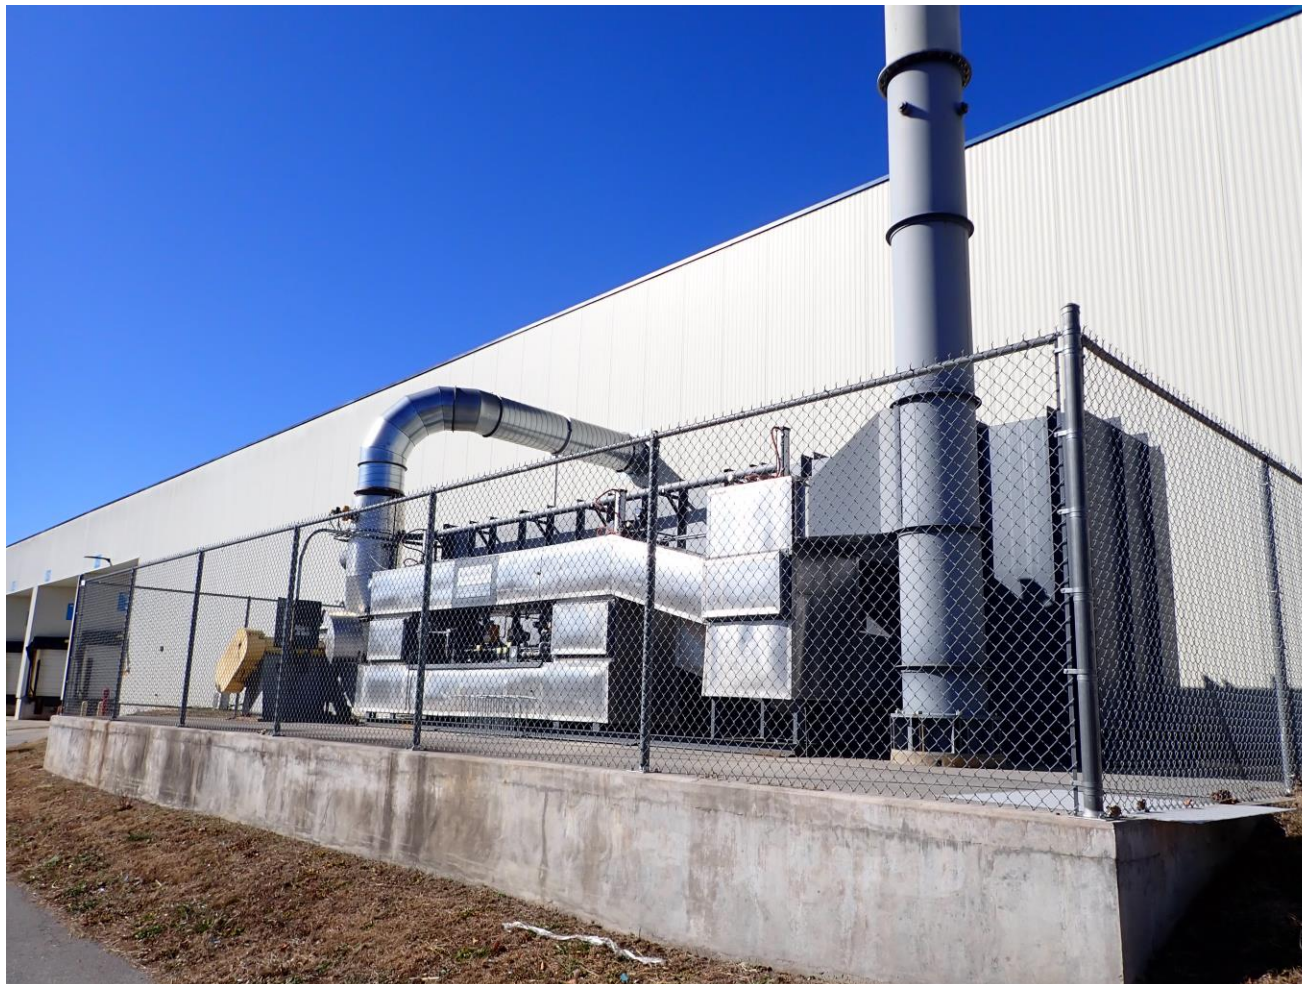
Photo Number: 022

Photo Description: Oxidizer Unit #6

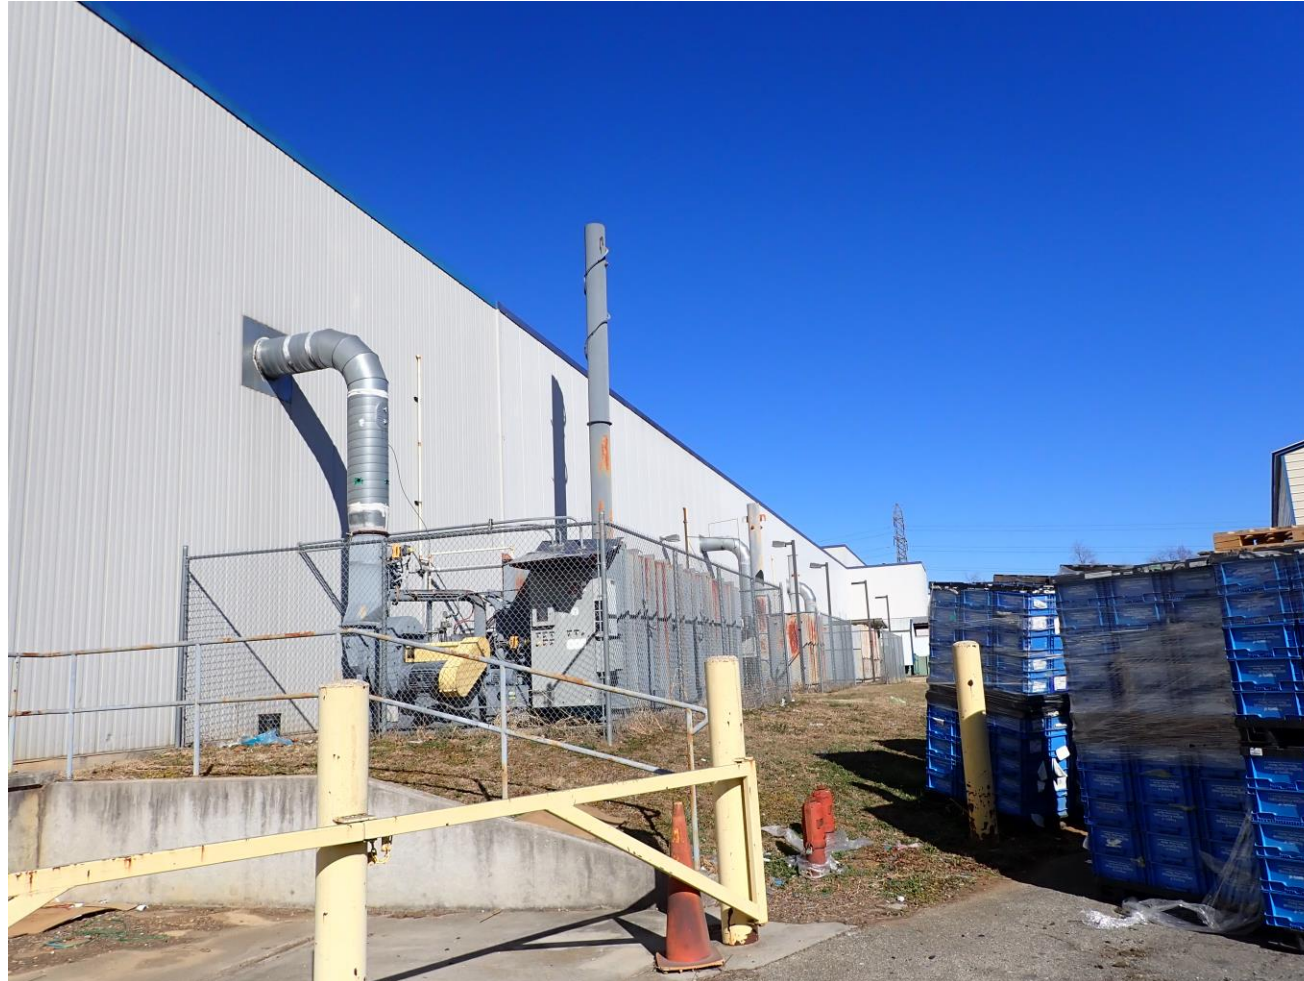
Photo Number: 023

Photo Description: Oxidizer Units #4, #3 and #5

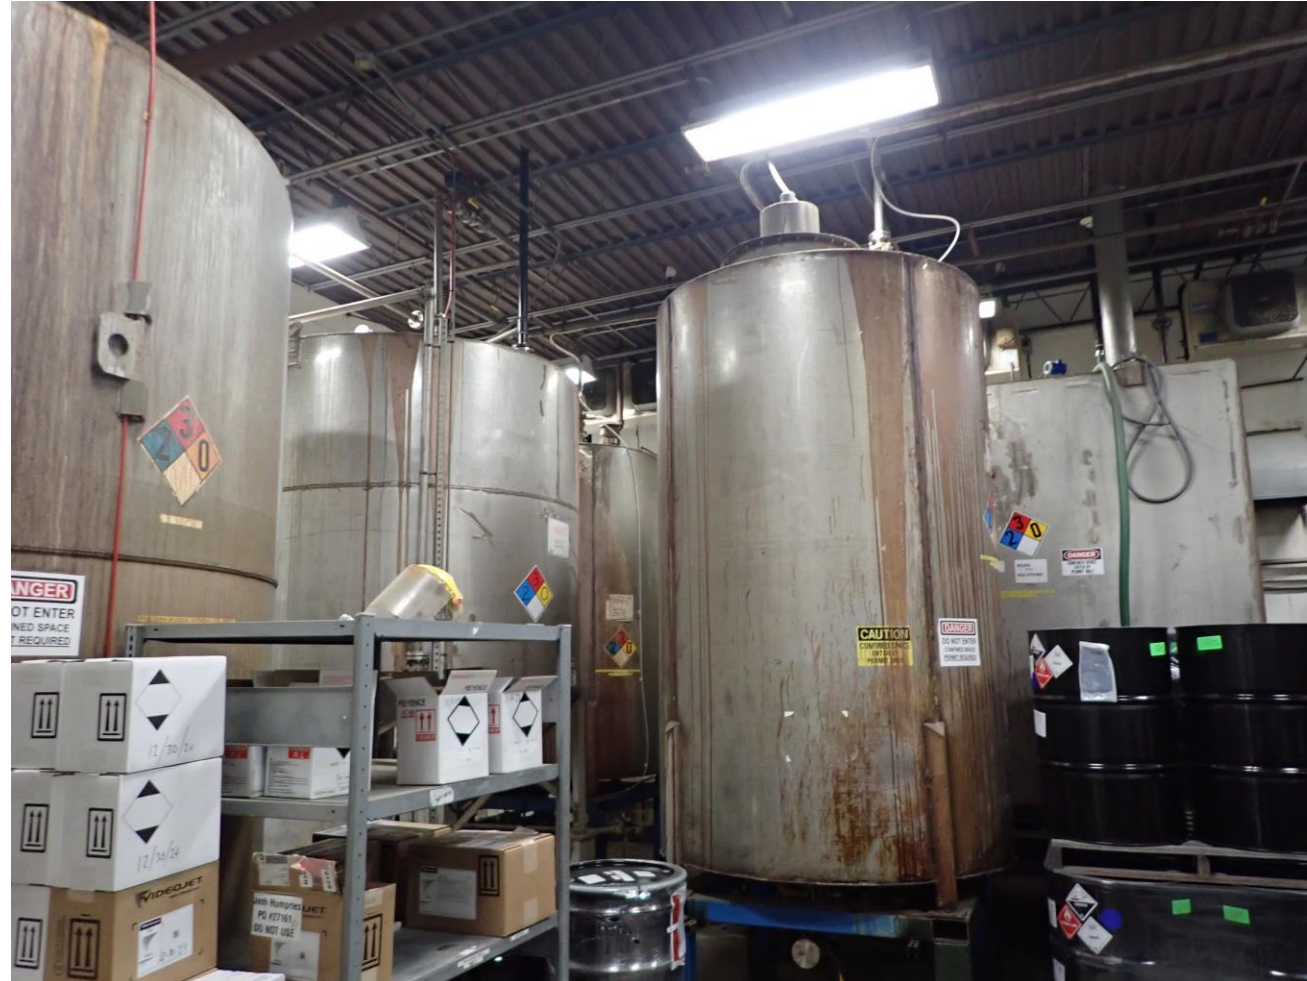
Photo Number: 024

Photo Description: Chemical Storage Picture #1

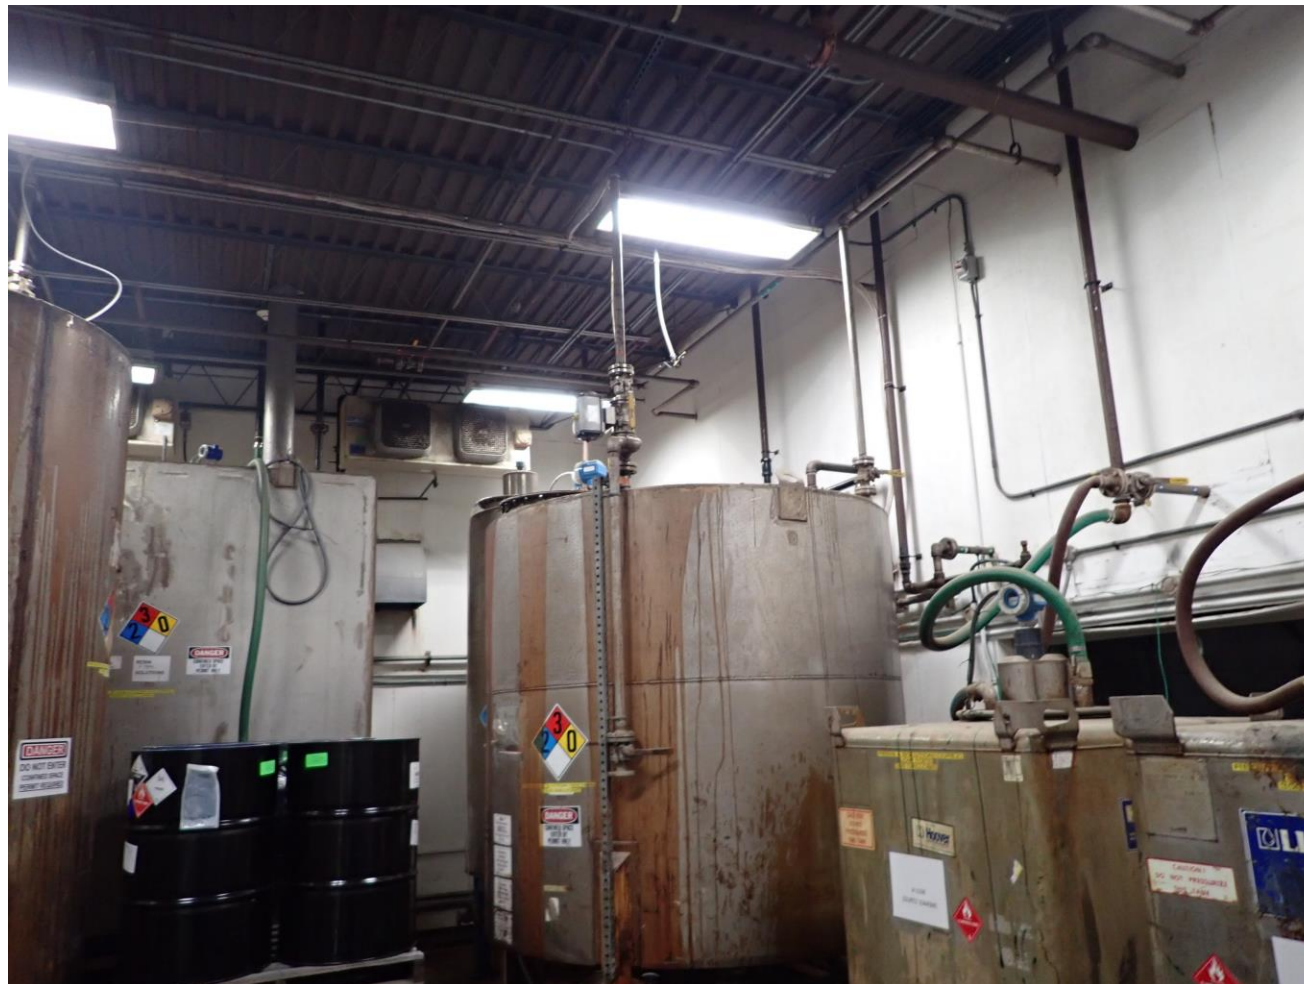
Photo Number: 025

Photo Description: Chemical Storage Picture #2

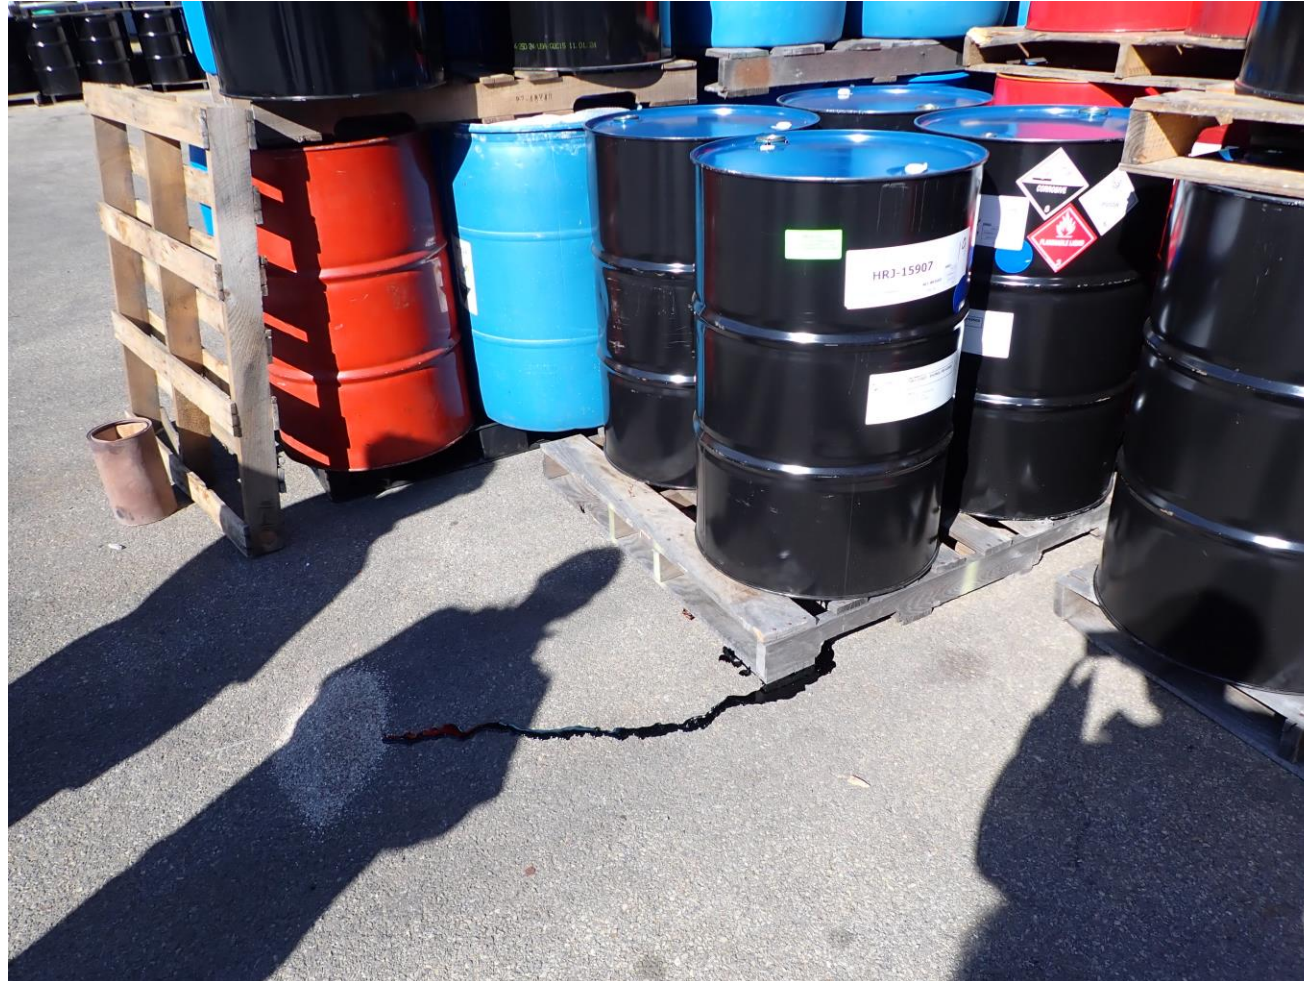
Photo Number: 026

Facility representatives then led the inspection team outside to see oxidizers #3 - #6. After observing the oxidizers, the inspection team went to the building storing many of Dynax's chemicals. The inspection team observed three Resin A tanks (5,000 gallons, 2,000 gallons, and 1,500 gallons), three Resin B tanks of the same size, and a 1,500-gallon methanol tank located in one room of the building. The inspection team also observed a 5,500-gallon Hydrochloric Acid (HCl) tank in a containment in another room of the building. Facility representatives stated there were no RMP (Risk Management Program) requirements because it was less than 37% HCl. The inspection team also observed an 8,000-gallon methanol tank outside of this building. While in this area, the inspection team observed a leaking green resin from a 55-gallon drum. Facility representatives started taking corrective actions while the inspection team was still in the area.

- White substance observed on the exhaust for scrubber #3.
- Drum located outside the chemical storage building observed to have a line of material flowing downhill from the drum displaying the drum was not completely enclosed.
- Issues with stack testing requirements related to the two active consent orders that Dynax has with VADEQ.

Photo Description: Resin Leak From Drum

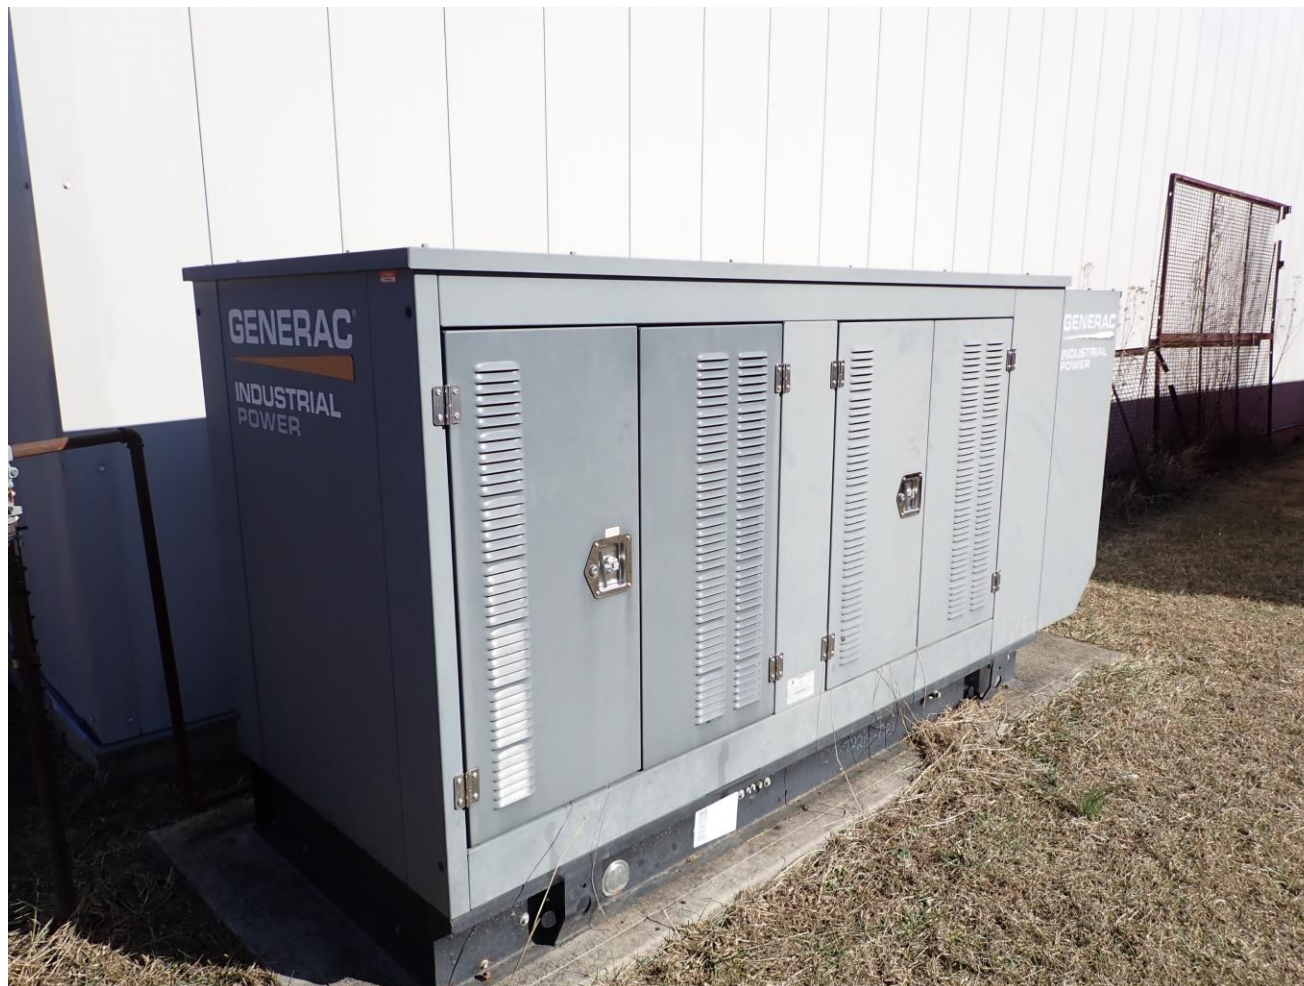
Photo Number: 027

The inspection team then continued inspecting the exterior by going to the wastewater treatment plant emergency generator. During the inspection, the inspection team could not access the enclosure since it was locked, and Facility representatives did not have a key. Following this emergency generator, the inspection team went to oxidizer #2. The oxidizer was a COR-PAK thermal oxidizer installed in May 2004 operating at  $1.3'' \text{ H}_2\text{O}$ . Facility representatives stated the digital readout was not functioning, but all information is more readily available to all Dynax employees through the SCADA system.

Photo Description: Emergency Generator (WWGEN)

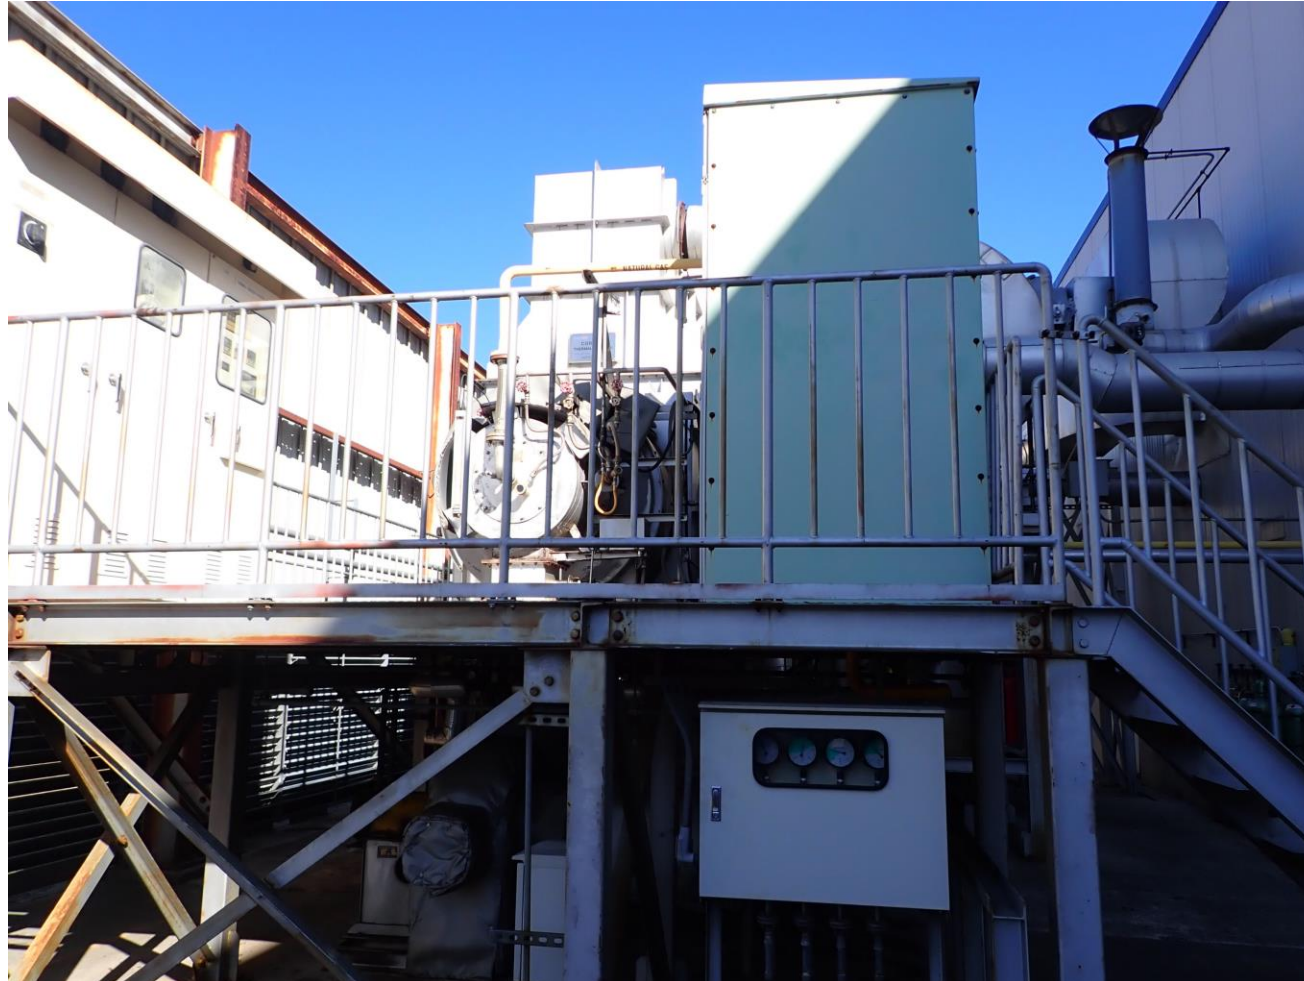
Photo Number: 028

Photo Description: Oxidizer Unit #2

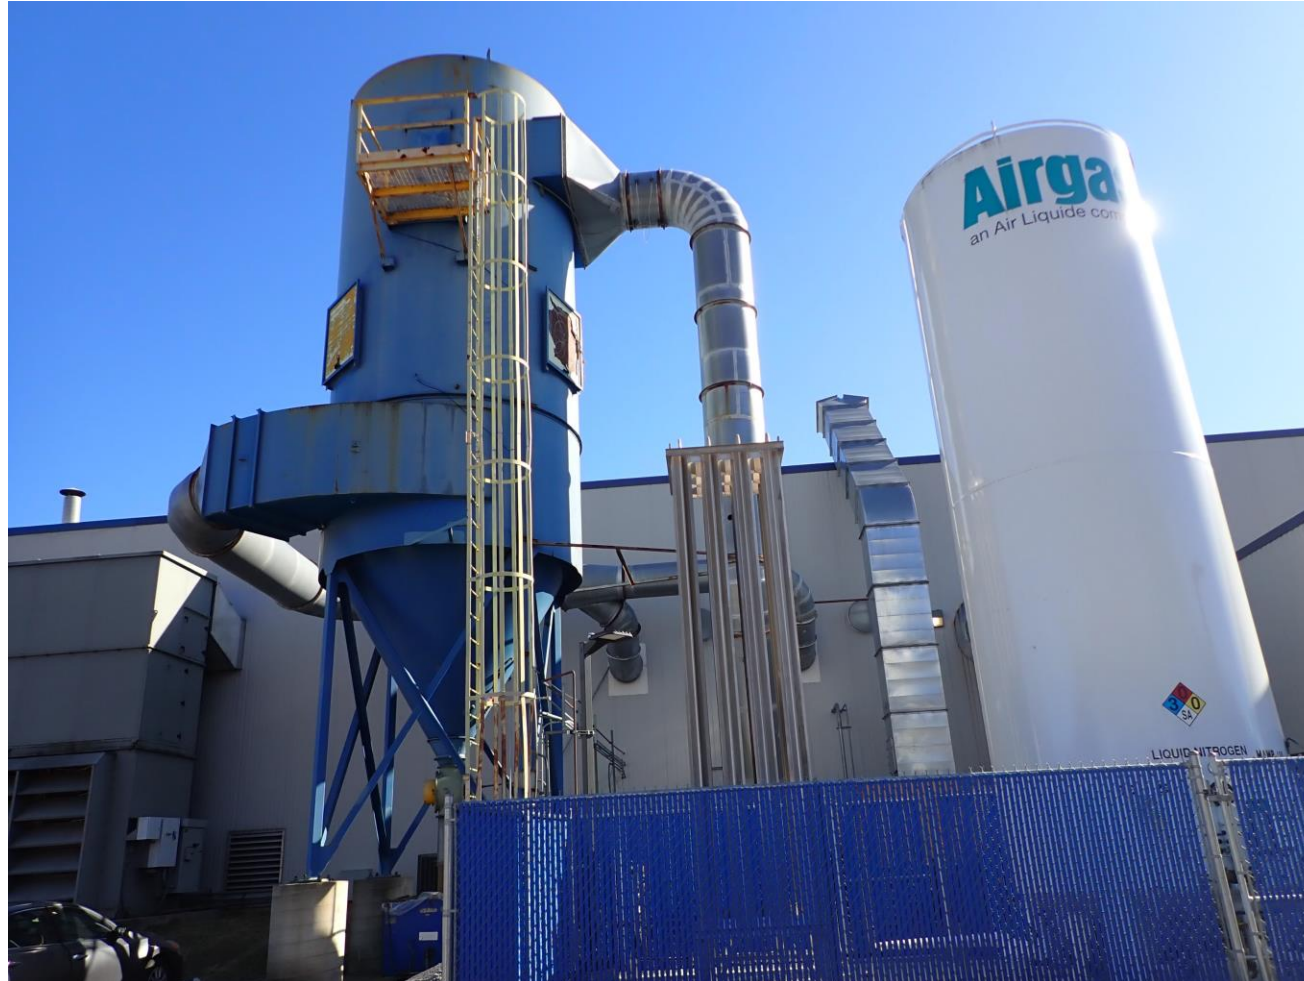
Photo Number: 029

Photo Description: Main Baghouse

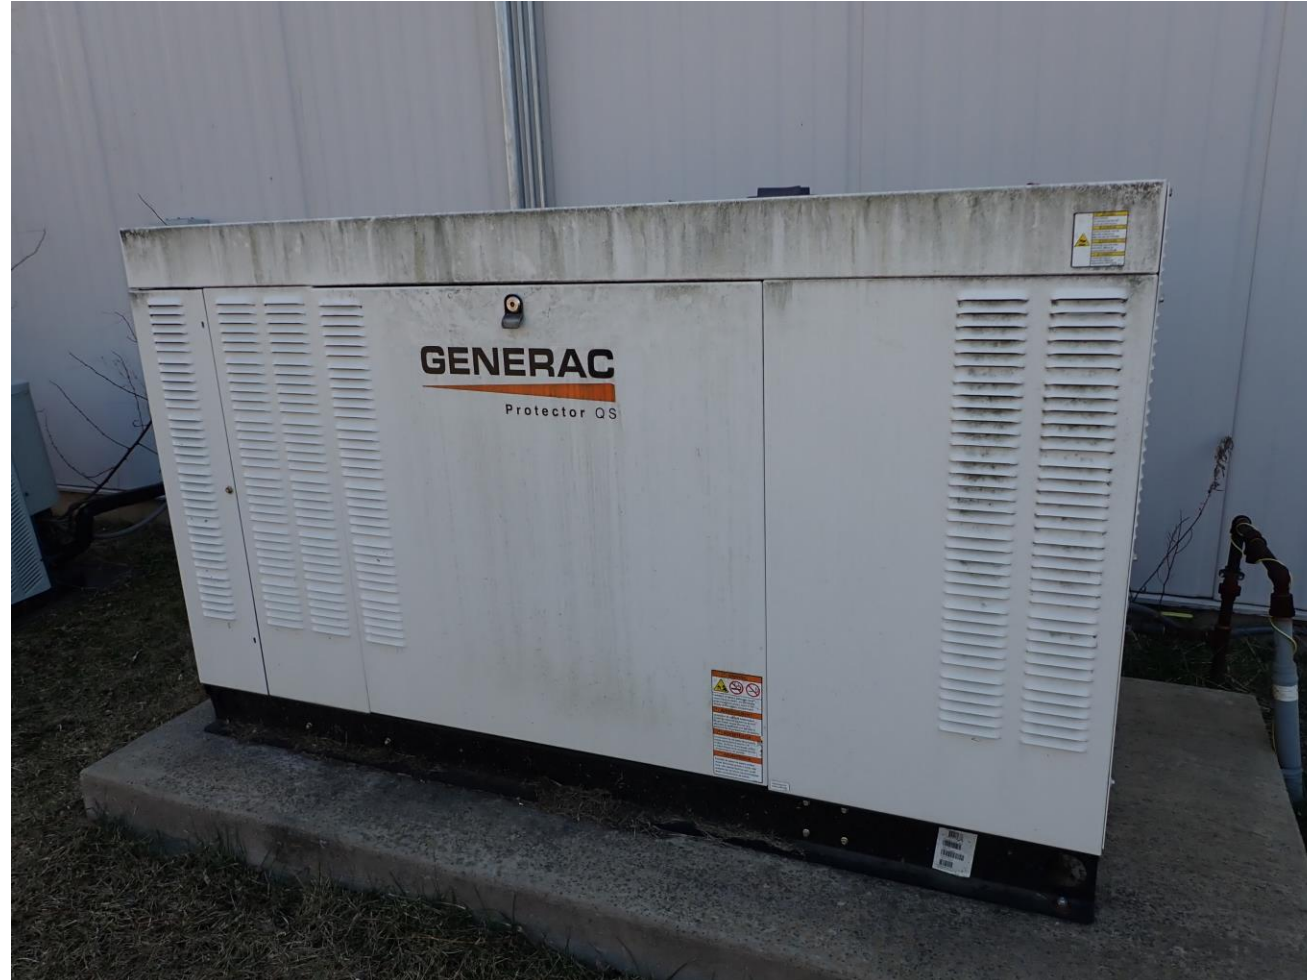
Photo Number: 030

The inspection team then concluded the walkthrough by observing the building's main baghouse and second emergency generator (ITGEN). Facility representatives stated that ITGEN was under maintenance and has not started up since December 2024.

Photo Description: Emergency Generator (ITGEN)
