## Region 6 - Enforcement & Compliance Assurance Division

### INSPECTION REPORT

| Company Name: | McCann Resources, Inc | |
| Facility Name: | Bowring Lease | |

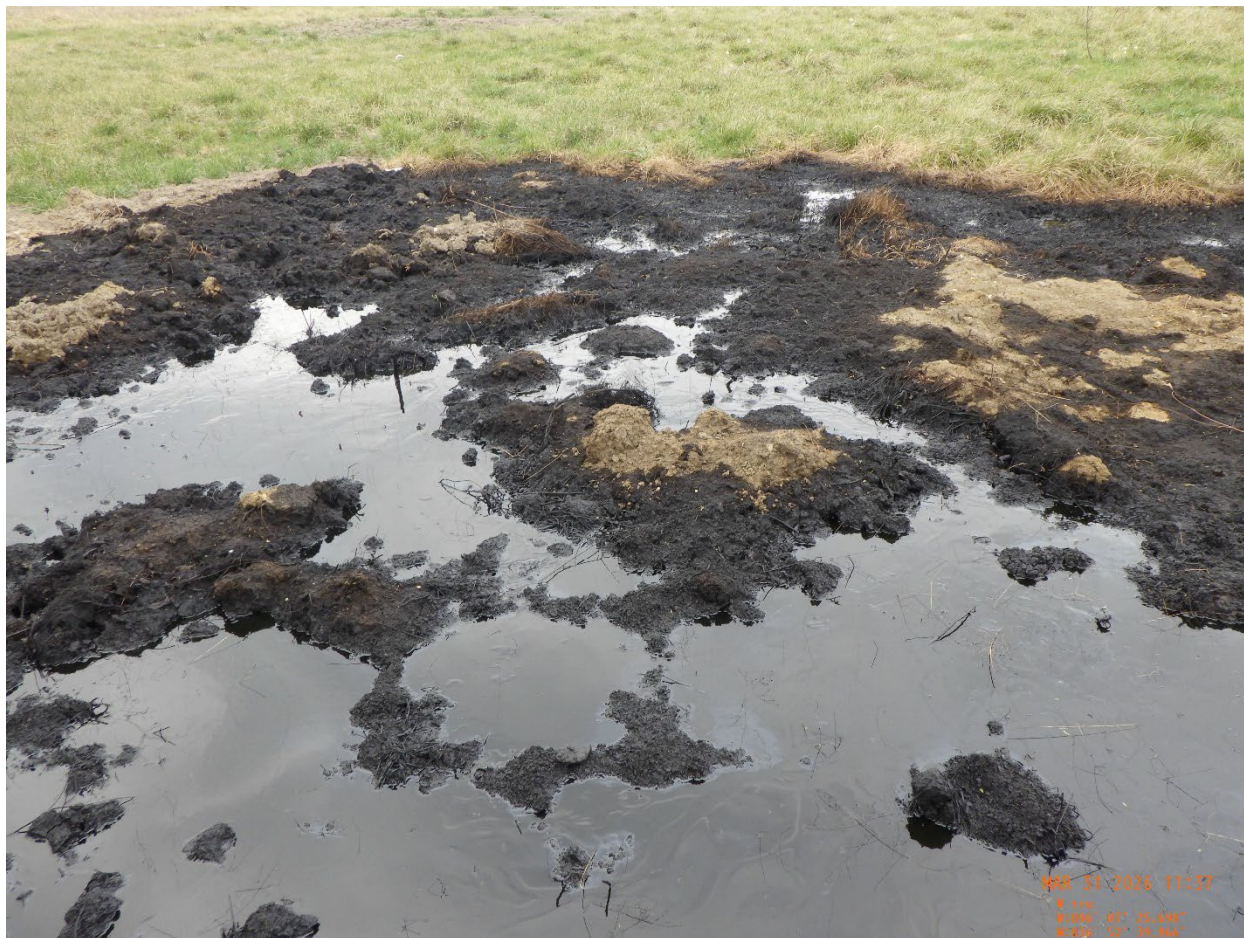
Photo No. 1

I observed the release point of the spill. At the time of the inspection, oil and saltwater were actively purging from the soil near the center of a large oil-soaked area of bare soil. Further investigation to the north of the spill revealed the poly flowline where it was laid above ground. The spill was discovered when the EPA inspector was passing by the area and smelled a strong odor of crude oil in Bowring, Oklahoma. See photo No. 1 of the attached photo log. For additional location and photo metadata, see Appendix 1, photo log, which is attached to this report.

**Description:** This was the release point of the spill, a buried poly flowline, actively releasing oil and saltwater.

At the conclusion of the inspection and in response to a request from Mark McCann, EPA inspector turned off the production well which was causing the spill.

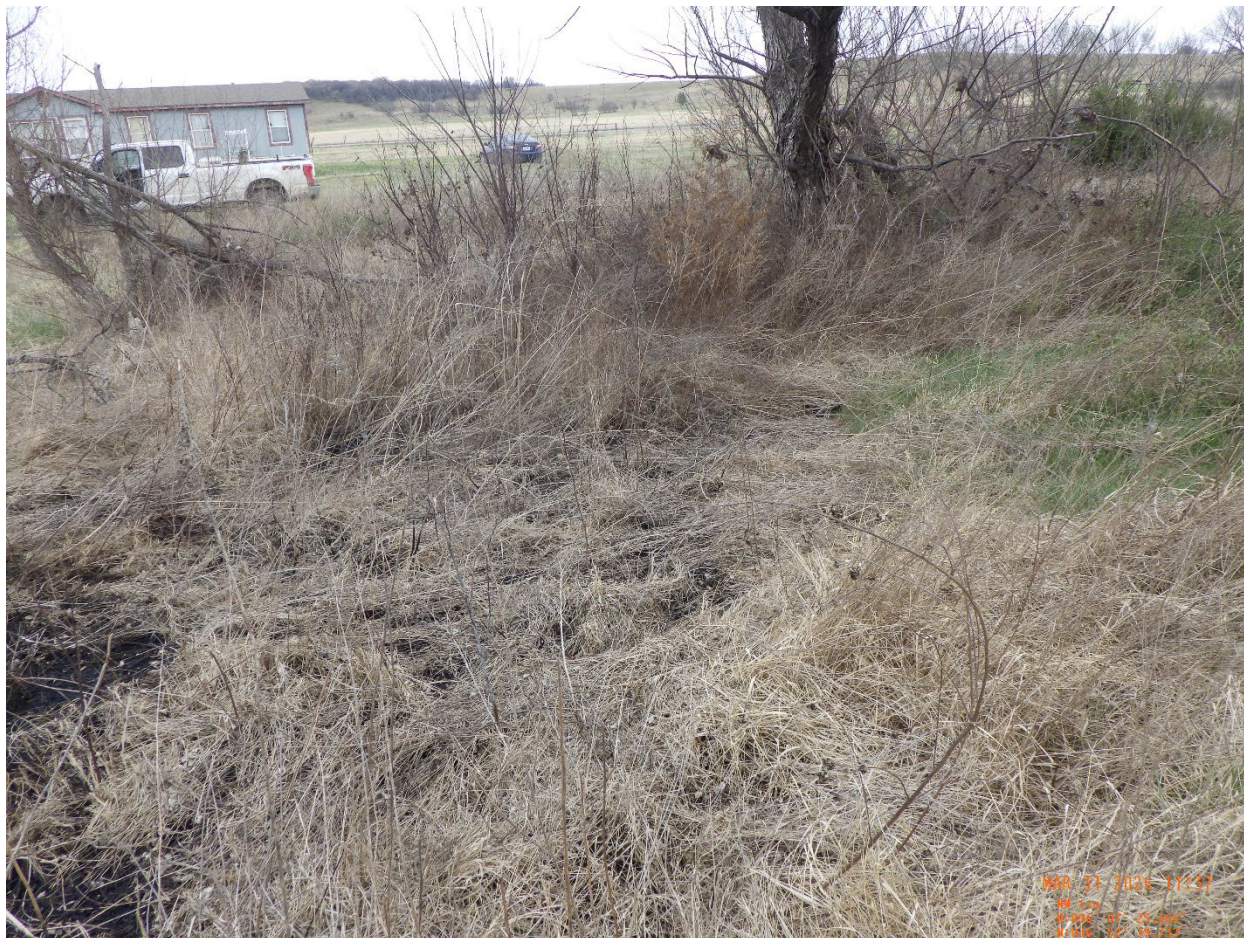
Photo No. 2

Standing near the release point, I observed the overland flowpath of the oil and saltwater. The flowpath varied from 10-25 feet in width and was primarily oil, oil-soaked soil, dead grass and dead trees, see photo No. 2.

**Description:** This was oil and oil-soaked soil along the overland flowpath migrating to the northwest from the release point.

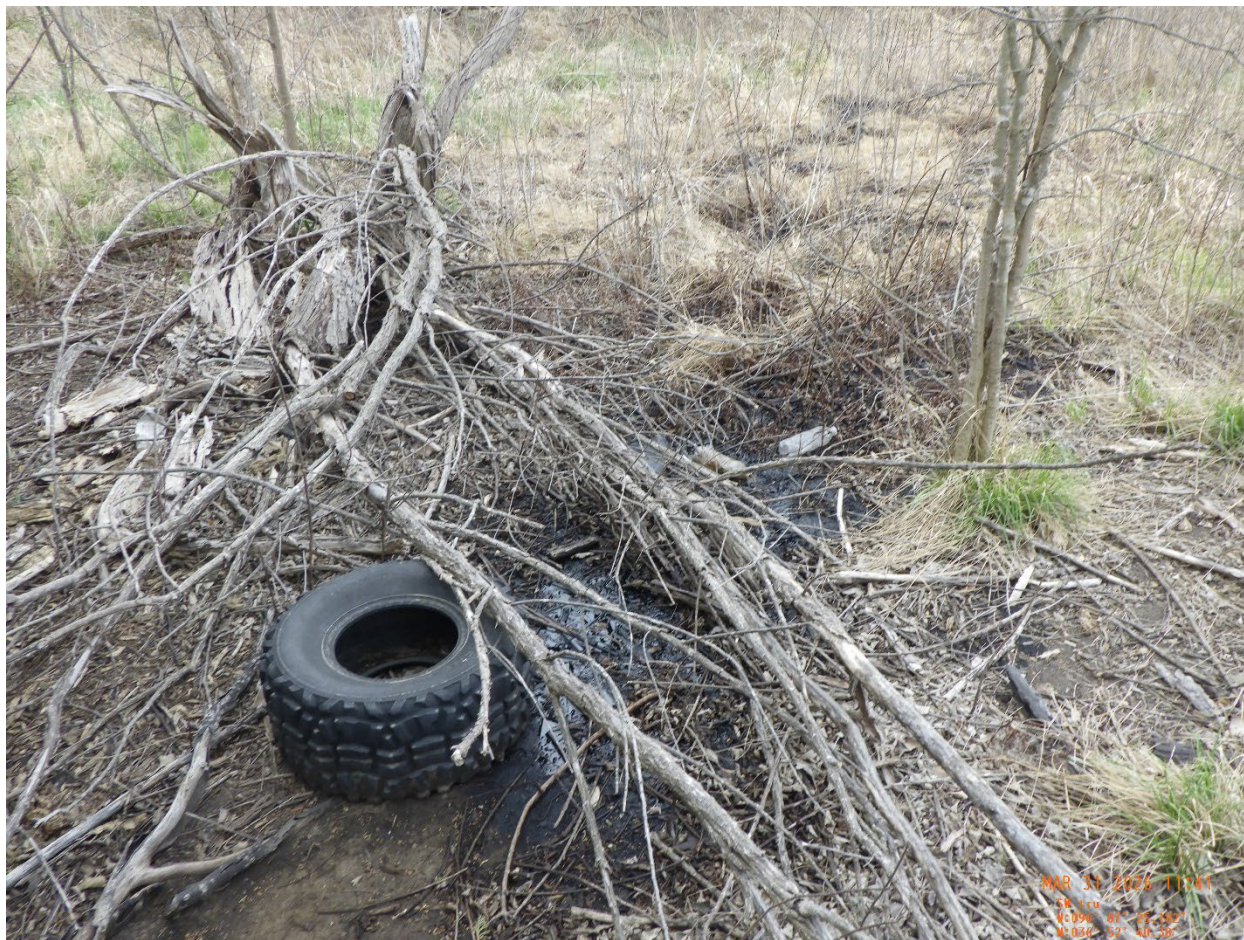
Photo No. 3

Approximately 100-150 feet north of the release point, I observed the end of spill impacts. See photo No 3.

**Description:** This was the end of spill impacts during the inspection. This location was approximately 100 feet north from the release point.
