**Well Inspection**  
**Osage DNR / Environmental Protection Agency**  
**1201 Elm Street, Suite 500**  
**Dallas, Texas 75270**

| <b>Operator Info</b> | McCann Resources, Inc<br>1613 West 6th Street<br>Bartlesville, OK 740033404<br>Phone: 918-337-4747 | <b>Inventory ID</b> | OS5929000 | | |
| | | <b>Well ID</b> | 11-B | | |
| <b>Location</b> | NE 04 27N 11E | <b>Status</b> | Inactive | <b>Well Type</b> | Enhanced Recovery |

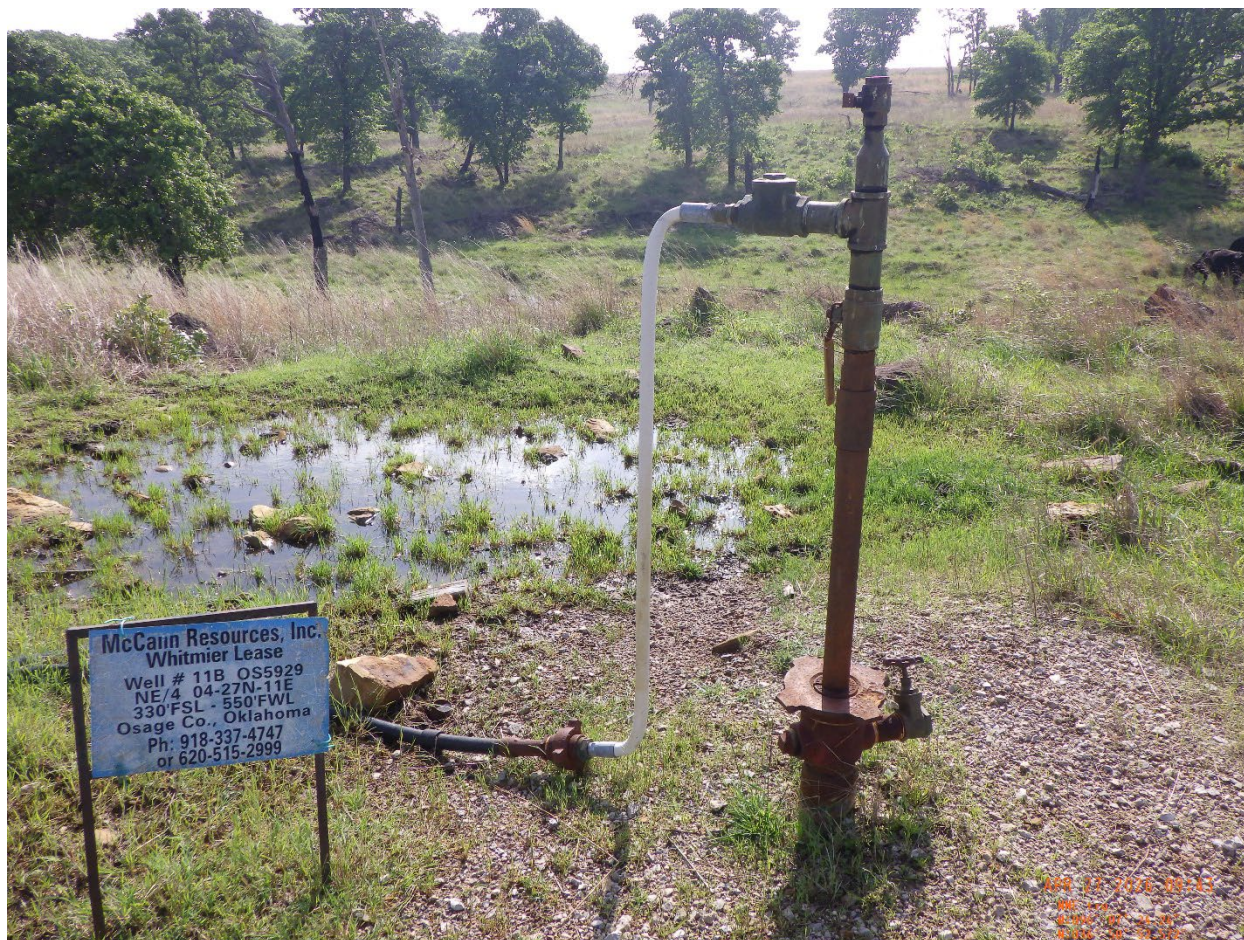
Photo No. 1

**Description:** This was well OS5929000 at the time of the inspection. At the time of the inspection, the well was connected but not injecting. The well was overdue for MIT.
