**UNITED STATES ENVIRONMENTAL PROTECTION AGENCY**  
**REGION 5**  
**77 WEST JACKSON BOULEVARD**  
**CHICAGO, ILLINOIS 60604**

**SUBJECT:** CLEAN WATER ACT INSPECTION REPORT  
*United Mobile Homes of Ohio, Inc – Lake Sherman Village MHC, 7227 Beth Avenue SW, Navarre, Ohio, Stark County*

**Date of Inspection:** September 5, 2024

**Inspection Type:** *Compliance Evaluation with Sampling*

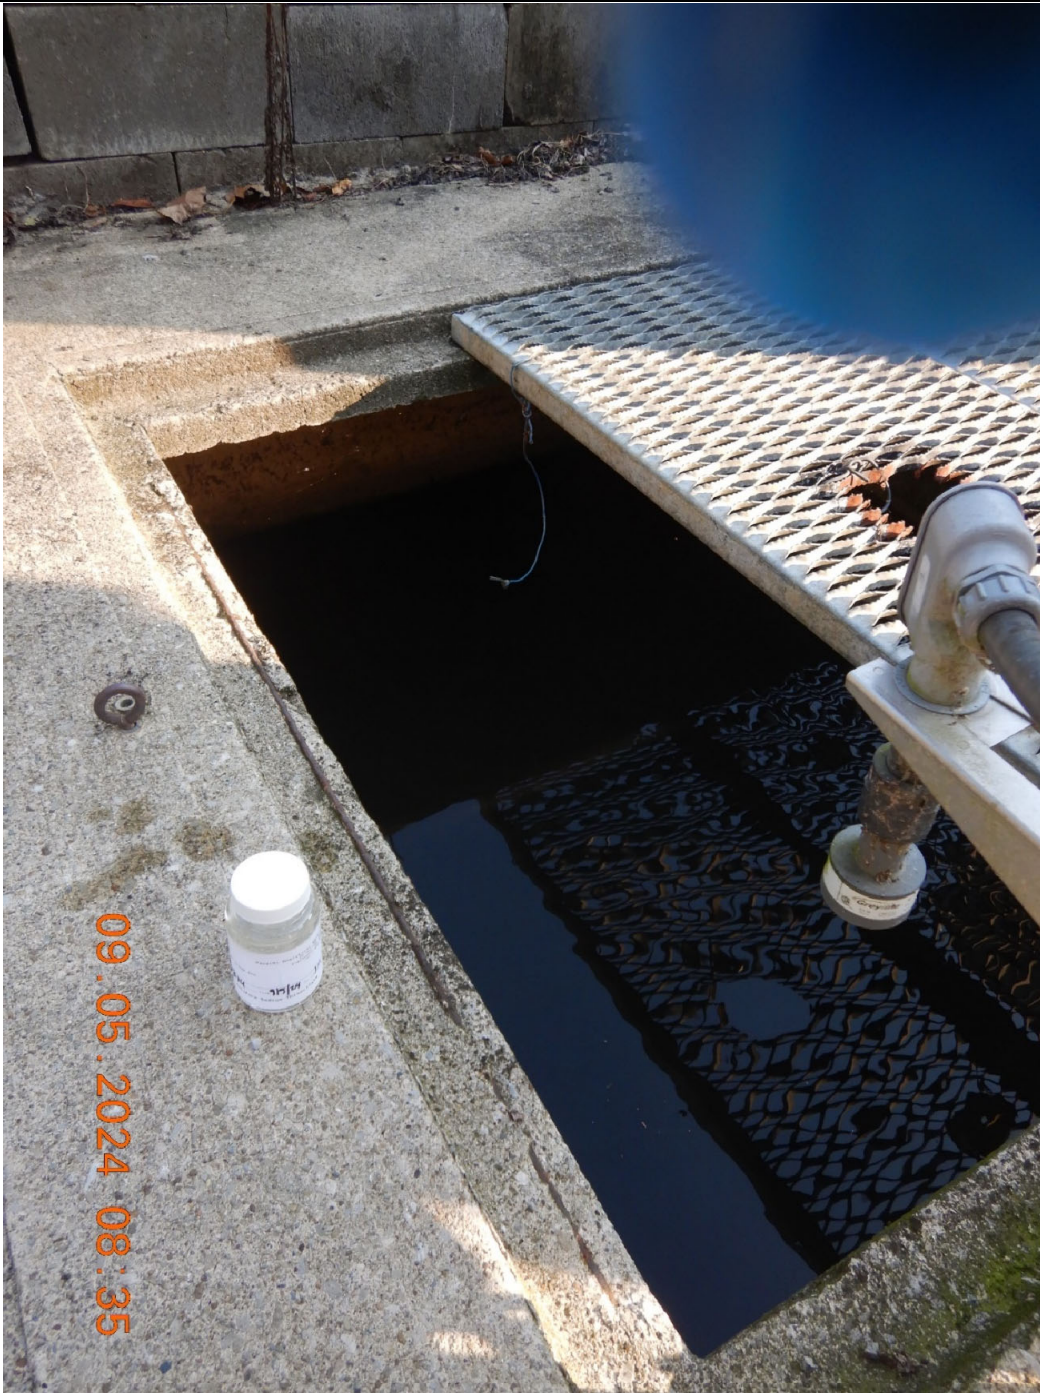
1: DSCN2254.JPG

Description: Sample S01 taken from the end of the chlorine contact chamber, just upstream of the flow measurement weir.

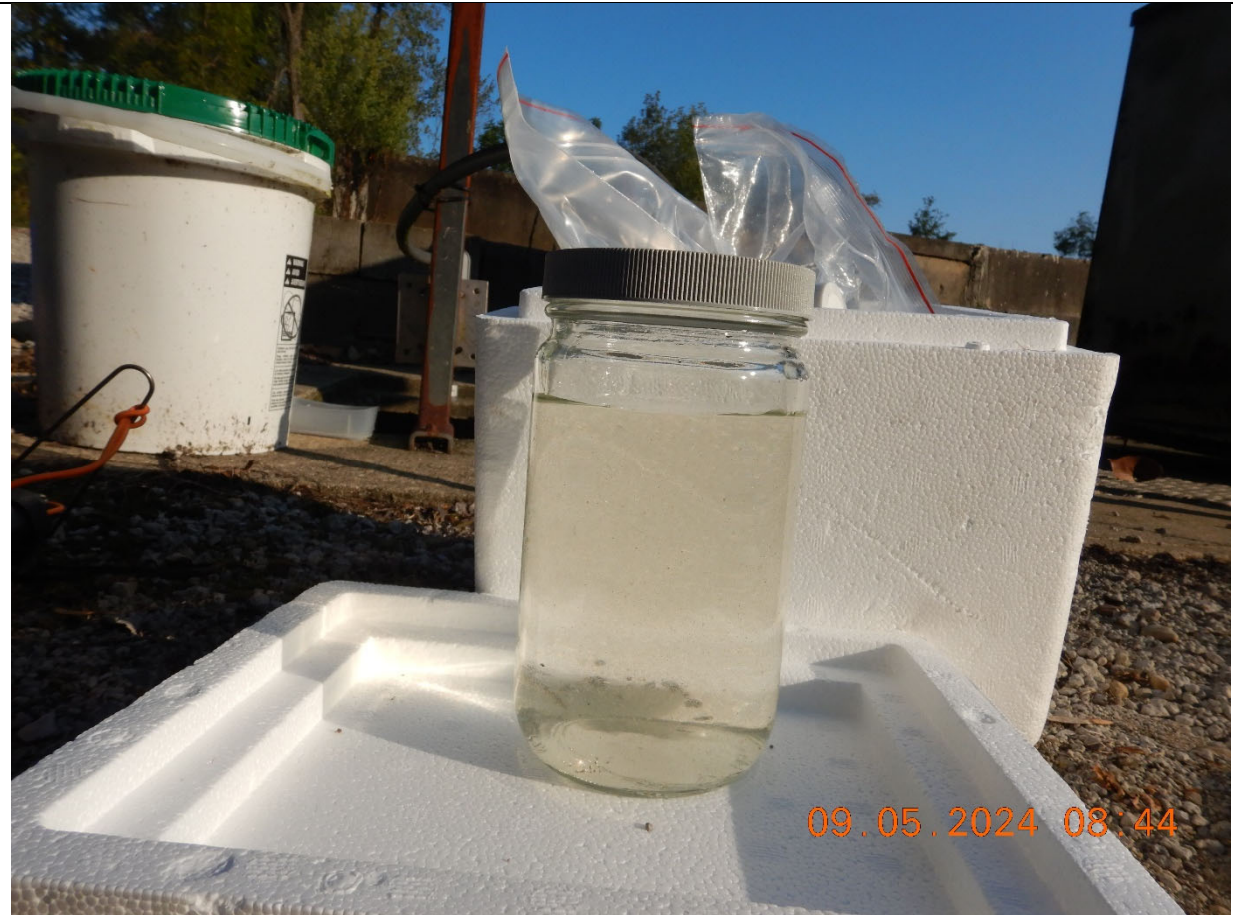
2: DSCN2255.JPG

At the time of the inspection the filters were being bypassed. The effluent had a cloudy or discolored appearance as shown in Photos 2 and 3. The turbidity of the discharge was 7.3 NTU equivalents. During a prior inspection conducted on May 30, 2024 the filters were in service and the effluent turbidity was 0 NTU equivalents.

Description: Visual grab of the effluent. At the time of the inspection the effluent was cloudy and discolored.

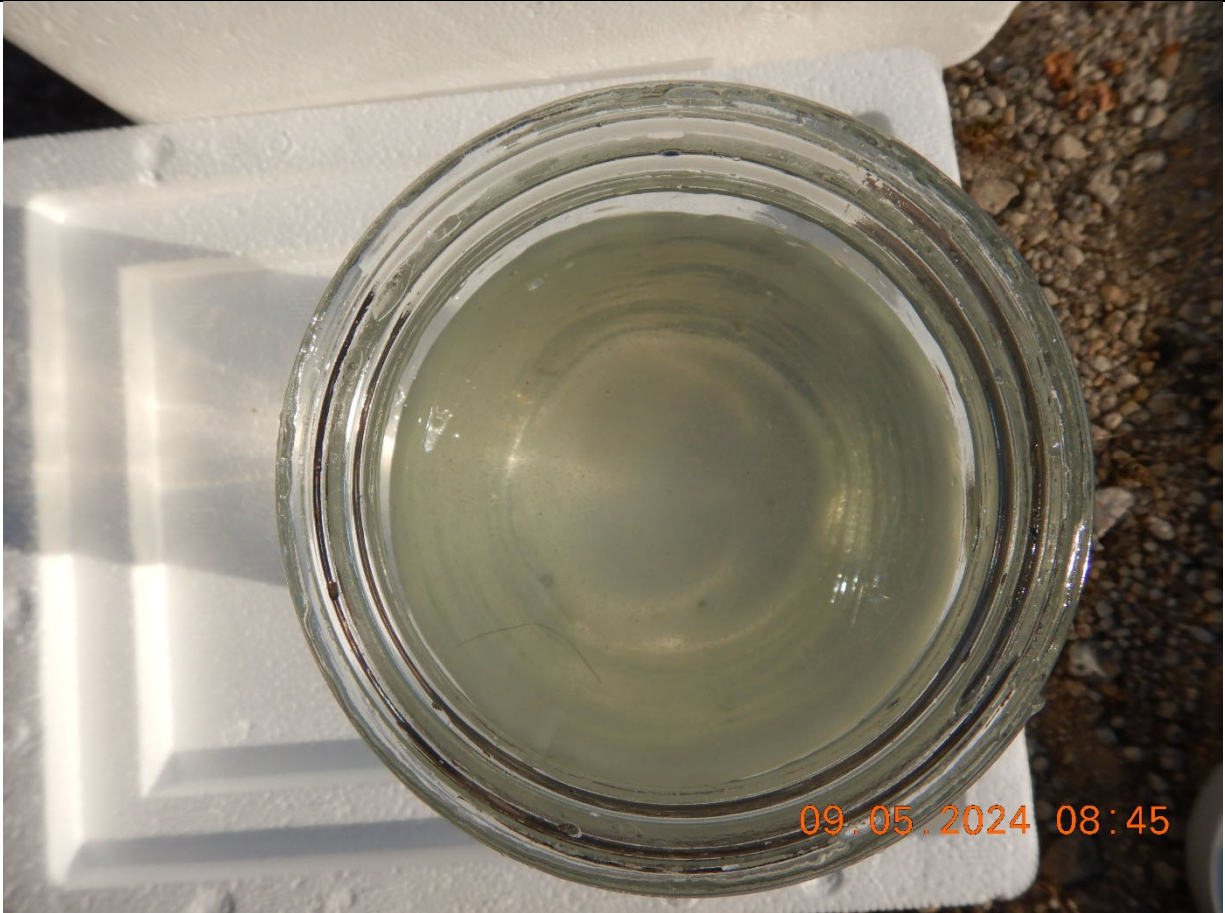
3: DSCN2256.JPG

Description: Visual grab of the effluent. At the time of the inspection the effluent was cloudy and discolored.

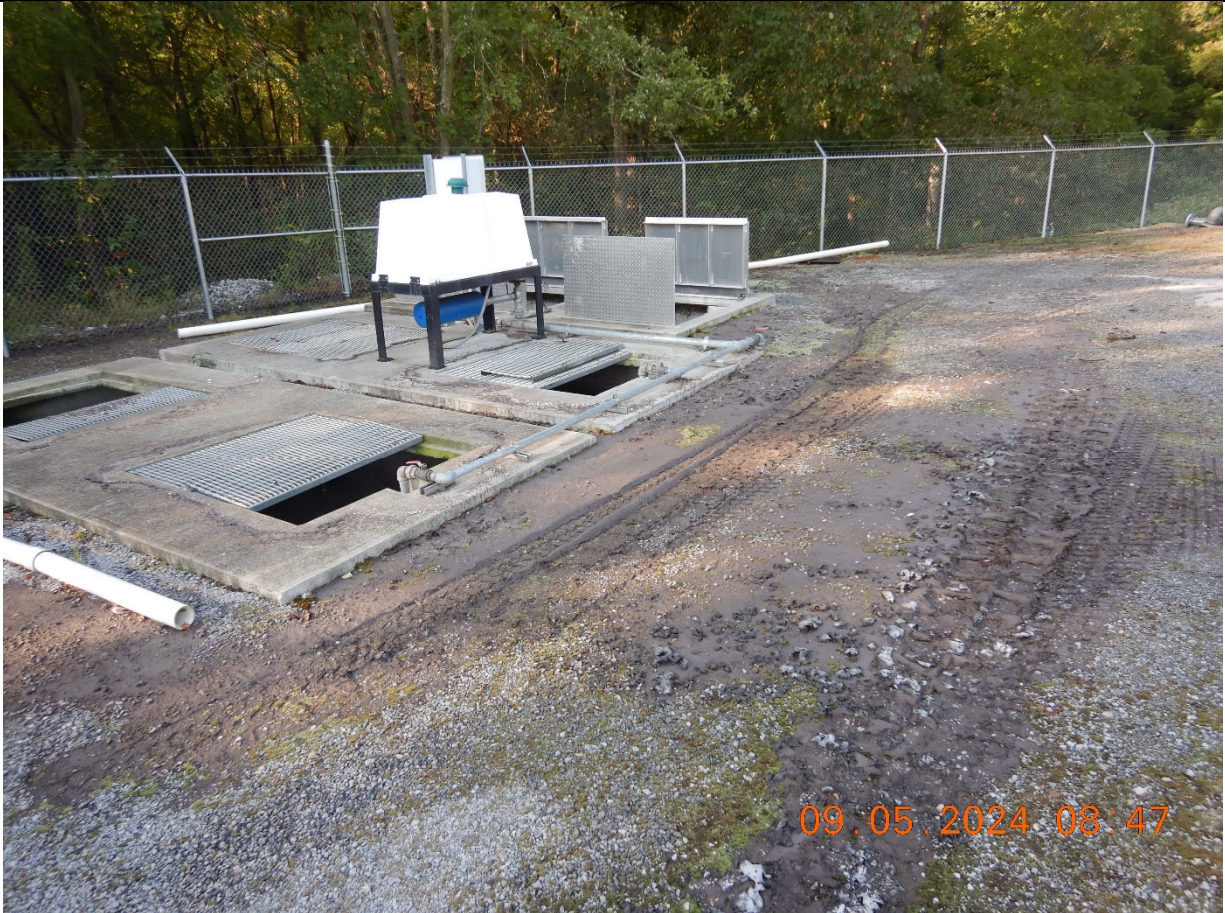
4: DSCN2257.JPG

Sometime between Tuesday (9/3/24) morning and Wednesday (9/4/24) morning the pumps in the dosing chamber, which pumps to the sand filters, became inoperable. When Ron arrived at the site on Wednesday morning, water had begun to backup in the plant and was overflowing from the south aeration basin onto the ground in between the south and middle aeration basins. See photos 4 through 6. The ground in that area slopes toward a receiving stream to the south of the treatment plant in the direction shown in photo 5.

Description: Looking at the south aeration basin. Per Ron Miller, this basin had overflowed onto the ground shown in the foreground of this photo.

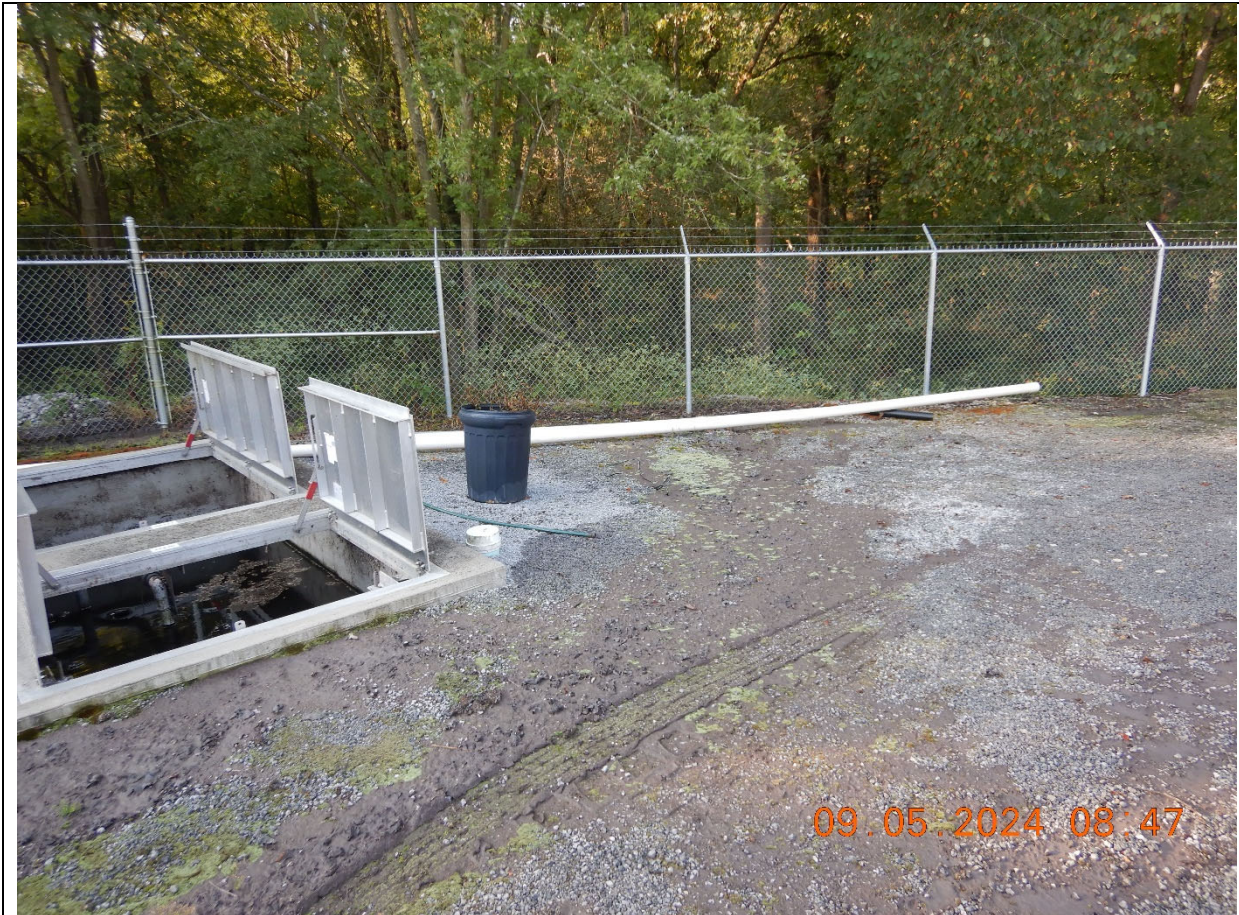
5: DSCN2258.JPG

Description: Looking at the south aeration basin. Per Ron Miller, this basin had overflowed onto the ground shown in the foreground of this photo.

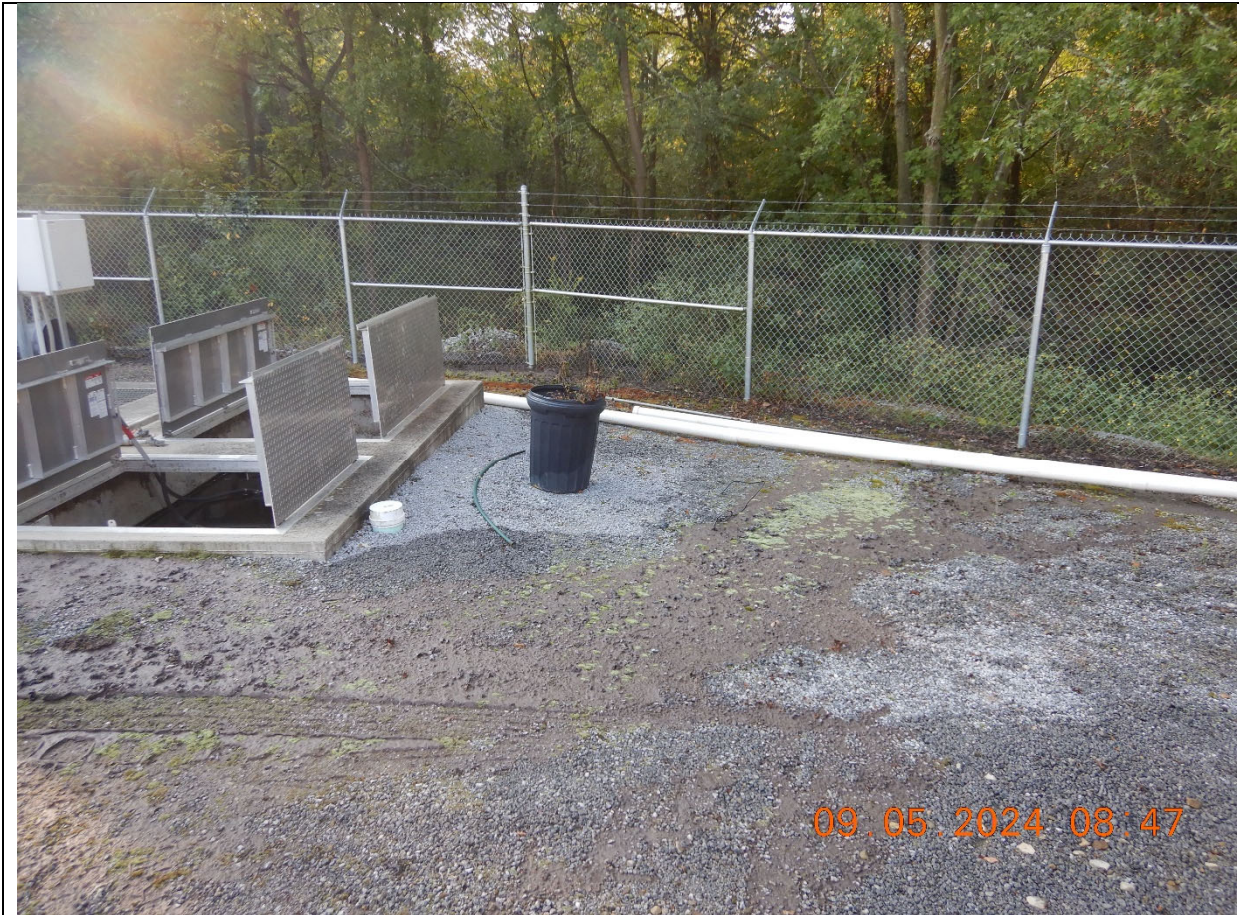
6: DSCN2259.JPG

Description: Looking at the south aeration basin. Per Ron Miller, this basin had overflowed onto the ground shown in the foreground of this photo.

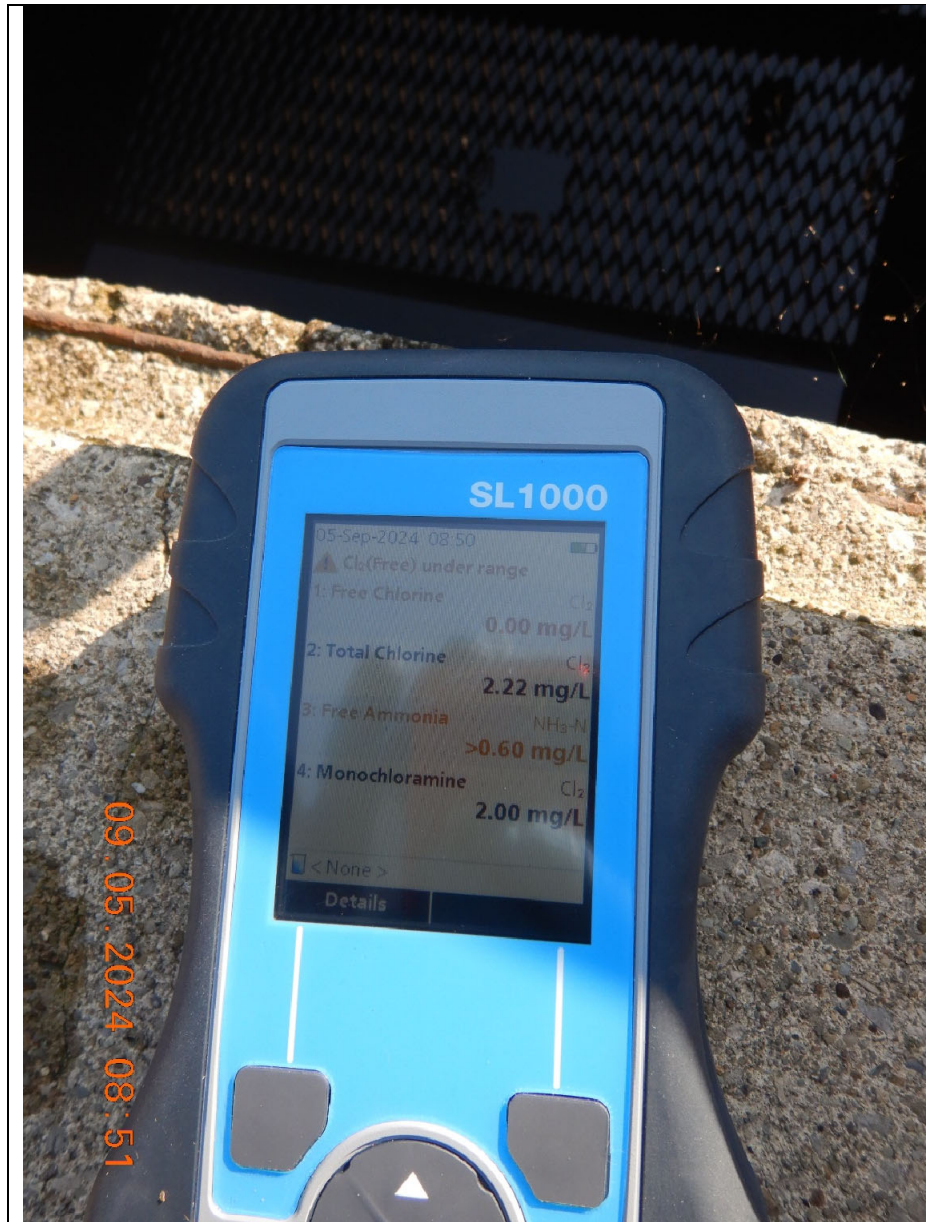
7: DSCN2260.JPG

At the time of the inspection, the chlorine dosing could not be determined, however the chlorine dosing was not enough to maintain an effective free chlorine residual. The concentration of ammonia in the discharge was high enough to fully react with all available free chlorine, eliminating the free chlorine from the hypochlorite disinfectant.

Description: Result of the monitoring conducted by EPA at the end of the chlorine contact chamber using a Hach SL1000.
