**Region 6 - Enforcement & Compliance Assurance Division**  
**INSPECTION REPORT**

| Inspection Date(s): | 12/23/2024 | |
| Facility Name: | <b>Rio Rancho WWTP-Lift Station -21</b> | |
| Identification/Permit Number: | NM0027987 | |

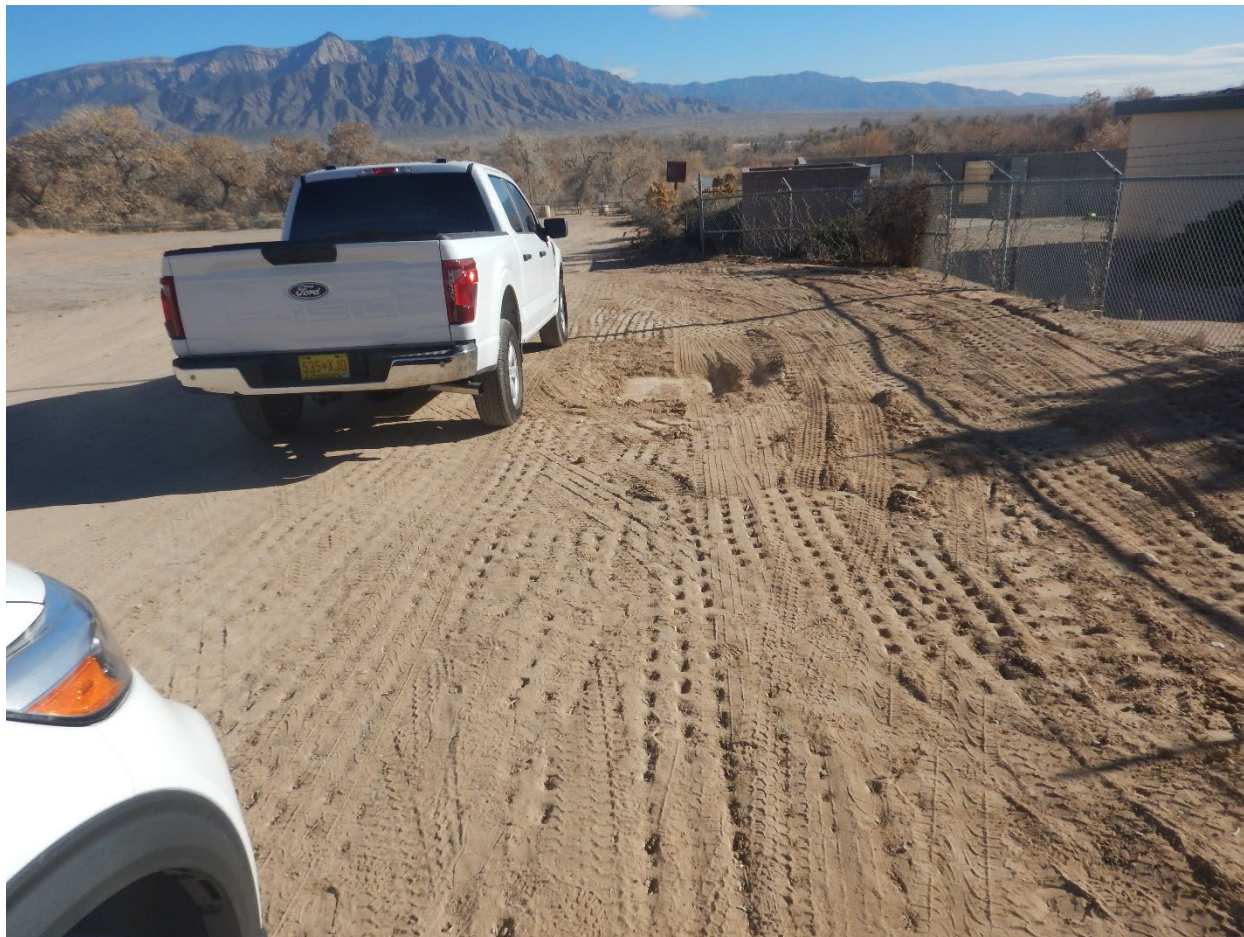
Photo No. 1

- Lift Station -21- experienced 14-inch line failure on December 8, 2024. SSO flows were ceased at approximately 11:00 PM (December 8, 2024) after line repairs were completed. SSO flows continued for approximately 15+ hours (approximately 0700 to 2300 hrs.). Backfill was completed at approximately 00:18 AM (December 9, 2024).

View looking approximately East adjacent to wire fabric perimeter fence of former WWTP #3 of the compacted land surface area where collapsed force was repaired. (DSCN2743) (12/23/2024) 2:43 PM. Photographed by D. Esparza

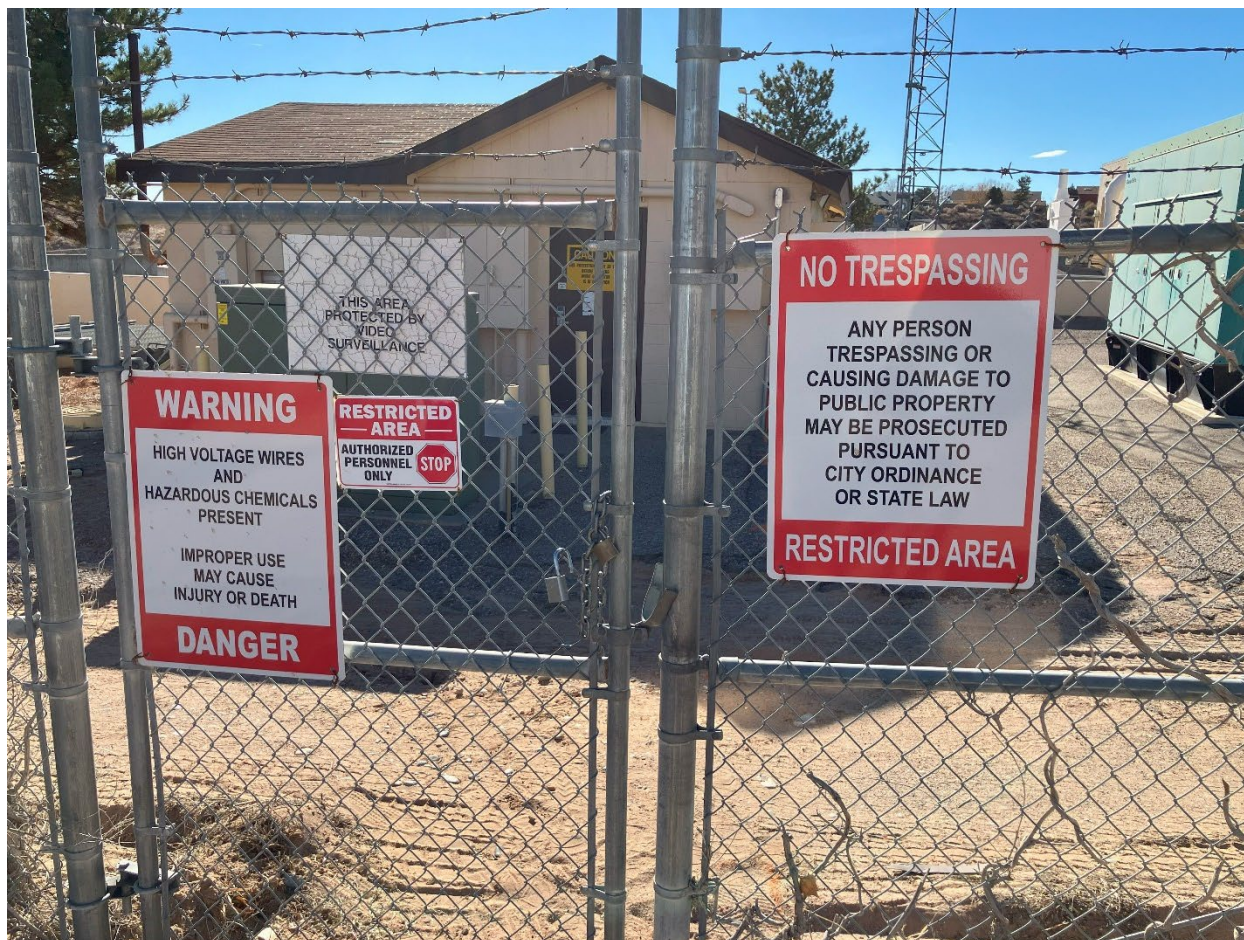
Photo No. 2

View of warning signage on outside of WWTP #3 and LS-#21 wire fabric perimeter fencing. (IMG\_0456)  
Photographed by N. Fuad

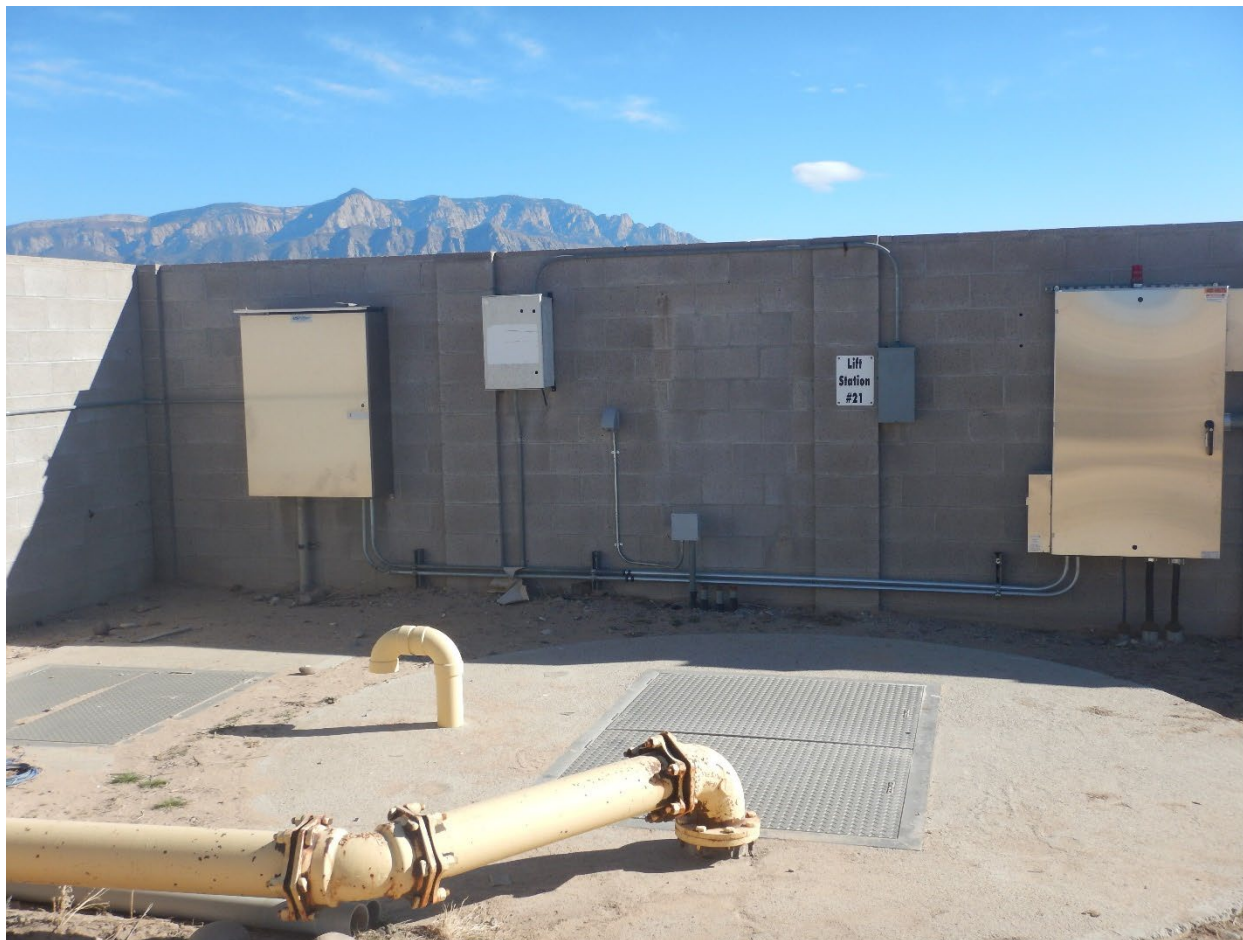
Photo No. 3

View of Lift Station #21 piping, electrical panels and wet well enclosures inside the former WWTP #3 perimeter fence. (DSCN2746) (12/23/2024) 2:44 PM. Photographed by D. Esparza

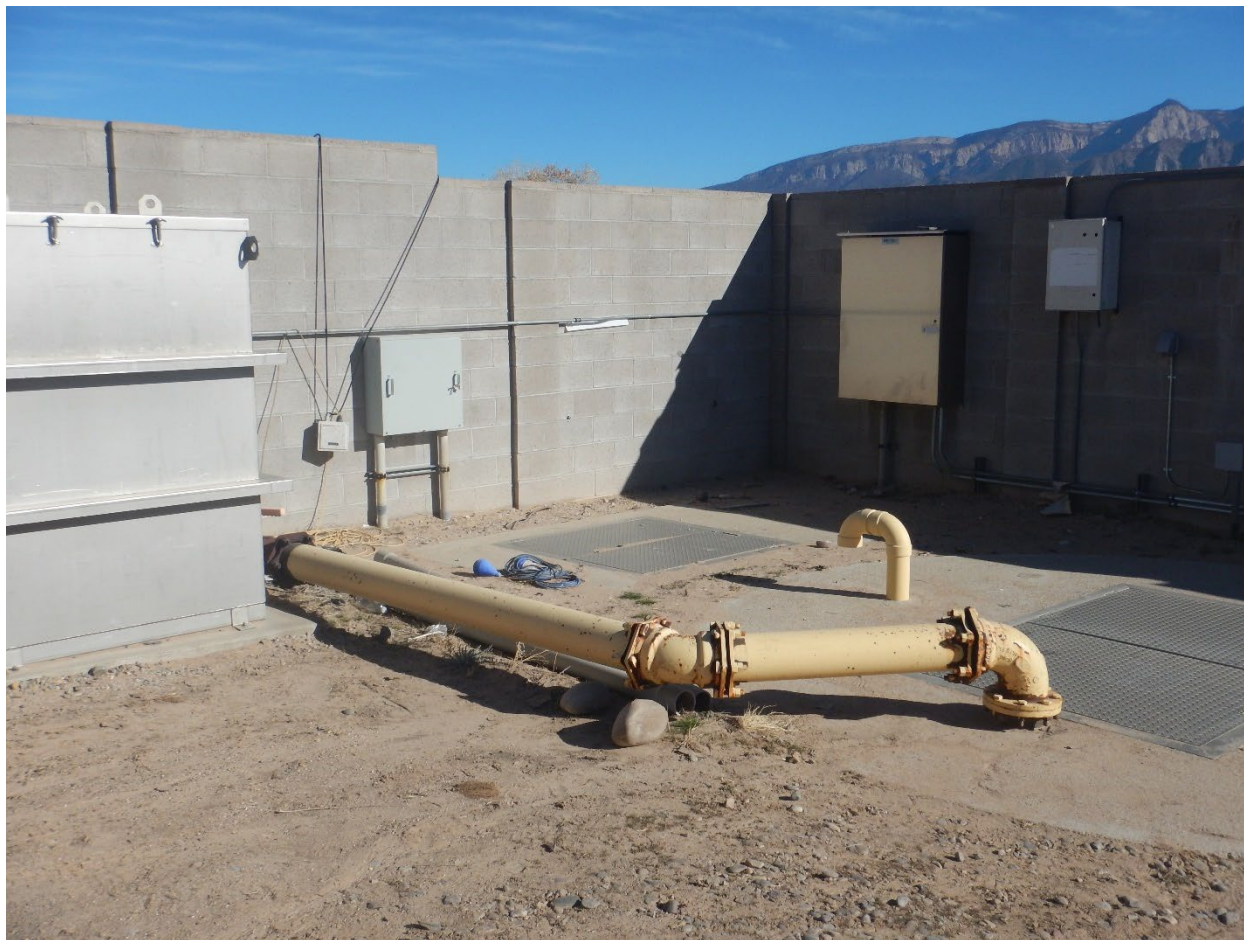
Photo No. 4

Another view of Lift Station #21 piping, electrical panels and wet well enclosures inside the former WWTP #3 perimeter fence. Note: the lack of piping support, fitting (flange) condition (corrosion/rust), visible corrosion near concrete masonry unit (CMU) wall penetration in an approximate Northerly direction and land surface debris. Additionally, this piping connects to the collapsed force main (located outside the CMU wall). (DSCN2747) (12/23/2024) 2:45 PM. Photographed by D. Esparza

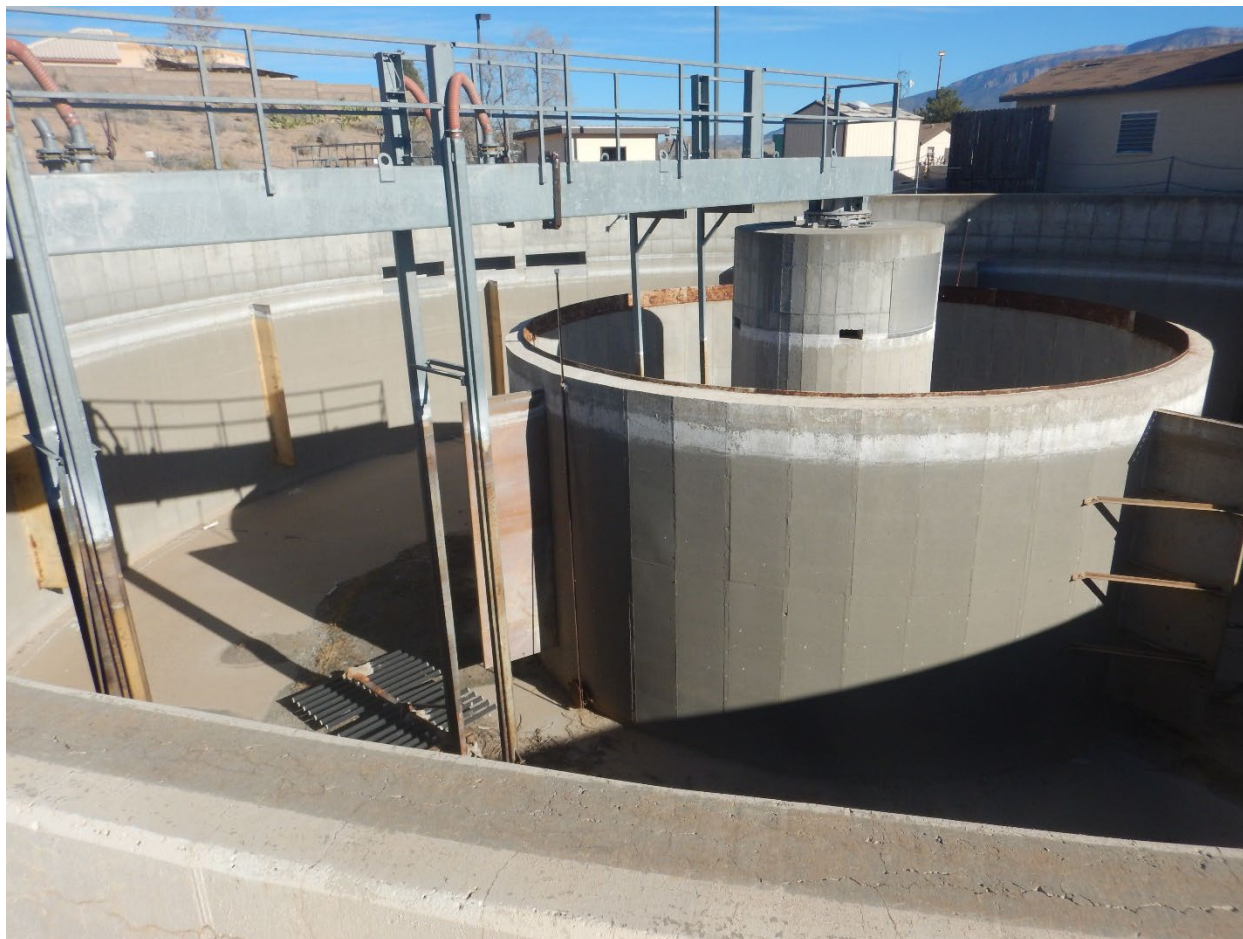
Photo No. 5

- The adjacent WWTP #3 (NPDES permit NM0029602, issued on June 6, 2016, and terminated March 24, 2021) was observed to confirm, previous treatment basins were not utilized as equalization (EQ) basins.

View of one of Rio Rancho's WWTP #3 (NPDES permit NM0029602, issued on June 6, 2016, and terminated March 24, 2021) clarifiers. This treatment process basin is located within the fenced perimeter and west of LS-#21. NOTE: the treatment basins and other appurtenant ancillary equipment were viewed to confirm they were not being utilized as EQ basins. (DSCN2749) (12/23/2024) 2:51 PM. Photographed by D. Esparza

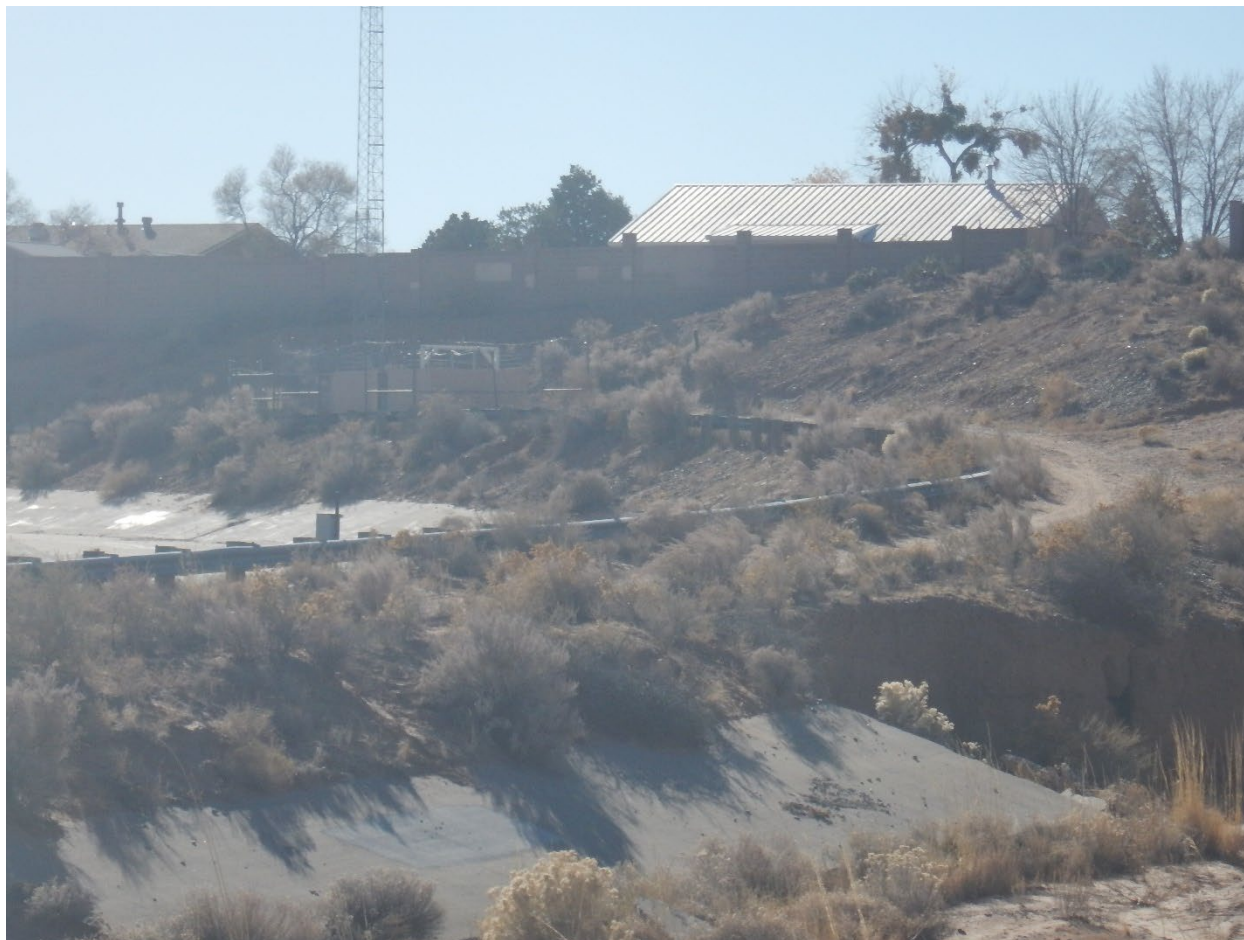
Photo No. 6

View of LS-#8 located approximately 900-feet Southeast of LS-#21. NOTE: LS-#8 collects the influent flows from Rivers Edge 1 subdivision and pumps via a closed conduit 6-inch force main to the LS-#21 wet well. (DSCN2751) (12/23/2024) 2:59 PM. Photographed by D. Esparza

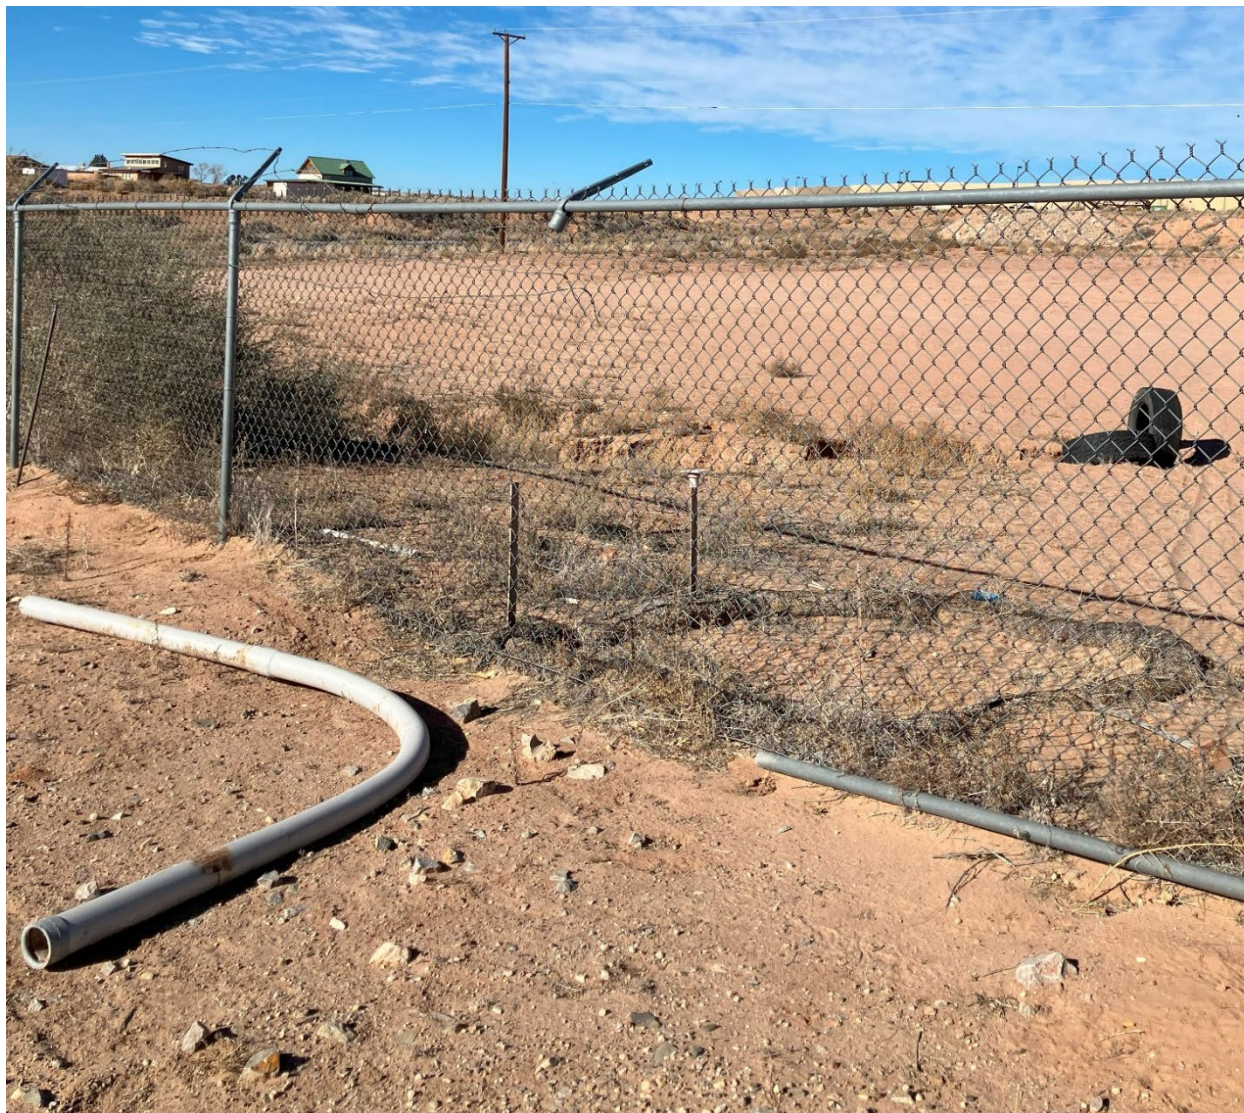
Photo No. 7

- Though some of the Lift Stations observed during this December onsite inspection-maintained perimeter fencing various areas of the fencing exhibited damage, others lacked secure site fencing at all, exhibited vagrant vegetive growth, had visible evidence of previous storm event erosion and/or lacked visible flashing lights or audible alarms. Additionally, visible notification signage was lacking.

View looking north of LS-#15 damaged wire fabric perimeter fencing. NOTE: stormwater wattles outside fencing. (IMG\_0537-cropped) Photographed by N. Fuad

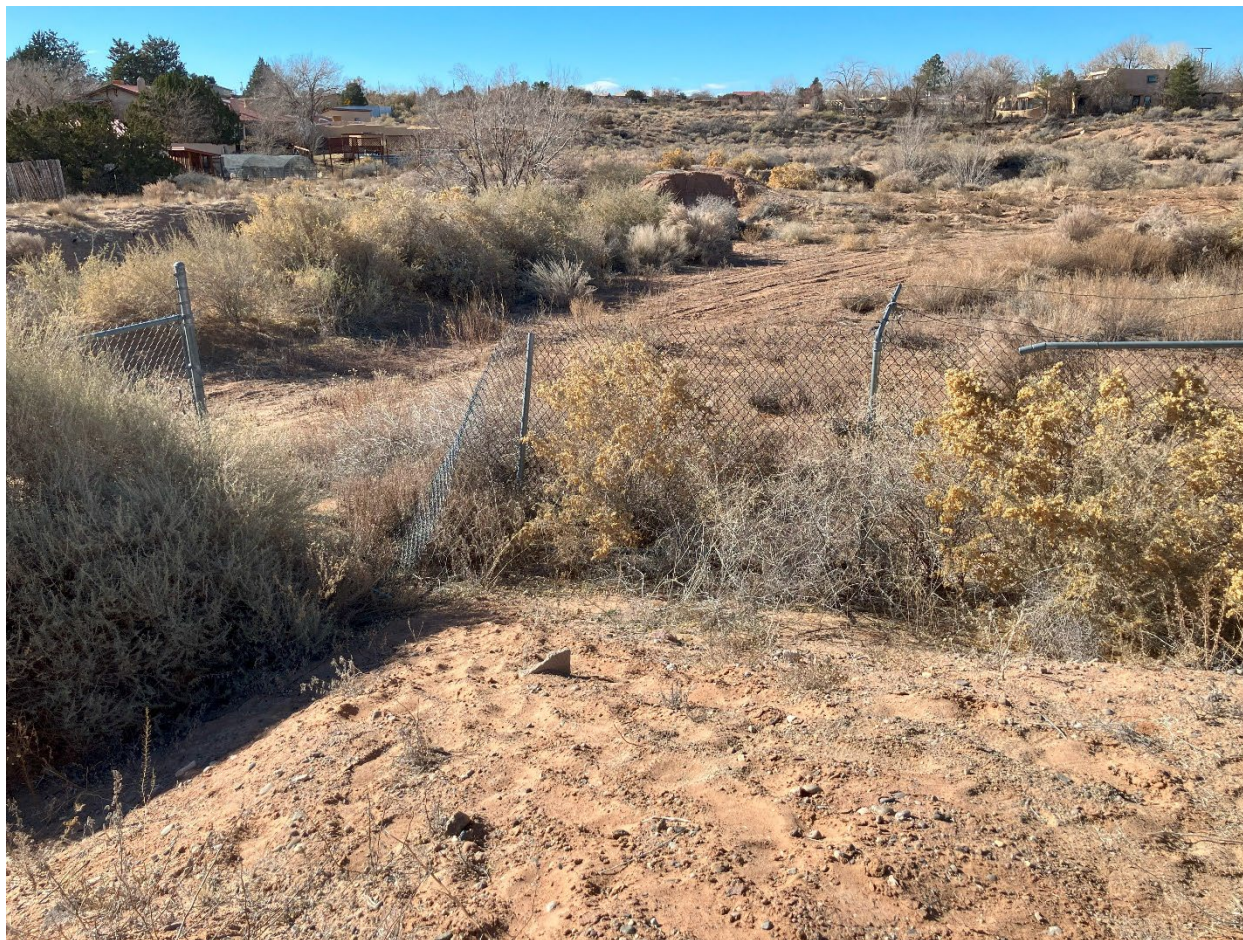
Photo No. 8

Another view of damaged perimeter wire fabric fencing of LS-#15. NOTE: the excessive vagrant vegetive growth inside and along fencing allows for perimeter degradation and vermin attraction. (IMG\_0543)  
Photographed by N. Fuad

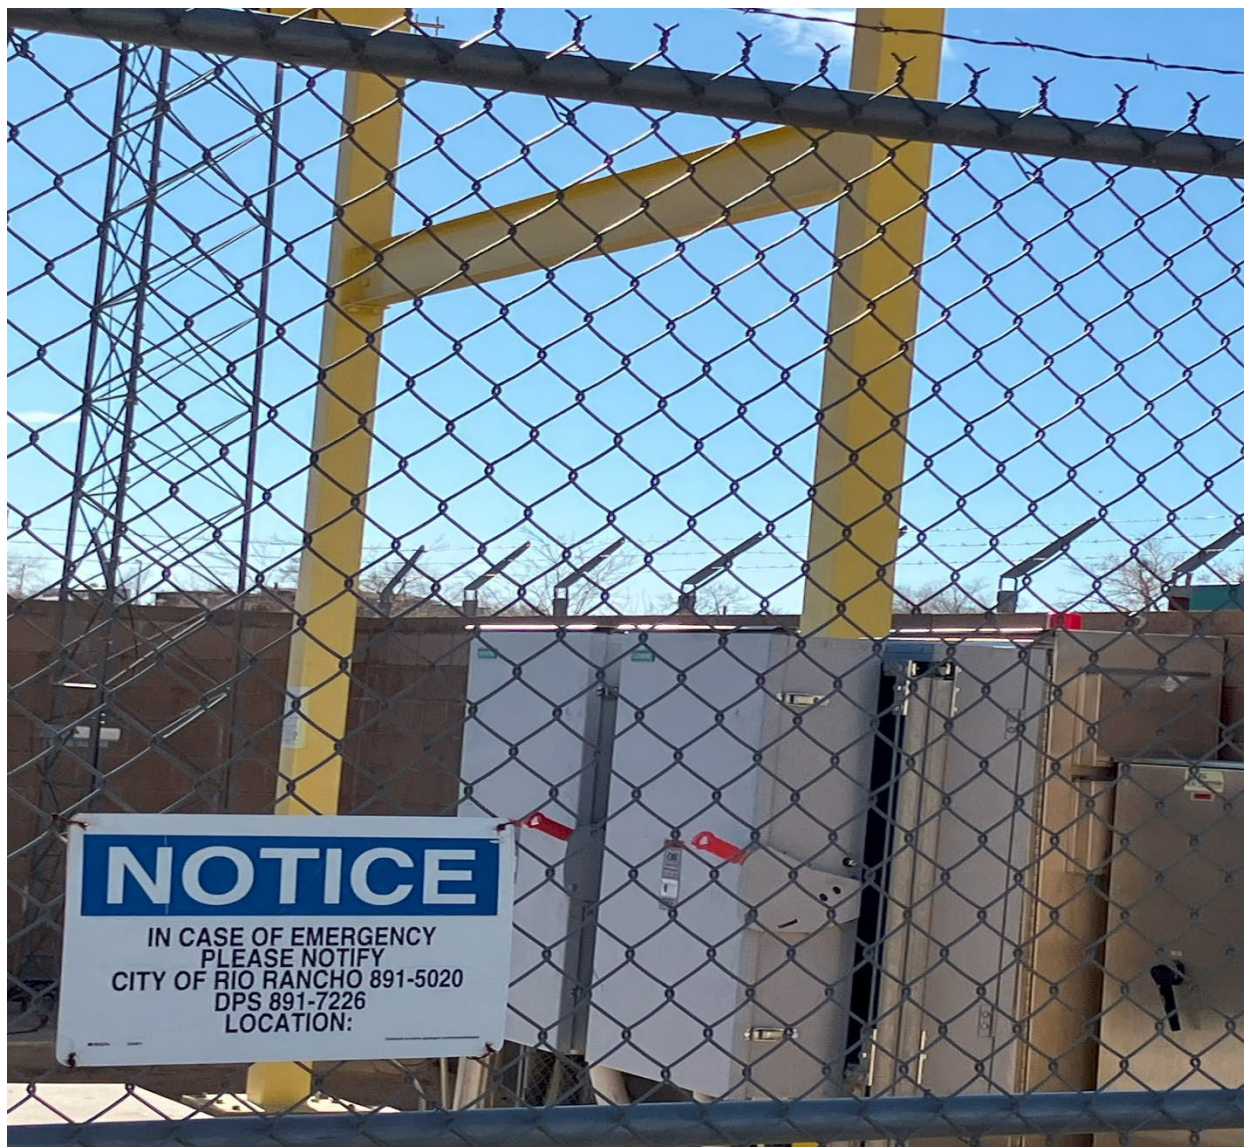
Photo No. 9

View of minimal warning or electrical hazard signage inside of LS-#15. NOTE: the appearance of a flashing light (alarm) in the center right of photograph located below enclosure. (IMG\_0545) Photographed by N. Fuad

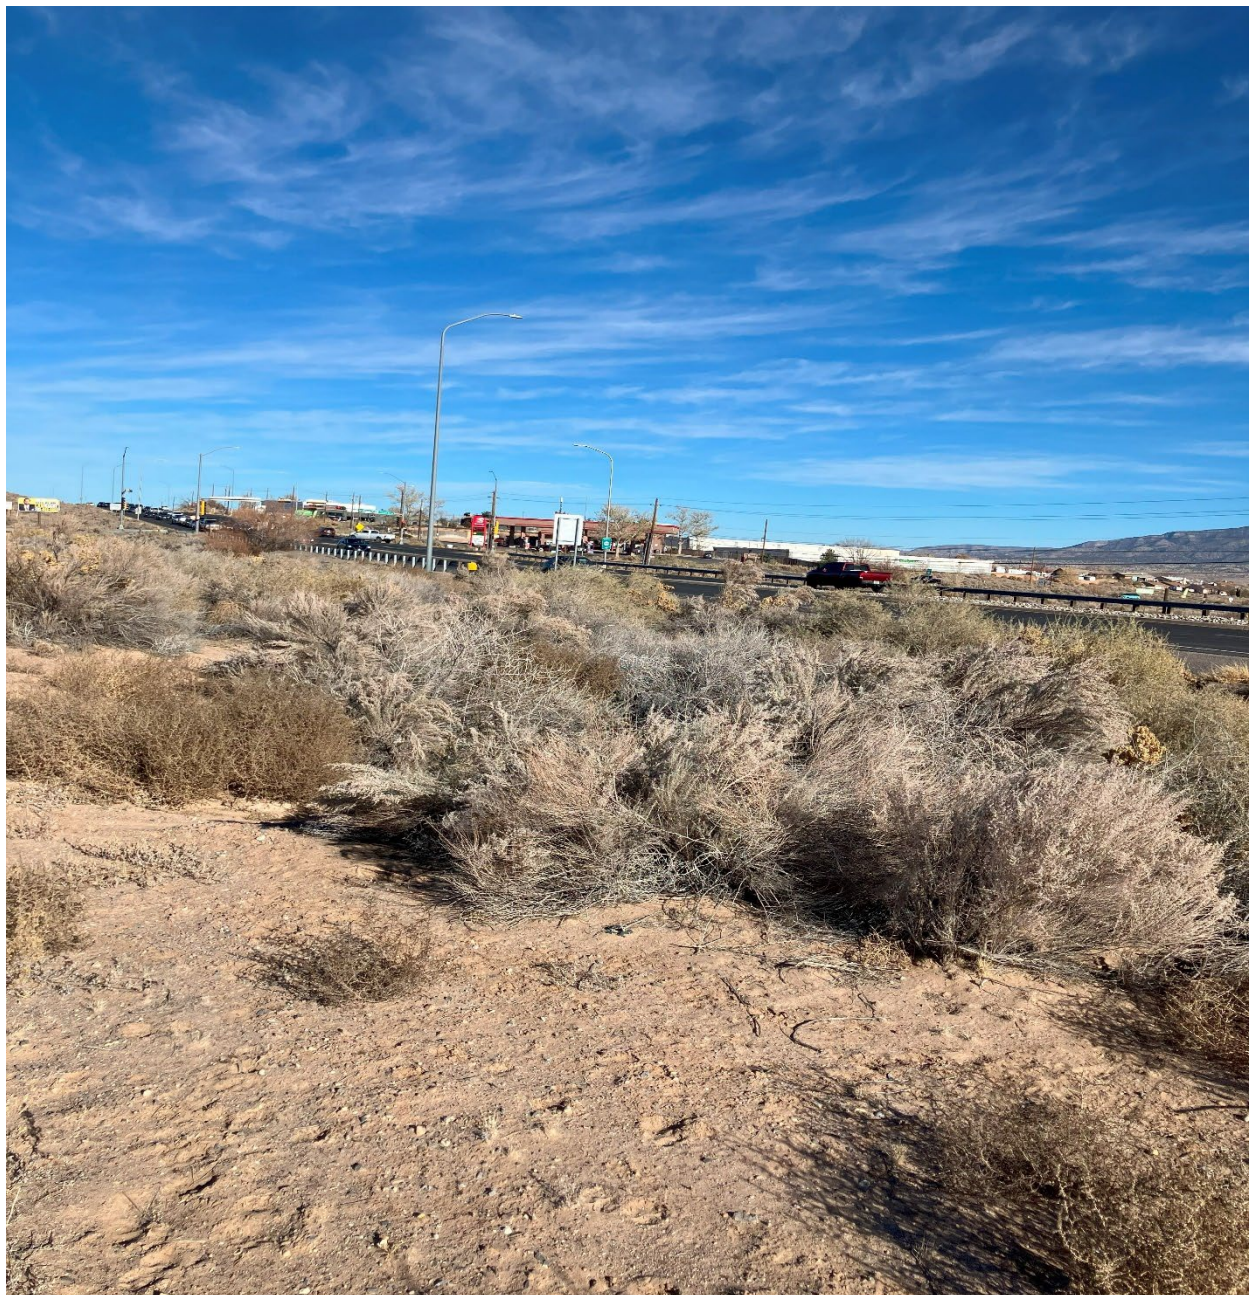
Photo No. 10

View looking from LS-#22 approximately northeast towards State Highway 528 (aka Pat D 'Arco Highway)  
NOTE: lack of perimeter fencing. (IMG\_0561) Photographed by N. Fuad

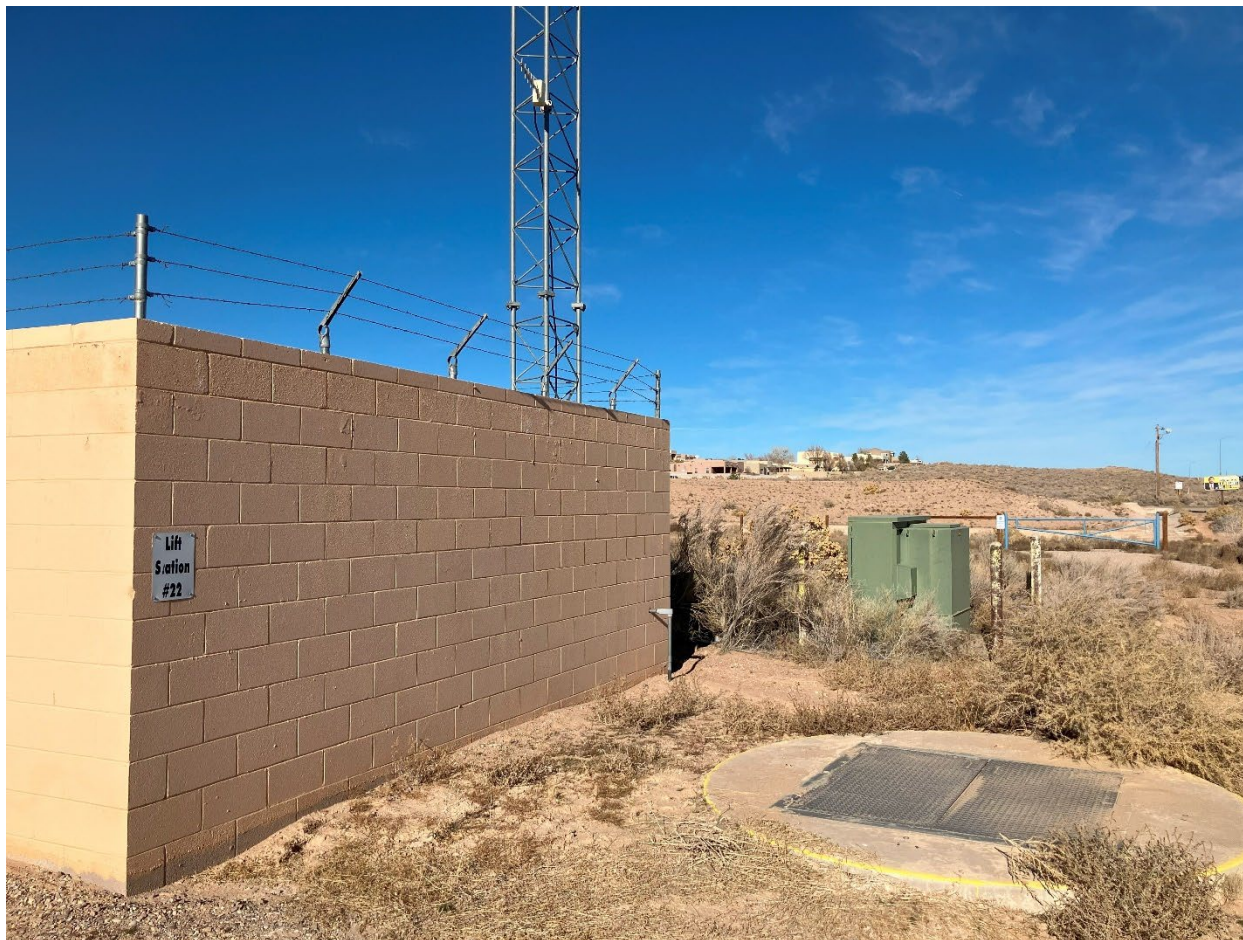
Photo No. 11

View of north side of LS-#22. NOTE: the lack of perimeter fencing adjacent to state highway 528 potentially allowing unauthorized access to the wet well and ancillary equipment. Additionally, the SCAFCA access gate is denoted in the upper right of the photograph. (IMG\_0562) Photographed by N. Fuad.

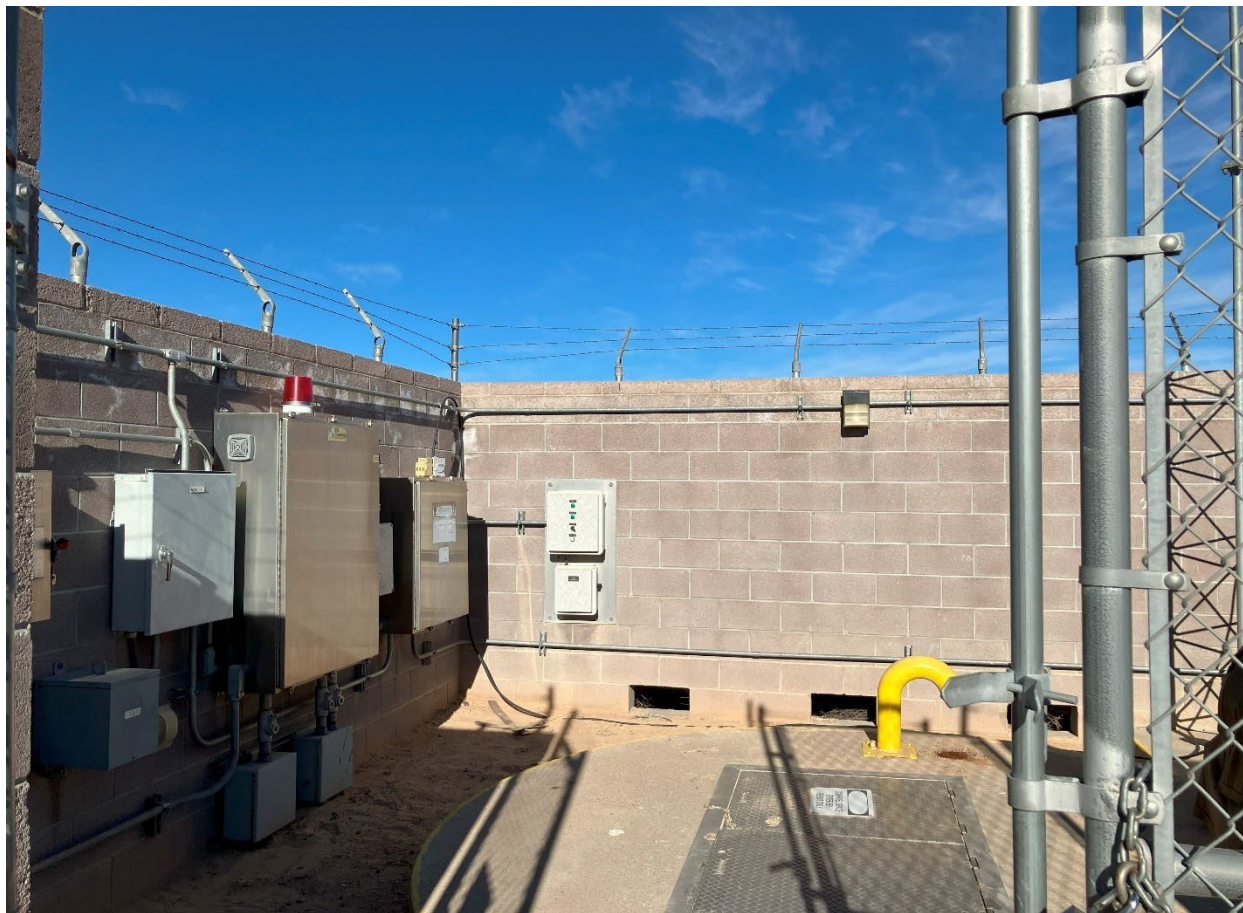
Photo No. 12

View inside of CMU enclosure of LS-#22 exhibiting electrical control panels and lift station vault. NOTE: the flashing light alarm below the top of the enclosure. (IMG\_0563) Photographed by N. Fuad.

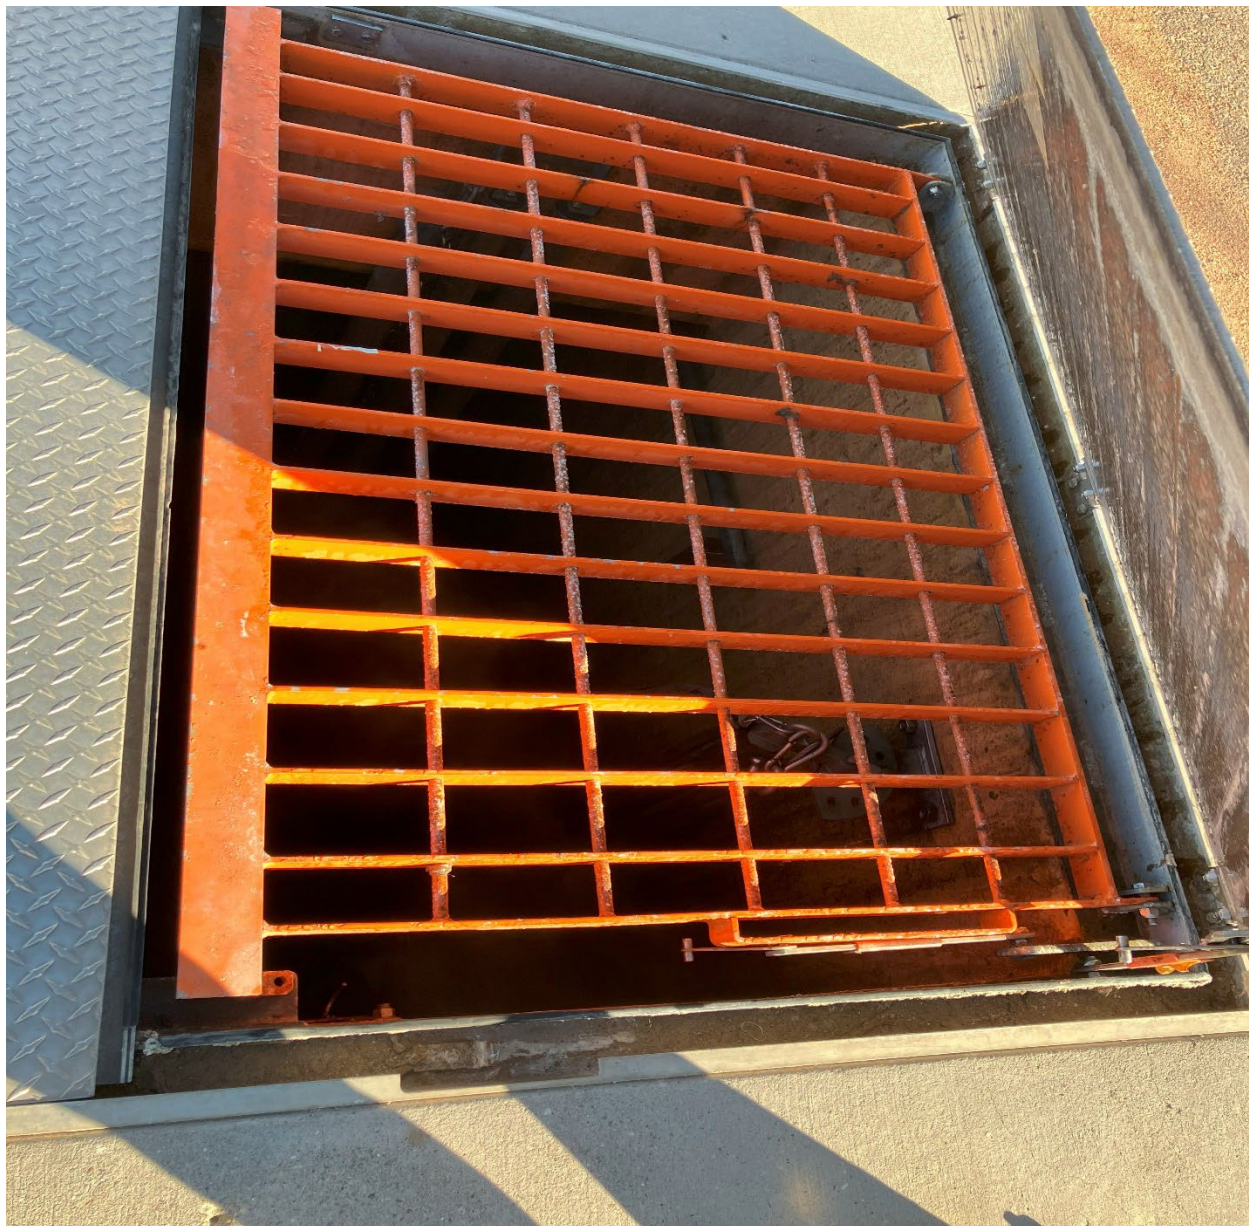
Photo No. 13

View of safety gate within locked hatchway of LS-#10 wet well. NOTE: LS-#10 is located within a secure CMU enclosure, maintains adequate perimeter lighting (elevated poles) and stated audible alarms. (IMG\_0566) Photographed by N. Fuad

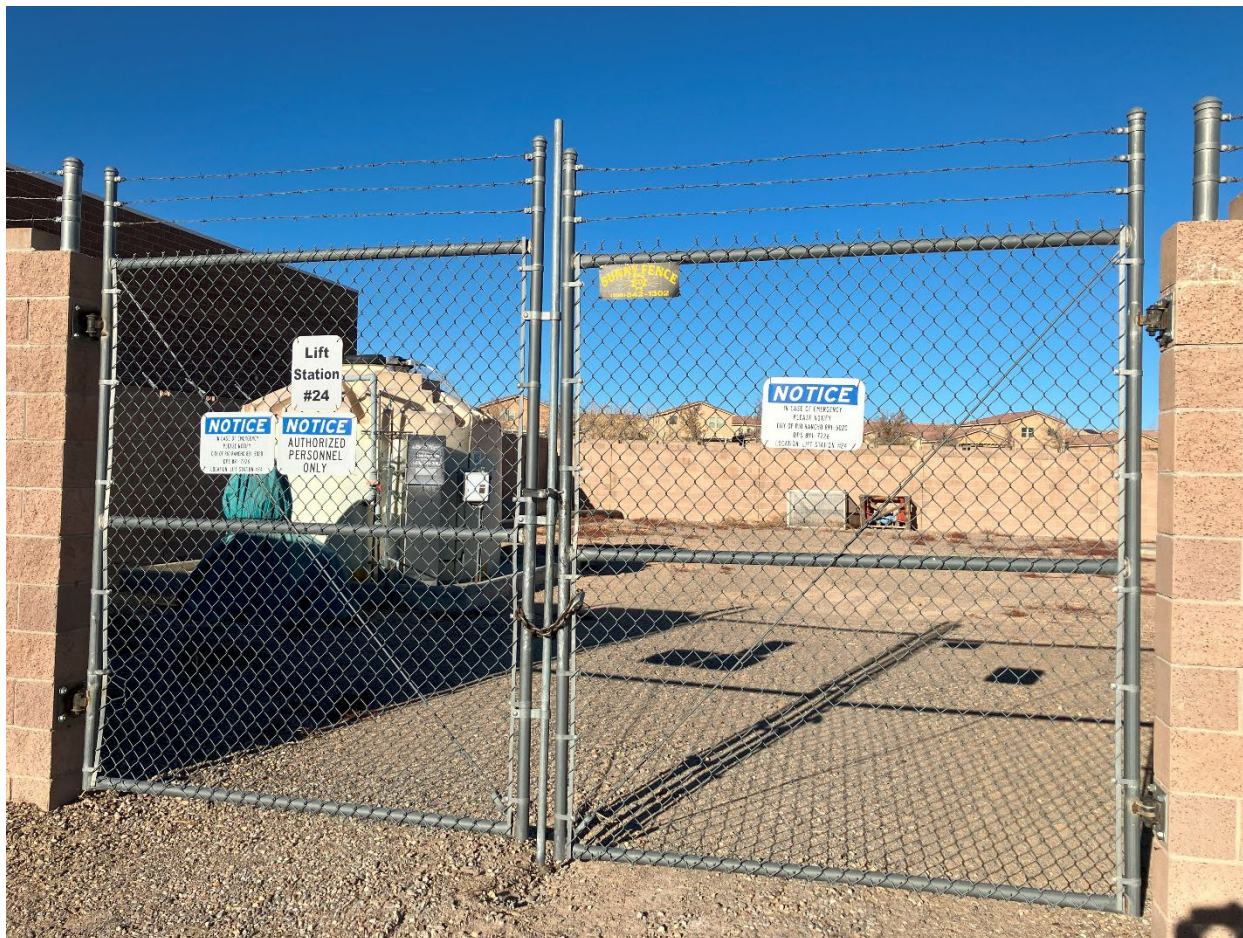
Photo No. 14

View of wire fabric gate and secondary CMU wall of LS-#24, located within Water Reclamation Facility (WRF) #6 (aka Cabezon WRF). NOTE: WRF #6 effluents are also t pumped into an injection well authorized under New Mexico Environment Department (NMED) discharge permit DP-215. (IMG\_0571) Photographed by N. Fuad

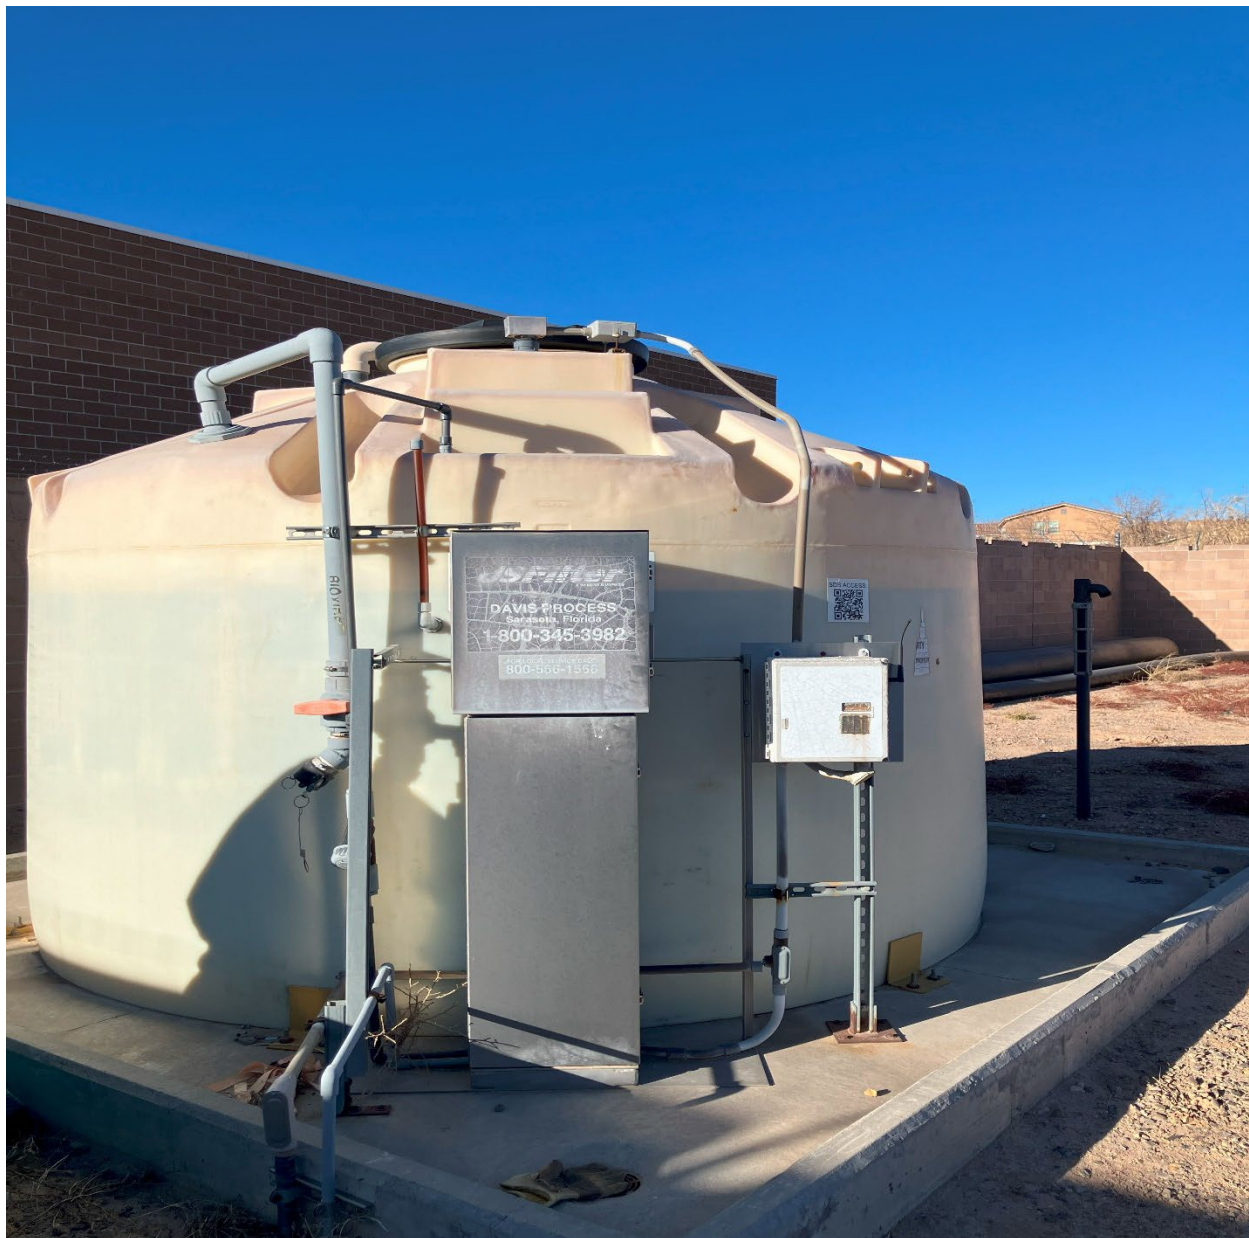
Biocide tank located within LS-#24 is no longer in use. The tank contents are slowly being emptied to the wet well. NOTE: the degradation of the chemical safety signage. (IMG\_0576) Photographed by N. Fuad

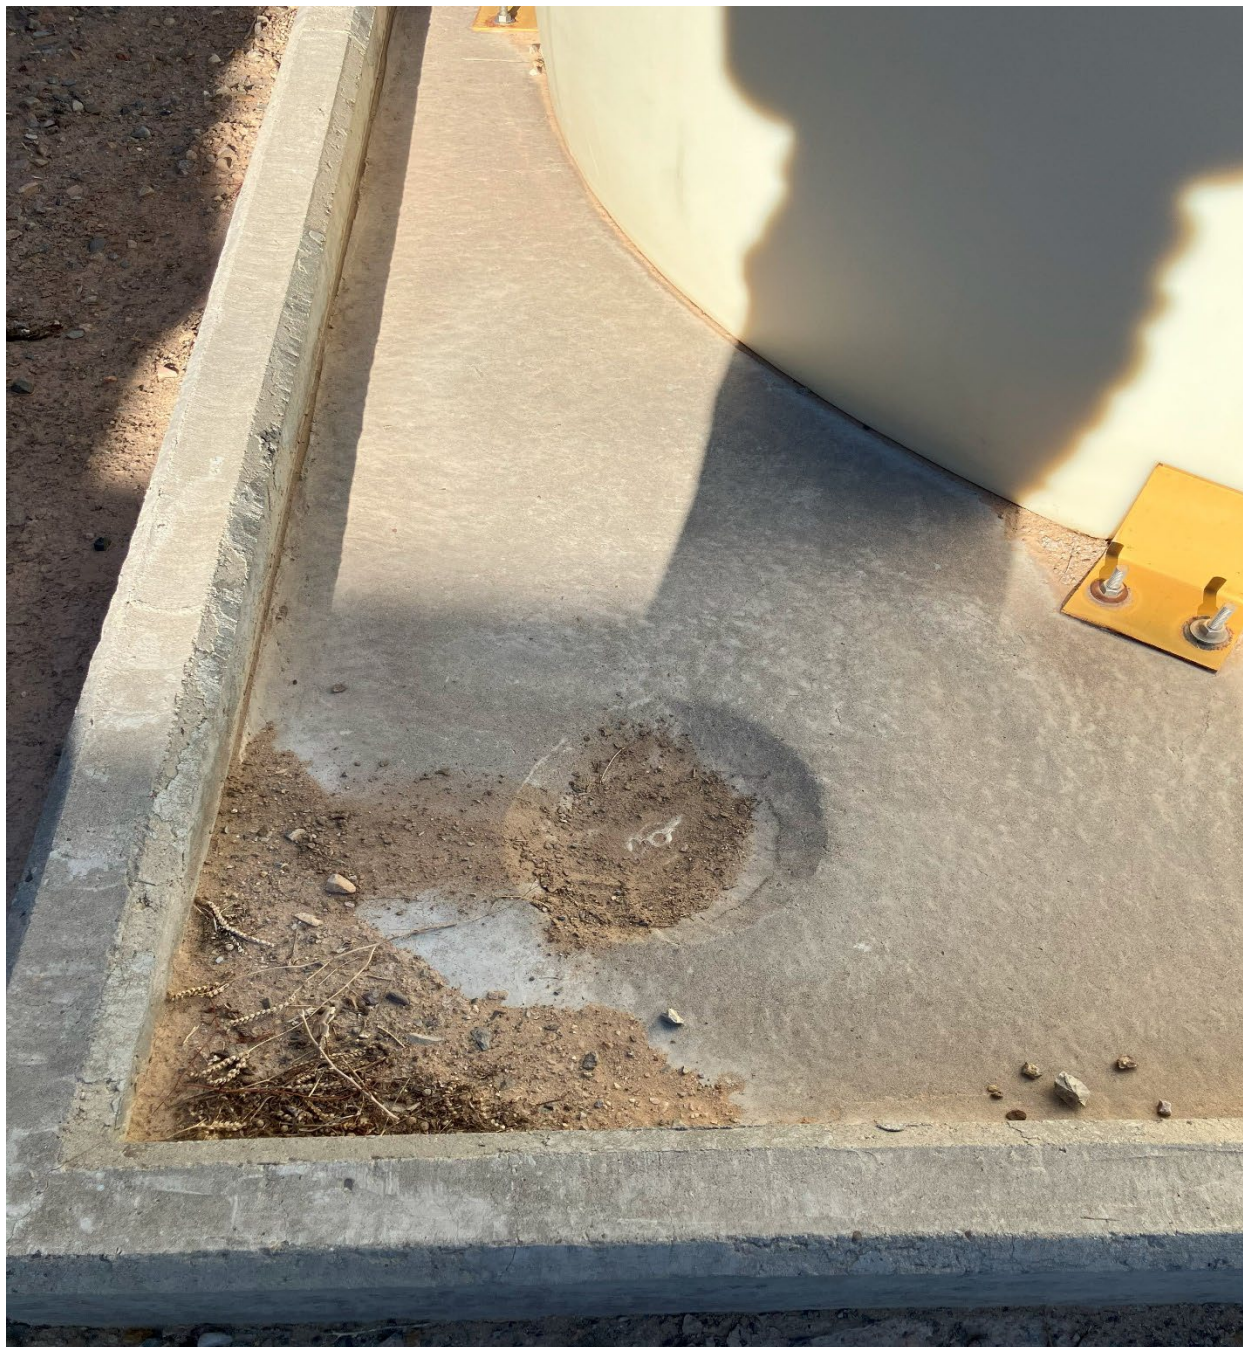
View of the secondary containment obstructed drop drain for the Bioxide tank at LS-#24. (IMG\_0576)  
Photographed by N. Fuad
