**Region 6 - Enforcement & Compliance Assurance Division**  
**INSPECTION REPORT**

| Inspection Date(s): | 12/23/2024 | |
| Facility Name: | <b>Rio Rancho WWTP-Lift Station -21</b> | |
| Identification/Permit Number: | NM0027987 | |

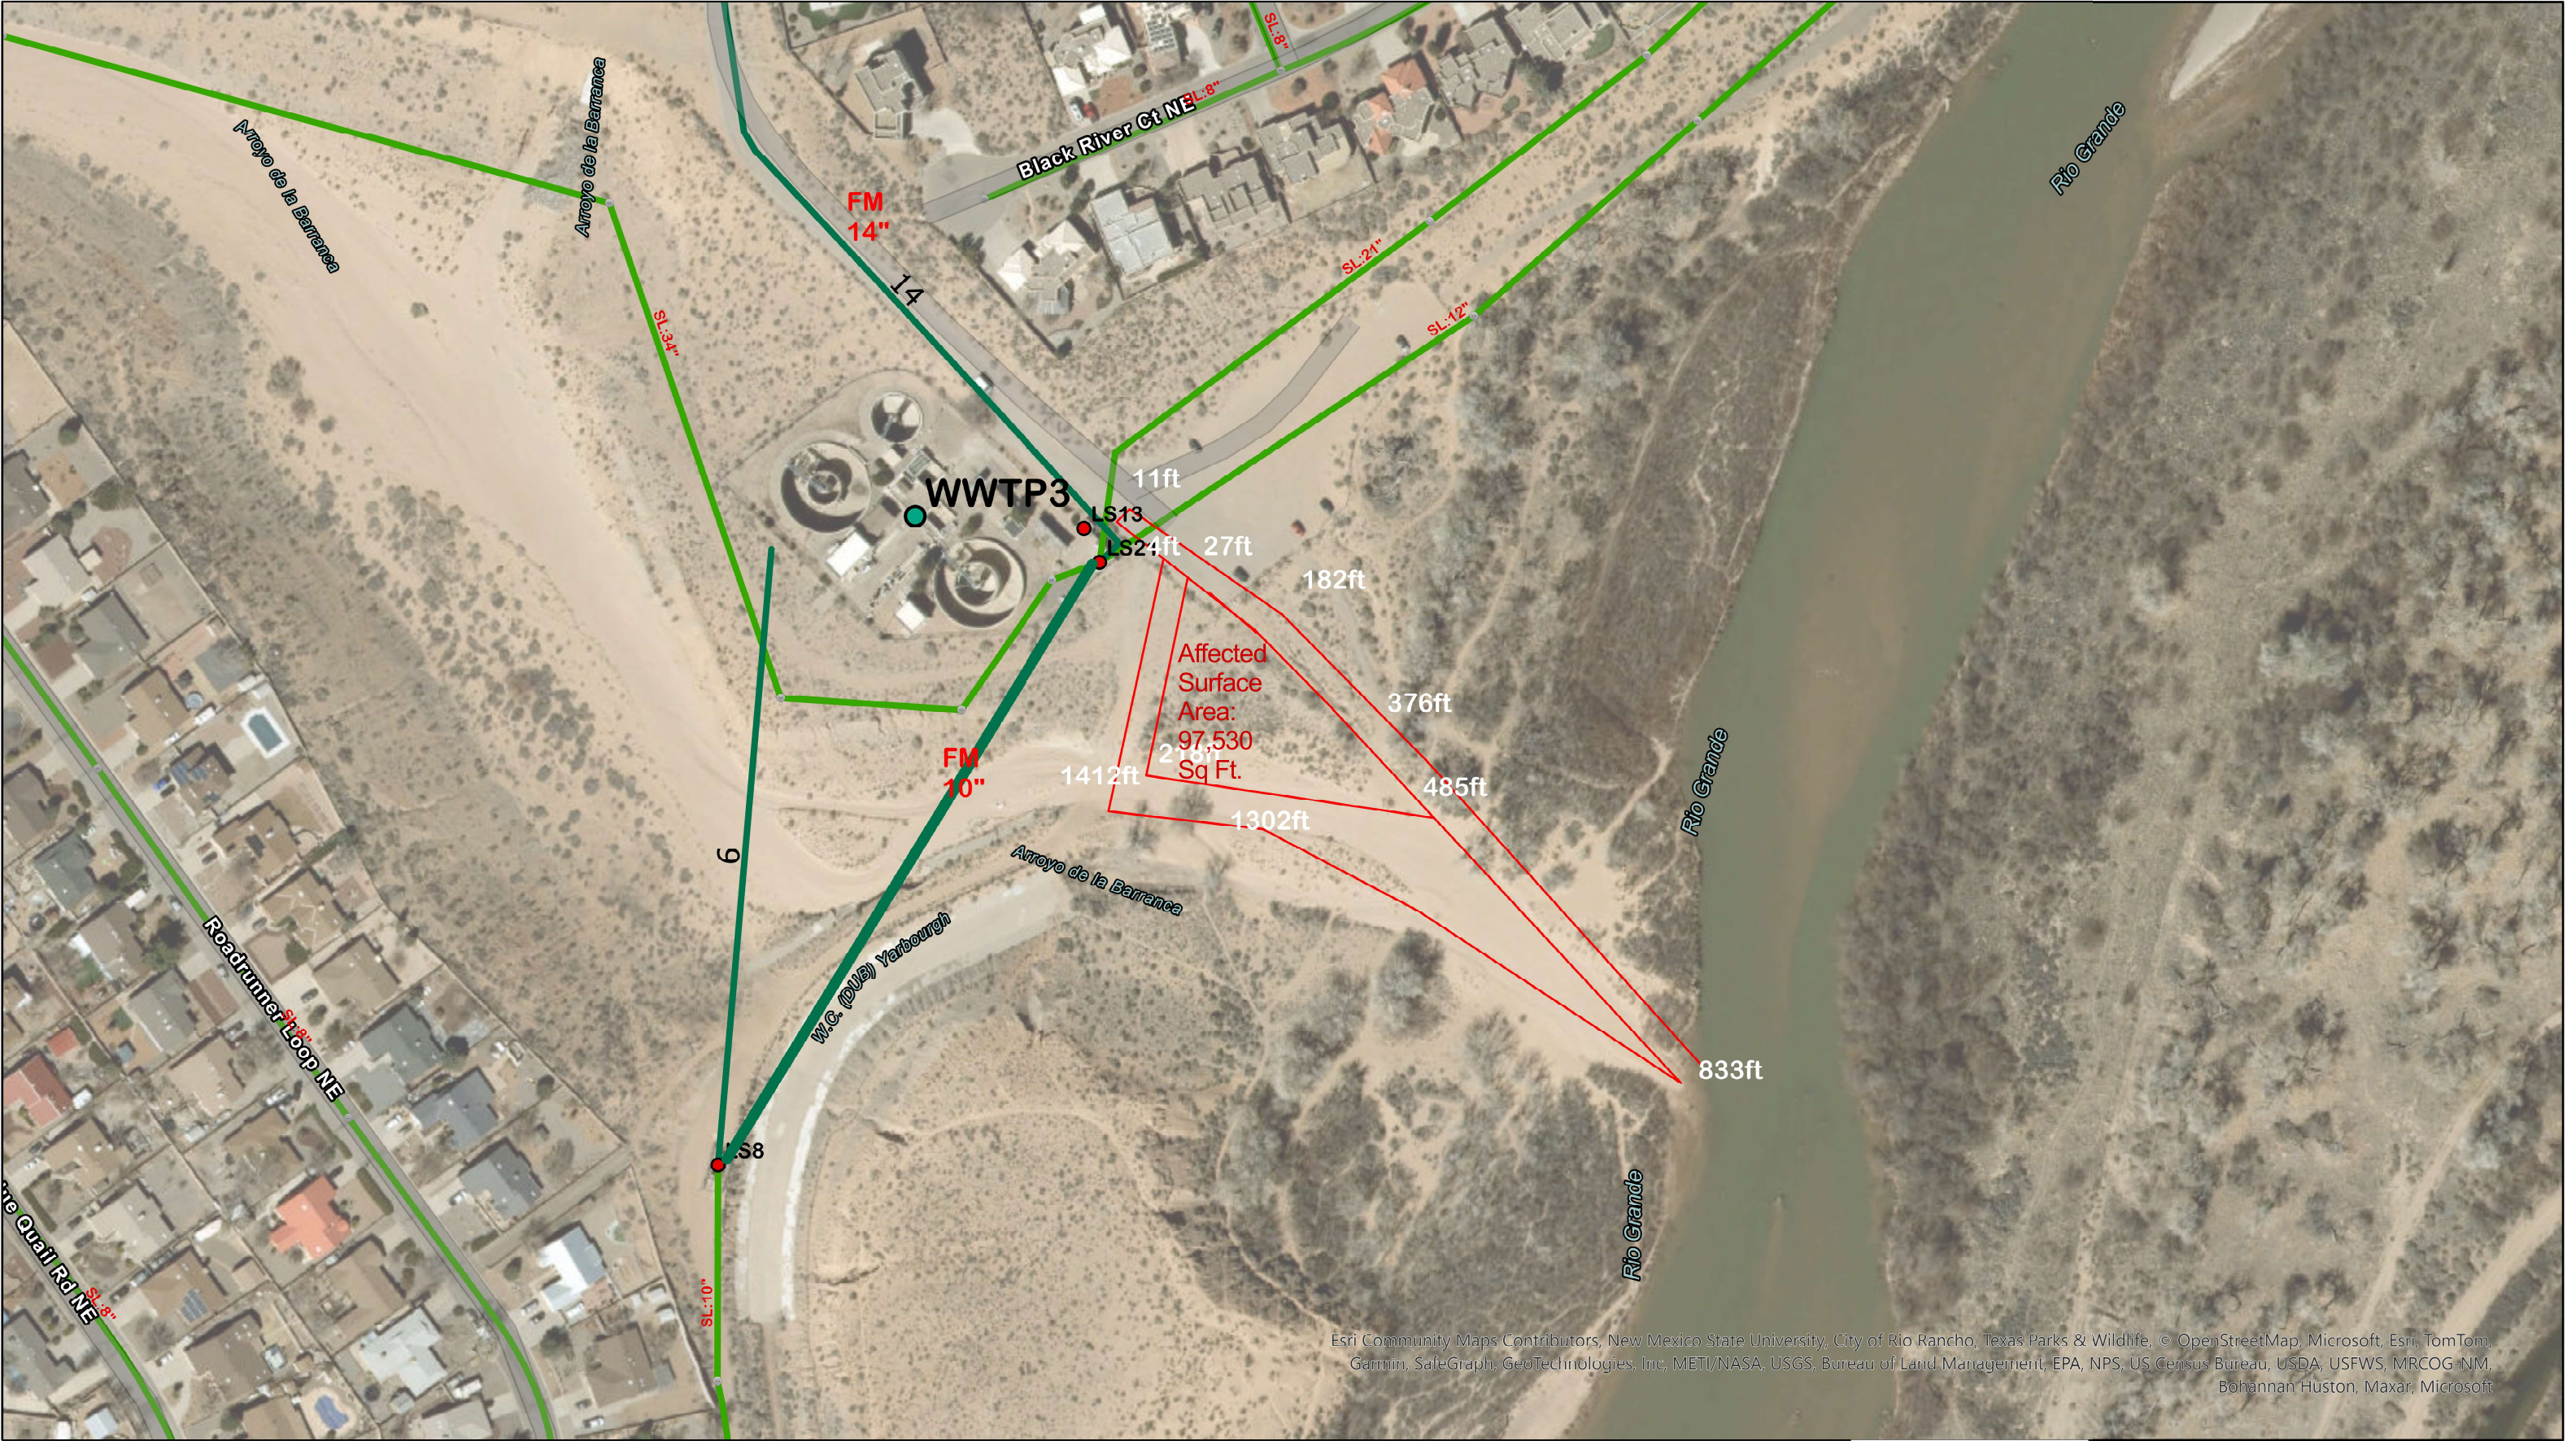
### LS-21 Gravity and Force Main- Impacted Area

See LS\_21 Gravity and FM on shared drive (**Appendix 4 LS-21 Gravity- Force Mains and Impacted Area**). The surface area was calculated through google maps, please see attached document (LS\_21 Gravity and FM\_4). A total area of 3,251 Ft was determined and multiplied by the arroyo size towards the entry into the Rio Grande, 30 Ft. This results in a surface area total of 97,530 Sq Ft.
