**UNITED STATES ENVIRONMENTAL PROTECTION AGENCY  
REGION 8  
RESOURCE CONSERVATION AND RECOVERY ACT**

**Facility Name:** Polar Bear Water Treatment      **Facility Location:** 41.755800, -107.585100

**Type and Purpose of Inspection:** Compliance Evaluation Inspection

**Facility Type:** Commercial Oilfield Waste Disposal Facility (COWDF)

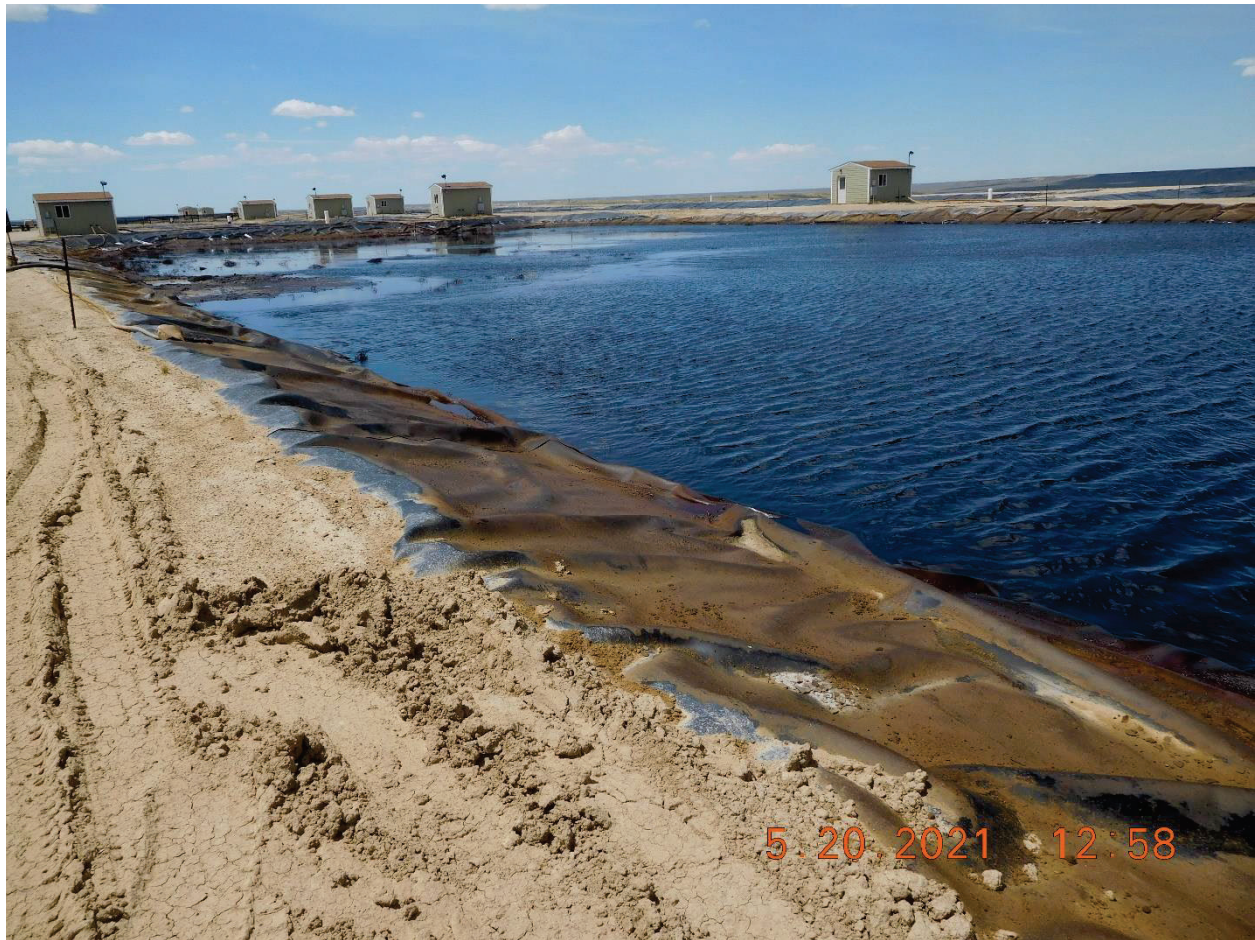
**Data Collected and Observations:** During the walk-through I observed that evaporation pond HP-8 (southeastern-most pond, see Attachment 1 – Site Map) contained crude oil floating on the surface. Almost the entire surface the pond (approximately 99%) contained a thin layer of floating oil. See Attachment 2 – Photo Log, photos 1403 to 1407.

Oily waste that is not physically restricted from access by birds and other wildlife is a concern because of the potential for injury or mortality. Specifically, the large amount of oil on pond HP-8 and the poor condition of the netting over the slop/skim pit pose a potentially serious threat to birds and other wildlife.

Photo 1403: DSCN1403.jpg – photo of pond HP-8 with oil covering approximately 99% of the surface. Photo taken facing west

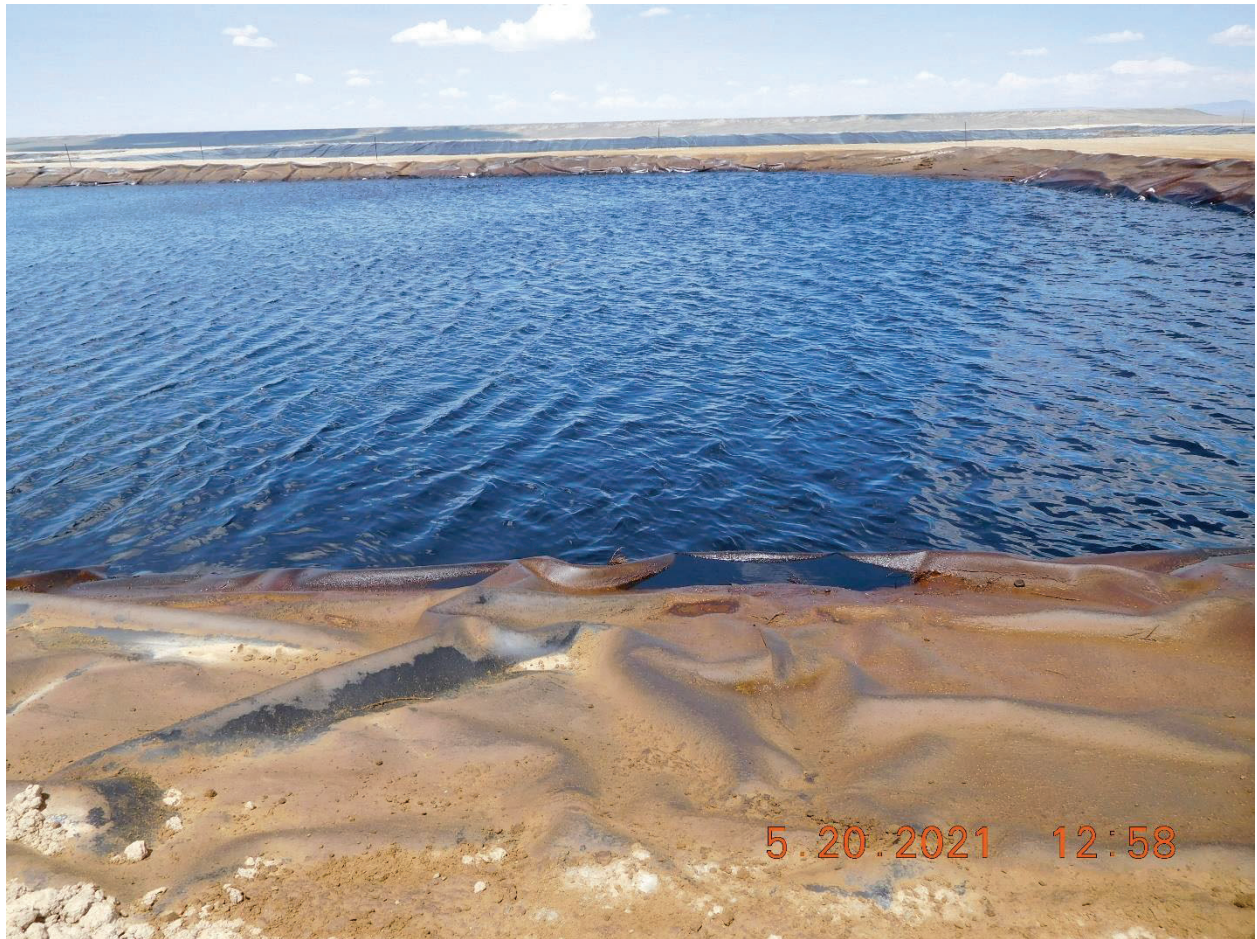
Photo 1404: DSCN1404.jpg – photo of pond HP-8, panned right from photo 1403.

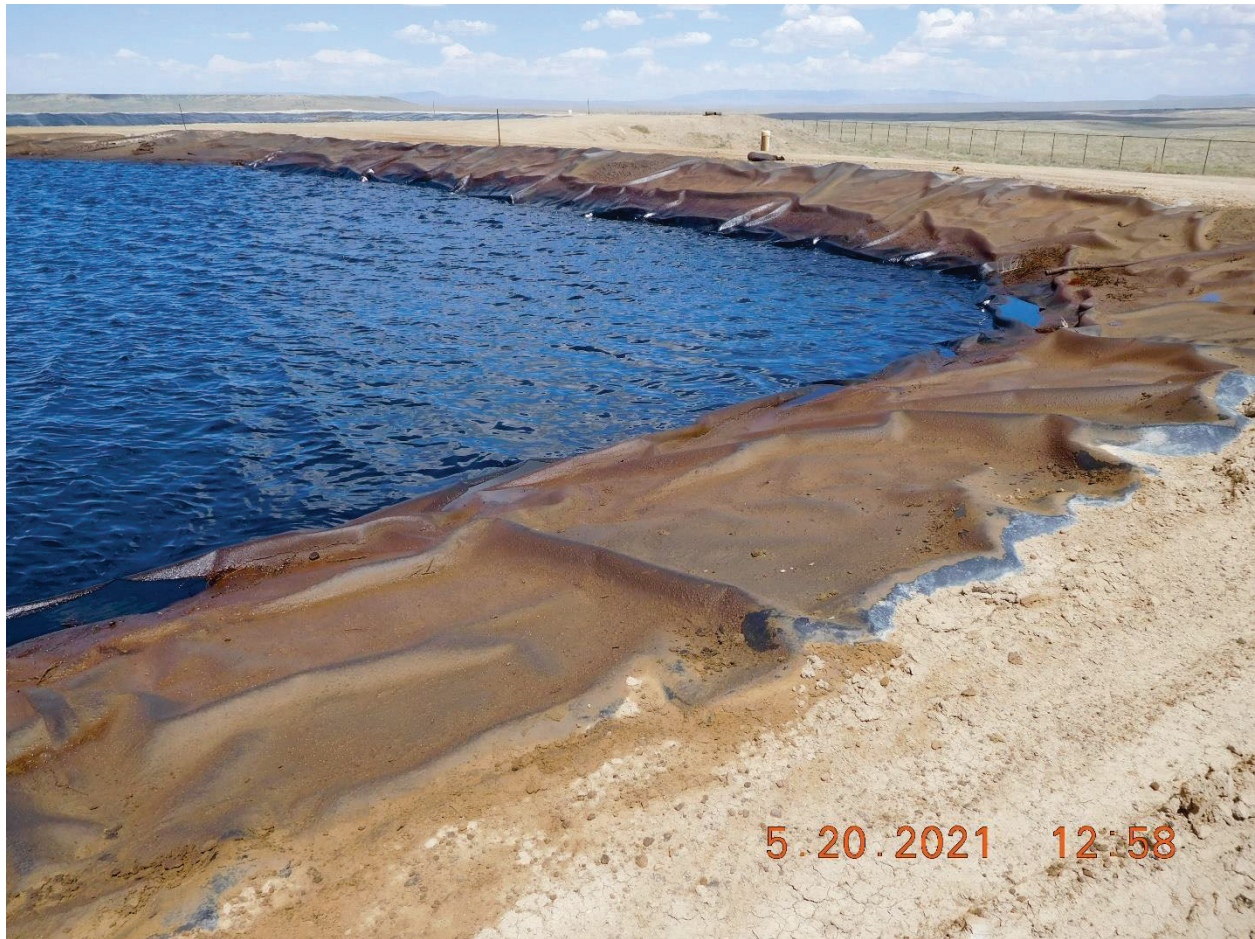
Photo 1405: DSCN1405.jpg – photo of pond HP-8, panned right from photo 1404.

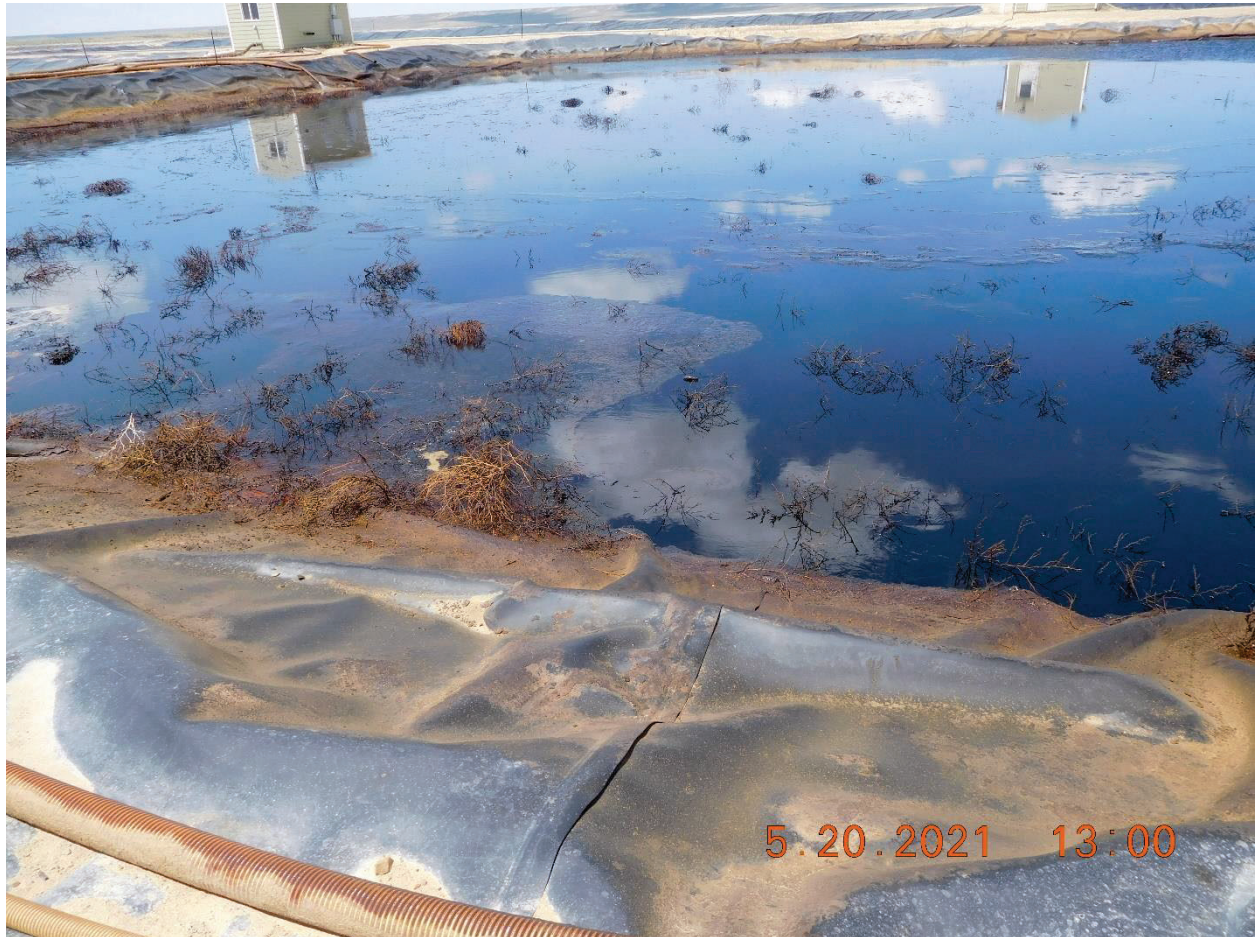
Photo 1406: DSCN1406.jpg – photo of pond HP-8, facing northwest from approximately the midpoint of the pond. Photo shows a small amount of the pond surface not covered in oil.

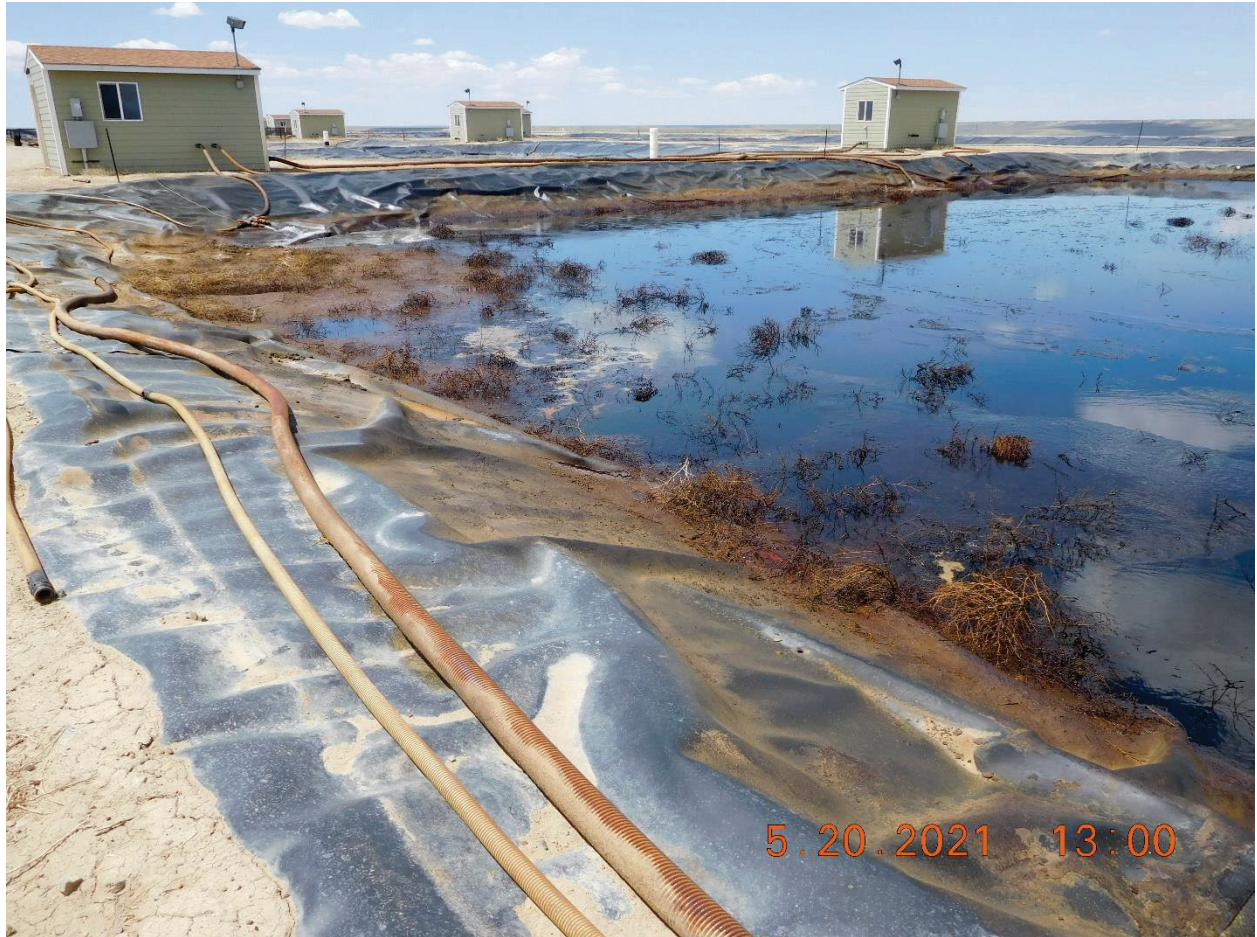
Photo 1407: DSCN1407.jpg – photo of pond HP-8, panned left from photo 1406.

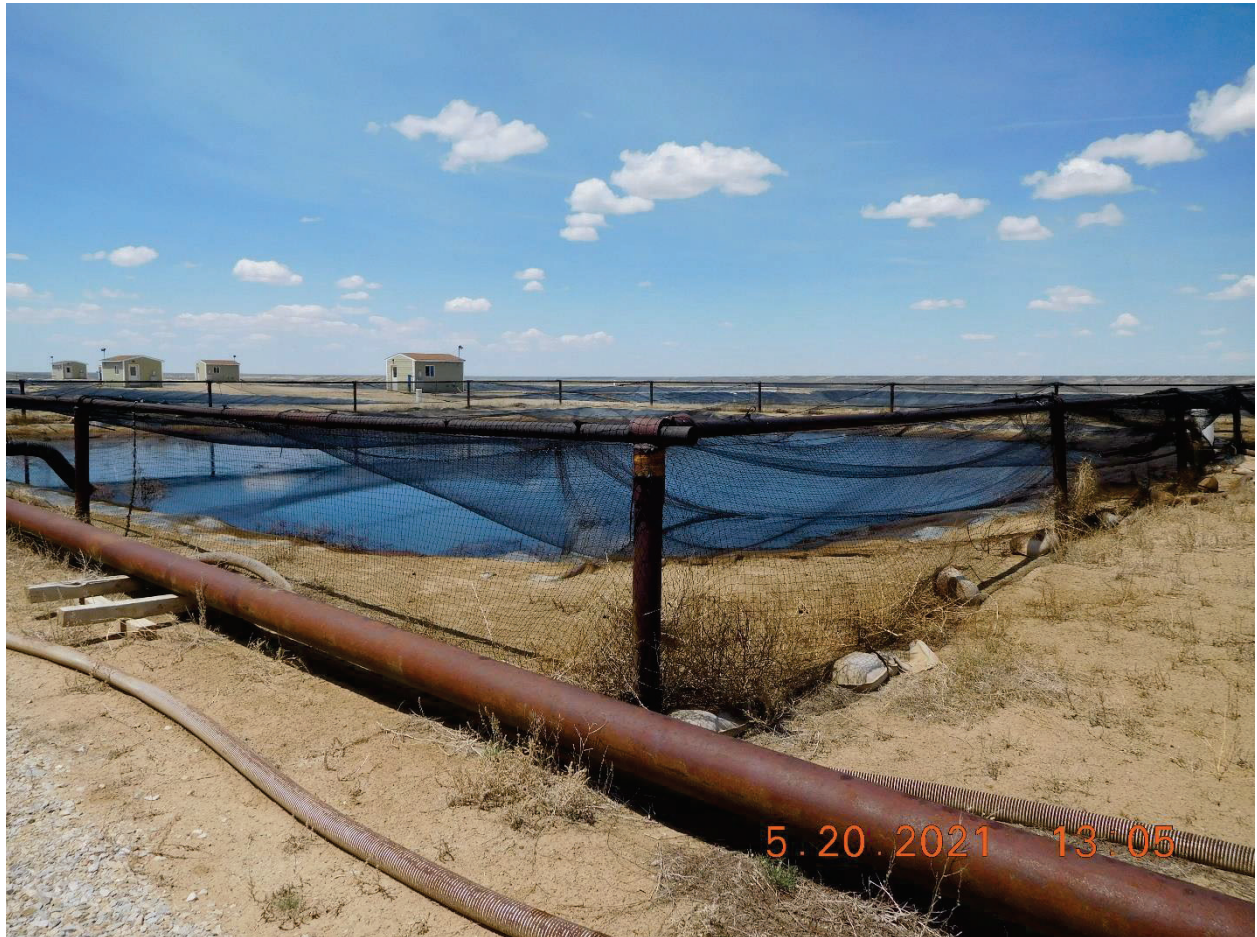
At the slop/skim pit I observed that the netting covering the slop pit was in poor condition. See Attachment 2 – Photo Log, photos 1408 to 1410.

Photo 1408: DSCN1408.jpg – photo of slop/skim pit, facing northwest. Netting is in poor condition, with very large holes and sagging into the pit.

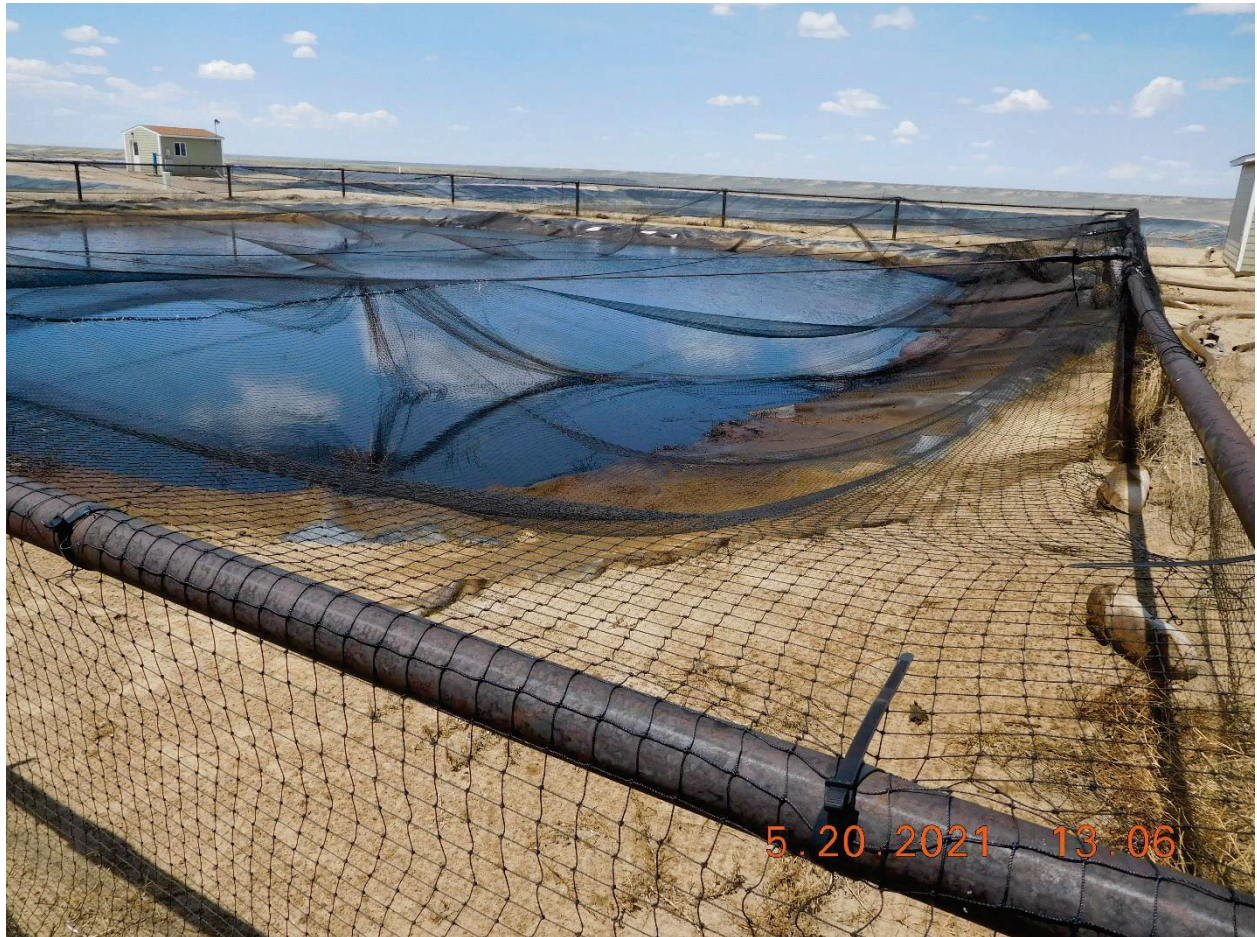
Photo 1409: DSCN1409.jpg – photo of slop/skim pit, same angle as photo 1408 but taken at a closer distance to the pit.

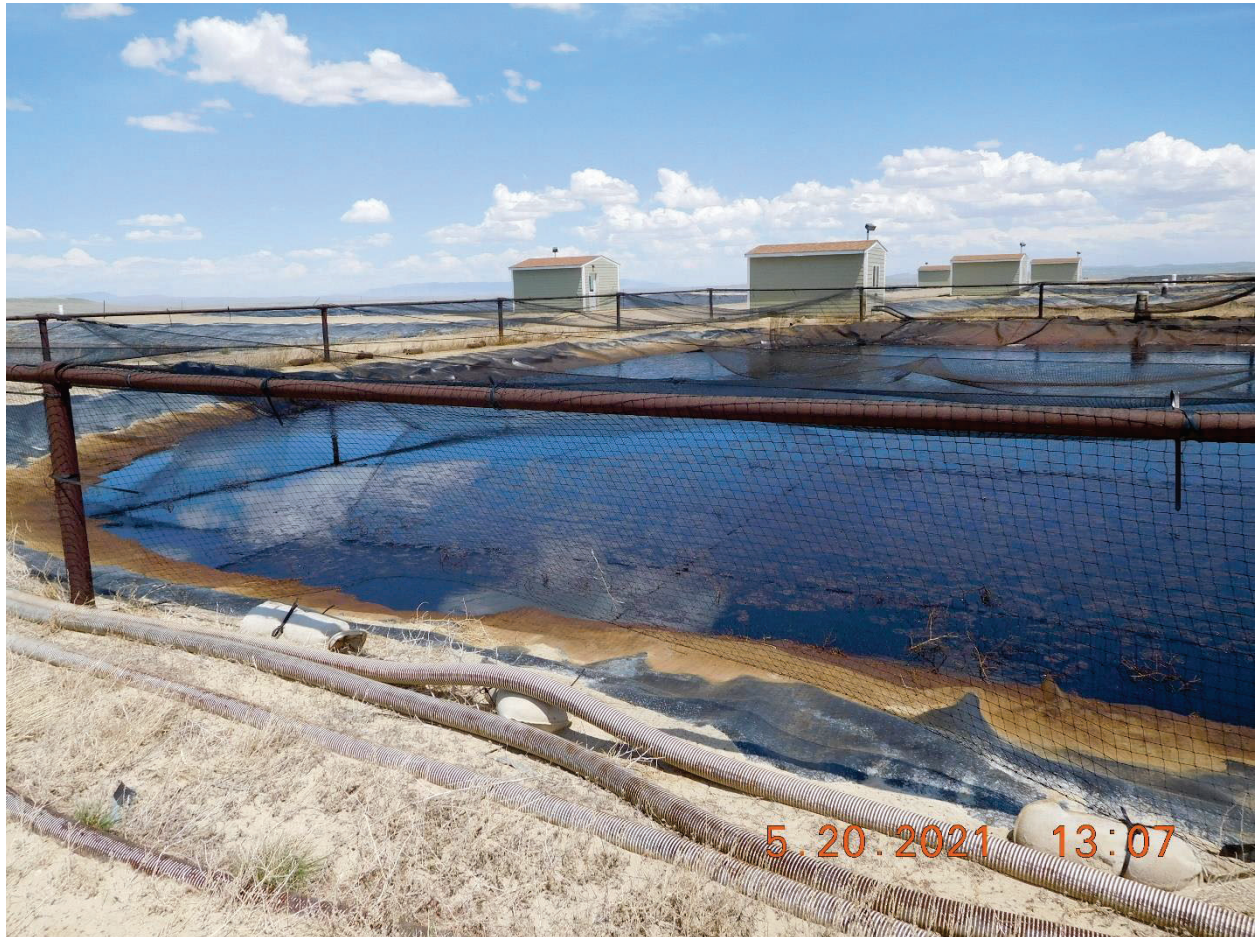
Photo 1410: DSCN1410.jpg – photo of slop/skim pit, taken from approximately the midpoint of the pit facing northwest.
