**Region 6 - Enforcement & Compliance Assurance Division**  
**INSPECTION REPORT**

| Inspection Date(s): | 03/11/2024 | |
| Company Name: | <b>LBOC, LLC</b> | |
| Facility Name: | <b>Flowline Spill</b> | |

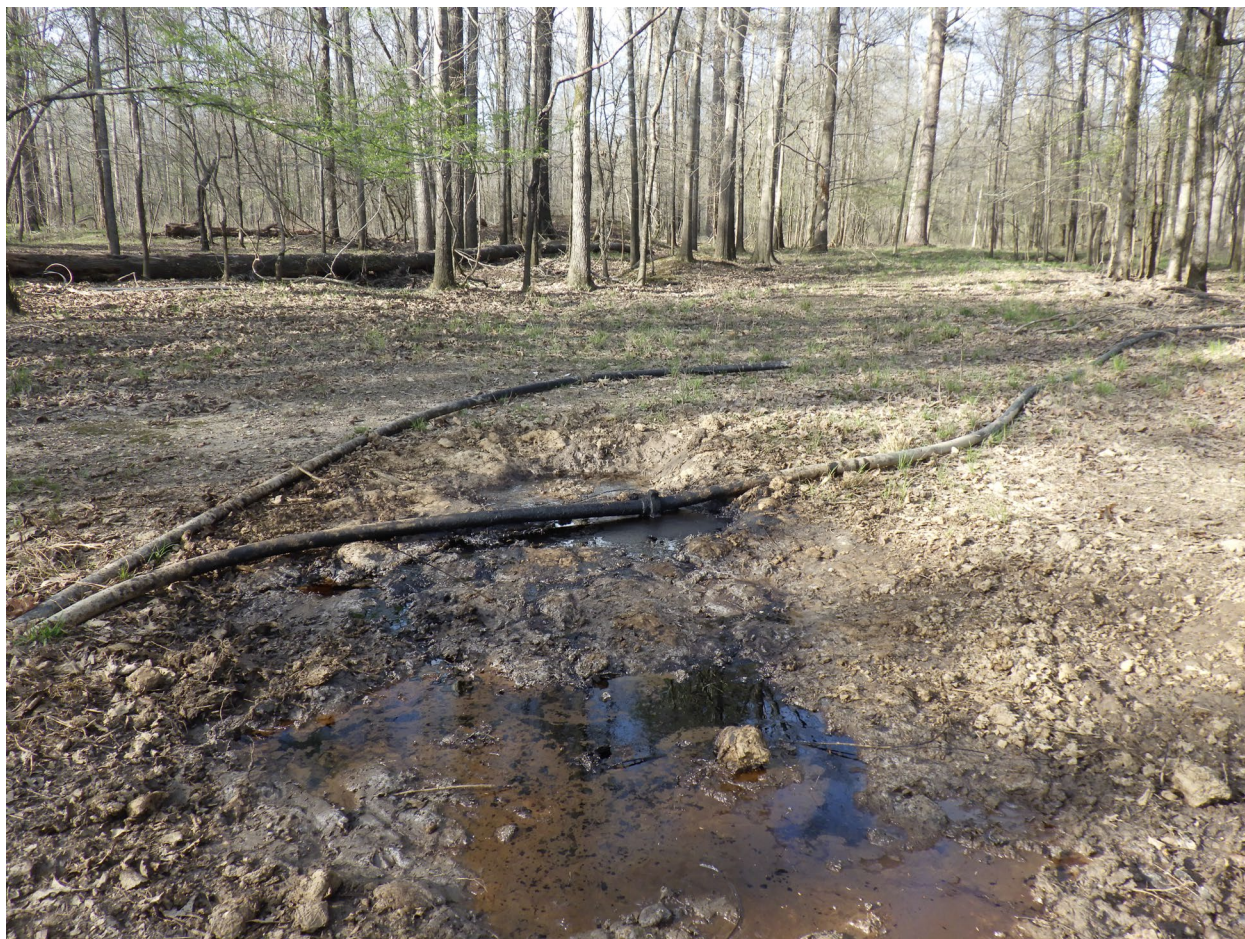
Photo No. 1

I observed a leaking flowline on the east side of Oil Field Road 10, see Appendix 1 (photo log), Photo No. 1. For additional GPS location and photo metadata, see Appendix 1.

**Description:** This photo was taken facing north-northeast and shows an overview of the spill.

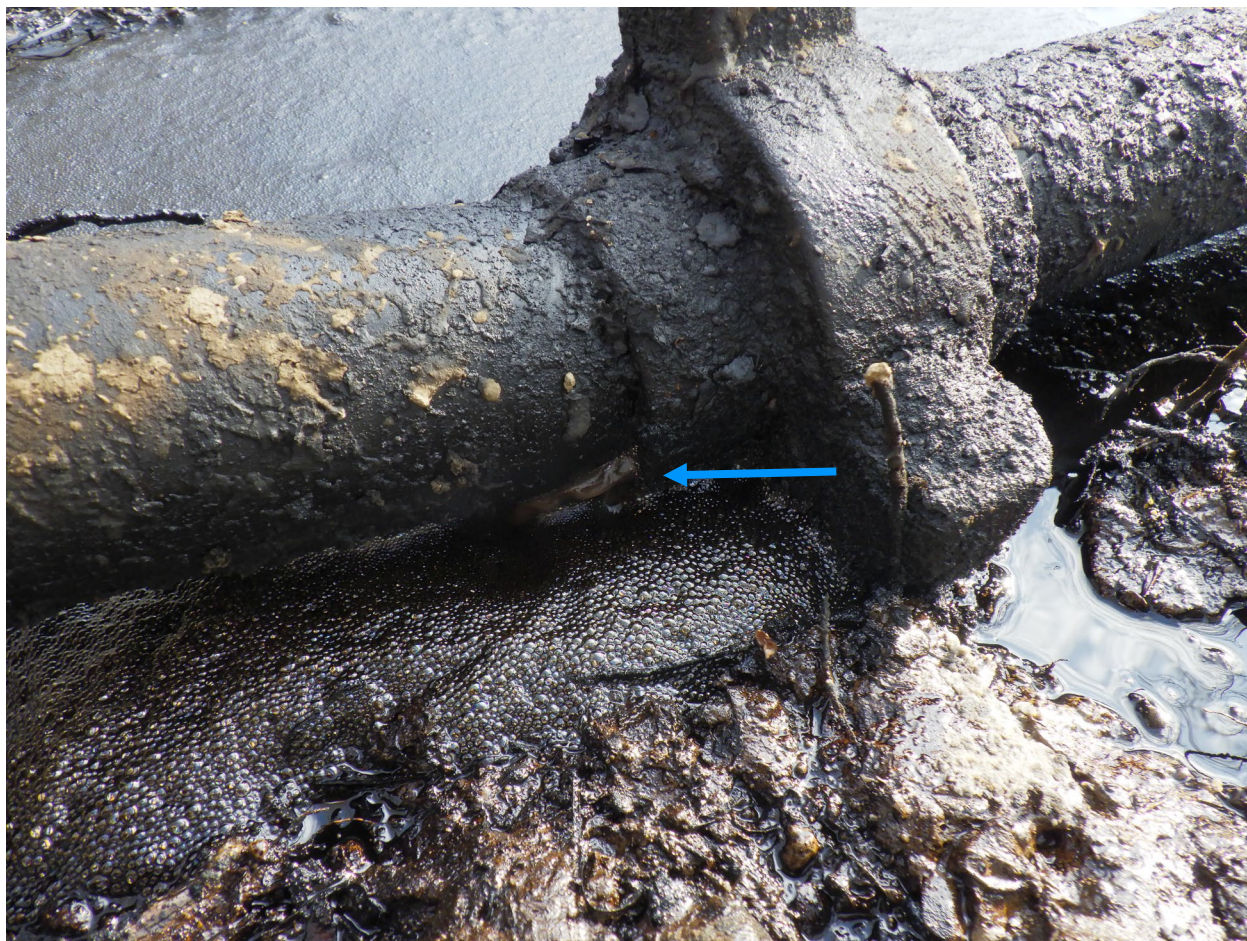
Photo No. 2

I observed the release point (33.332628, -92.507652), which was a hole at a coupling on the flowline, see Photo No. 2. Loose oil surrounded the release point, see photo No. 3.

No closing conference was held due to no LBOC, LLC staff being present during the inspection. The area of concern at the time of the inspection is the active leak from the coupling on the flowline.

**Description:** This photo was taken facing south-southwest and shows the release point (see blue arrow) on the coupling of the flowline. Loose oil surrounds the flowline.

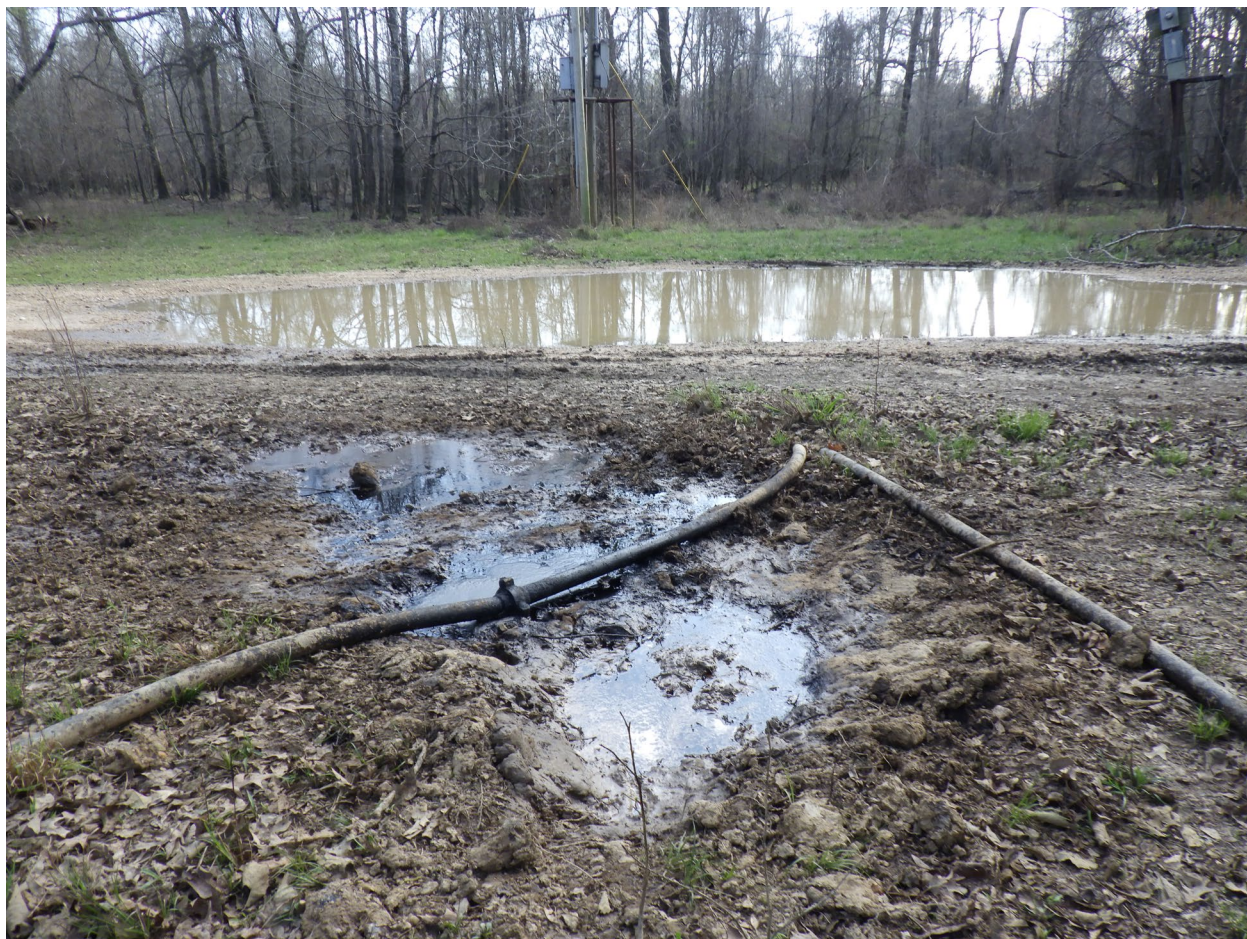
Photo No. 3

**Description:** This photo was taken facing south-southwest and shows an overview of the flowline spill. The photo also shows an oil sheen around the flowline.
