**Region 6 Compliance Assurance and Enforcement Division  
INSPECTION REPORT**

| Inspection Date(s): | 4/24 & 26/2024 | | |
| Facility Name: | Sterlington Generating Plant | | |
| Identification/Permit Number: | LA0007579 (AI No.19483) | | |

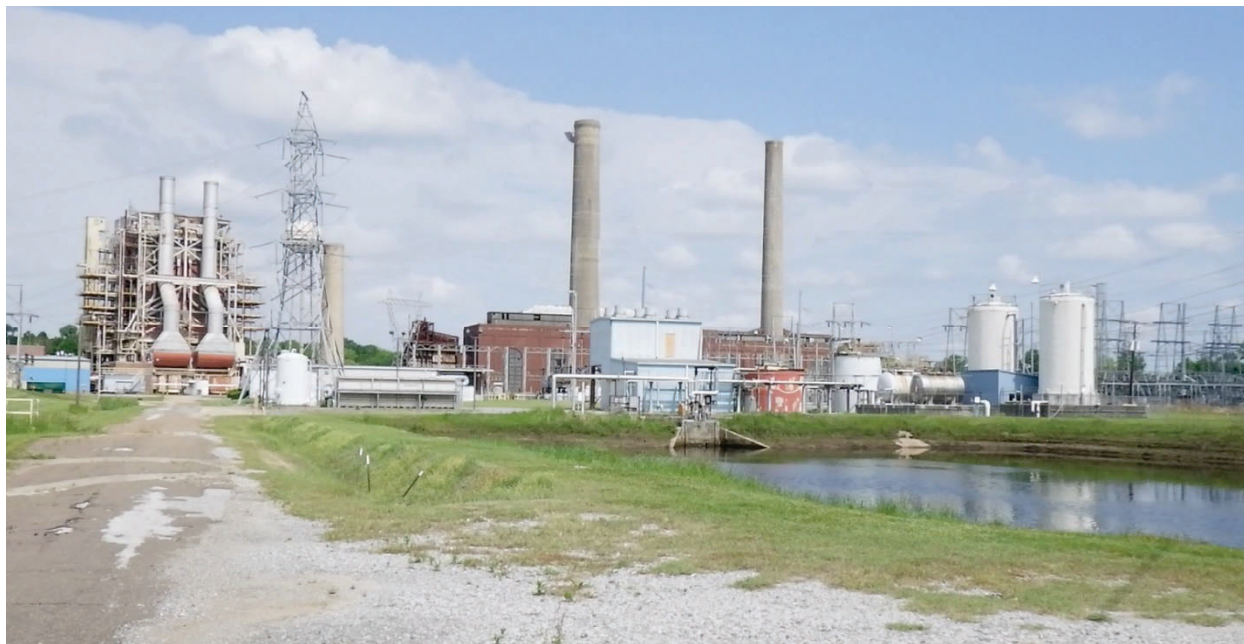
This outfall includes an intermittent discharge of overflow from the stormwater surge pond. This outfall is active. There was no flow or discharge at the time of the inspection (See Photo No. 1 in Appendix 1).

Photograph File Name: FacilitySiteOutfall007.JPG  
Date of Photograph: 04/24-26/2024  
Latitude and Longitude: 32.703151 -92.08103  
Orientation: N  
Map Datum: WGS-84  
Time of Photo: 09:00 AM  
Photographer: Jack Arias  
Description: This image shows the entrance of the facility.

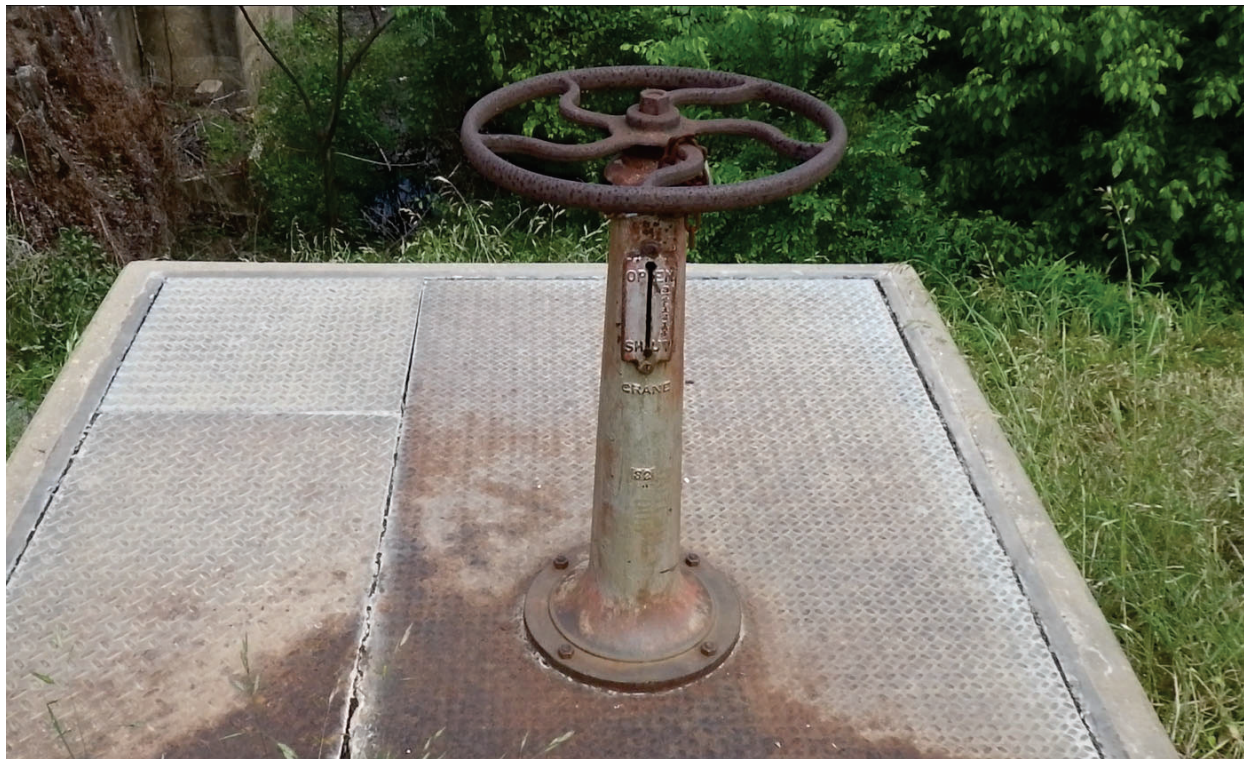
Photo No. 2

The Sterlington Generating Plant (SGP) is not active or in operation. SGP is retiring operations and stopped intake of river water (see Photo Nos. 2 - 3 in Appendix 1).

Description: This image shows the outfall 003 and water intake pump that intake fresh water from Quachita River for the cooling and industrial processes at the facility.

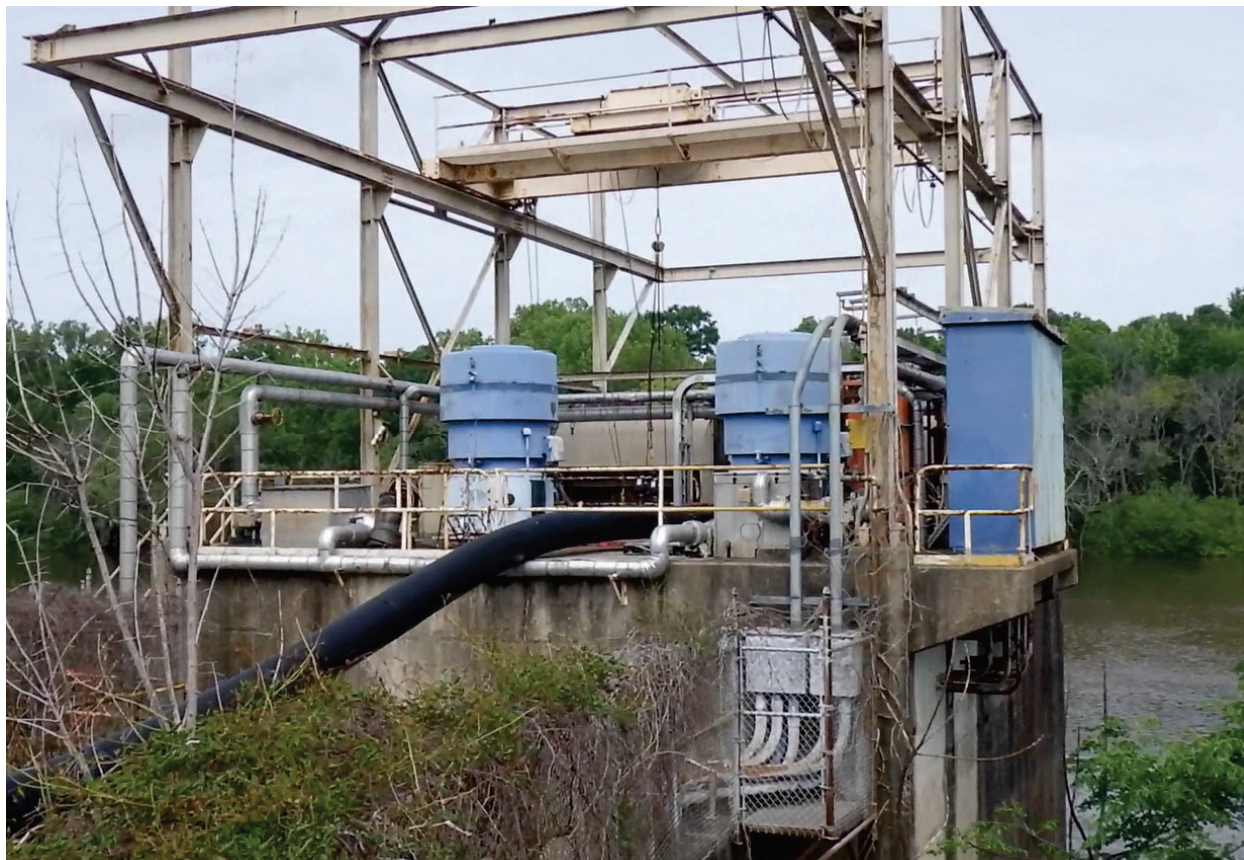
This outfall includes an intermittent discharge of low contamination potential storm water runoff from an area located southwest of the generating station administrative building. Outfall 003 is only used during emergency storm events to discharge accumulated stormwater runoff from the western portion of the plant to the Ouachita River. Discharges from this area must be released manually through the opening of hand wheel valves. Discharge area is routinely routed to the Oily Waste Pond that discharges through Outfall 005. This outfall is active. There was no flow or discharge at the time of the inspection (see Photo No. 3 in Appendix 1).

Photograph File Name: PumpsIntake.JPG  
Date of Photograph: 04/24-26/2024  
Latitude and Longitude: 32.703973 -92.080971  
Orientation: W  
Map Datum: WGS-84  
Time of Photo: 9:30 AM  
Photographer: Jack Arias  
Description: This image shows the water pumps that are used to intake fresh water from Quachita River. Not in operation.

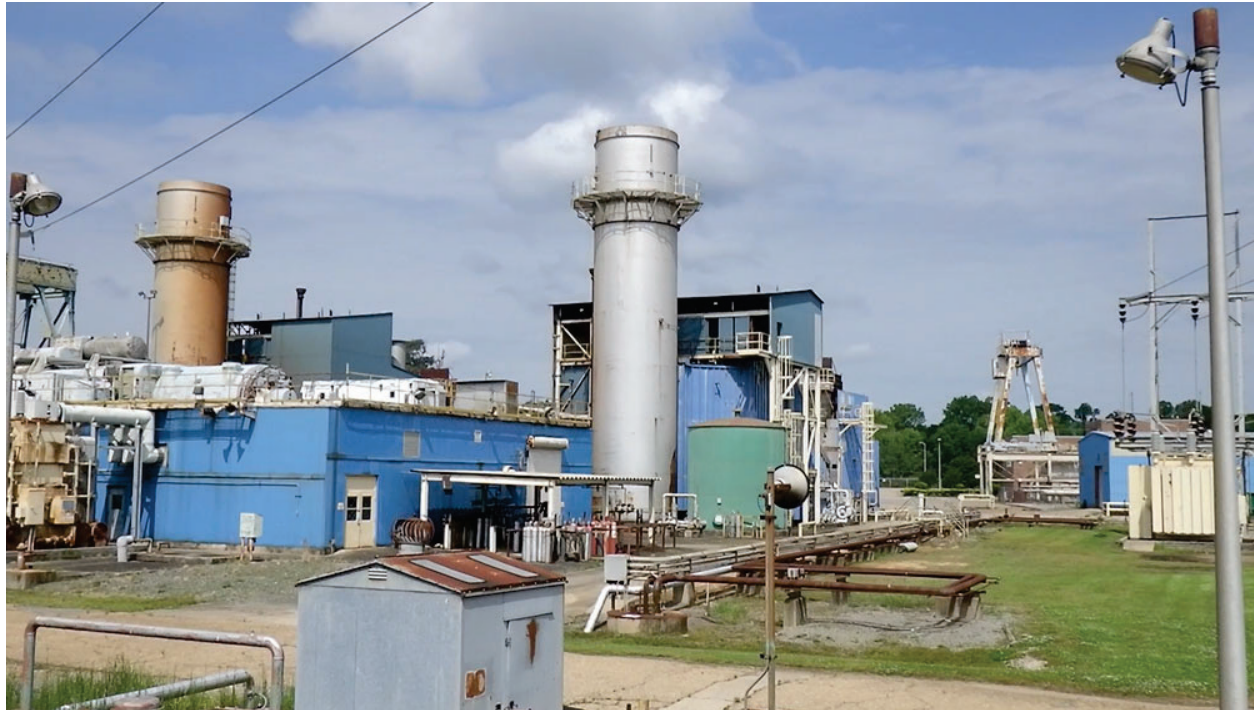
Photo No. 4

Photograph File Name: CombustionArea.JPG  
Date of Photograph: 04/24-26/2024  
Latitude and Longitude: 32.703004 -92.080165  
Orientation: NE  
Map Datum: WGS-84  
Time of Photo: 9:35 AM  
Photographer: Jack Arias  
Description: This image shows the combustion area and unit 7 at the facility. Not in operation.

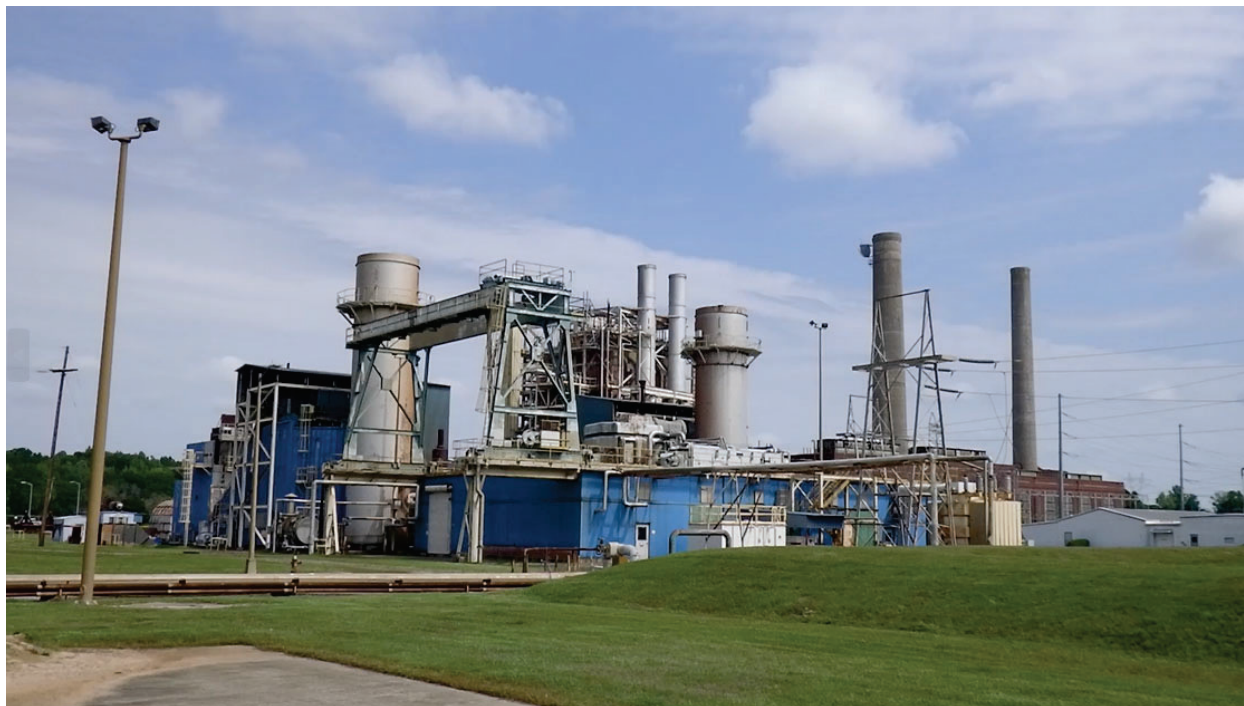
Photo No. 5

The Sterlington Generating Plant (SGP) is not active or in operation. SGP is retiring operations and stopped cooling and combustion activities at the facility (see Photo Nos. 5 - 6 in Appendix 1).

Photograph File Name: CombustionArea.JPG  
Date of Photograph: 04/24-26/2024  
Latitude and Longitude: 32.703609 -92.080025  
Orientation: NE  
Map Datum: WGS-84  
Time of Photo: 10:00 AM  
Photographer: Jack Arias  
Description: This image shows the combustion area, stacks, and unit 7 at the facility. Not in operation.

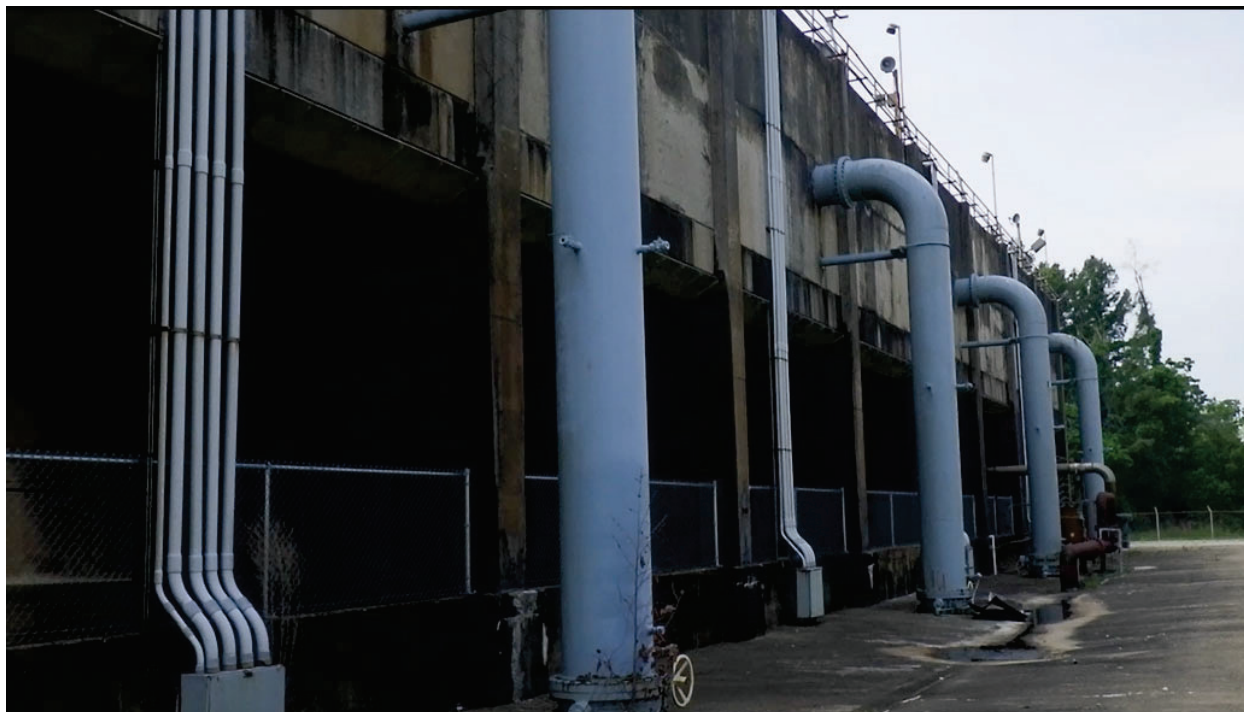
Photo No. 6

Photograph File Name: CoolingArea.JPG  
Date of Photograph: 04/24-26/2024  
Latitude and Longitude: 32.701138 -92.080326  
Orientation: SE  
Map Datum: WGS-84  
Time of Photo: 10:07 AM  
Photographer: Jack Arias  
Description: This image shows the cooling towers system. Not in operation.

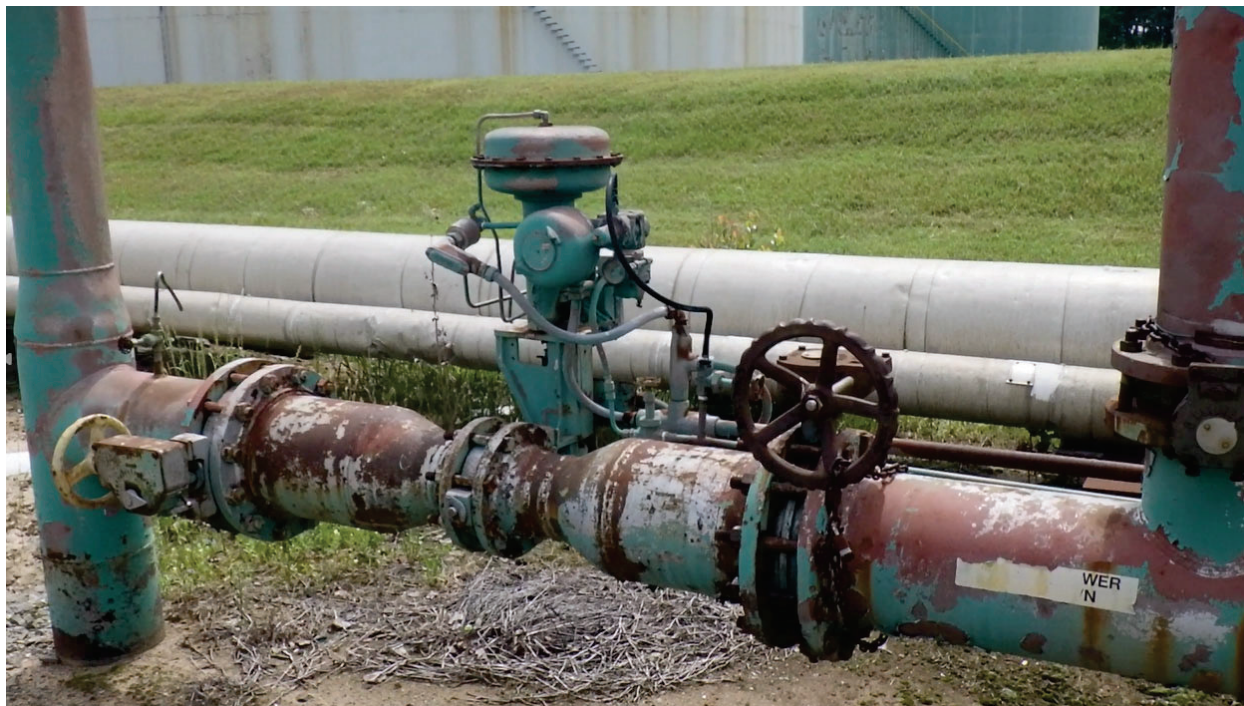
This outfall includes an intermittent discharge of hydrostatic test wastewater from hydrostatic tests conducted on various pipes, tanks, vessels, and/or equipment. This outfall is not active. There was no flow or discharge at the time of the inspection (See Photo No. 7 in Appendix 1).

Photograph File Name: Outfall205.JPG  
Date of Photograph: 04/24-26/2024  
Latitude and Longitude: 32.701721 -92.079981  
Orientation: E  
Map Datum: WGS-84  
Time of Photo: 10:15 AM  
Photographer: Jack Arias  
Description: This image shows the outfall 001 system.

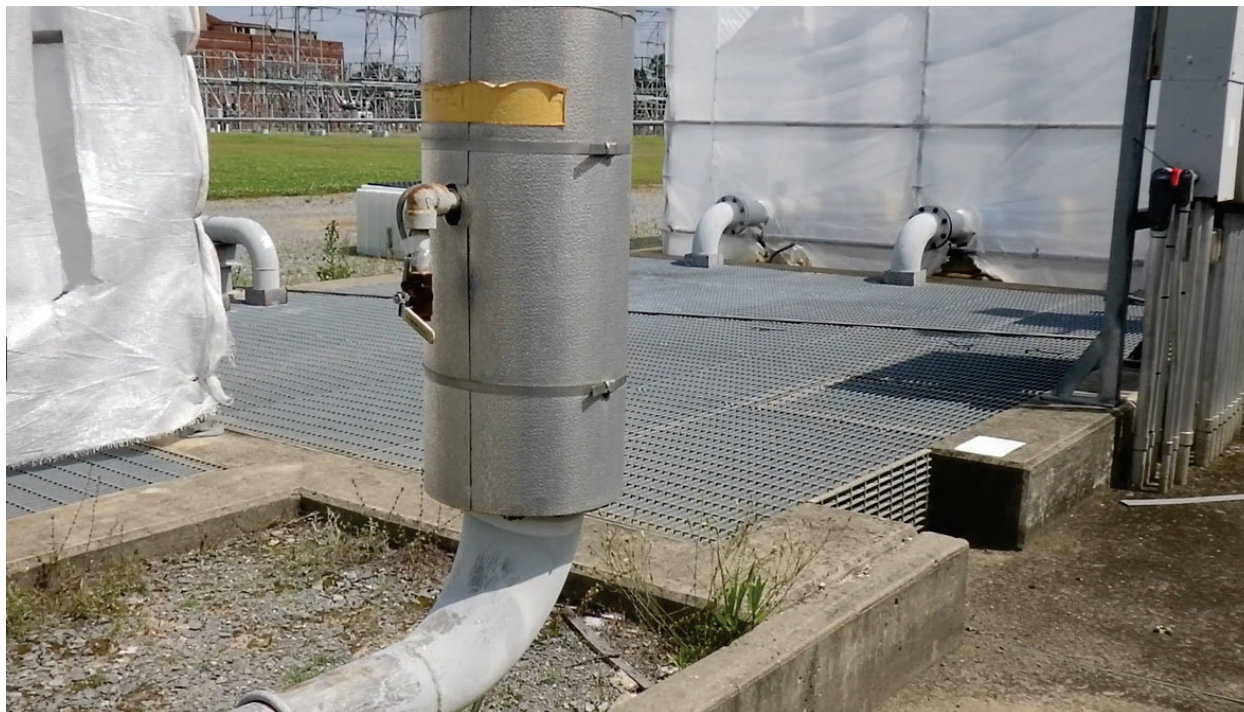
This outfall includes an intermittent discharge of first flush stormwater from the oil/water separator (Internal Outfall 305) and post first flush stormwater from the main plant area including low volume wastewaters as defined by 40 CFR 423, together with wastewater from boiler blowdown, spent acid, spent caustic, ammonia, and rinse water from demineralizer/regeneration system, laboratory drains, clarifier blowdown, contracted water treatment equipment, and seal water leak off; low contamination potential purged groundwater; maintenance wastewaters, including but limited to, pressure washing of floors, vehicle and building rinse waters (without the use of biodegradable detergents); fire system test wastewater; decommissioning waters; Unit 7 cooling tower drift and minimal flow control valve leakage; previously monitored hydrostatic test wastewater (Internal Outfall 205); and previously monitored metal cleaning and chemical metal cleaning wastewater (Internal Outfall 105). This outfall is not active. There was no flow or discharge at the time of the inspection (See Photo No. 8 in Appendix 1).

Photograph File Name: Outfall005.JPG  
Date of Photograph: 04/24-26/2024  
Latitude and Longitude: 32.70208 -92.079829  
Orientation: E  
Map Datum: WGS-84  
Time of Photo: 10:20 AM  
Photographer: Jack Arias  
Description: This image shows the outfall 005 system.

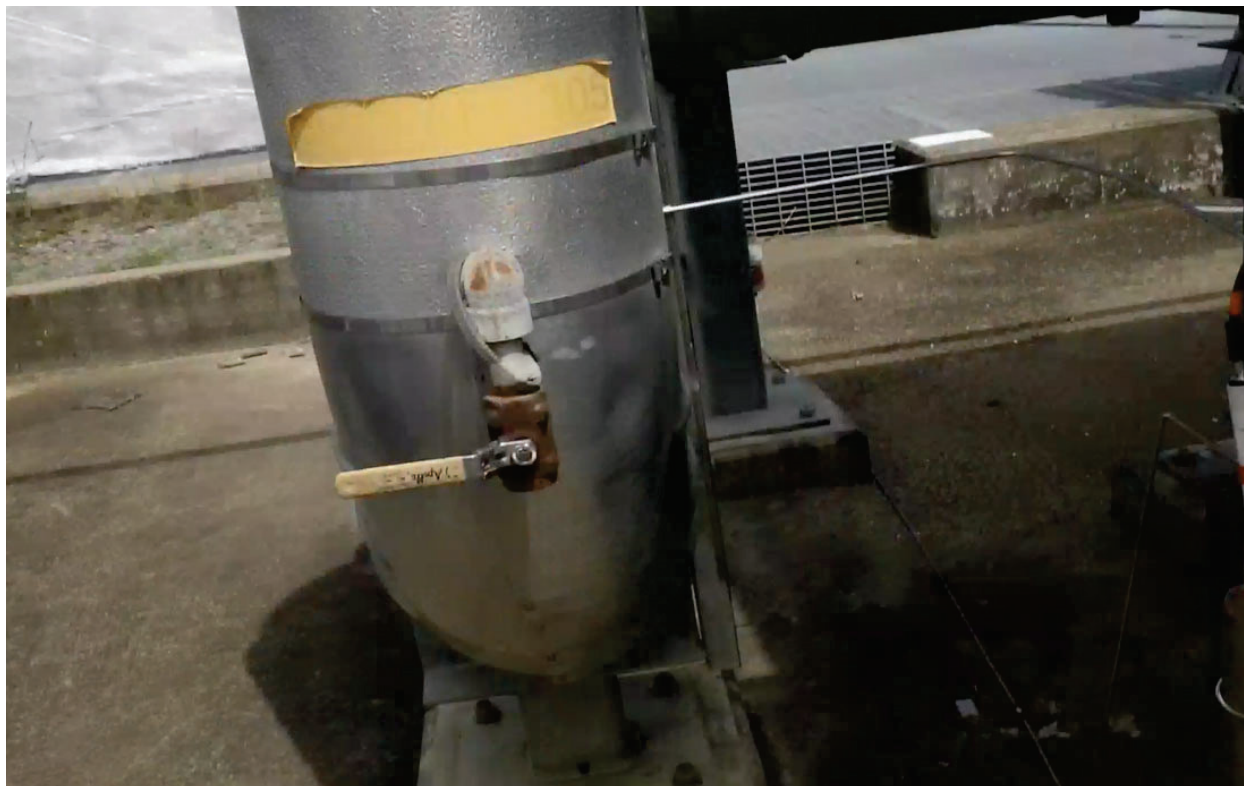
This outfall includes an intermittent discharge of first flush stormwater and process water from the main plant area and the switchyard including low volume wastewaters; low contamination potential purged groundwater: miscellaneous non-process wastewaters; fire system test wastewater; decommissioning waters; unit 7 cooling tower drift and minimal flow control valve leakage: previous monitored discharge from internal outfalls 105 and 205. This outfall is not active. There was no flow or discharge at the time of the inspection (see Photo No. 9 in Appendix 1).

Photograph File Name: Outfall305.JPG  
Date of Photograph: 04/24-26/2024  
Latitude and Longitude: 32.70208 -92.079829  
Orientation: E  
Map Datum: WGS-84  
Time of Photo: 10:30 PM  
Photographer: Jack Arias  
Description: This image shows the outfall 305 system.

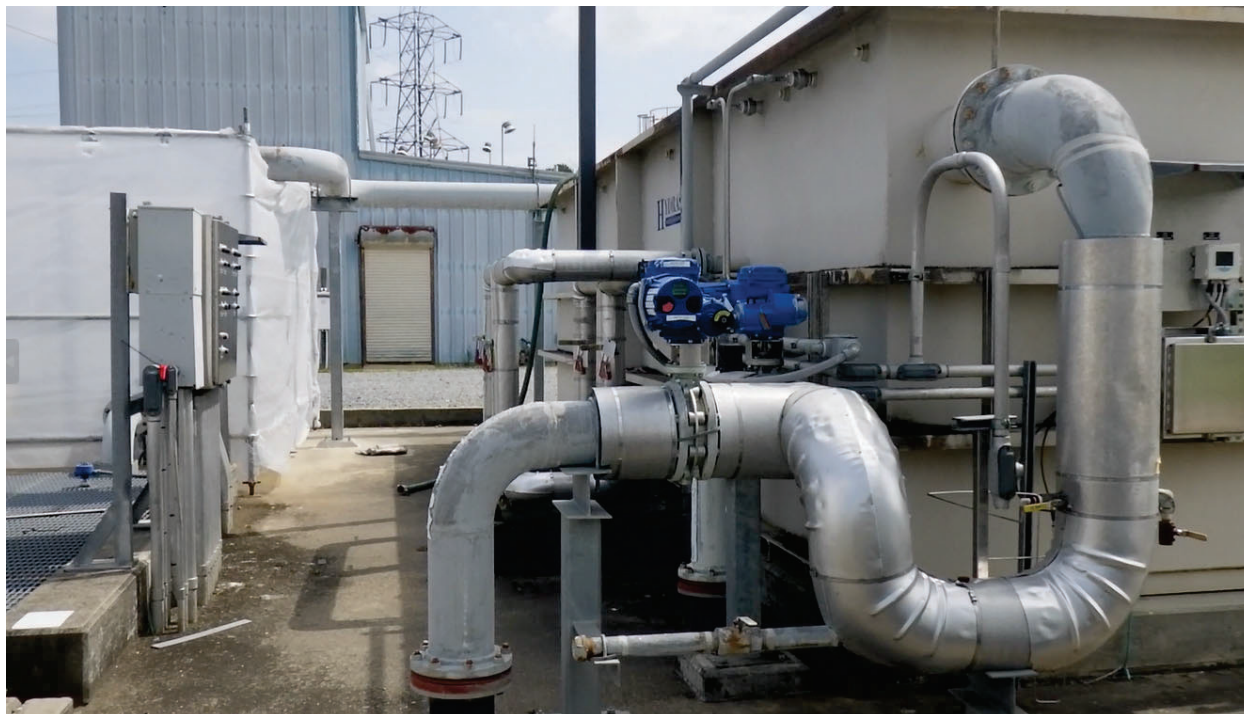
This outfall includes an intermittent discharge of decommissioning wastewaters and metal cleaning and metal chemical cleaning wastewaters, including but not limited to, chemical cleaning washwater, fireside washwater, and air preheater washwater. This outfall is not active. There was no flow or discharge at the time of the inspection (see Photo No. 10 in Appendix 1).

Photograph File Name: Unit 7Outfall105.JPG  
Date of Photograph: 04/25/2024  
Latitude and Longitude: 32.689569 -92.017883  
Orientation: E  
Map Datum: WGS-84  
Time of Photo: 10:40 AM  
Photographer: Jack Arias  
Description: This image shows unit 7 and outfall system.

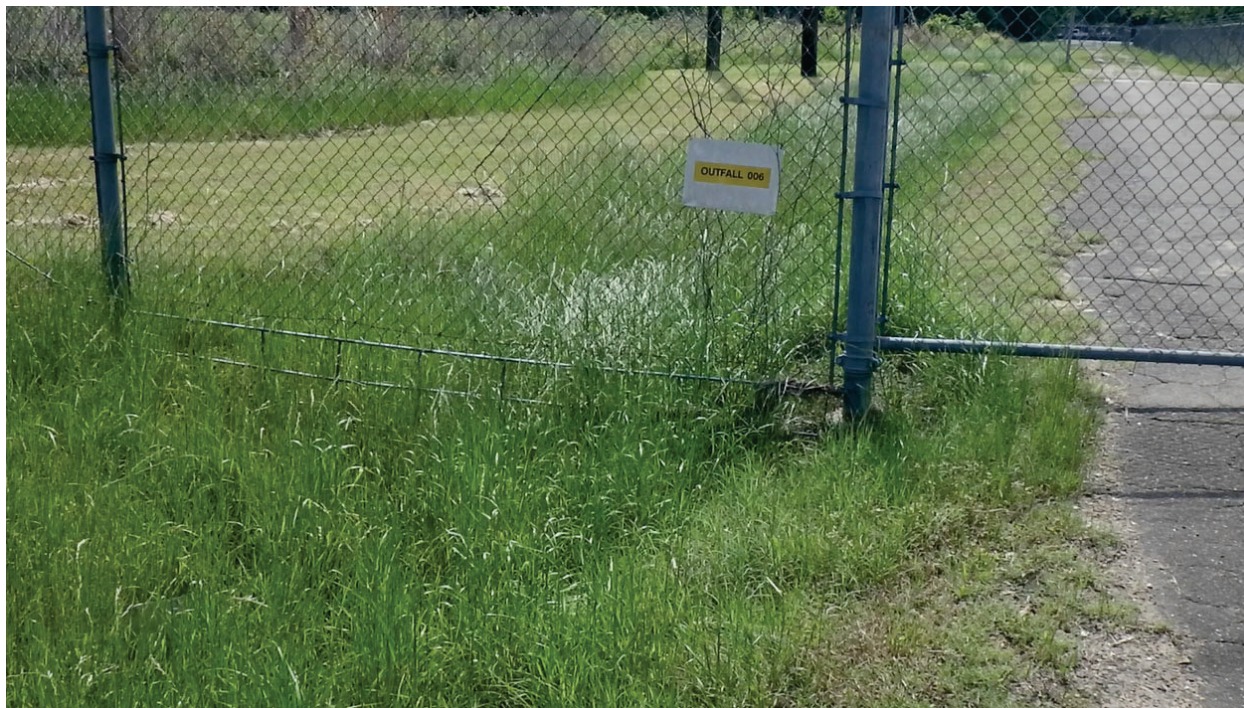
This outfall includes an intermittent discharge flow contamination potential stormwater runoff. This outfall is active. There was no flow or discharge at the time of the inspection (see Photo No. 11 in Appendix 1).

Photograph File Name: Outfall006.JPG  
Date of Photograph: 04/24-26/2024  
Latitude and Longitude: 32.701337 -92.077996  
Orientation: SE  
Map Datum: WGS-84  
Time of Photo: 10:50 AM  
Photographer: Jack Arias  
Description: This image shows outfall 006.

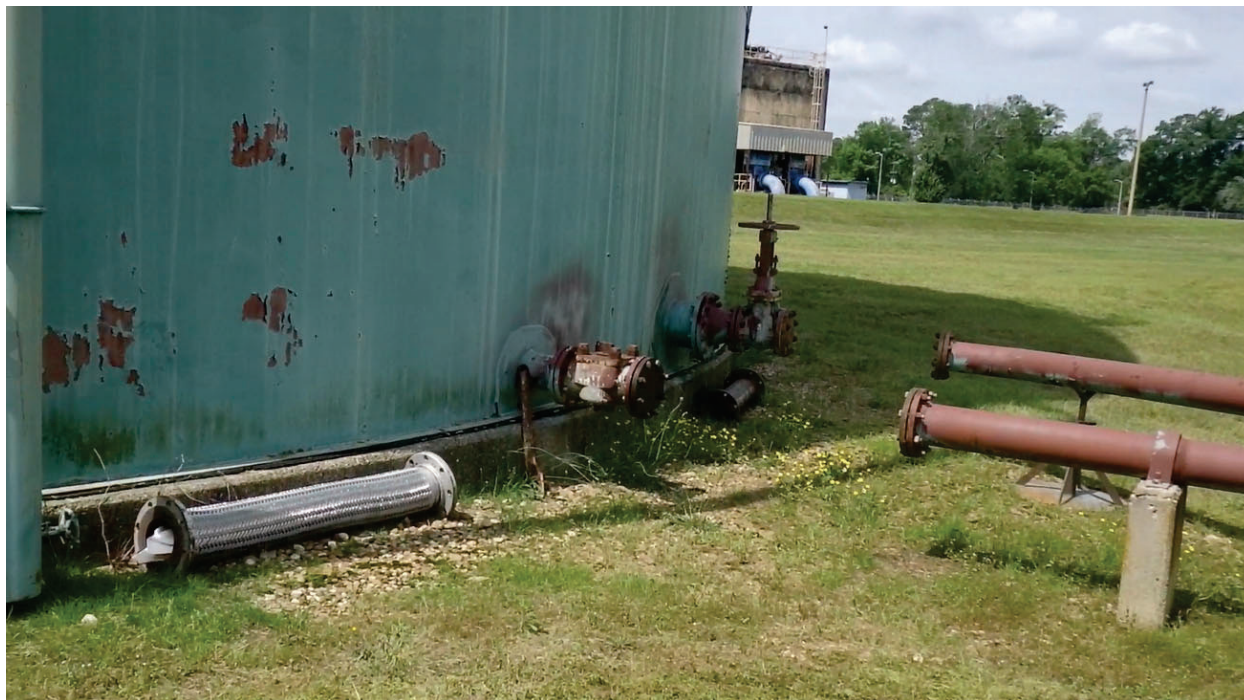
Photo No. 12

Photograph File Name: DieselTank.JPG  
Date of Photograph: 04/24-26/2024  
Latitude and Longitude: 32.701296 -92.079065  
Orientation: SE  
Map Datum: WGS-84  
Time of Photo: 11:10 AM  
Photographer: Jack Arias  
Description: This image shows the diesel tank.

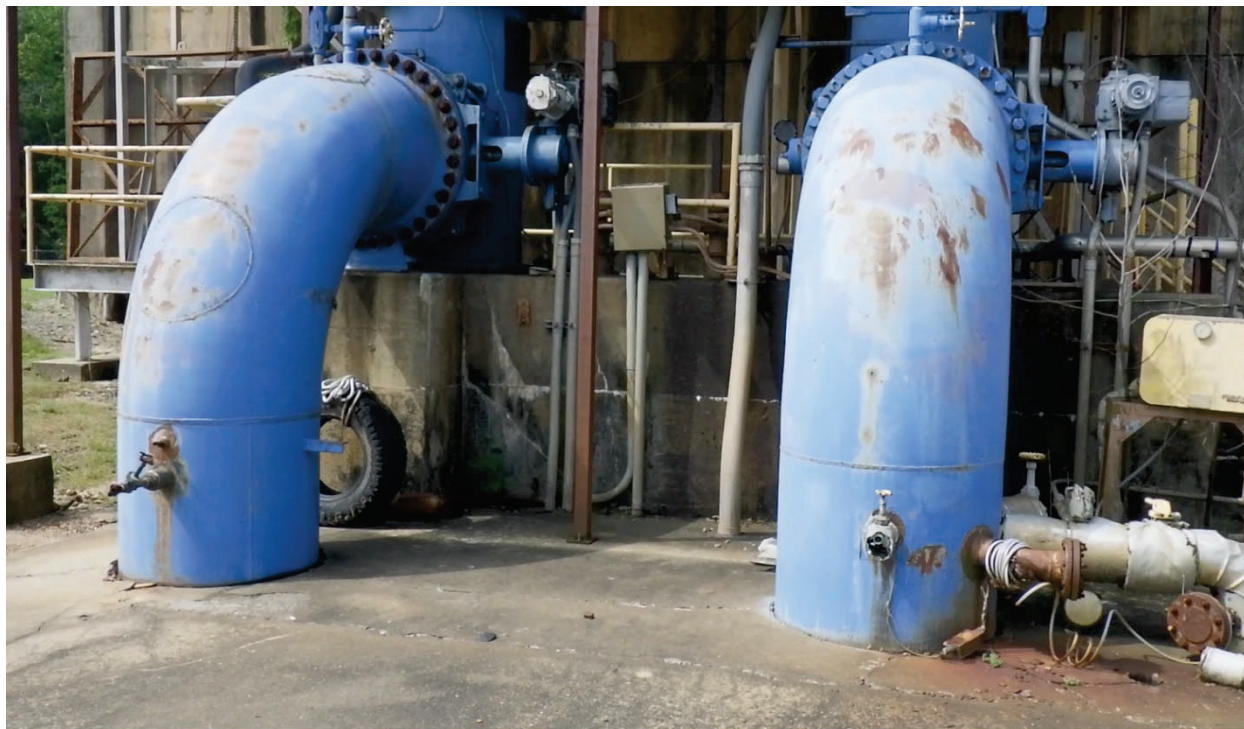
This outfall includes an intermittent discharge of cooling tower blowdown from unit 7, dust control and equipment washdown (without soaps and detergents) and decommissioning wastewaters. This outfall is not active. There was no observed flow or discharge at the time of the inspection (see Photo No. 13 in Appendix 1).

Photograph File Name: Outfall001.JPG  
Date of Photograph: 04/24-26/2024  
Latitude and Longitude: 32.701329 -92.080034  
Orientation: SE  
Map Datum: WGS-84  
Time of Photo: 11:20 AM  
Photographer: Jack Arias  
Description: This image shows the outfall 001.

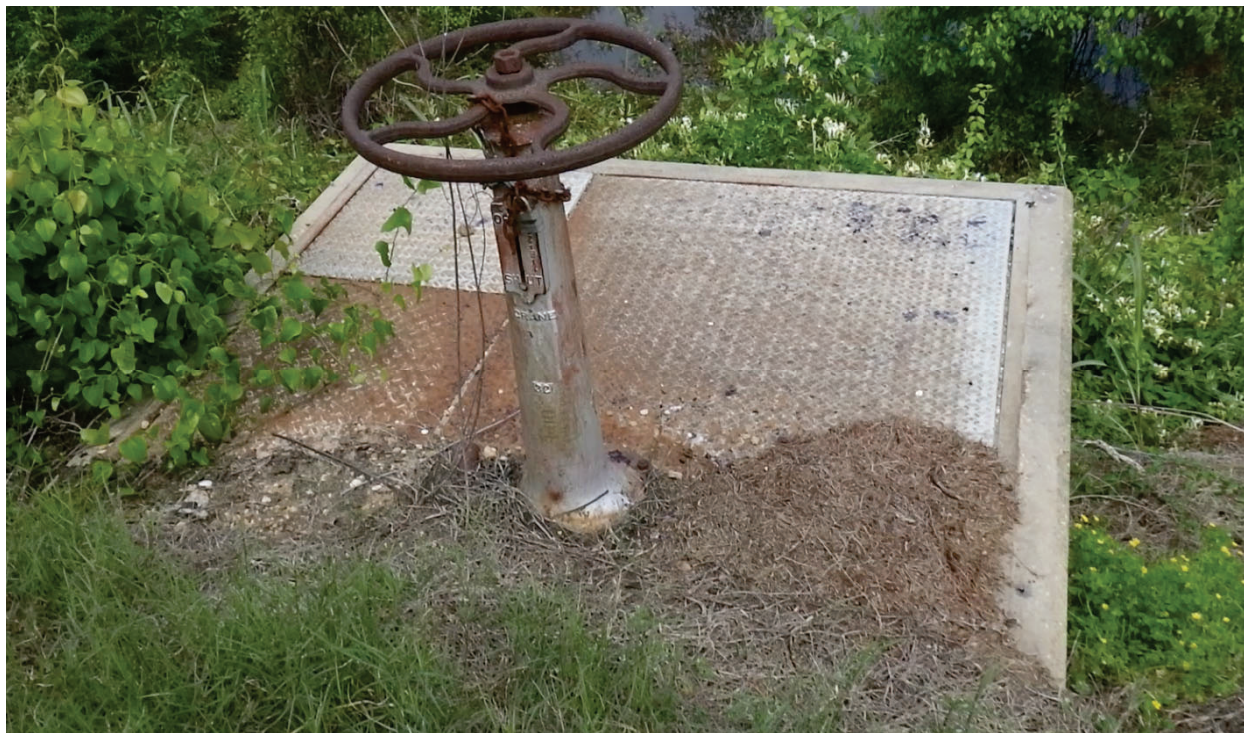
This outfall includes an intermittent discharge of low contamination potential stormwater from an area located west northwest of the generating station administrative building, only used during emergency storm events to discharge accumulated stormwater runoff from the western portion of the plant to the Ouachita River. Discharges from this area must be released manually through the opening of hand wheel valves. This discharge is routinely routed to the Oily Waste Pond that then discharges through Outfall 005. This outfall is active. There was no flow or discharge at the time of the inspection (see Photo No. 14 in Appendix 1).

Photograph File Name: Outfall004.JPG  
Date of Photograph: 04/24-26/2024  
Latitude and Longitude: 32.703878 -92.080712  
Orientation: SE  
Map Datum: WGS-84  
Time of Photo: 11:30 AM  
Photographer: Jack Arias  
Description: This image shows the outfall 004.
