**UNITED STATES ENVIRONMENTAL PROTECTION AGENCY**  
**REGION 10**  
1200 Sixth Avenue, Suite 155  
Seattle, WA 98101

**SUBJECT:** CLEAN WATER ACT INSPECTION REPORT  
Anchorage Sand & Gravel Co., Inc. – Klatt Road Facility, Anchorage, Alaska

**PREPARED BY:** Tara Martich, CWA Enforcement Specialist  
Water Enforcement & Field Branch, Surface Water Enforcement Section

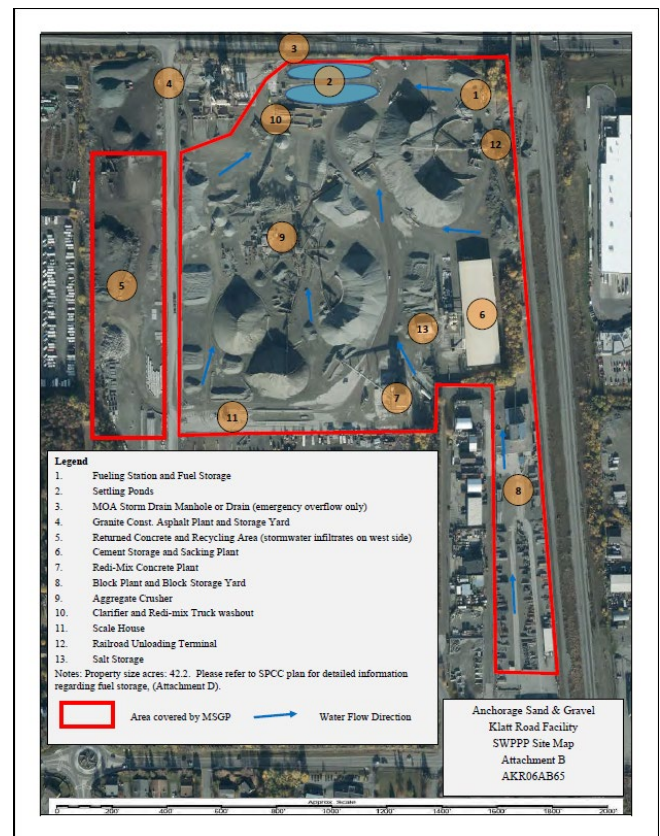
**Figure 1: Areas covered by 2020 SWPPP**

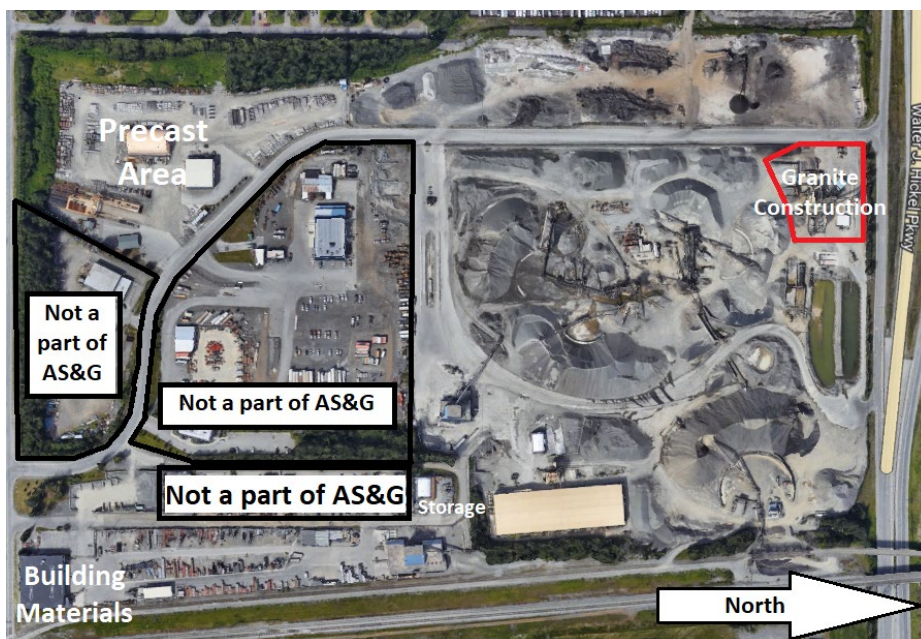
AS&G displays a large aerial photograph of the Klatt Road Facility in its conference room. EPA asked about operations visible in the aerial photograph but excluded from the Klatt Road Facility SWPPP map. EPA identified three additional areas that are part of the Klatt Road Facility operations: 1) Precast Area, 2) Building Materials, and 3) Storage. AS&G shared that it specifically excluded Building Materials from the Klatt Road Facility SWPPP because of Building Materials’ SIC number.

Figure 2: Aerial of Klatt Road Facility. Precast Area, Building Materials & Storage are owned/operated by AS&G.

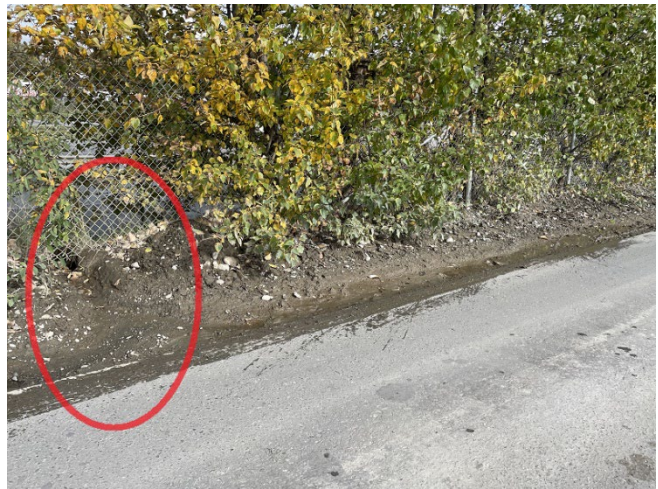
We walked along an internal facility road that borders the northern edge of the property. Along that roadway, we could see a cut in the bank where stormwater had recently discharged. There was very wet mud in the cut.

**Figure 3: Facility Road Along Northern Boundary with Cut**

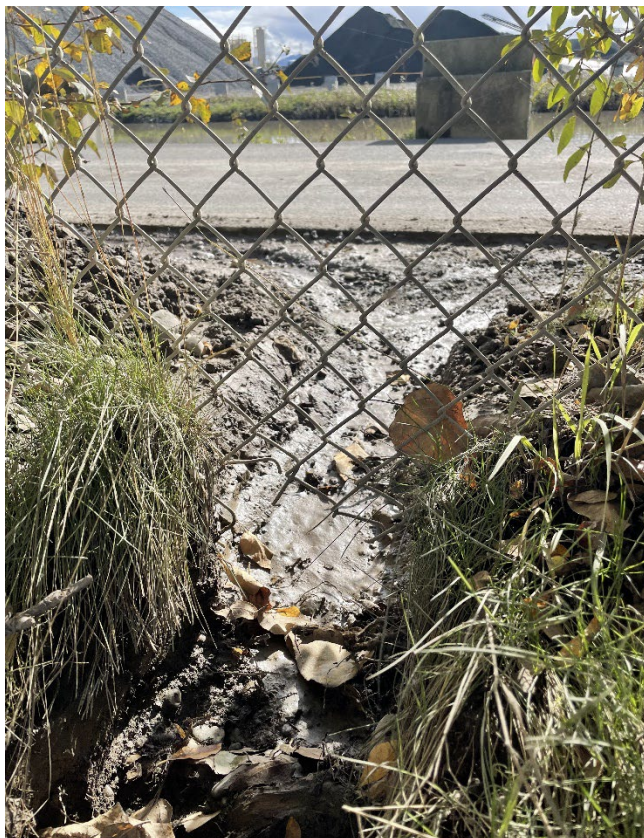
**Figure 4: View of Cut from Northern Side of Fence**

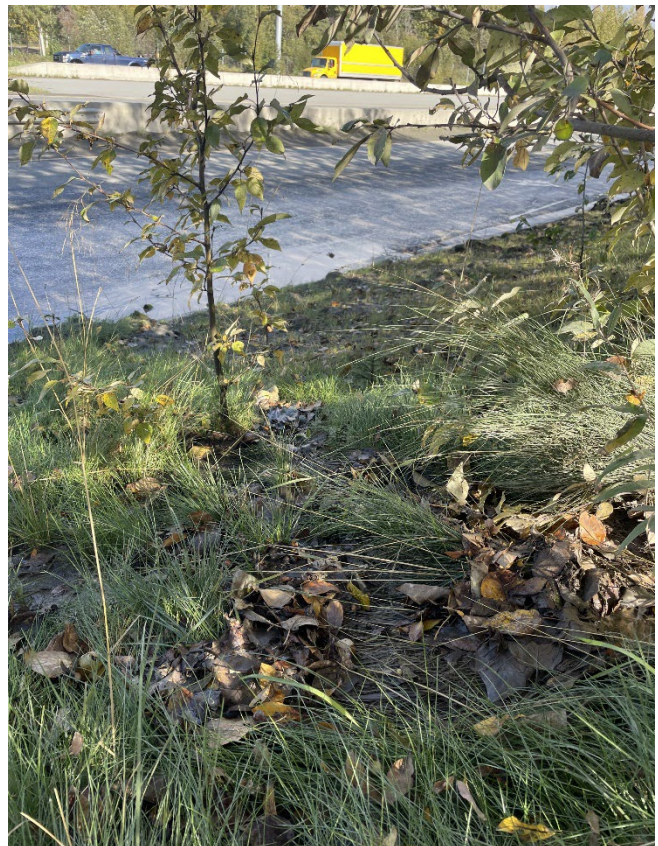
EPA looked at where the cut flowed to. We could see leaves and grass covered with mud and a path to where the muddy discharge flowed. A large deposit of sediment sat at the bottom of the path. Some young grasses grew on the sediment, indicating the that the sediment pile had grown over time. The

**Figure 5: Path of Discharge through Cut, Muddy Grass/Leaves**

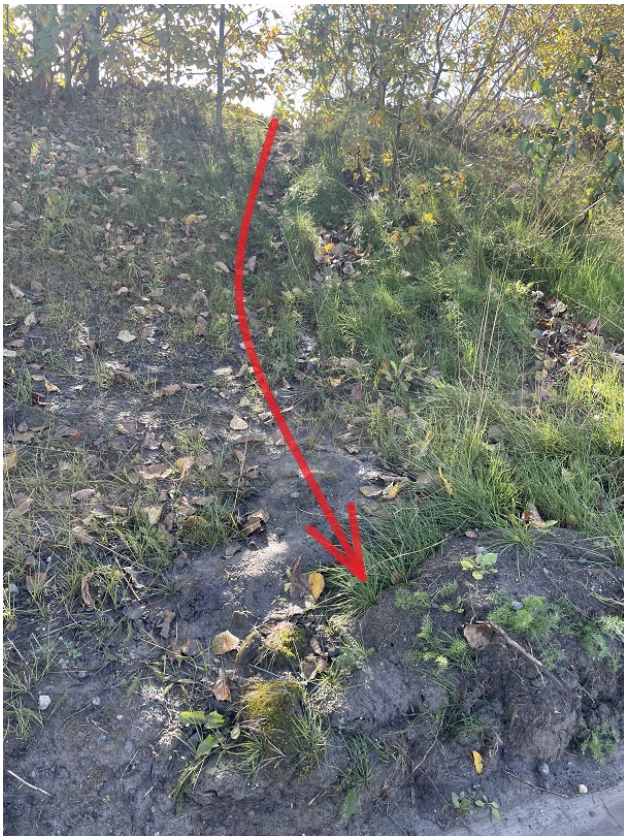
**Figure 7: Path from Cut & Sediment Deposit**

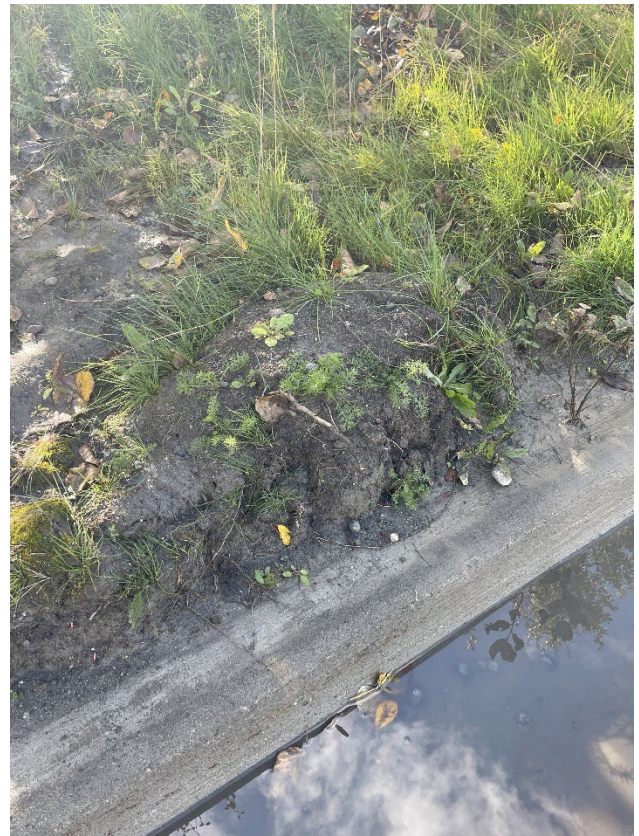
**Figure 6: Sediment Deposit and Curb**

northernmost face of the pile dropped at an almost 90-degree angle to the curb. The curb, next to the deposit, appeared well-maintained. A storm drain inlet is located a few feet east of the sediment pile.

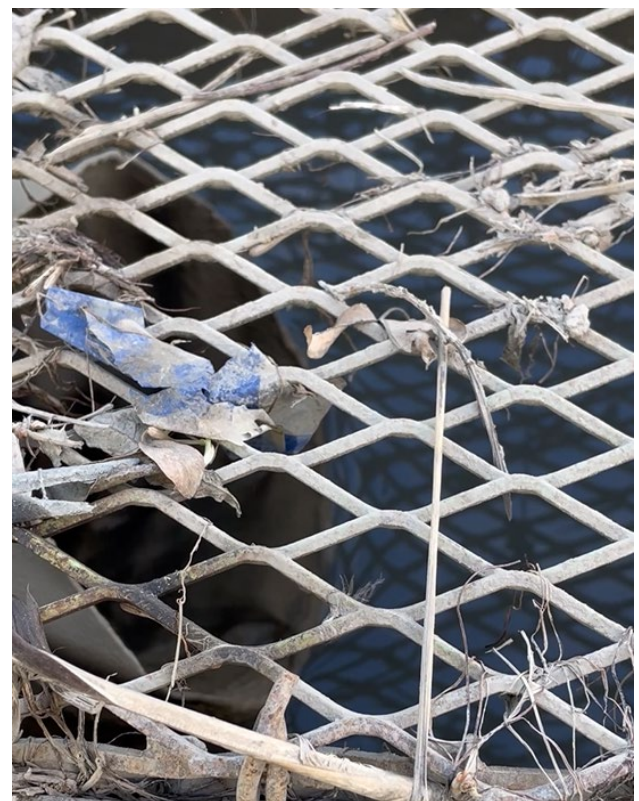
Next, we looked at the onsite pond and its discharge overflow pipe. When we arrived at the discharge overflow pipe, it was actively discharging. Debris on the grate above the overflow-pipe indicated the water was higher than the grate at some point.

Kris Shippen commented that he was surprised to see the pond discharging and then further commented that the discharging was new. We pointed out to Kris Shippen the mudline on the vegetation around the pond. The mudline was more than a foot above the current pond level. We told AS&G the mudline indicated the pond had been discharging for some time. Kris appeared to understand. He said he would pull a sample of the discharge.

**Figure 8: Overflow Pipe Discharging**

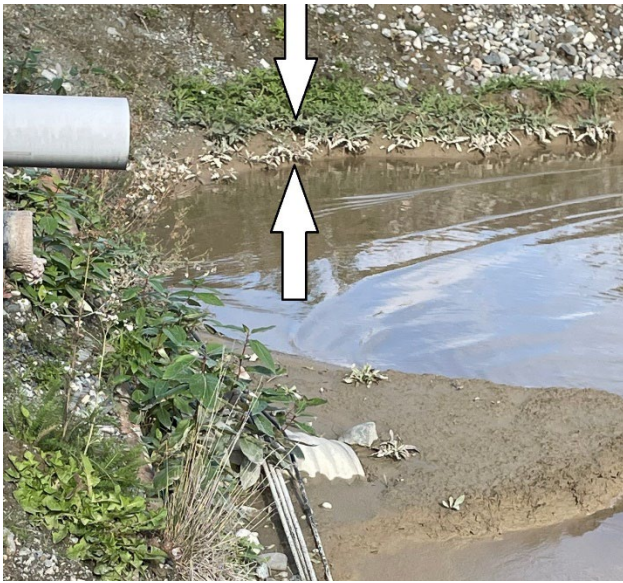
**Figure 9: Mudline at Pond**

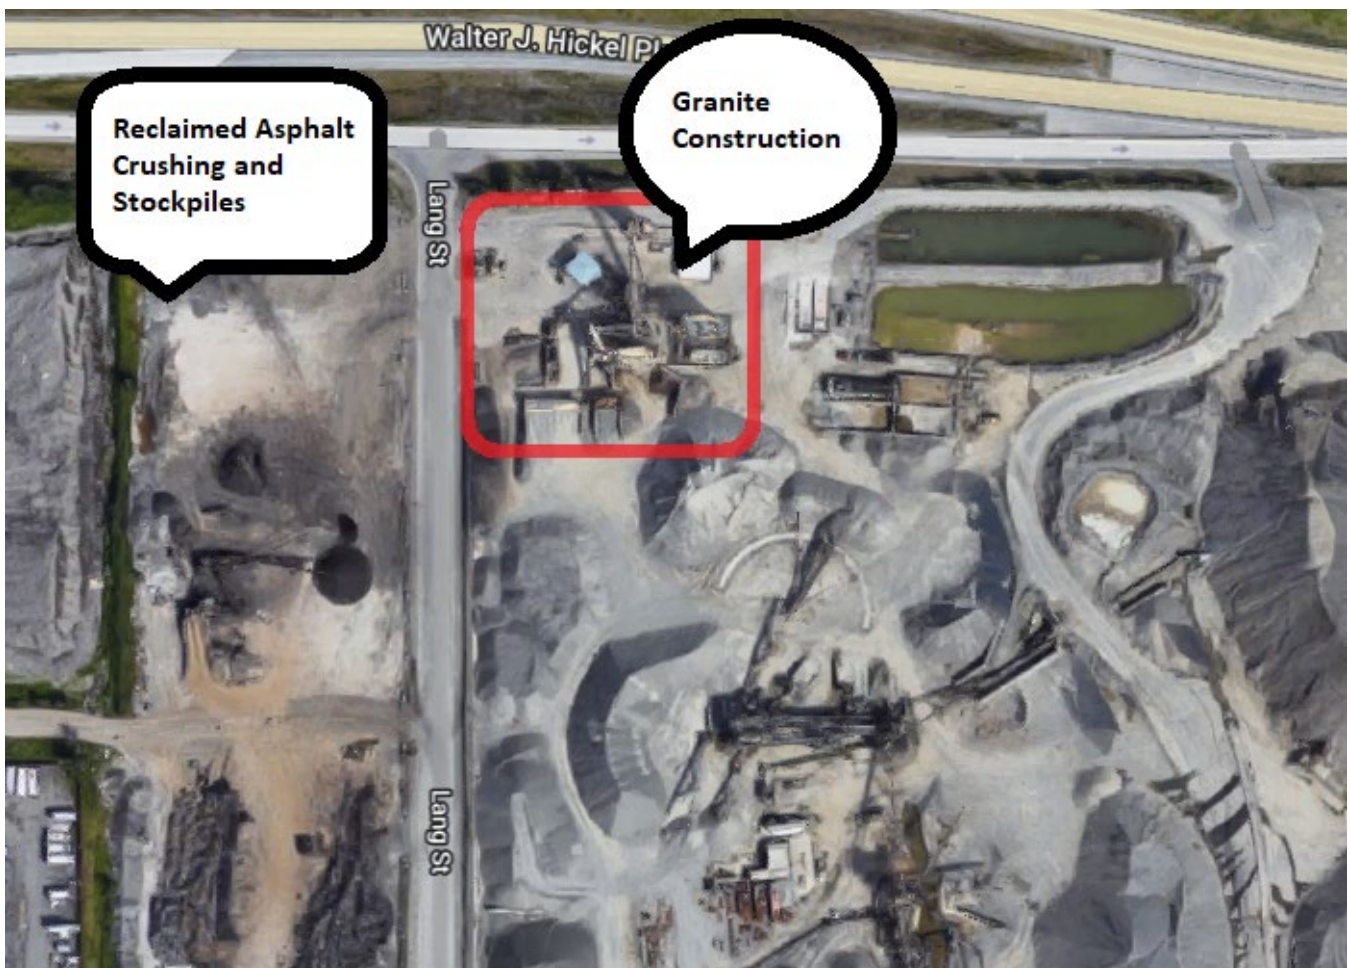
Lang Street, a municipal street, runs through the middle of AS&G's operation. West of Lang Street AS&G crushes and stockpiles reclaimed asphalt pavement and other materials. When we walked across Lang Street, we observed discharges entering the storm drains on both the northeast and northwest corners of Lang Street and Hickel Parkway.

Turbid waters sheet-flowed across the surface of the reclaimed asphalt pavement crushing operation. No BMPs were present to filter the sheet flow from the reclaimed asphalt paving area before it entered

**Figure 10: Granite Construction / Reclaimed Asphalt Crushing & Stockpiles**

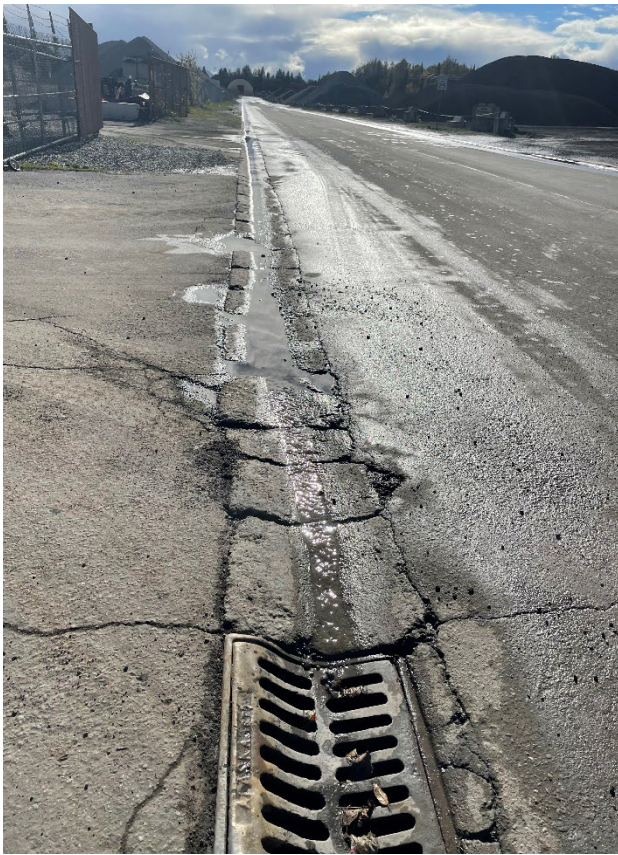
**Figure 11: Discharge into Storm Drain at NE Corner of Lang Street & Gilman Parkway**

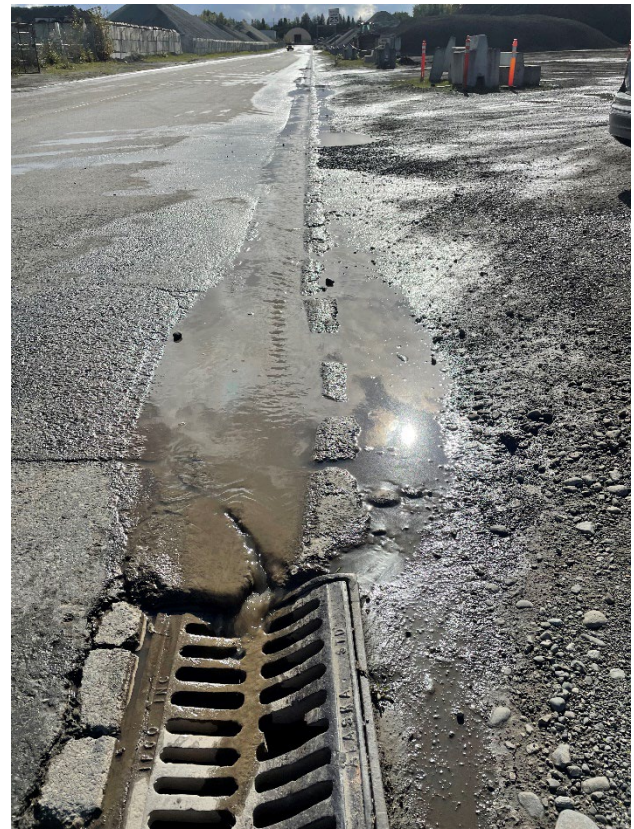
**Figure 12: Discharge into Storm Drain at Reclaimed Asphalt Recycling (NW corner of Lang Street and Gilman Parkway)**

into the gutter on Lang Street, and then into the storm drain. We pointed the turbid discharge out to Kris Shippen. Kris commented he would need to figure out how to collect a sample and mentioned he believed the water could include contaminants from properties upstream. We followed the water flow. Upstream properties were not discharging. We also told Kris, if/when AS&G's upstream neighbor(s)' discharged, Kris could collect a sample of that (before it came into contact with AS&G's discharge) to establish a baseline.

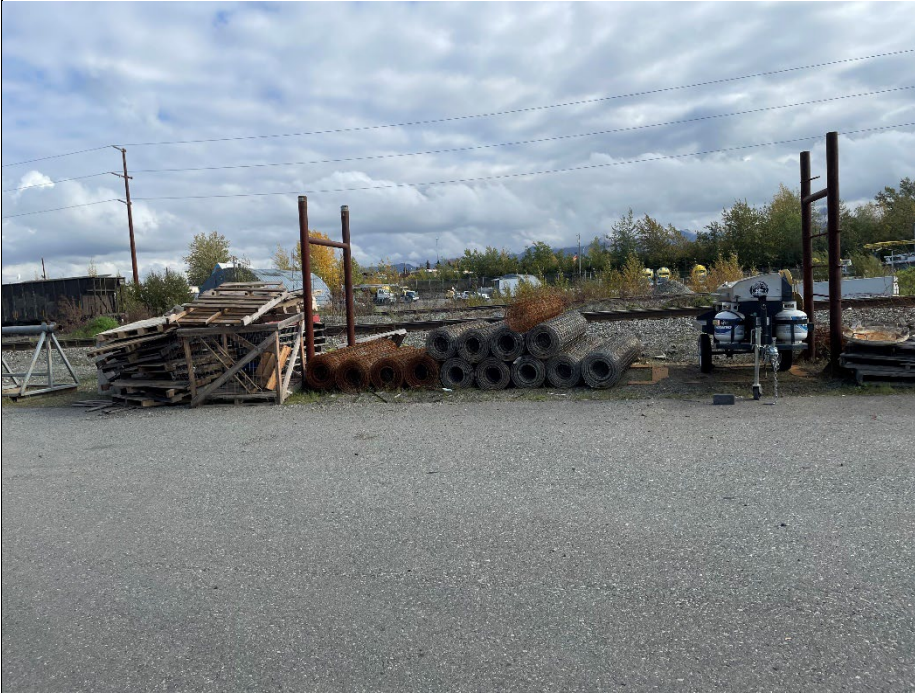
Picture 5: Materials Stored at Building Materials and Excluded from SWPPP

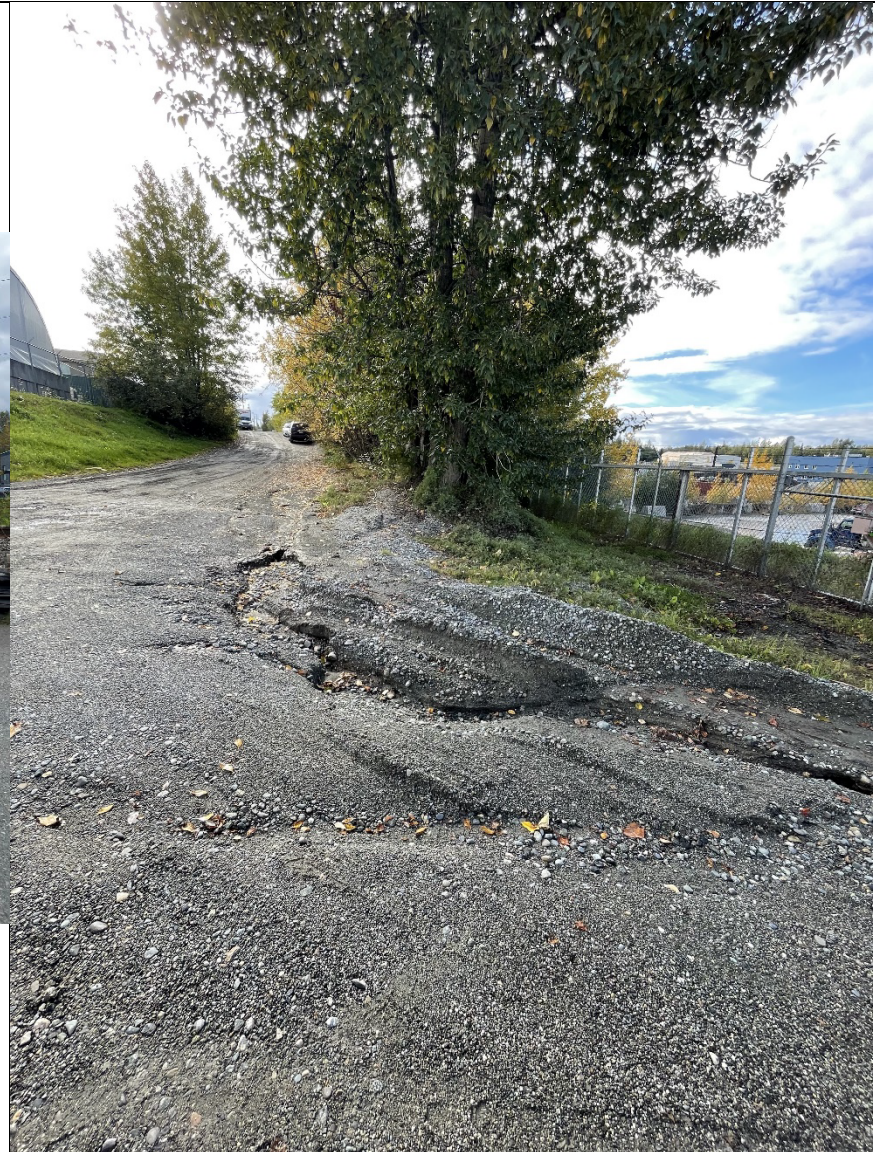
Picture 6: Evidence of Onsite Erosion

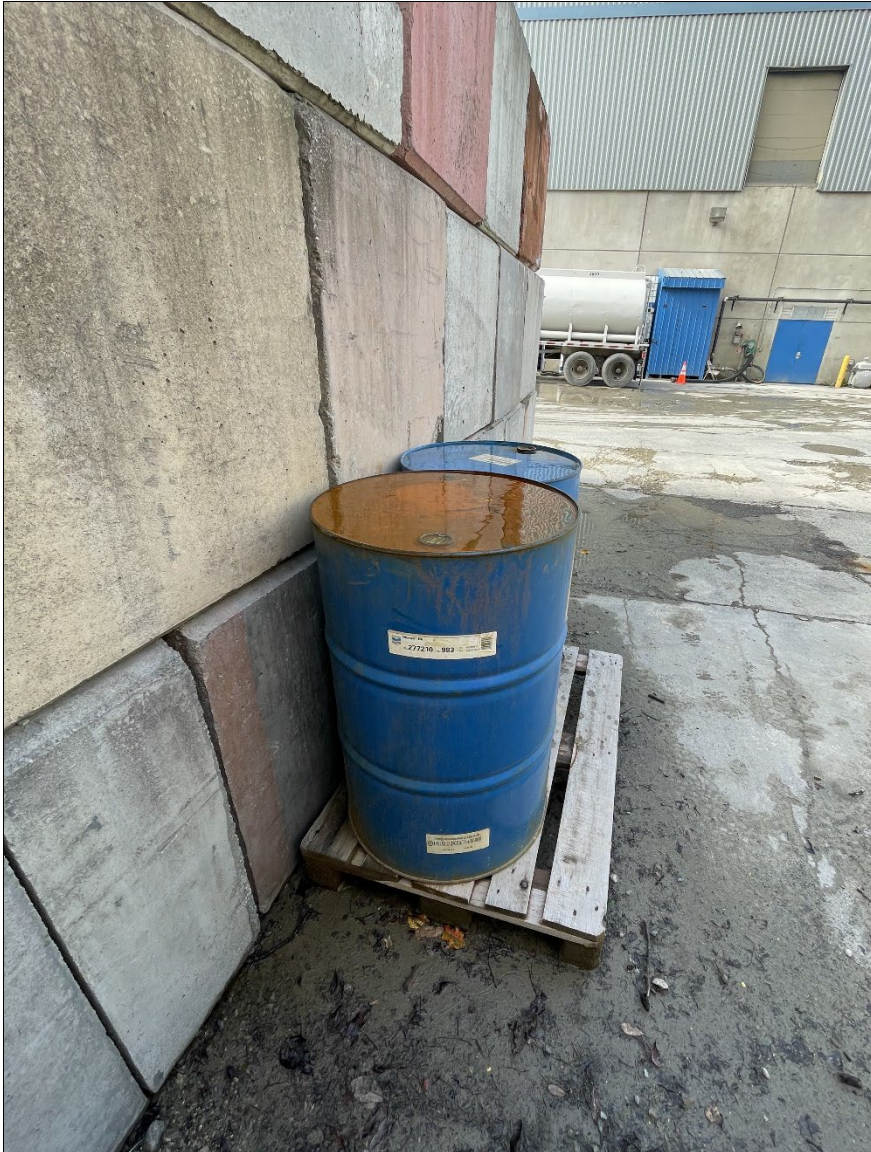
Picture 7: Chevron Meropa 150

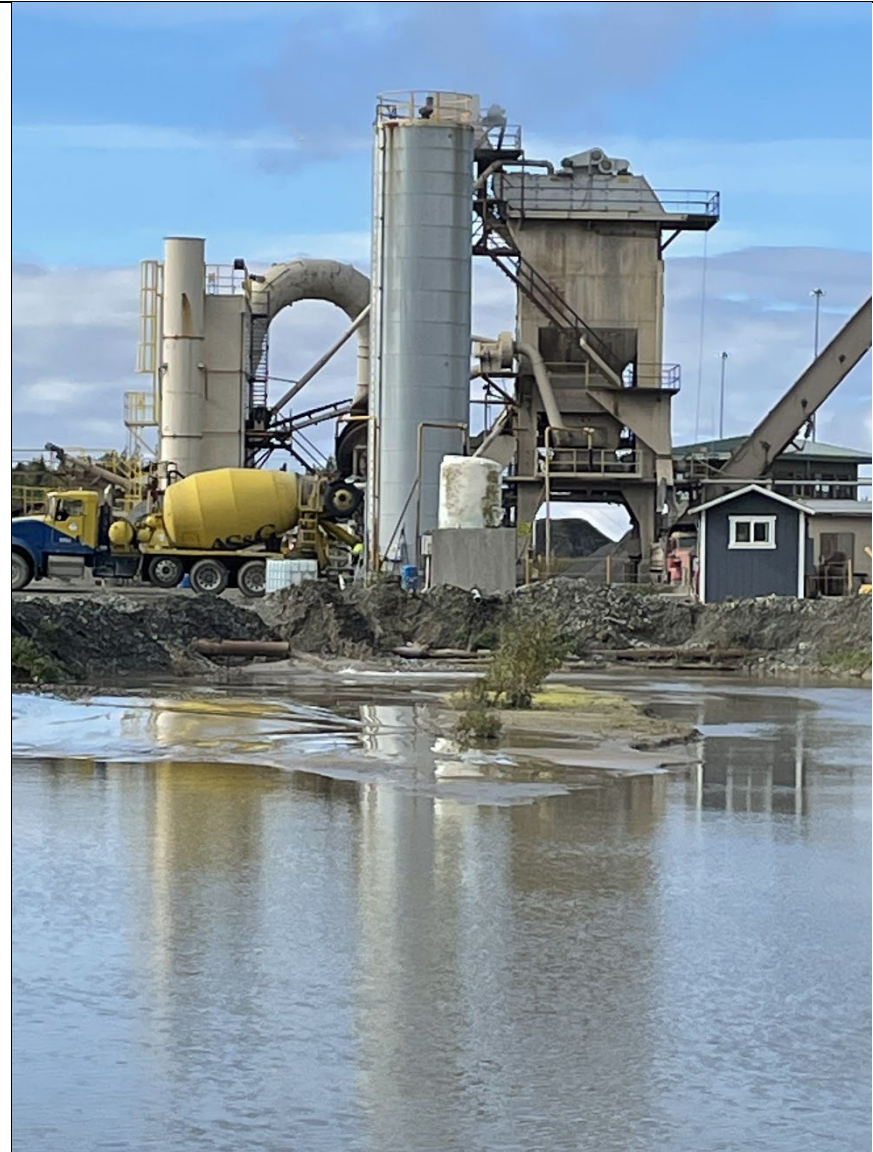
Picture 8: Anchorage Sand & Gravel Pond and Ready Mix Truck at Granite Construction Ready Mix Plant

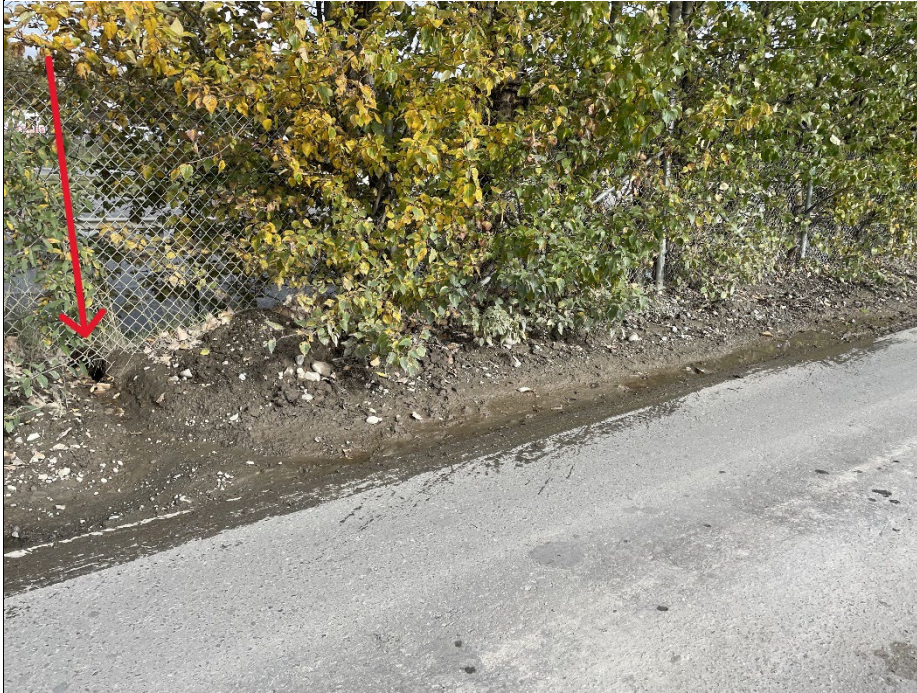
Picture 9: Location of Discharge North of Pond

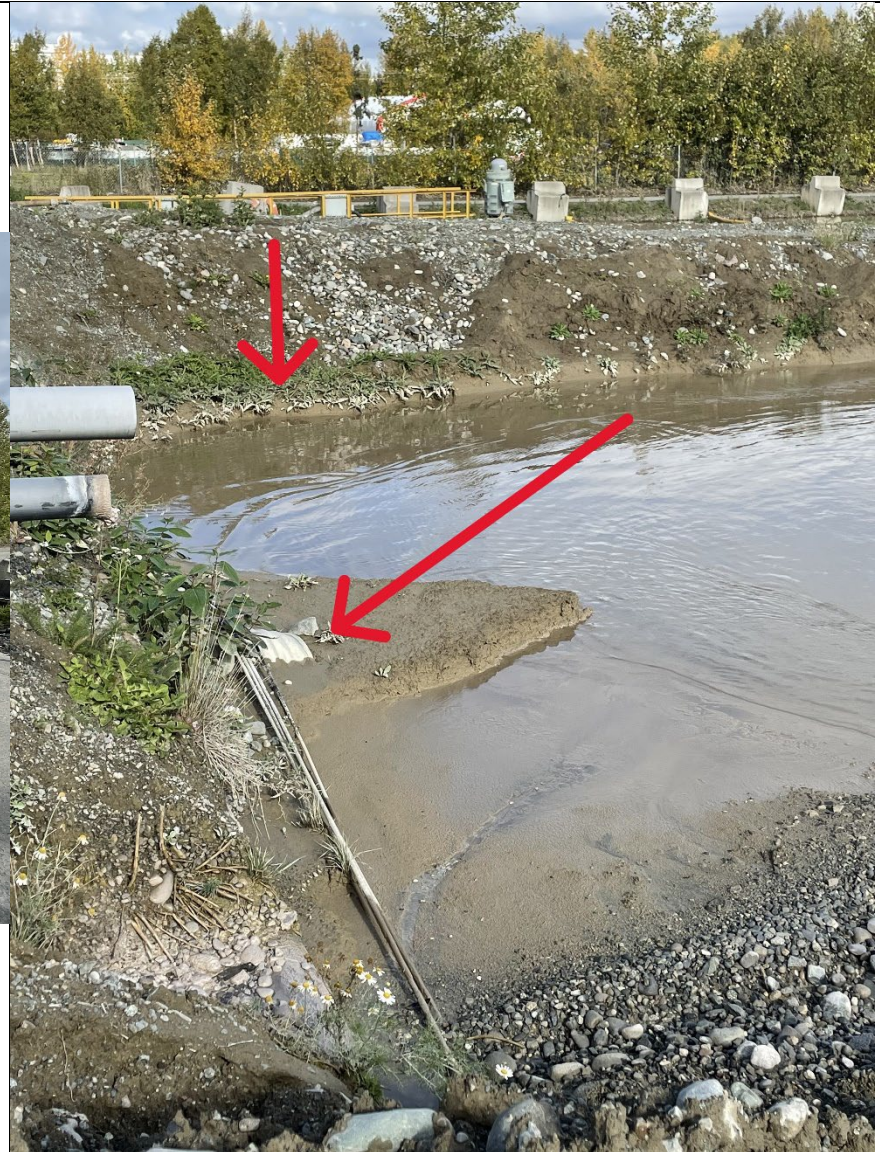
Picture 12: Onsite Pond Mudline and Buried Pipe

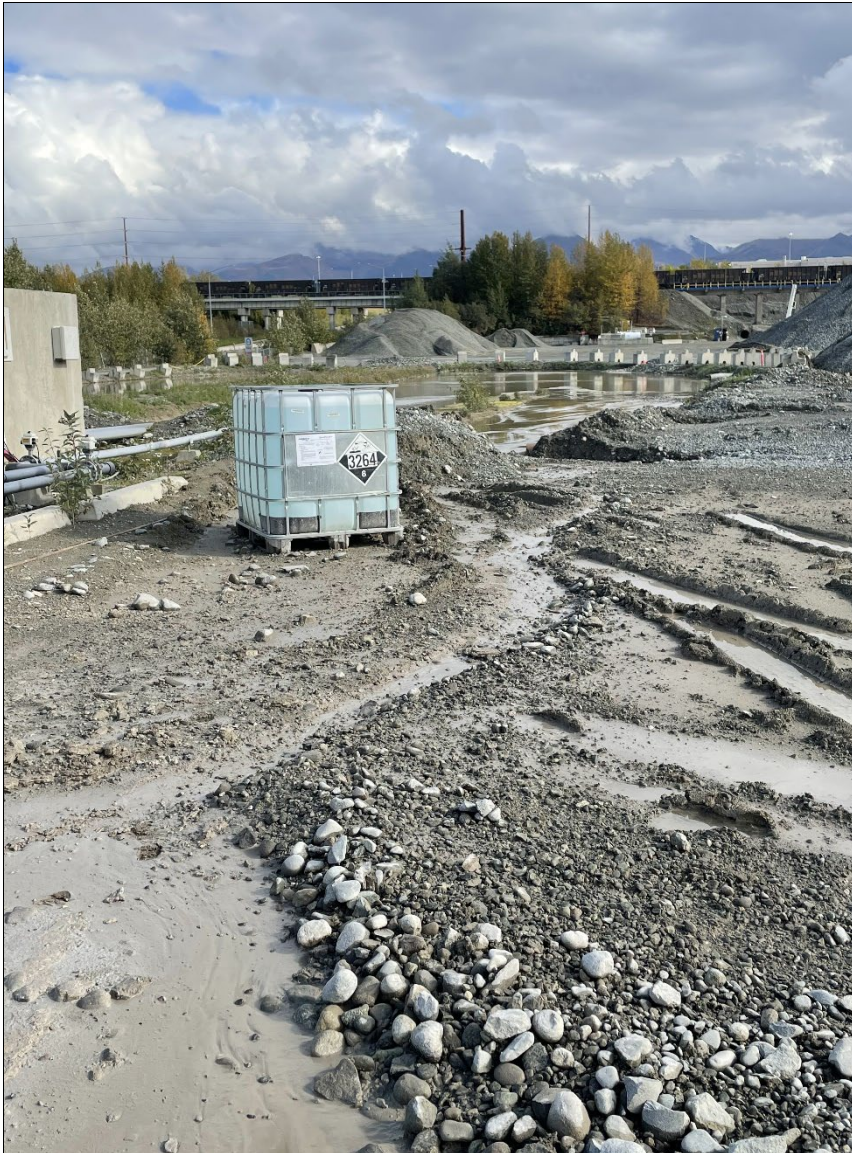
During the site walk, we noted several drums, and other materials stored in areas that did not include spill containment and/or located in areas where water flowed towards the onsite ponds.

Picture 13: Material Stored in the Water Flow Path to Pond

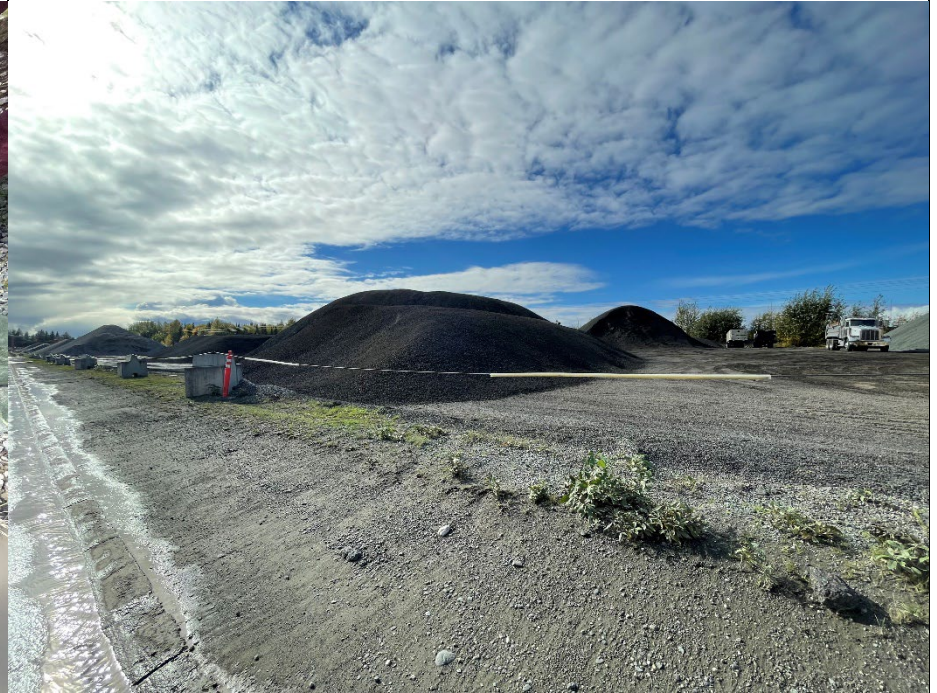
Picture 16: Sheet Flow from Recycle Asphalt Paving (RAP) Processing Area

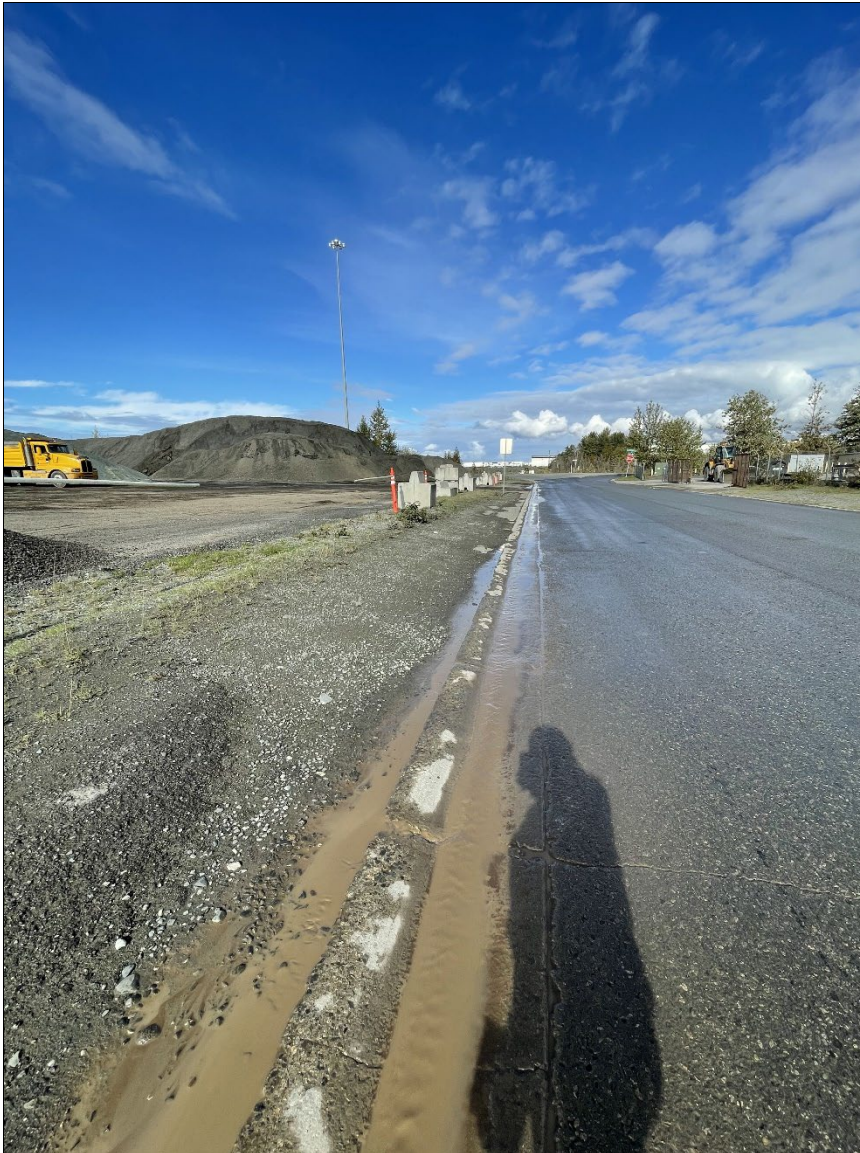
Picture 17: Discharge from RAP Processing Area

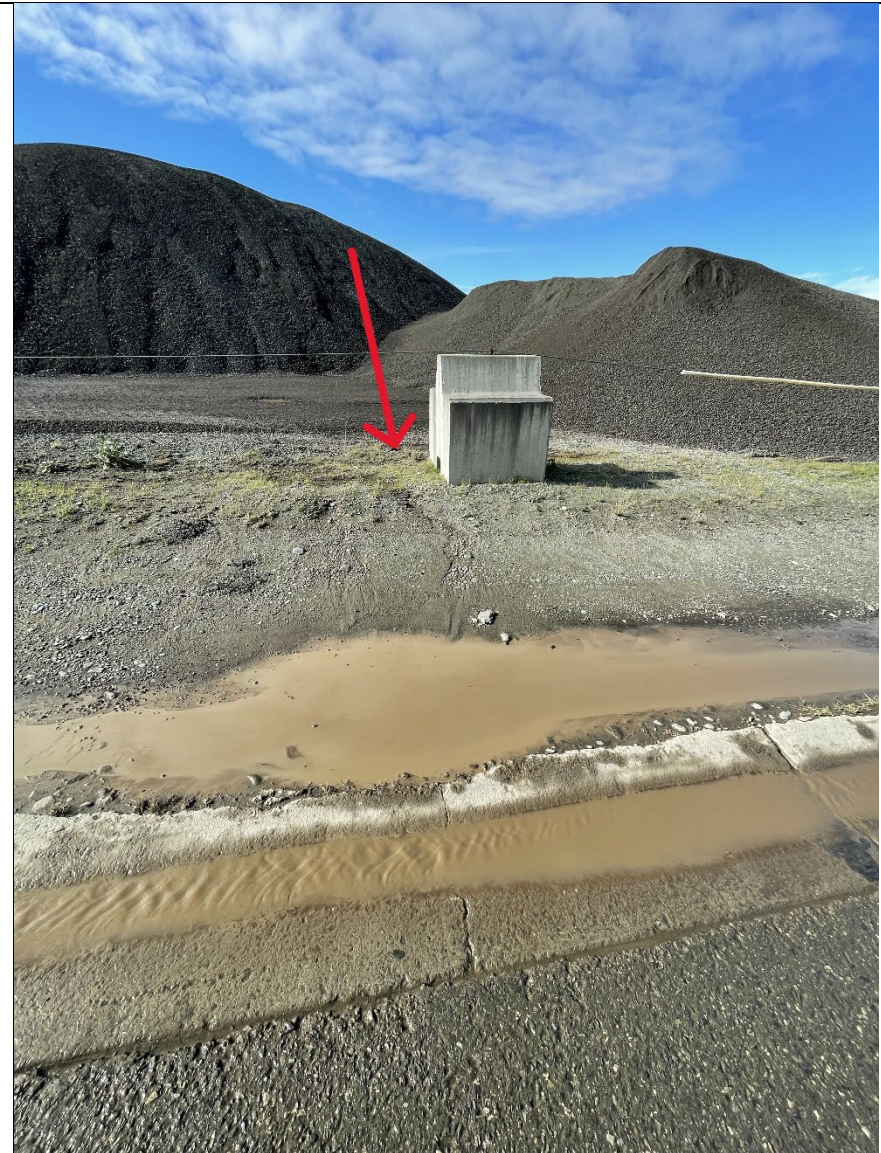
Picture 18: Discharge from RAP Processing Area

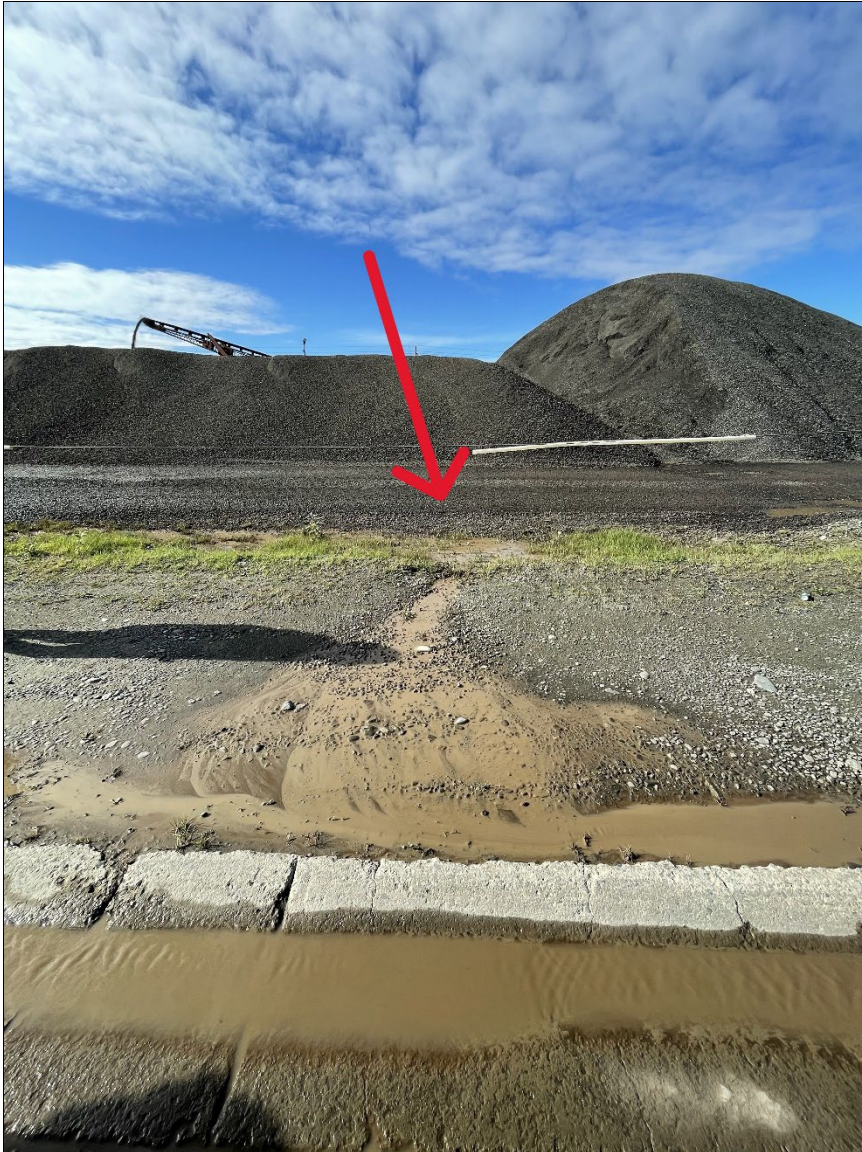
Picture 19: Discharge from RAP Processing Area

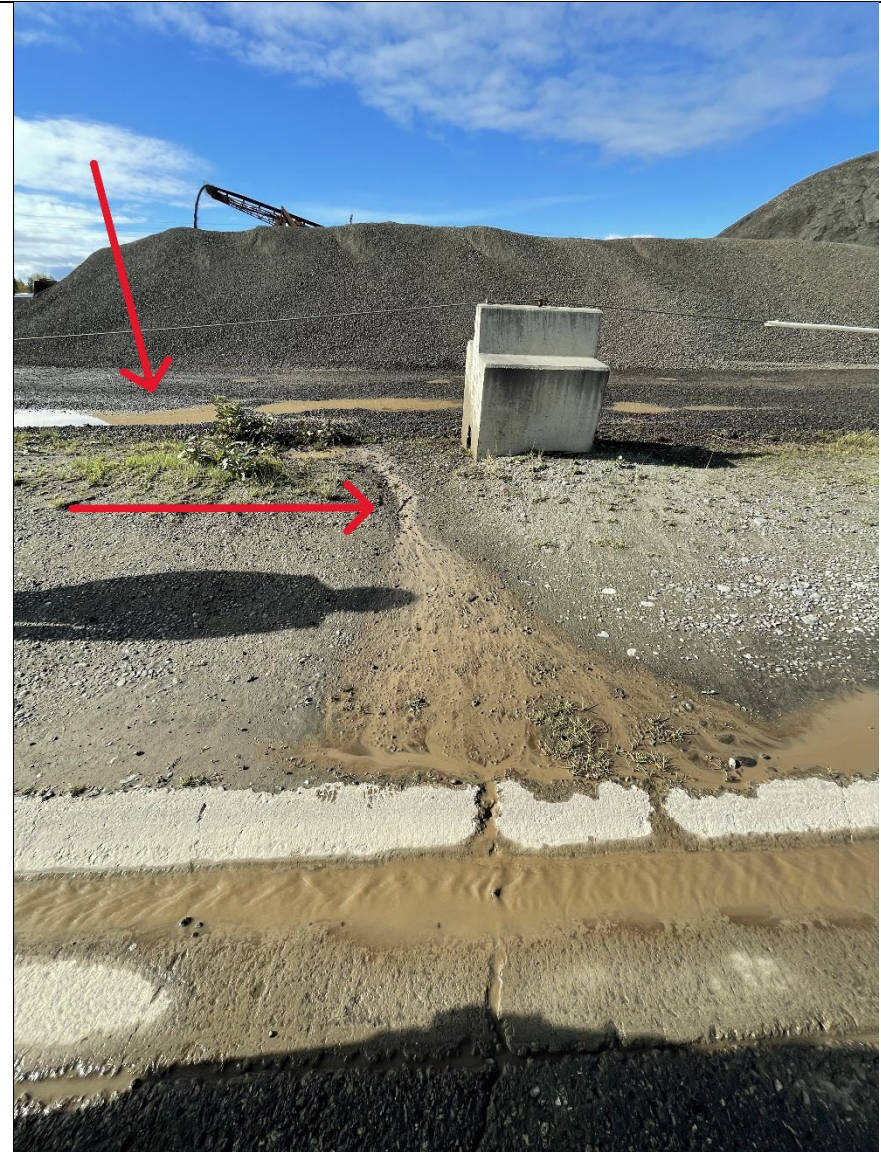
Picture 20: Discharge from RAP Processing Area

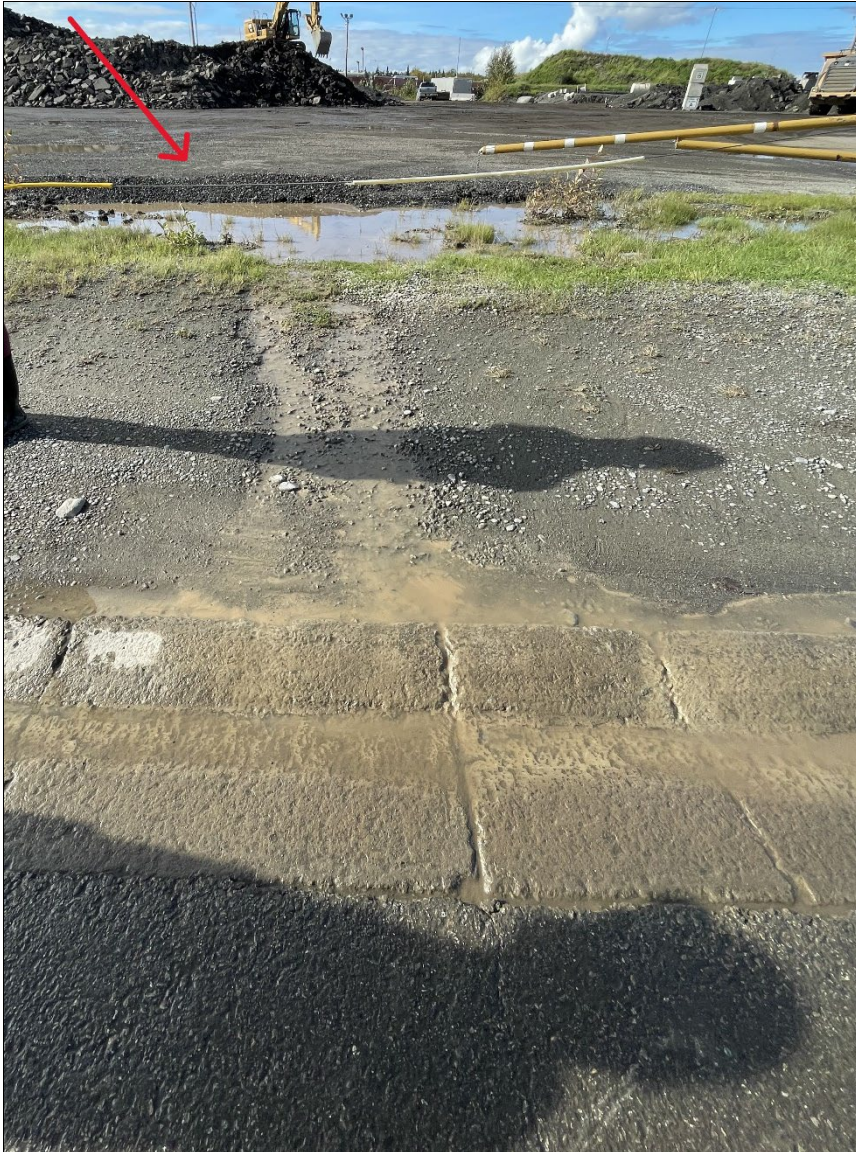
Picture 21: Discharge from RAP Processing Area

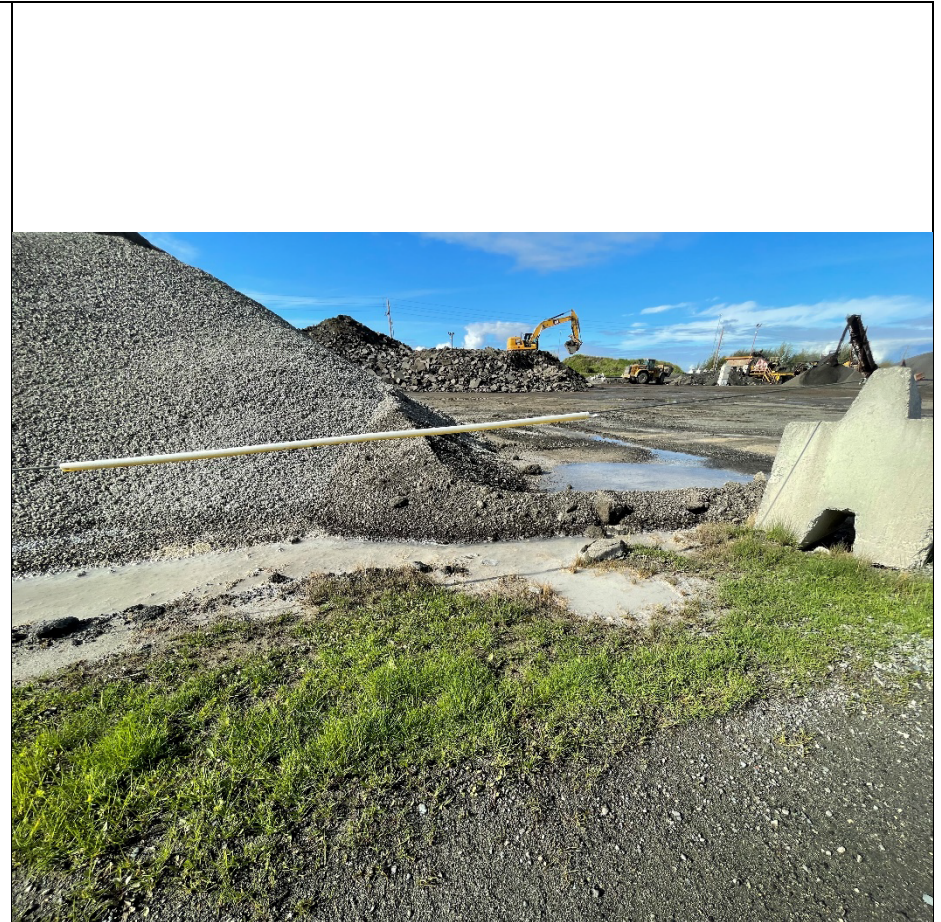
Picture 22: Ponding and Sheet Flow from RAP Processing Area

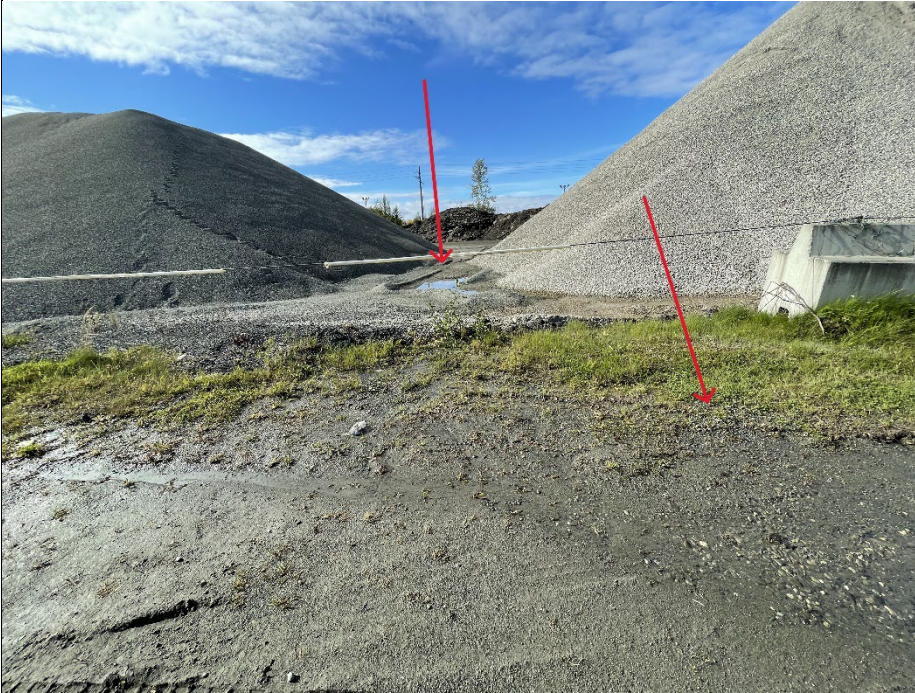
Picture 23: Ponding and Sheet Flow from RAP Processing Area

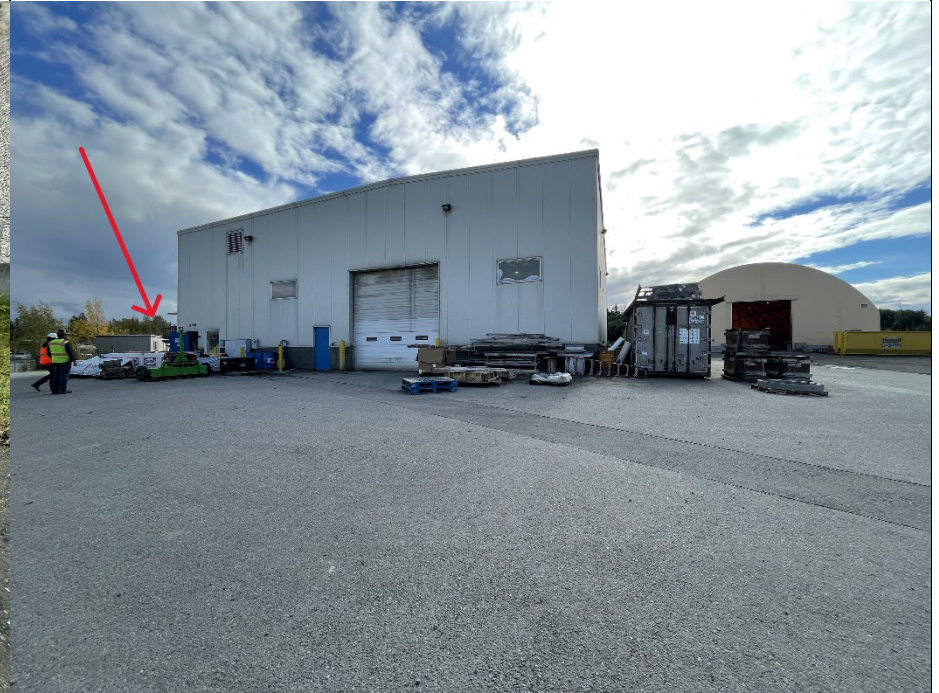
Picture 24: Precast Area and Materials Stored Outside

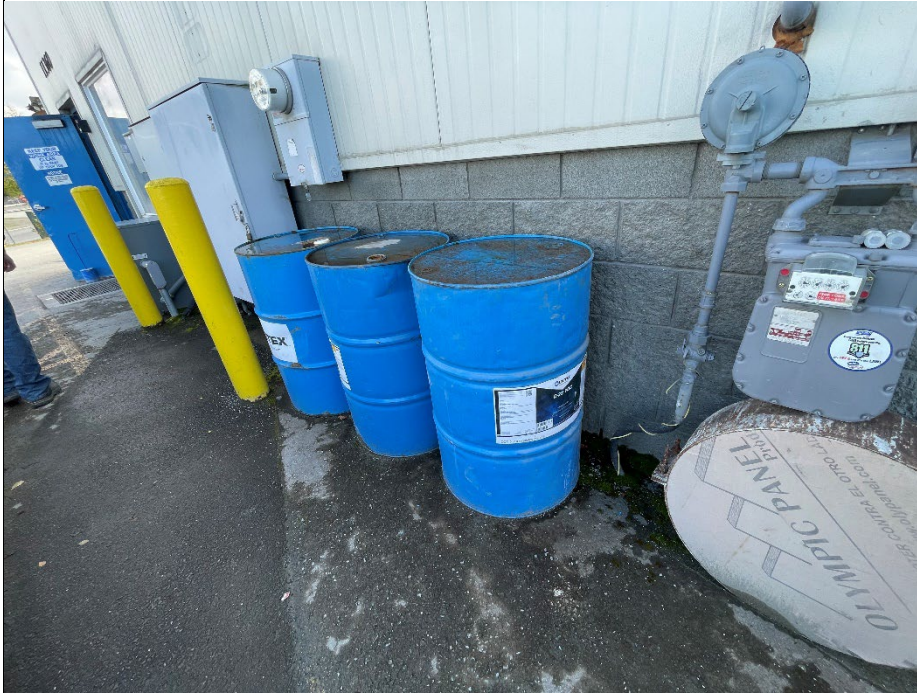
Picture 25: Precast Area and Materials Stored Outside
