**UNITED STATES ENVIRONMENTAL PROTECTION AGENCY**  
**REGION 10**  
1200 Sixth Avenue, Suite 155  
Seattle, WA 98101

**SUBJECT:** CLEAN WATER ACT INSPECTION REPORT  
Anchorage Sand & Gravel Co., Inc. – Klatt Road Facility, Anchorage, Alaska

**PREPARED BY:** Tara Martich, CWA Enforcement Specialist  
Water Enforcement & Field Branch, Surface Water Enforcement Section

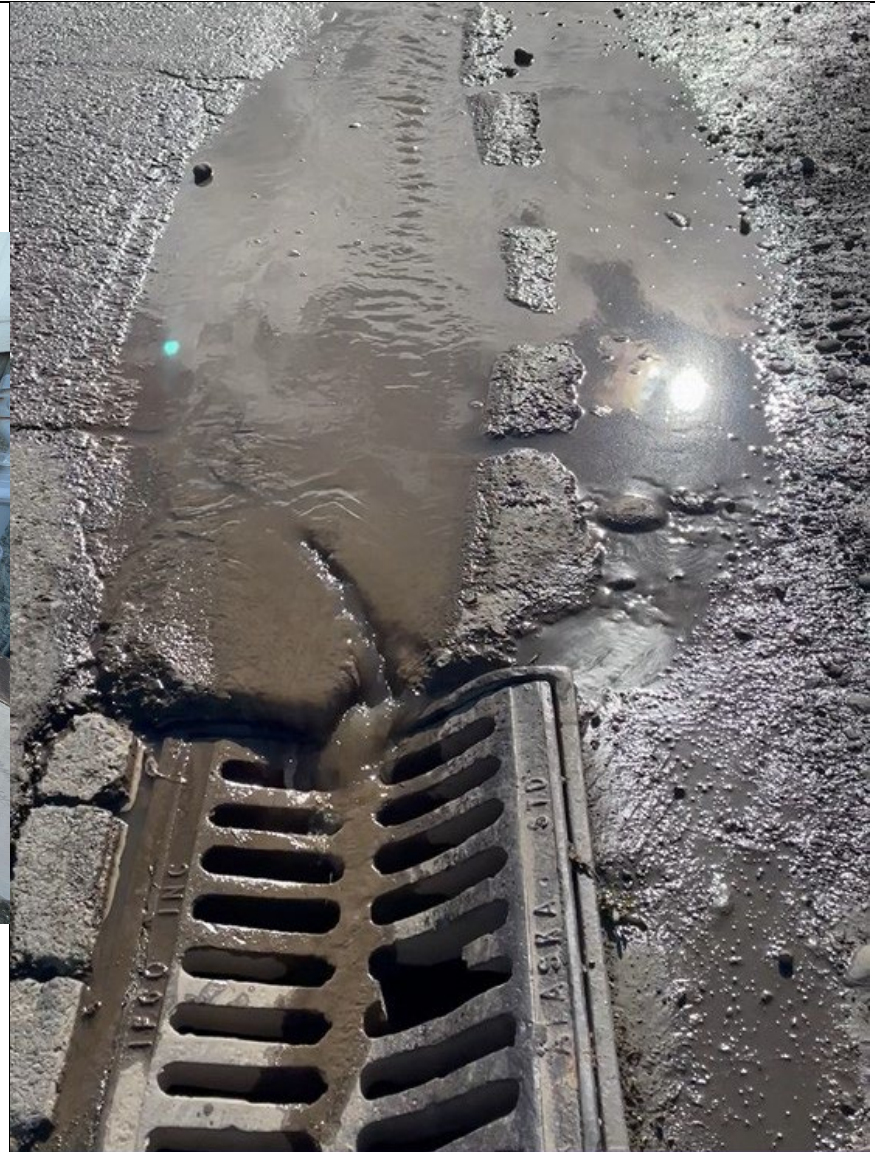
Picture 26: Discharge at NW Corner of Lang and Gilman

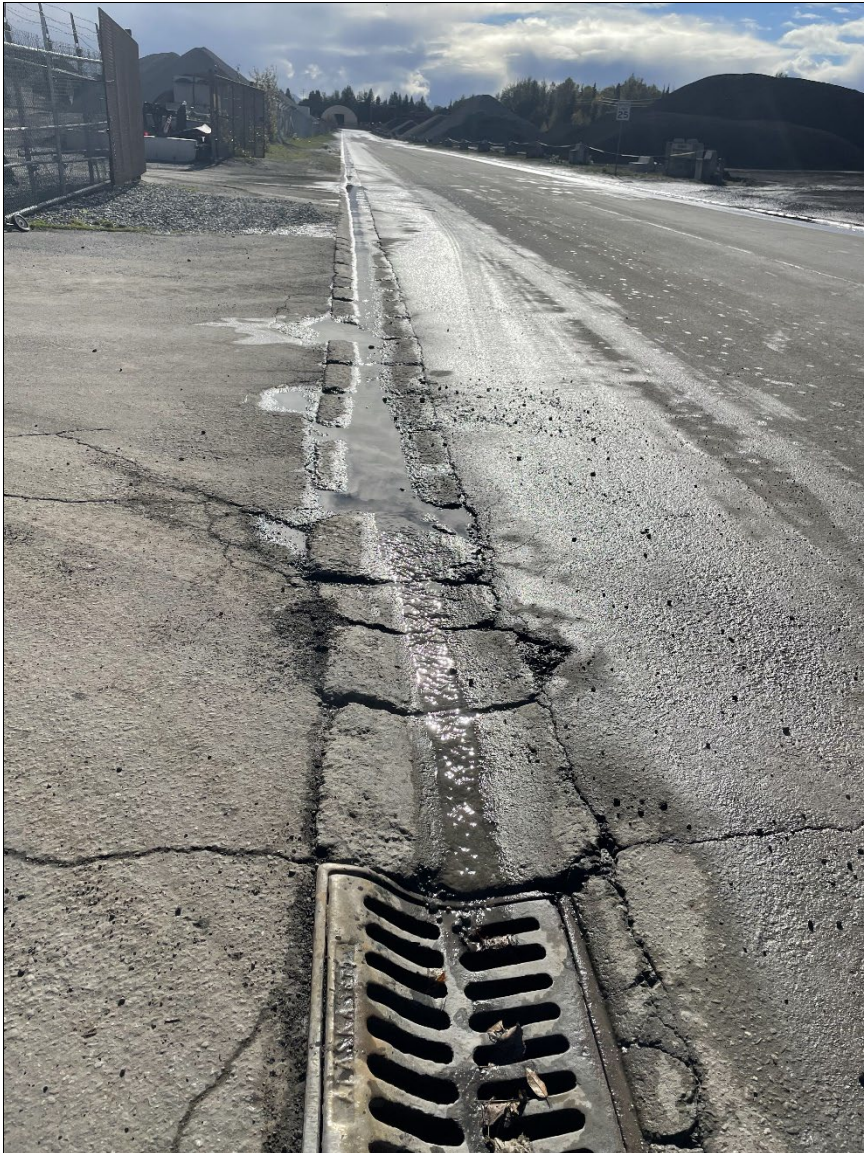
Picture 27: Discharge at NE Corner of Lang St. and Gilman Pkwy.

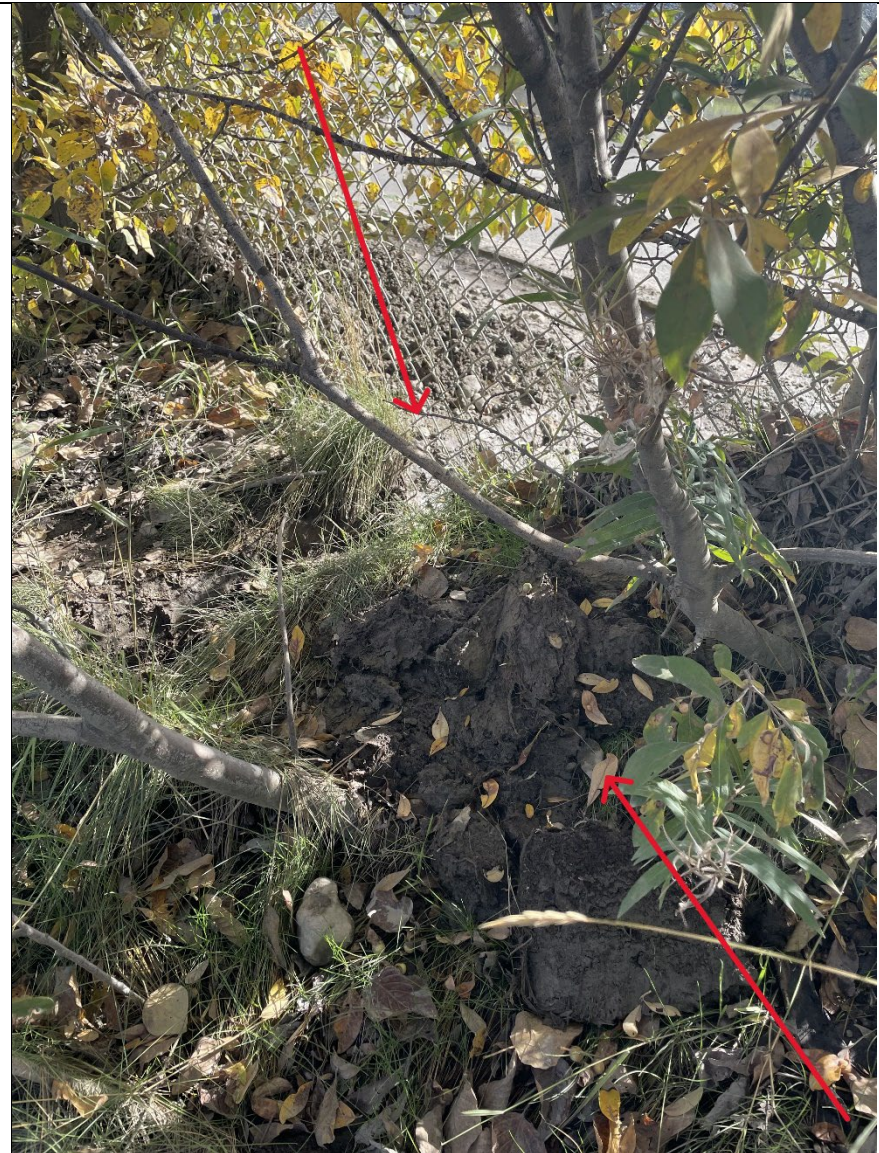
Picture 28: Apparent Removal of Mud from Discharge Location along Northern Facility Road

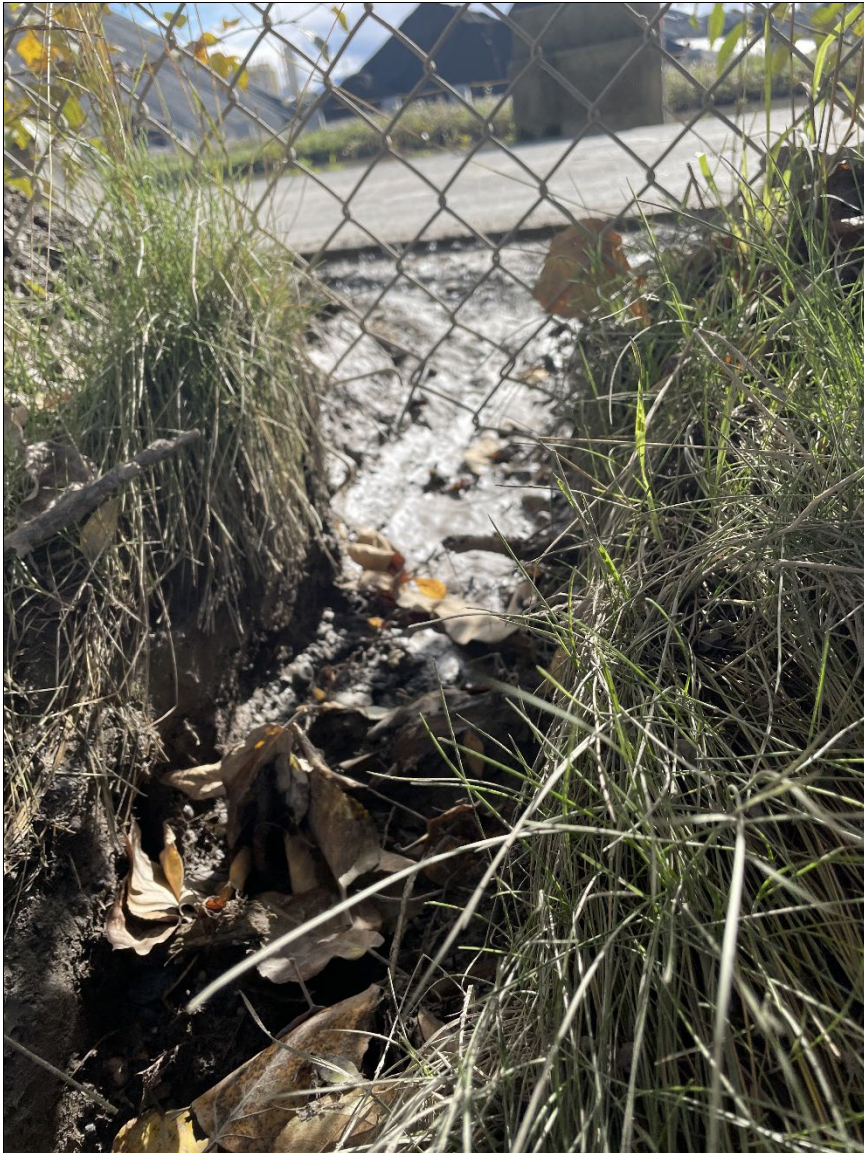
Picture 29: Discharge along Northern Facility Road

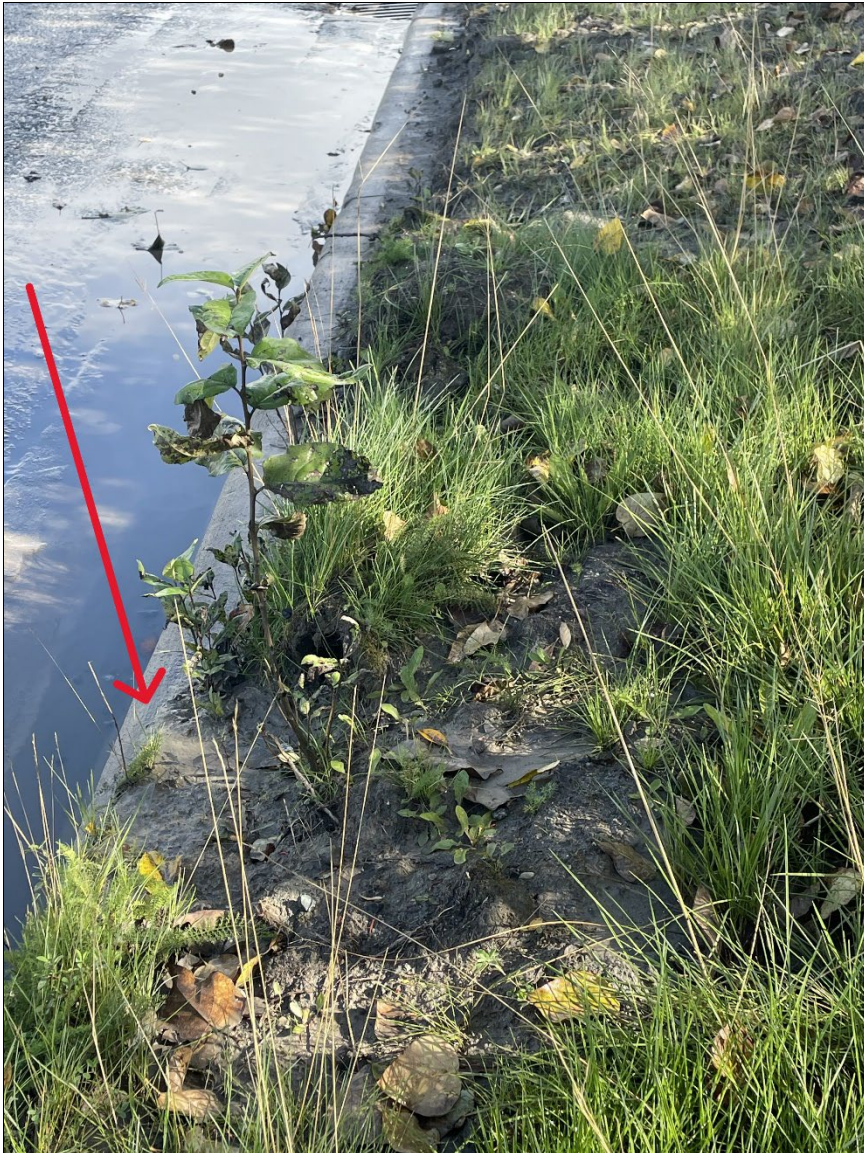
Picture 31: Discharge and Sediment from Northern Facility Road

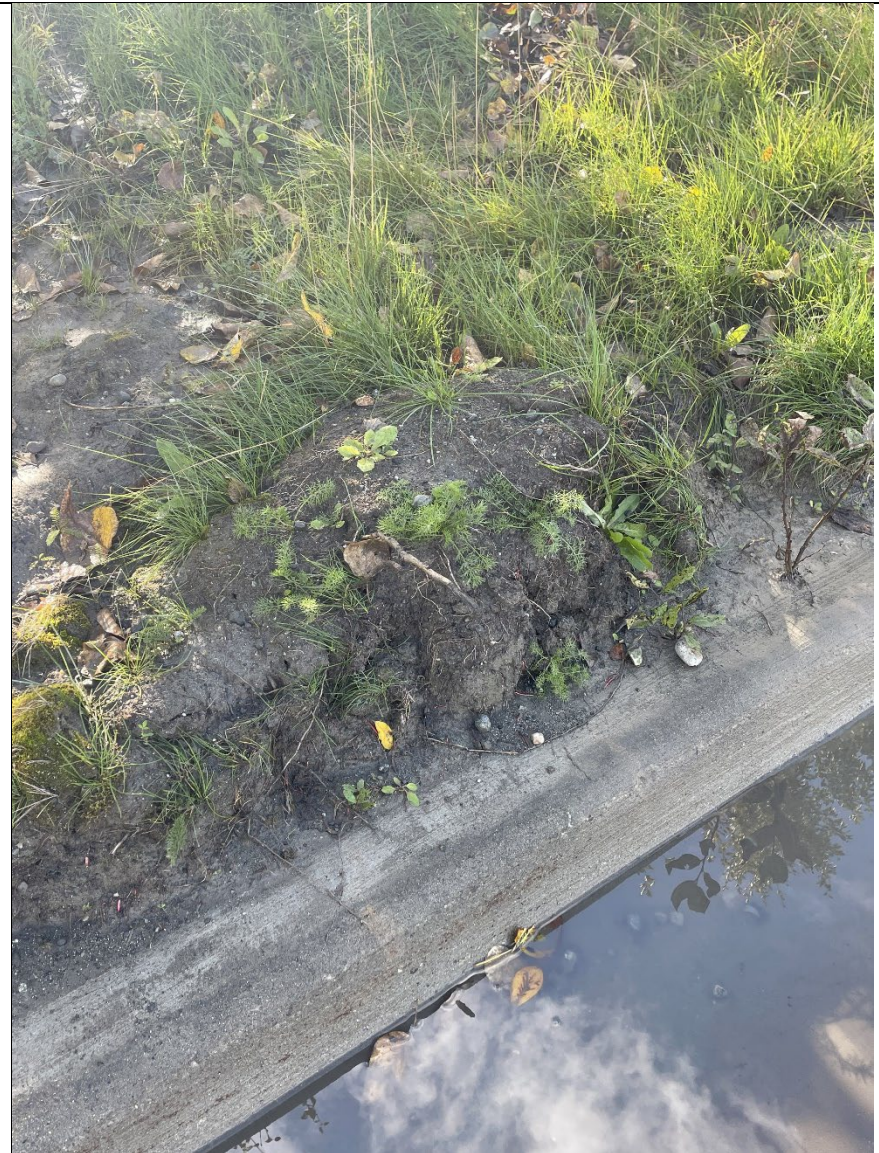
Picture 32: Buildup of Sediment from Discharge along Northern Facility Road

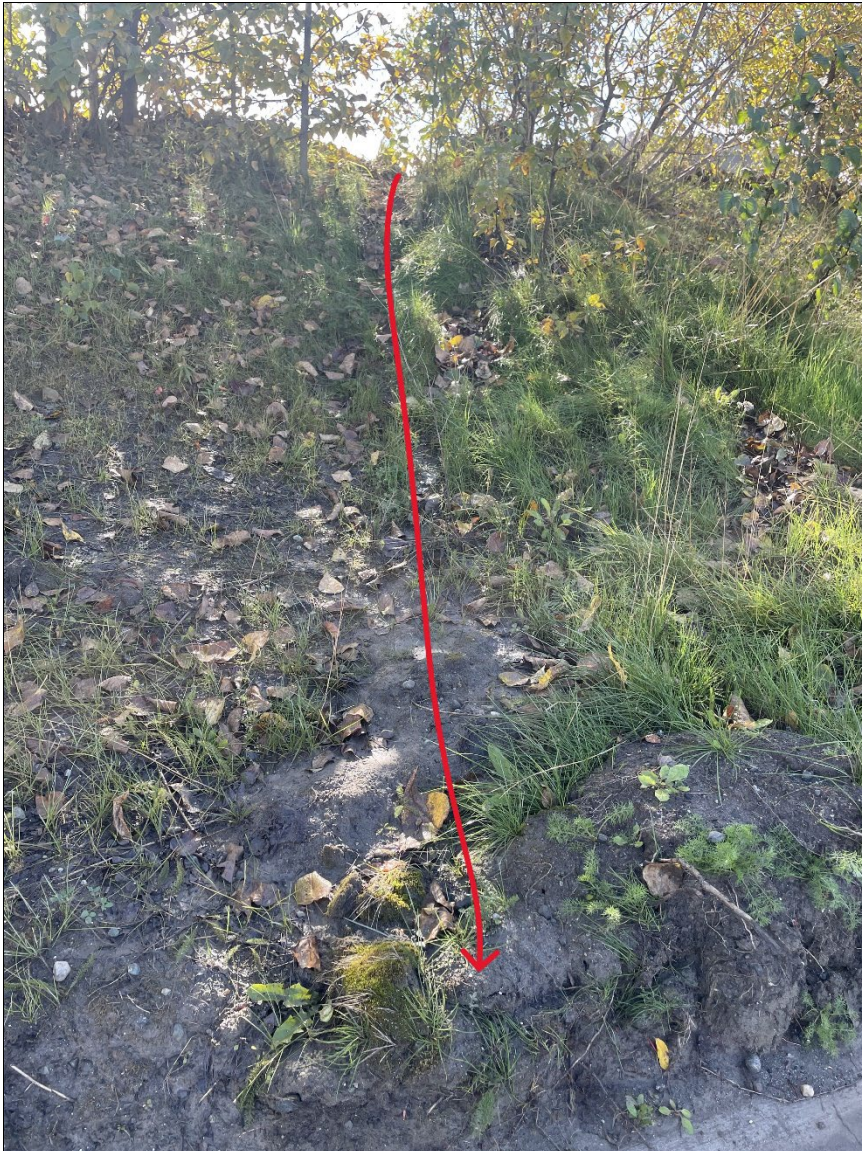
Picture 33: Sediment and Sediment Path from Discharge along Northern Facility Road

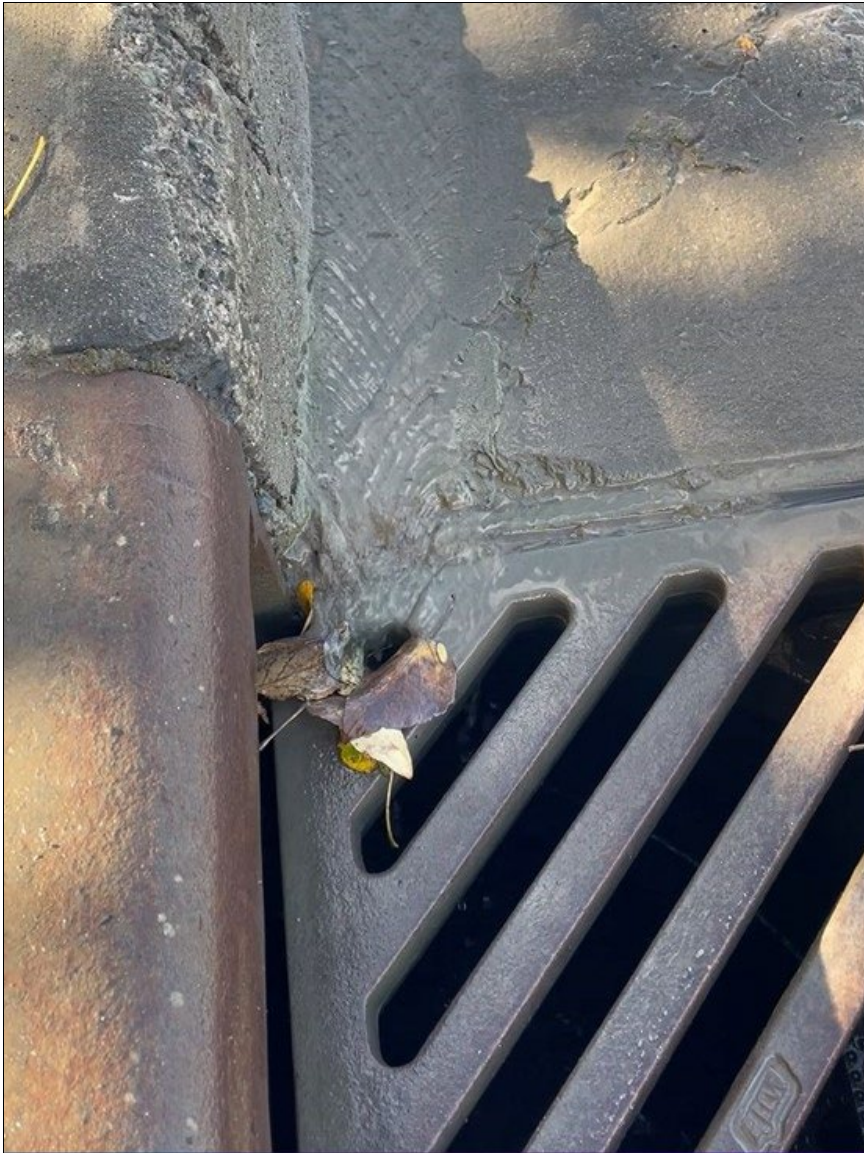
Picture 35: Discharge from AS&G into Storm Drain in Gilman Pkwy.

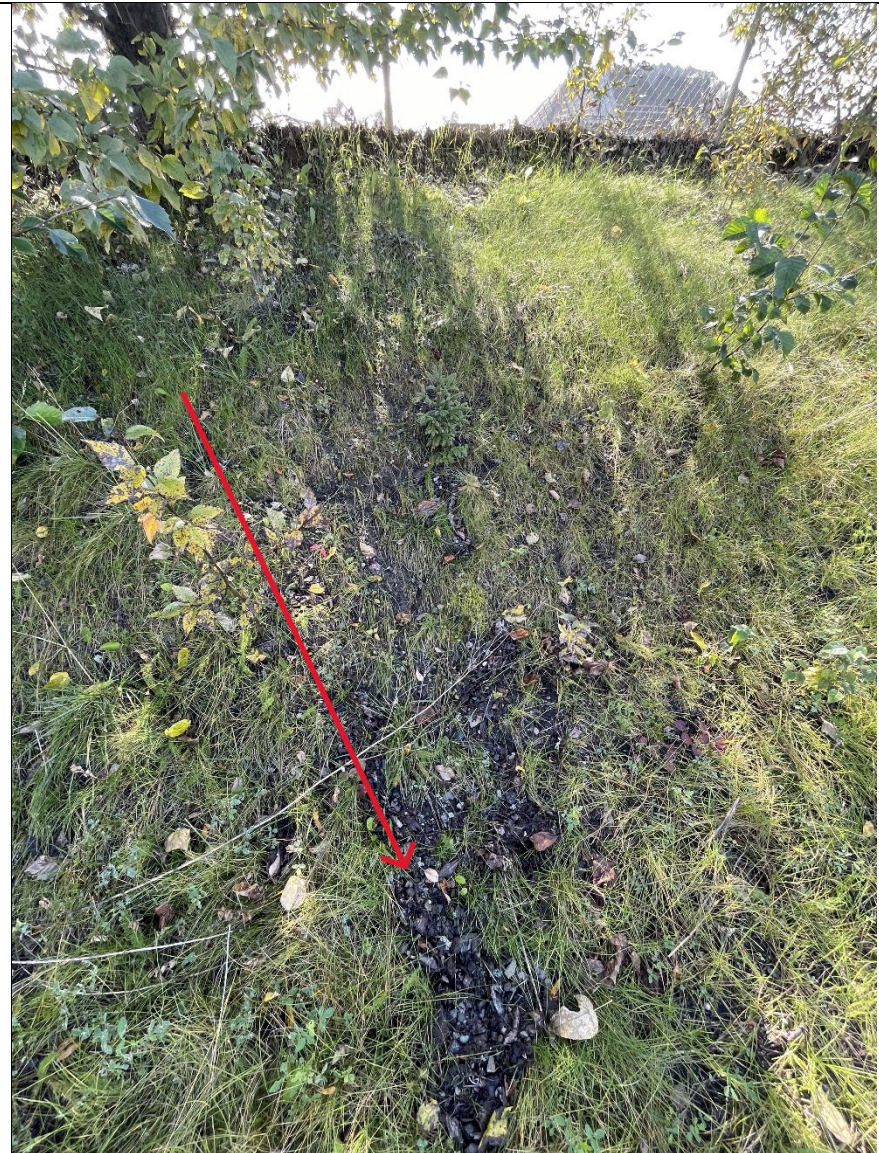
Picture 36: Sediment and Cobble Deposited from the Discharge along Northern Facility Road
