INSPECTION REPORT

| <b>Type of Inspection</b> | Compliance Evaluation Inspection (CEI) | | |
| <b>Permittee Name</b> | Village Of Maxwell | | |
| <b>Permit Number(s) (If Applicable)</b> | NM0029149 | | |

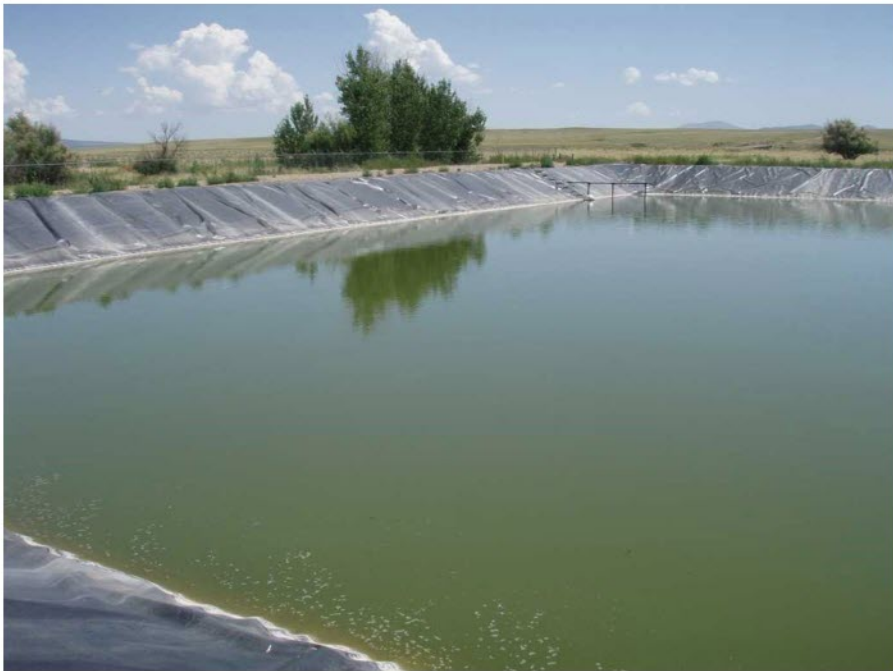
| North Lagoon | | | P1011038.JPG |

| North Lagoon after rehab | | | |

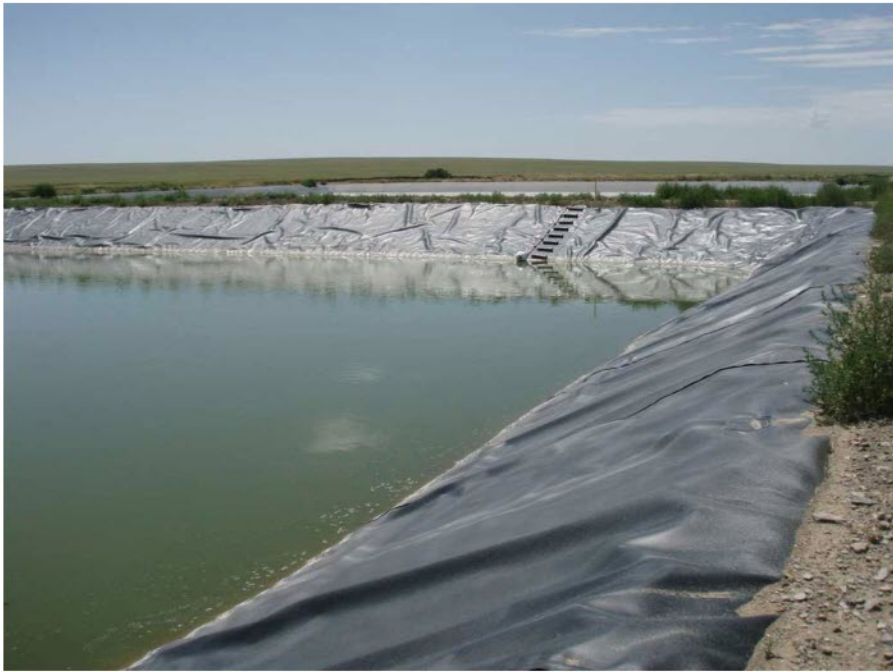
| North Lagoon | | | P1011039.JPG |

| North Lagoon after rehab | | | |

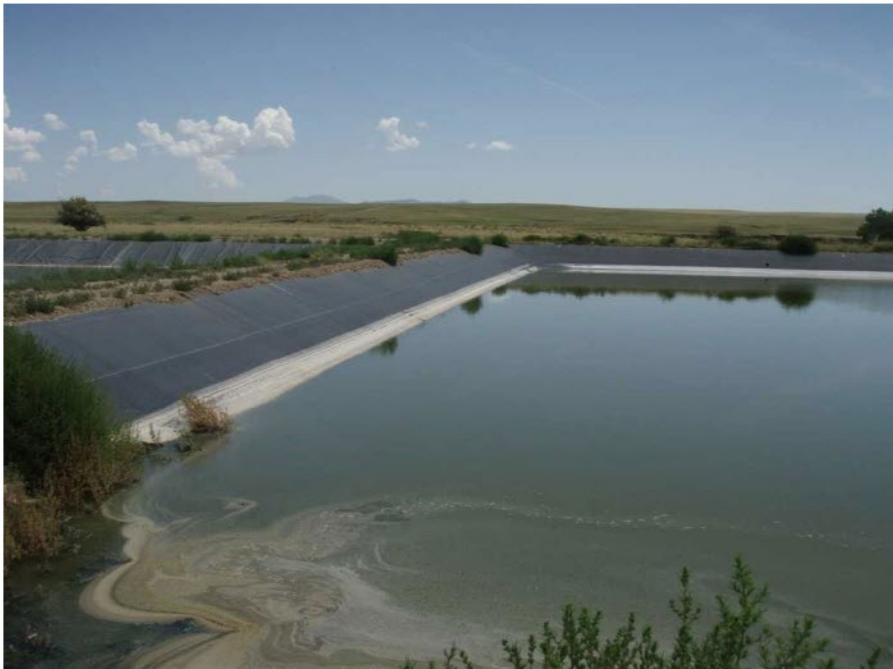
| South Lagoon | | | P1011043.JPG |

| <b>Location/Area/Sub-area</b> | <b>Description</b> |
|---|---|
| South Lagoon | The South Treatment Lagoon is waiting for funding to be cleaned and repaired with new liner. |

| South Lagoon rehab of lagoon had not occurred at the time of this inspection. | | | |

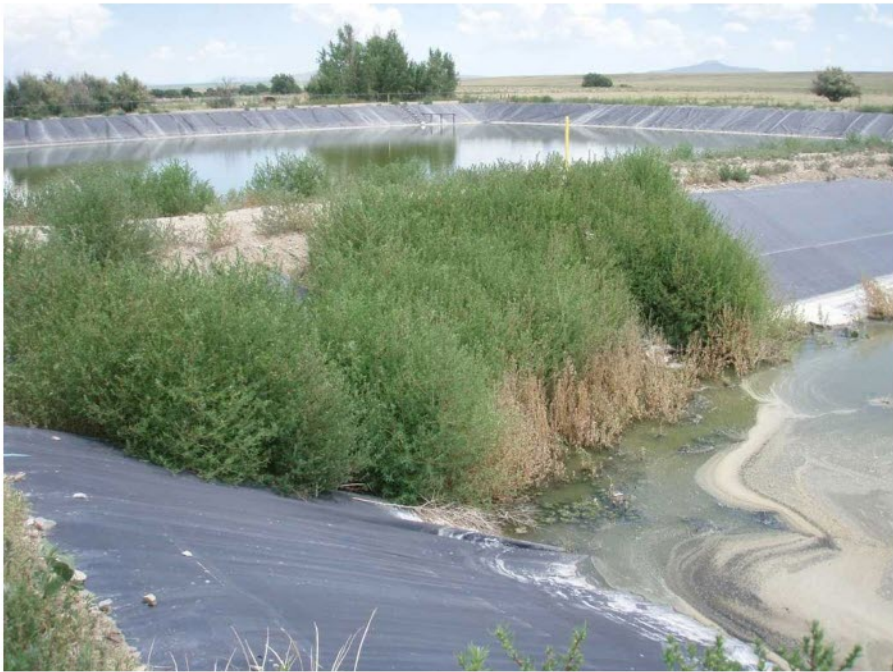
| South Lagoon | | | P1011041.JPG |

| Growth in the berm on South Lagoon where the liner has been blown and torn off. | | | |

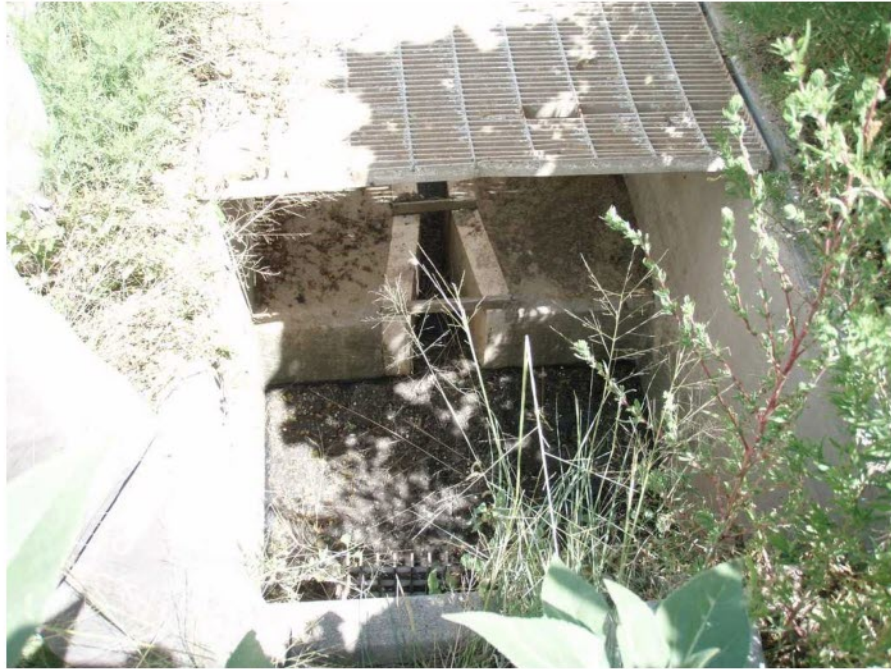
| Lagoon In-Let Weir | | | P1011040.JPG |

| Inlet weir to the lagoon system. From the weir inlet gravity flows to the South Lagoon. | | | |

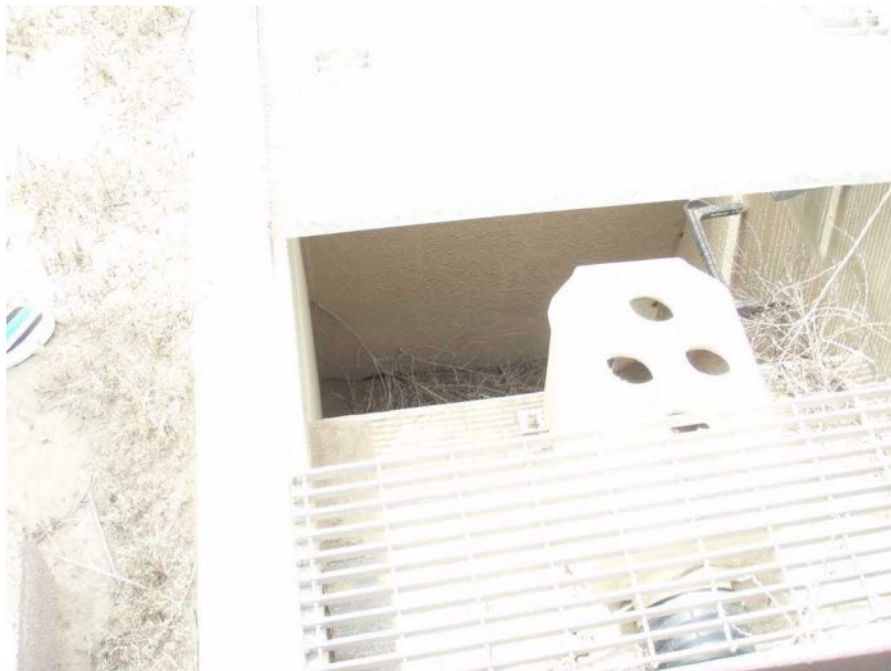
| Discharge Structure | | | P1011048.JPG |

| Discharge structure used for chlorine tables. Discharge has not occurred or appears to have occurred for some time. | | | |

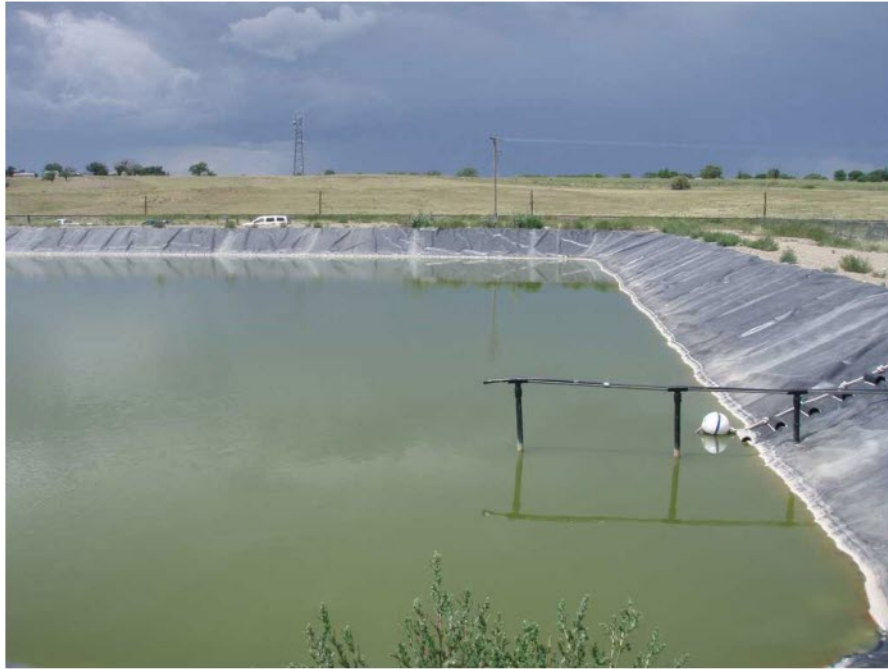
| North Lagoon | | | P1011050.JPG |

| Ground water inlet structure from North Lagoon used to irrigate state permitted groundwater discharge areas. | | | |

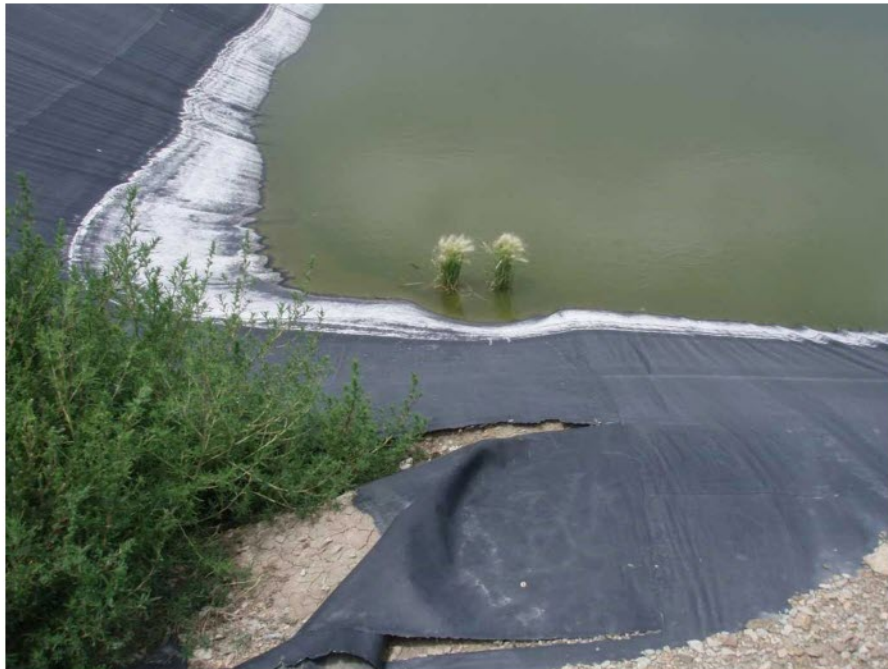
| South Lagoon | | | P1011046.JPG |

| Wind blown tears of liner on the South Lagoon with growth on the berms. | | | |

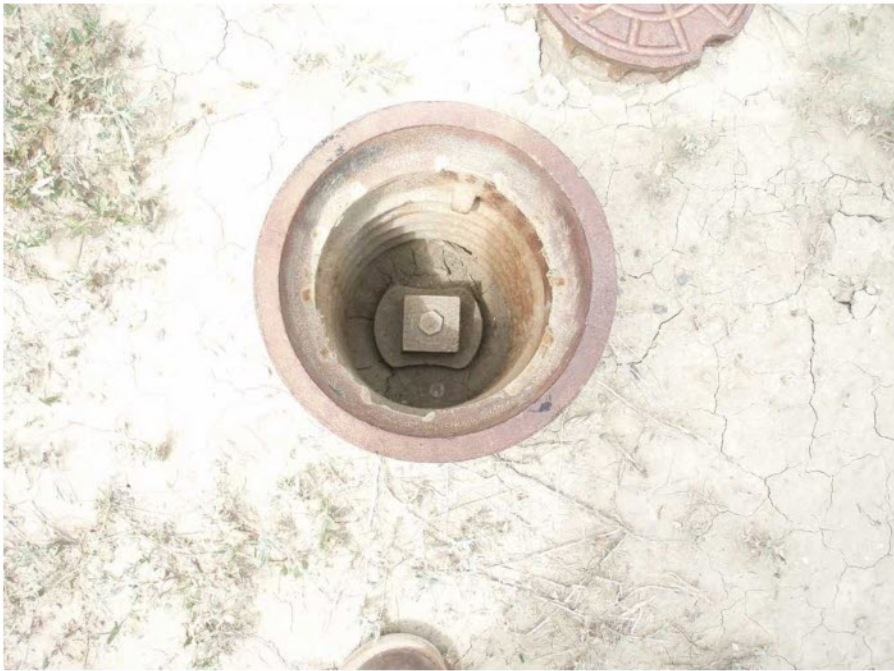
| Discharge Valve | | | P1011049.JPG |

| Discharge valve from the South Lagoon. The valve appears not to have been used in some time. no discharge at the time of the inspection. | | | |

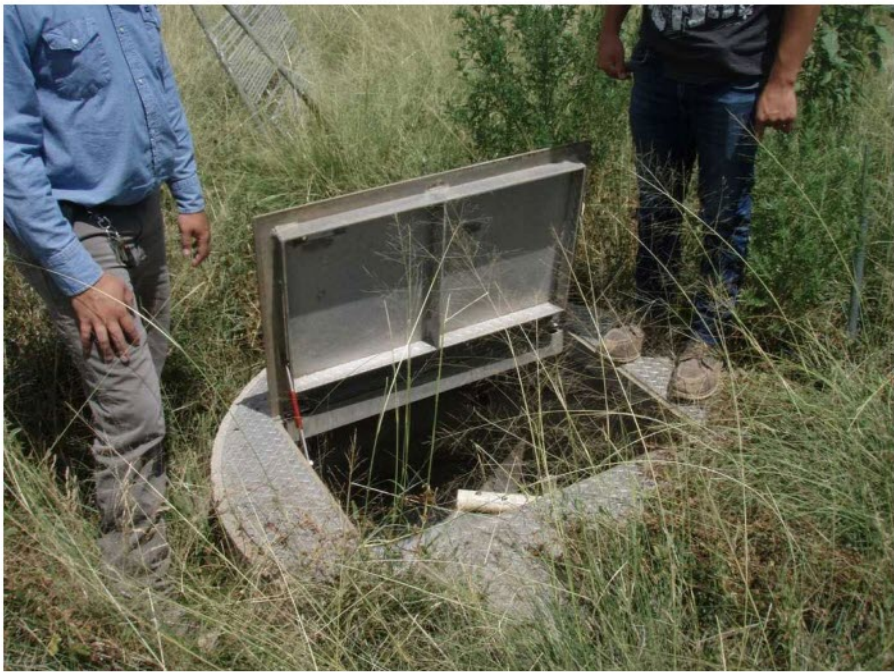
| Lagoon Lift Station | | | P1011051.JPG |

| <b>Location: 3. Treatment System</b> | | |
|---|---|---|
| Lagoons cannot be utilized at full capacity due to gravity flow to the Lagoons. Head pressures from the lagoons creates backflow into the collection system. An old lift station located at the lagoons is in place to correct this problem, but no pumps were observed in the lift station. Backflows into the gravity collection system may also cause sanitary sewer overflows (SSOs) in town, if lagoons are not properly maintained. | | |

| Lift station at the lagoon system that is not in use at the time of the inspection. | | | |

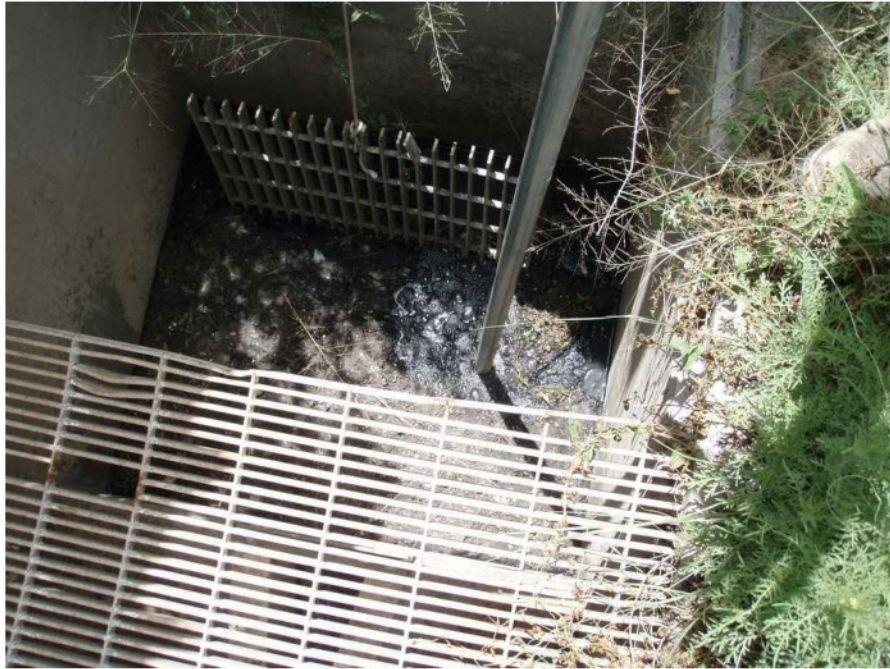
| Lagoon gravity flow inlet | | | P1011053.JPG |

| <b>AOC Reference #: KA1-OB-002</b> | |
|---|--|
| Lagoons cannot be utilized at full capacity due to gravity flow to the Lagoons. Head pressures from the lagoons creates backflow into the collection system. An old lift station located at the lagoons is in place to correct this problem, but no pumps were observed in the lift station. Backflows into the gravity collection system may also cause SSOs in town if lagoons are not properly maintained. | |

| Inlet to the lagoon system with gravity flow. Flow is backing up due to the gravity flow and not being pumped. | | | |

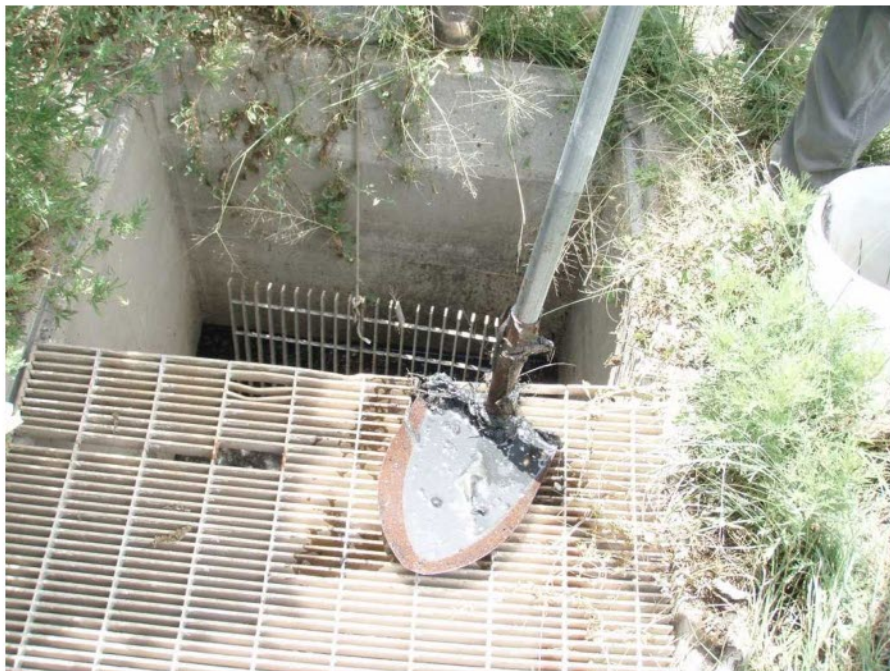
| Inlet gravity flow to Lagoon | | | P1011054.JPG |

| Inlet to the lagoon system with gravity flow. Flow is backing up due to the gravity flow and not being pumped. | | | |
