## Region 6 - Enforcement & Compliance Assurance Division

### INSPECTION REPORT

| Company Name: | <b>Calgary Energy, LLC</b> | |
| Facility Name: | <b>Tidal Osage 1 Lease</b> | |

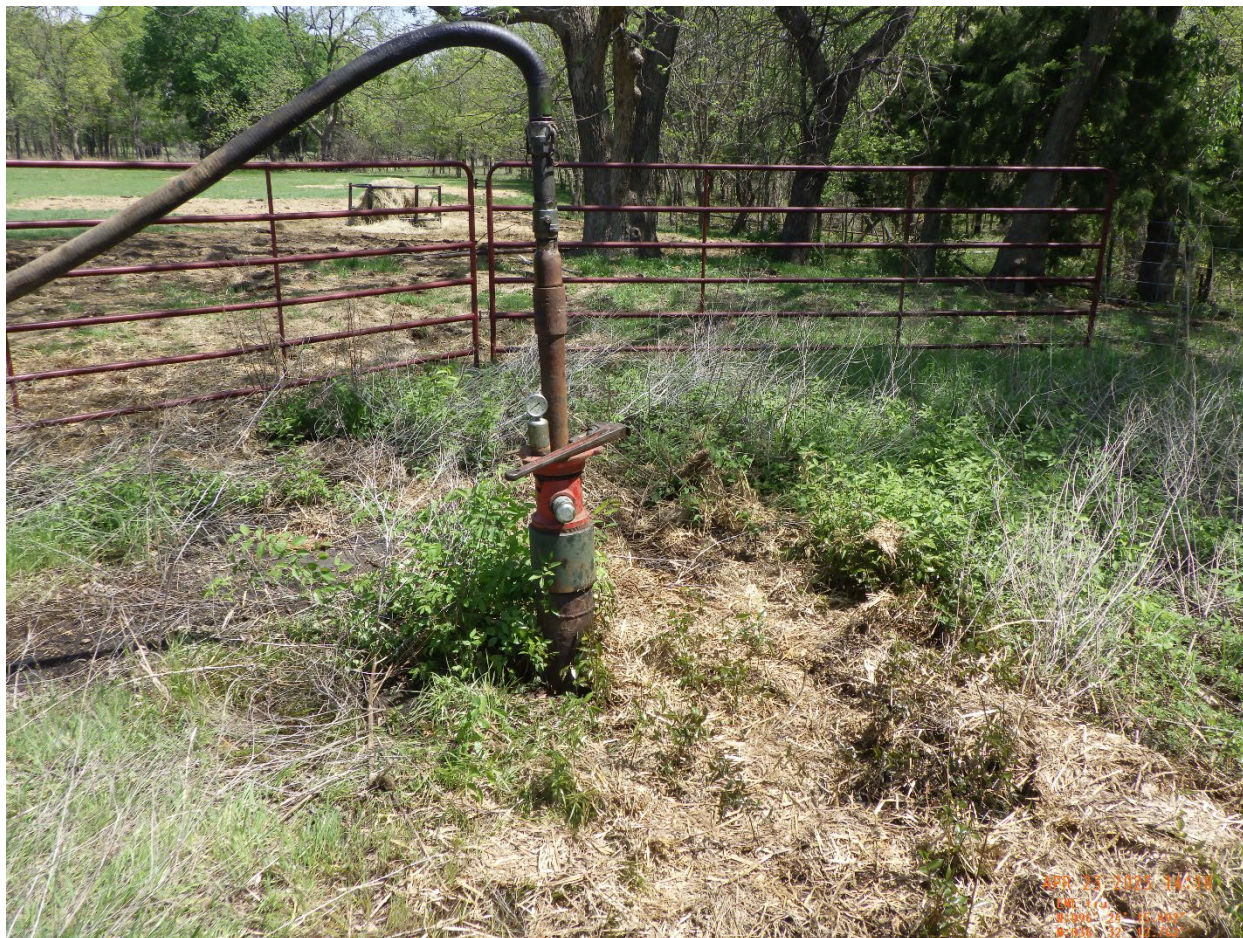
Photo No. 1

I observed the release point for the spill which was the Tidal Osage 1 well 1-2. The well was temporarily abandoned and was not in production at the time of the spill and inspection. This was the second occurrence of the well surfacing oil from a subsurface casing leak. See photo No. 1 and 2. For additional GPS location information and photo metadata, please see Appendix 1 (photo log) attached to this report.

**Description:** This was the source of the spill, Tidal Osage 1 well number 1-2. The well was inactive at the time of the surfacing event.

A permanent solution to the failed well casing should be achieved to prevent additional recurrence of the spill event.

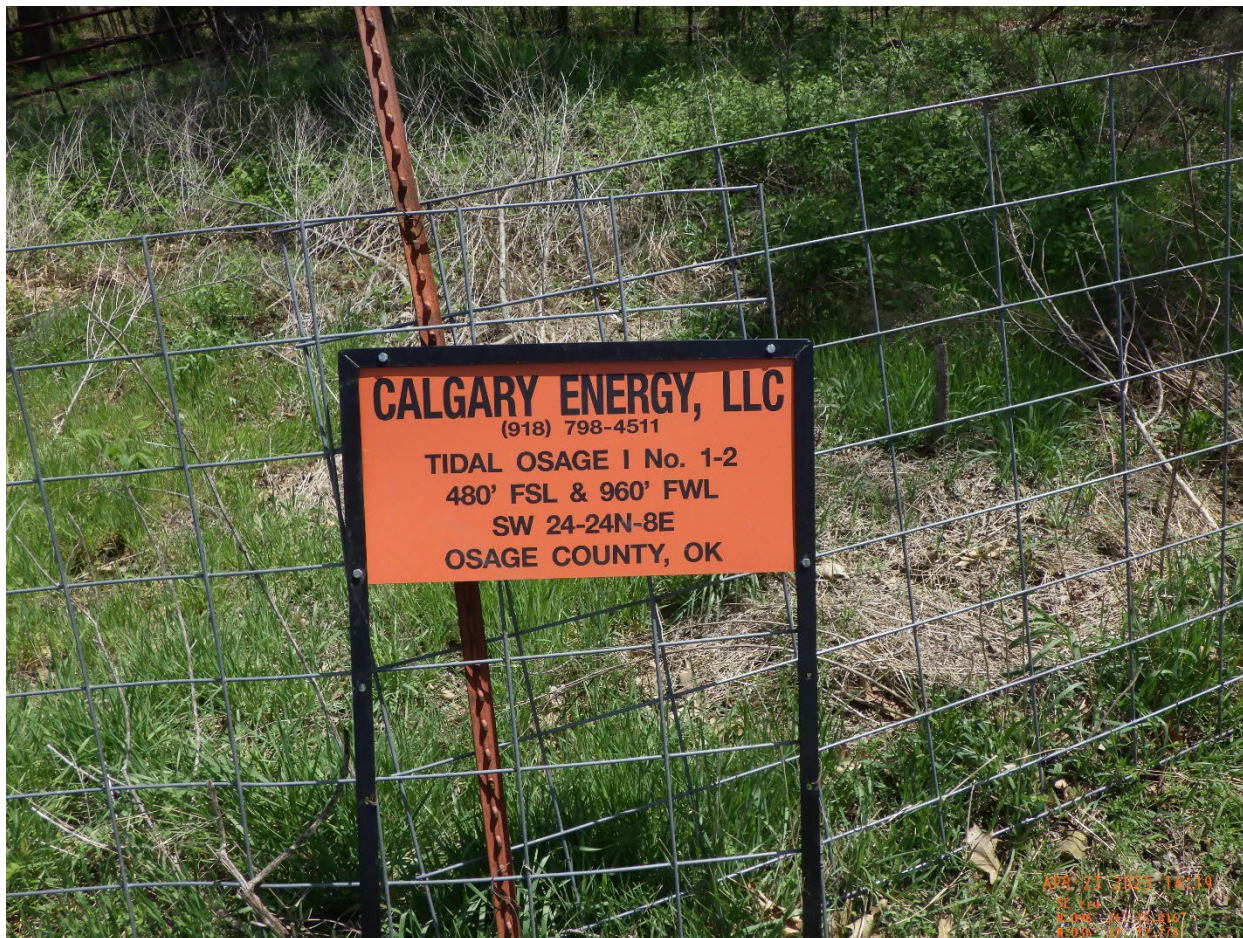
Photo No. 2

**Description:** This was the well sign for well 1-2.

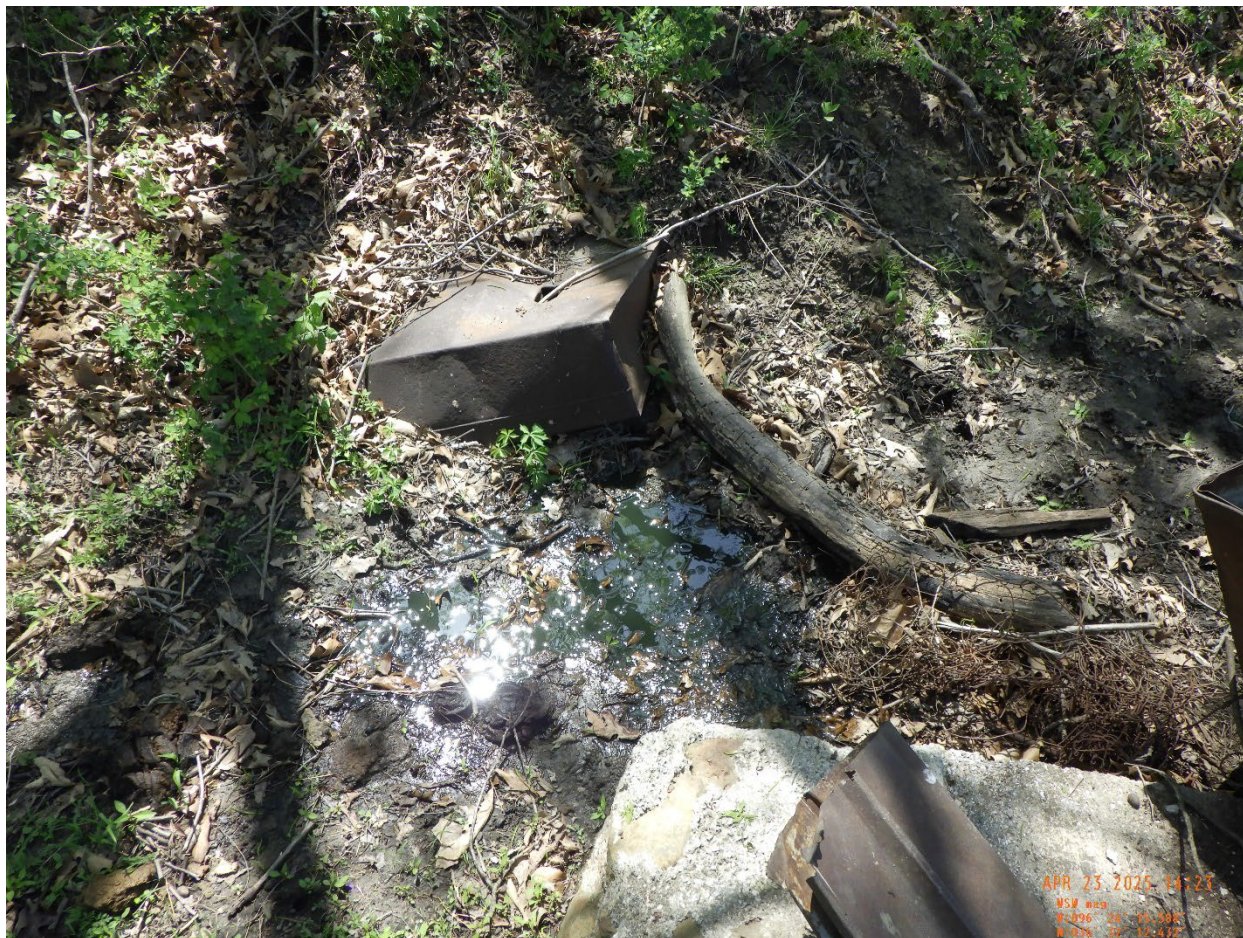
Photo No. 3

I observed a pool of oil off the west edge of the well location along the flowpath of the spill. See photo No. 3.

**Description:** This was a pool of oil located off the west side of the well location along the flowpath.

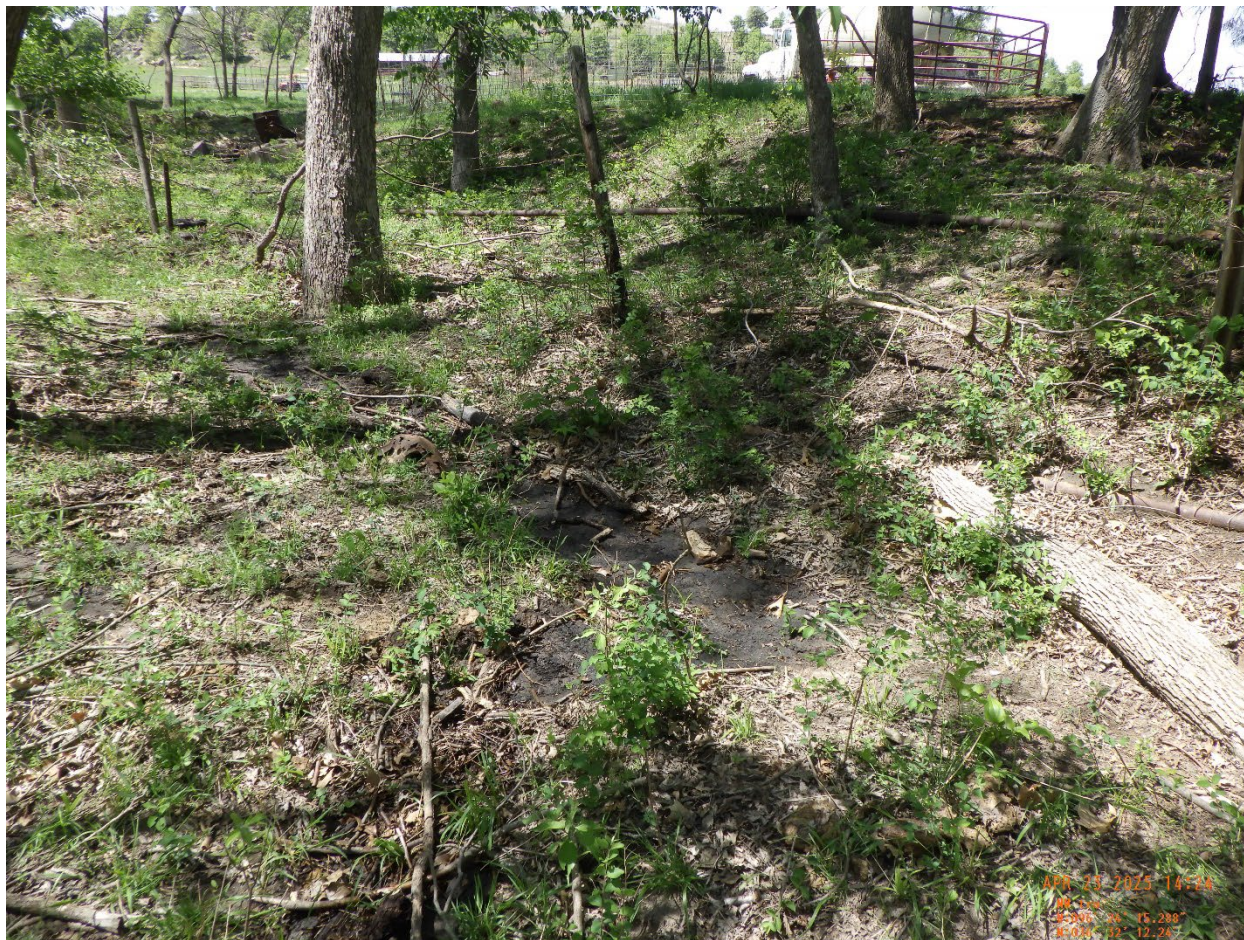
Photo No. 4

I observed the flowpath of the spill from the point of entry (POE) into the unnamed tributary of Little Hominy Creek back toward the release point. The flowpath varied between 1 foot and 15 foot in width. See photo No. 4.

**Description:** This was a view of the flowpath from the point of entry (POE) into the unnamed tributary of Little Hominy Creek back to the release point.

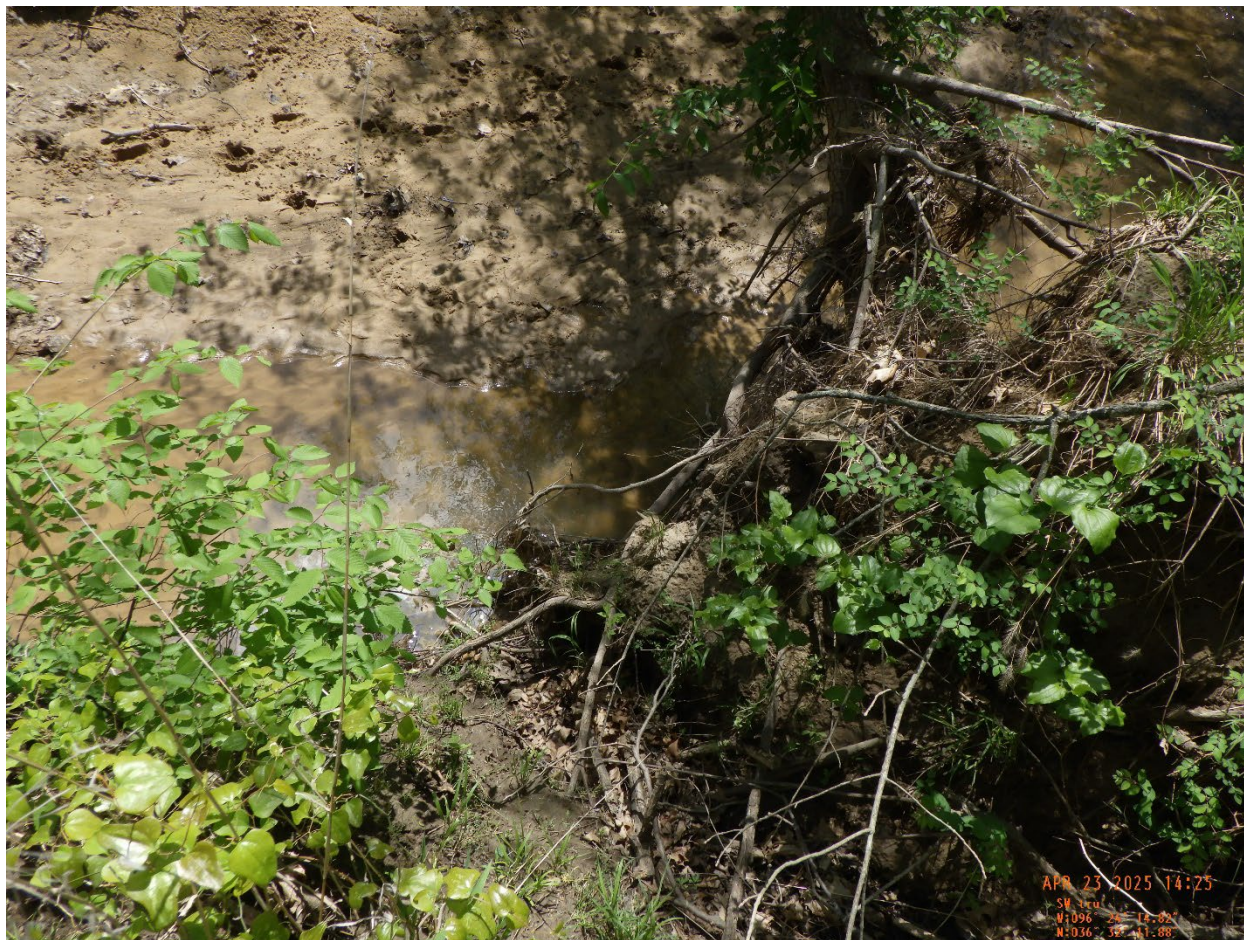
Photo No. 5

I observed the POE into the unnamed tributary of Little Hominy Creek. At the time of the inspection there was no active flow of oil into the tributary. See photo No. 5.

**Description:** This was the POE into the unnamed tributary of Little Hominy Creek.

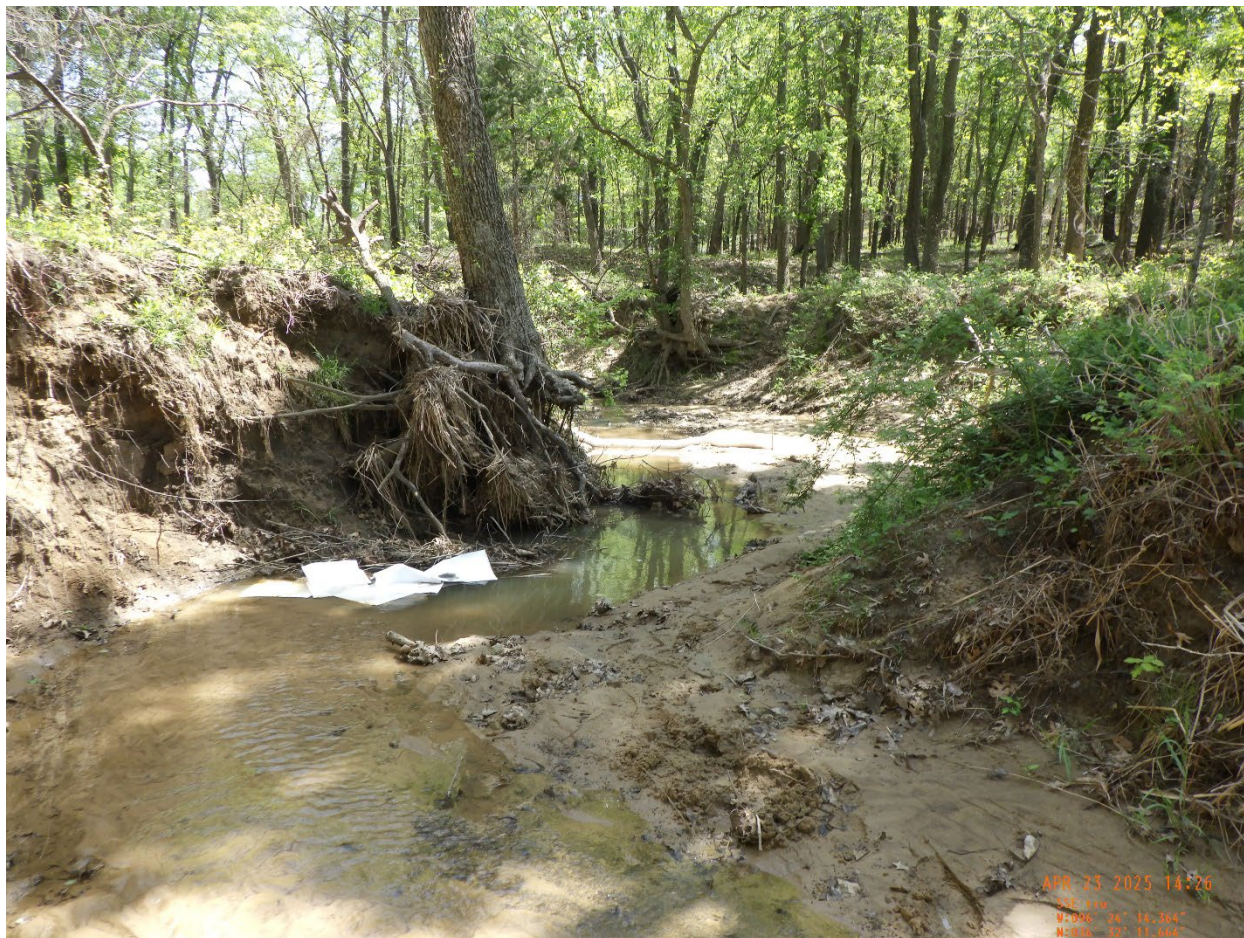
Photo No. 6

Downstream from the POE, I observed floating oil, absorbent pads and an oil absorbent boom which had been placed to prevent downstream migration of oil. See photos No. 6-8.

**Description:** This was a photo of oil absorbent pads and a floating oil absorbent boom which had been placed by the operator to contain oil and prevent further downstream migration.

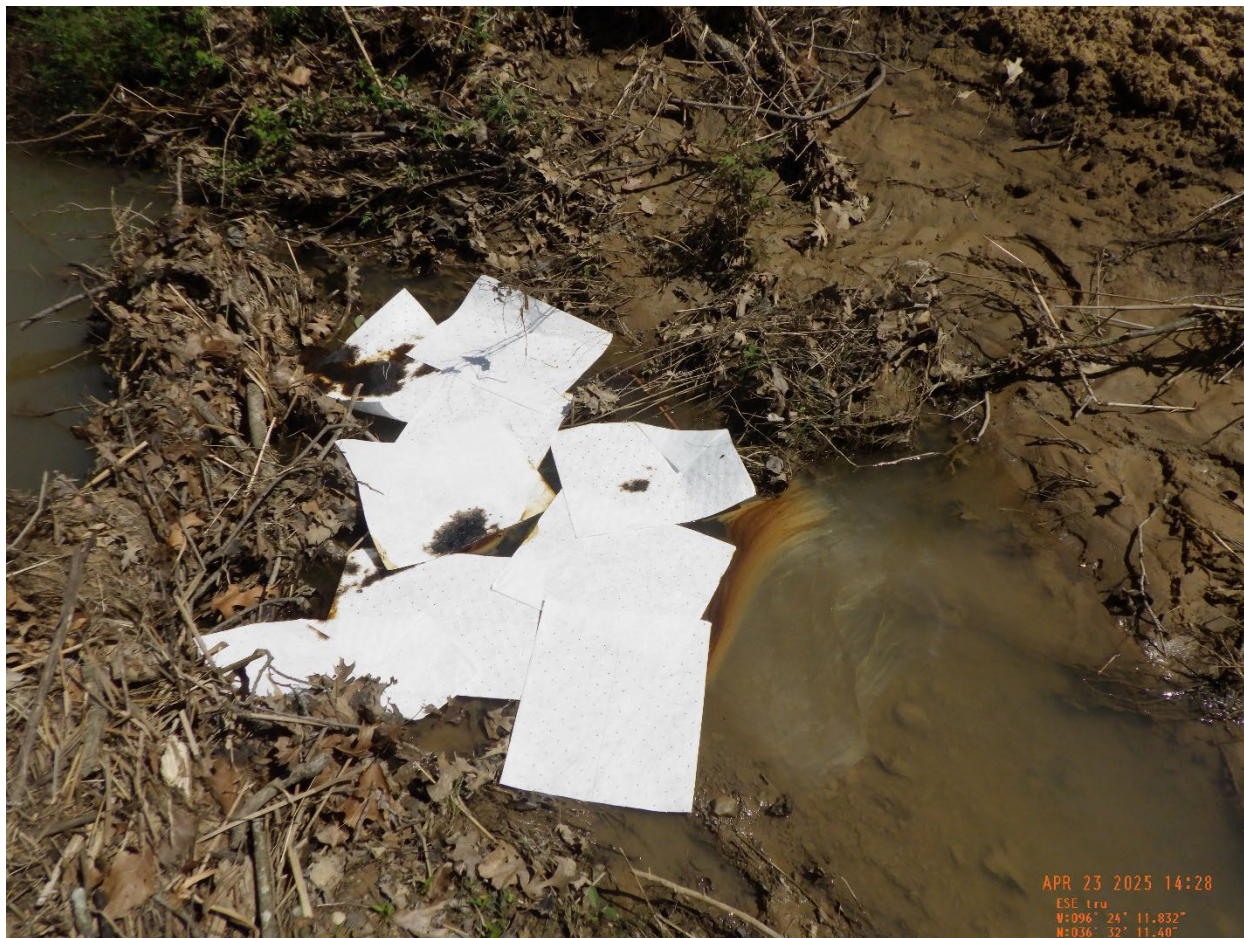
Photo No. 7

**Description:** This was oil and oil absorbent pads observed along the impacted tributary of Little Hominy Creek.

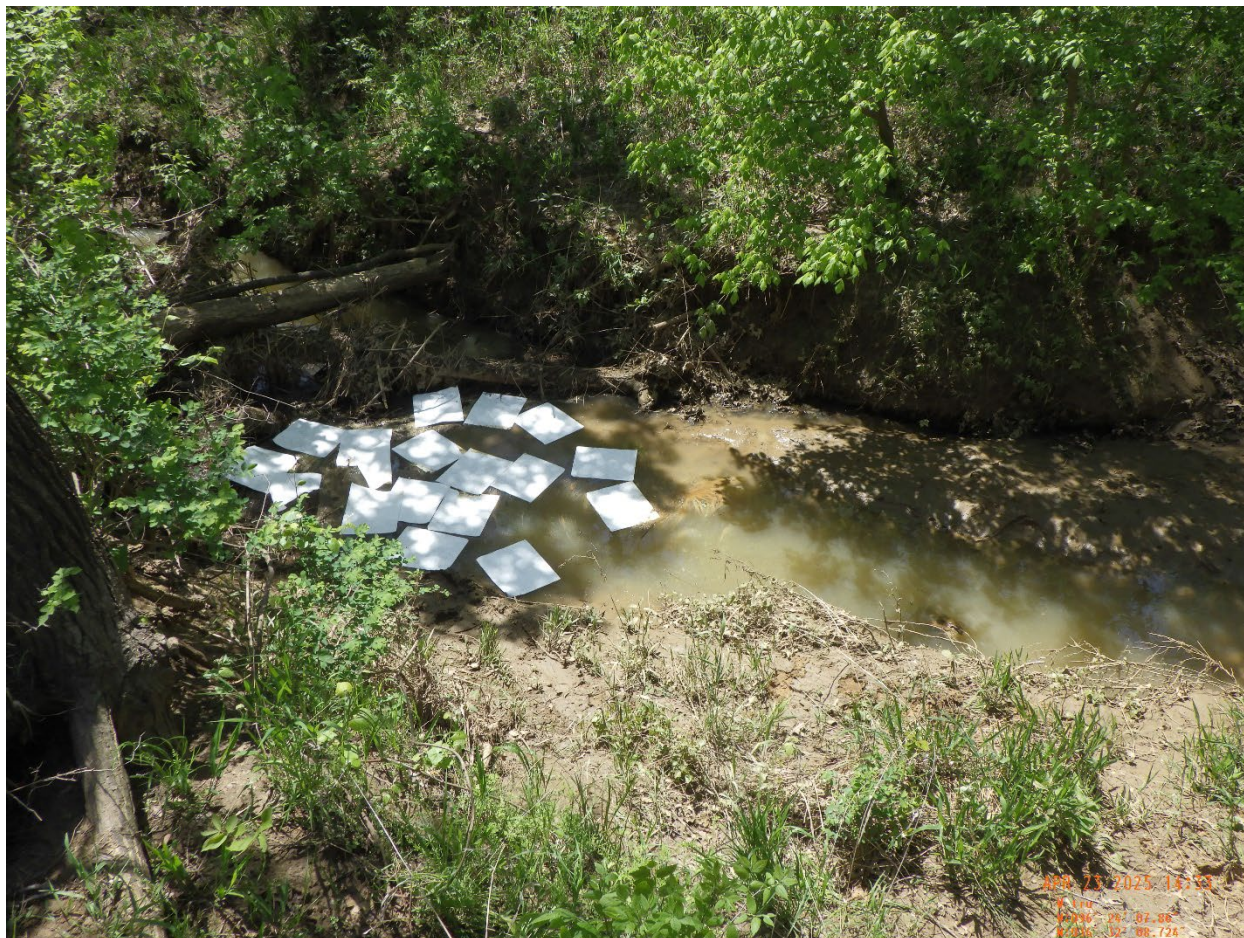
Photo No. 8

**Description:** A photo of oil absorbent pads on the surface of the impacted tributary.

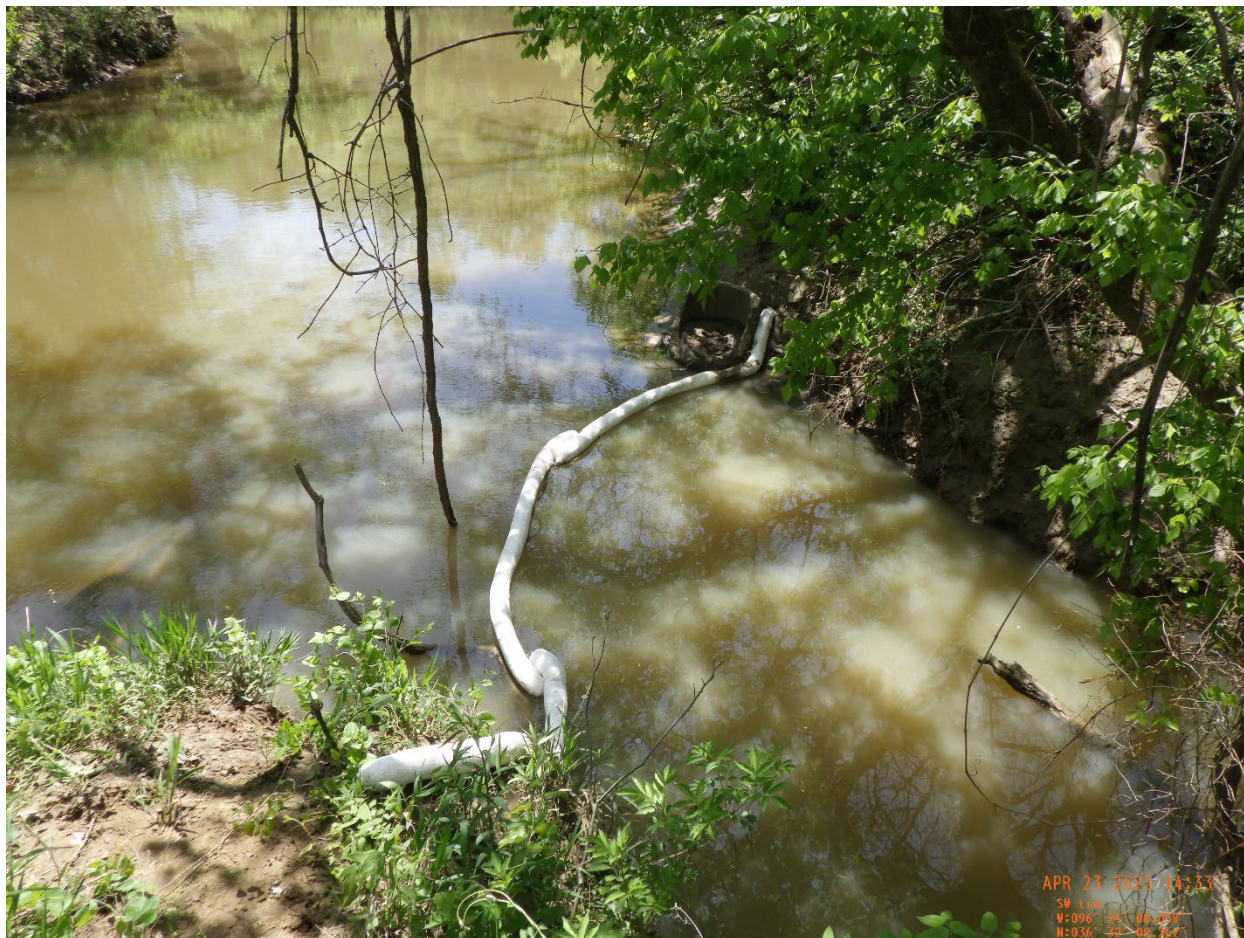
Photo No. 9

I observed the confluence of the impacted tributary and Little Hominy Creek. At the time of the inspection, oil had not reach Little Hominy Creek. See photo No. 9.

**Description:** This was an oil absorbent boom placed to prevent downstream migration into Little Hominy Creek. At the time of the inspection, no oil was present at the boom.
