Happy Import Auto Salvage  
Industrial User Inspection Report  
May 19, 2021

## U.S. Environmental Protection Agency Region 5

**Purpose:** Industrial Stormwater Inspection

**Facility:** Happy Import Auto Salvage, INRM00795  
305 South Tibbs Avenue  
Indianapolis, Indiana 46261 (317) 484-9780

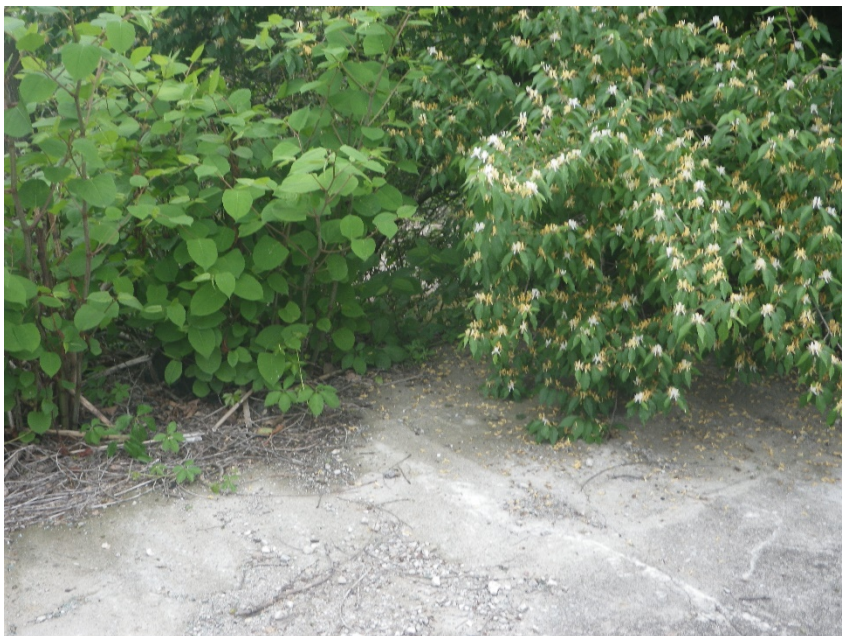
IMGP0013

A primary focus of the inspection team was to locate Outfall 001 as described in the NOI and SWPPP BMP layout. The inspection team investigated the heavily vegetated and very steep embankment for a discrete pipe thought to be Outfall 001. Several low areas on the East embankment of Eagle Creek appeared to contain broken pipes. Upon investigation, some of these locations were comprised of old vehicle wheel cowlings and automotive parts integrated into the embankment soil matrix. Mr. Browder did not think that a unique discharge pipe designated as Outfall 001 existed to Eagle Creek (Photo #13) as there are no storm sewers or storm inlets within the salvage area.

Description: Eagle Creek looking down heavily vegetated steep embankment.

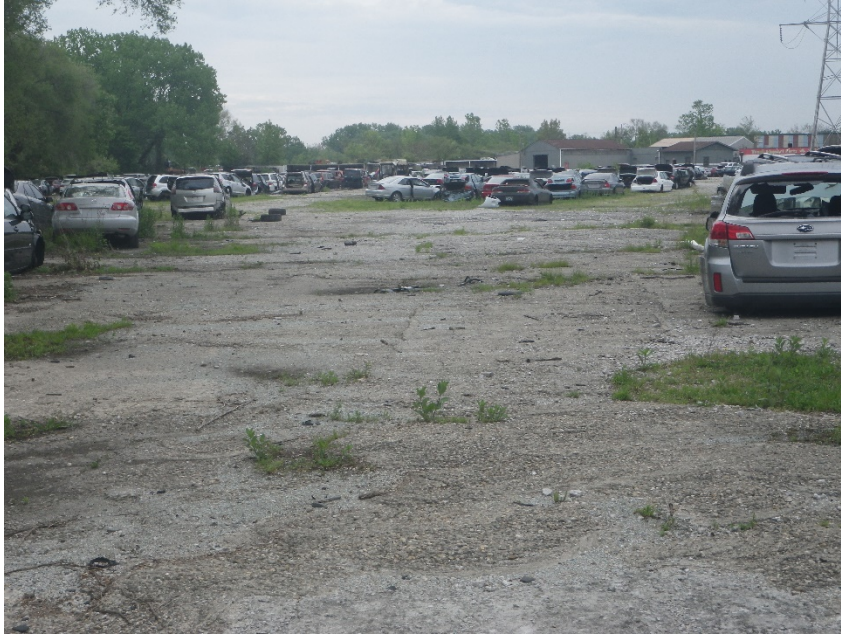
IMGP0014

Working our inspection activities south along the Eagle Creek embankment located east of the salvage yard, the team discovered numerous areas of potential storm water runoff location to Eagle Creek from the salvage yard (Photo #14). These areas contained accumulated vegetation and debris on the low side of the concrete sloped toward Eagle Creek at the embankment.

- At several areas along the embankment, EPA observed concrete sloped toward Eagle Creek indicating that stormwater flow from the facility could flow by gravity to Eagle

Creek. Holes observed in the embankment indicated that the embankment may not be sufficiently stabilized to prevent point source discharges.

Description: The concrete in this area was sloped toward Eagle Creek.

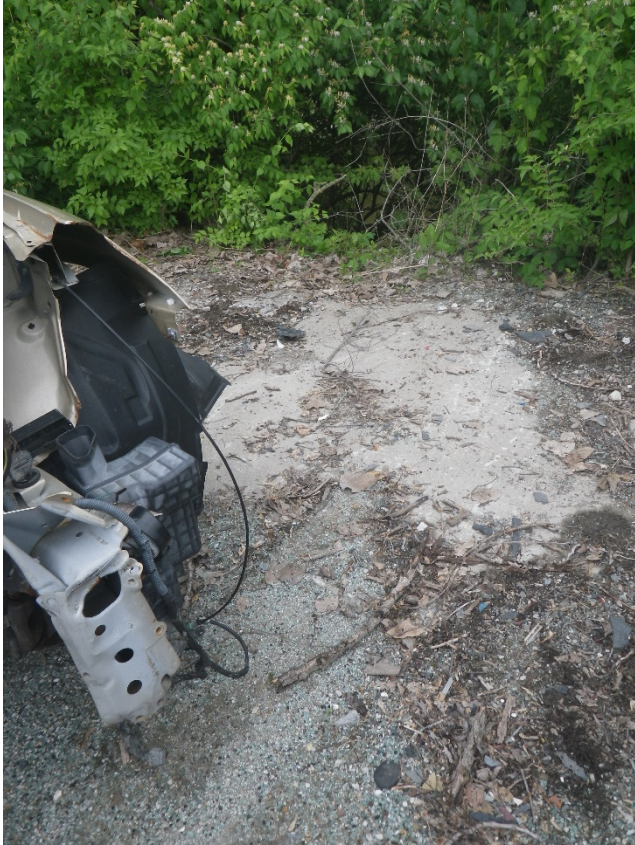
IMGP0020

We proceeded to continue to walk south through the salvage yard and then toward the embankment and discovered another runoff path toward Eagle Creek with an aperture to Eagle

Creek (Photo #20). It was unable to be determined if this aperture contained a pipe or rip rap debris as the end was obstructed with rip rap materials.

Description: Concrete in this area slopes downhill toward Eagle Creek with leaves and debris.  
Top of rounded concrete object observed which was full of debris.

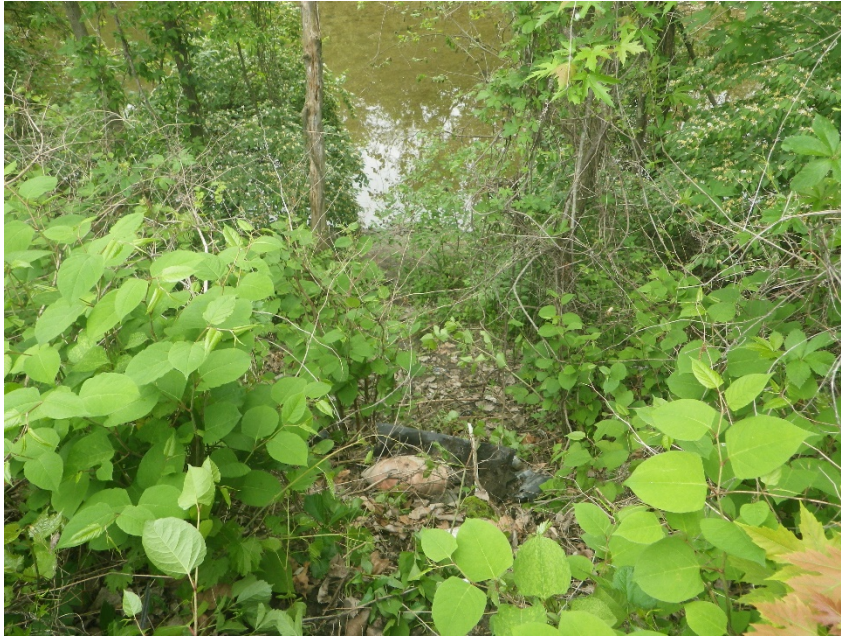
IMGP0021

As we continued south along the embankment, the team located another stormwater runoff path to Eagle Creek (Photo #21).

Description: Concrete in this area slopes downhill toward Eagle Creek.

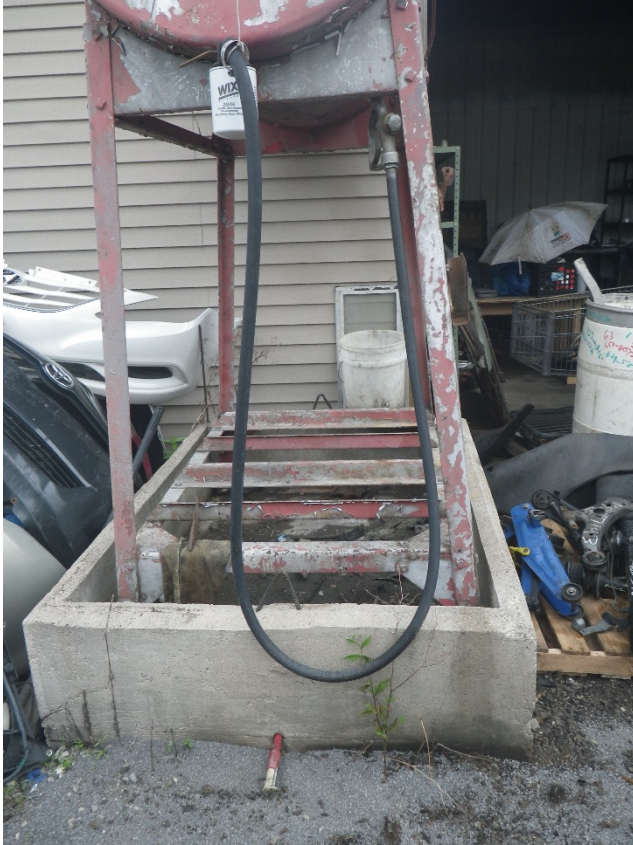
IMGP0024

After inspecting the vehicle storage area and the embankment located west of Eagle Creek, the inspection team observed covered storage of transmission and engines that were drained of fluids (Photo #23). The team then inspected the shop area and found the 300-gallon diesel fuel storage tank which had a concrete secondary containment structure located below. This tank was adjacent to a white 55-gallon drum that served as a secondary containment structure for collected antifreeze. The secondary containment structure appeared to be inadequate for the 300-gallon diesel fuel tank and was found to have a drain plug attachment that was not secured to the concrete structure (Photo #24 & #25).

Description: Diesel fuel storage tank and antifreeze storage tank in white secondary drum.
