# ECHLIN *Ignition* SERVICE BULLETIN

THE ECHLIN MANUFACTURING COMPANY

FEBRUARY 1977

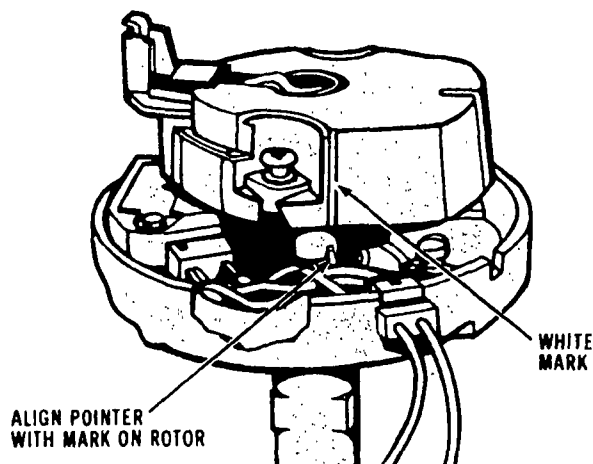
Next, look at the rotor. You will notice that it has a white mark down the left side which should be lined up with a pointer located on the inside base of the distributor. If not, loosen the distributor and adjust until the pointer is in line with the white mark on the rotor. (See Illustration)

Retighten the distributor bolt. This is the final distributor position and the distributor should not be moved or changed when setting the timing.

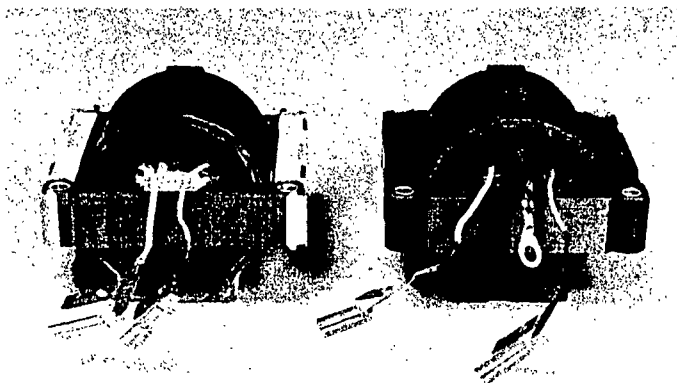
Upon replacing the ignition coil in an eight cylinder General Motors vehicle equipped with the High Energy Ignition System, it is sometimes required to replace an ignition coil with two wires with an ignition coil with three wires attached.

A considerable amount of confusion has been generated in the field as some mechanics, upon their first installation, were unsure of where the extra black wire should be attached.

Because of the improvements between the two wire and three wire coil, it is now necessary to provide a "ground" when installing the newer three wire coil. The black ground wire should be attached to a coil mounting bolt closest to the black grounding wires exit from the coil. The other two wires are attached to the distributor cap connection housing in the same location that the original wires were attached.
