**Region 6 - Enforcement & Compliance Assurance Division**  
**INSPECTION REPORT**

| Regulatory Program(s) | Clean Air Act Section 112(r) and 40 Code of Federal Regulations (C.F.R.) Part 68<br>Chemical Accident Prevention Provisions – Risk Management Program (RMP) | |
| Company Name: | <b>Eagle US 2 LLC</b> | |
| Facility Name: | <b>Eagle US 2 LLC, Lake Charles Plant</b> | |

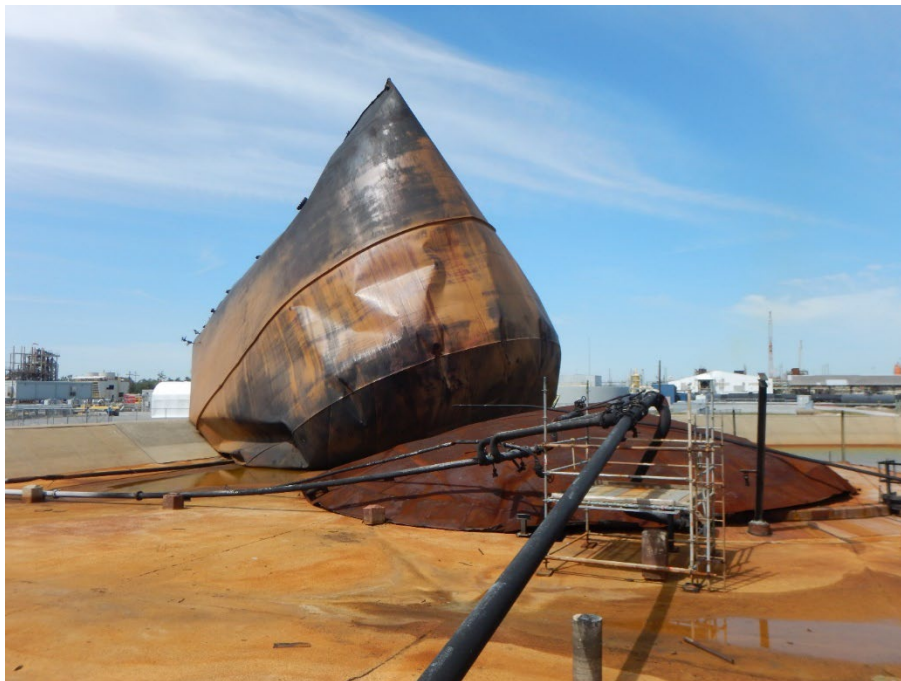
Westlake failed to conduct an adequate external inspections of tank T-3 on February 16, 2017, and on February 23, 2021, in accordance with API 653, as the inspection was limited to areas adjacent to the fixed platform walkway and proper access to the roof was not provided. The report for the API 653 External Inspection on February 16, 2017, indicated that the “roof was inspected from the walkway, and there was blistering, and severe corrosion on several welds, and some buckling in the roof plates. Provisions for better roof access would need to be made for further roof inspection.” A recommendation was made to “build scaffold or other means for access to all areas of the roof externally for full visual inspection.”

Westlake failed to ensure that the frequency of inspections and tests of the tank T-3 level transmitter was consistent with the applicable manufacturer recommendations or good engineering practices. There was no documentation to demonstrate that preventative maintenance, inspection and testing was performed on the T-3 level transmitter since 2018, and no records of engineering or historical analysis to support modifying the inspection and testing schedule for the level transmitter.

Photo taken on April 19, 2022, at 9:22 AM Central Standard Time.  
Location/direction: Eagle US 2 LLC, Lake Charles, LA Plant, Facing Southwest  
Photo subject: EDC Unit; T-3 tank
