# **REPORT OF CONCENTRATED ANIMAL FEEDING OPERATION INSPECTION**

Neosho Valley Feeders, LLC  
26059 Victory Road  
Parsons, Kansas 67357  
620-423-5418  
NPDES Permit # KS0041726

April 9, 2024

U.S. ENVIRONMENTAL PROTECTION AGENCY  
Region 7  
Enforcement and Compliance Assurance Division

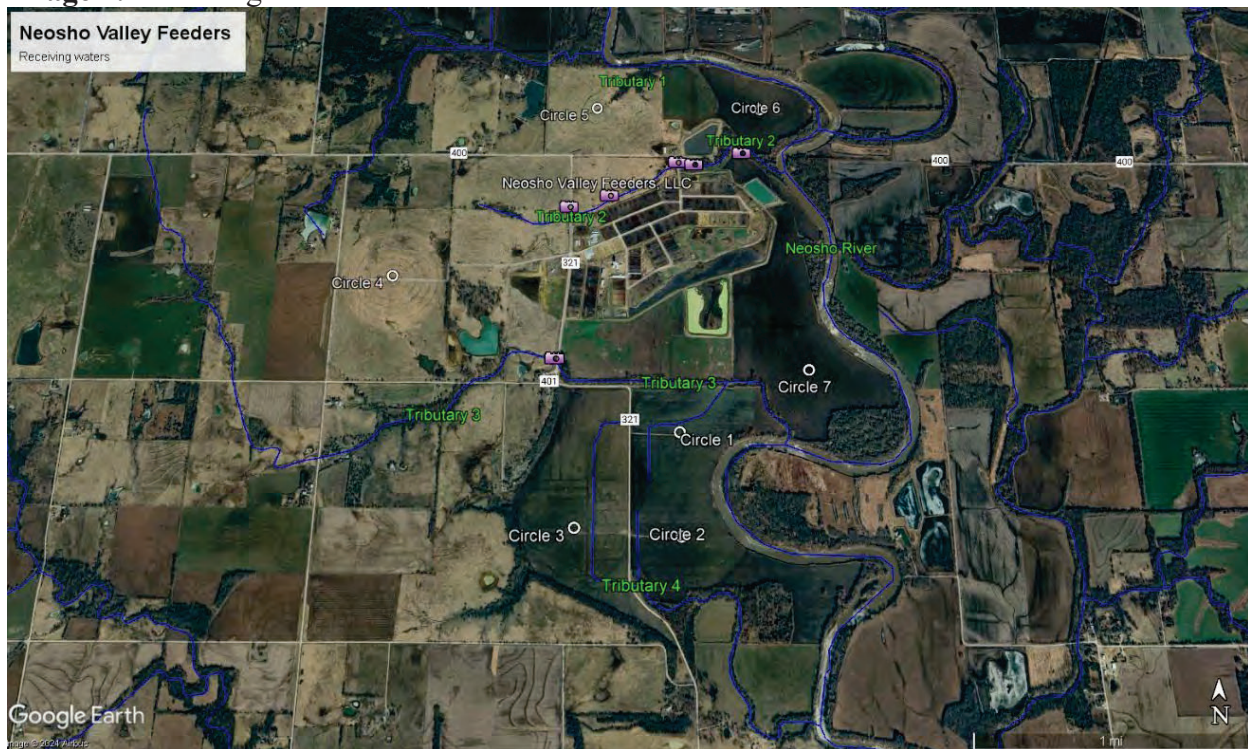
**Image 1. Receiving Waters**

**Receiving Water.** The Neosho Valley Feeders LLC facility is located in the Halfmoon Lake-Neosho River Watershed (HUC 110702050202). The Neosho River and several unnamed tributaries receive clean diverted flow and uncontrolled flow from this facility. At least four unnamed tributaries of the Neosho River are located in proximity of the feedlot or of fields irrigated by center pivots for the land application of wastewater. For the purposes of this inspection, unnamed tributaries will be labeled as designated in Image 1 and visual inspection locations are marked by a purple camera.

The Neosho River flows from north to south forming the eastern boundary of parcels owned by Neosho Valley Feeders LLC. The receiving section of the Neosho River (State Waterbody ID: KS-1107020511) is classified as a general purpose water with designated uses including special aquatic life, primary contact recreation B, domestic water supply, food procurement, ground water recharge, industrial water supply, irrigation, and livestock watering. I did not visually inspect the Neosho River.

Tributary 1 flows from south to north and empties into the Neosho River. It drains flow from the Circle 5 field. A portion of the tributary has riparian cover and a portion flows through the irrigated area with no riparian cover. I did not visually inspect Tributary 1.

Tributary 2 flows from west to east along the north diversion berm of the feedlot and empties into the Neosho River. Tributary 2 receives flow from pasture on both sides of Victory Road, the Circle 6 field, and other agricultural fields. I visually inspected Tributary 2 at five locations: the

Tributary 3 flows from west to east and empties into the Neosho River. Tributary 3 receives flow from Circle 4 via another tributary, the pasture on Victory Road storing uncontrolled feed stock and a manure stockpile, Circle 7, Circle 1, and other agricultural fields. I visually inspected the Tributary 3 at the road crossing with Victory Road (Photos 3, 6, 9).

Tributary 4 flows from west to east and empties into the Neosho River. It receives flow from Circle 3 and Circle 2. I did not visually inspect Tributary 4.
