**Region 6 - Enforcement & Compliance Assurance Division**  
**INSPECTION REPORT**

| Inspection Date(s): | 06/09/2022 | |
| Company Name: | McCann Resources, Inc | |
| Facility Name: | Dixon-Rock Lease | |

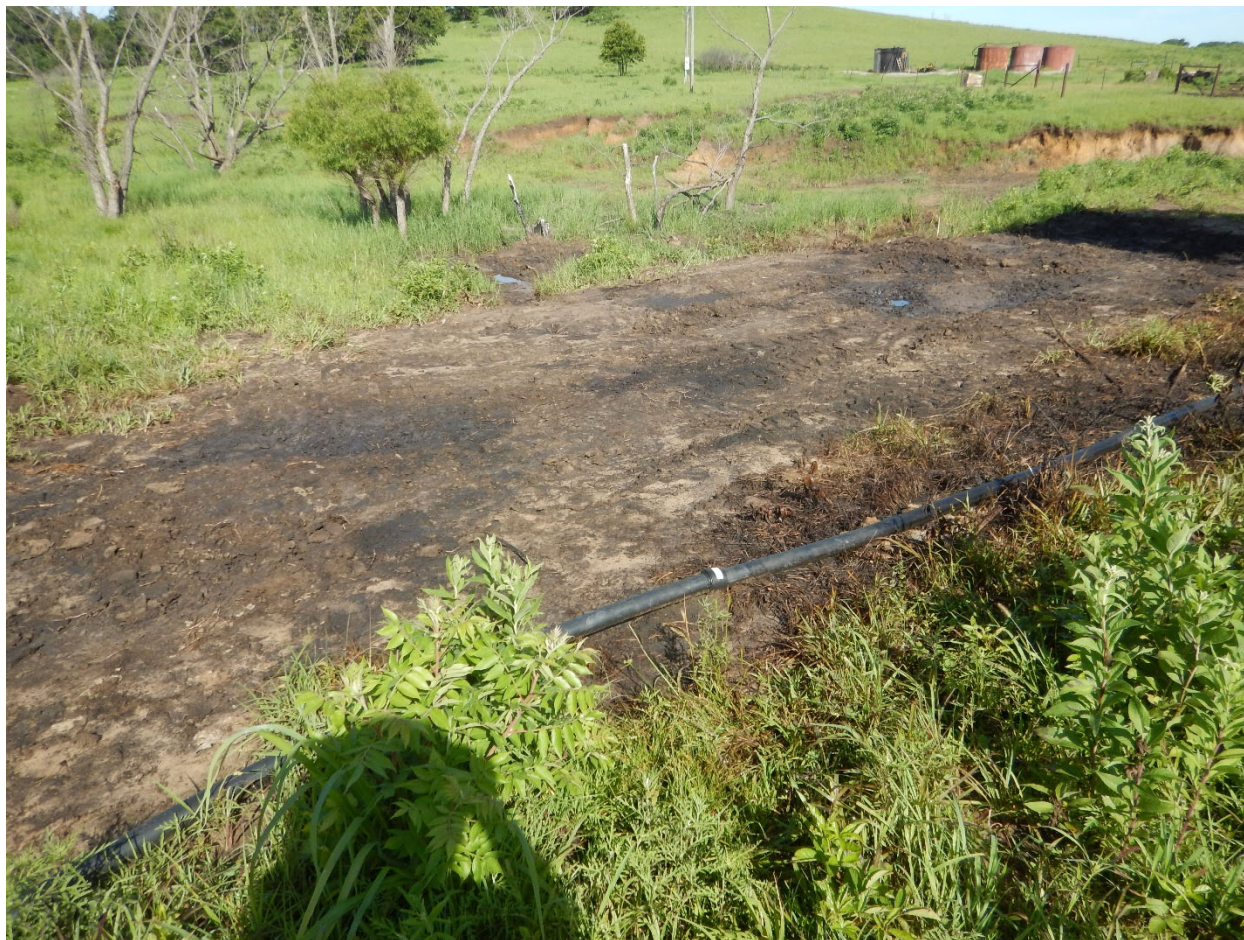
Photo No. 1

I observed the Release Point (GPS 36.893911, -96.126546) of the spill as seen in photo No. 1 of Appendix 1 (photo log). I observed oil-stained vegetation present in the area surrounding the release point as well as disturbed soil, which was mostly free from oil staining, this was evidence of recent efforts to clean the flowpath of the spill. I observed a “background” Total Dissolved Solids (TDS) field of 124.8 mg/L approximately 25 feet upstream from the Point of Entry (POE) in a pool of water which was not impacted by the spill, this observation is documented in photo No. 2.

**Description:** This was the release point of the spill. Oil-stained grass was documented in the photo. The area of disturbed soil suggested recent clean-up efforts had been conducted.

EPA Region 6 Inspector noted the primary areas of concern being the removal of small amounts of crude oil still present on the surface of the tributary as well as removal waters with elevated TDS from the tributary. The operator should clean or remove the oil-stained vegetation along the banks of the impacted tributary. A final area of concern is the need to ensure proper cleaning of the flowpath from the release point to the point of entry into the impacted tributary.

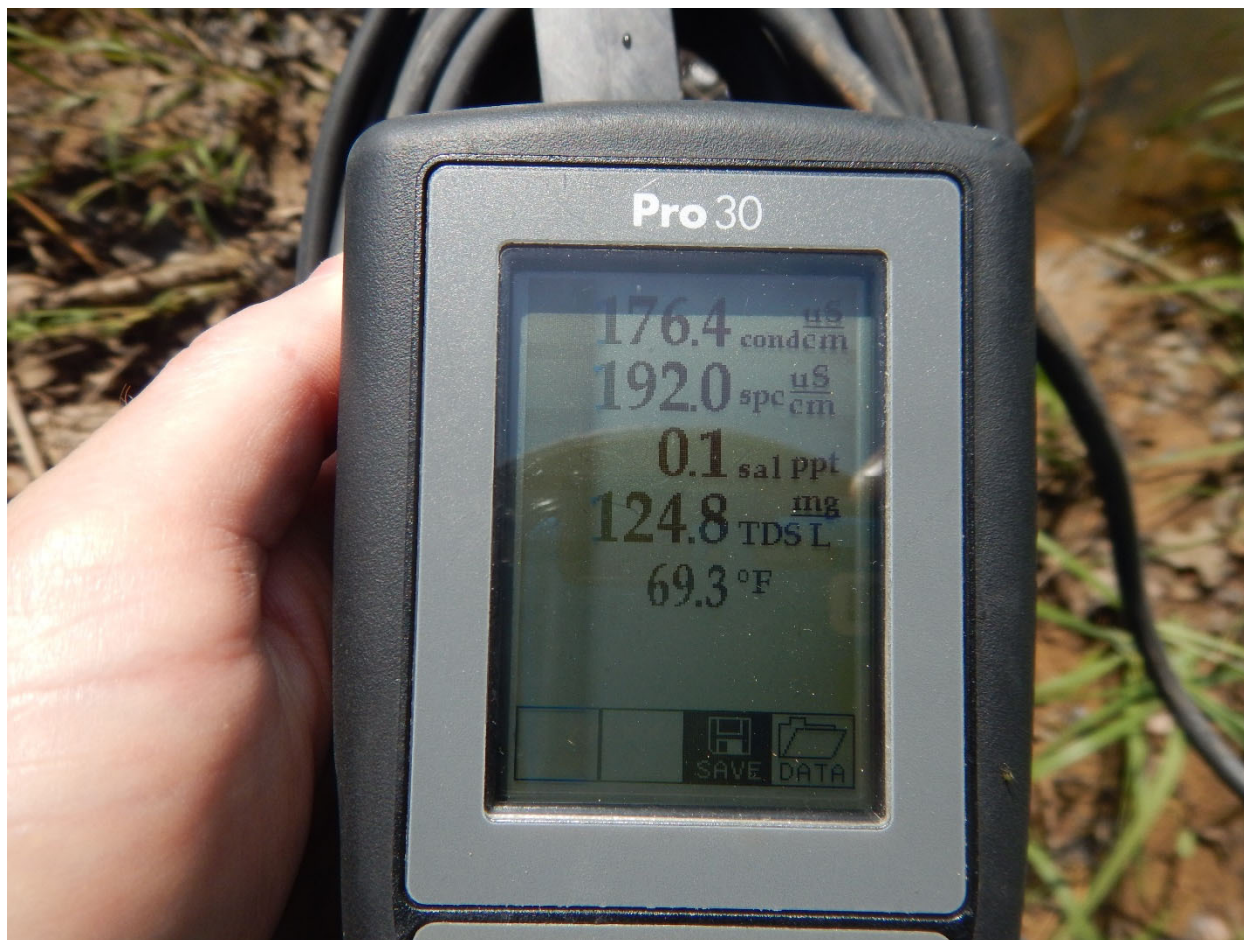
Photo No. 2

**Description:** This was a Total Dissolved Solids (TDS) field reading of 124.8 mg/L taken approximately 25 feet upstream from the Point of Entry (POE) into the tributary. This was taken in a pool of water which was not impacted by the spill and should be considered when establishing "background" TDS levels for the impacted tributary.

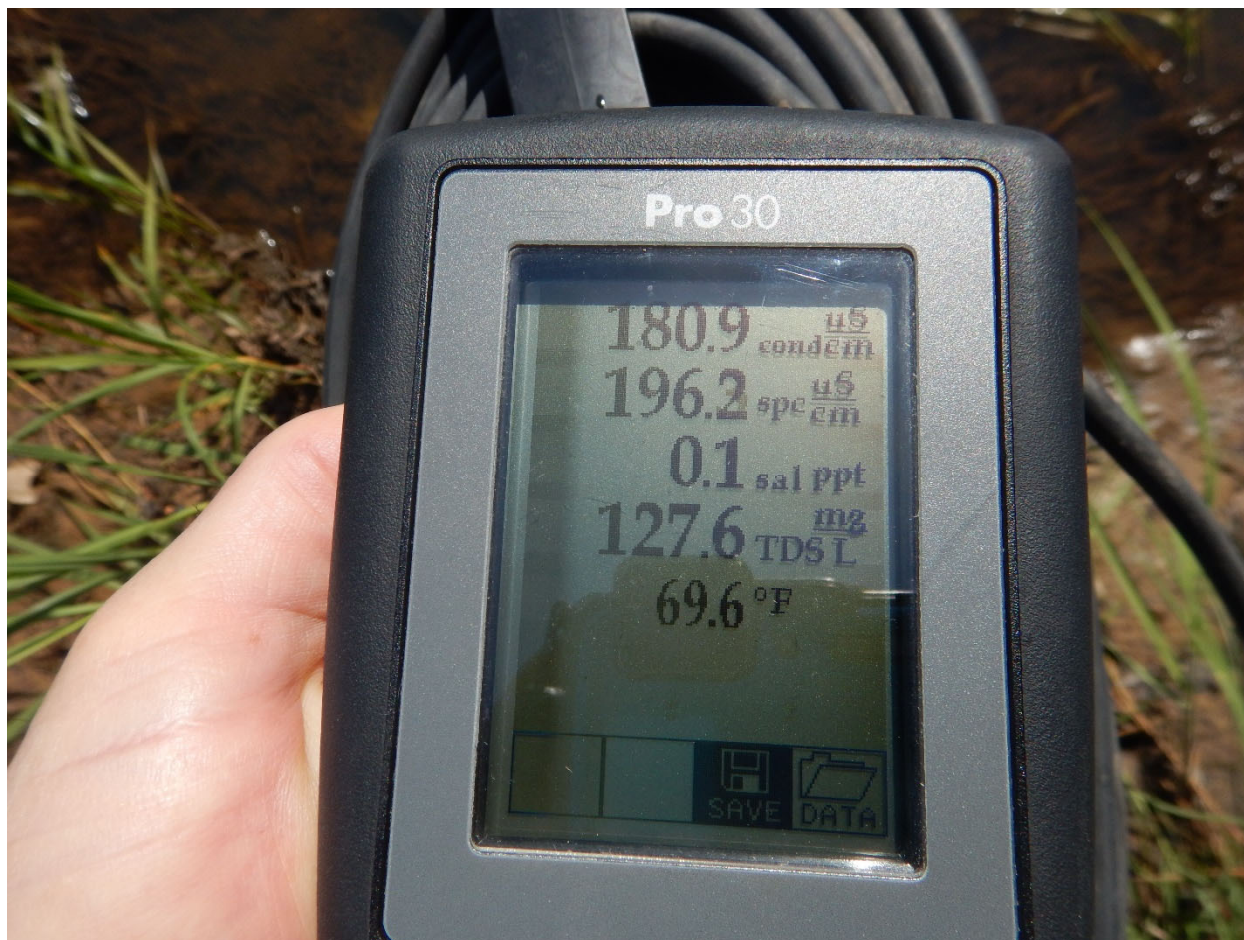
Photo No. 3

I observed the POE (GPS 36.893981, -96.126726) into the main channel of the impacted tributary. I observed a TDS field reading of 127.6 mg/L at the POE which is documented in photo No. 3.

**Description:** This was a TDS field reading of 127.6 mg/L taken at the POE into the main channel of the impacted tributary. This showed substantial improvement from the initial inspection and is now well within the "background" range for TDS in the area.

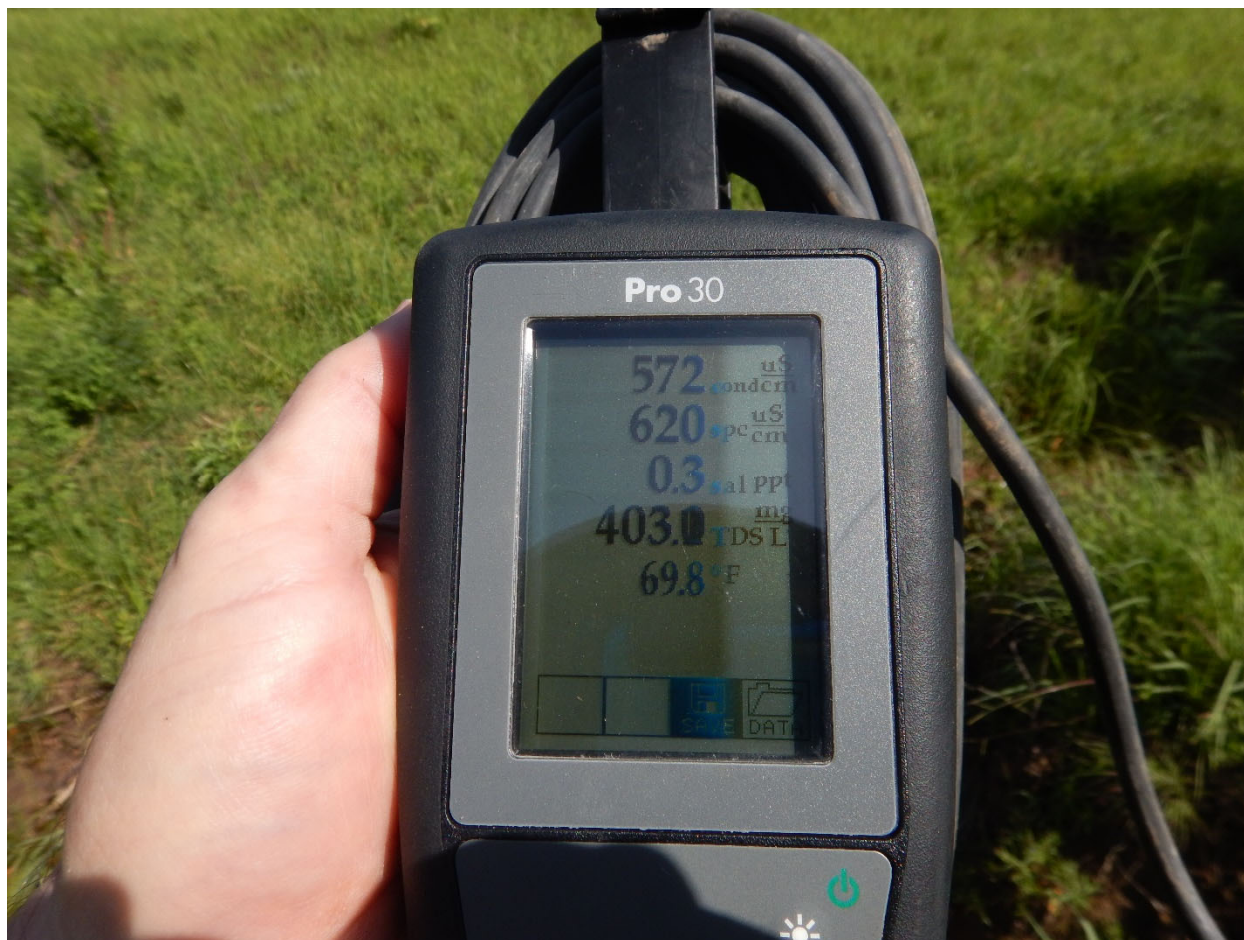
Photo No. 4

**Description:** This was an elevated TDS field reading of 403.0 mg/L taken in the main channel of the impacted tributary, downstream from the POE.

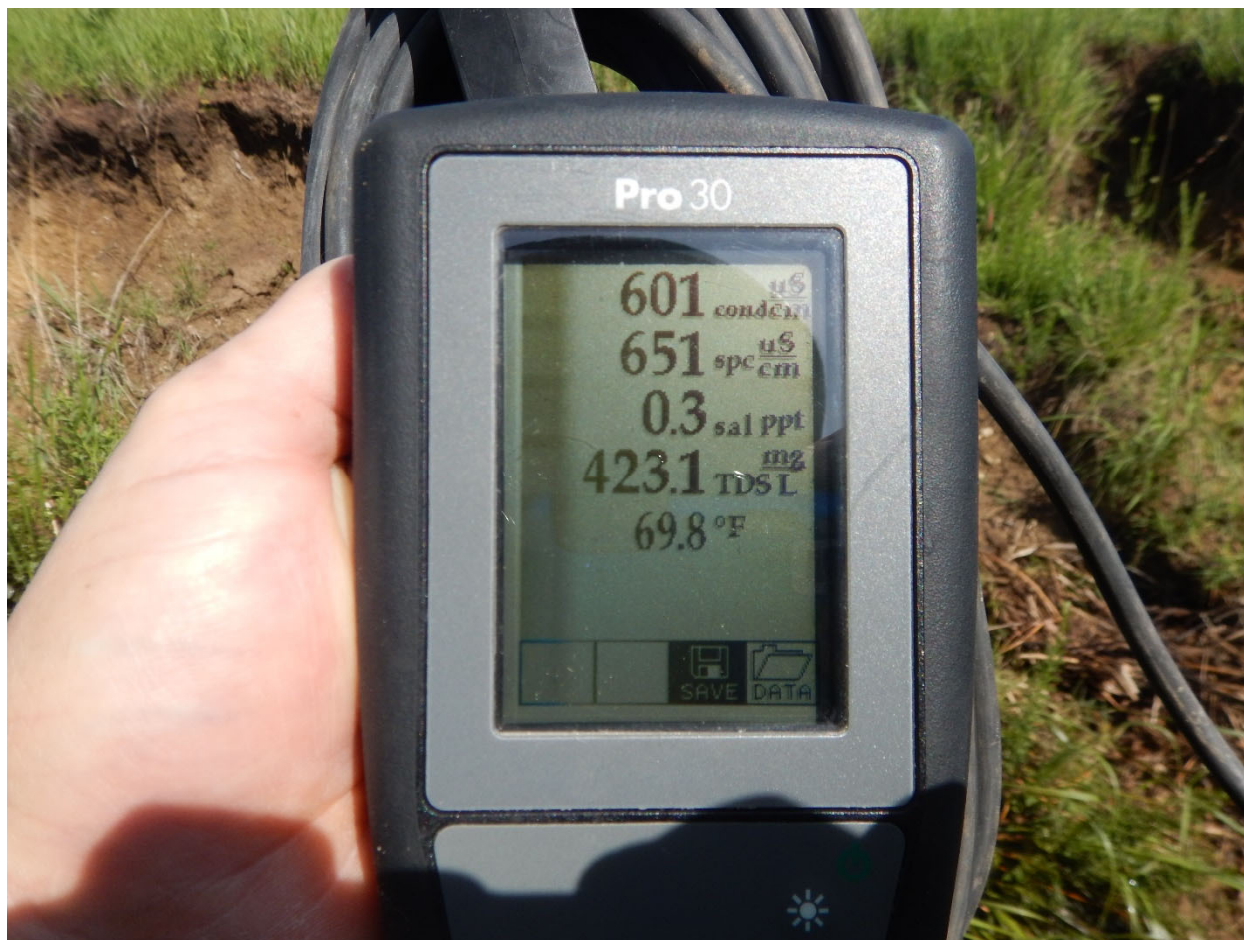
Photo No. 5

**Description:** This was an elevated TDS field reading of 423.1 mg/L taken in the main channel of the impacted tributary, downstream from the POE.

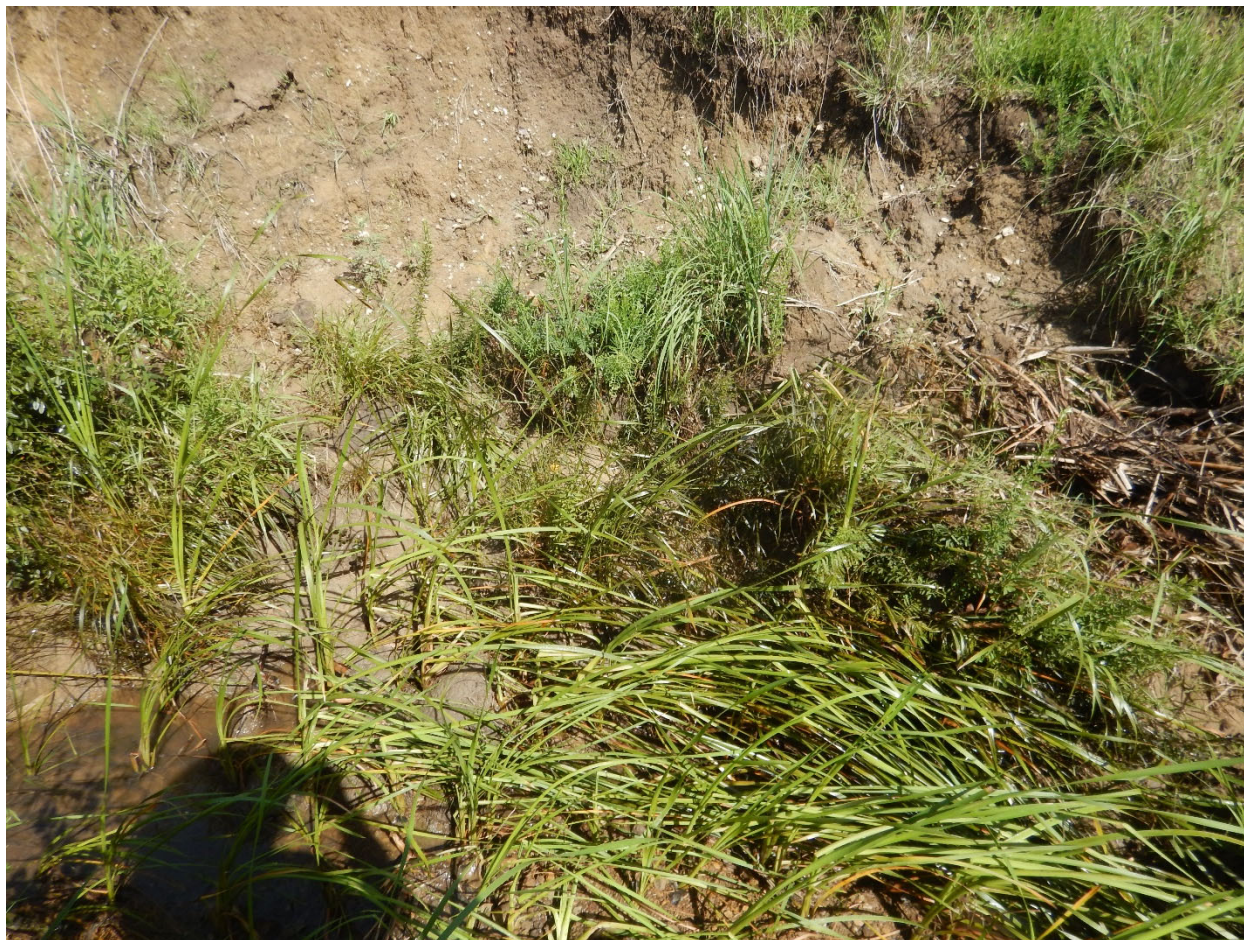
Photo No. 6

**Description:** This was a photo documenting oil-stained grass along the bank of the tributary. The oil-stained grass appeared "wet" or "glossy" in the photo.

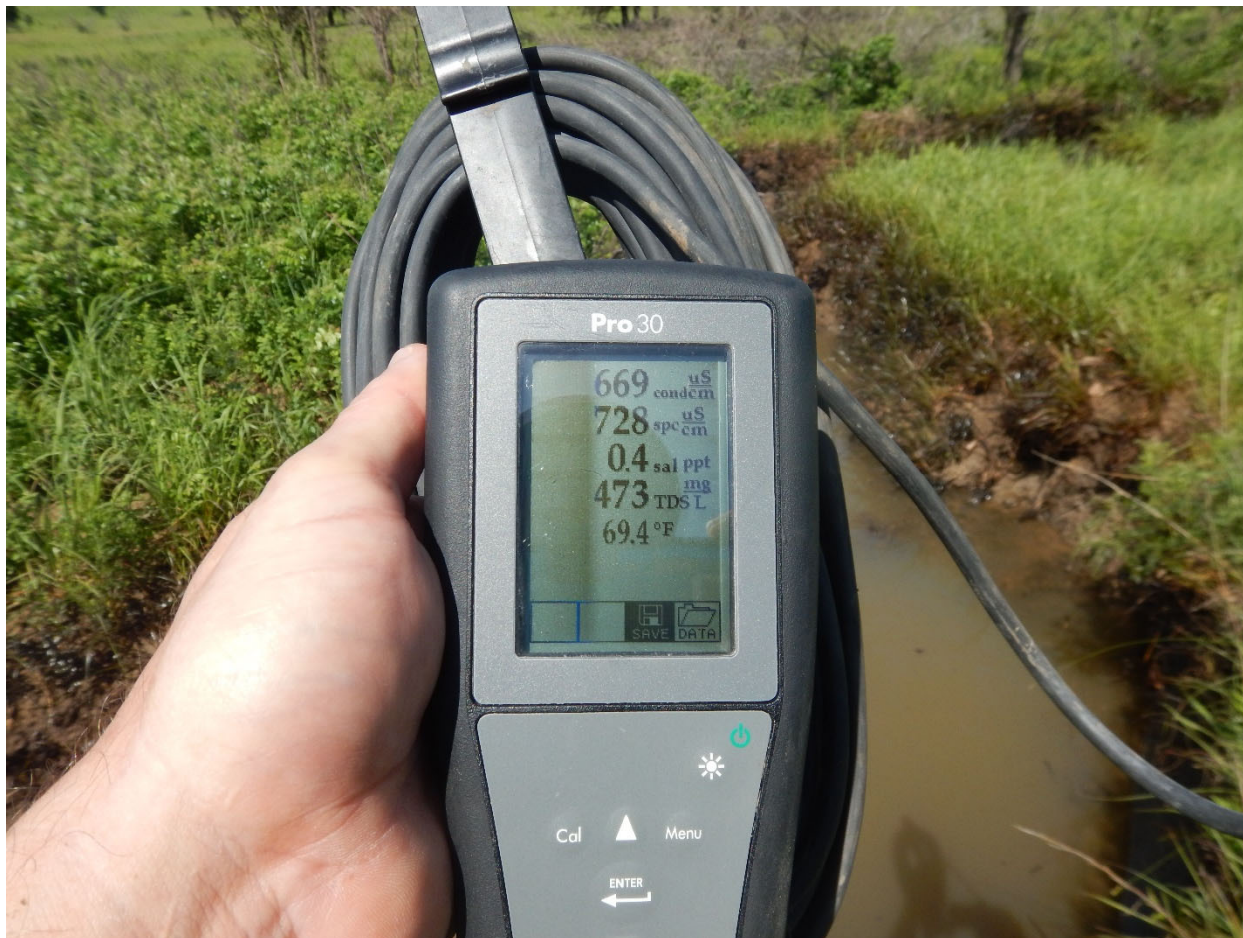
Photo No. 7

I observed an elevated TDS field reading of 473 mg/L and significant oil staining at (GPS 36.898963, -96.124948) these observations are documented in photos No. 7, 8 and 9. I observed oil stains on the vegetation along the top edge of the tributary’s banks which indicated the high flow level mark of the

**Description:** This was an elevated TDS field reading of 473 mg/L taken in the main channel of the impacted tributary.

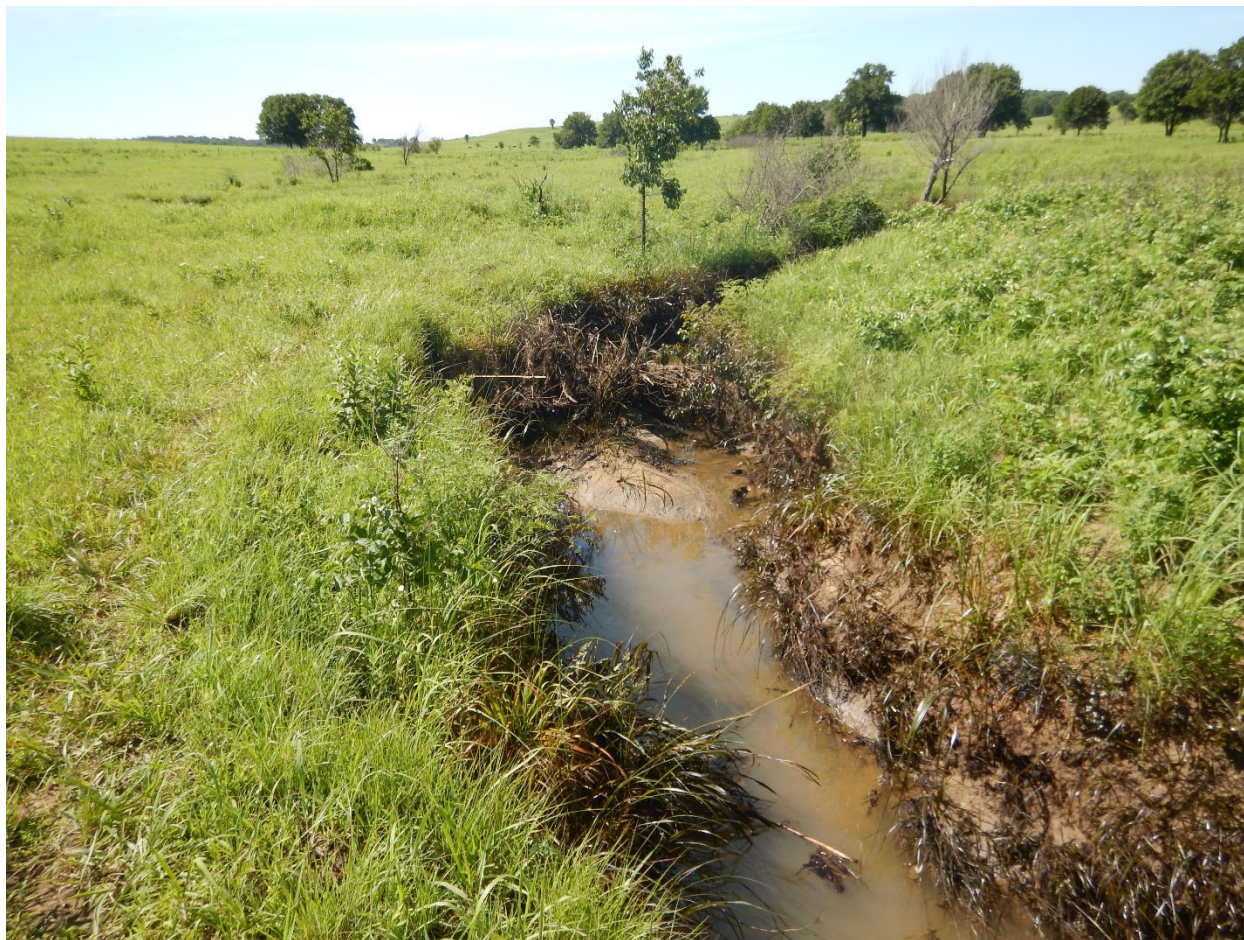
Photo No. 8

tributary during recent rainfall events. This period of high flow and high-water level occurred while oil was present on the surface of the water.

**Description:** This photo documented the oil-stained vegetation along the banks of the tributary. The oil-stained vegetation was present at the top of the banks of the tributary, evidence that the stream flowed at maximum capacity while oil was still present on the surface of the water.

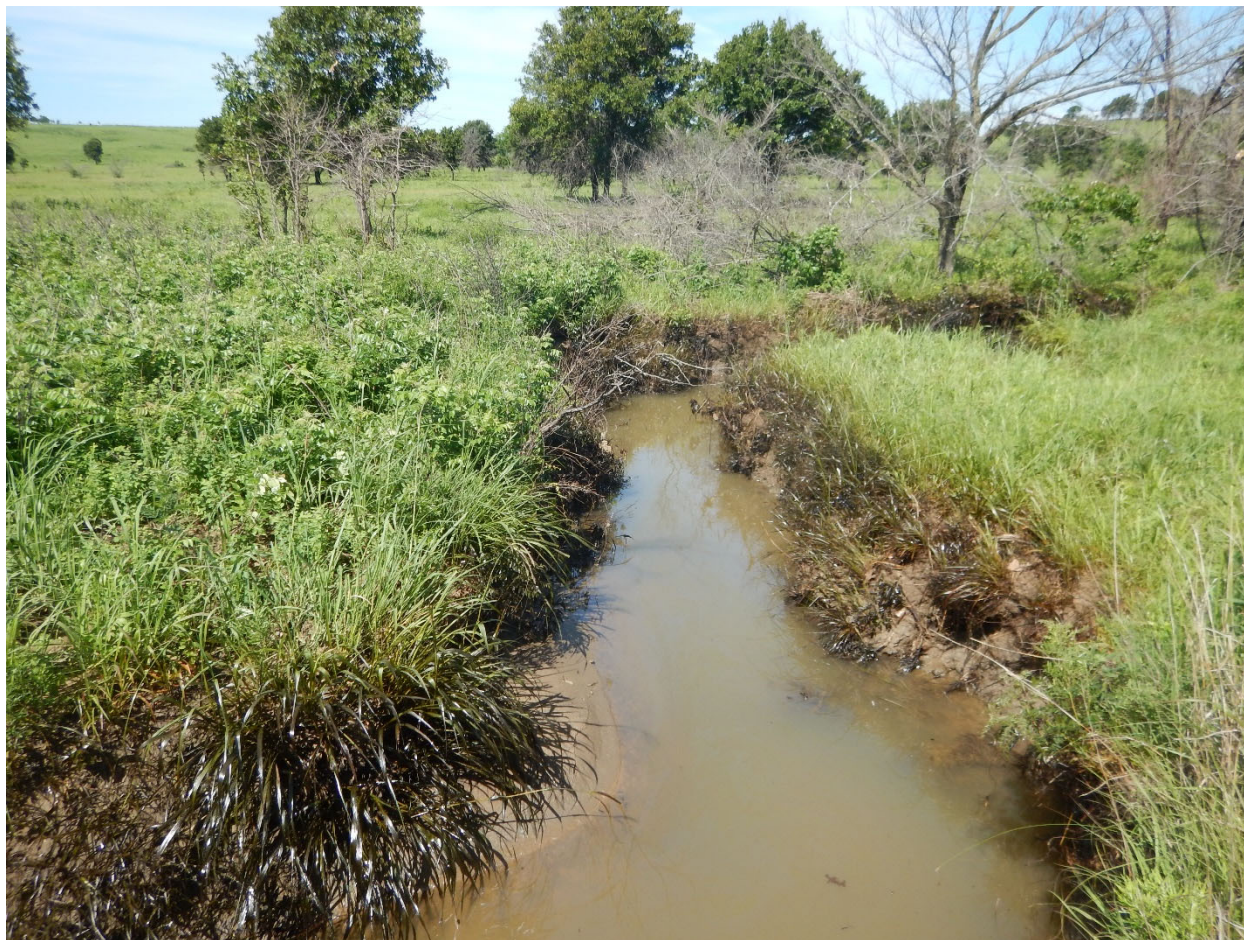
Photo No. 9

**Description:** This photo documented the significant oil staining present on the vegetation along the banks of the impacted tributary. The oil-stained vegetation documented the high-water mark achieved during recent rainfall events along the impacted tributary.

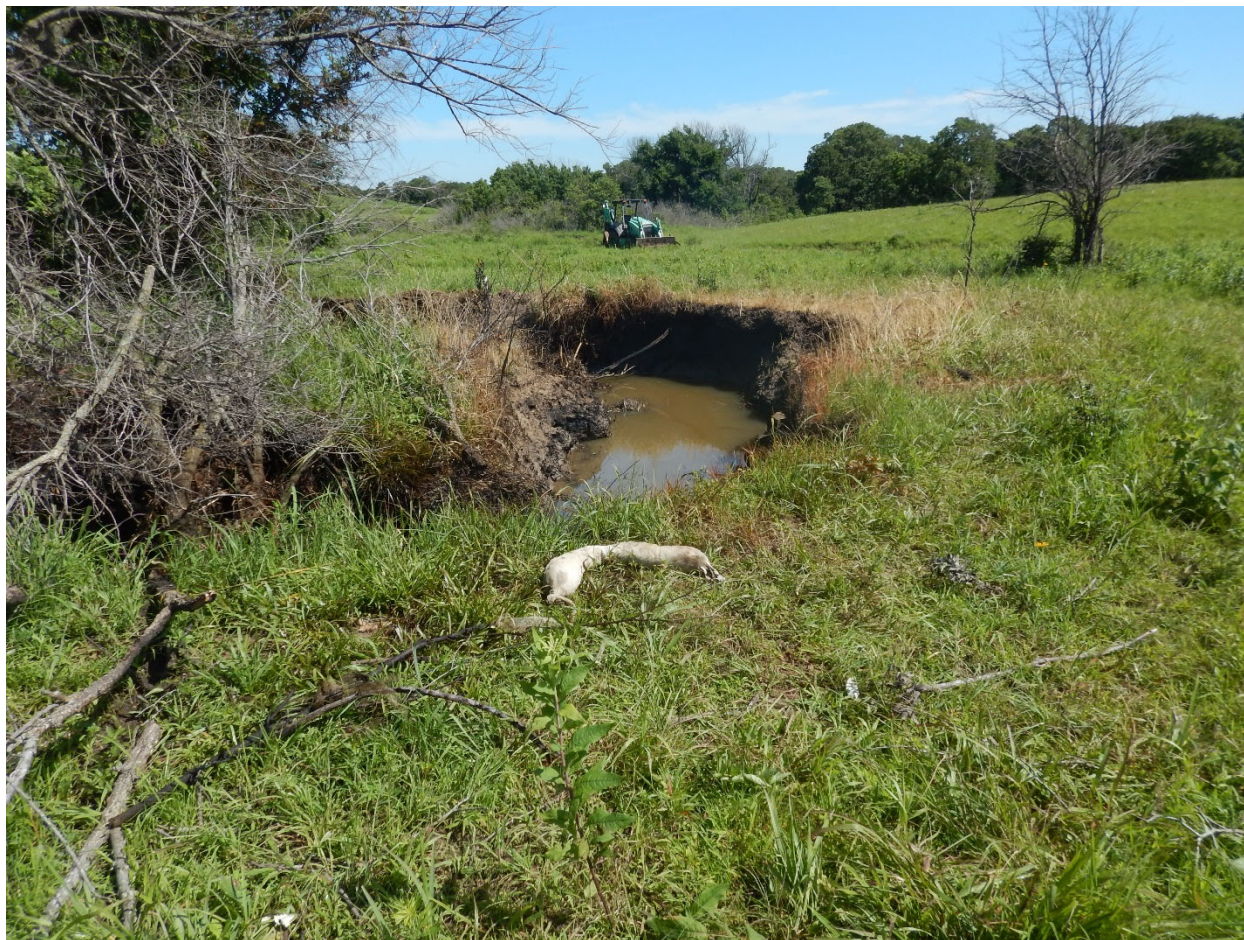
Photo No. 10

I observed dead grass and charred vegetation at (GPS 36.899088, -96.124947) along the banks of the tributary which indicated oil or oil-stained vegetation had been burned at the location, these observations are documented in photo No. 10. At the same location, I observed a backhoe which had been used to place a temporary containment dam across the impacted tributary. I also observed an oil absorbent containment boom laying near the impacted tributary. I observed a floating, oil absorbent containment boom and a small amount of oil on the surface of the impacted tributary, these observations are documented in photo No. 11. Observations from photo No. 10 and 11 were all at the same location.

**Description:** This photo documented dead grass and charred vegetation along the banks of the impacted tributary. It appeared the oil had been burned along this portion of the tributary. There was an oil absorbent boom laying near the tributary. There was a green backhoe in the photo which had been used to place a temporary containment dam across the impacted tributary.

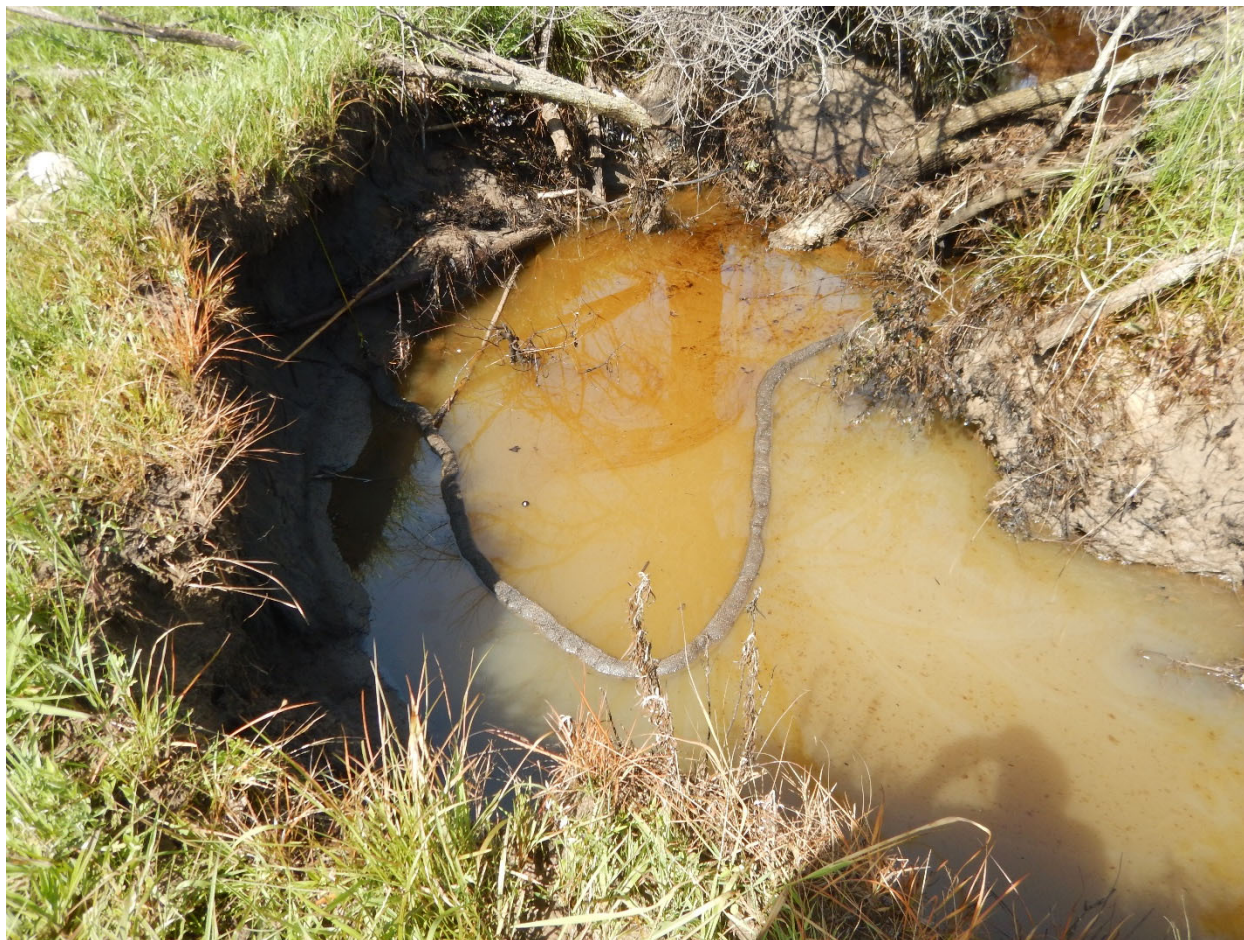
Photo No. 11

**Description:** This photo documented a small amount of oil floating on the surface of the tributary. There was a floating, oil absorbent containment boom installed on the tributary at this location. This is the same location where charred vegetation and dead grass were present.

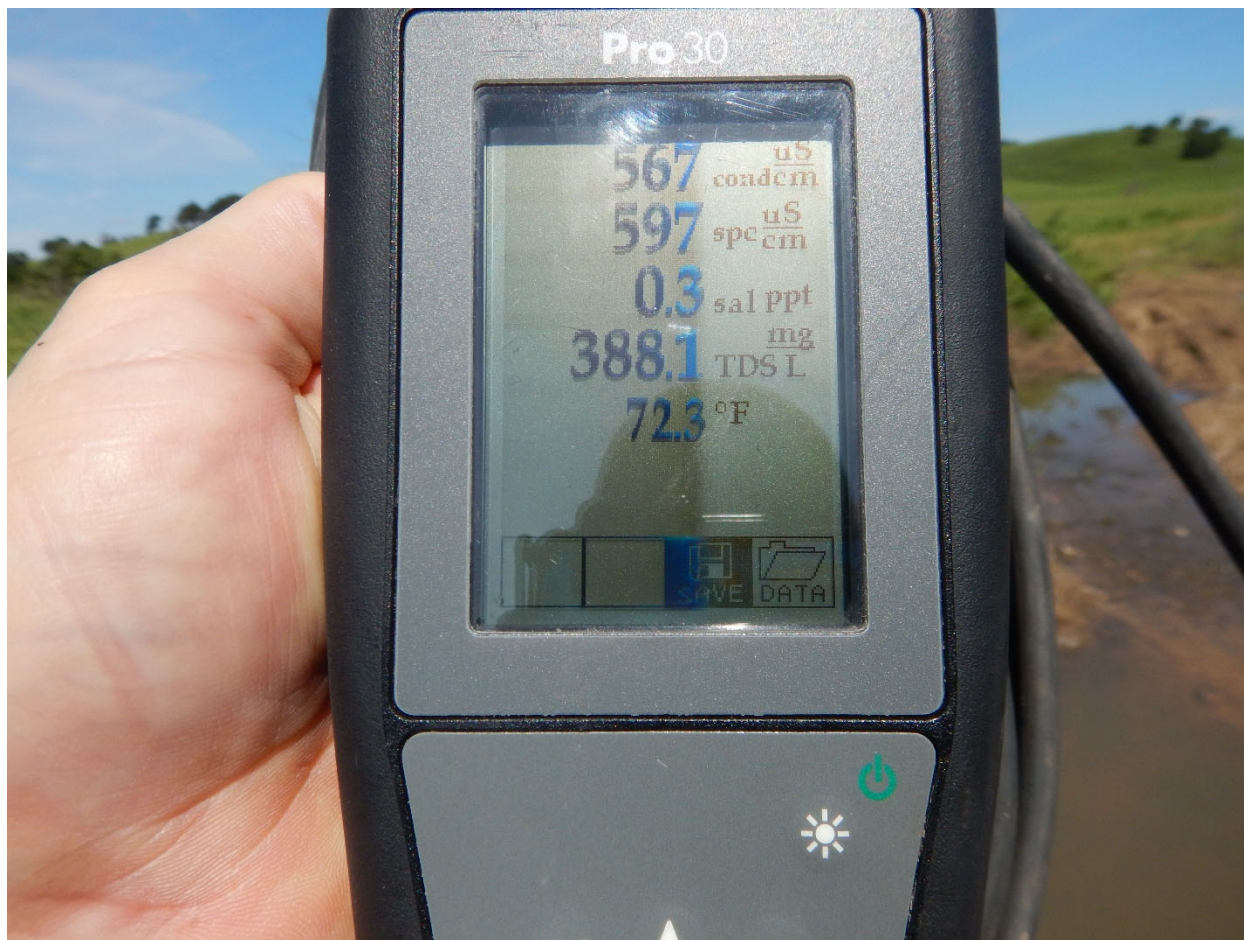
Photo No. 12

Approximately .55 miles downstream from the POE, I observed an elevated TDS field reading of 388.1 mg/L (GPS 36.899682, -96.125121) in the main channel of the impacted tributary, which is documented in photo No. 12. This was the location where I last observed spill impacts during the initial spill inspection conducted 06/01/2022. At the same location, I observed the remnants of a temporary containment dam which had been most washed away by recent rainfall events as well as significant oil staining on the vegetation along the banks of the impacted tributary. The remnant of the containment dam and oil staining are documented in photo No. 13.

**Description:** This was an elevated TDS field reading of 388.1 mg/L taken in the main channel of the impacted tributary. This reading was taken approximately .55 miles downstream from the POE. This was the location of the furthest downstream documented spill impacts during the initial inspection.

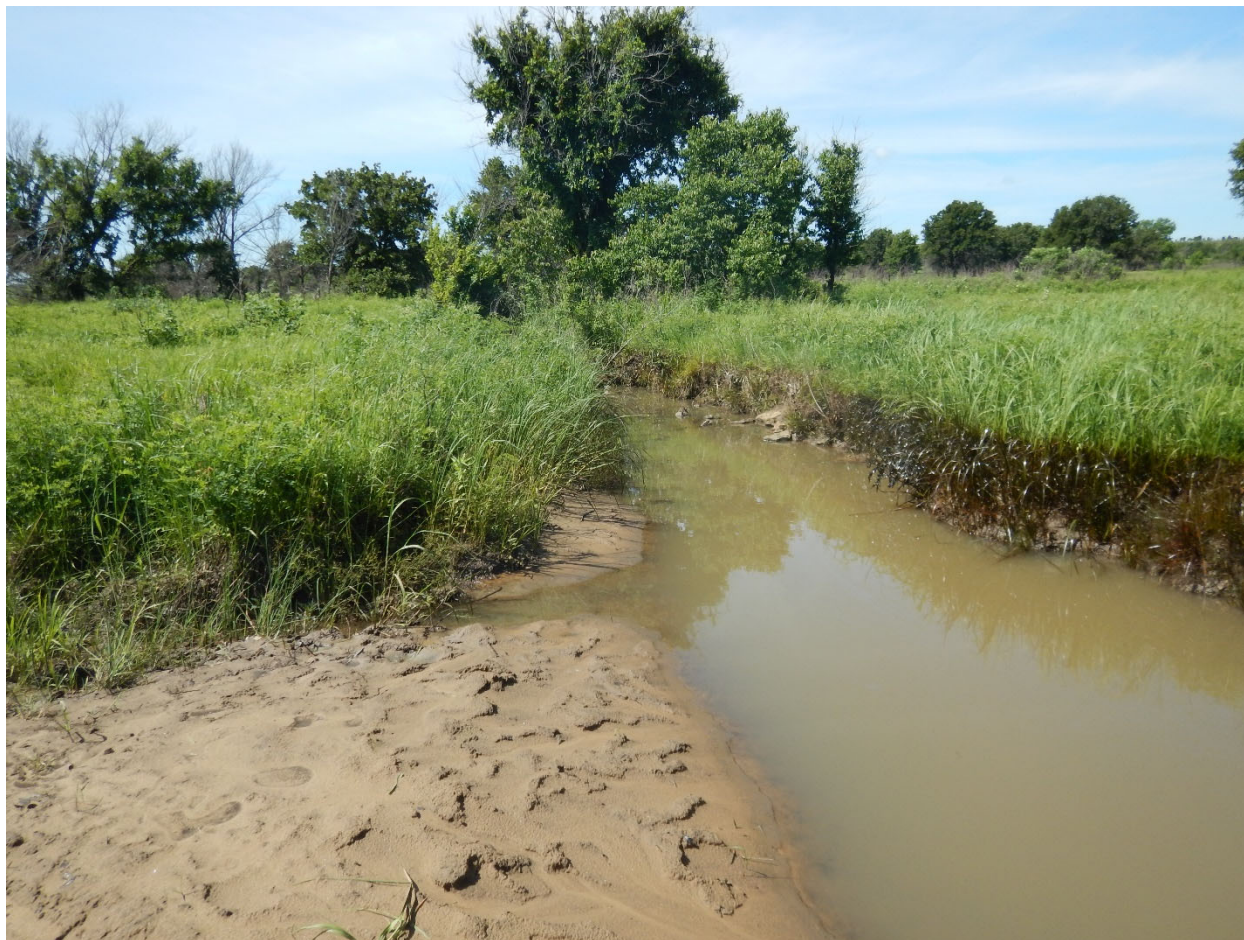
Photo No. 13

**Description:** This was a photo of significant oil-stained vegetation along the impacted tributary. This was the location where a temporary containment dam had been placed across the impacted tributary but was washed away at the time of the inspection. The oil-stained vegetation defines the high-water mark achieved during recent rainfall events.

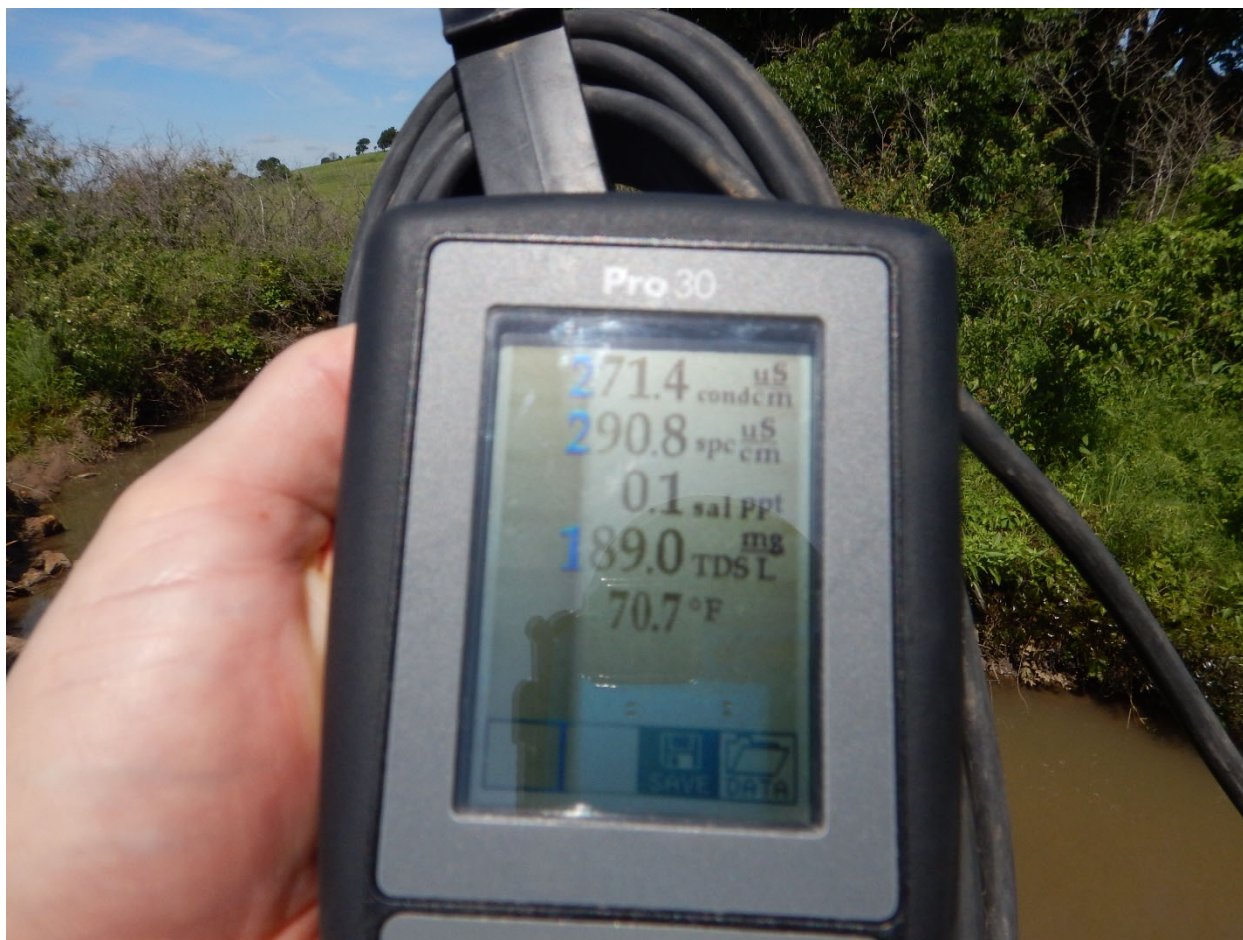
Photo No. 14

I observed a TDS field reading of 189.0 mg/L at (GPS 36.899972, -96.124707), which is documented in photo No. 14. At the same location, I observed oil staining on the vegetation along the bank of the impacted tributary, which can be seen in photo No. 15. These observations were made approximately 150 feet downstream from the location where spill impacts were last documented during the initial inspection.

**Description:** This was a TDS field reading of 189.0 mg/L taken downstream, beyond the point where any spill impacts were documented during the initial spill inspection.

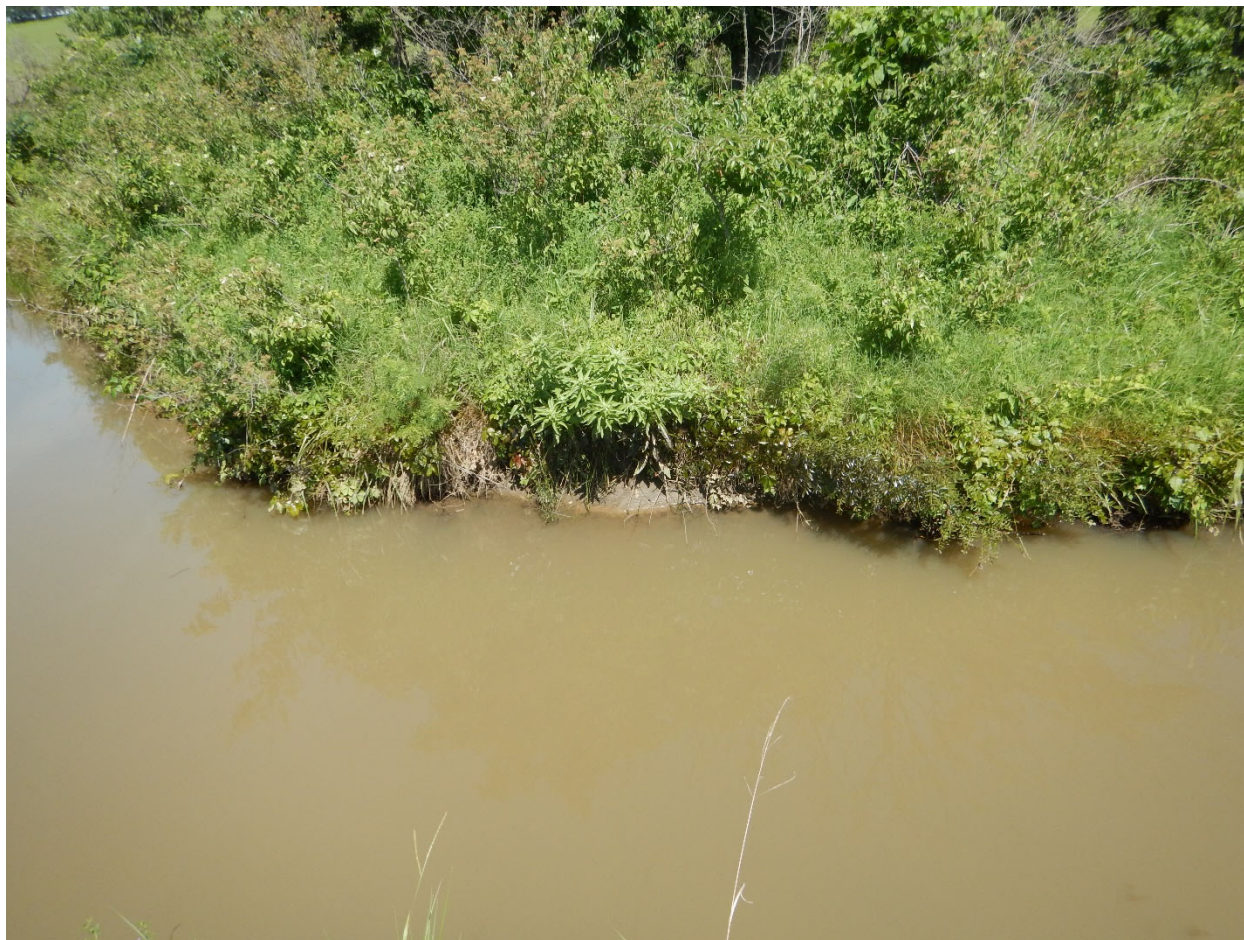
Photo No. 15

**Description:** This photo documented oil-stained vegetation along the impacted tributary. The oil-staining documents the high-water mark along the tributary, which was achieved during recent rainfall, while oil was still present on the surface of the tributary. This was the furthest downstream location where spill impacts were observed.
