**Region 6 Compliance Assurance and Enforcement Division  
INSPECTION REPORT**

| Inspection Date(s): | November 17, 2017 | | |
| Company Name: | Trinity Operating, LLC | | |
| Facility Name: | Roxy No. 4-20/29H | | |

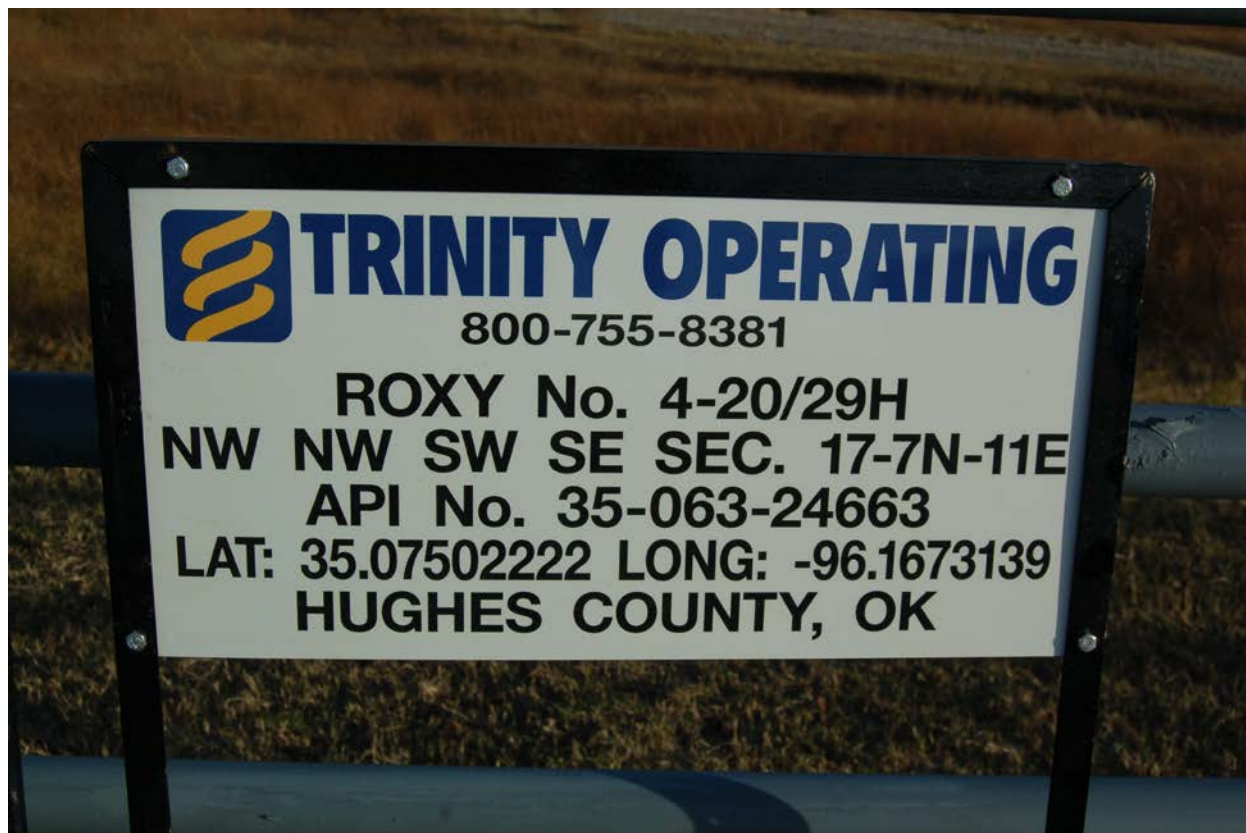
Photo No. 1

Description: This image shows the sign on at the Trinity Operating, LLC - Roxy No. 4-20/29H pad site.

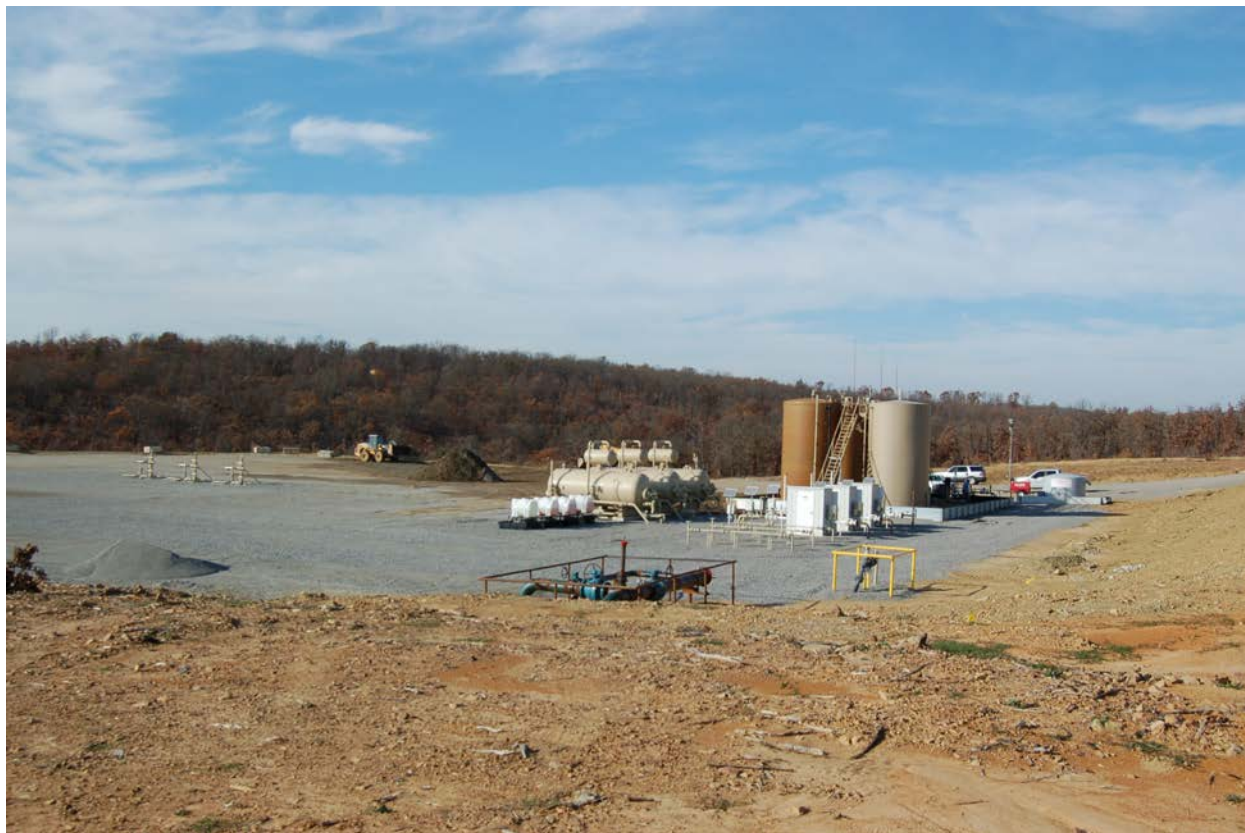
Photo No. 2

Description: The Roxy pad site is shown here. I observed that contaminated gravel and dirt were piled up.

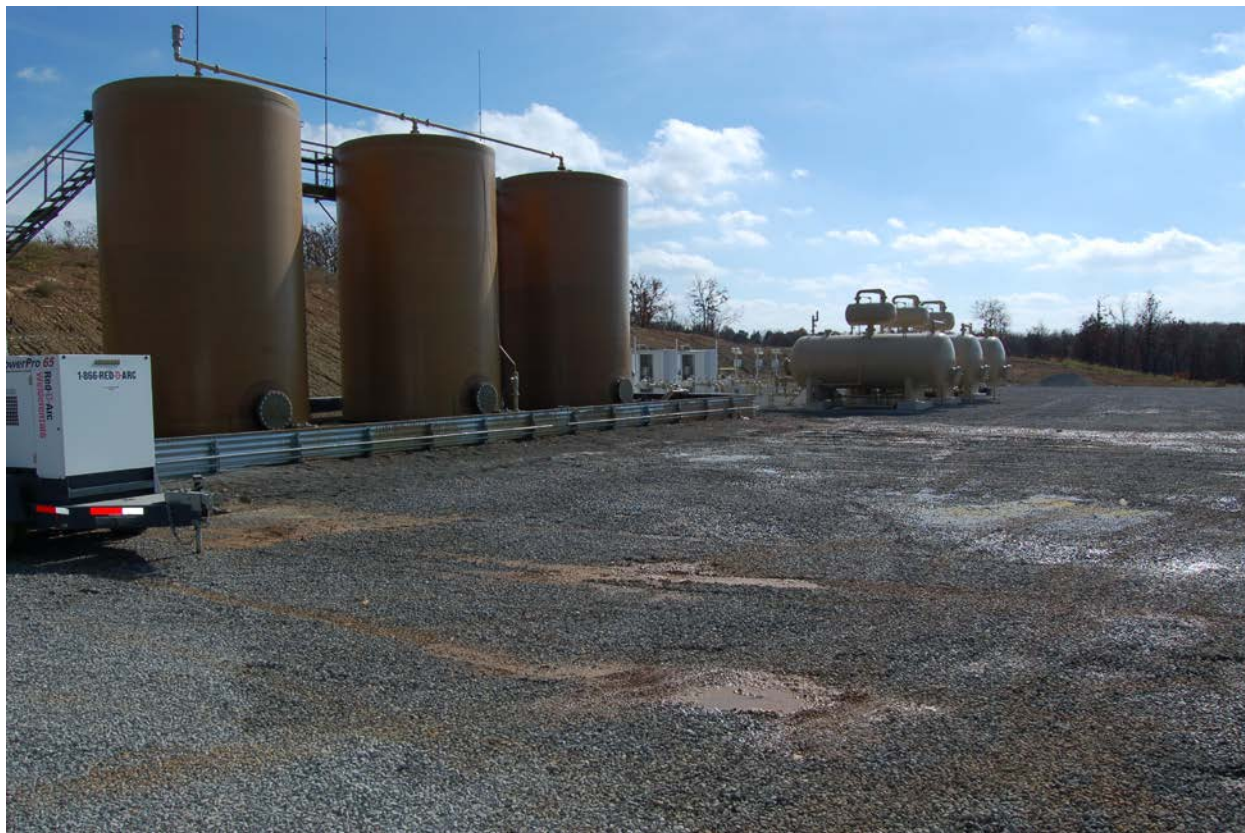
Photo No. 3

Description: The tank battery was the source of the brine and oil discharge. Power failure led to the tanks overflowing into the secondary containment area. The containment then overflowed to a nearby drainage ravine.

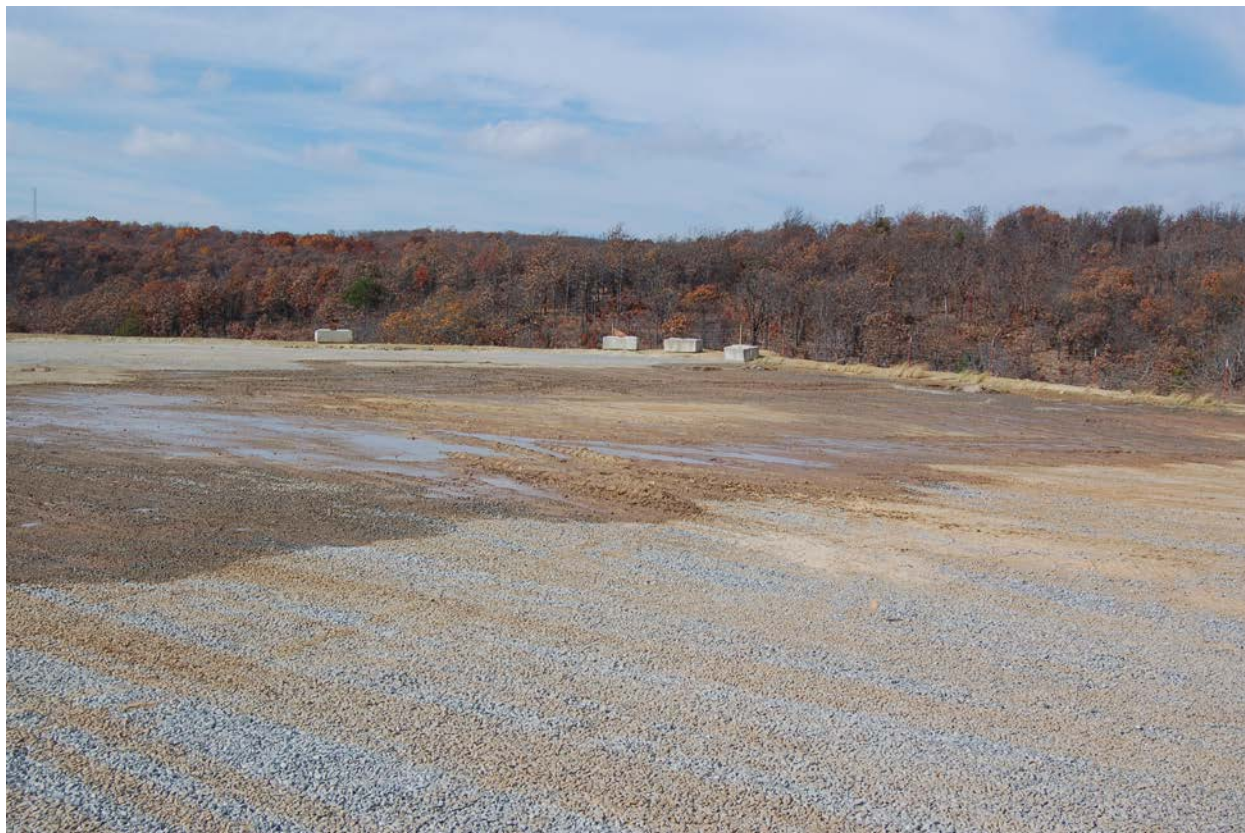
Photo No. 4

Description: The oil and brine ran northwest across the pad site location to a drainage ravine that passes on the west side of the site.

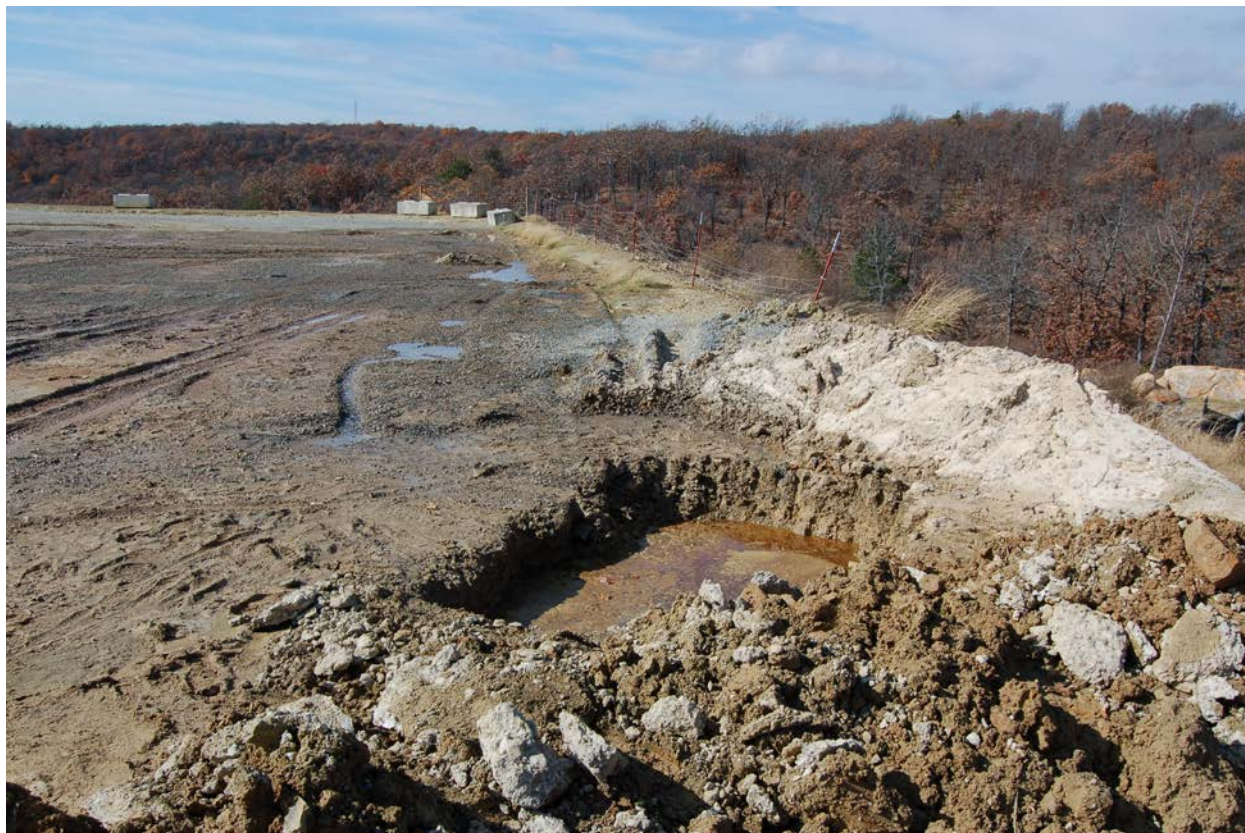
Photo No. 5

Description: The discharge ran over the edge of the pad here. The area was saturated with brine and some oil. A berm and hole were dug in this area to prevent further runoff.

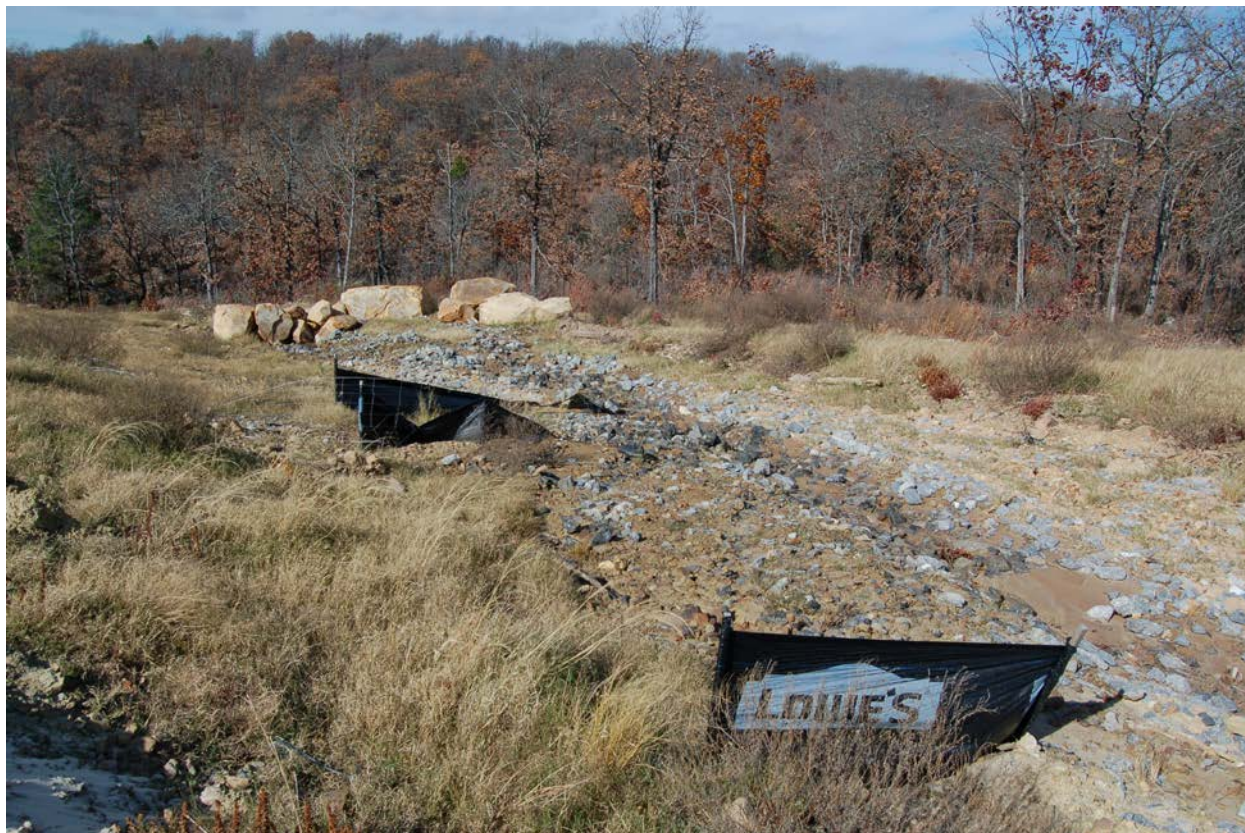
Photo No. 6

Description: The discharge traveled down the hill here toward the drainage ravine.

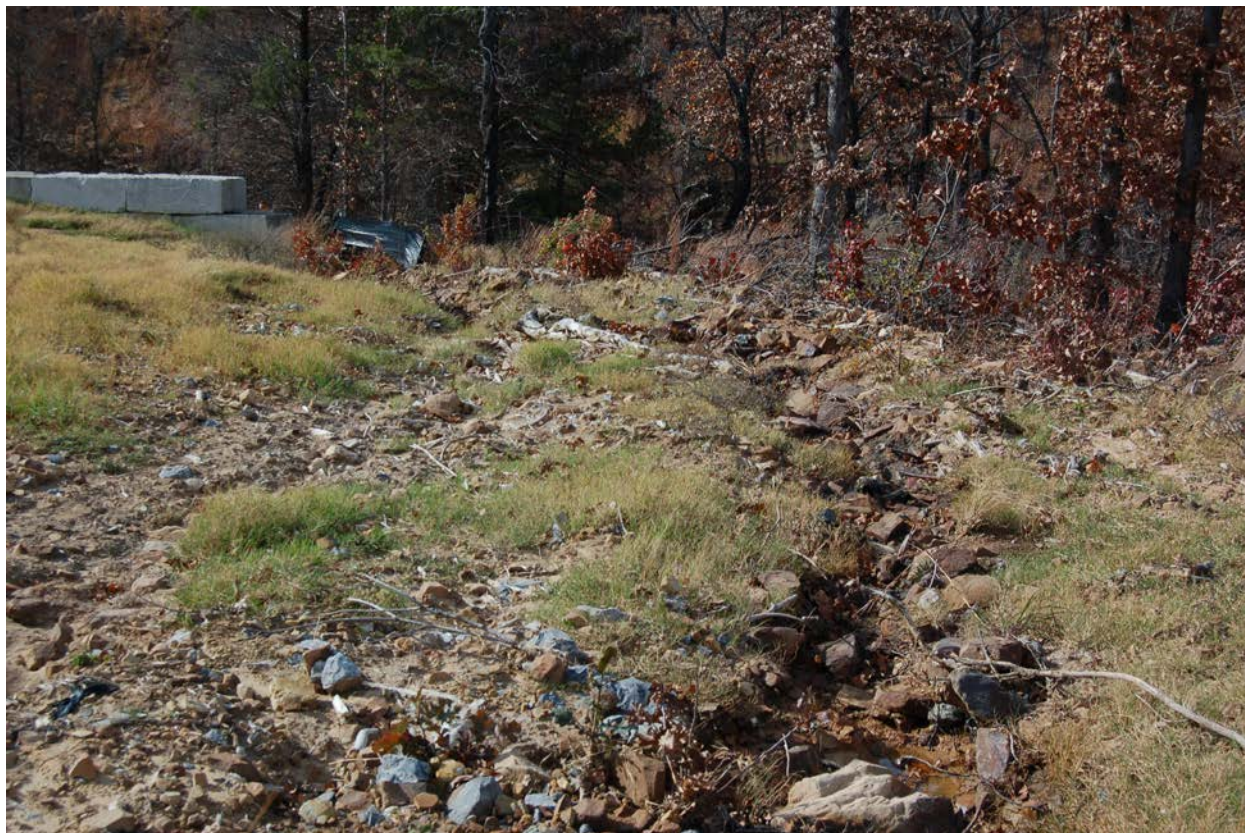
Photo No. 7

Description: The discharge ran down the hill here toward the drainage ravine.

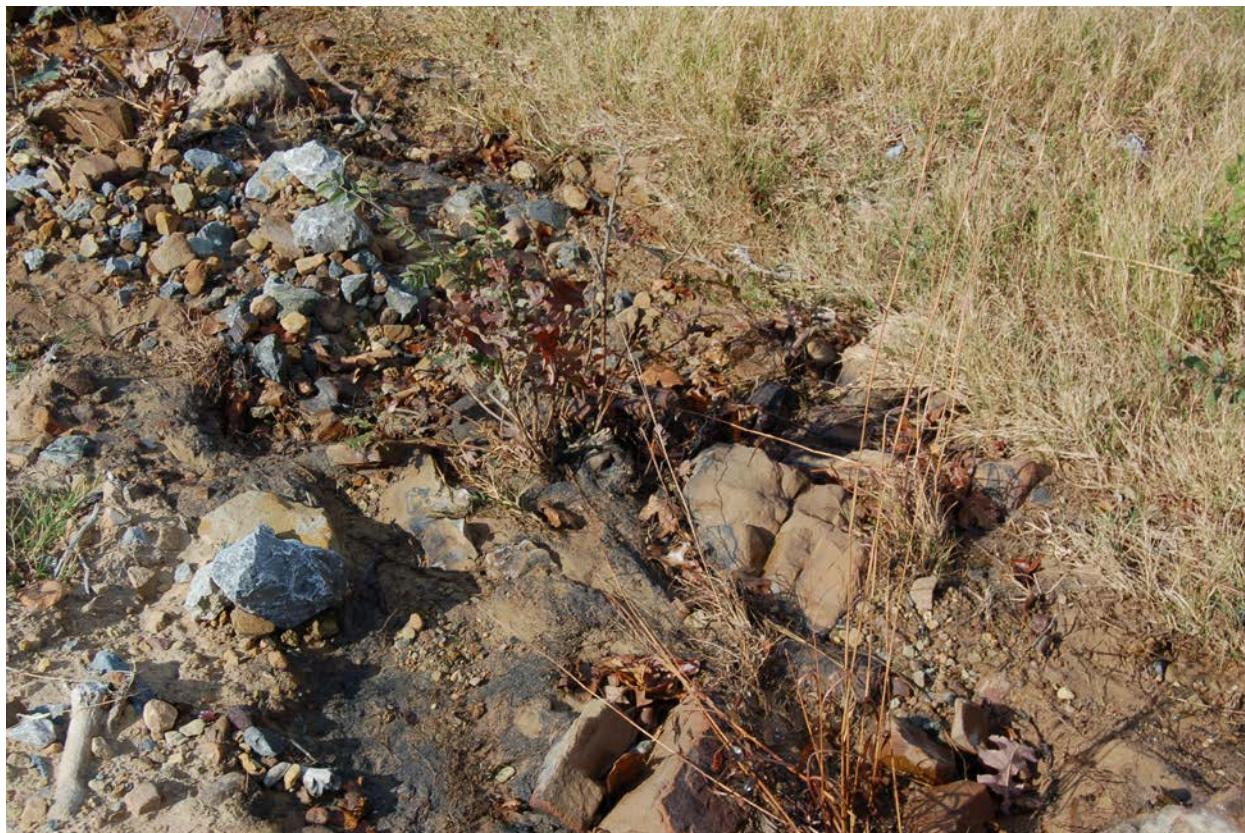
Photo No. 8

Description: I observed oil staining on the rocks along the discharge path at this location.

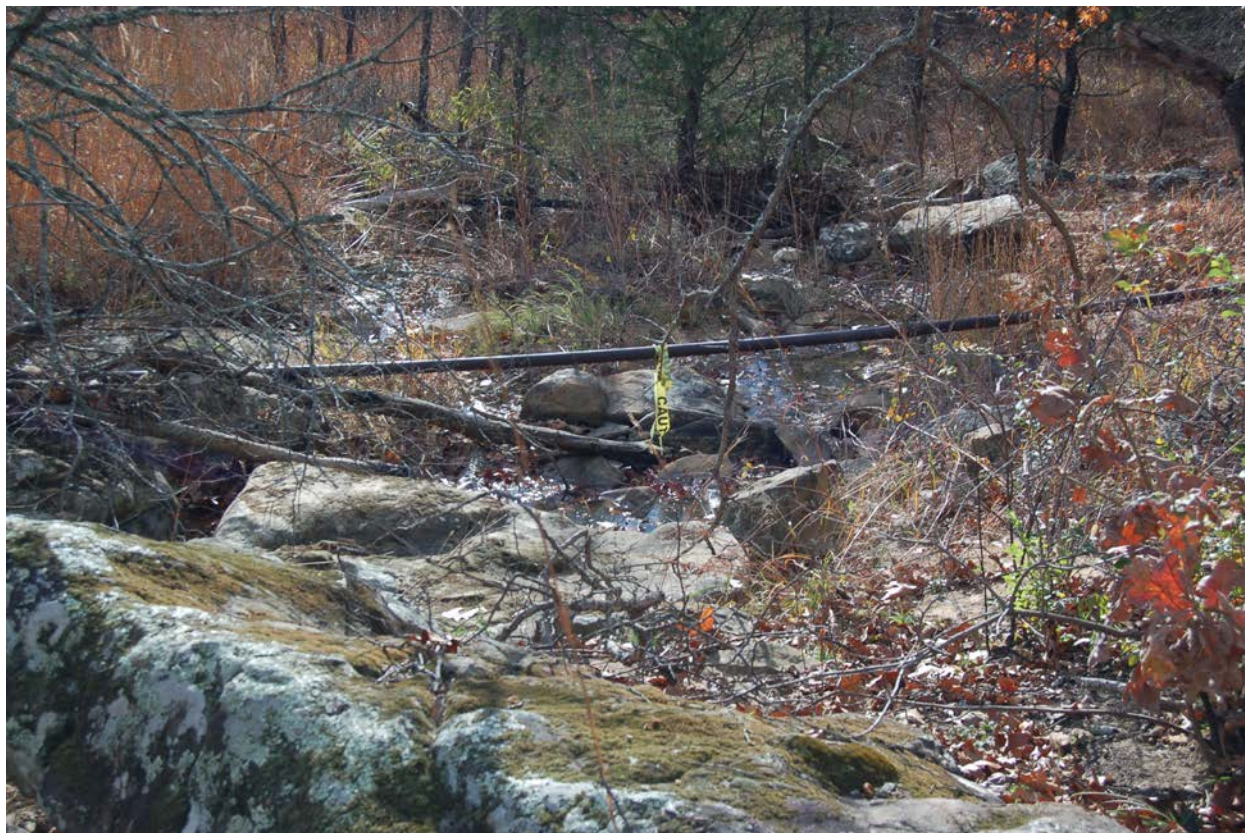
Photo No. 9

Description: This is near the point of entry to the drainage ravine. I observed that brine and oil were pooled up at this location.

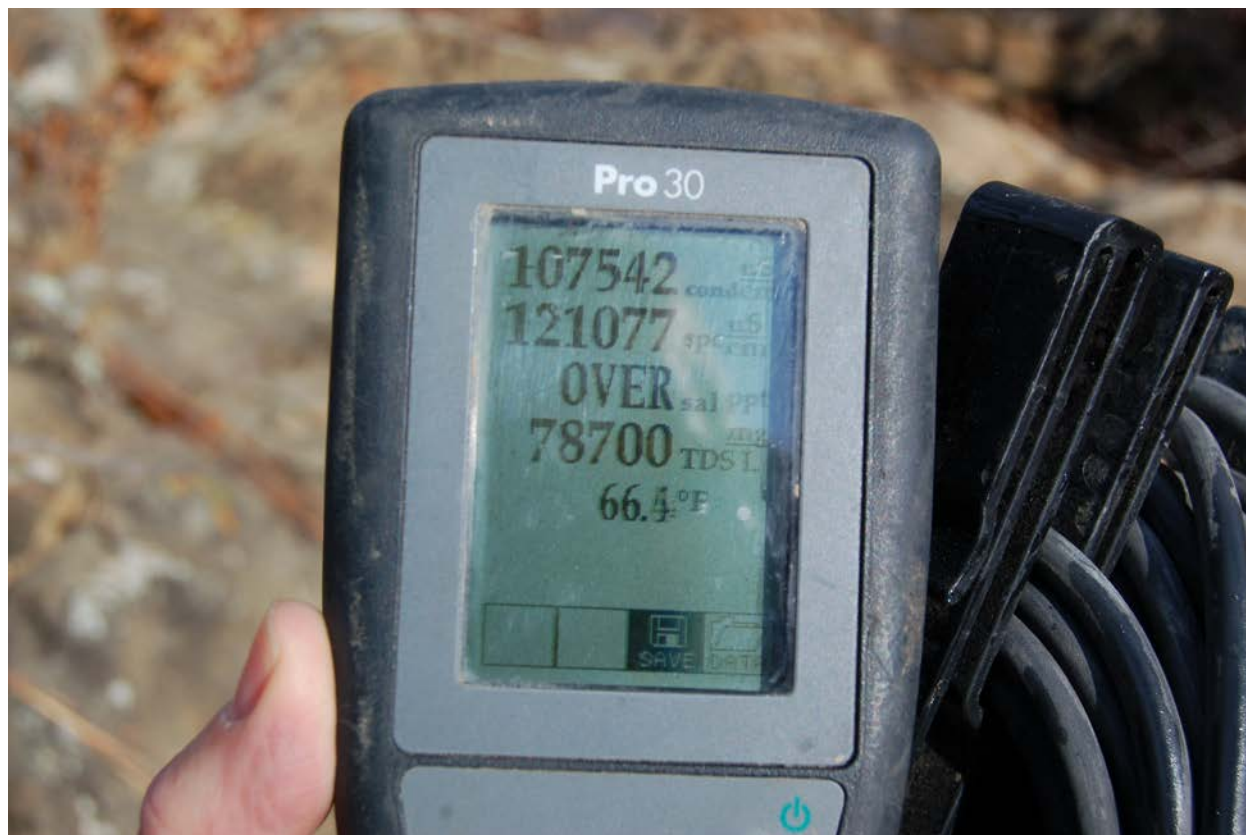
Photo No. 10

Description: With a calibrated YSI 30 Pro Conductivity meter, I took a Total Dissolved Solids (TDS) reading of 78,700 mg/L along the flow path in the drainage ravine.

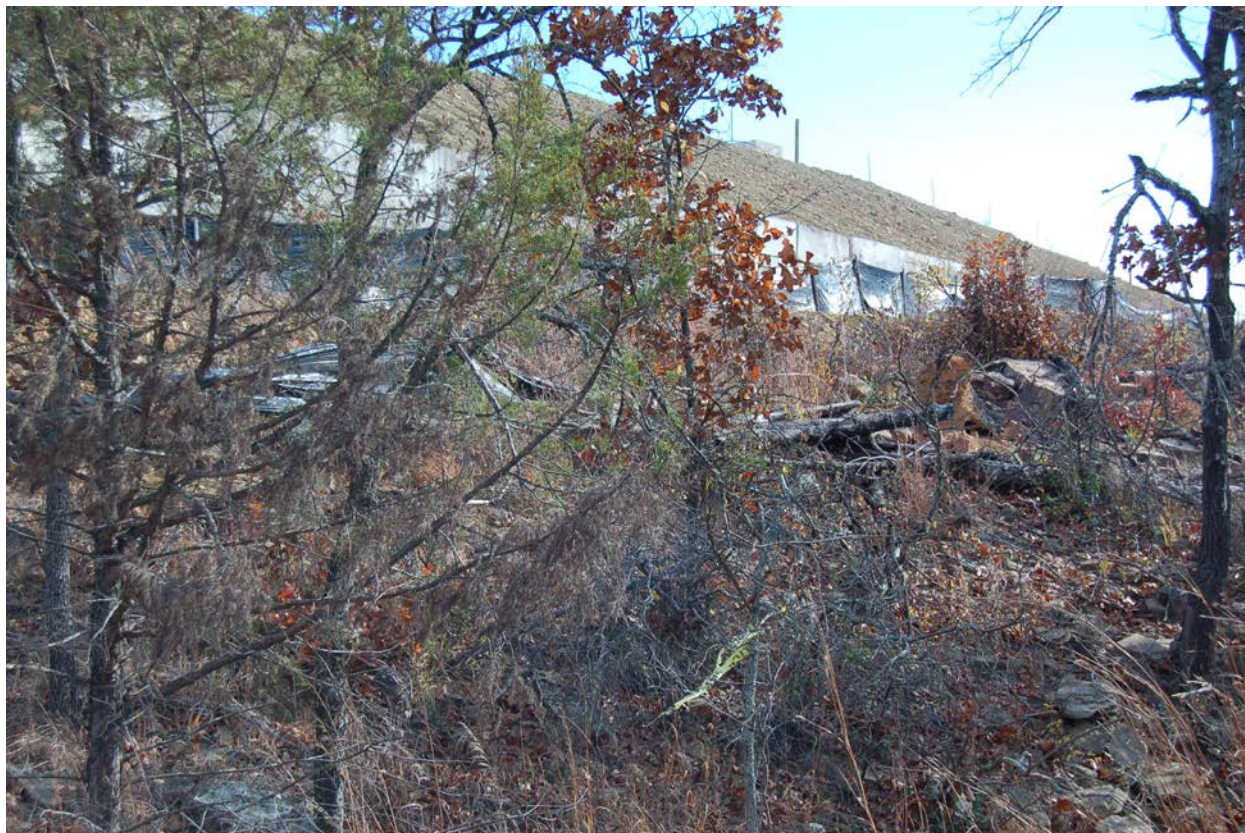
Photo No. 11

Description: This is a view of the west side of the pad from the drainage ravine. Flow was south toward the tributary of Coal Creek.

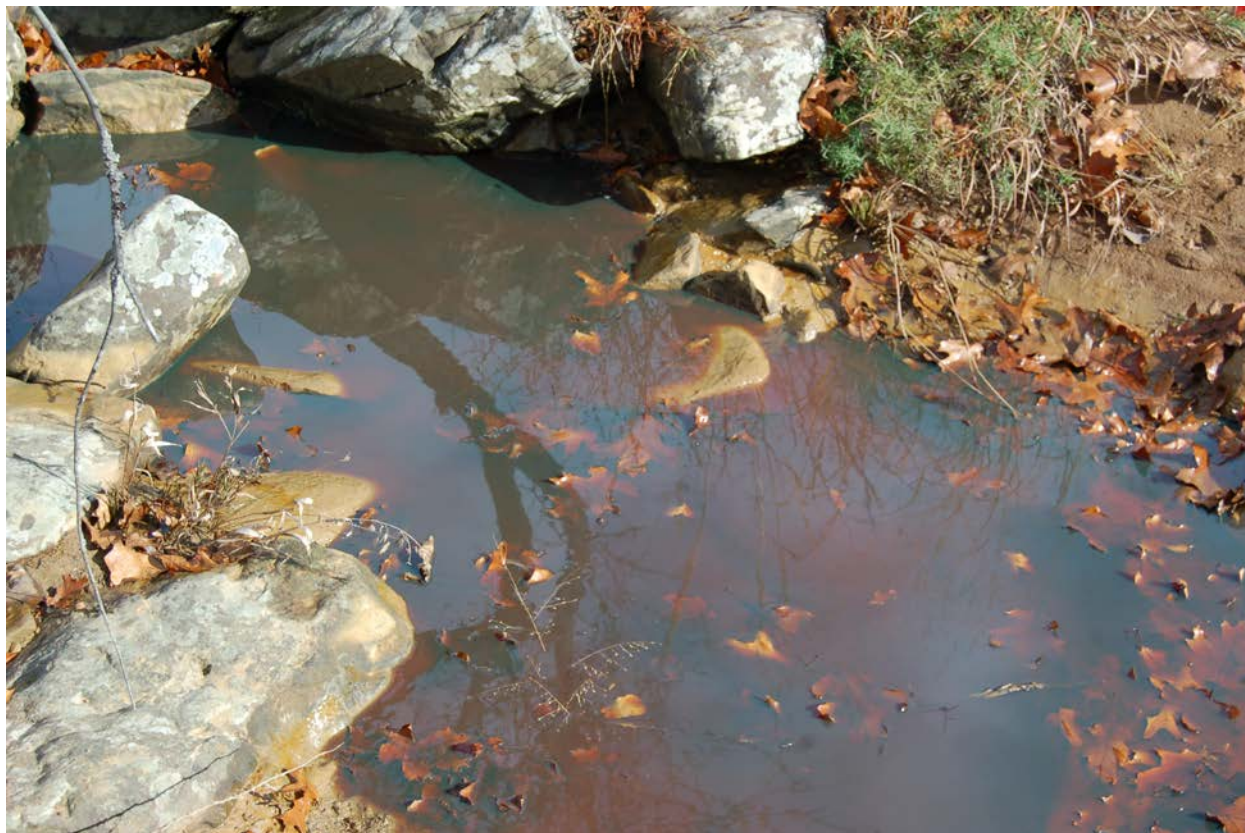
Photo No. 12

Description: I observed that oil and brine fluids were pooled in the ravine below the pad site.

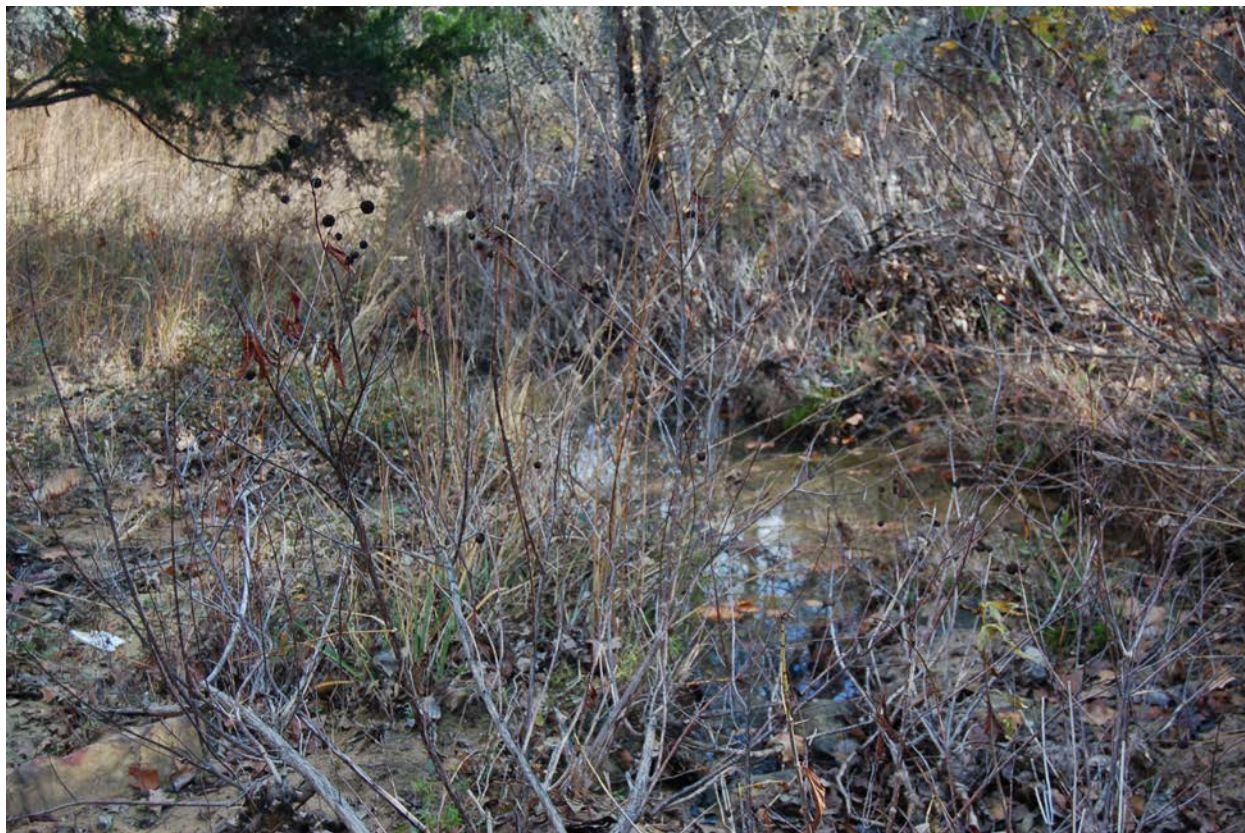
Photo No. 13

Description: This was the point where the drainage ravine meets the tributary of Coal Creek. That tributary joins the ravine from the northwest and then flows south and east toward the main branch of Coal Creek.

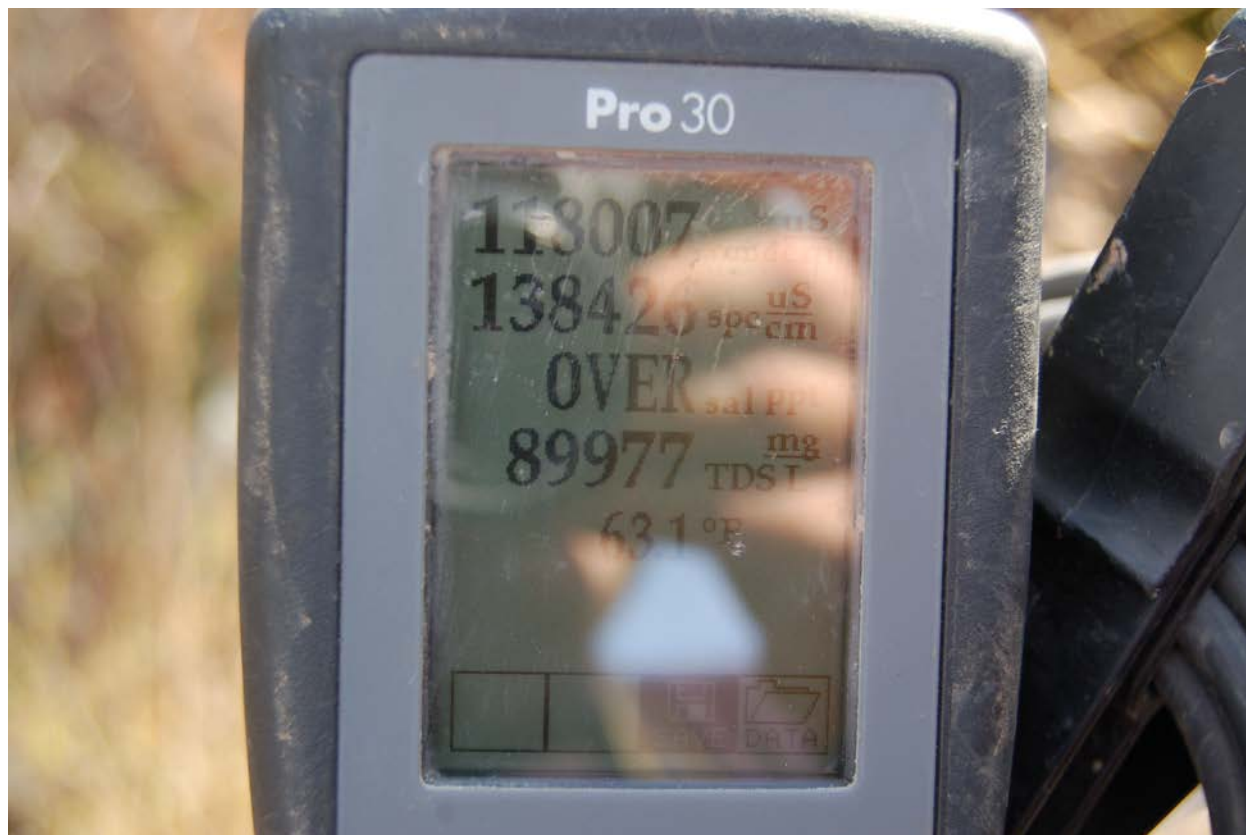
Photo No. 14

Description: The TDS at the point of entry to the tributary of Coal Creek was 89,977 mg/L.

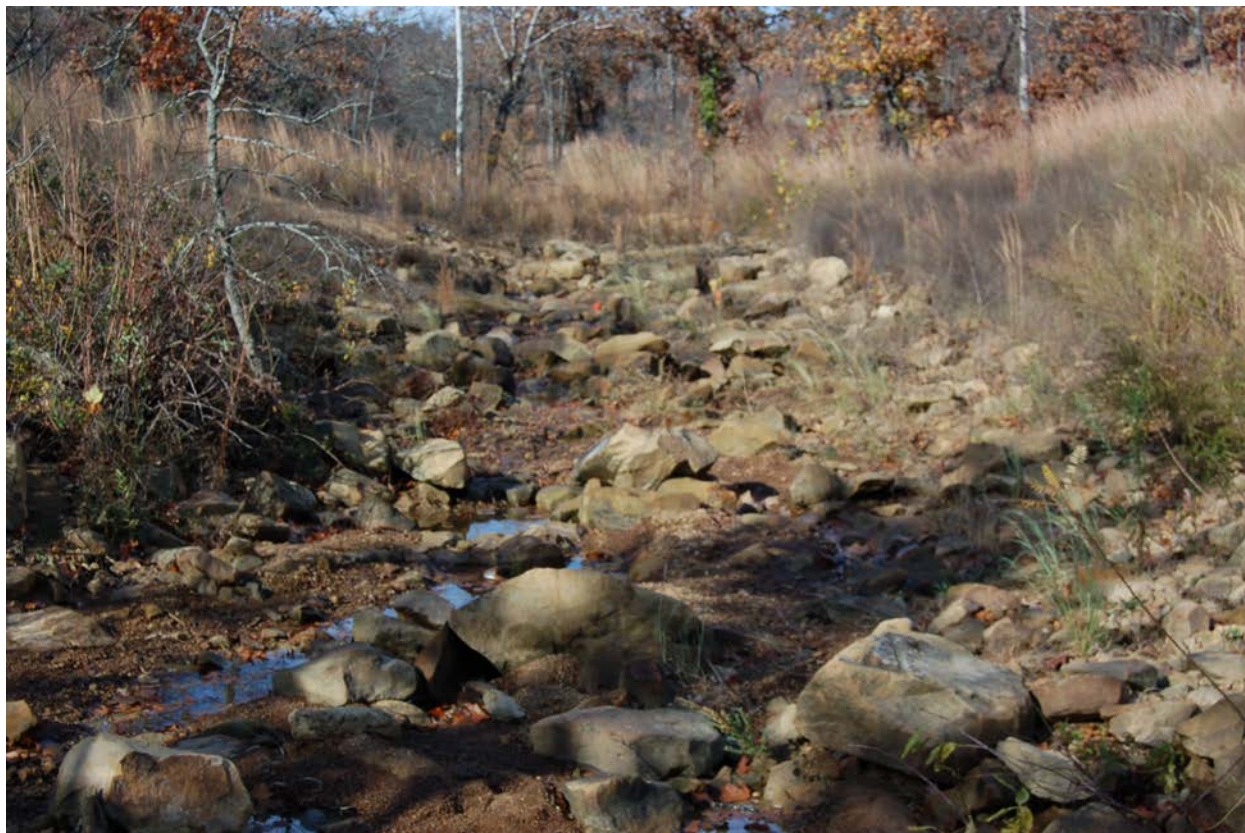
Photo No. 15

Description: The brine traveled south in the tributary. I did not observe oil or oil sheen at this location.

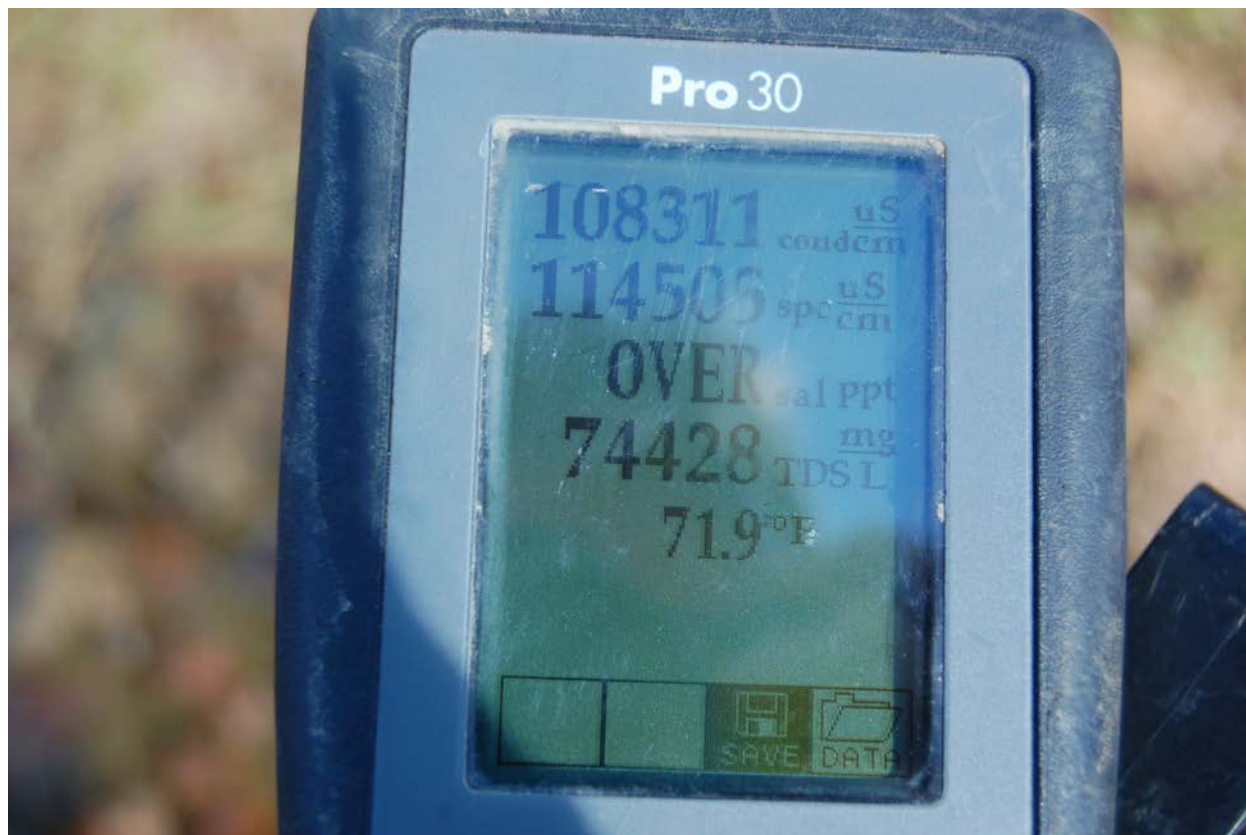
Photo No. 16

Description: TDS was 74,428 mg/L at the location shown in photo 15.

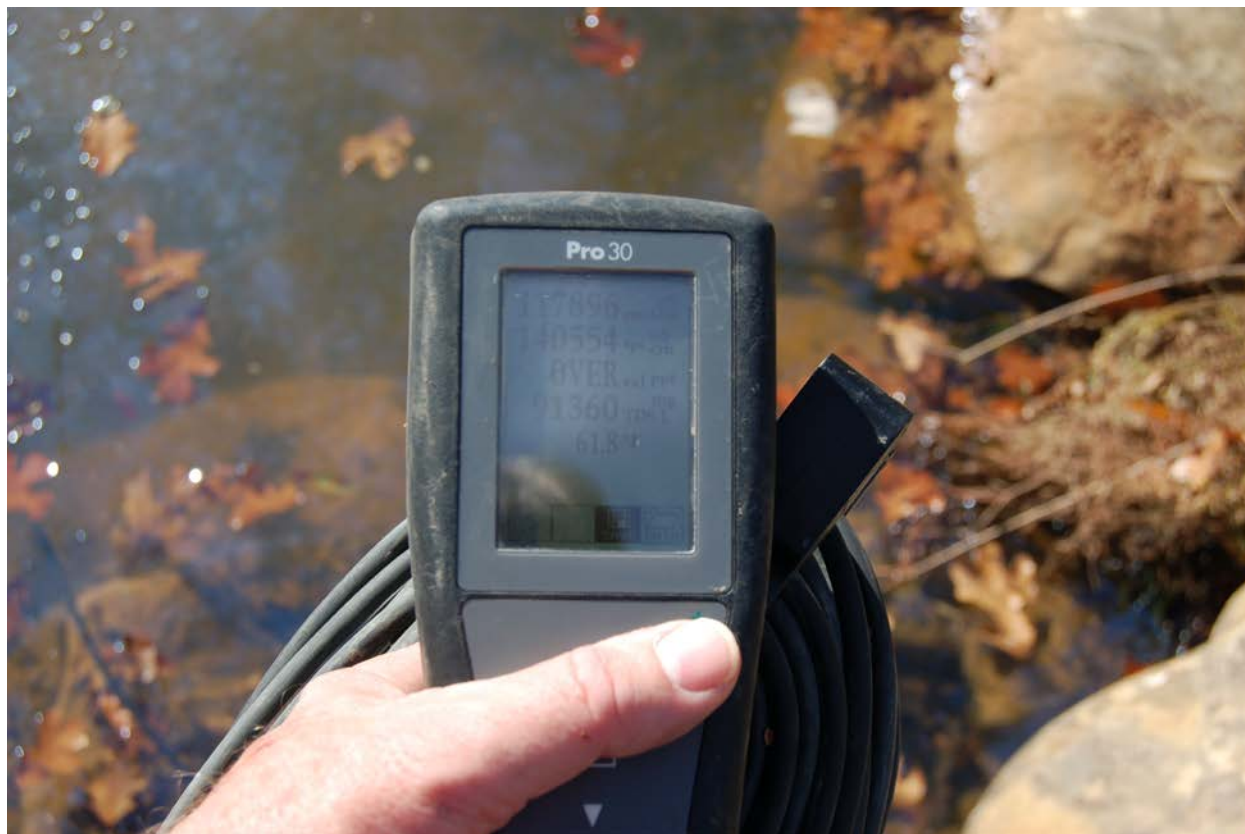
Photo No. 18

Description: TDS of the location shown in photo 17 was 91,360 mg/L.

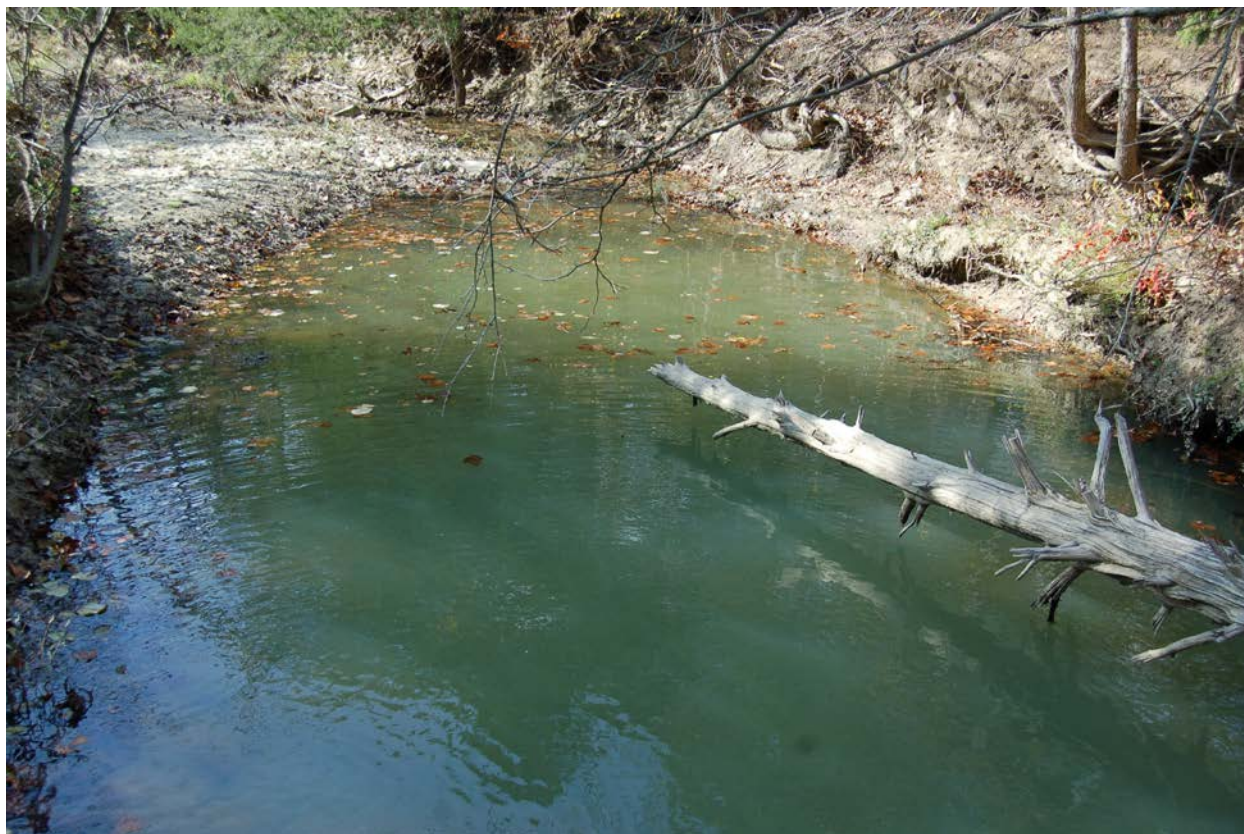
Photo No. 19

Description: This photo shows the location where the tributary enters Coal Creek. I observed that no brine or oil has reached this point during the inspection. TDS ranged from 150-250 mg/L (background TDS readings for this area).

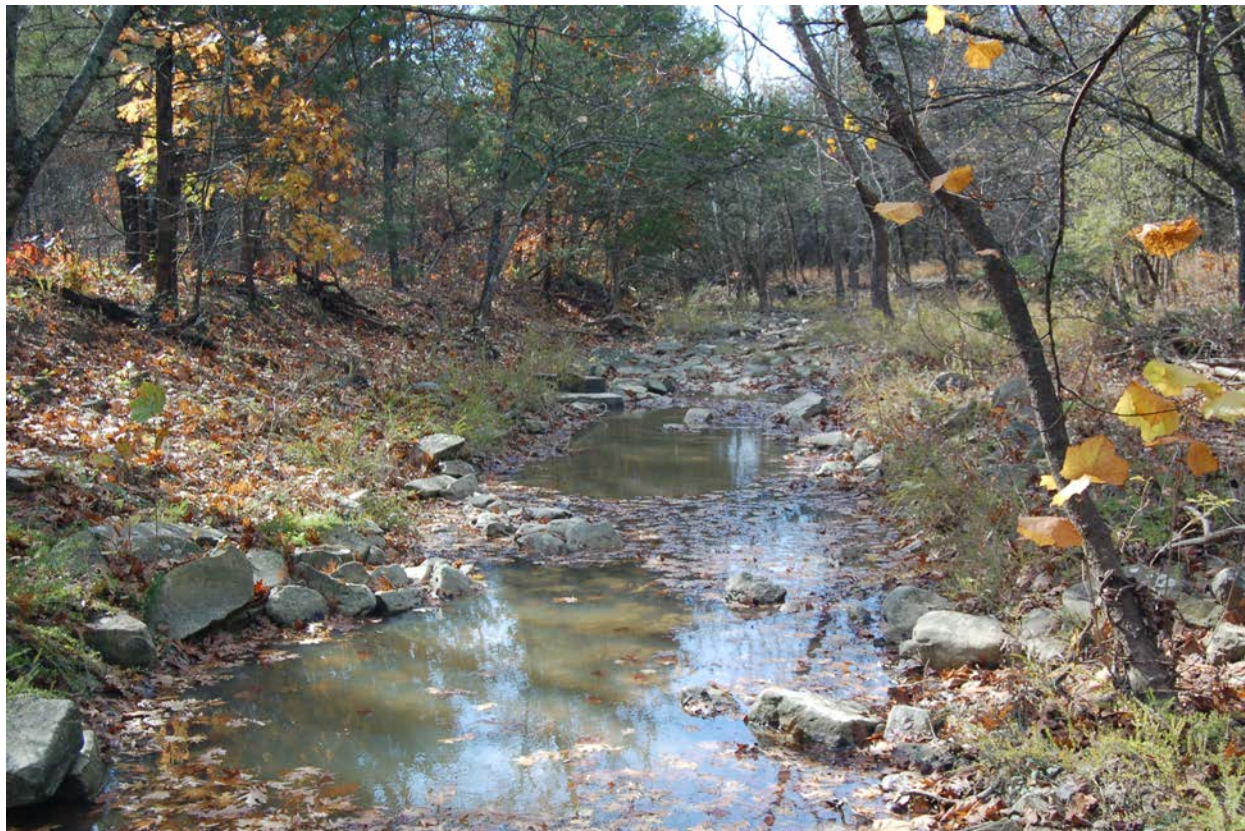
Photo No. 20

observe that this portion of Coal Creek was effected by the spill. I observed that all of the TDS field measurements ranged from 150 to 250 mg/L in the area near the confluence of the tributary of Coal Creek and Coal Creek downstream from the discharge. Photo 20 shows Coal Creek about a half a mile downstream of the point shown in Photo 19. Coal Creek as this location had TDS readings that ranged from 150-250 mg/L.

Description: This was the main part of Coal Creek even farther east of the location shown in Photo 19.

TDS ranged from 150-250 mg/L (background).
