## Region 6 - Enforcement & Compliance Assurance Division

### INSPECTION REPORT

| Company Name: | <b>Hanna Oil and Gas Company</b> | |
| Facility Name: | <b>Lincoln #2 &amp; Ballentine #1 Tank Battery</b> | |

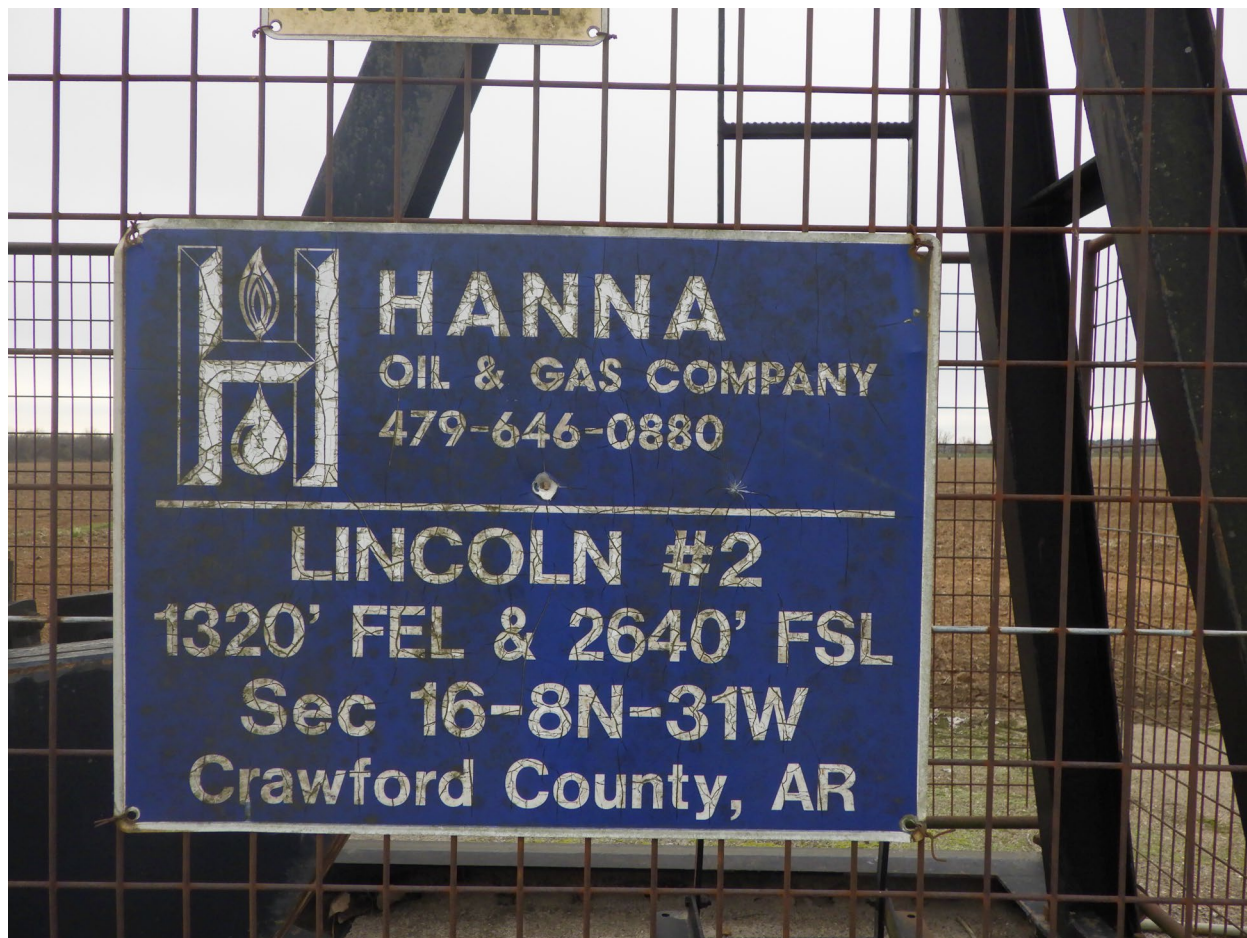
Photo No. 1

**Description:** Looking SSE, this photo shows one of two signs for gas wells associated with the facility.

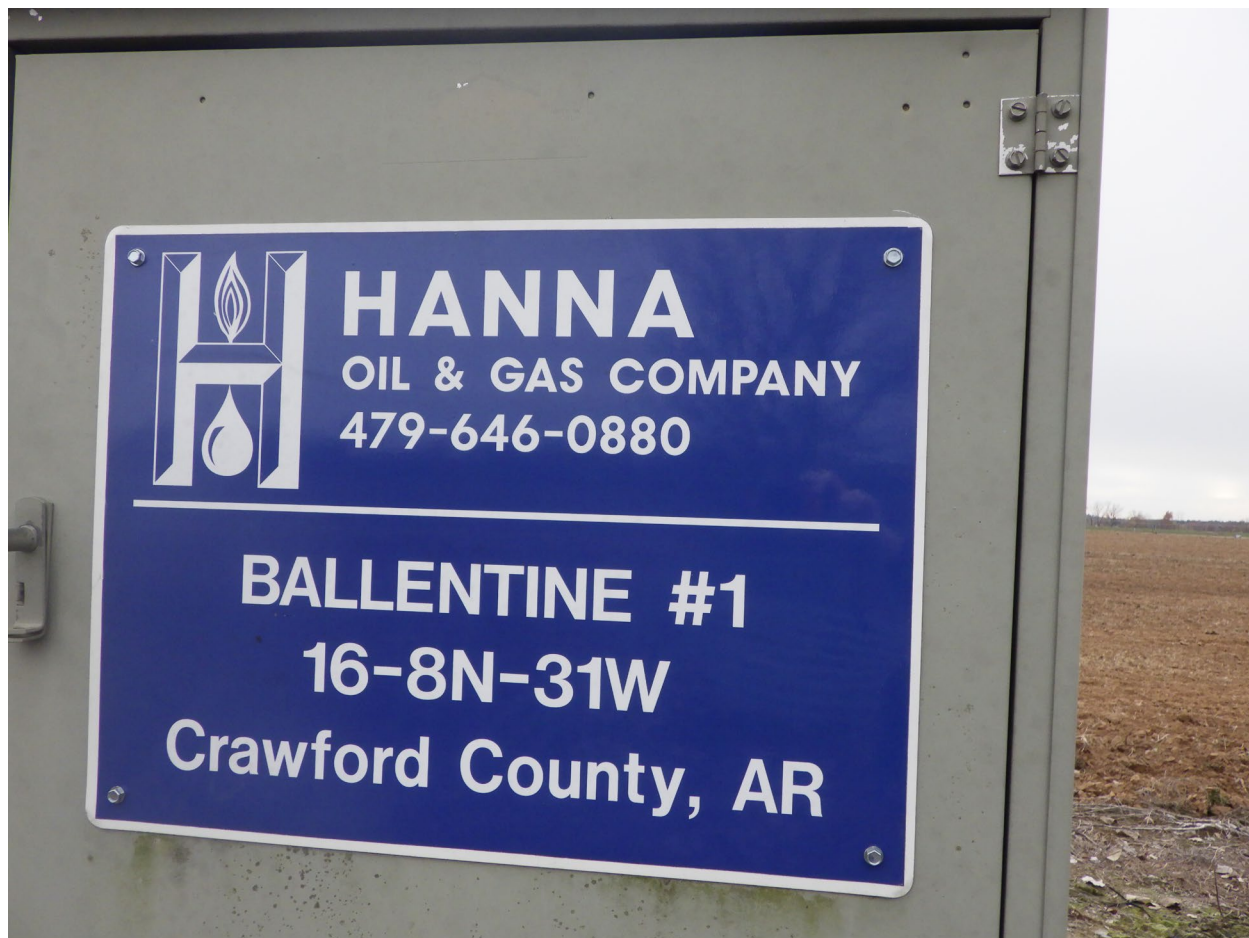
Photo No. 2

**Description:** Looking SE, this photo shows two of two signs for gas wells associated with the facility.

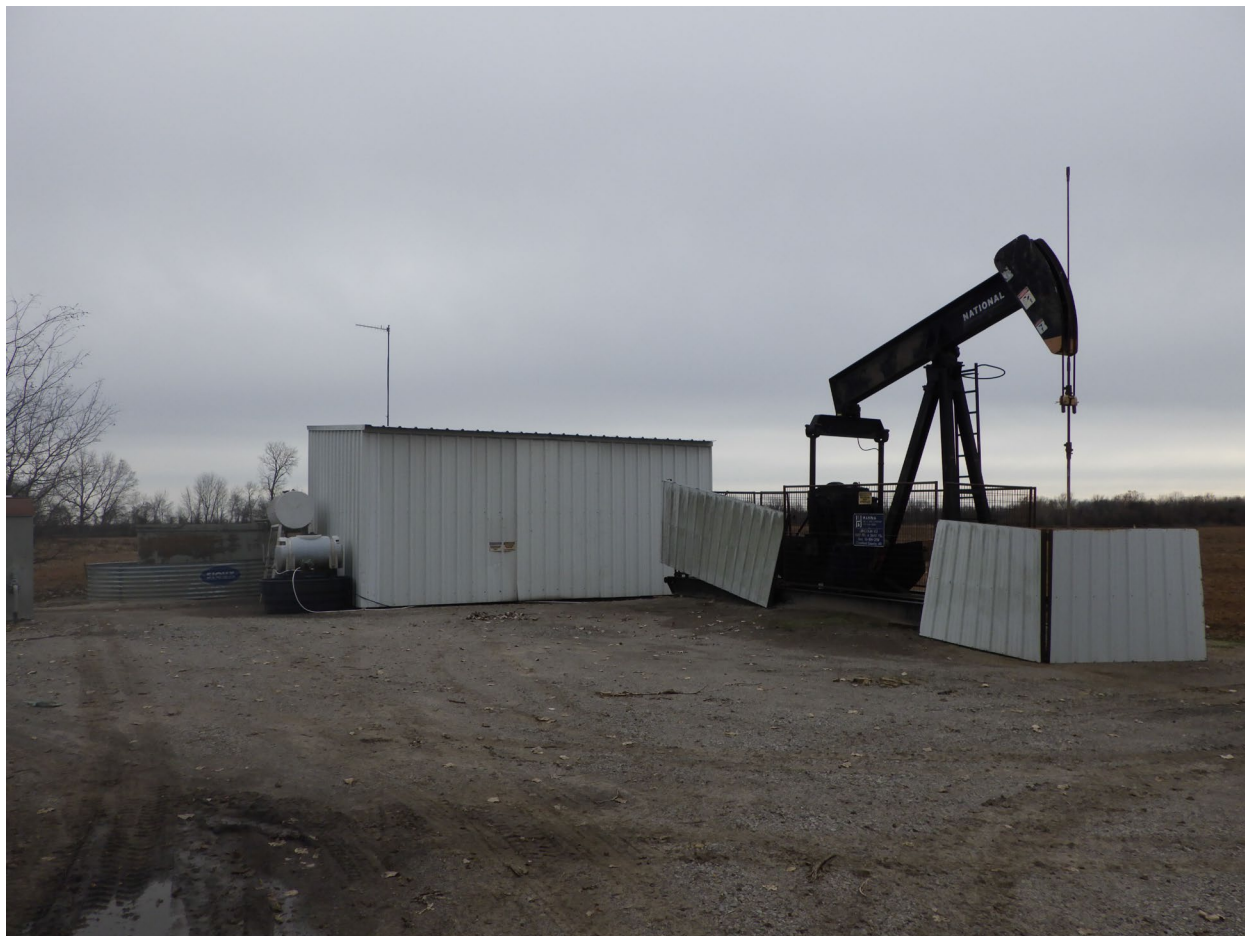
Photo No. 3

**Description:** Looking ESE, this photo shows an overview of the facility.

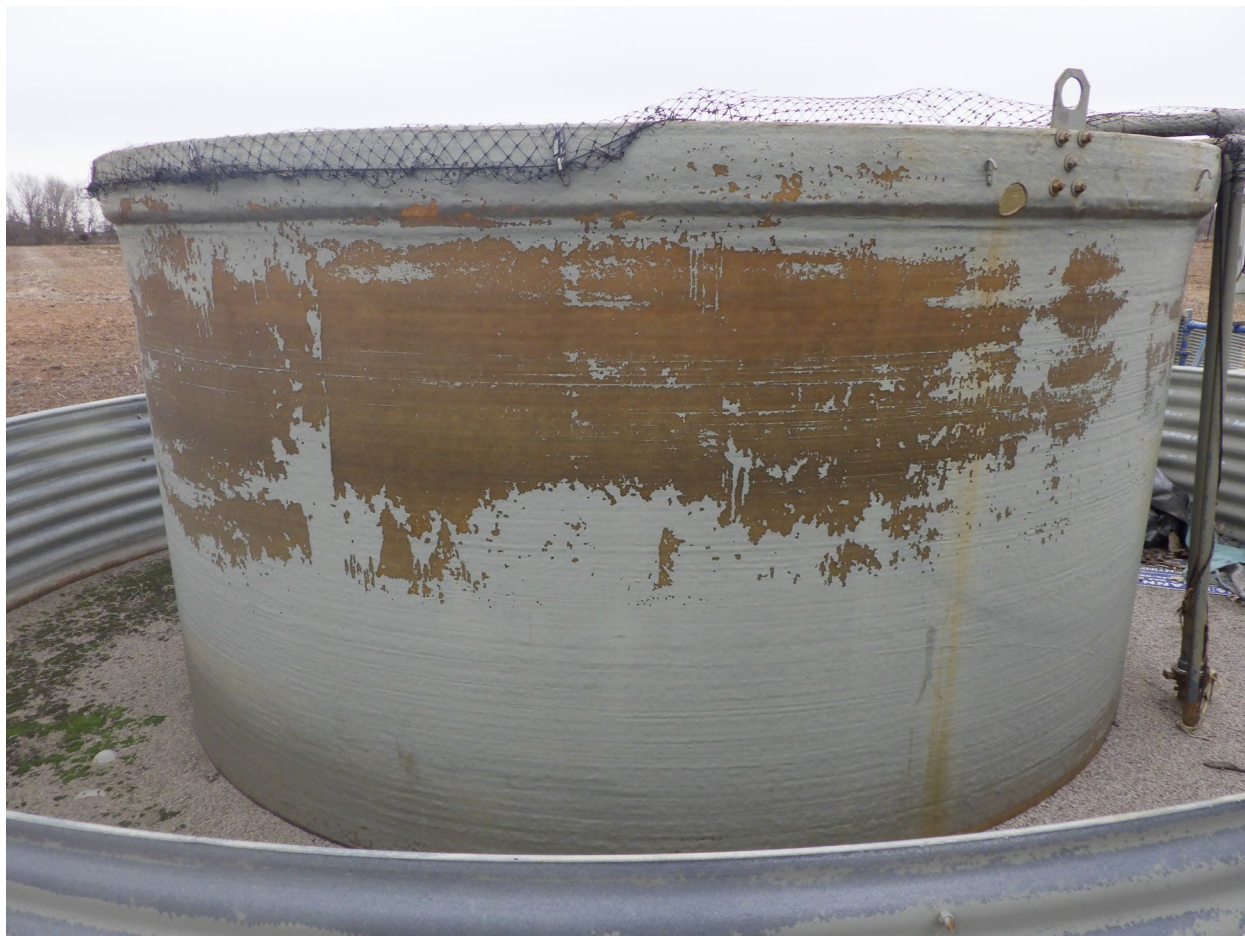
I observed one open-top storage tank (bird netting in place) within secondary containment, see Photo No. 4 and No. 5.

**Description:** Looking E, this photo shows the open-topped produced water tank inside secondary containment.

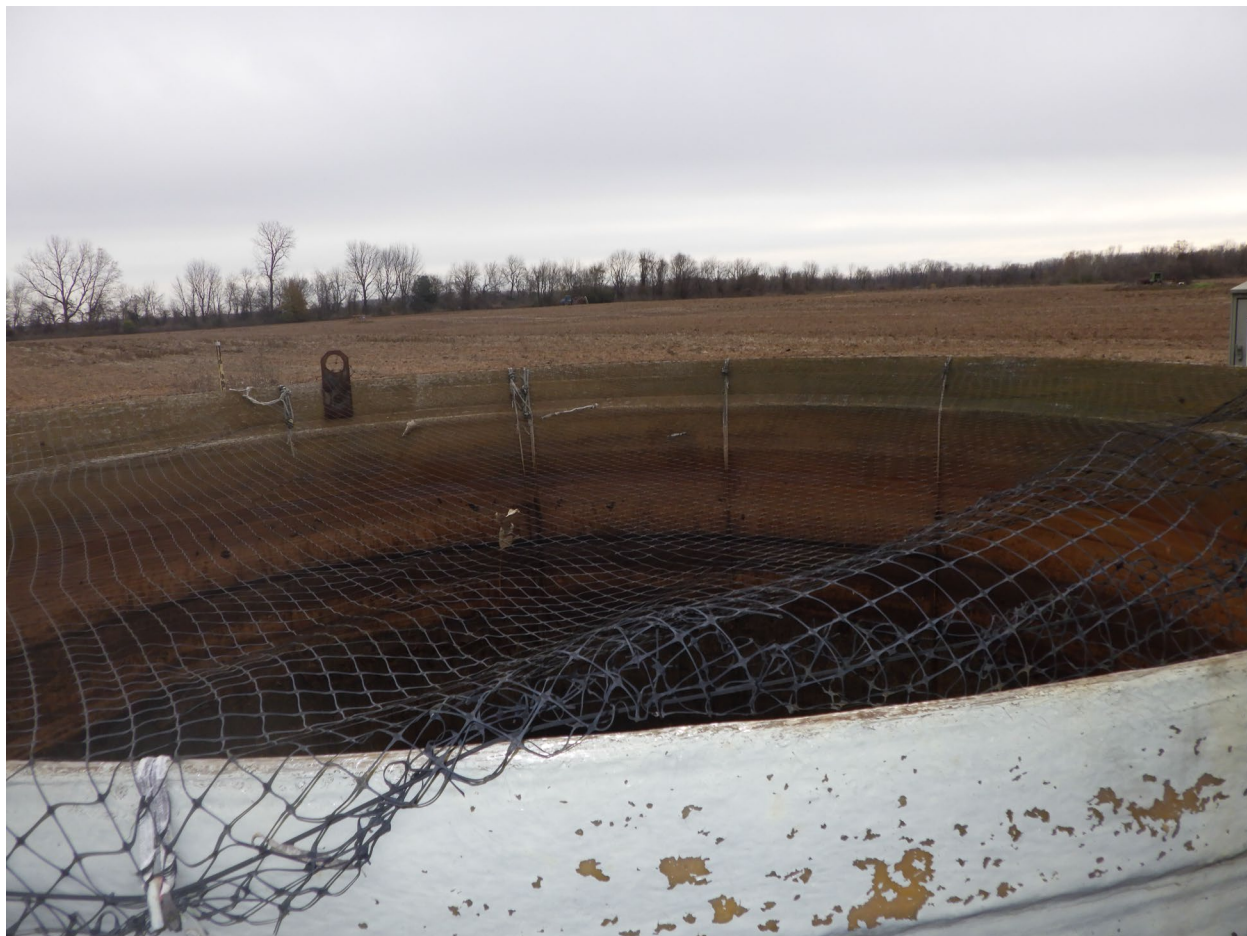
Photo No. 5

**Description:** Looking ESE, this photo shows a closeup of the open-topped storage tank from Photo No. 4 with bird netting applied.

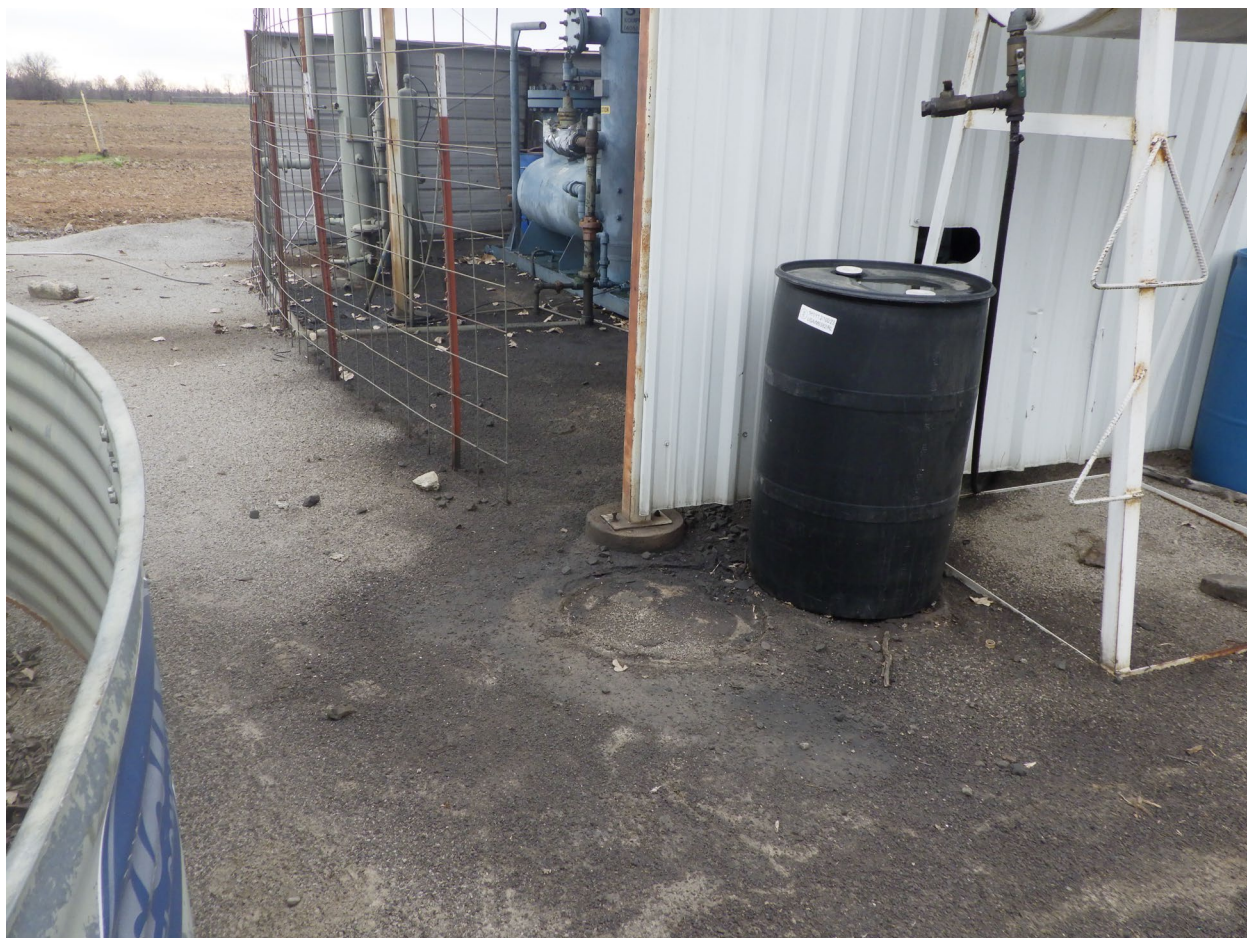
I observed the compressor onsite with an active hydraulic oil leak, see Photo No. 6 and No. 7.

- An active hydraulic oil leak from the compressor.

**Description:** Looking SE, this photo shows an active, ongoing leak of hydraulic oil from the compressor onsite.

Inspector will conduct follow-up phone calls and emails with the company representative(s) over the coming weeks and months to ensure areas of concern are properly addressed.

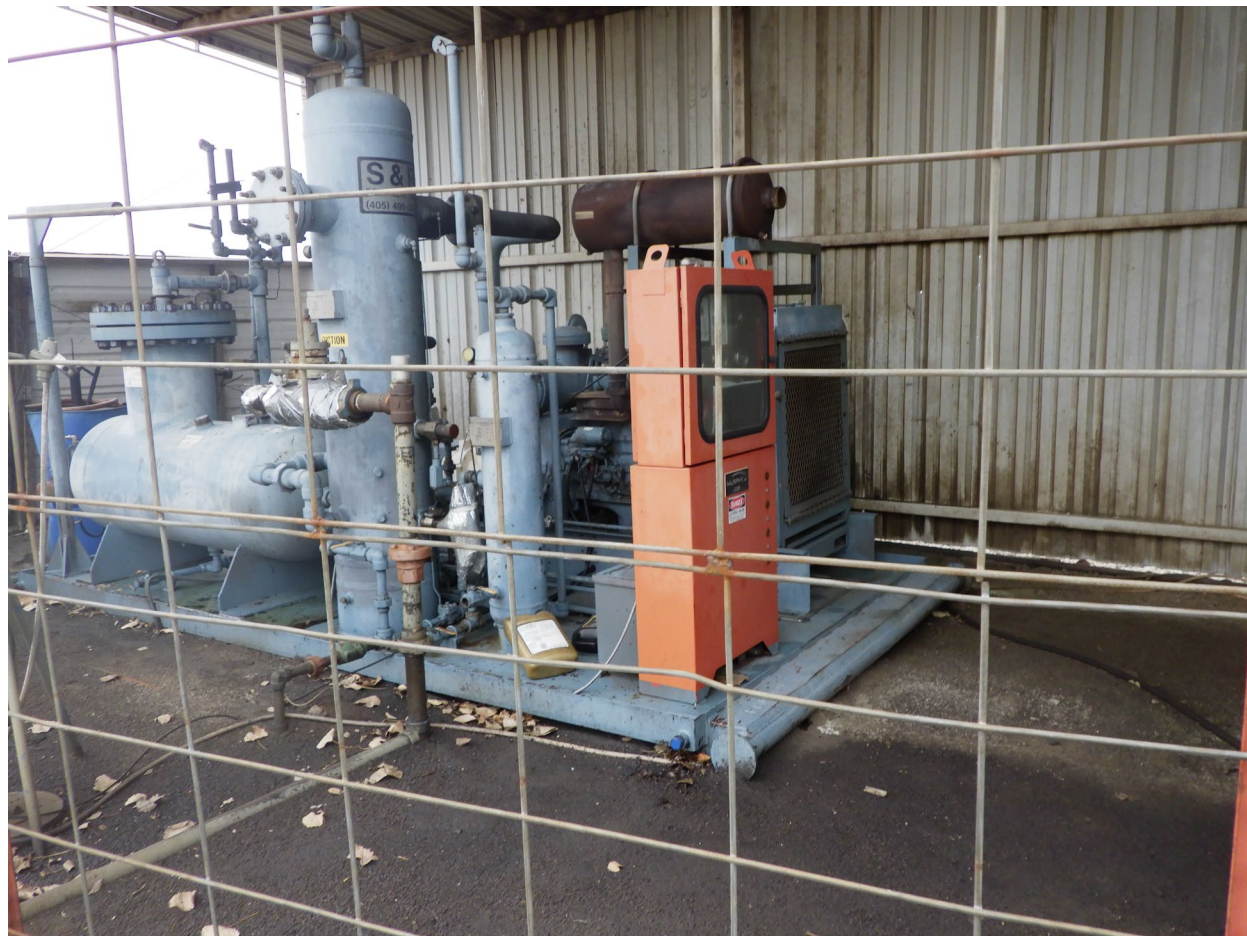
Photo No. 7

**Description:** Looking WSW, this photo shows an additional view of the compressor from Photo No. 6. Note oil staining around compressor.

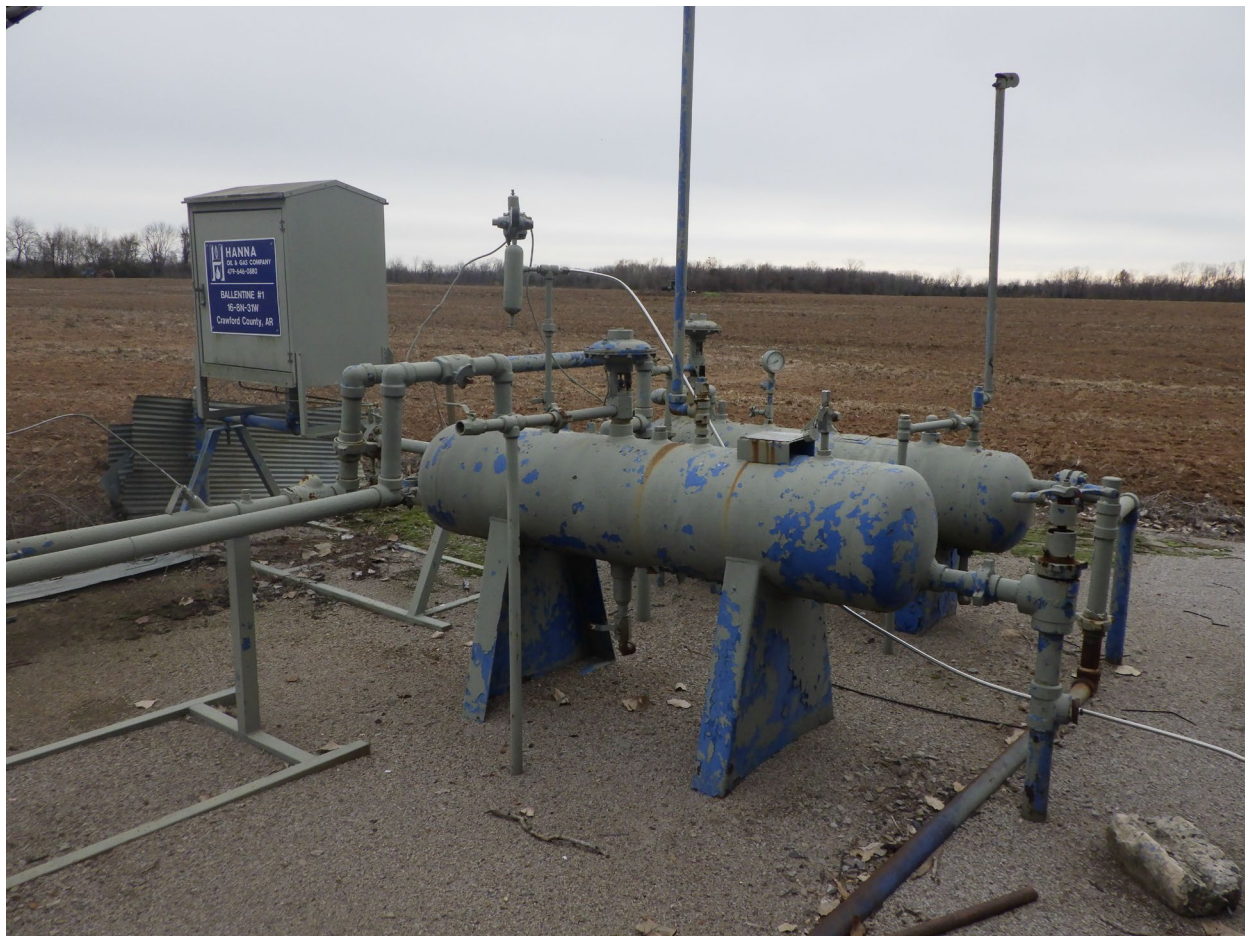
Photo No. 8

I observed the two 2-phase gas-water separators onsite, see Photo No. 8.

**Description:** Looking SE, this photo shows the two 2-phase gas-water separators for the gas wells.
