RE: BFG Accident: Case History Presentation

GEON VINYL DIVISION  
AVON LAKE GENERAL CHEMICAL PLANT  
Avon Lake, Ohio  
Compound Incident  
Repetitive Accident Type 8  
Chemical Fire

Summary

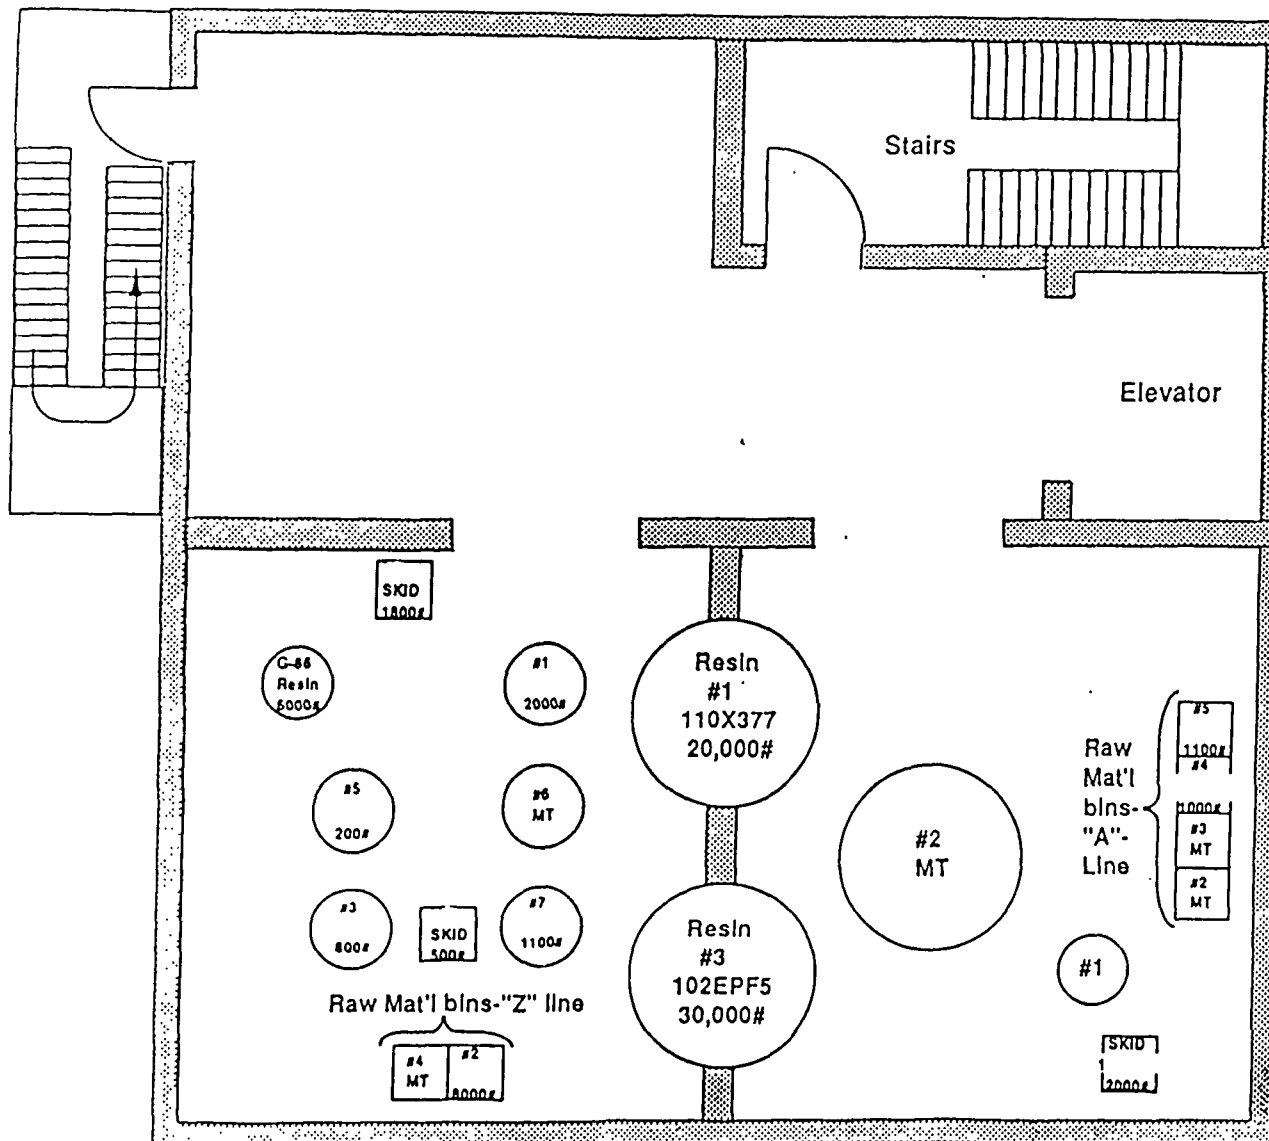
COMPOUND BUILDING, B/441  
RAW MATERIAL STORAGE BINS  
FOURTH FLOOR

On Monday, May 9, 1988 at 8:30 p.m. an explosion was experienced on the fourth floor of Compounding Building 441. The explosion emanated from bin #2 on "Z" line. The manway opened under pressure releasing a dusty material, an acrylic impact modifier, to the fourth floor. The initial explosion damaged #2 raw material receiving bin. It was rapidly followed by a secondary explosion and fire resulting from quantities of accumulated dust from horizontal surfaces which had become airborne after the initial explosion. Following the explosion, raw materials continued to burn on the fourth floor for approximately two hours.
