October 15, 1940

Memorandum on Baton Rouge Visit

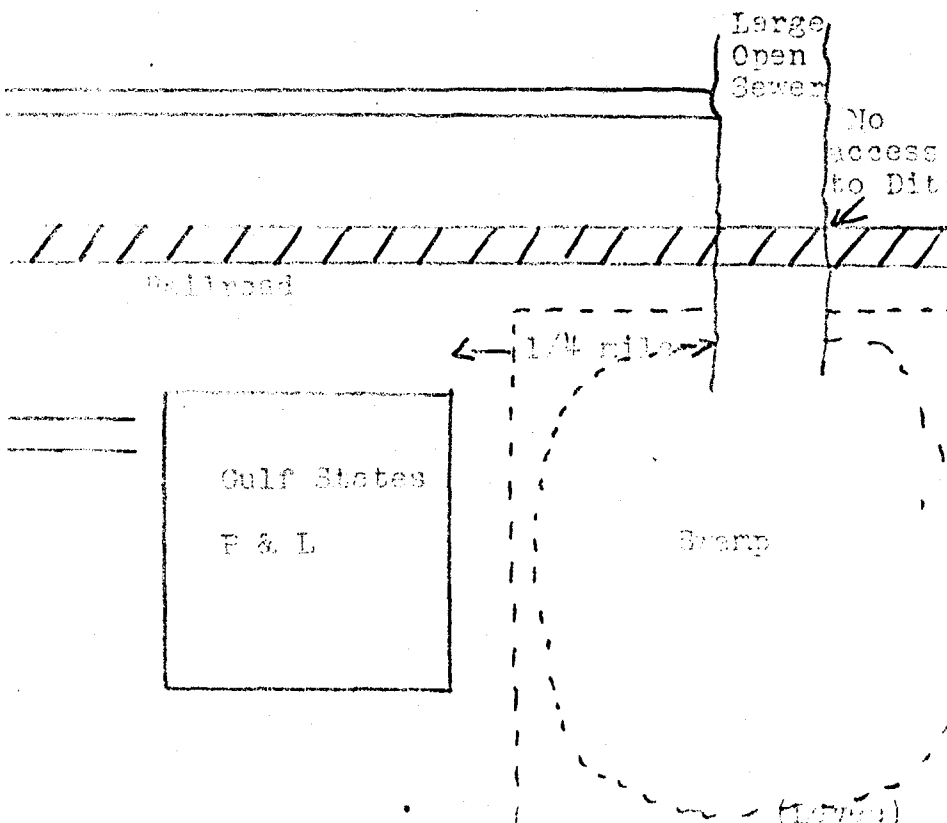
For the past few months the sludge washed from tank cars has been passed directly into the sewer instead of being transferred first to the sludge pit (bismuth). This adds further to the contamination of the water leaving the Lead Plant and passing into the Jersey sewer and thence into the river. This sewer line was traced and found to conform to the attached plan. Except where the line crosses the road (beneath the ground), the sewer is entirely within the property limits of the duPont or Jersey Companies. The swamp into which it drains prior to seepage into the river, is entirely fenced in on the property of the Jersey Company and would appear to be entirely safe in so far as inadvertent access is concerned.

A further problem may be created by the deposition of the sludge in the sewer line for the line from the Tank Car Wash House

enters the main sewer (process ditch) beyond the separator. A manhead at this juncture makes inspection possible.

(Separator cleaned by operating crew 1 x in 2 mo.)
