## **RCRA Inspection Report**

Marsh Furniture Company (MFC)  
1001 South Centennial Street  
Hight Point, North Carolina 27261

March 20, 2023

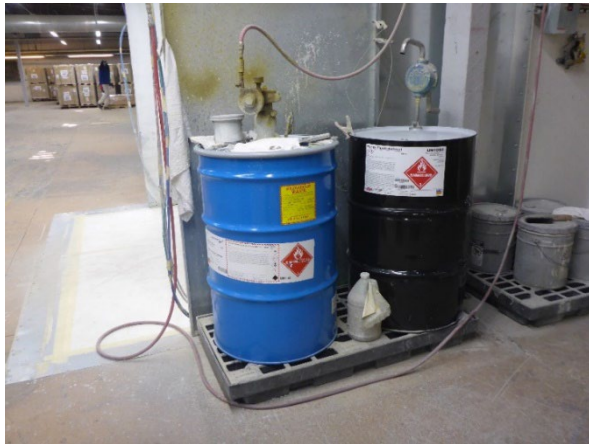
At the time of the inspection, MFC was still operating one offline manual spray booth (SB-13) in the Upstairs Roller Room. The facility manages one SAA in this area for accumulating line flush and spent solvents used to clean the spray gun and equipment in this manual spray booth. The inspectors observed one 55-gallon drum in this SAA (Photo 1). The drum was located on a secondary containment pallet next to the booth and it was equipped with an agitator. Bruce Braswell explained that MFC adds a neutralizer to a new drum before it is used to accumulate spent solvents. The agitator disperses this neutralizer, which prevents the waste from hardening so that it can be pumped from the drum into a tanker truck for transport off-site. The drum was labeled as waste paint related material and D001, F003, F005 hazardous waste. The drum was

**Upstairs Roller Room - Photo 1:** 55-gallon drum on a secondary containment pallet in the Upstairs Roller Room SAA. Drum was labeled hazardous waste D001, F003, F005 waste paint related material and marked with an indication of the hazards on the product label.

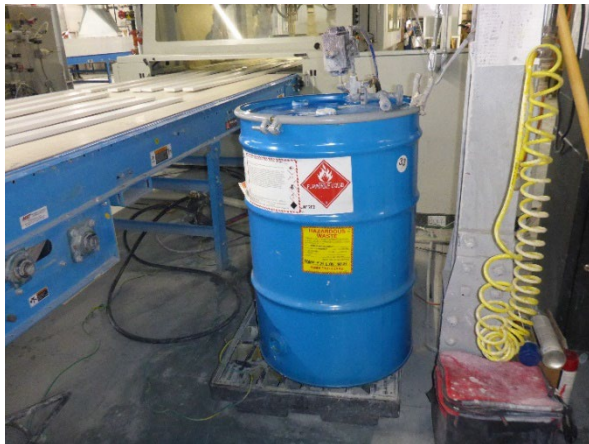
**Upstairs Barberan Paint Line - Photo 2:** 55-gallon drum on a secondary containment pallet in the Barberan #5 Liquid SAA. Drum was labeled hazardous waste D001, F003, F005 waste paint related material and marked with an indication of the hazards on the product label.

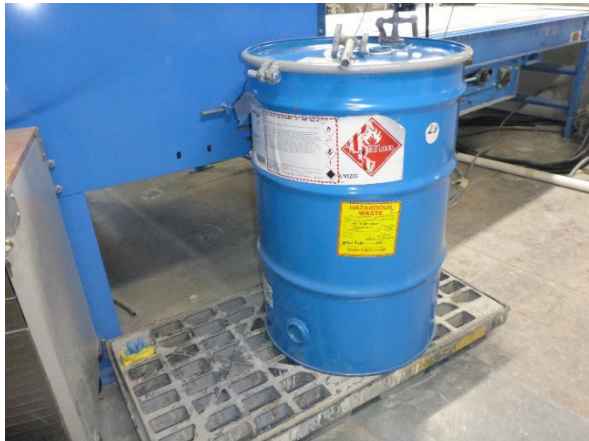
**Upstairs Barberan Paint Line - Photo 3:** 55-gallon drum on a secondary containment pallet in the Barberan #6 Liquid SAA. Drum was labeled hazardous waste D001, F003, F005 waste paint related material and marked with an indication of the hazards on the product label.

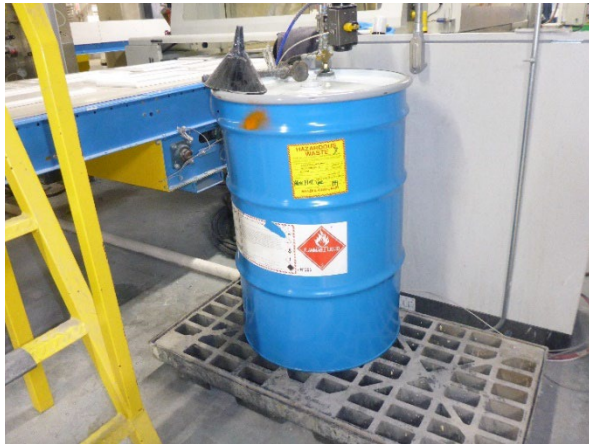
**Upstairs Barberan Paint Line - Photo 4:** 55-gallon drum on a secondary containment pallet in the Barberan #7 Liquid SAA. Drum was labeled hazardous waste D001, F003, F005 waste paint related material and marked with an indication of the hazards on the product label.

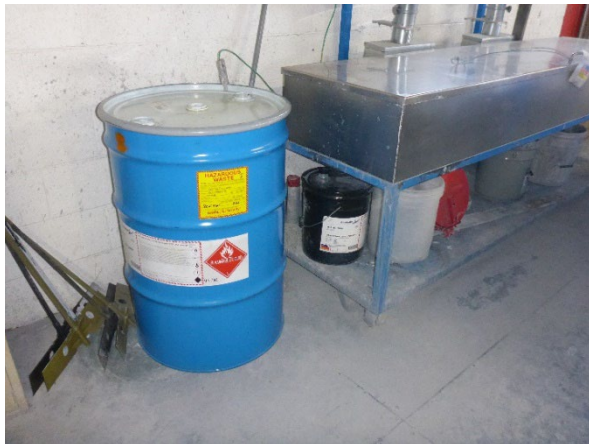
According to Bruce Braswell, the facility does not typically manage SAAs at the parts-washing sinks. However, MFC was managing one active SAA at the Barberan #6 parts-washing sink at the time of the inspection. The inspectors observed one 55-gallon drum in this SAA (Photo 5). The drum was labeled as waste paint related material and D001, F003, F005 hazardous waste (Photo 6). It was also identified with a flammable liquid DOT hazard placard and other GIS hazards on the original product label associated with that drum (Photo 7).

**Upstairs Barberan Paint Line - Photo 5:** 55-gallon drum in the Barberan #6 Parts Washer SAA. Drum was labeled hazardous waste D001, F003, F005 waste paint related material and marked with an indication of the hazards on the product label.

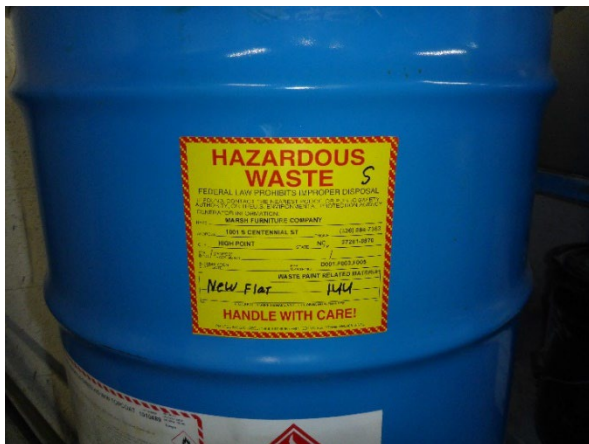
**Upstairs Barberan Paint Line - Photo 6:** Close-up of label on 55-gallon drum in the Barberan #6 Parts Washer SAA shown in Photo 5. Drum was labeled hazardous waste D001, F003, F005 waste paint related material.

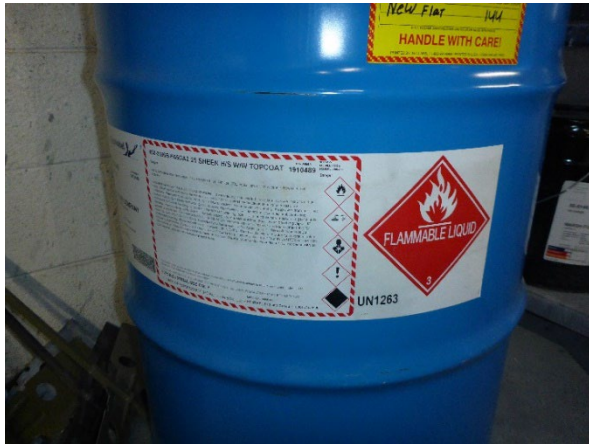
**Upstairs Barberan Paint Line - Photo 7:** Close-up of label on 55-gallon drum in the Barberan #6 Parts Washer SAA shown in Photo 5. Drum was marked with an indication of the hazards on the product label.

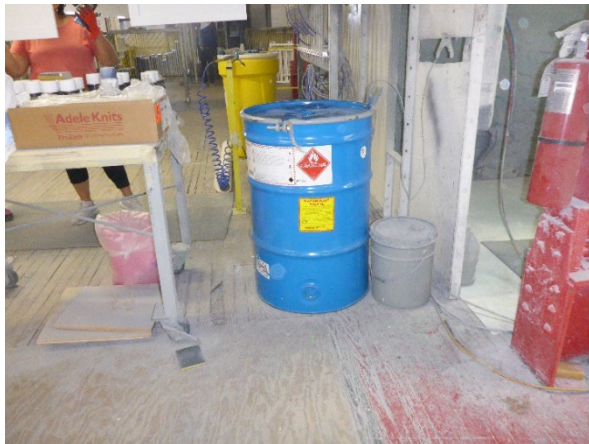
**Upstairs New Hanging Lines - Photo 8:** 55-gallon drum in the New Hanging Line 1 Stage 3.1 (NHL 1 S – 3.1) SAA. Drum was labeled hazardous waste D001, F003, F005 waste paint related material and marked with an indication of the hazards on the product label.

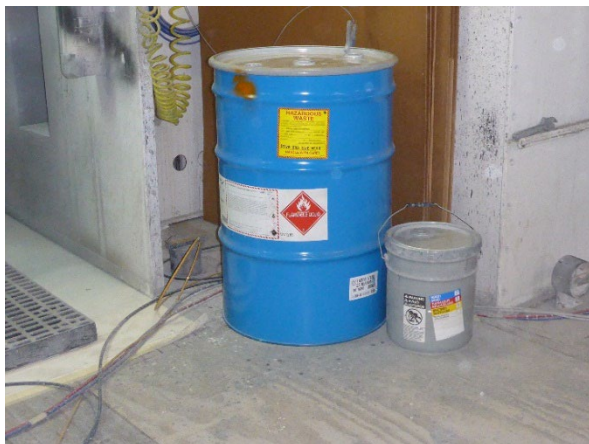
**Upstairs New Hanging Lines - Photo 9:** 55-gallon drum in the New Hanging Line 1 Stage 3.2 (NHL 1 S – 3.2) SAA. Drum was labeled hazardous waste D001, F003, F005 waste paint related material and marked with an indication of the hazards on the product label.

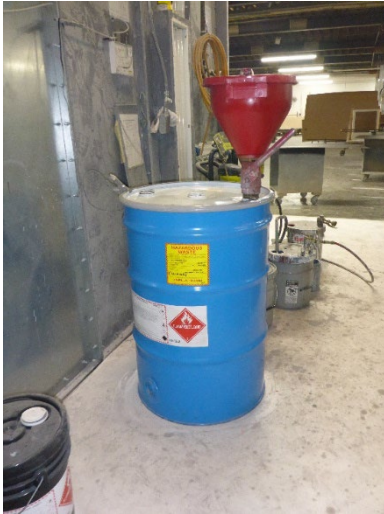
**Custom Modification Shop - Photo 10:** 55-gallon drum in the Custom Modification Shop Spray Booth SAA. Drum was labeled hazardous waste D001, F003, F005 waste paint related material and marked with an indication of the hazards on the product label.

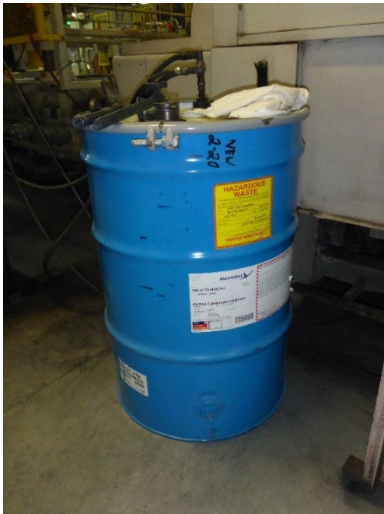
- One 55-gallon drum (Photo 11) used to accumulate waste paint related material generated from flushing stain lines and spray guns with cleaning solvents and from cleaning overspray off the conveyor belt used to transfer cabinetry part through the Barberan unit. The drum was labeled as waste paint related material and D001, F003, F005 hazardous waste. It was also identified with a flammable liquid DOT hazard placard and other GIS hazards on the original product label associated with the drum.

**Downstairs Barberan Stain Line - Photo 11:** 55-gallon drum in the First Stage Stain Finishing Line Flush SAA. Drum was labeled hazardous waste D001, F003, F005 waste paint related material and marked with an indication of the hazards on the product label.

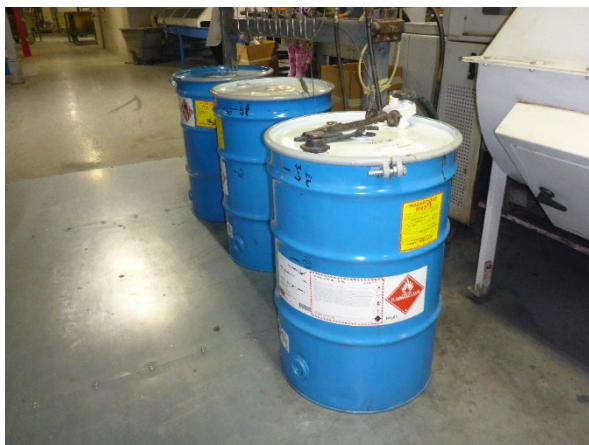
- One 55-gallon drum (Photo 12) used to accumulate waste paint related material generated from cleaning overspray off the conveyor belt used to transfer cabinetry parts through the Barberan unit. This drum was labeled as waste paint related material and D001, F003, F005 hazardous waste. It was also identified with a flammable liquid DOT hazard placard and other GIS hazards on the original product label associated with the drum.

It appears that the total volume of D001, F003, F005 hazardous waste paint related material exceeded 55-gallons in the SAA for accumulating waste paint related material generated by the process used to apply the second coat of stain.

**Pursuant to 15A NCAC 13A .0107(a) [40 C.F.R. § 262.15(a)(6)], a generator who accumulates hazardous waste in excess of 55 gallons must, with respect to that amount of excess waste, comply with 15A NCAC 13A .0107(a) [40 C.F.R. § 262.17(a)] or remove the excess waste from the SAA within three consecutive calendar days. During the three-consecutive-calendar-day period the generator must mark or label the container(s) holding the excess accumulation of hazardous waste with the date the excess amount began accumulating.**

**Downstairs Barberan Stain Line - Photo 12:** 55-gallon drum in the Second Stage Stain Finishing Line Wipe Rags SAA (on left), the Second Stage Stain Finishing Filters SAA (in the middle), and the Second Stage Finishing Overspray SAA (on right). Drum on the left was labeled hazardous waste D001 flammable paint rags; drum in the middle was labeled hazardous waste D001 solid paint filters; and drum on the right was labeled hazardous waste D001, F003, F005 waste paint related material. Each drum was marked with an indication of the hazards on the product label.

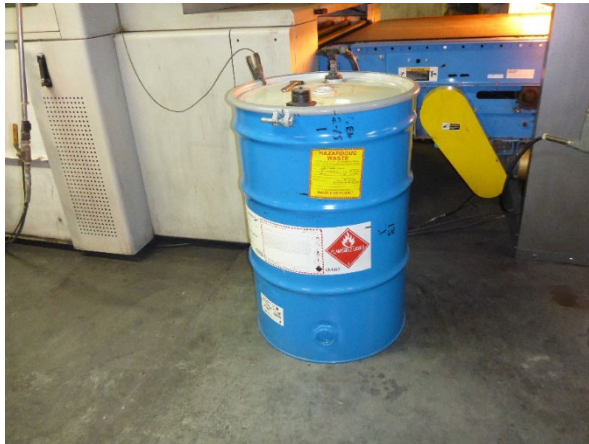
- One 55-gallon drum (Photo 13) used to accumulate waste paint related material generated from flushing stain lines and spray guns with cleaning solvents in the Barberan unit. The drum was labeled as waste paint related material and D001, F003, F005 hazardous waste. It was also identified with a flammable liquid DOT hazard placard and other GIS hazards on the original product label associated with the drum.

**Downstairs Barberan Stain Line - Photo 13:** 55-gallon drum in the Second Stage Stain Finishing line flush liquids SAA. Drum was labeled hazardous waste D001, F003, F005 waste paint related material and marked with an indication of the hazards on the product label.

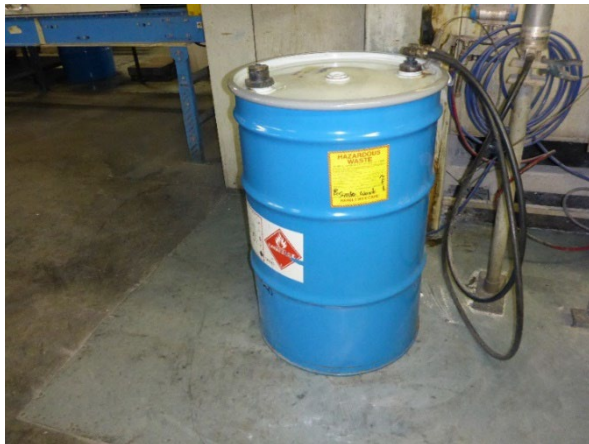
- One 55-gallon drum (Photo 14) used to accumulate waste paint related material generated from cleaning overspray off the conveyor belt used to transfer parts through in the Barberan unit. Although the drum was labeled as hazardous waste, the specific information on the label did not accurately identify the contents of the container (Photo 15). The drum was labeled as flammable solid paint filters and D001 hazardous waste. It was also identified with a flammable solid DOT hazard placard and other GIS hazards on the original product label associated with the drum. Personnel immediately replaced the hazardous waste label with one that identified the contents as waste paint related material and D001, F003, F005 hazardous waste. Personnel also replaced the flammable solid DOT hazard placard with a flammable liquid DOT hazard placard.

**Downstairs Barberan Stain Line - Photo 14:** 55-gallon drum in the Stain Finishing Line Sealer Line Flush SAA. Drum was labeled hazardous waste D001 flammable solid paint filters and marked with an indication of the hazards on the product label. Employees immediately replaced the hazardous waste label with one that read hazardous waste D001, F003, F005 waste paint related material.

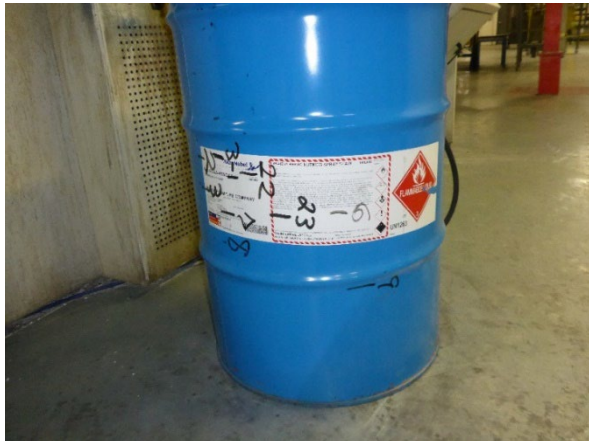
**Downstairs Barberan Stain Line - Photo 15:** Close-up of product label with indication of hazards on 55-gallon drum in the Stain Finishing Line Sealer Line Flush SAA.

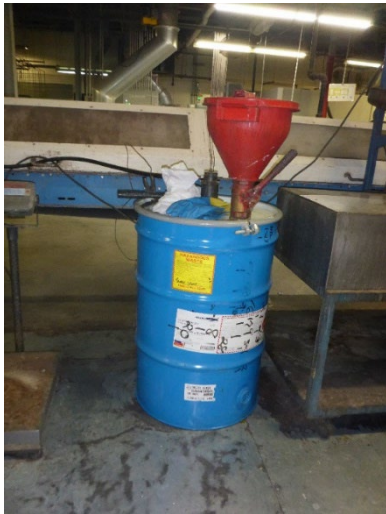
**Downstairs Barberan Stain Line - Photo 16:** 55-gallon drum in the Stain Sealer Line Flush and parts washer vat SAA. Drum was labeled hazardous waste D001, F003, F005 waste paint related material and marked with an indication of the hazards on the product label.

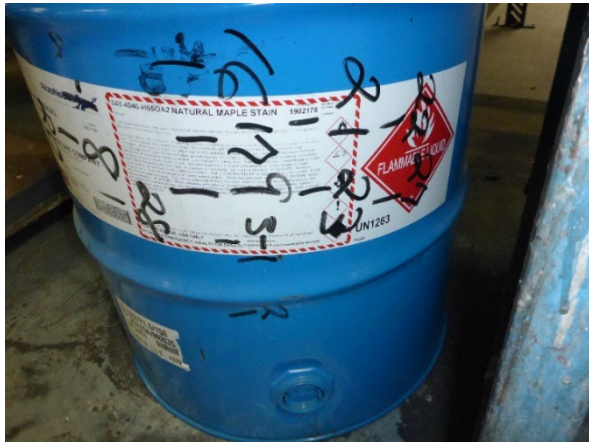
**Downstairs Barberan Stain Line - Photo 17:** Close-up of product label on 55-gallon drum in the Stain Sealer Line Flush and parts washer vat SAA.

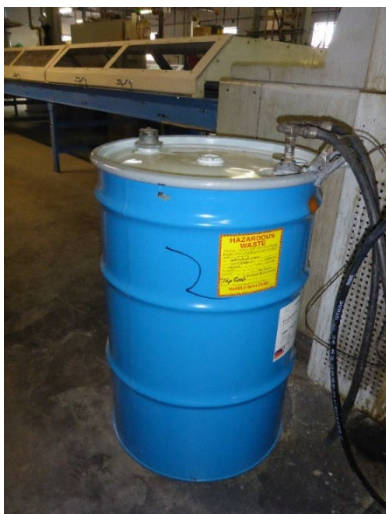
**Downstairs Barberan Stain Line - Photo 18:** 55-gallon drum in the Stain Topcoat Overspray Liquid SAA. Drum was labeled hazardous waste D001, F003, F005 waste paint related material and marked with an indication of the hazards on the product label.

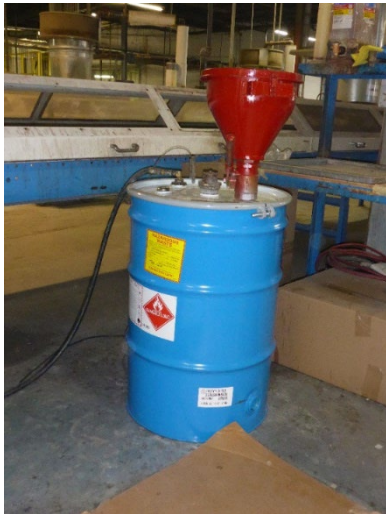
**Downstairs Barberan Stain Line - Photo 19:** 55-gallon drum in the Stain Topcoat Line Flush and parts washer vat SAA. Drum was labeled hazardous waste D001, F003, F005 waste paint related material and marked with an indication of the hazards on the product label.

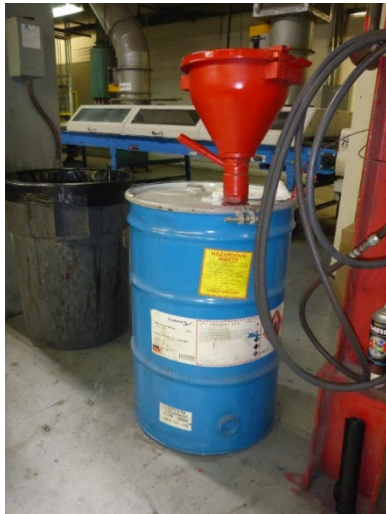
**Downstairs Barberan Stain Line - Photo 20:** 55-gallon drum in the First Stage Stain Finishing Line parts washer vat SAA. Drum was labeled hazardous waste D001, F003, F005 waste paint related material and marked with an indication of the hazards on the product label.

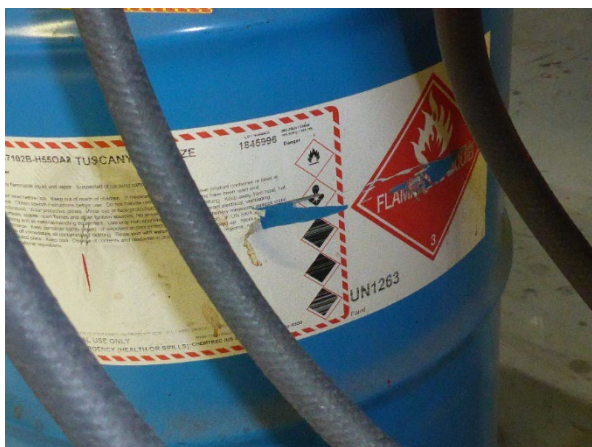
**Downstairs Barberan Stain Line - Photo 21:** Close-up of product label on 55-gallon drum in the Stain Finishing Line parts washer vat SAA.

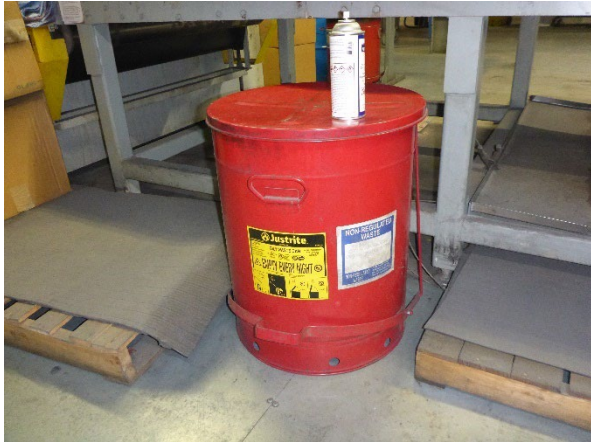
- One 20-gallon flip-top flammable can (Photo 22) used to accumulate wipes that were used to remove excess stain from cabinetry parts following the application of the second coat of stain. The 20-gallon container was labeled “solvent excluded wipes,” but it was not labeled with the words “hazardous waste” or with an indication of the hazards of its contents.
- One 55-gallon drum (Photo 23) used to accumulate wipes that were used to remove excess stain from cabinetry parts following the application of the second coat of stain. The 55-gallon drum was labeled D001 hazardous waste flammable solids, and it was also identified with a flammable solids DOT hazard placard. However, the bolt used to close the 55-gallon drum by tightening the ring that secures the lid to the container was not fastened.

Personnel explained that wipes are transferred from the 20-gallon container into the 55-gallon container, which is later moved to the CAA and eventually sent offsite as D001 hazardous waste flammable solids. The total volume of D001 hazardous waste flammable wipes may have exceeded 55-gallons in this SAA.

**Pursuant to 15A NCAC 13A .0107(a) [40 C.F.R. § 262.15(a)(5)], which is a condition of the SAA Permit Exemption, a generator is required to mark or label its containers with the words “Hazardous Waste” and with an indication of the hazards of the contents.**

**Pursuant to 15A NCAC 13A .0107(a) [40 C.F.R. § 262.15(a)(4)], which is a condition of the SAA Permit Exemption, a container holding hazardous waste must be closed at all times during accumulation, except when adding, removing, or consolidating waste; or when temporary venting of the container is necessary.**

**Downstairs Barberan Stain Line - Photo 22:** 20-gallon flip-top flammable can in the Second Stage Stain Finishing Line Wipe Rags SAA. Drum was labeled excluded solvent contaminated wipes but is emptied into a 55-gallon drum in this SAA. The 55-gallon drum is labeled hazardous waste D001 flammable paint rags.

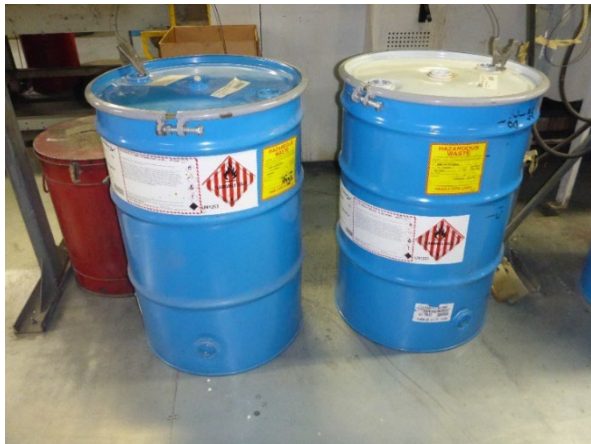
**Downstairs Barberan Stain Line - Photo 23:** 55-gallon drum in the Second Stage Stain Finishing Line Wipe Rags SAA (on left) and the Second Stage Stain Finishing Filters SAA (on right). Drum on the left was labeled hazardous waste D001 flammable paint rags and drum on the right was labeled hazardous waste D001 solid paint filters. Each drum was marked with an indication of the hazards on the product label.

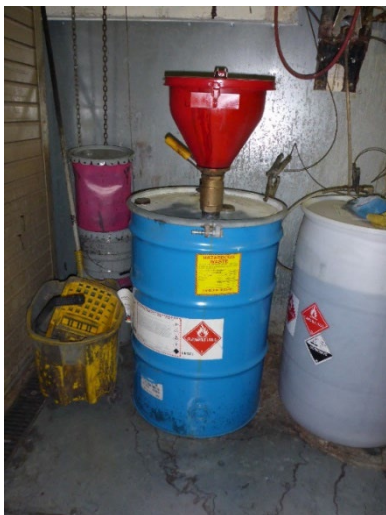
**Pump Room - Photo 24:** 55-gallon drum in the Pump Room SAA. Drum was labeled hazardous waste D001, F003, F005 waste paint related material and marked with an indication of the hazards on the product label.

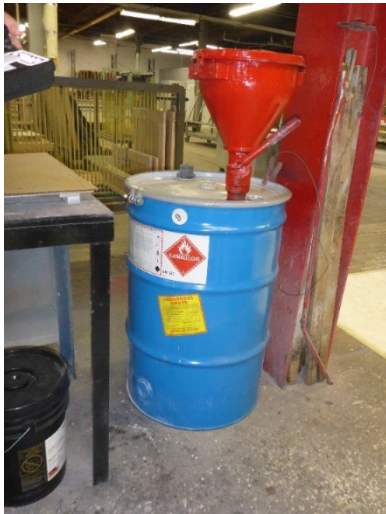
**Old Trim Out Area - Photo 25:** 55-gallon drum in the Old Trim Out Area Spray Booth SAA. Drum was labeled hazardous waste D001 flammable solid paint filters, and should have been labeled hazardous waste D001, F003, F005 waste paint related material. Drum was marked with an indication of the hazards on the product label.

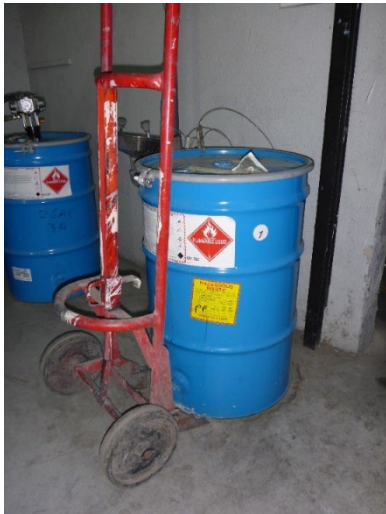
**Paint Pump Room - Photo 26:** 55-gallon drum in the Paint Pump Room SAA. Drum was labeled hazardous waste D001, F003, F005 waste paint related material and marked with an indication of the hazards on the product label.

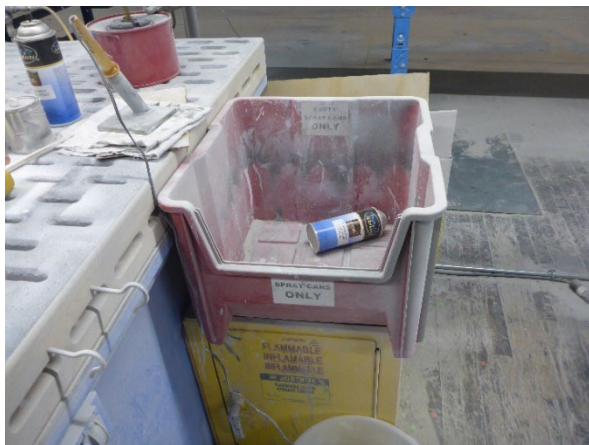
**Workstation Aerosol Cans - Photo 27:** Bin at workstation used to accumulate used aerosol cans. Bin is emptied and cans are brought to the aerosol can puncture station at the end of each day.

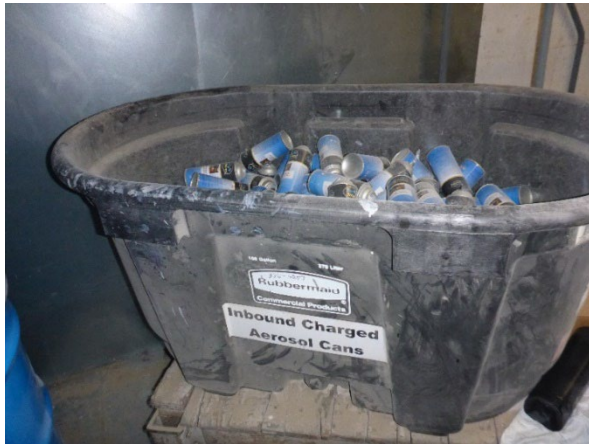
**Old Pump Room - Photo 28:** 100-gallon Rubbermaid tub of used aerosol cans next to the Aerosol Can Puncture Station SAA. Aerosol cans are waiting for processing by the puncture device.

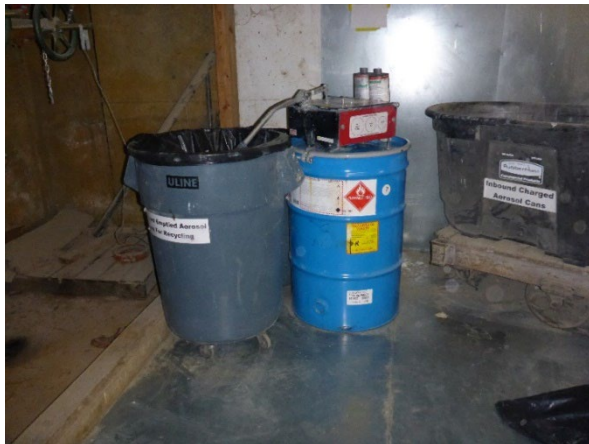
**Old Pump Room - Photo 29:** 55-gallon drum in the Aerosol Can Puncture Station SAA. Drum was labeled hazardous waste D001, F003, F005 waste paint related material and marked with an indication of the hazards on the product label.

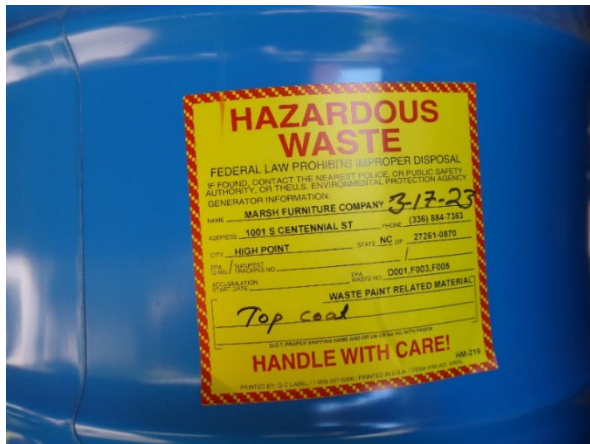
**Central Accumulation Area - Photo 31:** Close-up of label on 55-gallon drum in CAA shown on the left in Photo 32. Drum is labeled hazardous waste D001, F003, F005 waste paint related material, and it is marked with an accumulation start date of March 17, 2023.

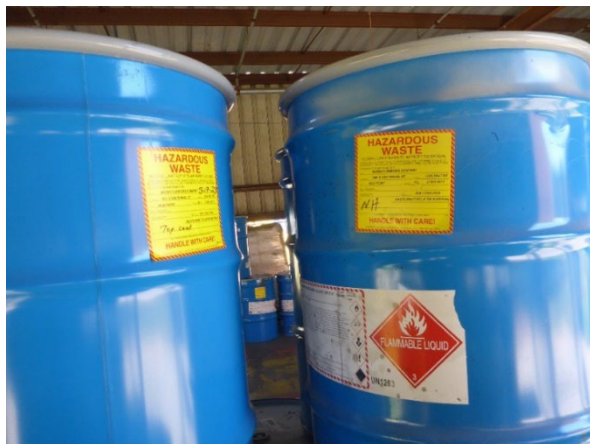
**Central Accumulation Area - Photo 32:** 55-gallon drum in CAA. Drum is labeled hazardous waste D001, F003, F005 waste paint related material, and it is marked with an indication of the hazards on the product label. However, the drum is not marked with an accumulation start date.

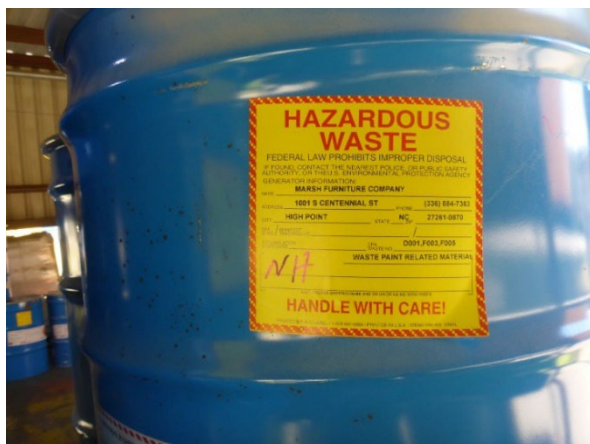
**Central Accumulation Area - Photo 33:** Close-up of label on 55-gallon drum in CAA shown on the right in Photo 32. Drum is labeled hazardous waste D001, F003, F005 waste paint related material, but it is not marked with an accumulation start date.

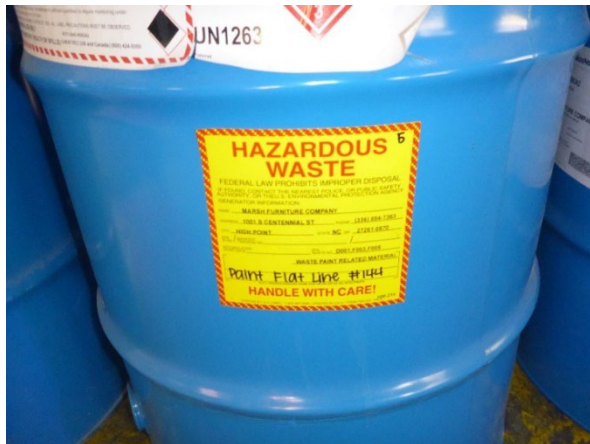
**Central Accumulation Area - Photo 34:** One drum of hazardous waste D001, F003, F005 waste paint related material in Row 1 of the CAA that was not marked with an accumulation start date.

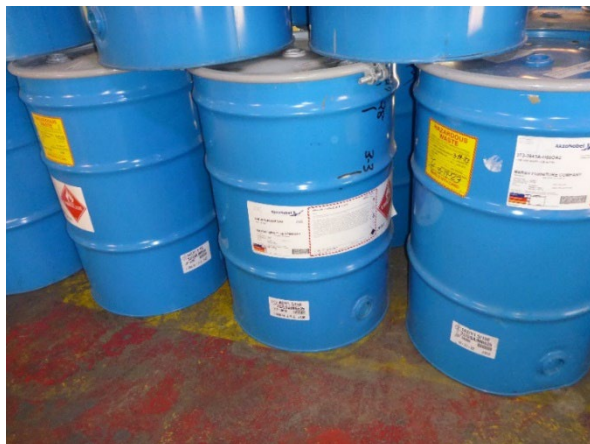
**Central Accumulation Area - Photo 35:** 55-gallon drum in CAA that is not labeled hazardous waste or marked with an accumulation start date.

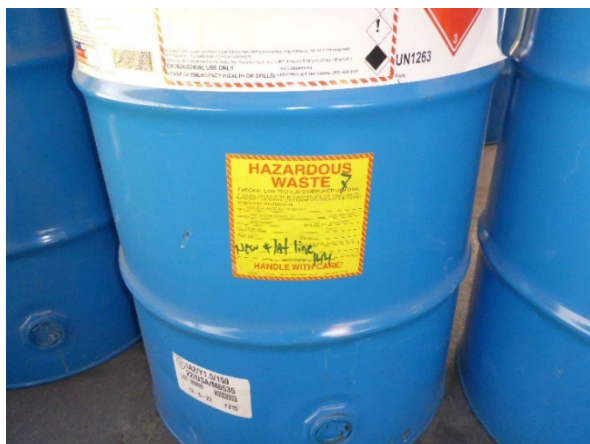
**Central Accumulation Area - Photo 36:** One drum of hazardous waste D001 in Row 4 of the CAA that was not marked with an accumulation start date.

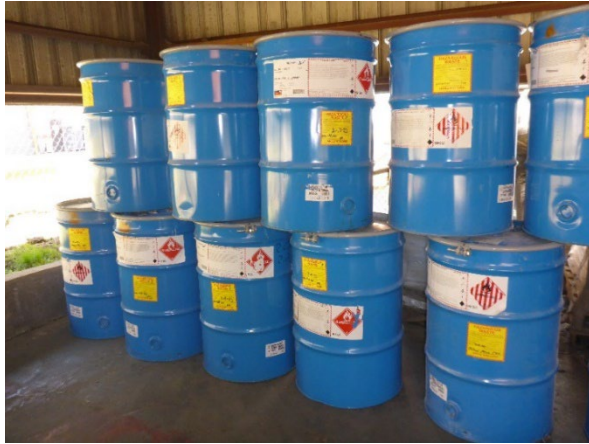
**Central Accumulation Area - Photo 37:** Row Four in the CAA. Drums of hazardous waste D001 flammable solids. Five drums were identified with an indication that they contained flammable liquids.
