## U.S. EPA Region 8 NPDES Inspection Report

| National Database Information | |
|---|---|
| Inspection Date: <b>September 20, 2022</b> | Inspection Type: <b>Compliance Evaluation Inspection</b> |

| Facility Location Information | |
|---|---|
| Site/Facility Name & Location:<br><b>St. Francis Wastewater Treatment Facility</b><br><b>St. Francis (Todd County), South Dakota 57572</b><br><b>West Lagoon: 43.148656, -100.909131</b><br><b>East Lagoon: 43.154742, -100.894499</b> | Email Report to:<br><b>Young Colombe</b><br><b>Sewer Revenue Department Director</b><br><b>Rosebud Sioux Tribe</b><br><b>ycolombe@sicangu.com</b> |

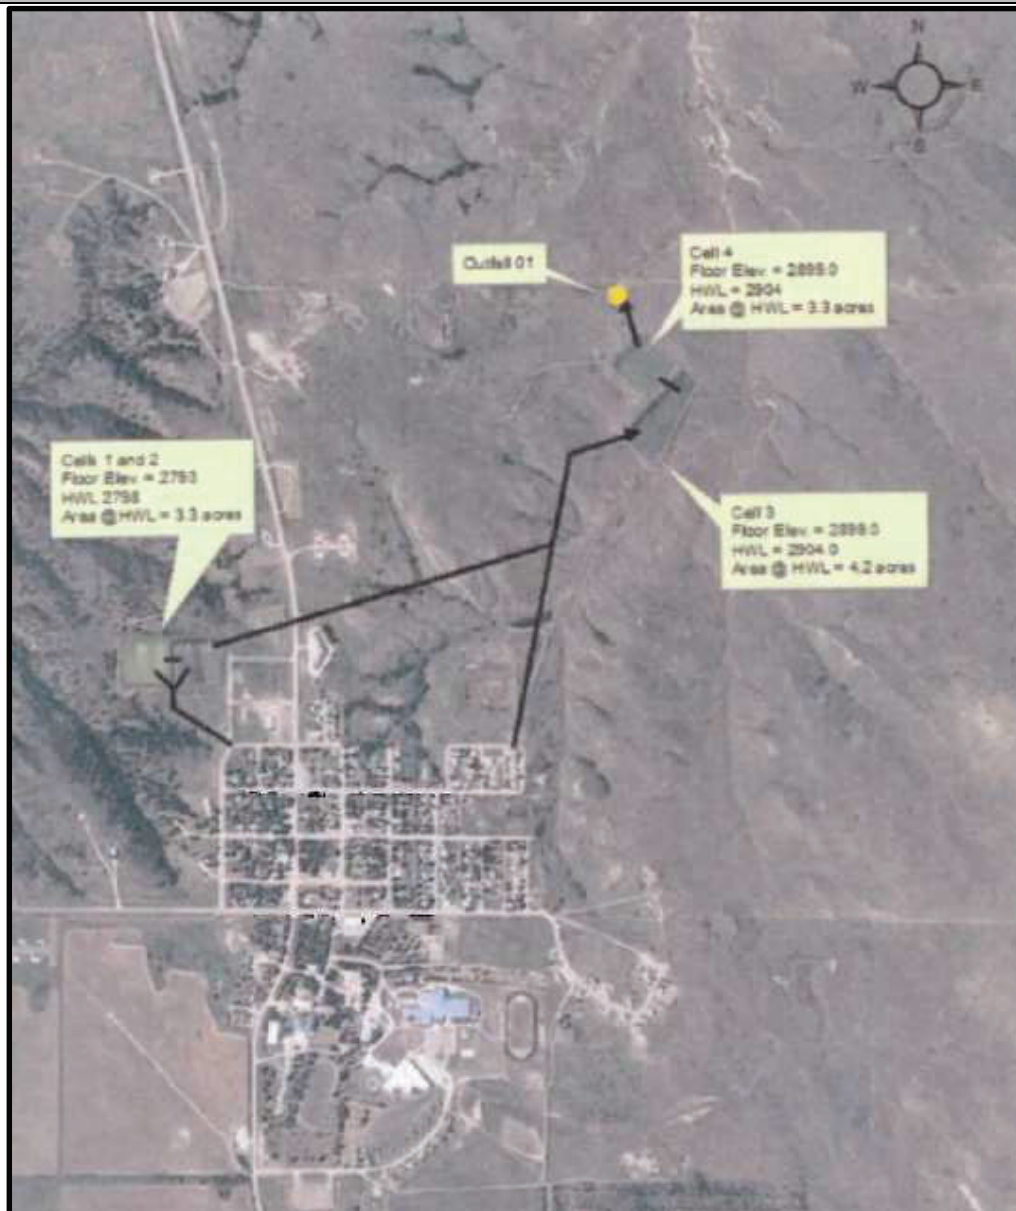
Figure 1. Presumed facility configuration as shown in schematic provided with the 2016 NOI

during the inspection, discussed further in this section and in Finding 2. According to the 2016 NOI and several IHS records, effluent flowed out of the West Lagoon from the northeast corner of Cell 2 via subsurface piping, gravity-flowed northeast, under Main Street, joined a gravity sewer main conveying wastewater from the East Collection System, and, from this juncture, all wastewater from the West Collection System, via the West Lagoon, and East Collection System, was conveyed into the East Lagoon (see Figure 1, below).

A copy of a facility schematic provided with the 2016 NOI showing the presumed facility configuration is included as Figure 1, below.
