## **RCRA Inspection Report**

Carolina Pole, Inc.  
237 Forestry Road  
Eutawville, South Carolina 29408

EPA ID# SCD982113128

November 30, 2022, at 9:15 a.m. EDT

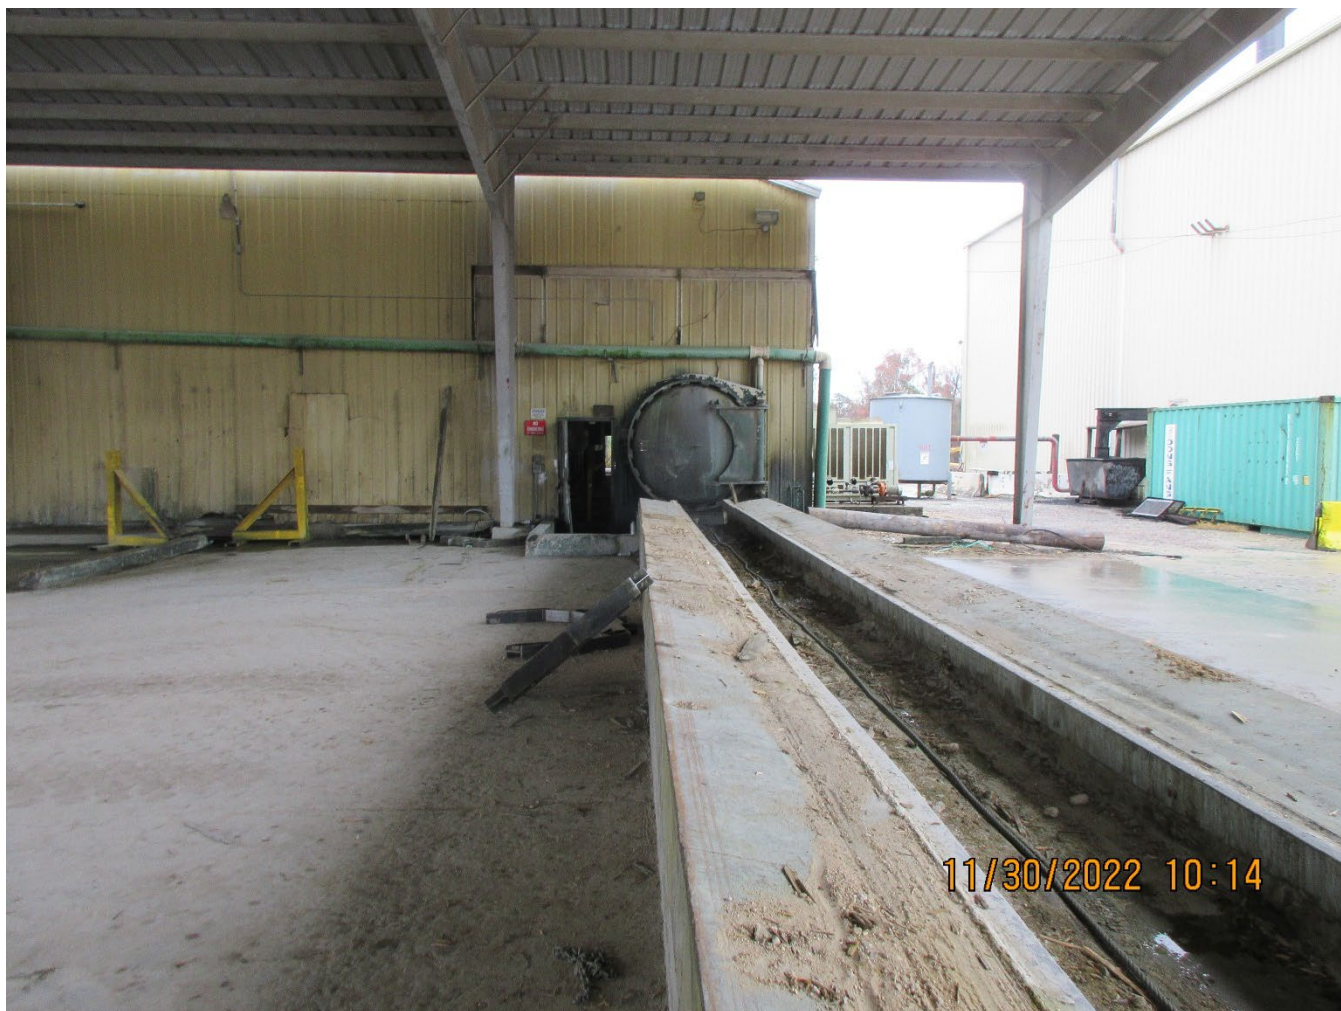
Each end of the rail system extending from the treatment tank is equipped with a concrete tank collection system (Photo 1) which captures drippage and debris from treated poles exiting the treatment cylinder. Treatment chemicals falling into the secondary containment system flow back towards the treatment cylinder and are collected in a concrete sump which is part of the collection system for reuse. Wood chips and other debris falling from the treated poles when they are rolled out from the treatment cylinder are also collected within the secondary containment system and a container at the base of the openings of the treatment cylinder (Photo 2)

Concrete pads exist beneath a metal roof for the staging of poles on both the east and west end of the treatment cylinder (Photos 1, 3 and 8). Each of these pads were well maintained and free of cracks or gaps.

Photo 1 – Rail system and concrete secondary containment system outside of west end of treatment tank

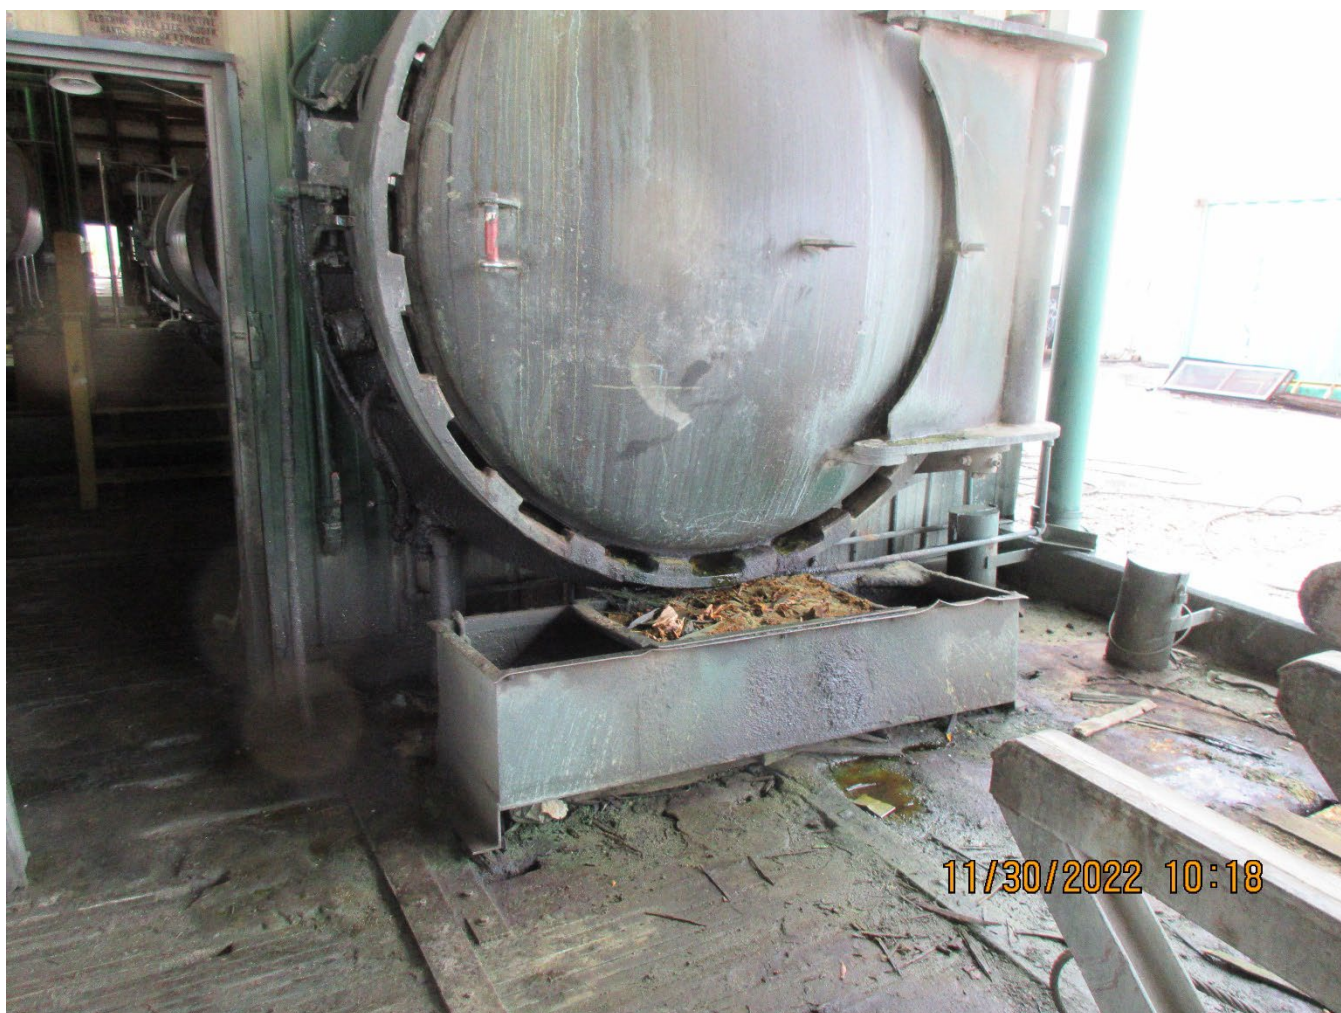
Photo 2 – West end of treatment cylinder and debris catch basin

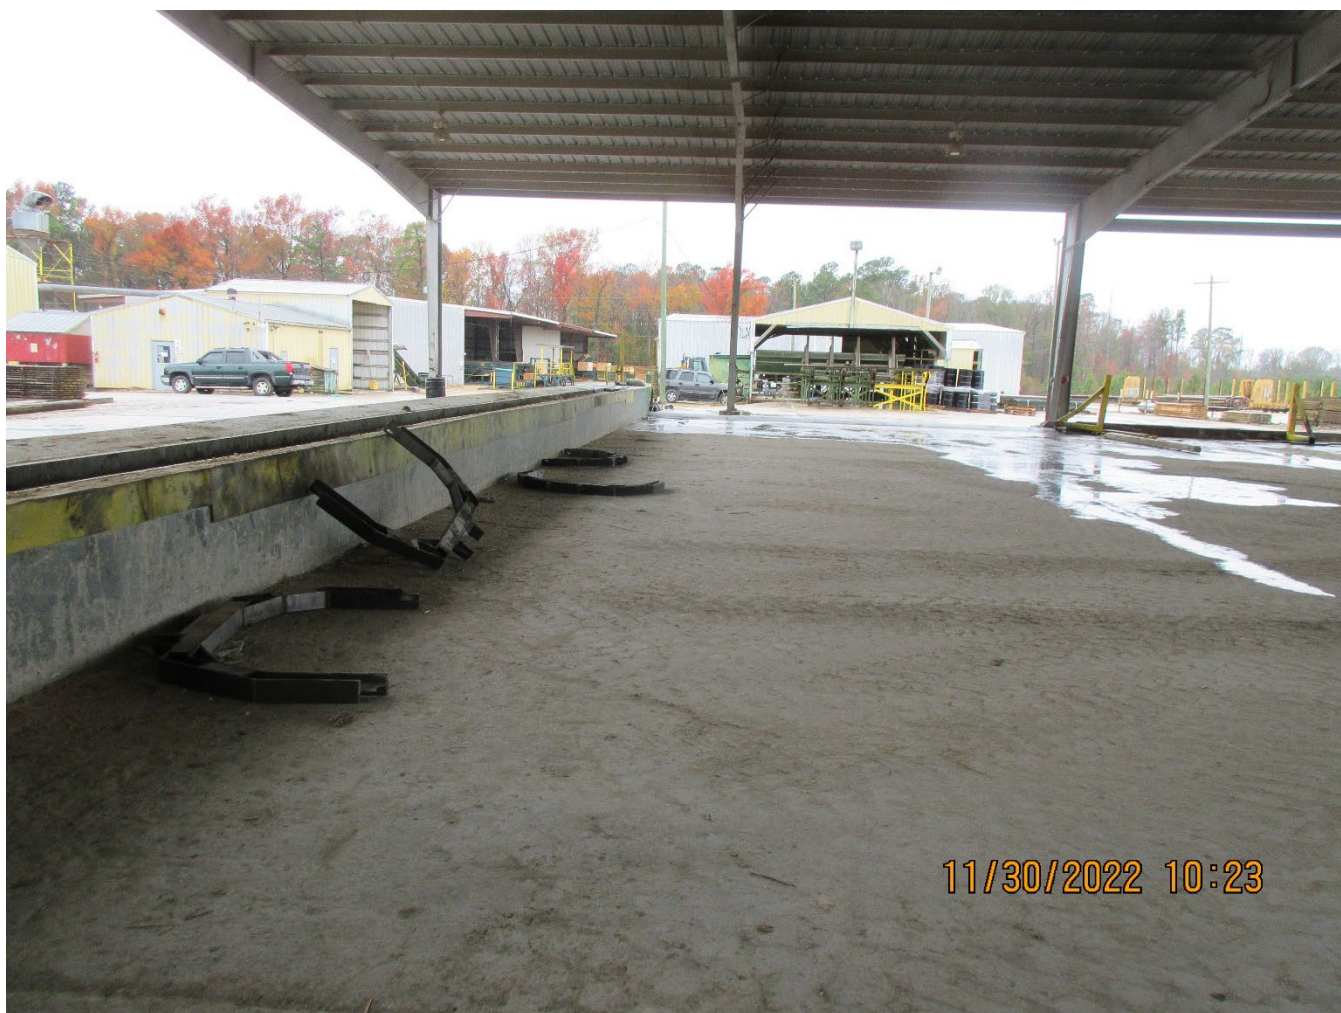
Photo 3 – Rail system and concrete catch basin/drip pad on west end of drip pad. Staging area on right side of drip pad in photo.

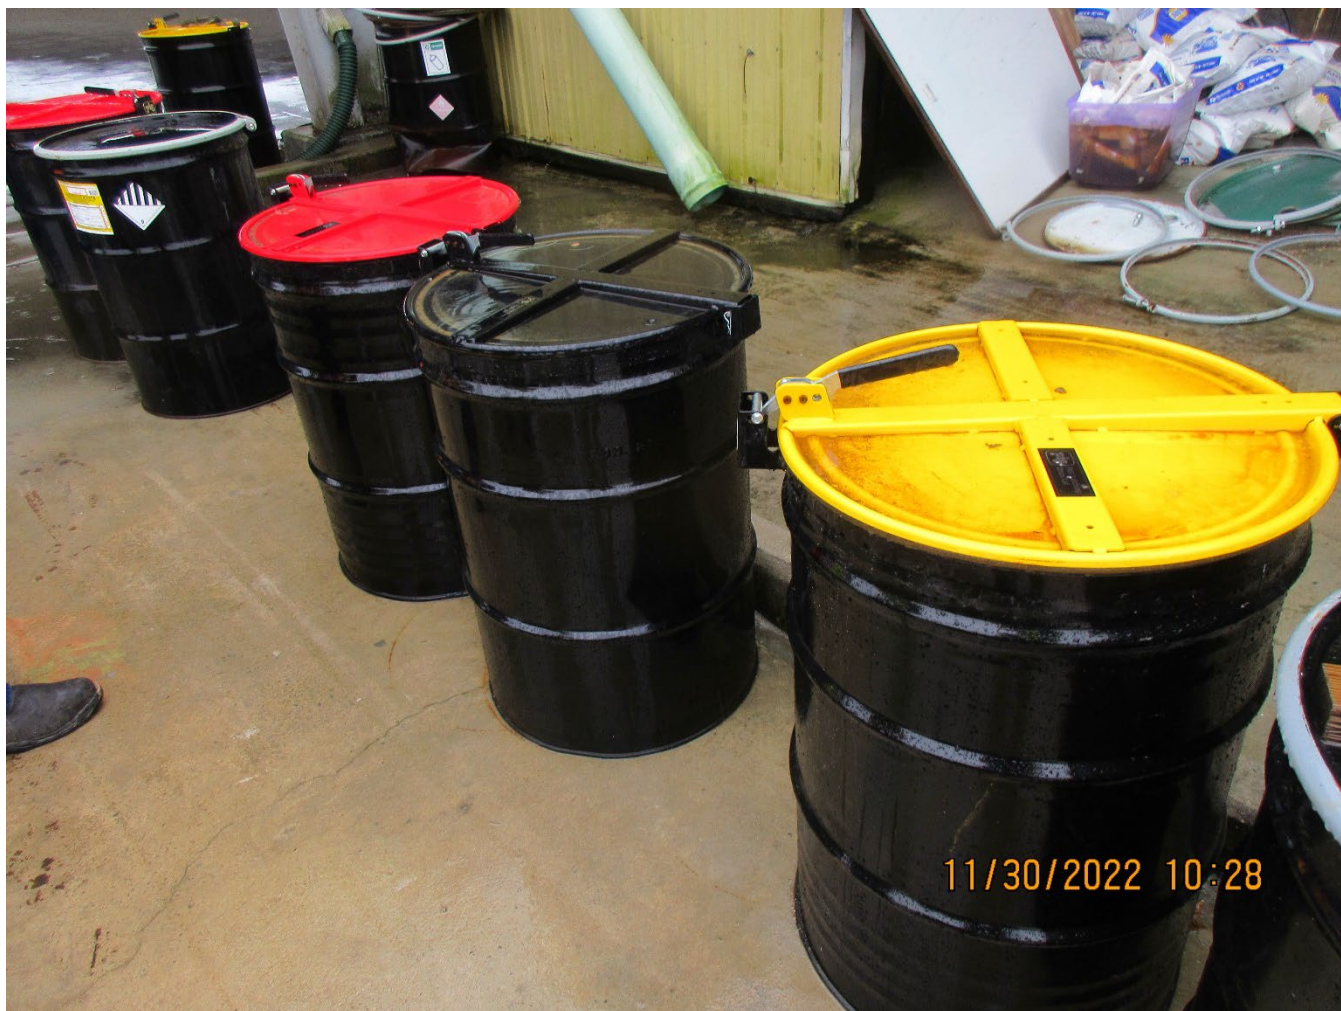
The facility operated a central accumulation area (CAA) for the collection of D004/D007 characteristic and F035 listed hazardous waste from the collection of contaminated debris from within the facility’s drip track and staging area (Photo 4, 5 and 6). At the time of the inspection,

twenty-five 55-gallon drums of D004/D007/F035 hazardous waste were observed in this area. The accumulation start date on each of the hazardous waste in drums was less than 90 days.

Photo 4 – Hazardous waste drums in CAA on north end of building housing treatment cylinder

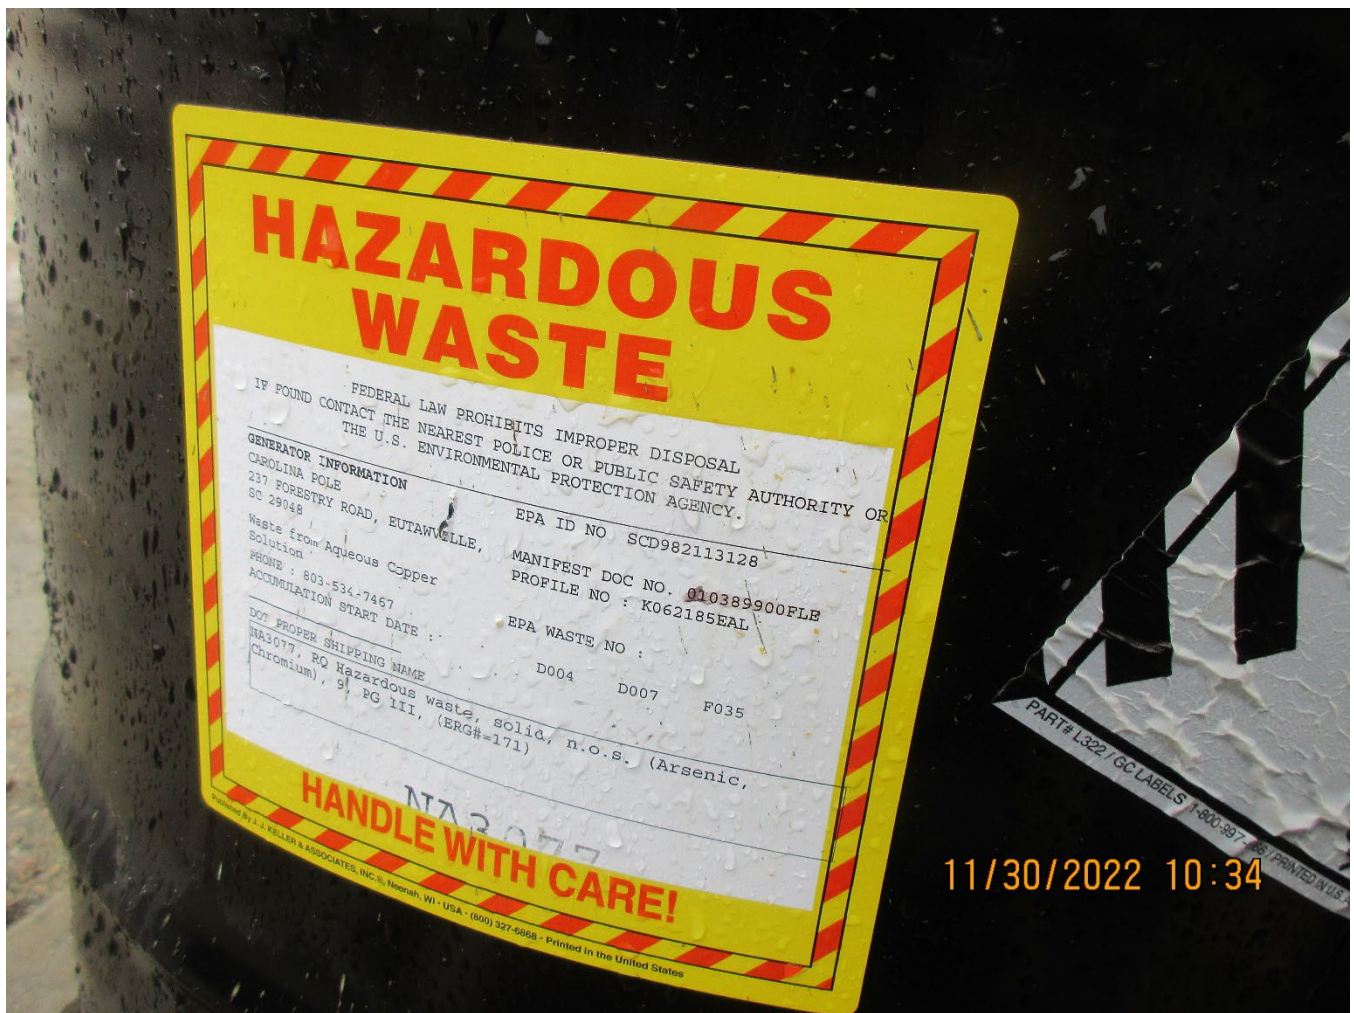
Photo 5 – Label on Drums of Hazardous Waste Drums in CAA

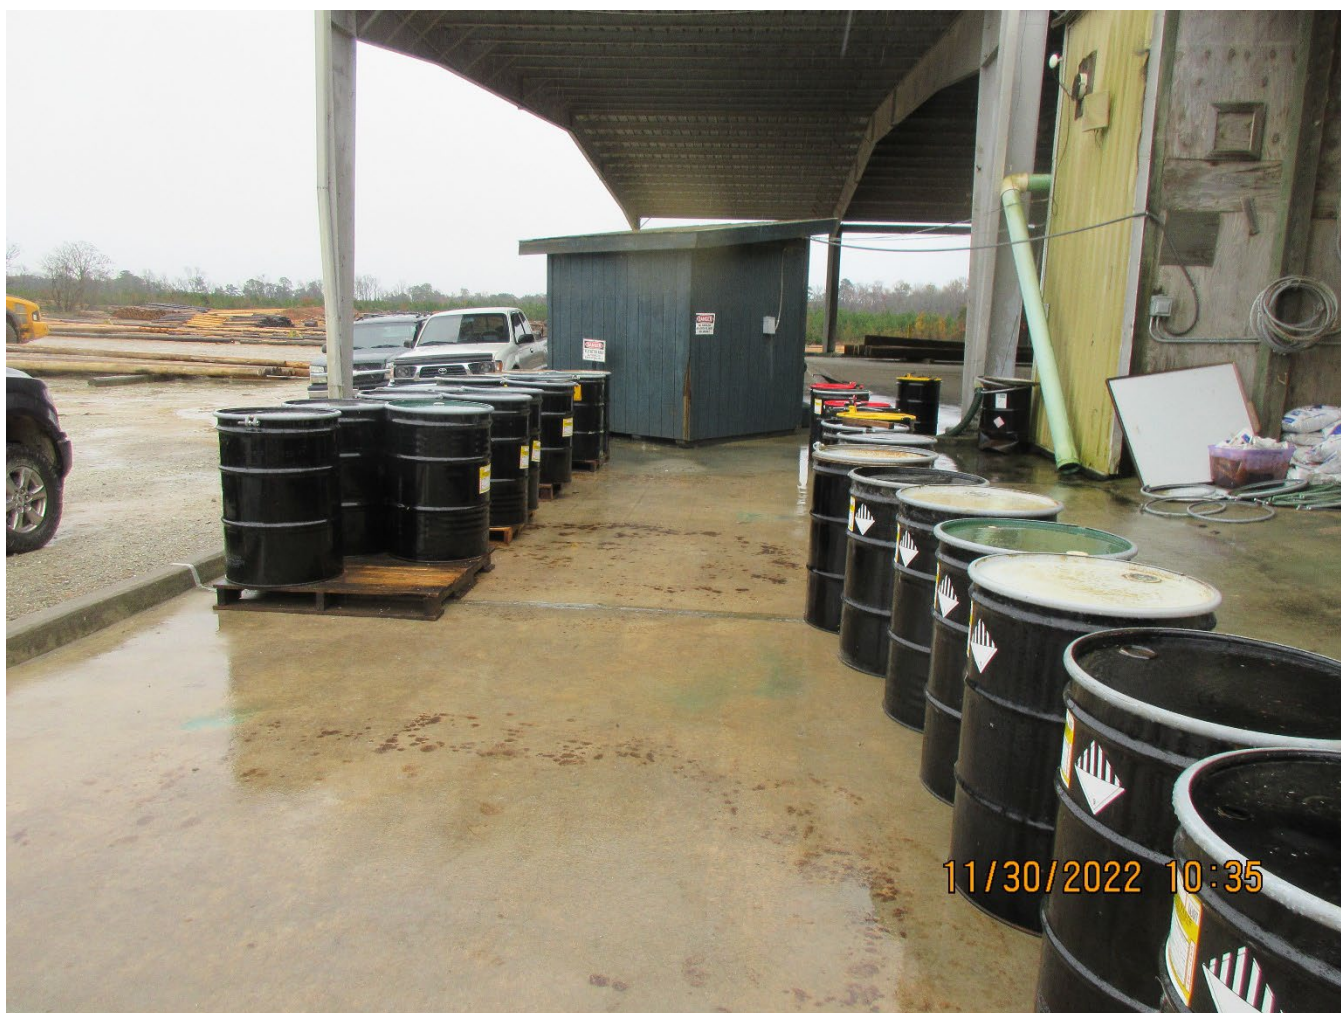
Photo 6 – Hazardous waste drums in CAA

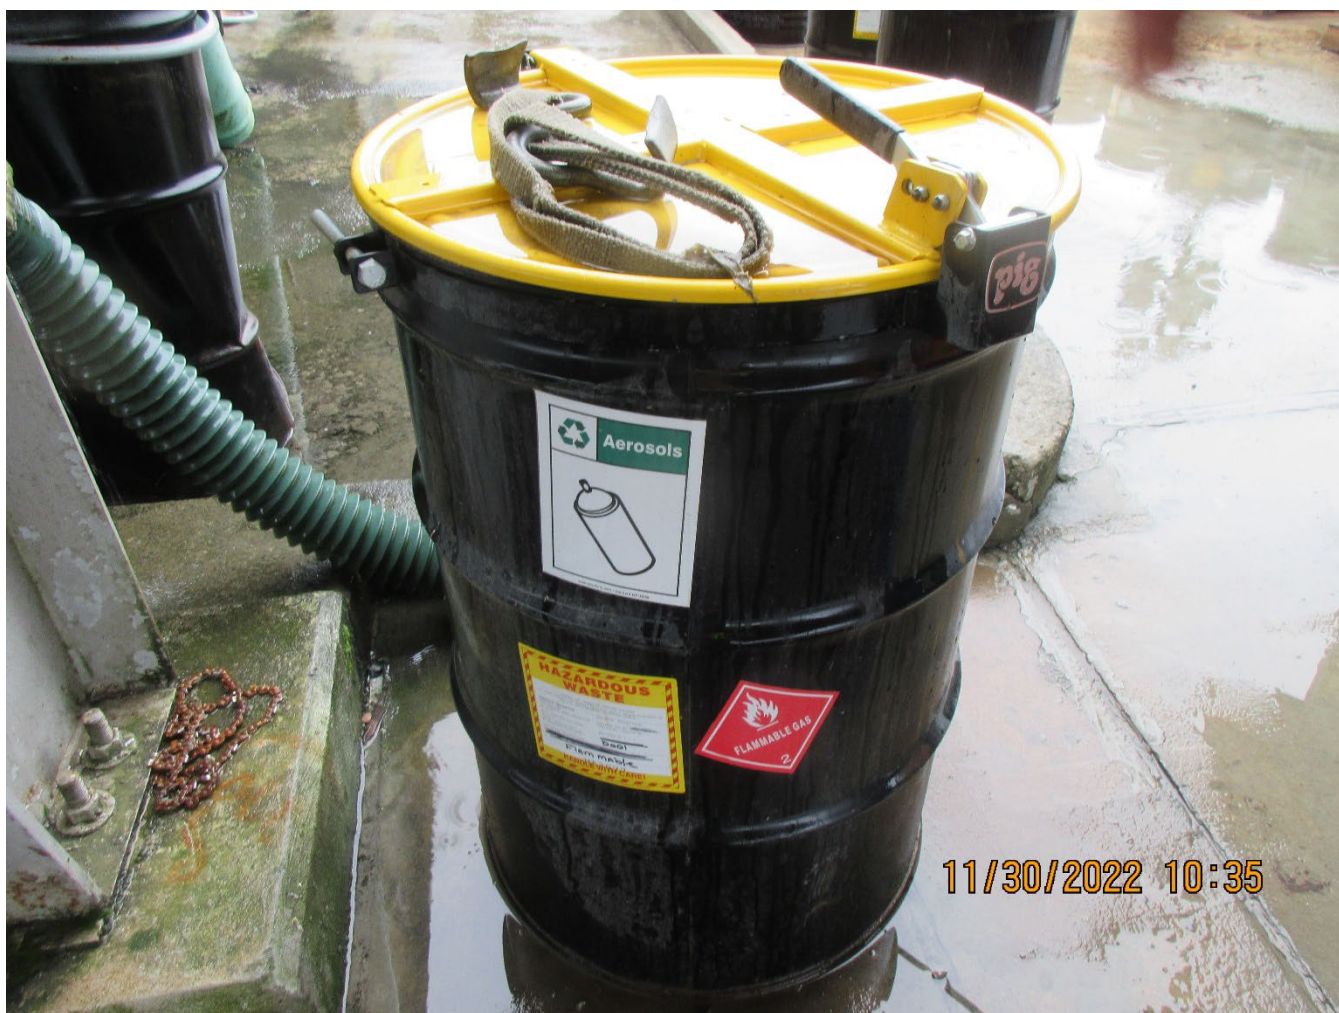
One 55-gallon container of D001 characteristic hazardous waste spent aerosol cans was observed within a SAA on the north side of the Treatment Building (Photo 7).

Photo 7 – Drum of D001 characteristic hazardous waste spent aerosol cans

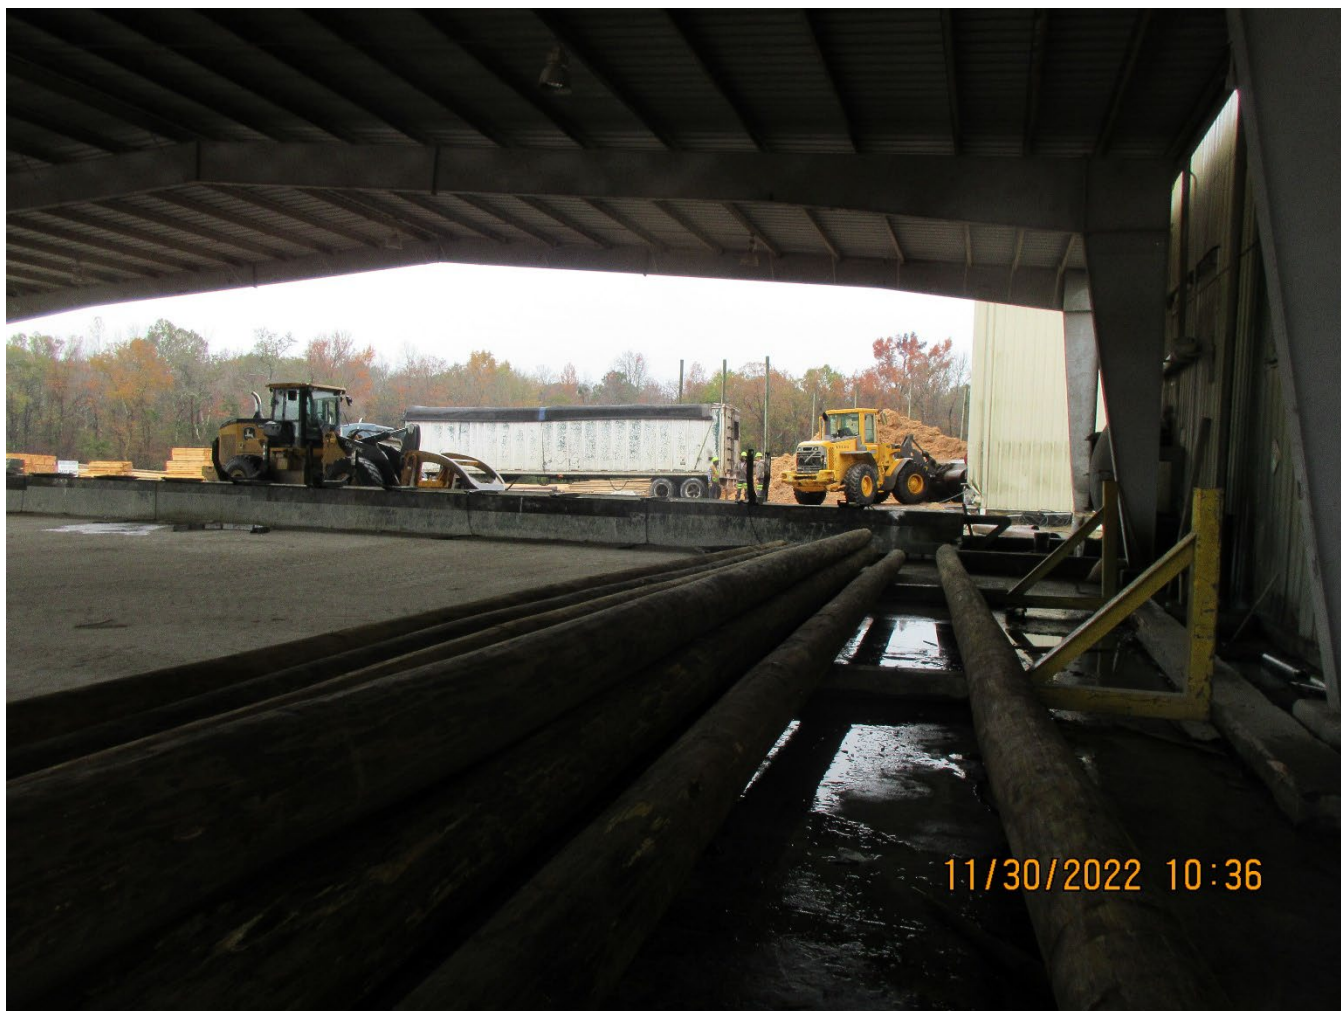
Photo 8 – Eastern Pole Staging Area
