PURPOSE OF INSPECTION

The purpose of the inspection by the U.S. Environmental Protection Agency (USEPA) at the Tilden Mining Company L.C. mine (Tilden) of the Cleveland-Cliffs Inc. facility (Cliffs or Facility) in Ishpeming, Michigan was to describe, evaluate, and document compliance with the Clean Water Act (CWA) and their National Pollutant Discharge Elimination System (NPDES) permit.

**Cleveland Cliffs Inc. – Tilden and Empire Mine
EPA Inspection 9/13/2022 – 9/15/2022
Photomap Overview**

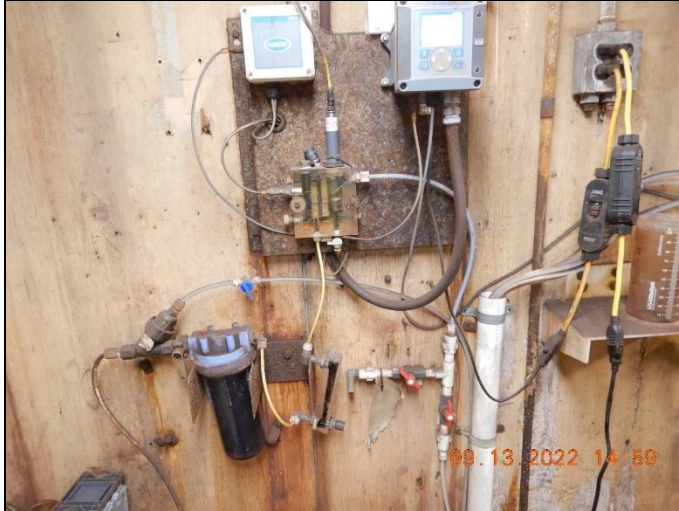
3: DSCN0962.JPG

- Chlorine measurements for compliance purposes at the Tilden wastewater treatment plant are collected with a continuous chlorine analyzer, which was equipped with a free chlorine reagent that would not provide a total chlorine residual value.

Description: Continuous chlorine analyzer at the Tilden sewage treatment system. The chlorine probe was labeled for free chlorine analysis.

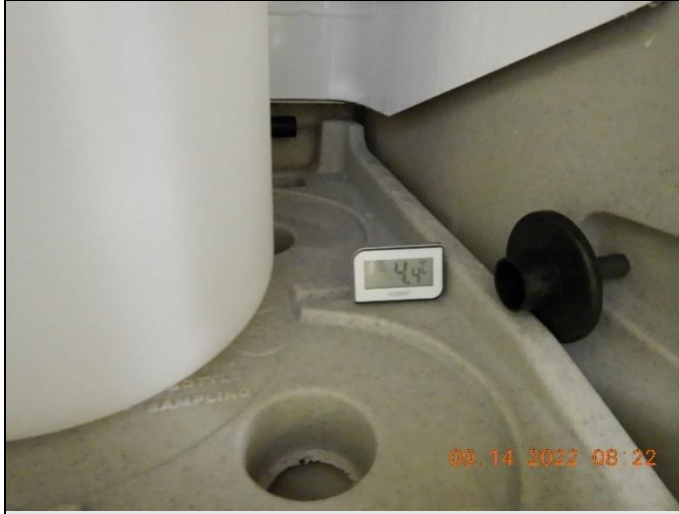
9: DSCN0968.JPG

Description: Non-NIST traceable thermometer at the location shown in photo 8.

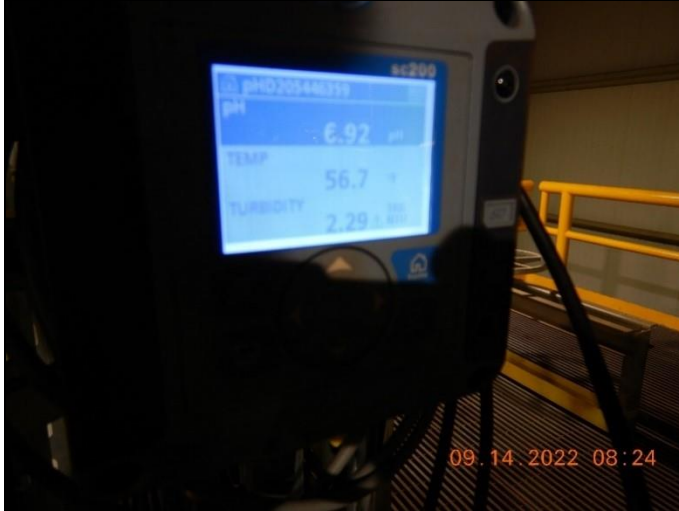
11: DSCN0970.JPG

Description: pH, temperature and turbidity measurements on train #2 at the treatment facility for the Tilden tailings basin discharge. Per Michael Korvela, these continuous measurements are for operational purposes only. At the time of the inspection, the turbidity measurement had an active alarm.

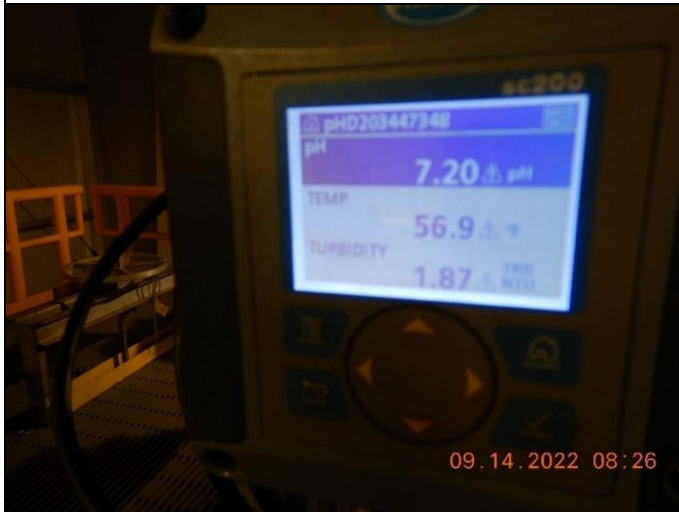
12: DSCN0971.JPG

Description: pH, Temperature and Turbidity measurements on train #1 at the treatment facility for the Tilden tailings basin discharge. Per Michael Korvela, these continuous measurements are for operational purposes only. At the time of the inspection, pH, temperature, and turbidity all had active alarms.

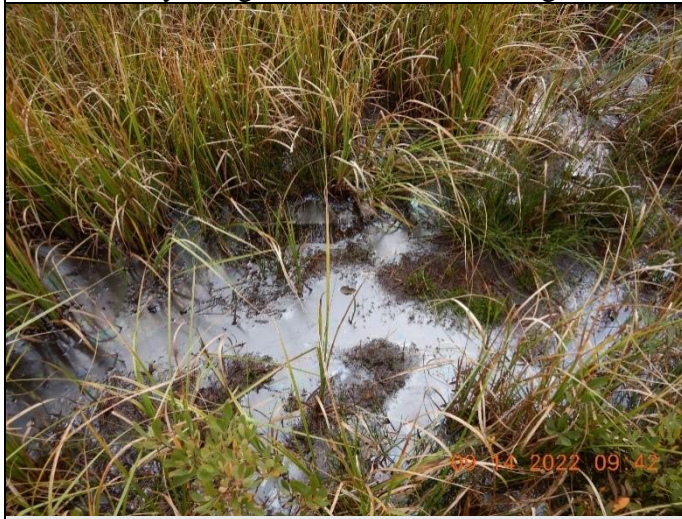
19: DSCN0983.JPG

Description: Location of possible daylighted seep at the east side of the tailings basin. The water had an iridescent sheen.

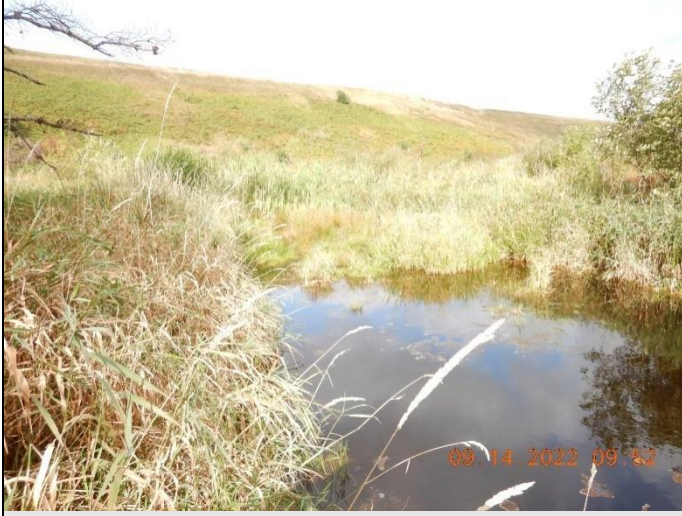
23: DSCN0987.JPG

Description: Location of possible daylighted seep at the east side of the tailings basin. The water had an iridescent sheen. Camera is looking upstream at the outslope of the tailings basin.

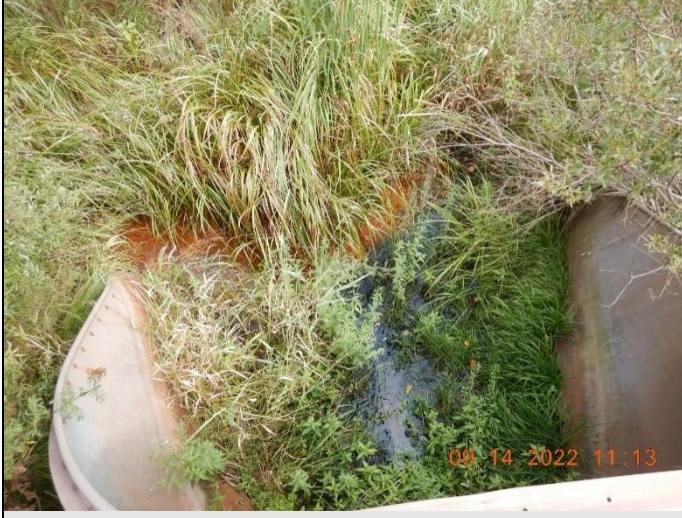
29: DSCN0993.JPG

- USEPA observed and conducted field monitoring of flowing water originating near Hoover Pond impoundment of process water. Water flowing from inside culvert connected to impoundment was originating from an unspecified source. Northeast of the culvert is a possible daylighted seep and EPA field monitoring at this location showed a conductivity of greater than 900 $\mu\text{S}/\text{cm}$, which is above the background values. The waterway, culvert, and possible daylight seep are depicted in photos 29 through 32.

Description: Downstream of Hoover Pond at the downstream end of a culvert leading away from Hoover Pond. This is the historic E003 discharge which is no longer an active outfall. At the time of the inspection there was water flowing through the culvert and joining with another surface conveyance of red discolored water. Monitoring point 06.

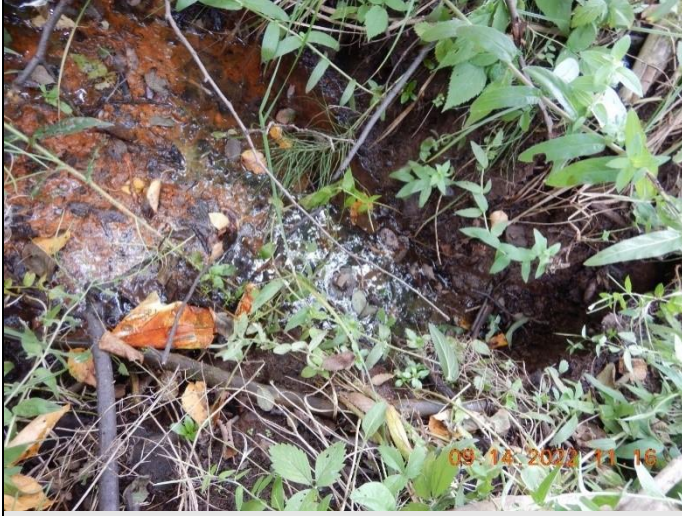
31: DSCN0995.JPG

Description: Northeast of the location of the downstream end of the culvert shown in photo 29. Possible location of a daylighted seep. At the time of the inspection the water shown in this photo was flowing and had a red/orange discoloration.

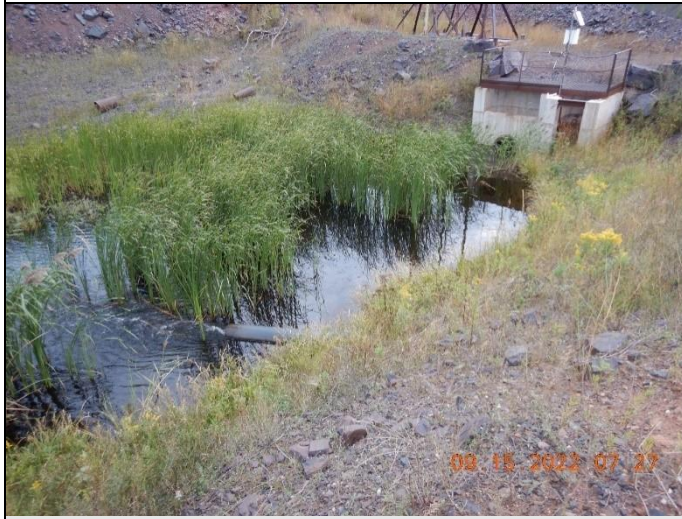
39: DSCN1003.JPG

Description: Staff gage at the historic Empire Outfall 003. Facility representatives said they no longer use this staff gage. Location of monitoring point 09.

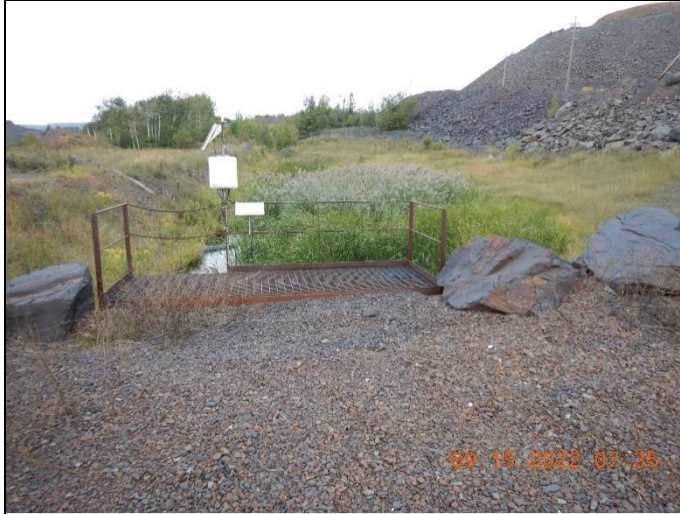
42: DSCN1006.JPG

- During the inspection, USEPA observed waste material from mining operations adjacent to a waterway known as Partridge Creek. Runoff from the slopes of the waste material would drain into a waterway flowing through a historic outfall 003. This is shown in Photos 37 through 42. The Facility representatives stated that NPDES compliance monitoring was no longer being conducted at this location because the discharge was not considered a wastewater. A copy of a cover letter from Michigan Department of Environmental Quality (now EGLE) on June 29, 2017, transmitting the compliance evaluation inspection notes from an April 27, 2017, visit at the Empire Mine (MI0000094) was given to EPA. The June 29, 2017, cover letter was provided as the record of the approval from EGLE. The June 29, 2017, letter references a low selenium concentration and no active mine pit dewatering as justification for changing the NPDES permit, which had expired in 2016.

Description: Area tributary to Partridge Creek. Runoff from this area is tributary to the control structure shown in photos 37 through 41.

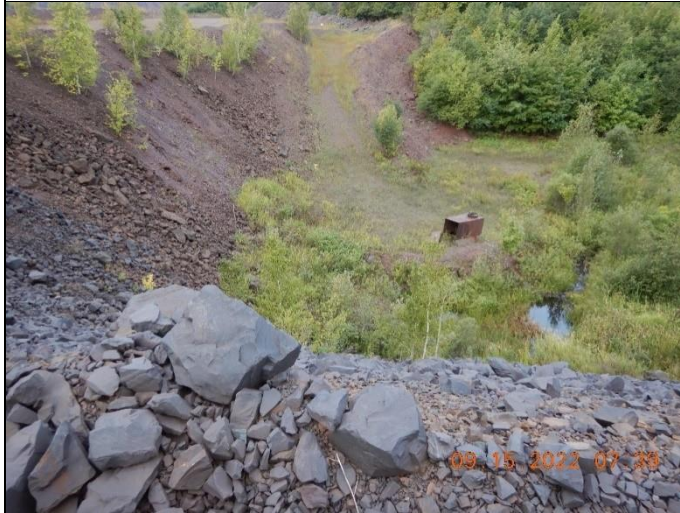
43: DSCN1007.JPG

Description: Area tributary to Partridge Creek. Area tributary to Partridge Creek. Runoff from this area is tributary to the control structure shown in photos 37 through 41.

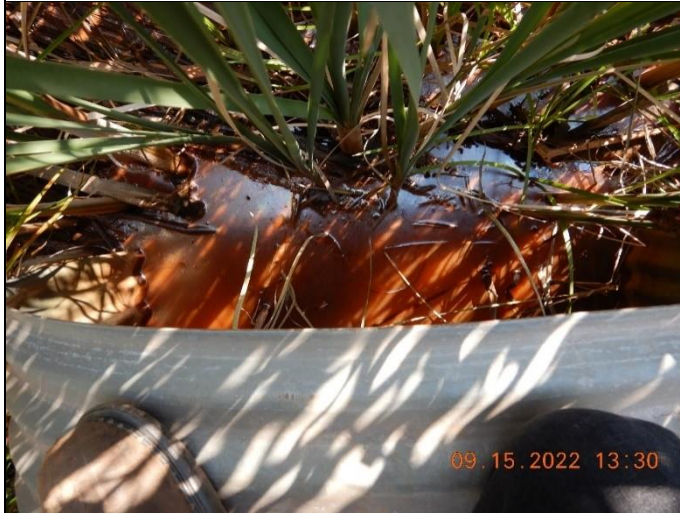
63: DSCN1027.JPG

- Locations CC-291 and CC-292 were not in the current version of the SWPPP available during the inspection, and are not associated with an NPDES outfall. USEPA field monitoring during the inspection showed a specific conductivity of 623 $\mu\text{S}/\text{cm}$ and 439 $\mu\text{S}/\text{cm}$ respectively. At the time of the inspection, these monitoring locations were flowing despite dry weather conditions.
- During the inspection, USEPA observed unvegetated rock piles in the tributary for the water flowing to the control structure for the historic Empire outfall E003.
- Several on-site water bodies present with dark orange coloring, suggesting high levels of iron and conductivity within the water.
 - Stormwater monitoring location '13' or CC-179, was visited during the inspection. The water at this location had an unnatural red color and is shown in photo 63.

Description: At the location of the stormwater monitoring location '13' or CC-179. This was the upstream end of a culvert under the County Road 476. At the time of the inspection, the water in this culvert had an unnatural red color. EPA monitoring location 18.
