**Region 6 - Enforcement & Compliance Assurance Division**  
**INSPECTION REPORT**

| Media Program: | Water | |
| Company Name: | <b>Jm Salvage, L.L.C.</b> | |
| Facility Name: | <b>Myers Auto Salvage</b> | |

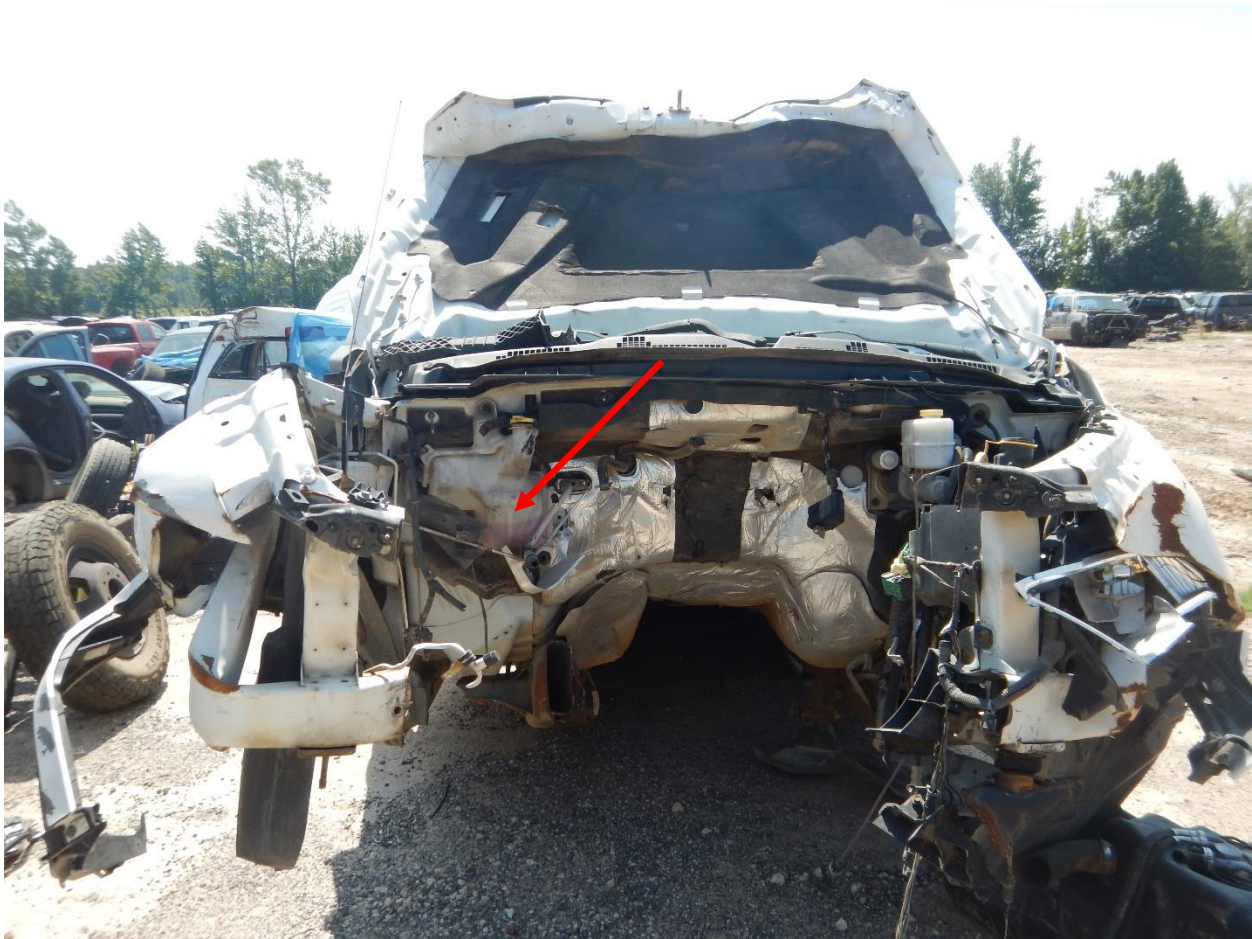
Photo No. 1

- a. Vehicles were improperly stored: hoods left up with fluid inside so that they were exposed to stormwater (See Appendix 1, Photograph Log, Photo Nos. 1-4). **TPDES General Permit TXR050000, Part V, Section M(2)(d)(2) and M(2)(e)**

Description: View, of improperly stored vehicle located in auto salvage yard, with hood left up and fluid inside container and exposed to stormwater (red arrow). Closer views provided in following photo #2.

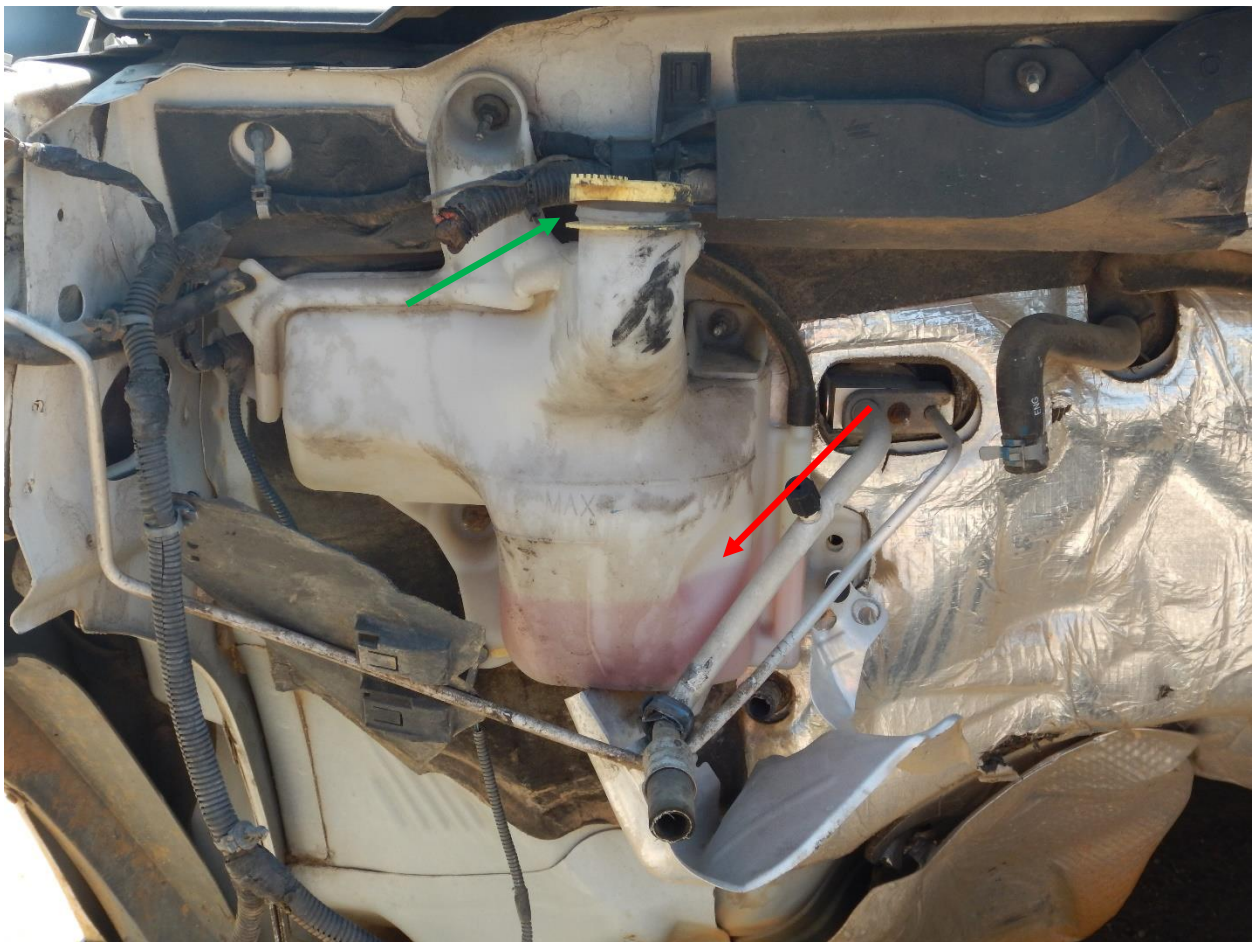
Photo No. 2

Description: Closer view, of improperly stored vehicle located in auto salvage yard, with hood left up and fluid inside container and exposed to stormwater (red arrow). Also note cap for the fluid's container was not fully closed, thus allowing the potential for stormwater to enter the container and potentially overspilling to the ground (see green arrow).

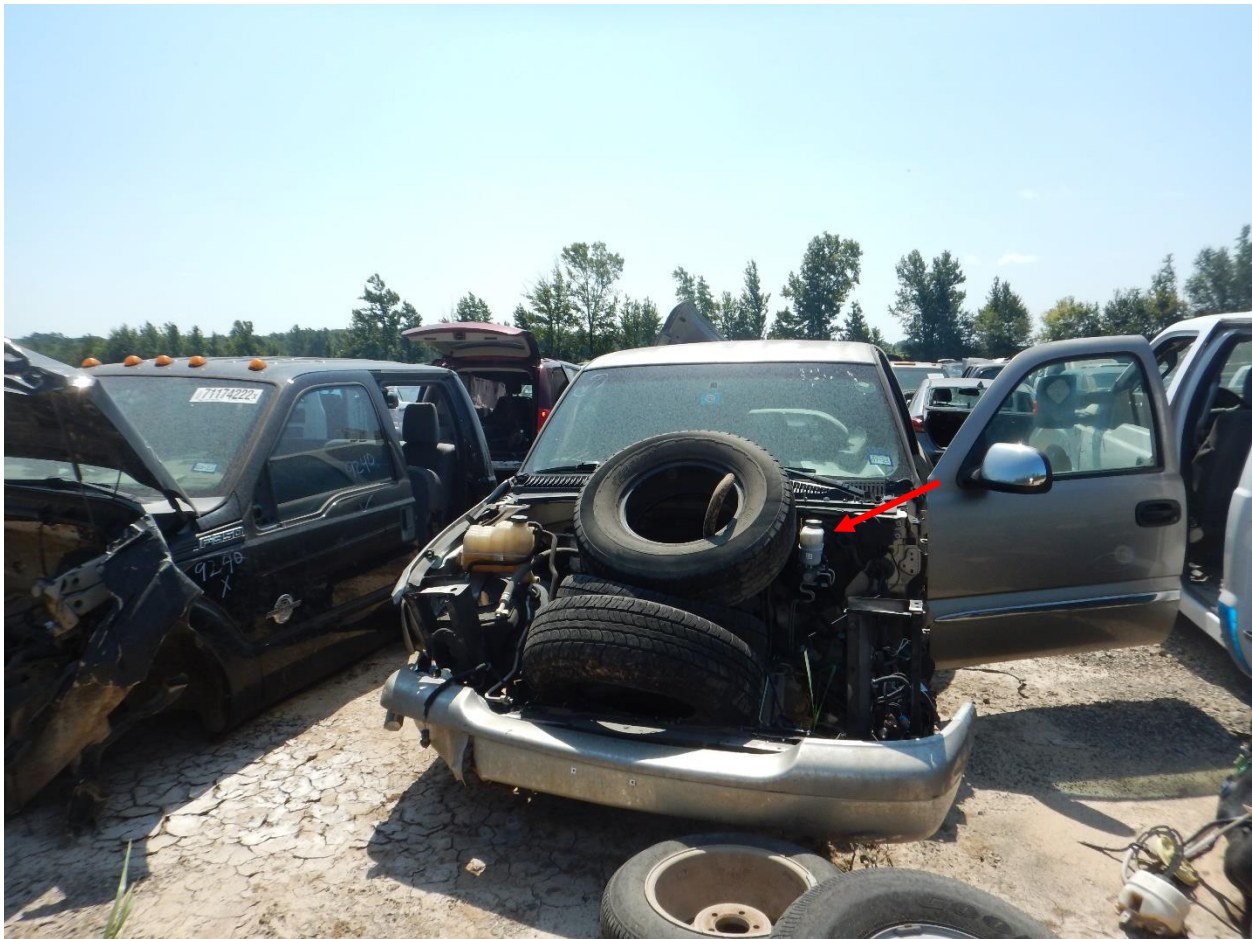
Photo No. 3

Description: View, of improperly stored vehicle located in auto salvage yard, with no hood remaining and fluid inside container and exposed to stormwater (red arrow). Closer views provided in following photo #4.

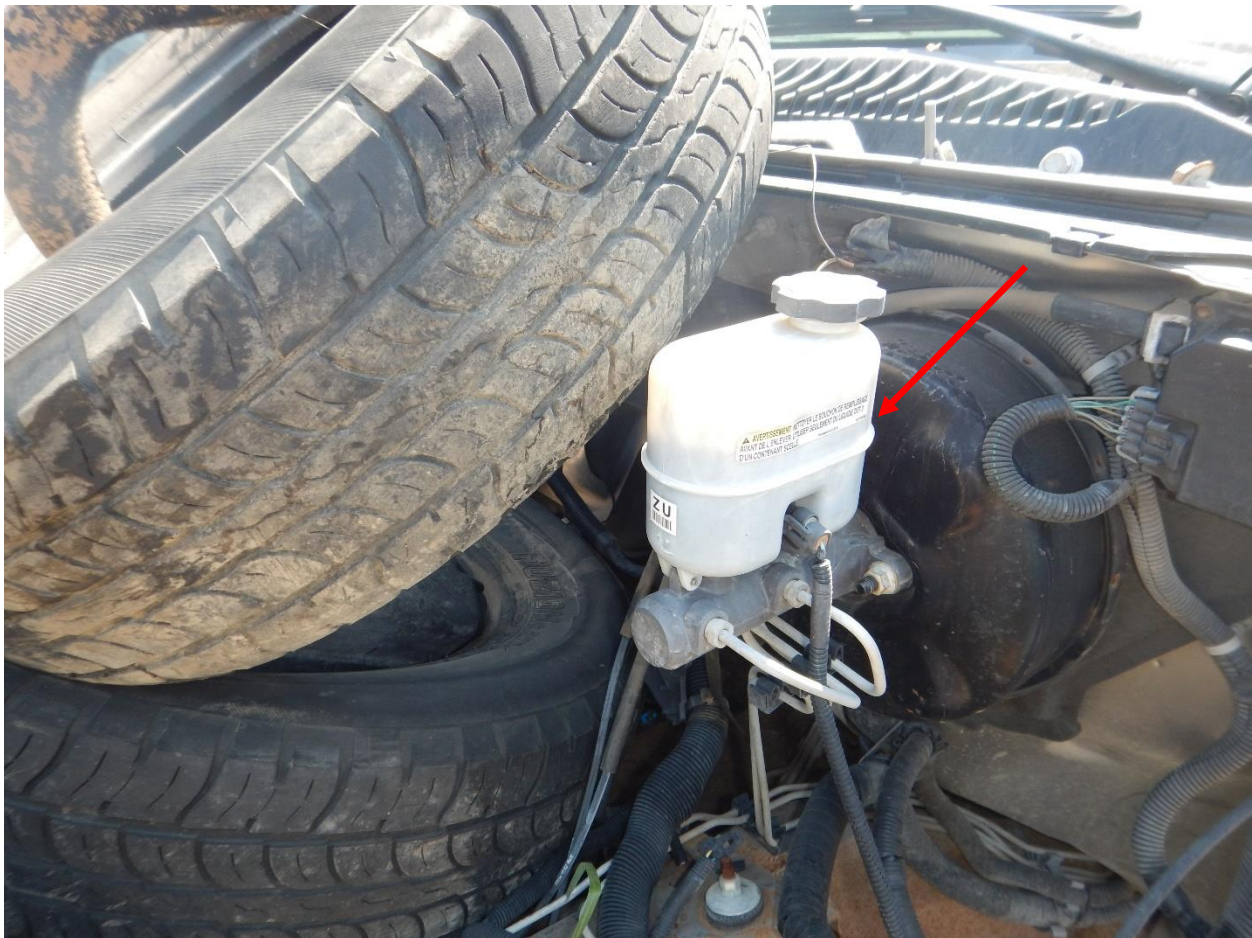
Photo No. 4

Description: Closer view, of improperly stored vehicle located in auto salvage yard, with no hood remaining and fluid inside container and exposed to stormwater (red arrow). Also note cap for the fluid's container was not fully closed, thus allowing the potential for stormwater to enter the container and potentially overspilling to the ground (see green arrow).

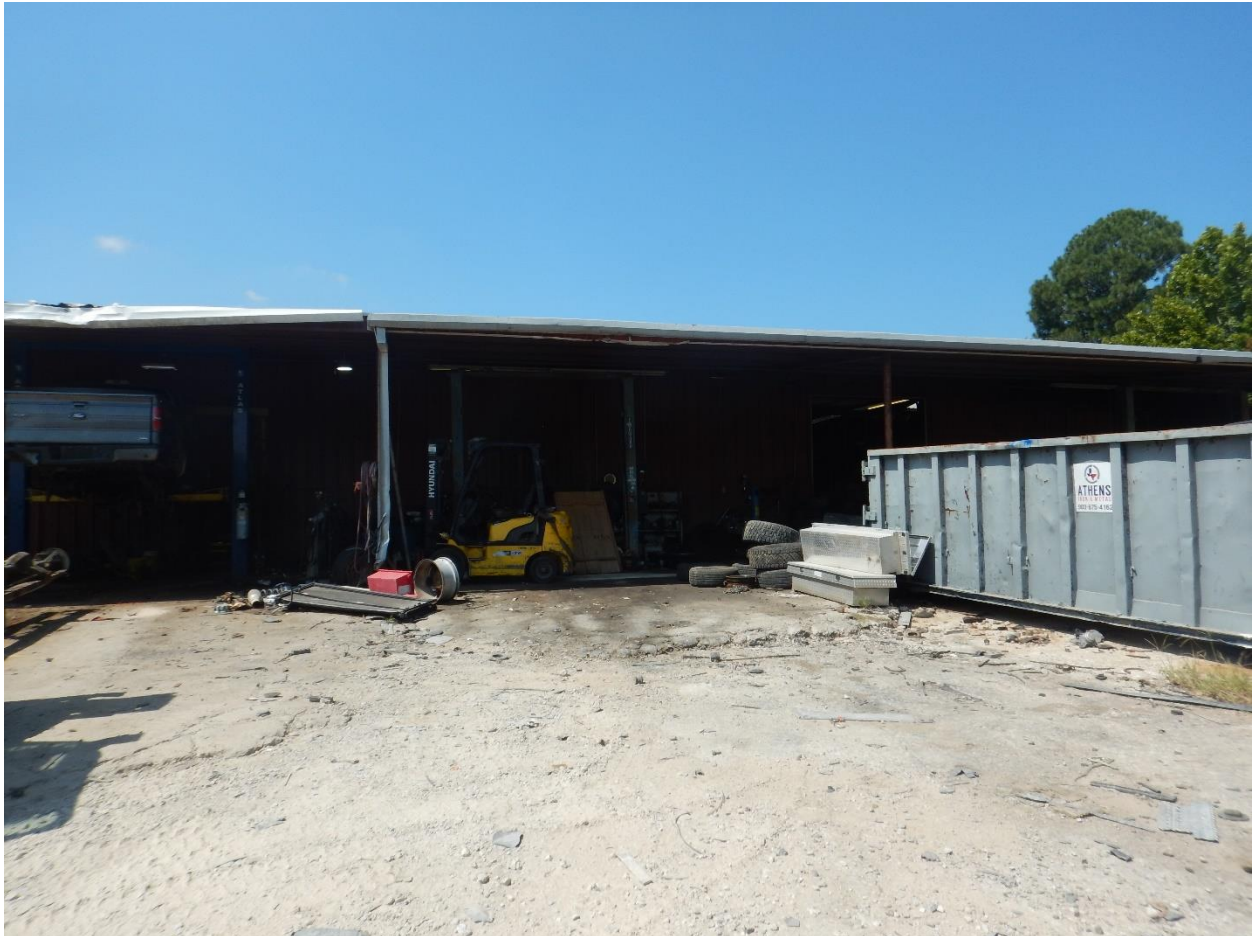
Photo No. 5

Description: View, of Myers Auto Salvage's Dismantling Area, not maintained in an effective operating condition (e.g., poor housekeeping). Closer views to follow.

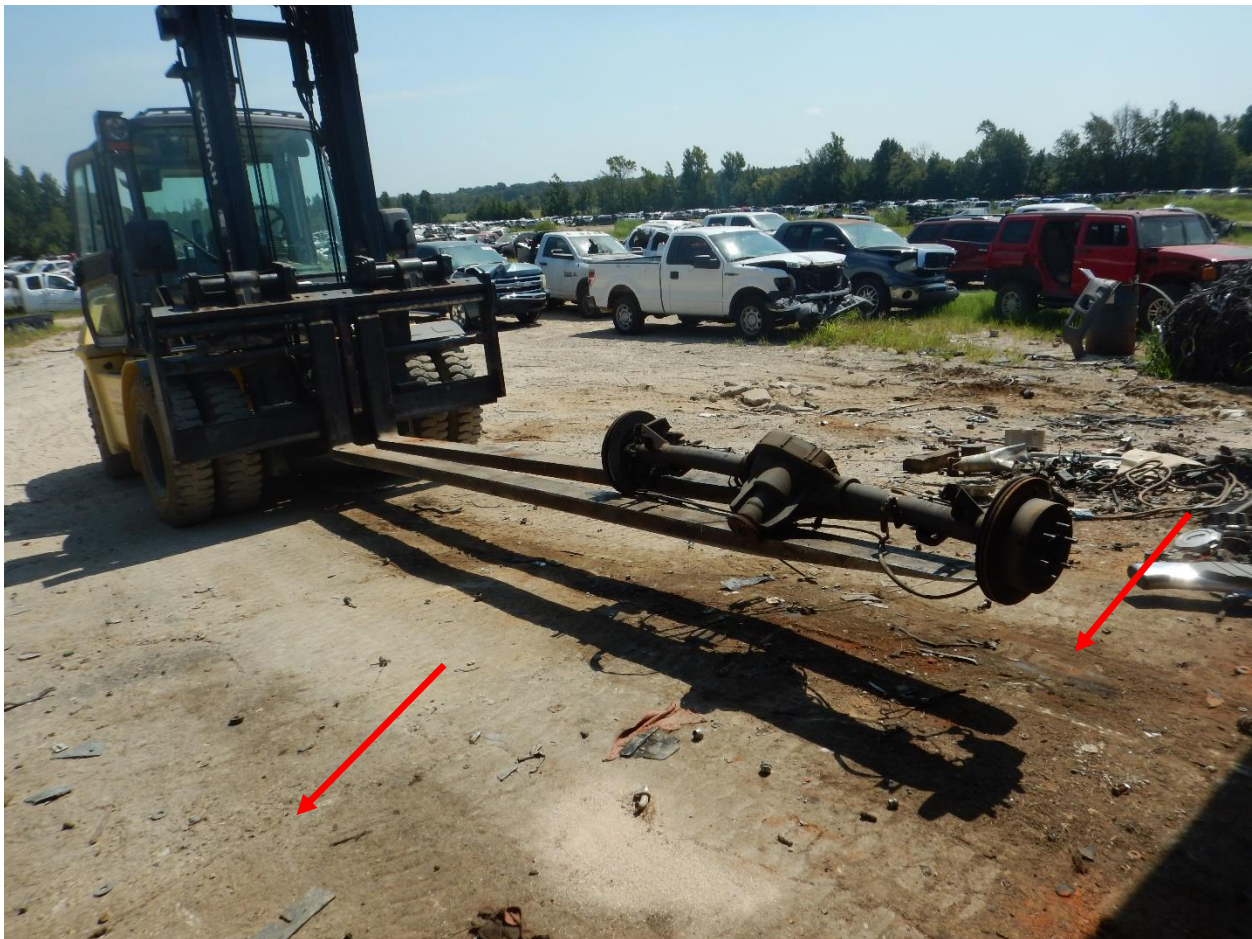
Photo No. 6

Description: Closer view, of Myers Auto Salvage's Dismantling Area, not maintained in effective operating condition (e.g., poor housekeeping as reflected by rusty-discolored staining of the soil).

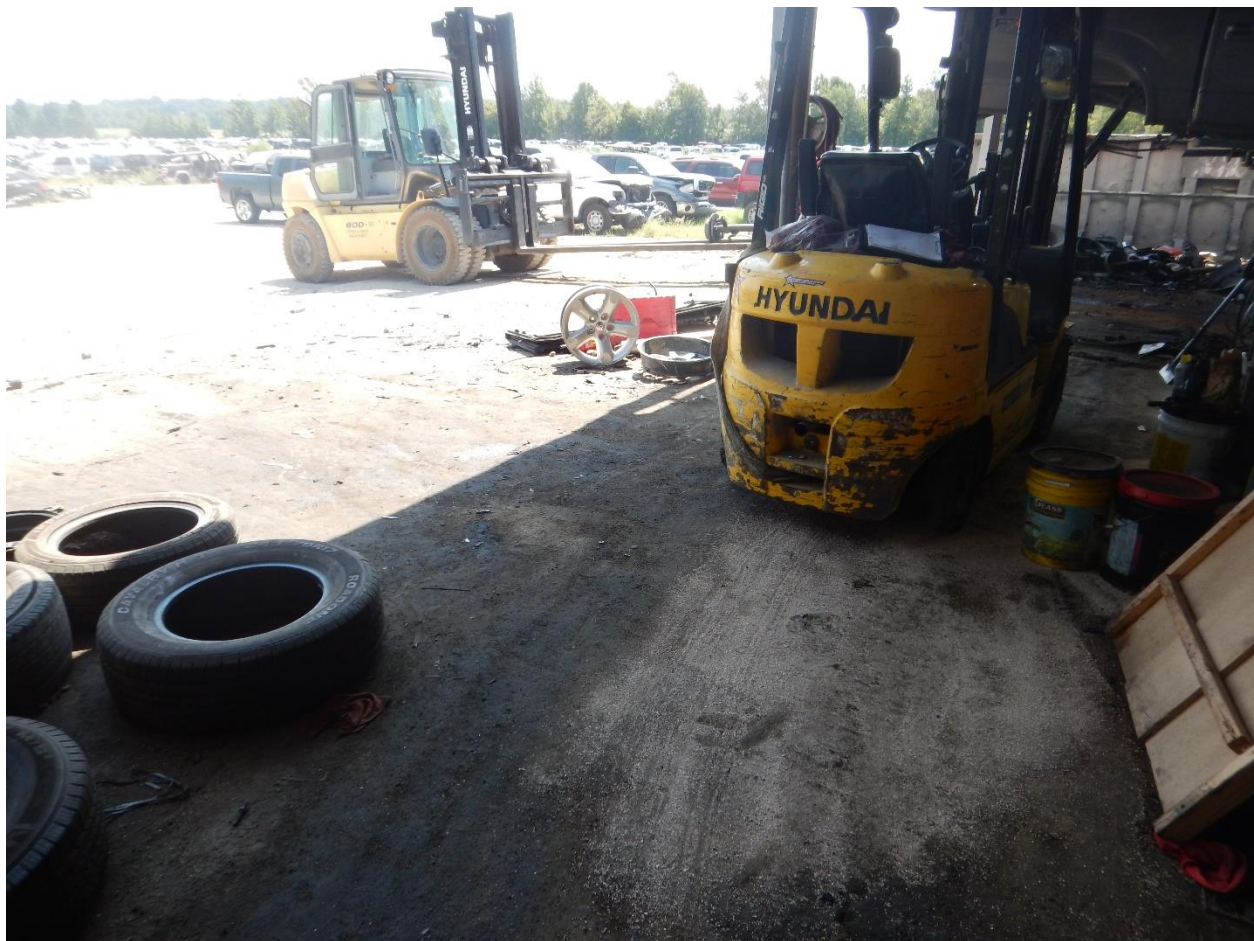
Photo No. 7

Description: Closer view, of Myers Auto Salvage's Dismantling Area, not maintained in an effective operating condition (e.g., poor housekeeping).

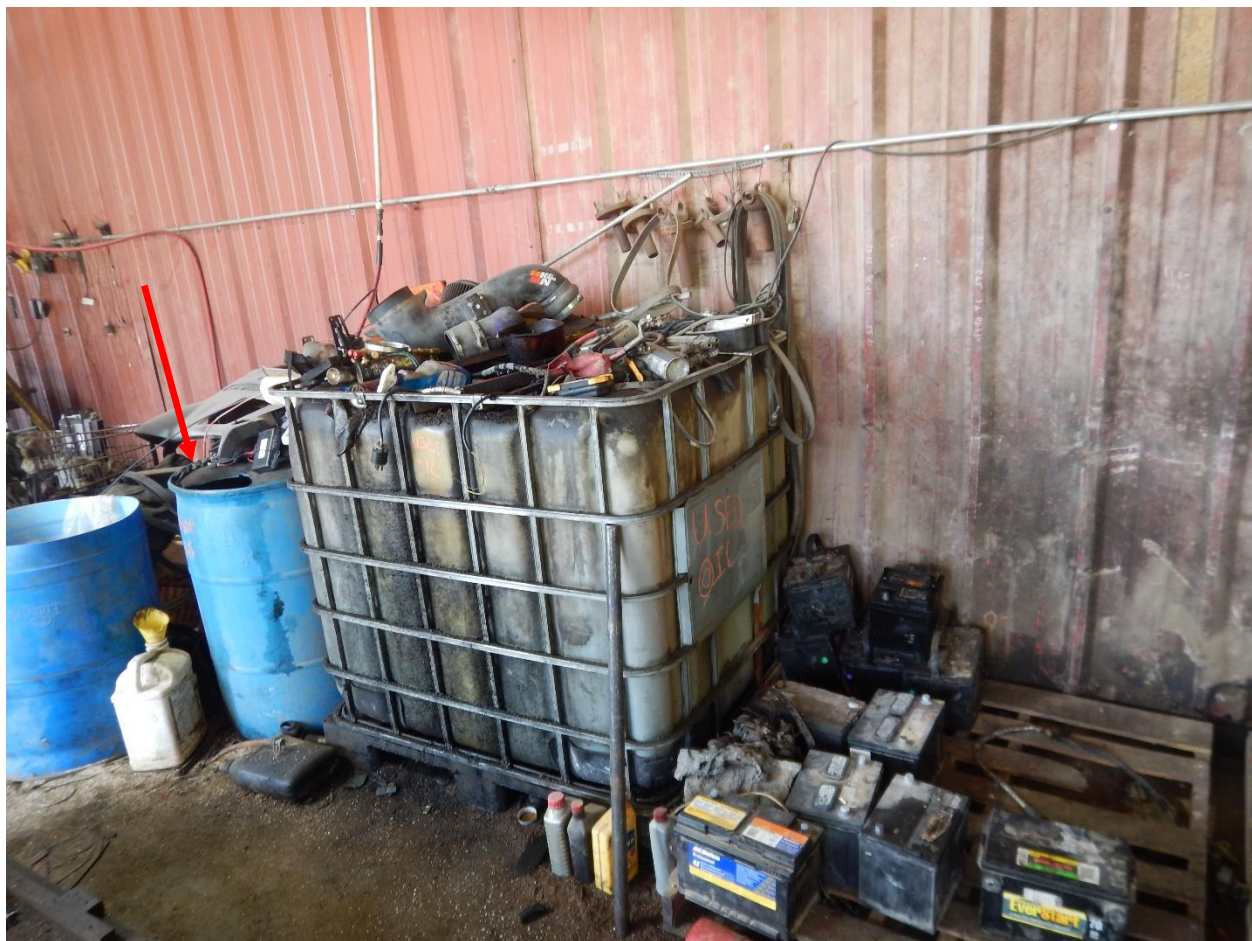
Photo No. 8

Description: Closer view, of Myers Auto Salvage's Dismantling Area, not maintained in an effective operating condition (e.g., poor housekeeping). While this area is located under a covered shed, it should be noted that due to heavy, oily staining in the immediate area, as well as observed standing water as reflected in photos #5, #6, and #7 the potential to impact stormwater runoff is possible. Closer view of drum reflected by red arrow captured in photo #9.

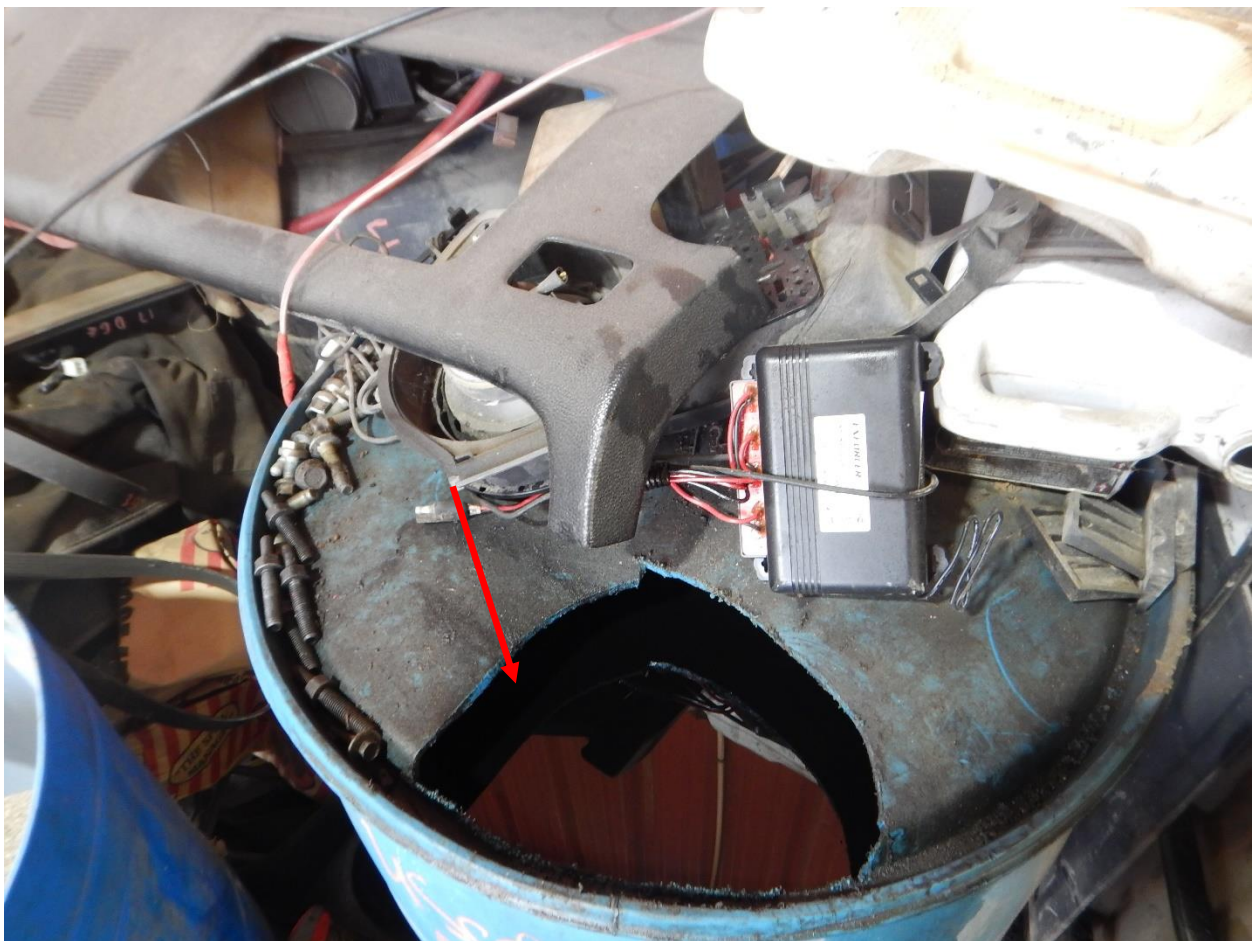
Photo No. 9

Description: Closer view, of Myers Auto Salvage’s Dismantling Area, not maintained in effective operating condition (e.g., poor housekeeping). The facility is not properly managing and/or storing used oil. Specifically, there was oil just below the rim of this drum, which was modified by cutting/carving out a section of the top to pour oil in the container. Other small equipment/material was observed sitting on top of the drum with no safeguards of preventing the items to fall into the oily drum.

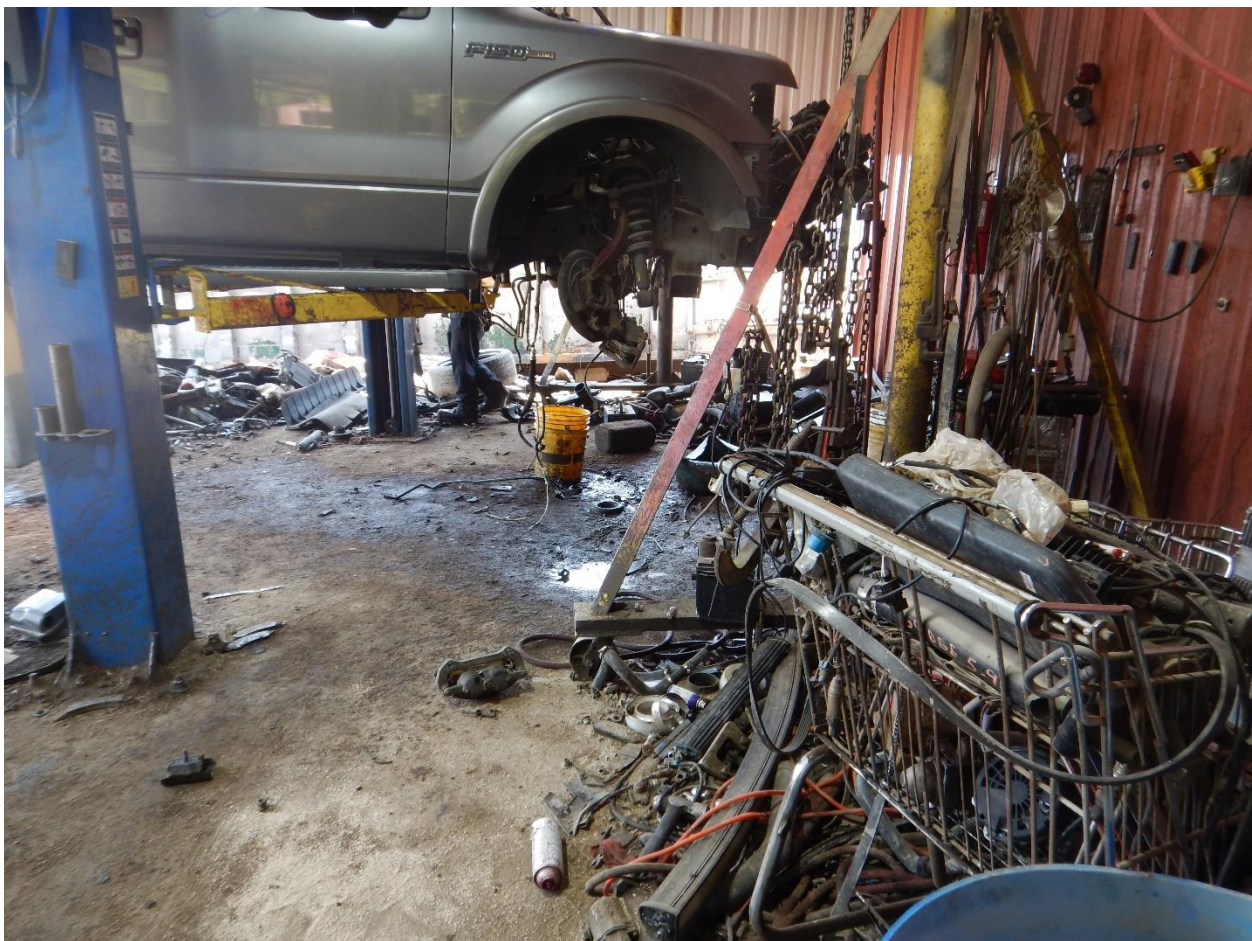
Photo No. 10

Description: Closer view, of Myers Auto Salvage's Dismantling Area, not maintained in effective operating condition (e.g., poor housekeeping). While this area is located under a covered shed, it should be noted that due to heavy, oily staining in the immediate area, as well as observed standing water as reflected in photos #5 and #6, the potential to impact stormwater runoff is possible.

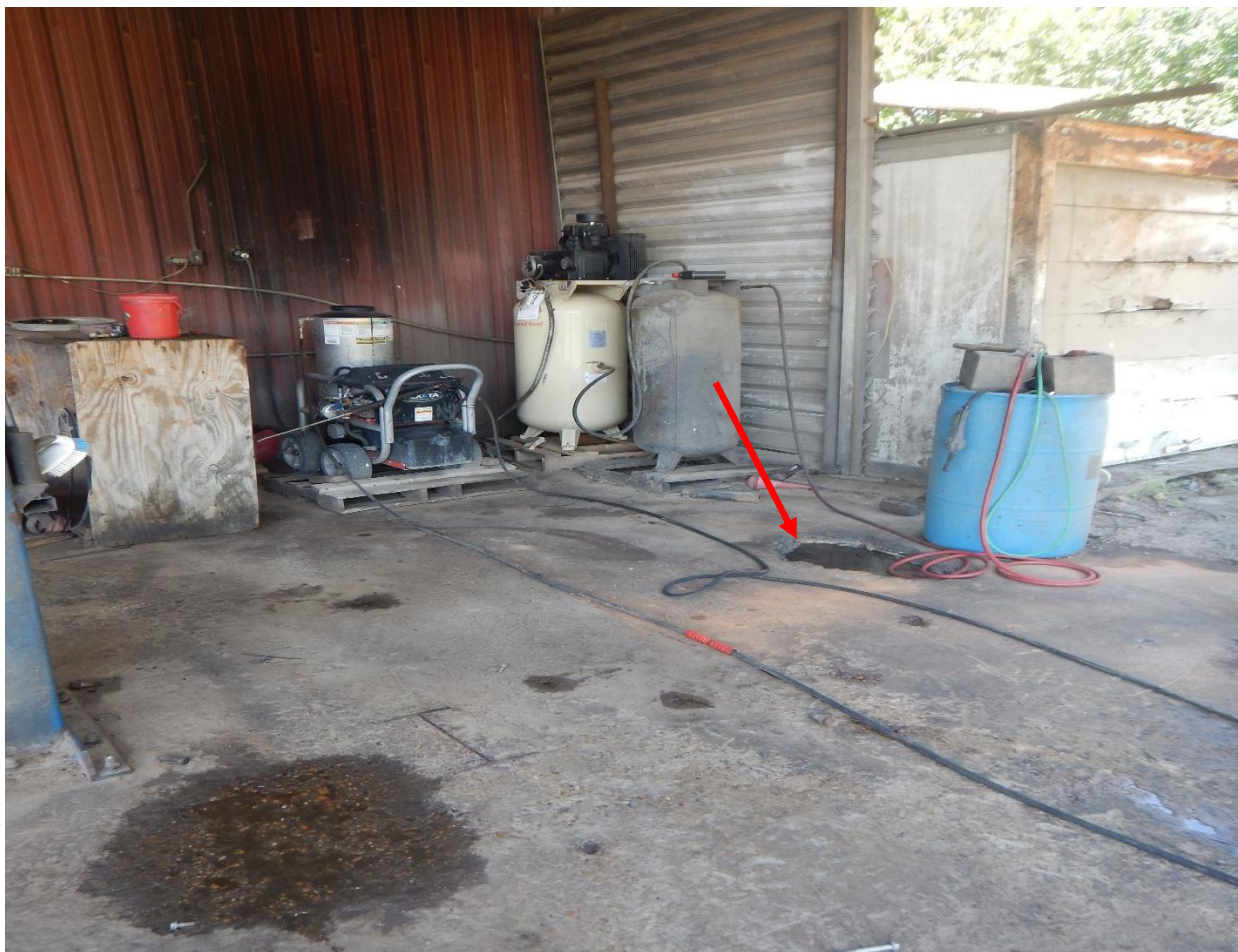
Photo No. 11

Description: Closer view, of Myers Auto Salvage's Dismantling Area, not maintained in an effective operating condition (e.g., poor housekeeping). While this area is located under a covered shed, it should be noted that due to heavy, oily staining in the immediate area, the potential to impact stormwater runoff is possible. Closer view of pooled water reflected by red arrow captured in photo #12.

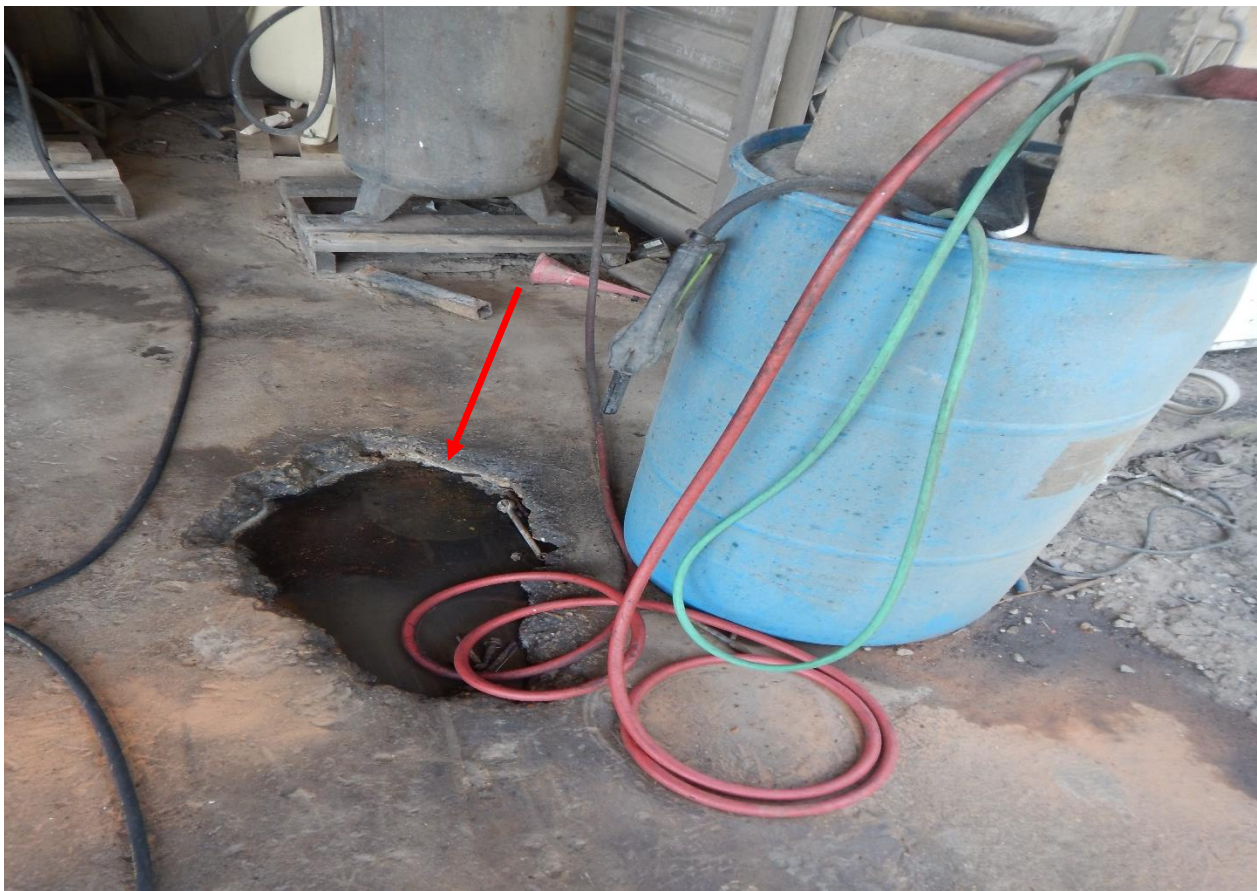
Photo No. 12

Description: Closer view, of Myers Auto Salvage's Dismantling Area, not maintained in an effective operating condition (e.g., poor housekeeping). The facility is not properly and/or timely responding to clean ups efforts associated with spills. Specifically, there was oily water settled in a pitted area. While the area is covered, there is an open space just above the area, which has the potential to allow stormwater, via windrift to enter the area and ultimately drain to the soil area immediately at the mouth of the dismantling area.

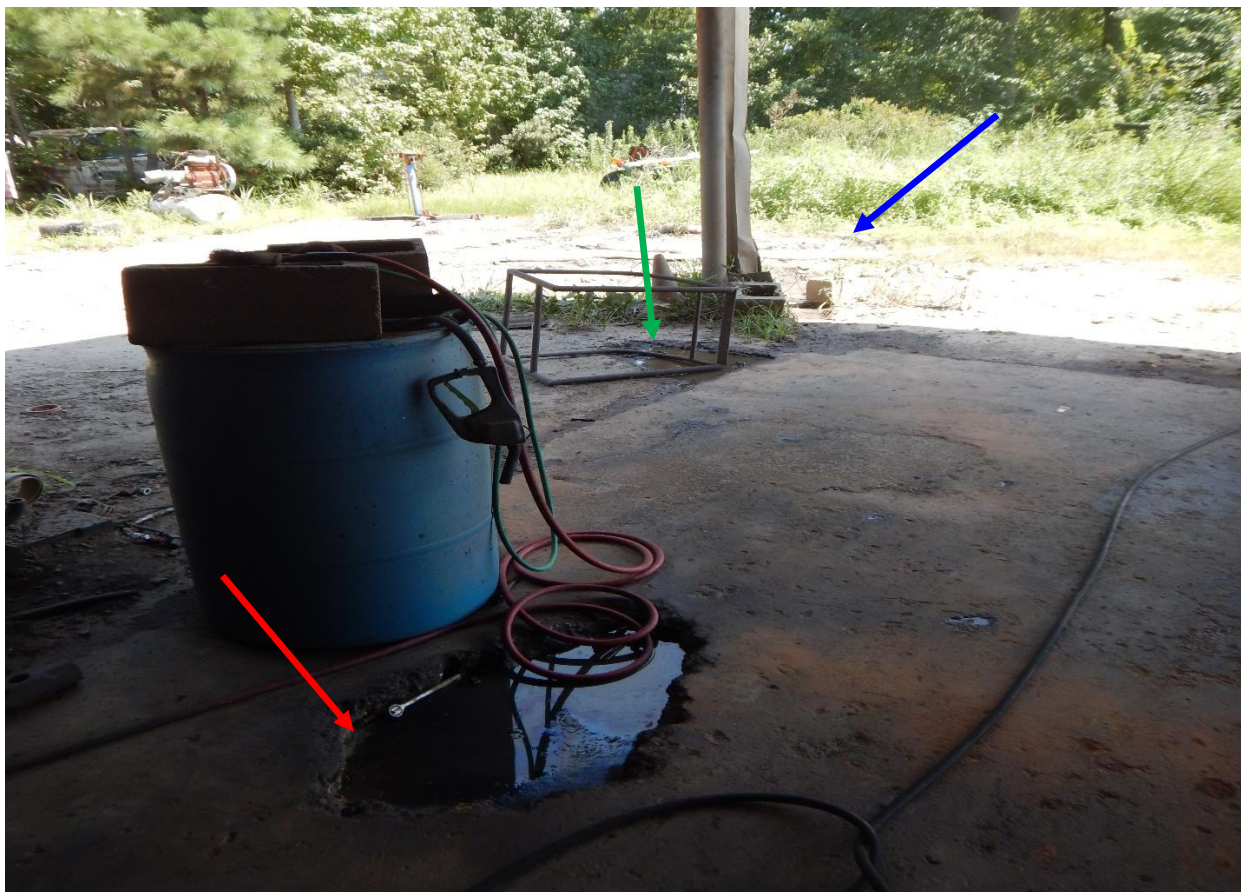
Photo No. 13

Description: Closer view, of Myers Auto Salvage's Dismantling Area, not maintained in an effective operating condition (e.g., poor housekeeping). Note: hydrocarbon sheen contained in pitted area (also reflected in photo #12). Closer view of green and blue arrowed areas captured in photos #14 and #15, respectively.

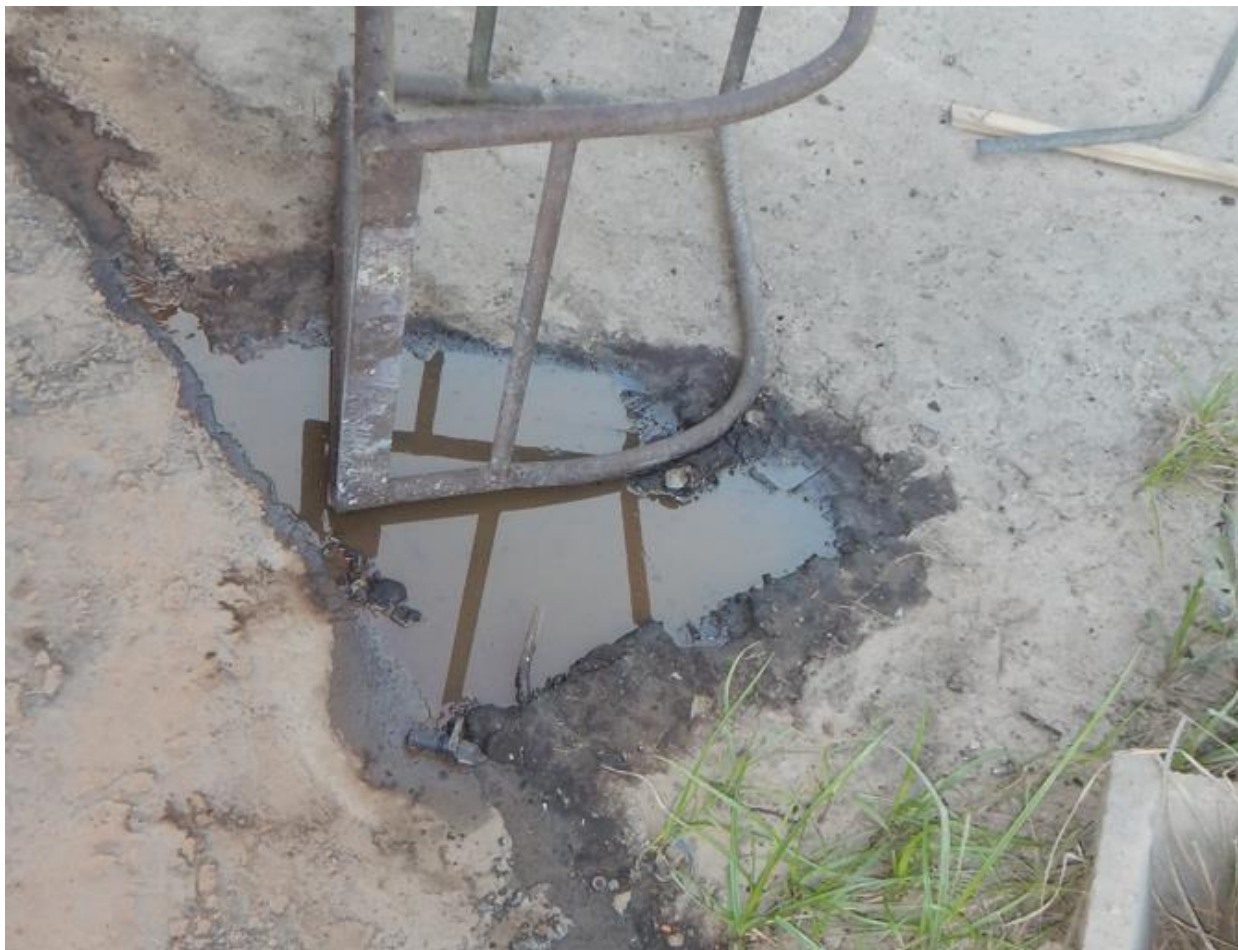
Photo No. 14

Description: Closer view, of Myers Auto Salvage's Dismantling Area, not maintained in an effective operating condition (e.g., poor housekeeping). Note: hydrocarbon sheen contained in pitted area (also reflected in photo #13, see green arrow).

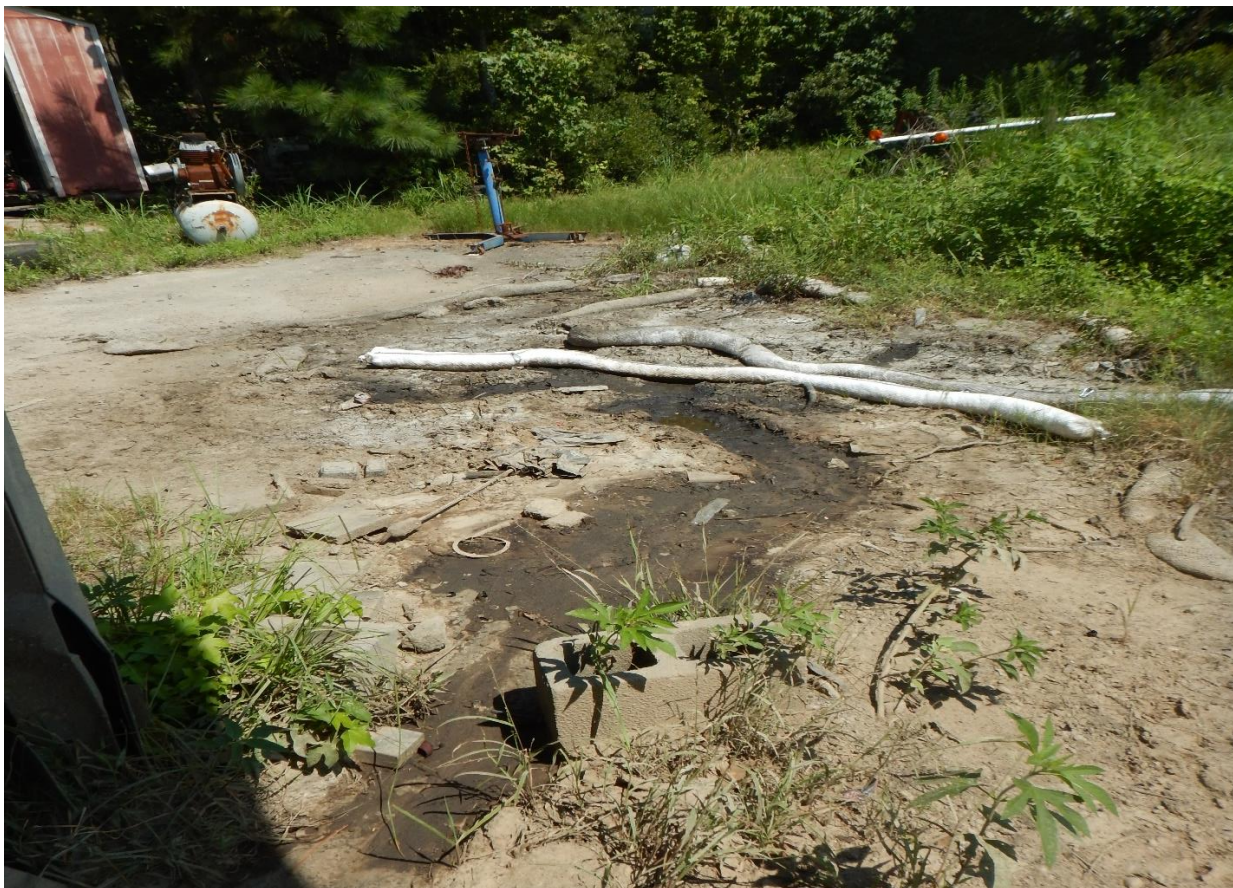
Photo No. 15

- b. Open-topped drums containing oily water were present on-site and oily-stained absorbent booms were present near an area pooled with hydrocarbon liquids/water. The oily-stained area located immediately at the entrance of the Dismantling area was referenced in past quarterly inspections conducted by the permittee's environmental consultant dating back to February 2022. Specifically, the area has been captured as an "area needing attention for next period" in the following quarterly inspection reports: February 2, 2022; July 29, 2022; October 3, 2023; January 18, 2024; and April 29, 2024. It was further noted that adequate/proper clean-up efforts for this area have remained incomplete and unresolved, at a minimum, for 30 months (See Appendix 1, Photograph Log, Photo Nos. 15-17) **TPDES General Permit TXR050000, Part III, Section (A)(4)(b)**

Description: View, immediately at the entrance of the Dismantling Area, not maintained in an effective operating condition (e.g., poor housekeeping). Note: oily-stained absorbent booms and oil-stained soil was observed during the site visit and has been in this condition dating back to February 2022, as noted in the quarterly inspections reviewed. An additional view of the area is captured in photo #16.

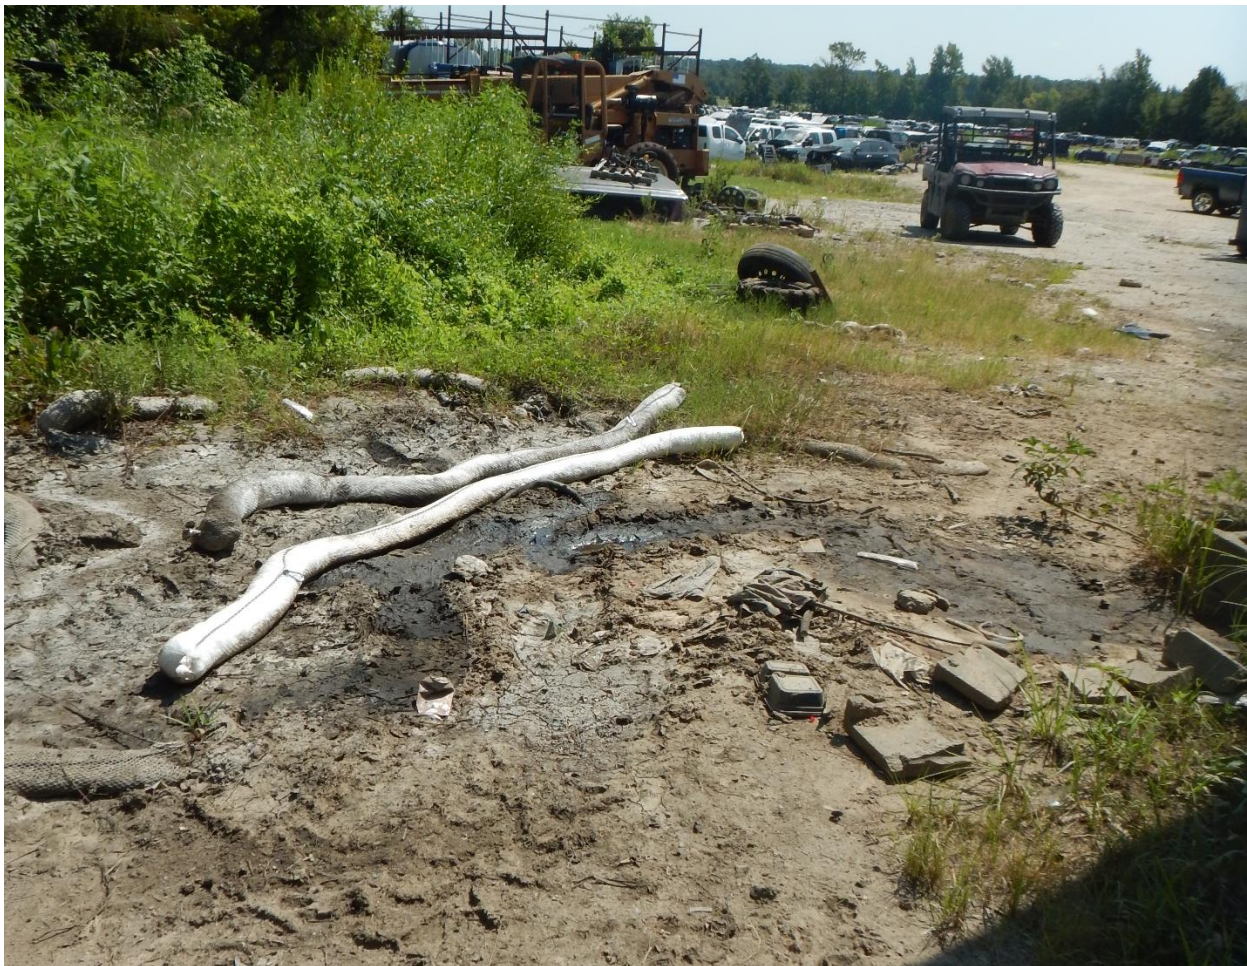
Photo No. 16

Description: Closer view, immediately at the entrance of the Dismantling Area, not maintained in an effective operating condition (e.g., poor housekeeping; oily-stained absorbent booms and oil-stained soil).

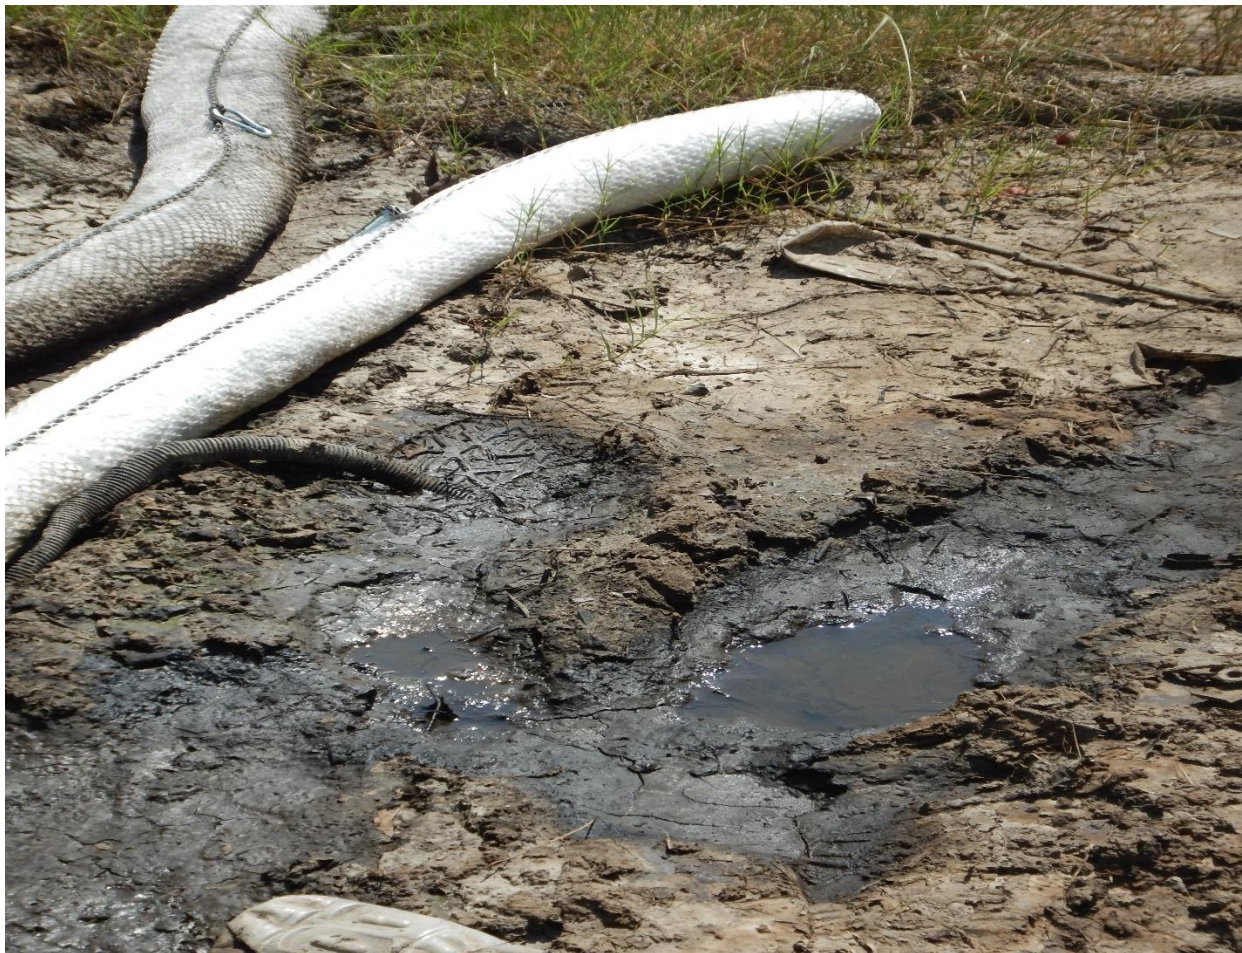
Photo No. 17

Description: Closer view, immediately at the entrance of the Dismantling Area, not maintained in an effective operating condition (e.g., poor housekeeping; oily-stained absorbent booms and oil-stained soil).

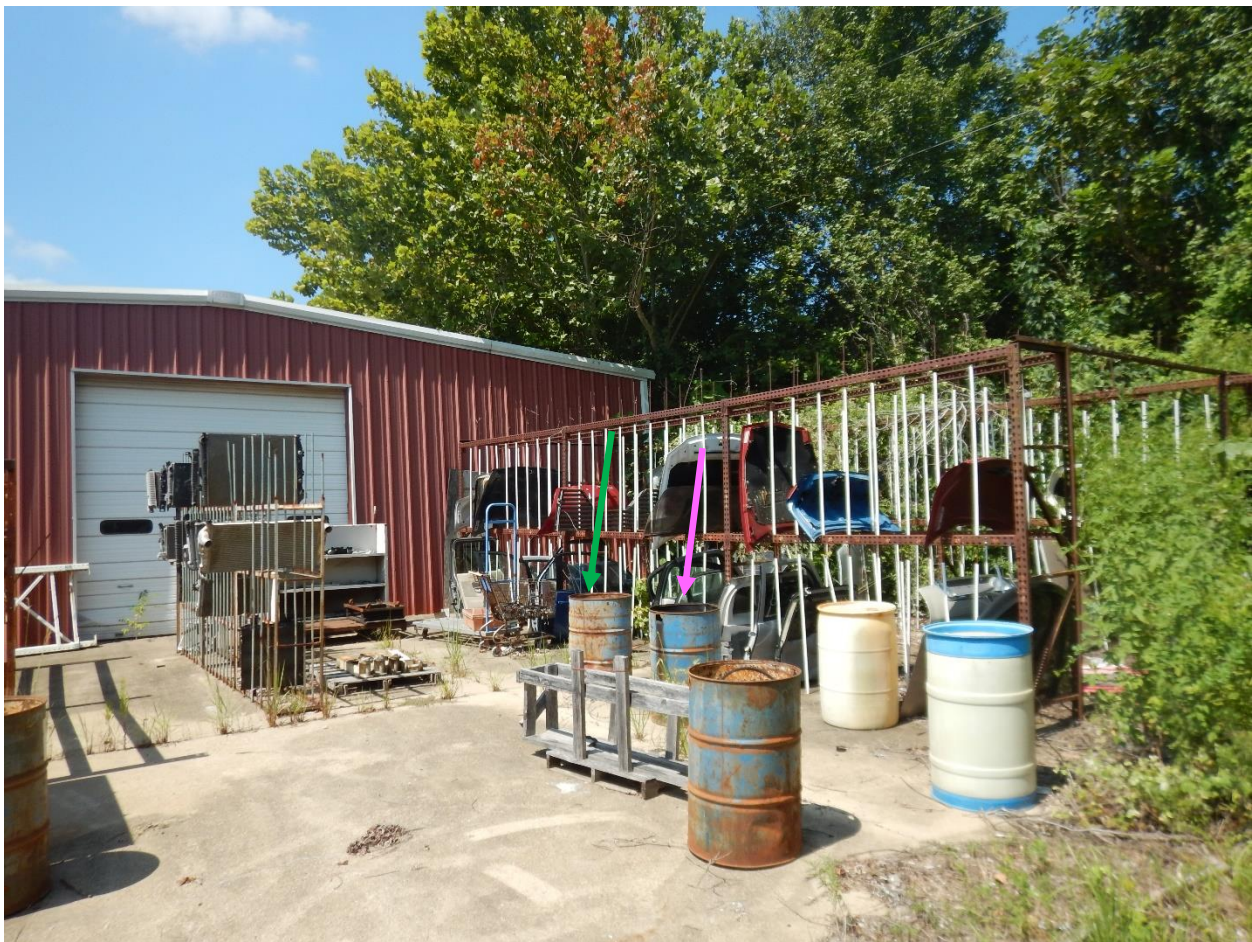
Photo No. 18

Description: View, of outside storage area behind warehouse, with view drums, windshields, hoods, and other various auto parts. Closer and additional views provided in following photos, and details regarding drums identified by pink and green arrows captured in photos #20 and #21, and #22, respectively.
