**Region 6 - Enforcement & Compliance Assurance Division**  
**INSPECTION REPORT**

| Media Program: | Water | |
| Company Name: | <b>Jm Salvage, L.L.C.</b> | |
| Facility Name: | <b>Myers Auto Salvage</b> | |

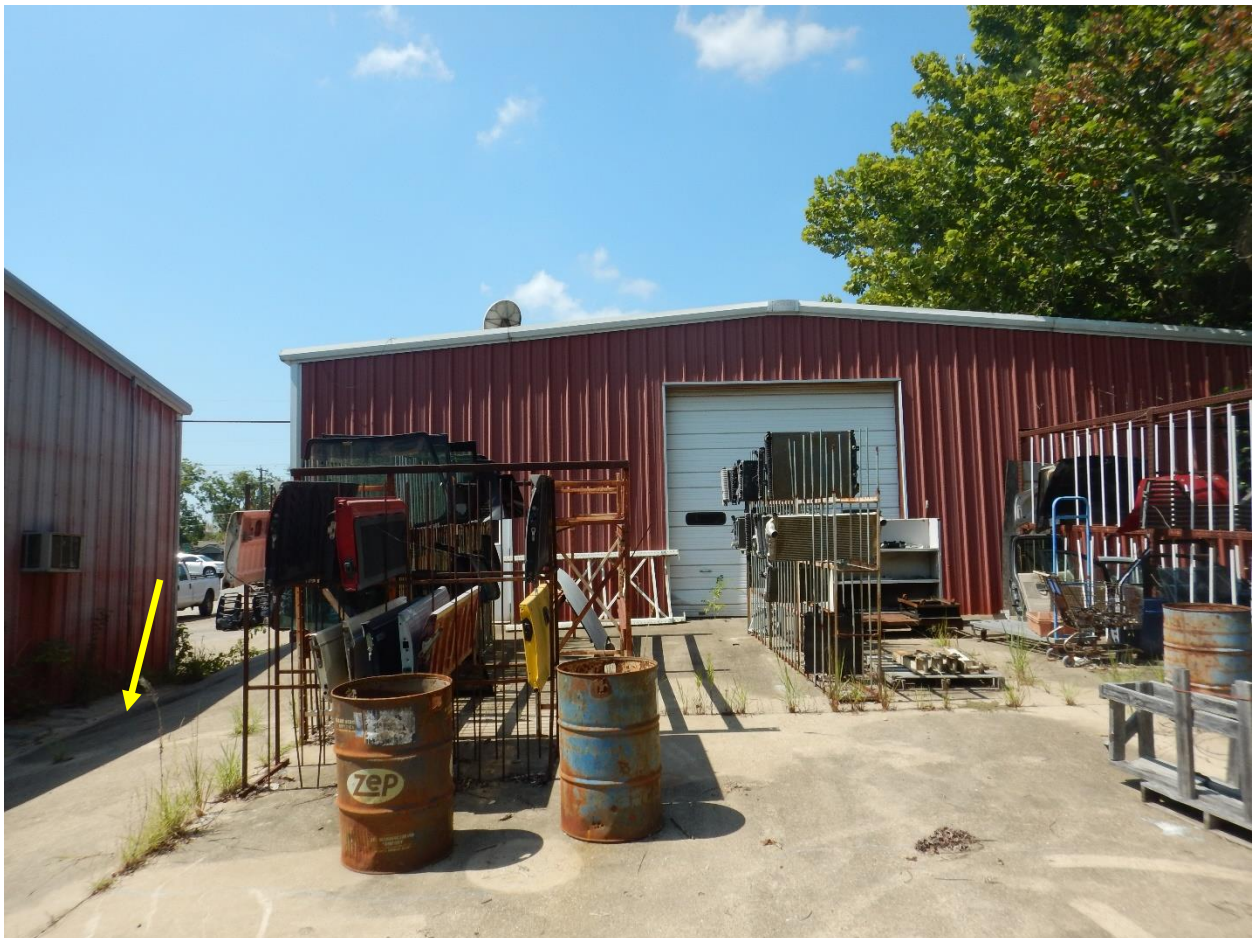
Photo No. 19

Description: Closer view, of outside storage area behind warehouse, with view of drums, windshields, hoods, and other various auto parts. Also, note the drain located to the left as reflected by yellow arrow. A closer view is provided in photo #26.

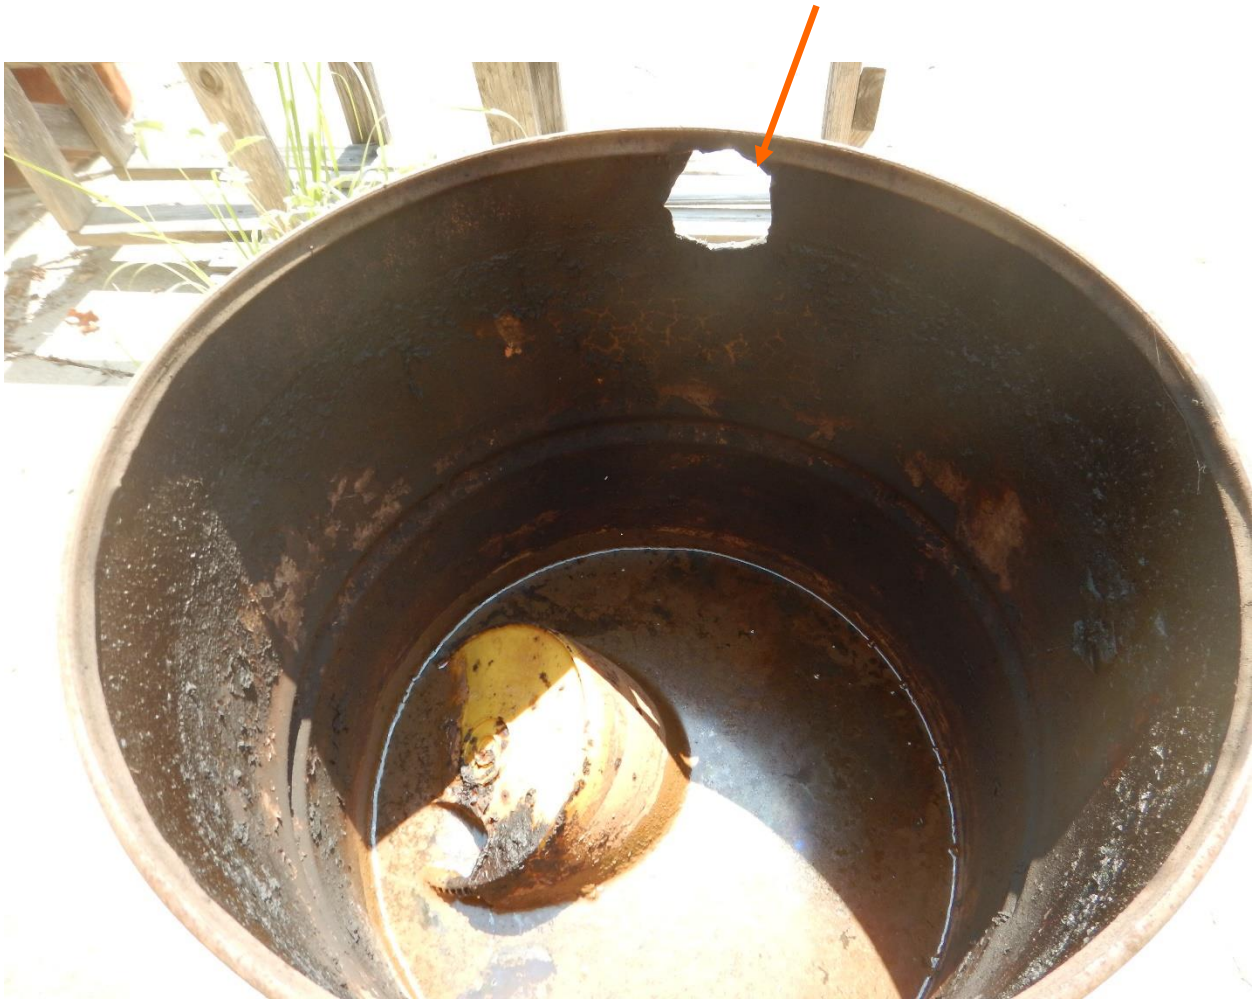
Photo No. 20

Description: Closer view, of drum identified in photo #18 (identified by pink arrow). Note, the contents of the uncovered drum were hydrocarbons, oily water, and a plastic bucket. It was also noted that the drum was damaged by the presence of a hole on the side, near the top of the drum (see orange arrow).

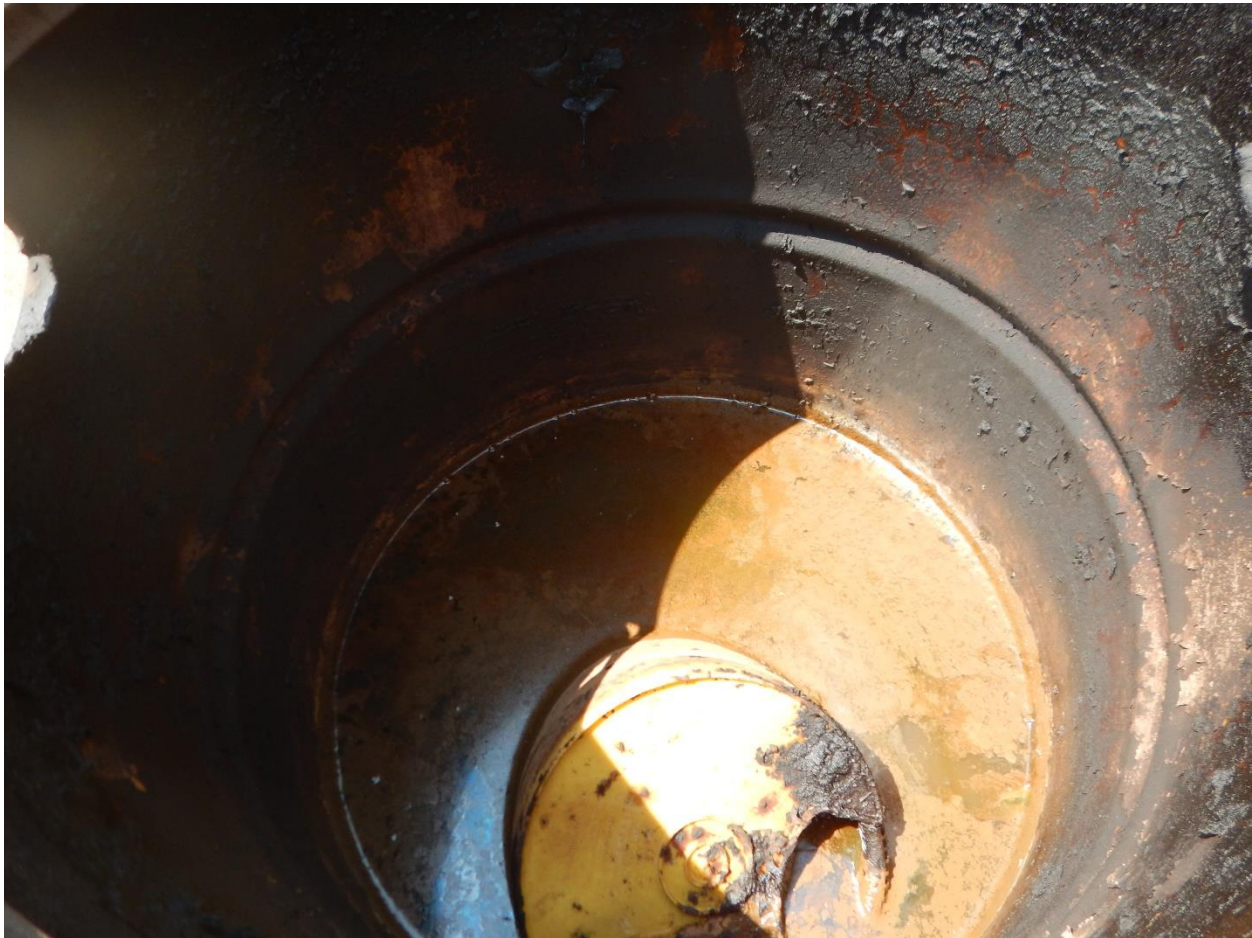
Photo No. 21

Description: Additional view, of drum identified in photos #18 and #20.

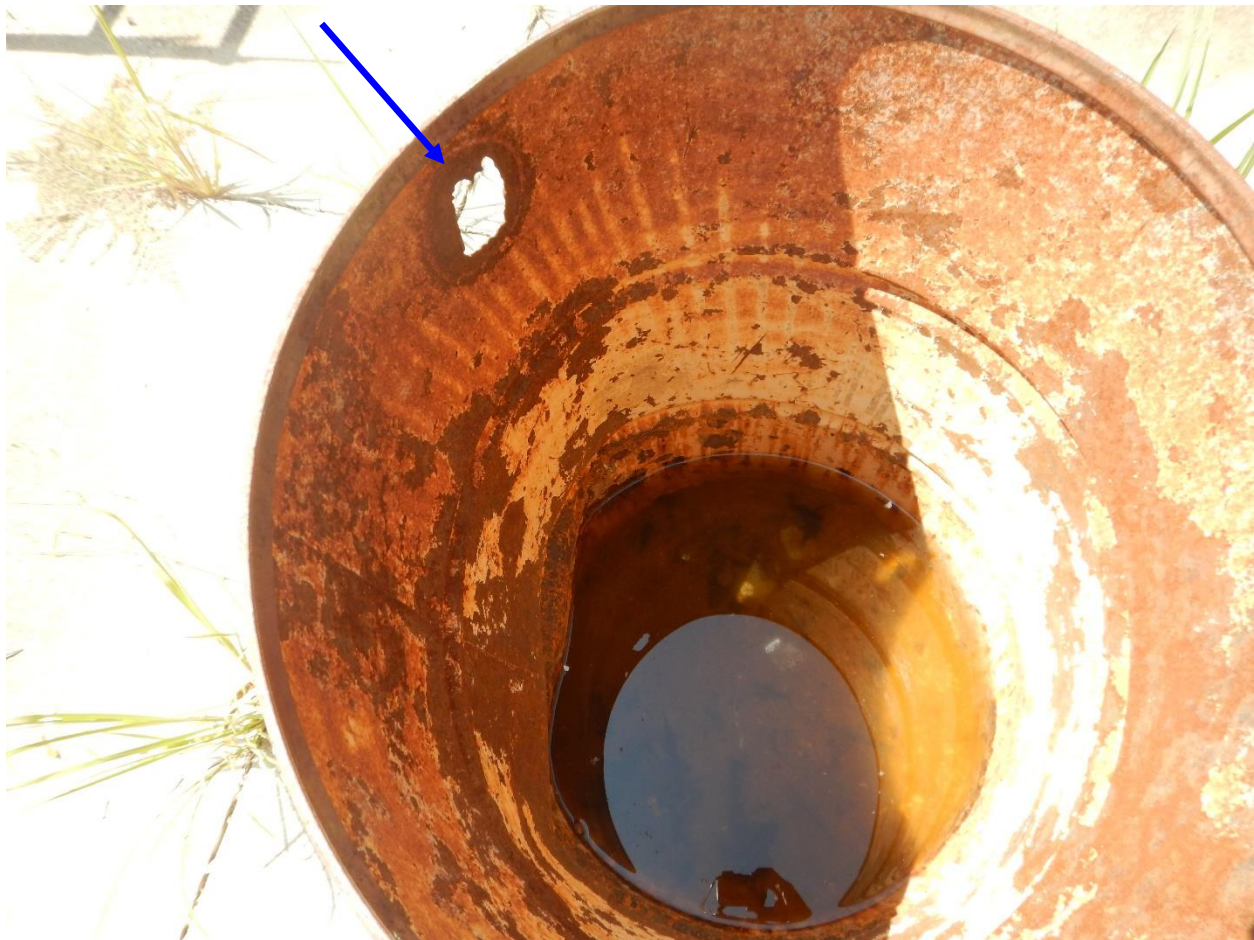
Photo No. 22

Description: Closer view, of drum identified in photo #18 (identified by green arrow). Note, the contents of the uncovered drum were oily water. It was also noted that the drum was damaged by the presence of a hole on the side, near the top of the drum (see blue arrow).

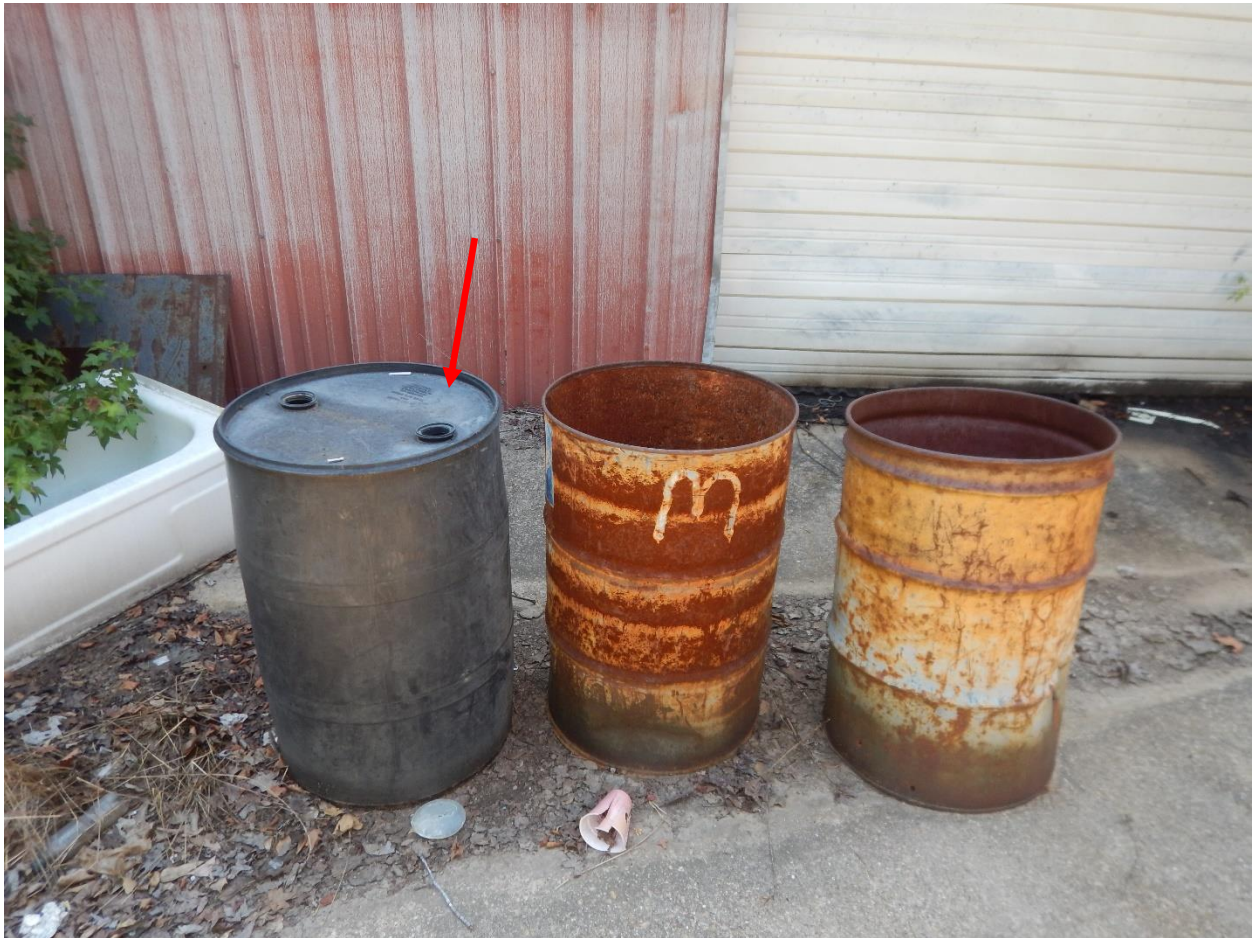
Photo No. 23

- c. Drums, and other containers were not properly labeled (See Appendix 1, Photograph Log, Photo No. 23). **TPDES General Permit TXR050000, Part III, Section (A)(4)(f)(3)**

Description: View, of outside storage area behind warehouse, with view additional drums. Note: The uncovered drums were emptied. See photo #24 for closer view and additional discussion regarding drum referenced by blue arrow, which was not labeled.

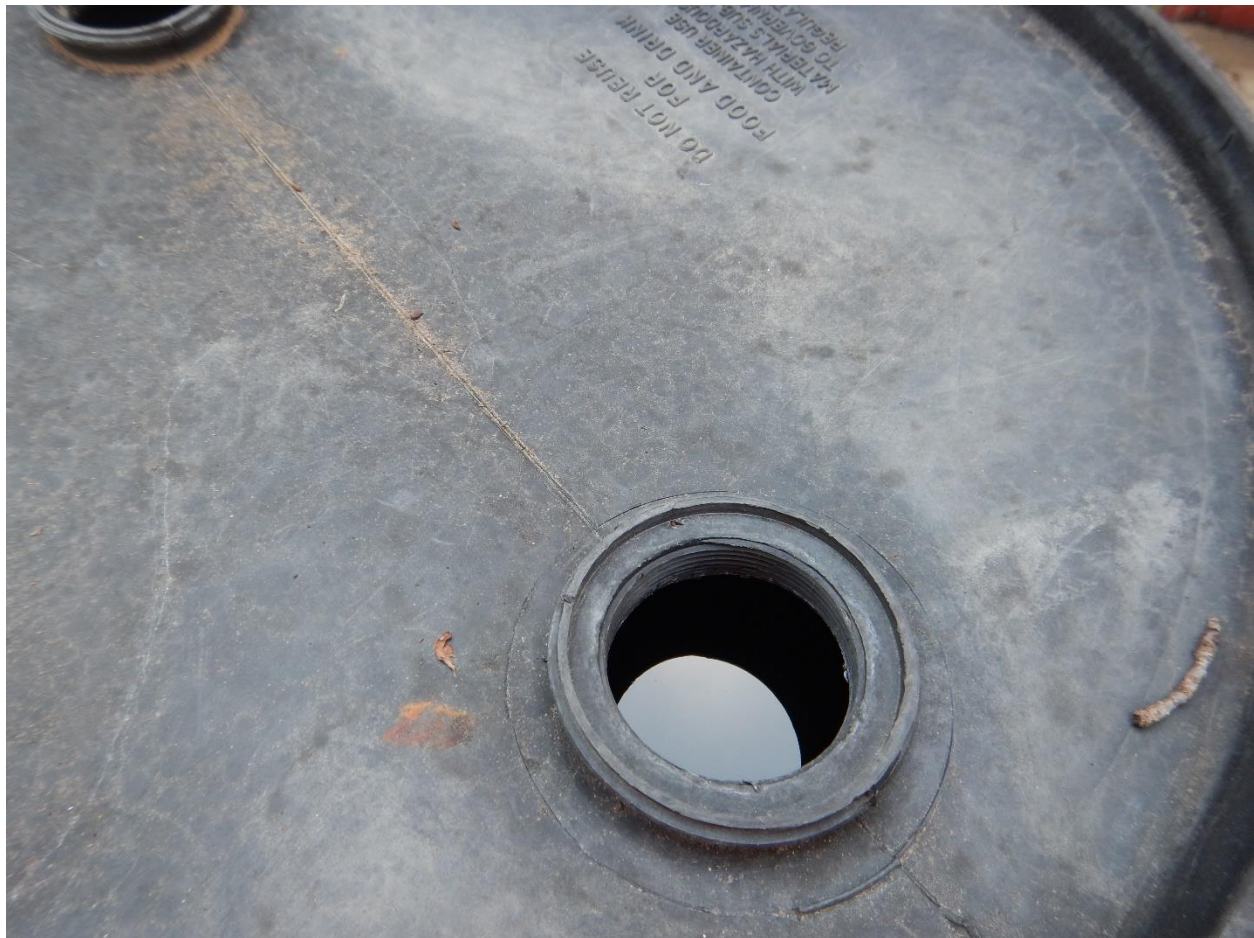
Photo No. 24

Description: Closer view, of drum identified by blue arrow in photo #22. Note, the facility is not properly managing and/or storing used oil. Specifically, there was oil/oily water just below the rim of this uncapped drum.

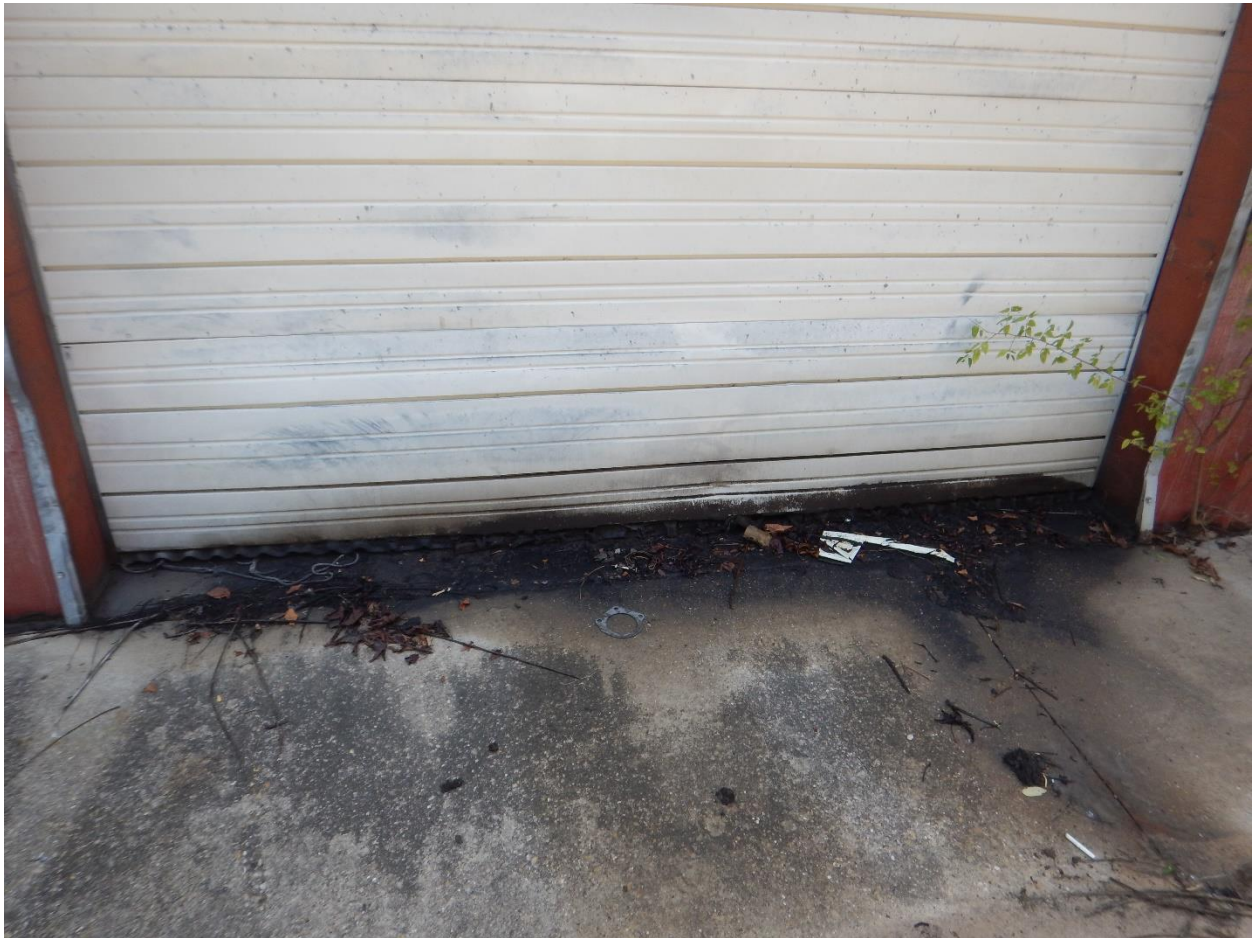
Photo No. 25

**Description:** View, of oily-stained area immediately at the door exiting the parts storage area.

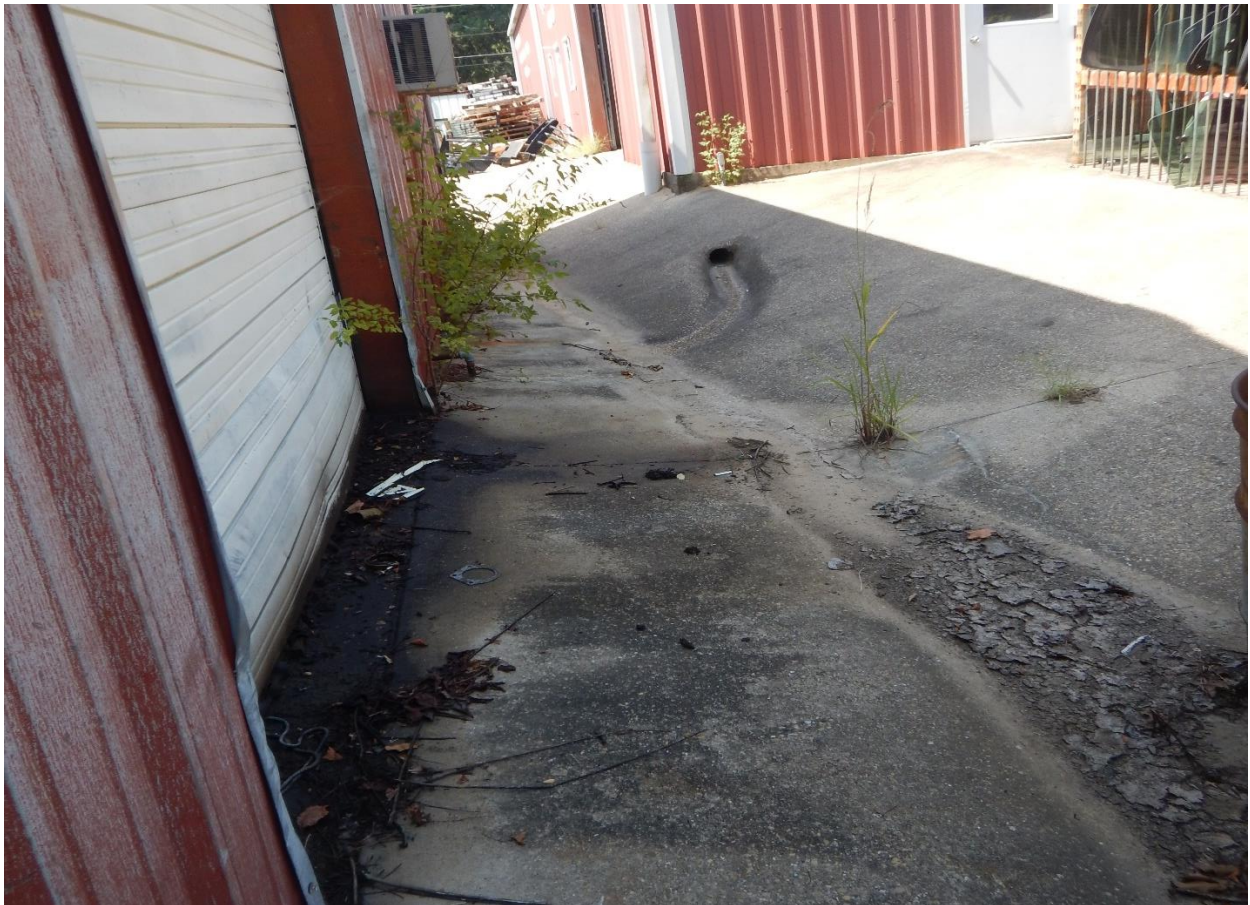
Photo No. 26

Description: Additional view, of oily-stained area immediately at the door exiting the parts storage area. Note drainage conveyance, to the north, which flows downstream of the soiled area into a grassy field. Additional view of area captured in photo #27.

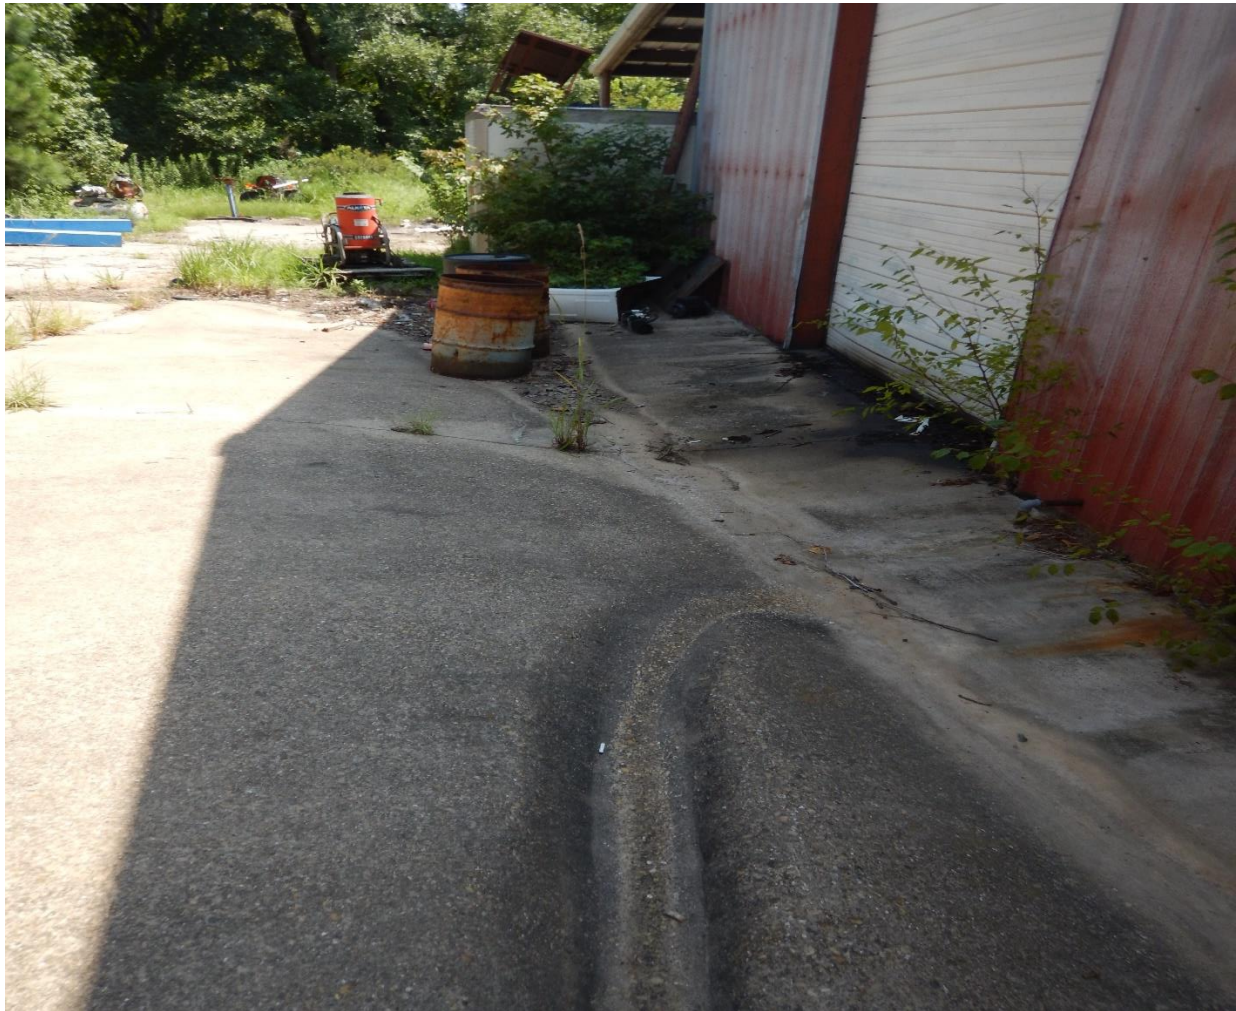
Photo No. 27

Description: Additional view, of oily-stained area immediately at the door exiting the parts storage area. Note drainage conveyance, to the north, which flows downstream of the soiled area into a grassy field.
