## Clean Water Act Section 404: Site Visit/Case Development

| Site Name | Mastro Ready Mix, Inc | | | | |

EPA CWA 404 Inspection Photolog  
Mastro Ready Mix, Inc.

July 18, 2023

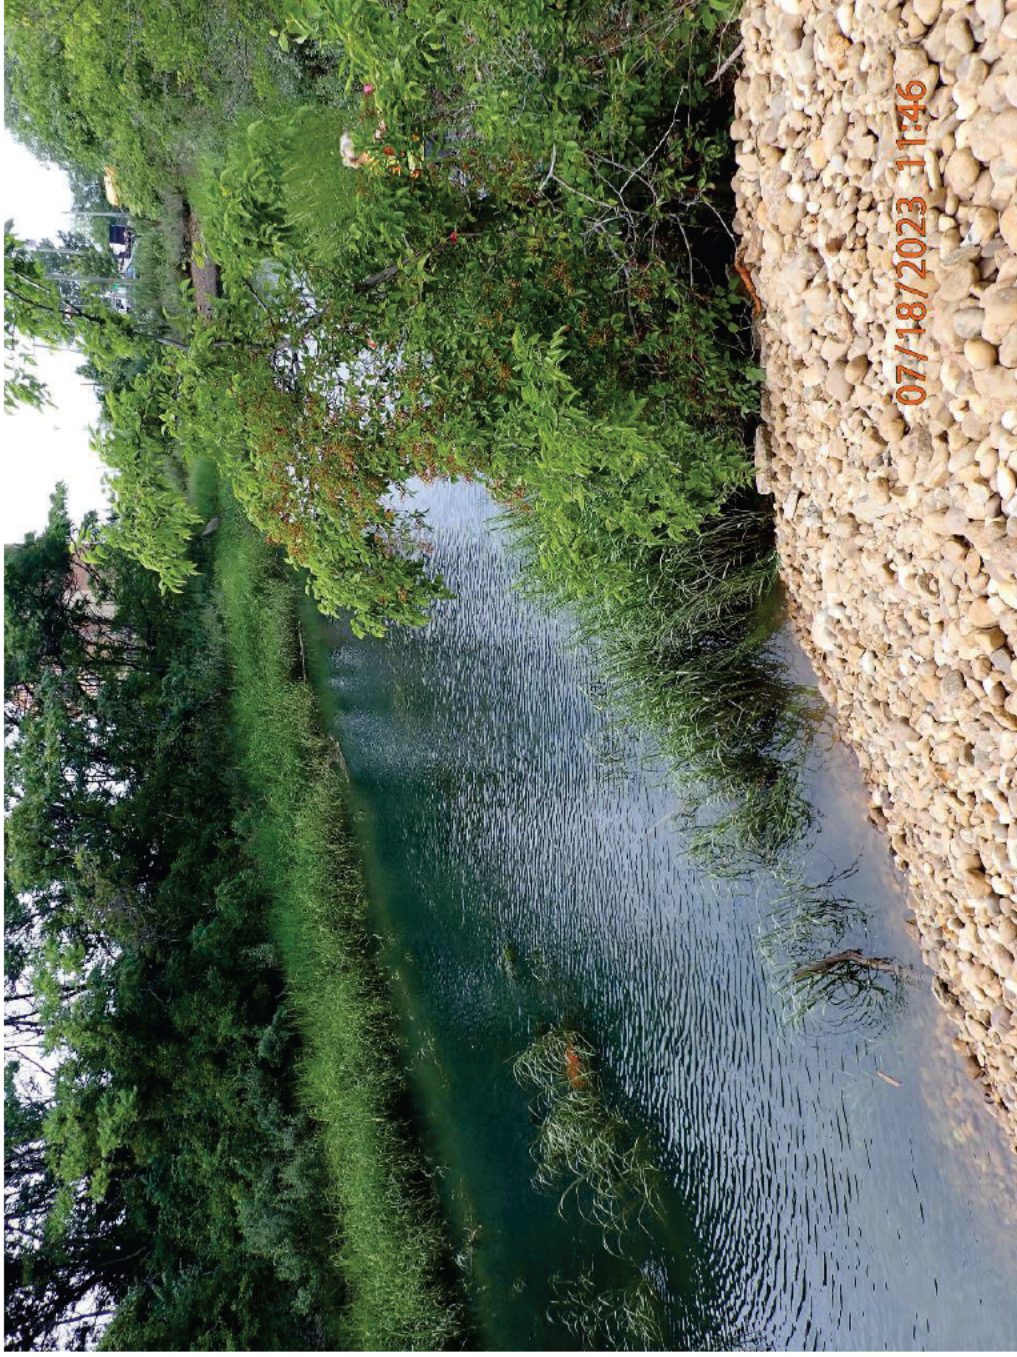
**Date:** 7/18/2023  
**Time:** 11:46 AM  
**Photographer:** S. Andreescu  
**Photo ID:** 1 – P7180107

**Description:**  
(1/4) Panorama of fill material  
in Hook Creek ecosystem

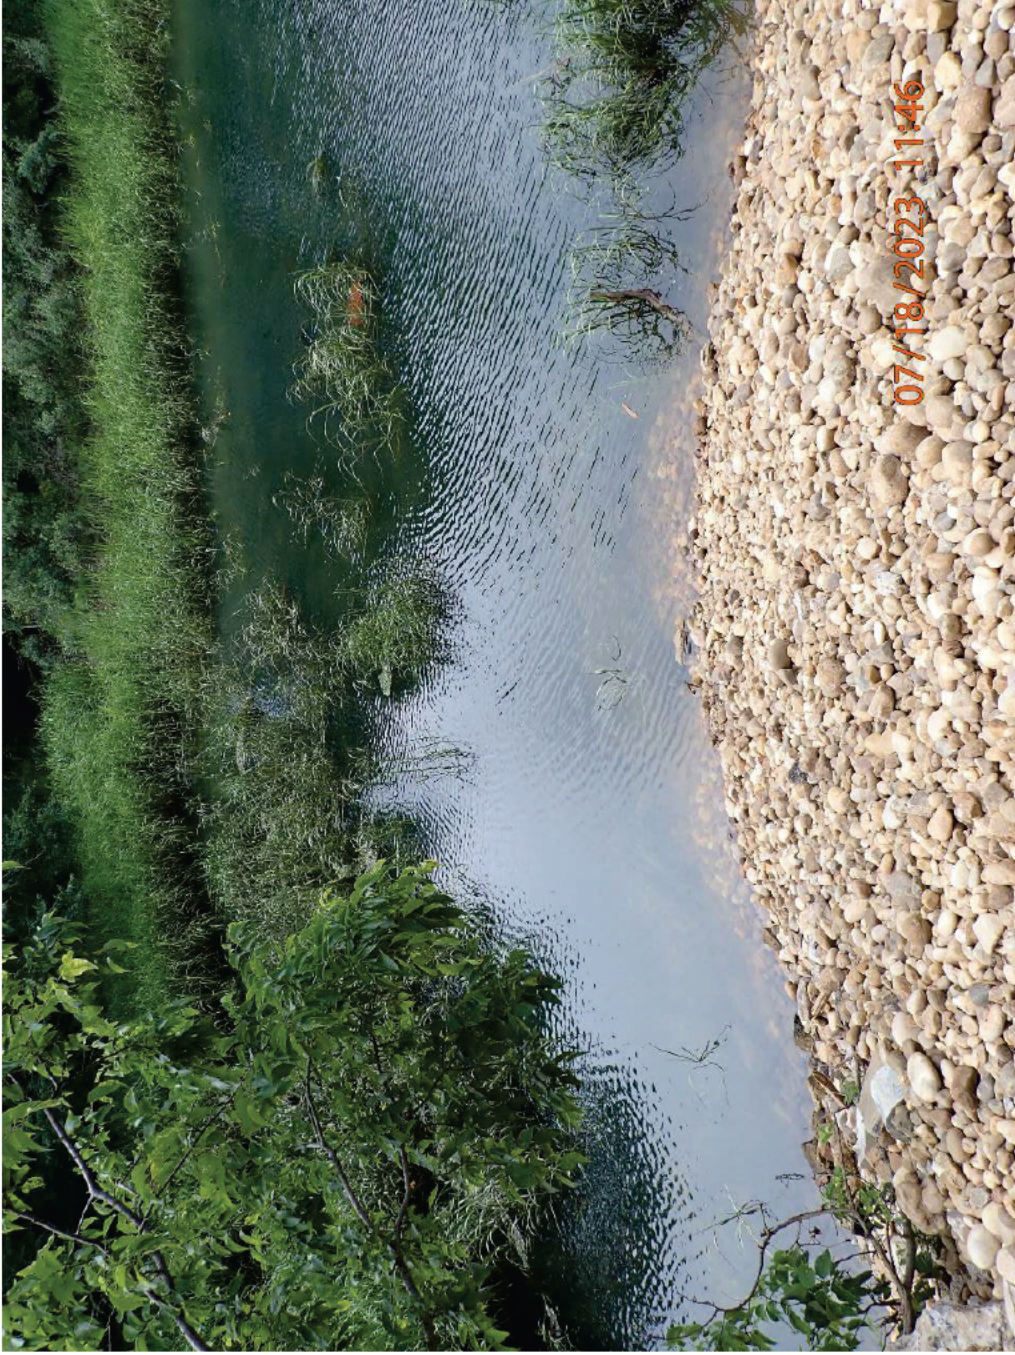
**Date:** 7/18/2023  
**Time:** 11:46 AM  
**Photographer:** S. Andreescu  
**Photo ID:** 2 – P7180108

(2/4) Panorama of fill material  
in Hook Creek ecosystem

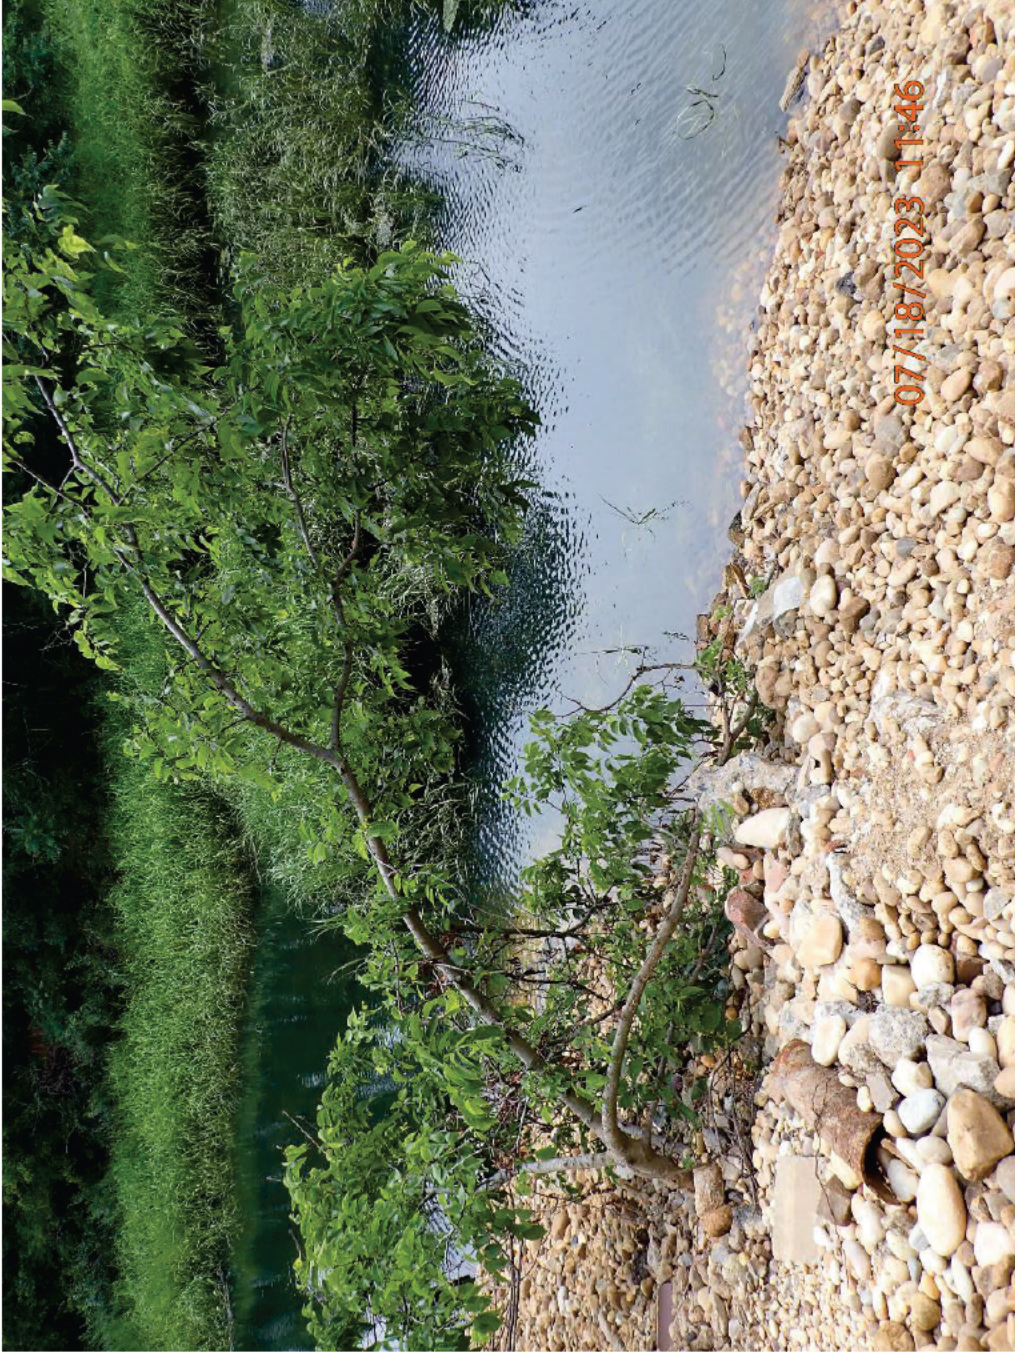
**Date:** 7/18/2023  
**Time:** 11:46 AM  
**Photographer:** S. Andreescu  
**Photo ID:** 3 – P7180109  
**Description:**  
(3/4) Panorama of fill material  
in Hook Creek ecosystem

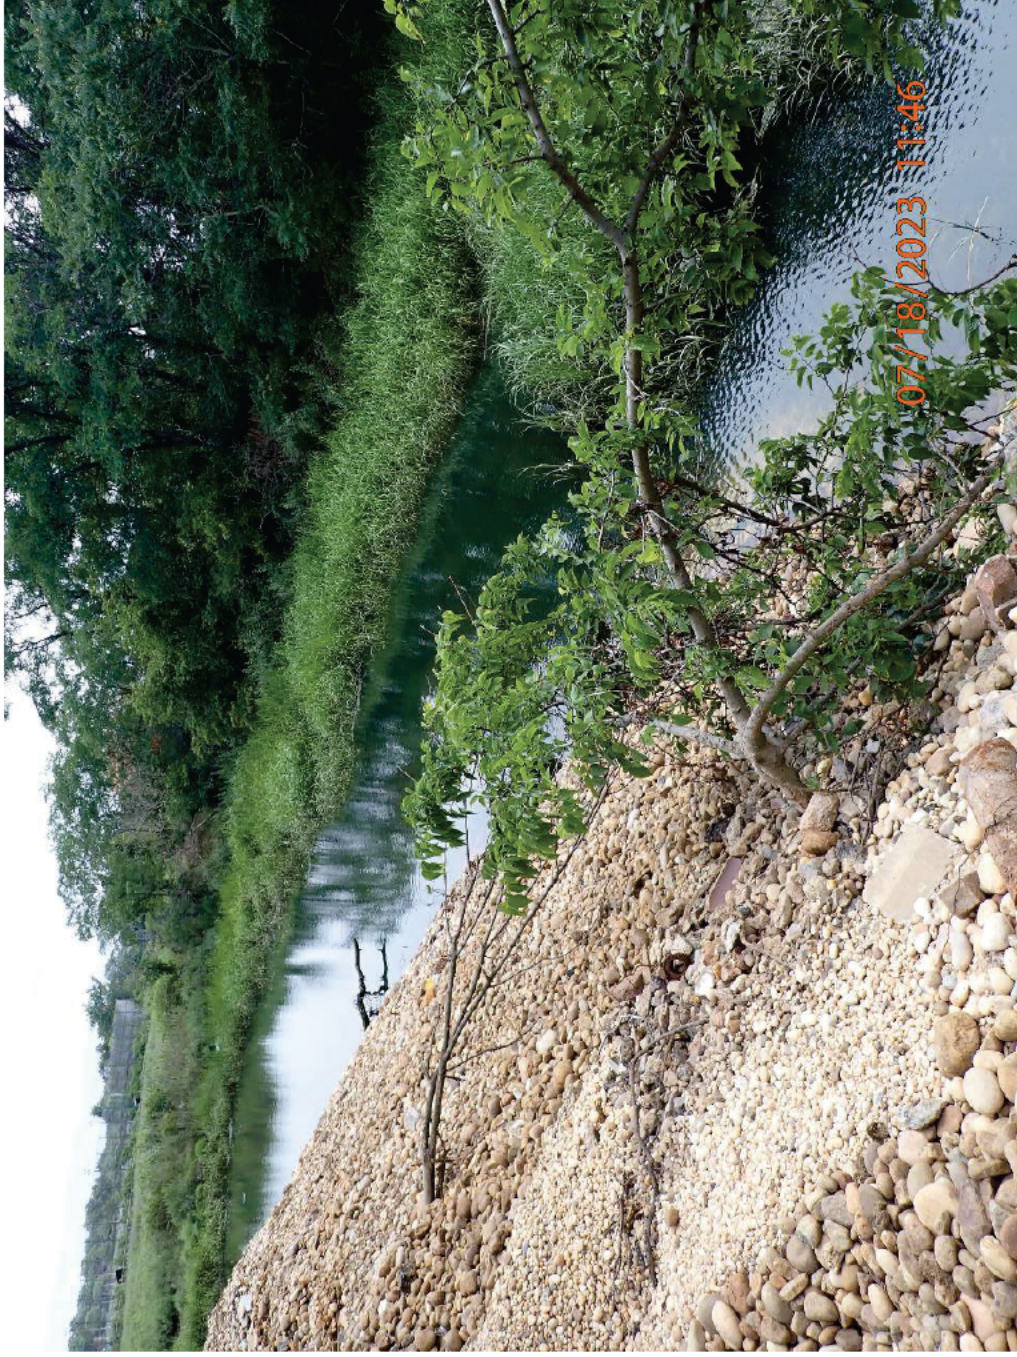
**Date:** 7/18/2023  
**Time:** 11:46 AM  
**Photographer:** S. Andreescu  
**Photo ID:** 4 – P7180110  
**Description:**  
(4/4) Panorama of fill material  
in Hook Creek ecosystem

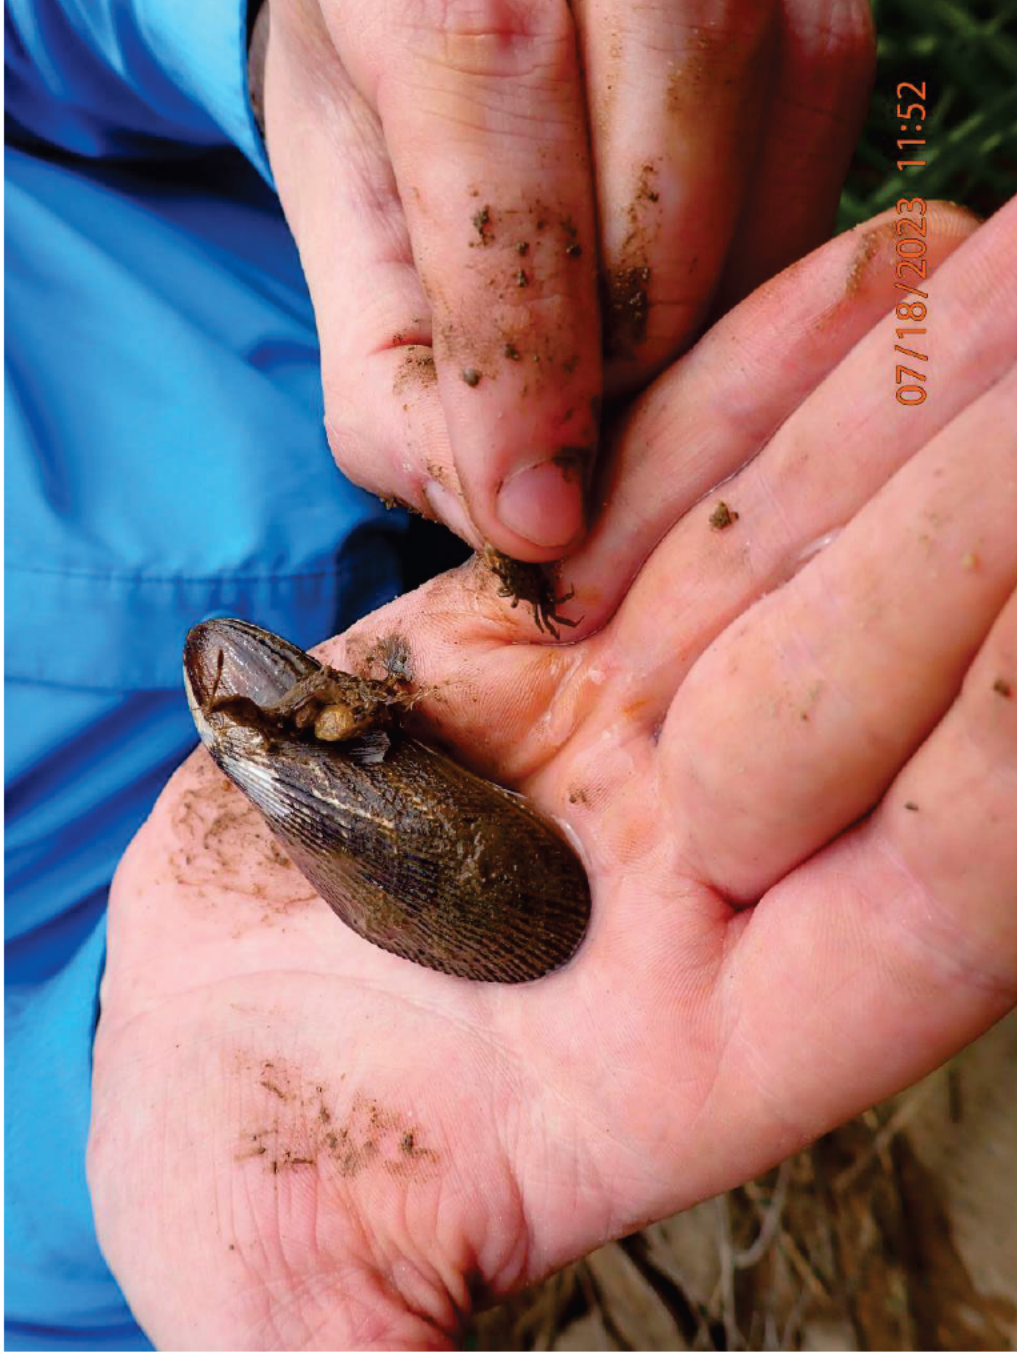
**Date:** 7/18/2023  
**Time:** 11:52 AM  
**Photographer:** S. Andreescu  
**Photo ID:** 5 – P7180111

Marine organisms found  
adjacent to fill material

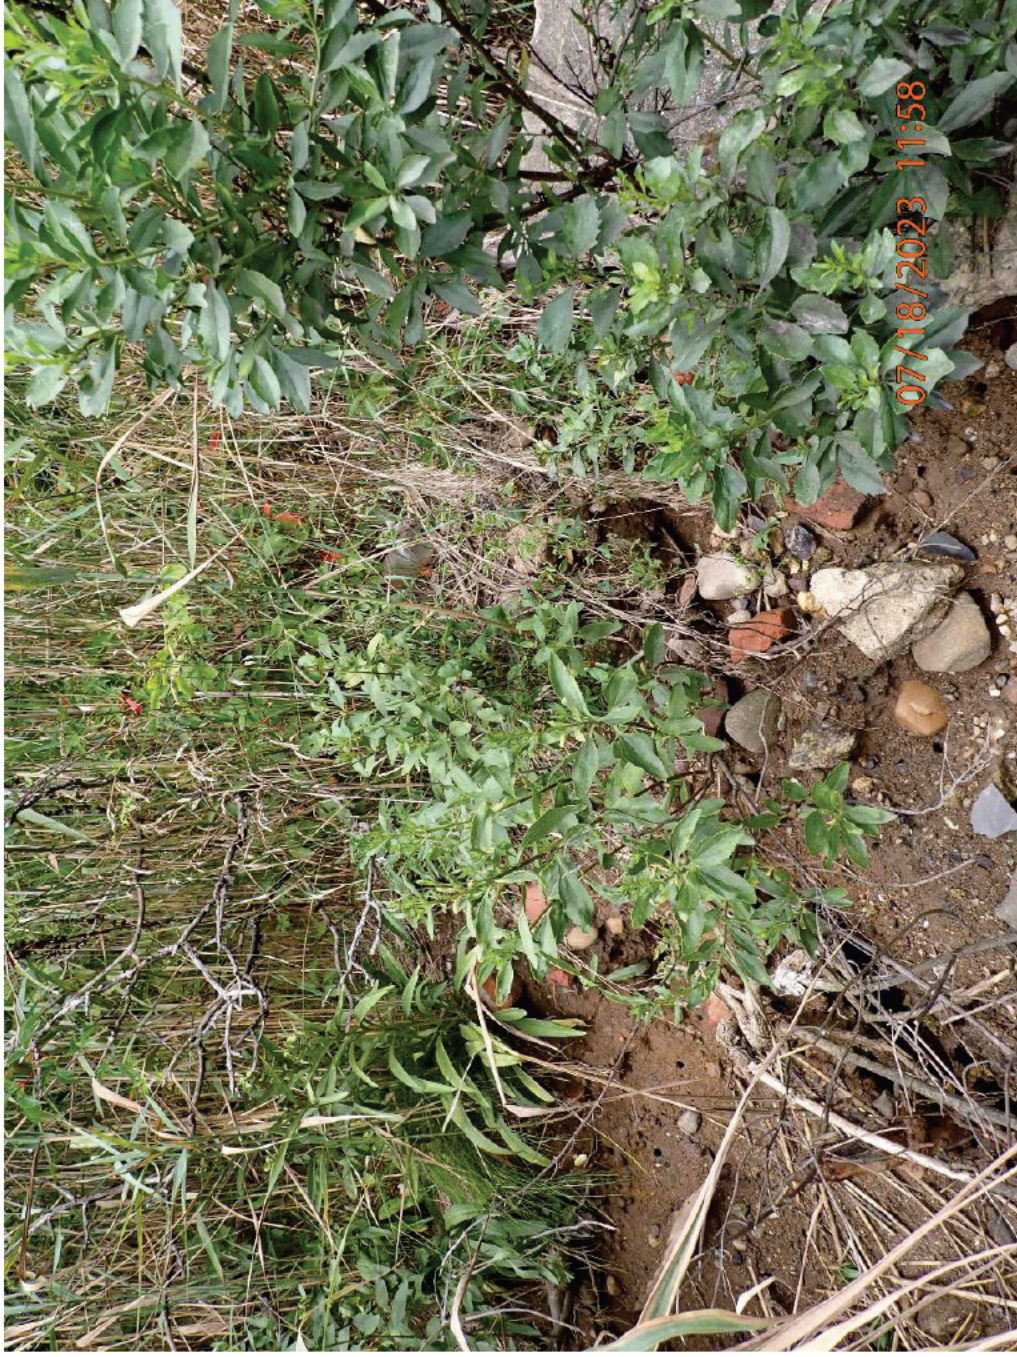
**Date:** 7/18/2023  
**Time:** 11:58 AM  
**Photographer:** S. Andreescu  
**Photo ID:** 6 – P7180112  
**Description:**  
(1/3) Panorama of high tide line

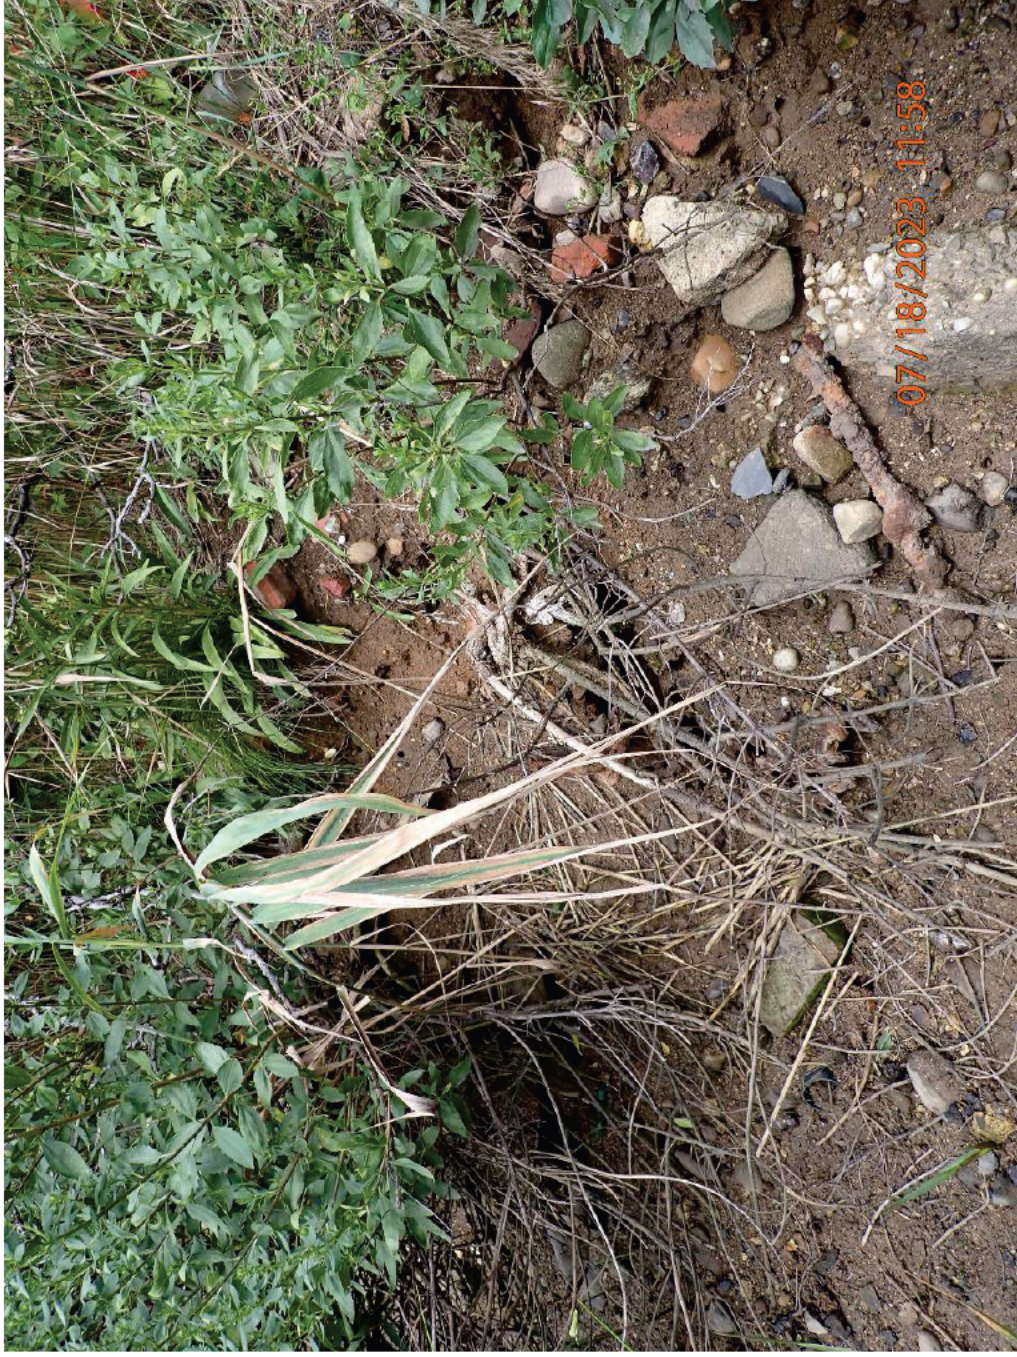
**Date:** 7/18/2023  
**Time:** 11:58 AM  
**Photographer:** S. Andreescu  
**Photo ID:** 7 – P7180113  
**Description:**  
(2/3) Panorama of high tide line

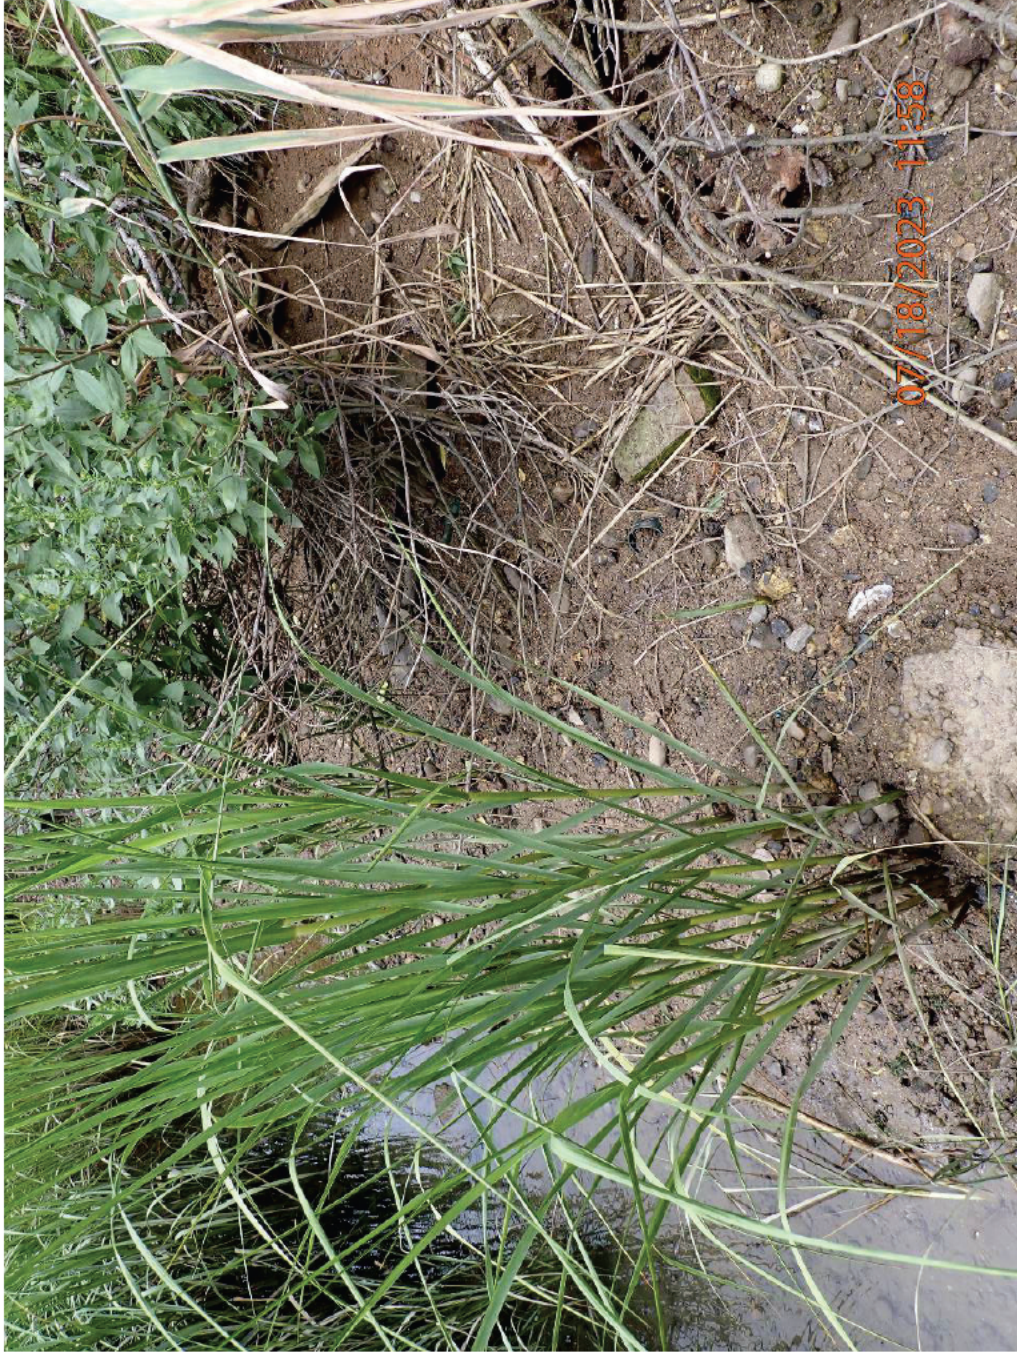
**Date:** 7/18/2023  
**Time:** 11:58 AM  
**Photographer:** S. Andreescu  
**Photo ID:** 8 – P7180114  
**Description:**  
(3/3) Panorama of high tide line

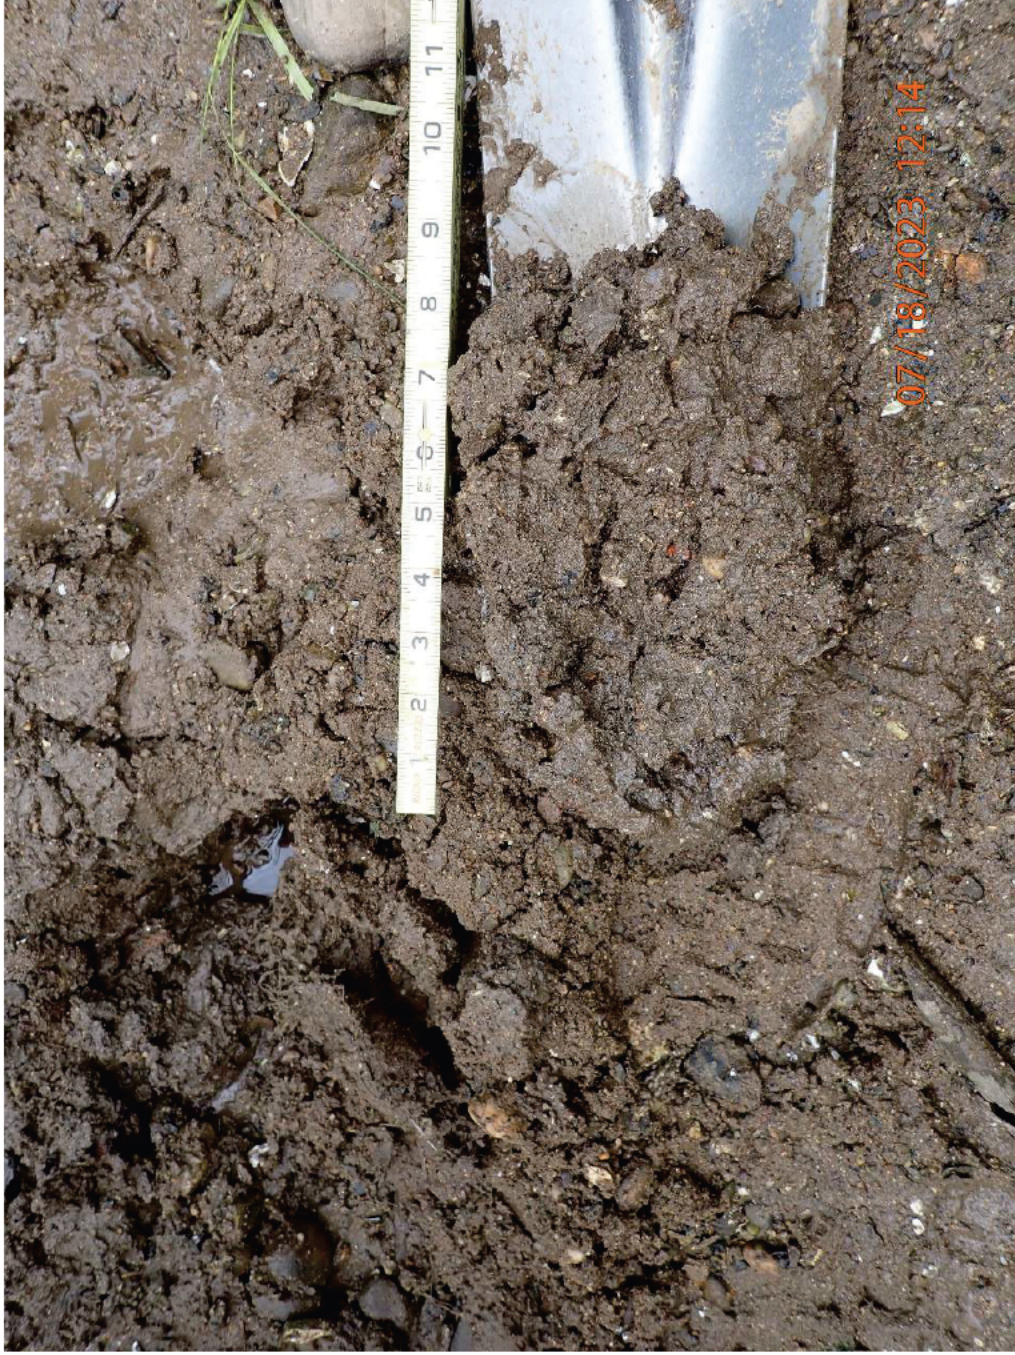
**Date:** 7/18/2023  
**Time:** 12:14 PM  
**Photographer:** S. Andreescu  
**Photo ID:** 9 – P7180115  
**Description:**  
Soil profile

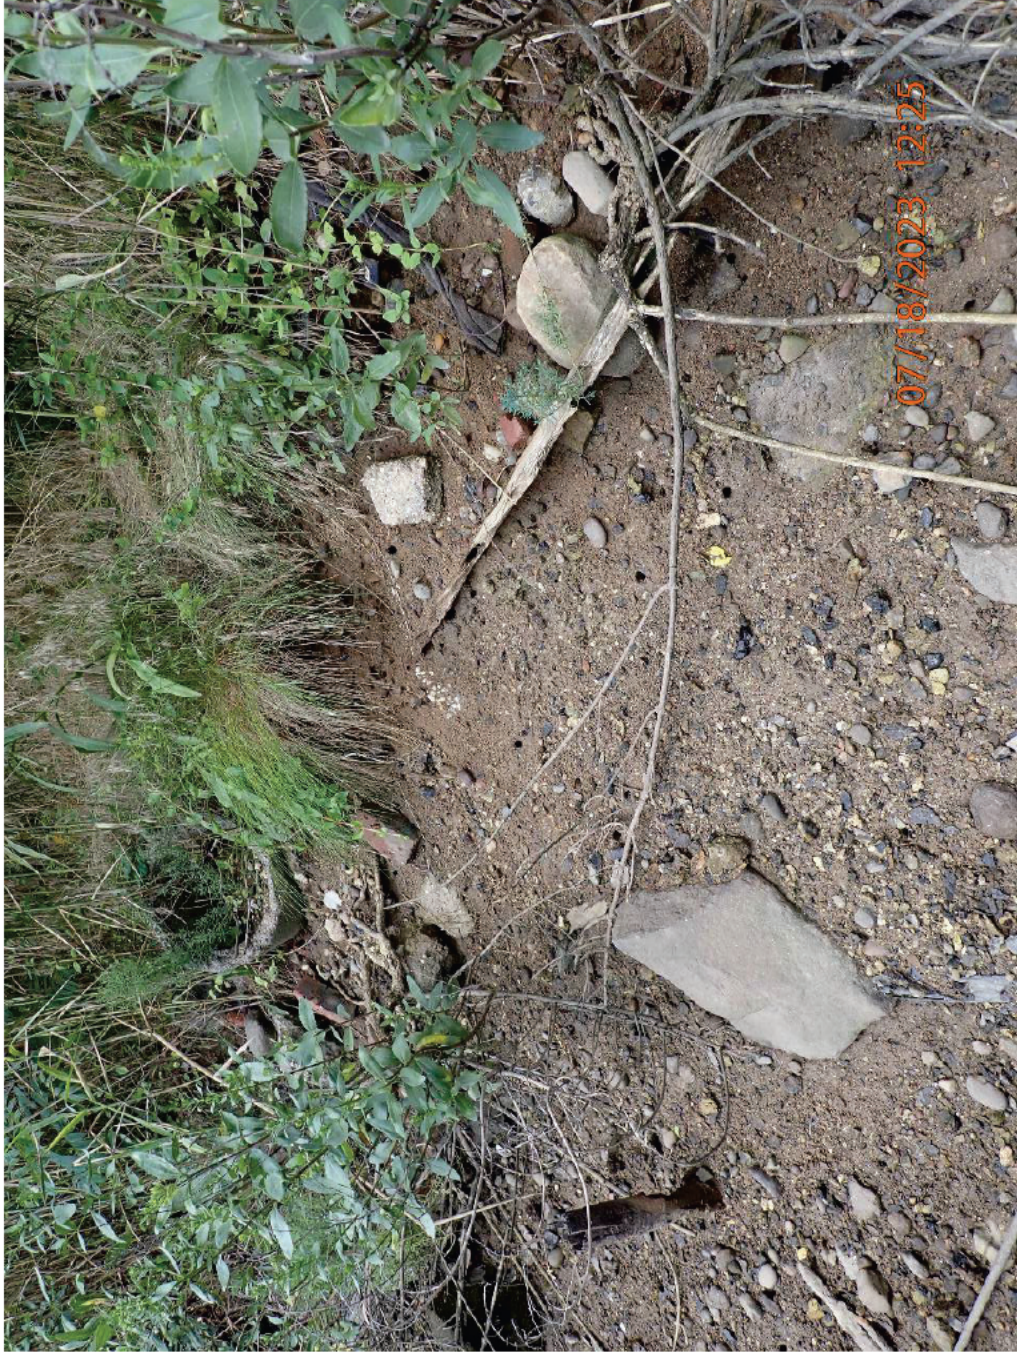
**Date:** 7/18/2023  
**Time:** 12:25 PM  
**Photographer:** S. Andreescu  
**Photo ID:** 11 – P7180117  
**Description:**  
Crab holes below high tide line

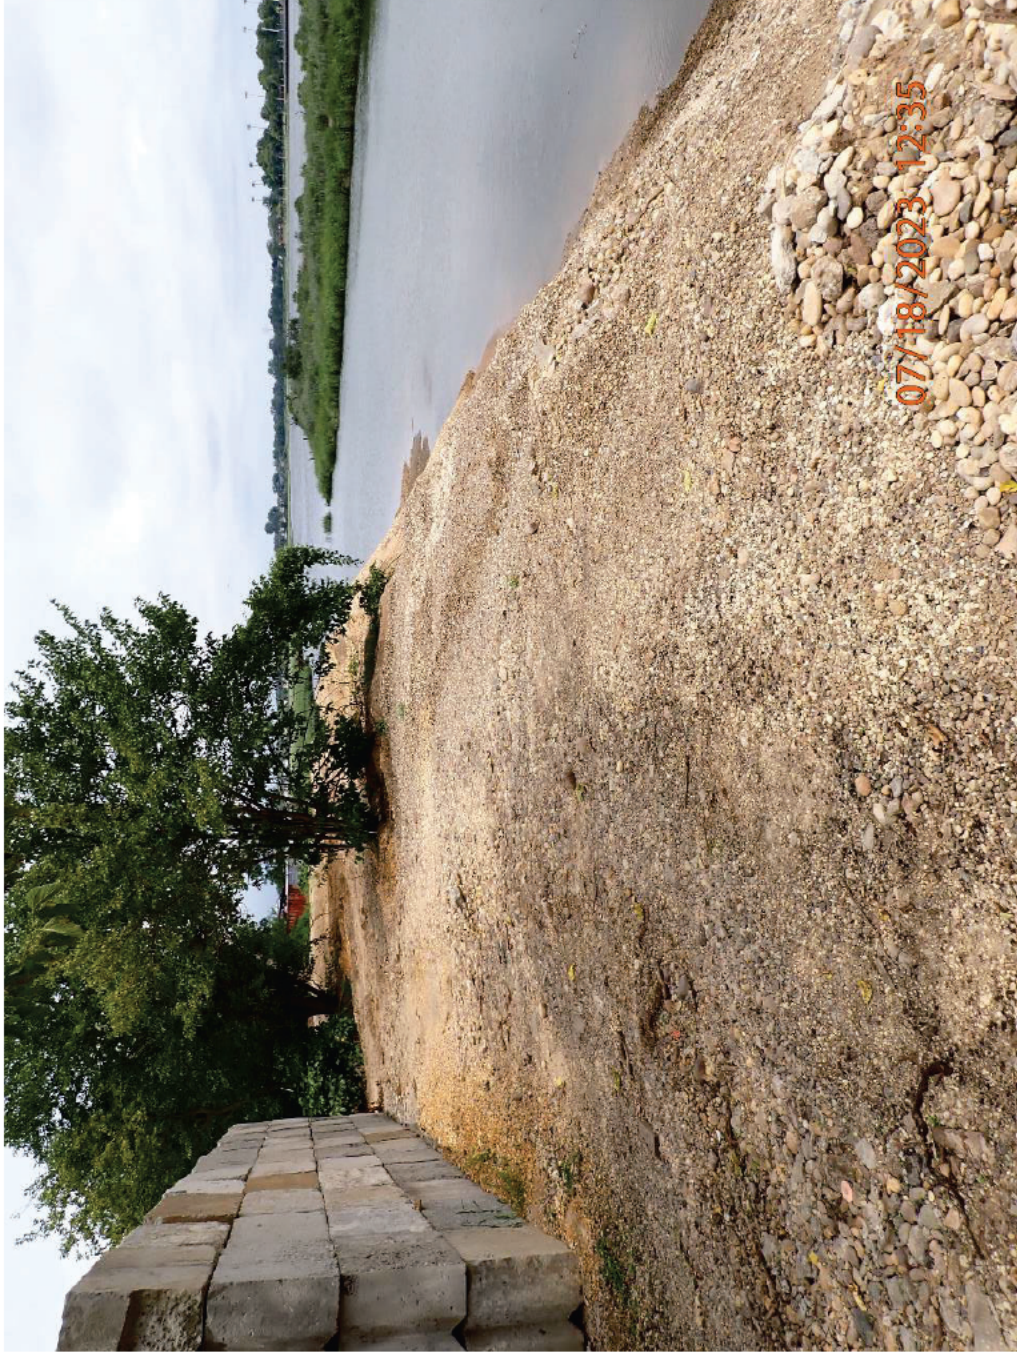
**Date:** 7/18/2023  
**Time:** 12:35 PM  
**Photographer:** S. Andreescu  
**Photo ID:** 12 – P7180118

(1/7) Panorama of fill in Hook  
Creek waters

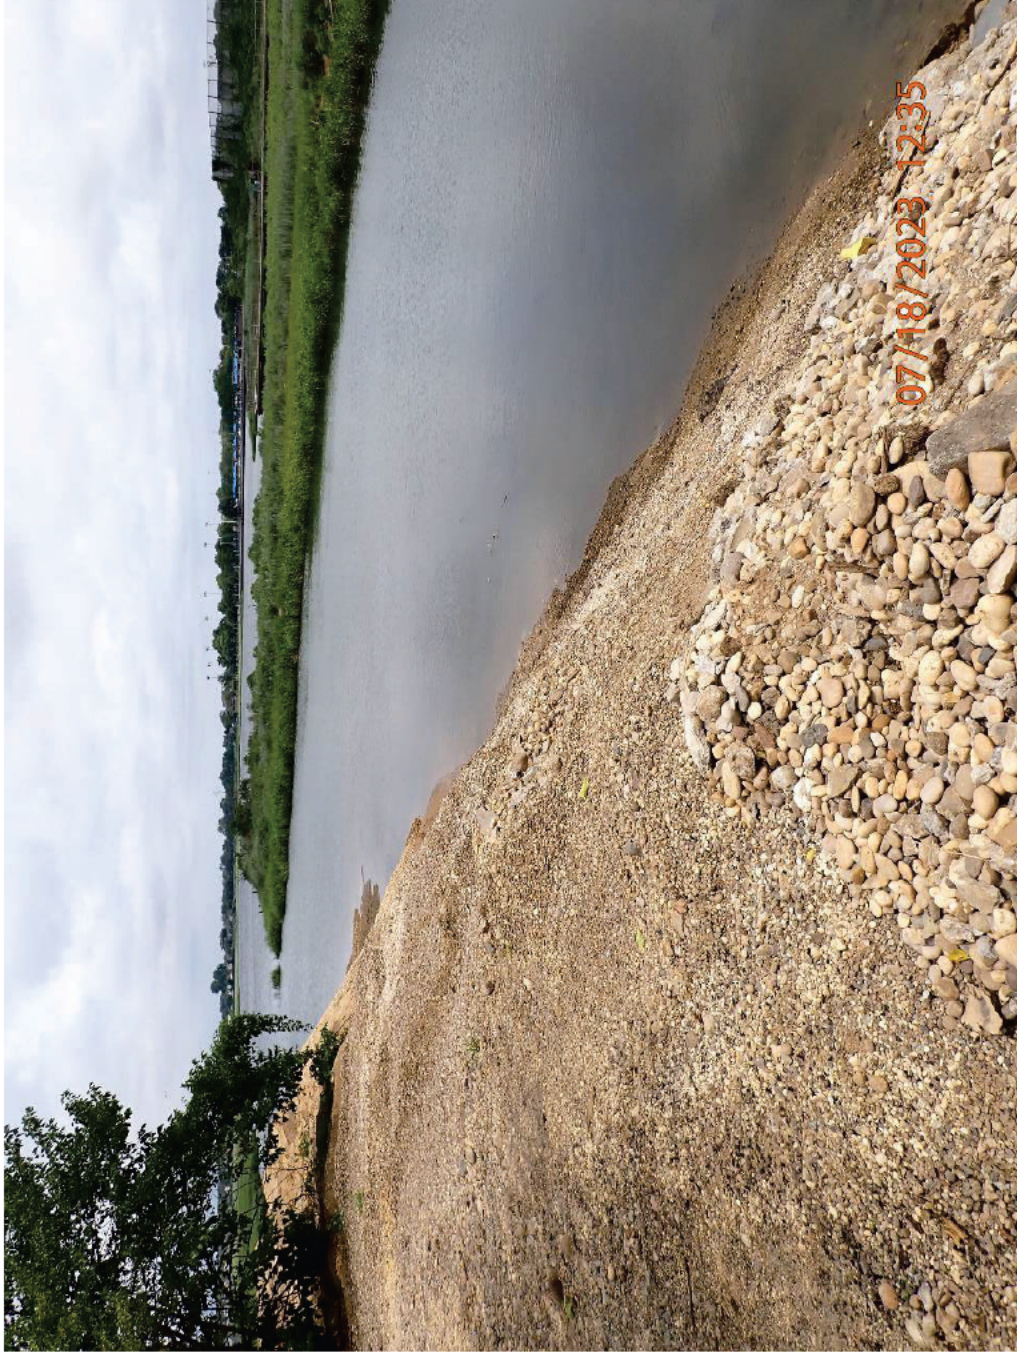
**Date:** 7/18/2023  
**Time:** 12:35 PM  
**Photographer:** S. Andreescu  
**Photo ID:** 13 – P7180119

(2/7) Panorama of fill in Hook  
Creek waters

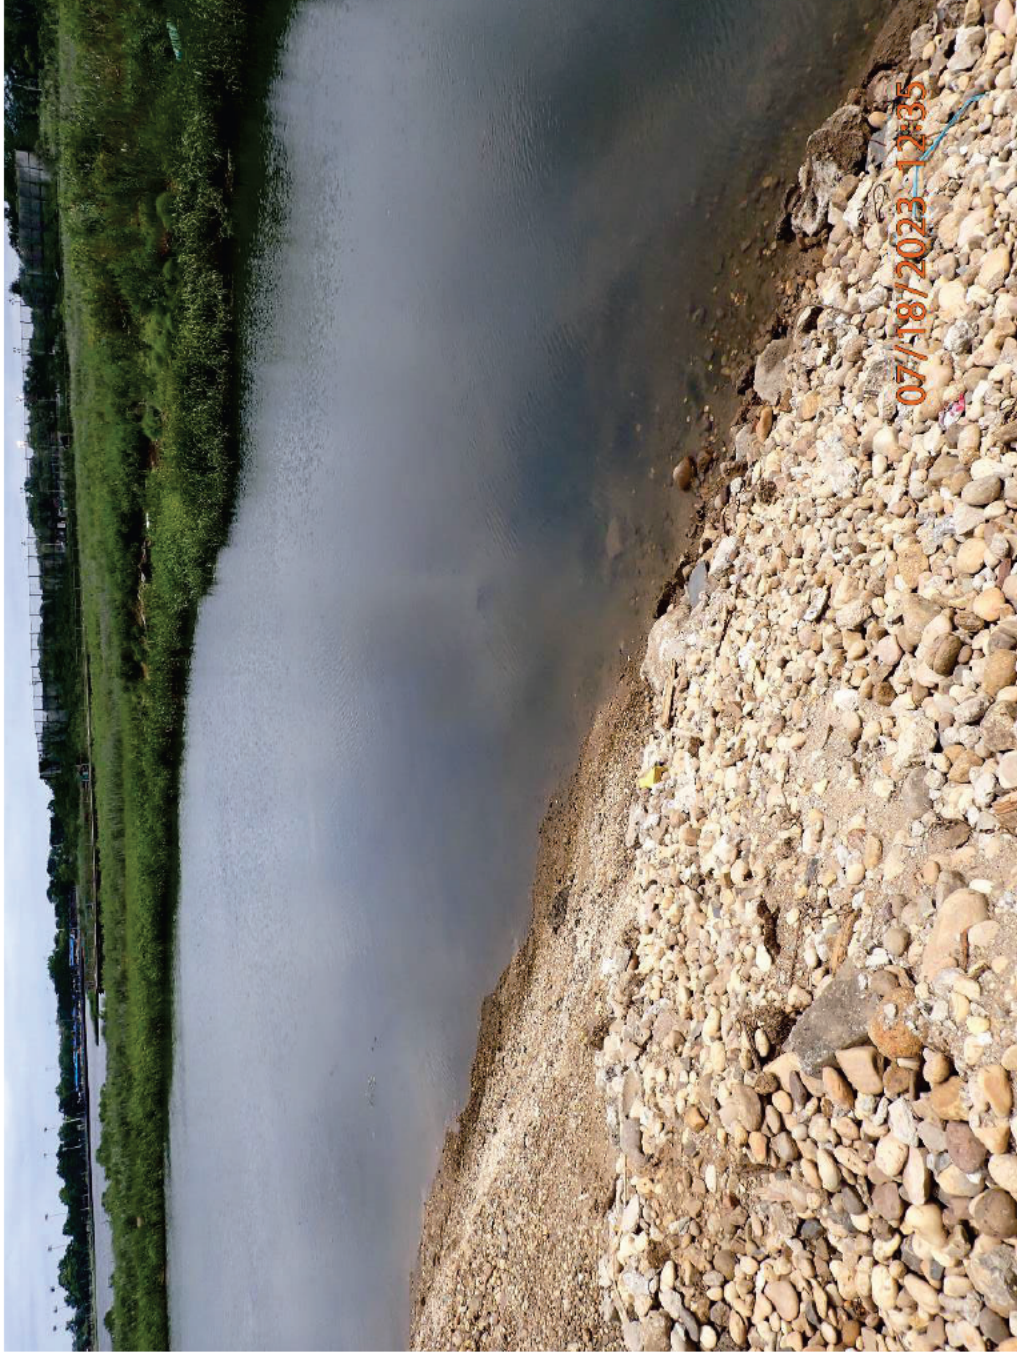
**Date:** 7/18/2023  
**Time:** 12:35 PM  
**Photographer:** S. Andreescu  
**Photo ID:** 14 – P7180120

(3/7) Panorama of fill in Hook  
Creek waters

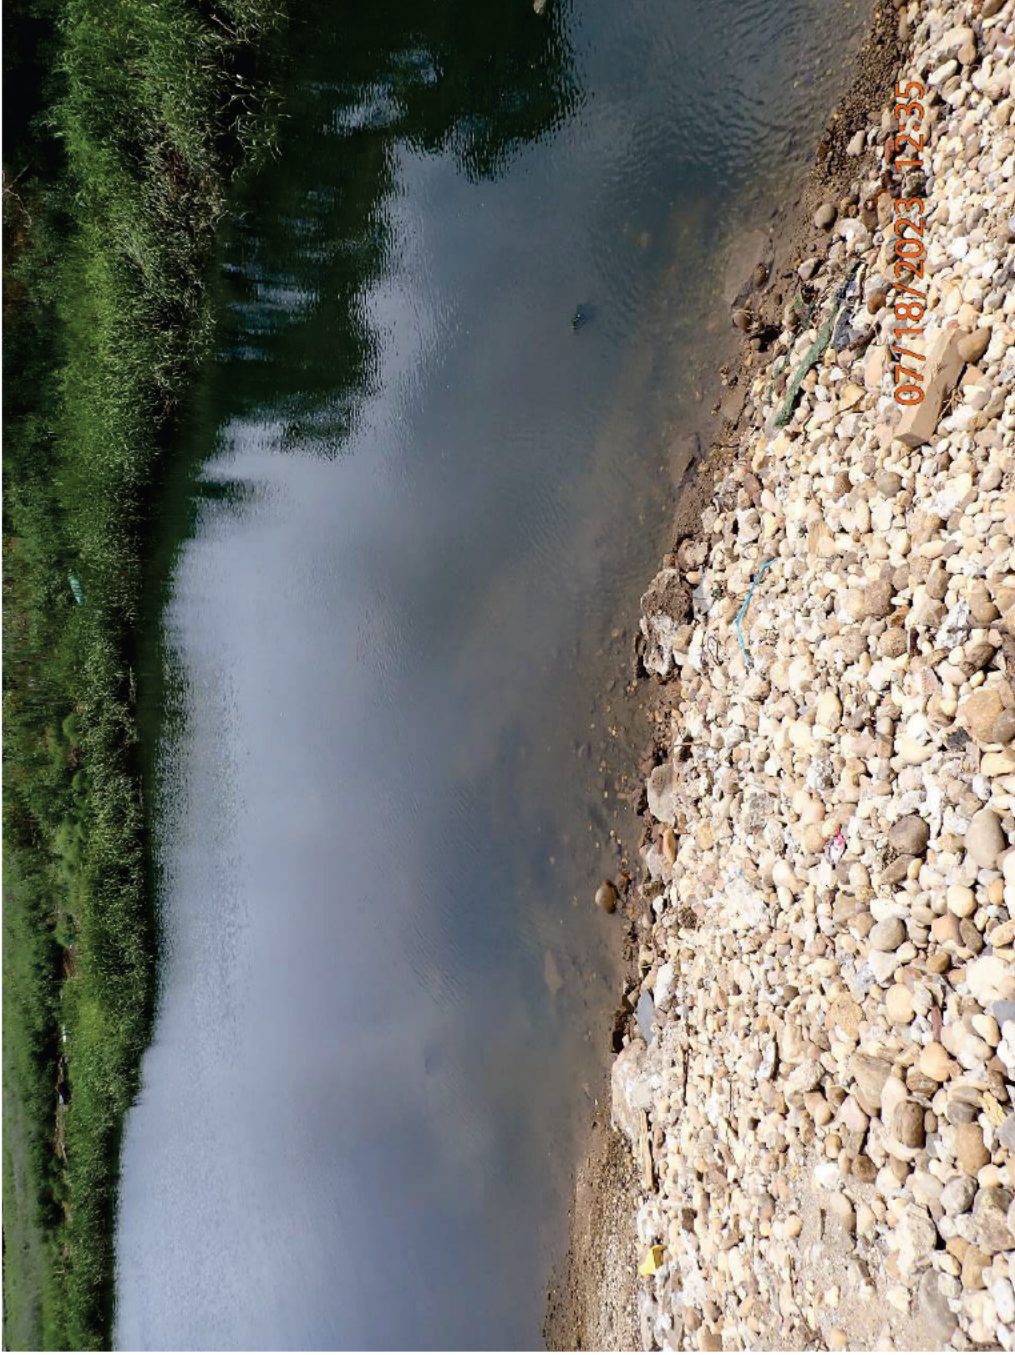
**Date:** 7/18/2023  
**Time:** 12:35 PM  
**Photographer:** S. Andreescu  
**Photo ID:** 15 – P7180121

(4/7) Panorama of fill in Hook  
Creek waters

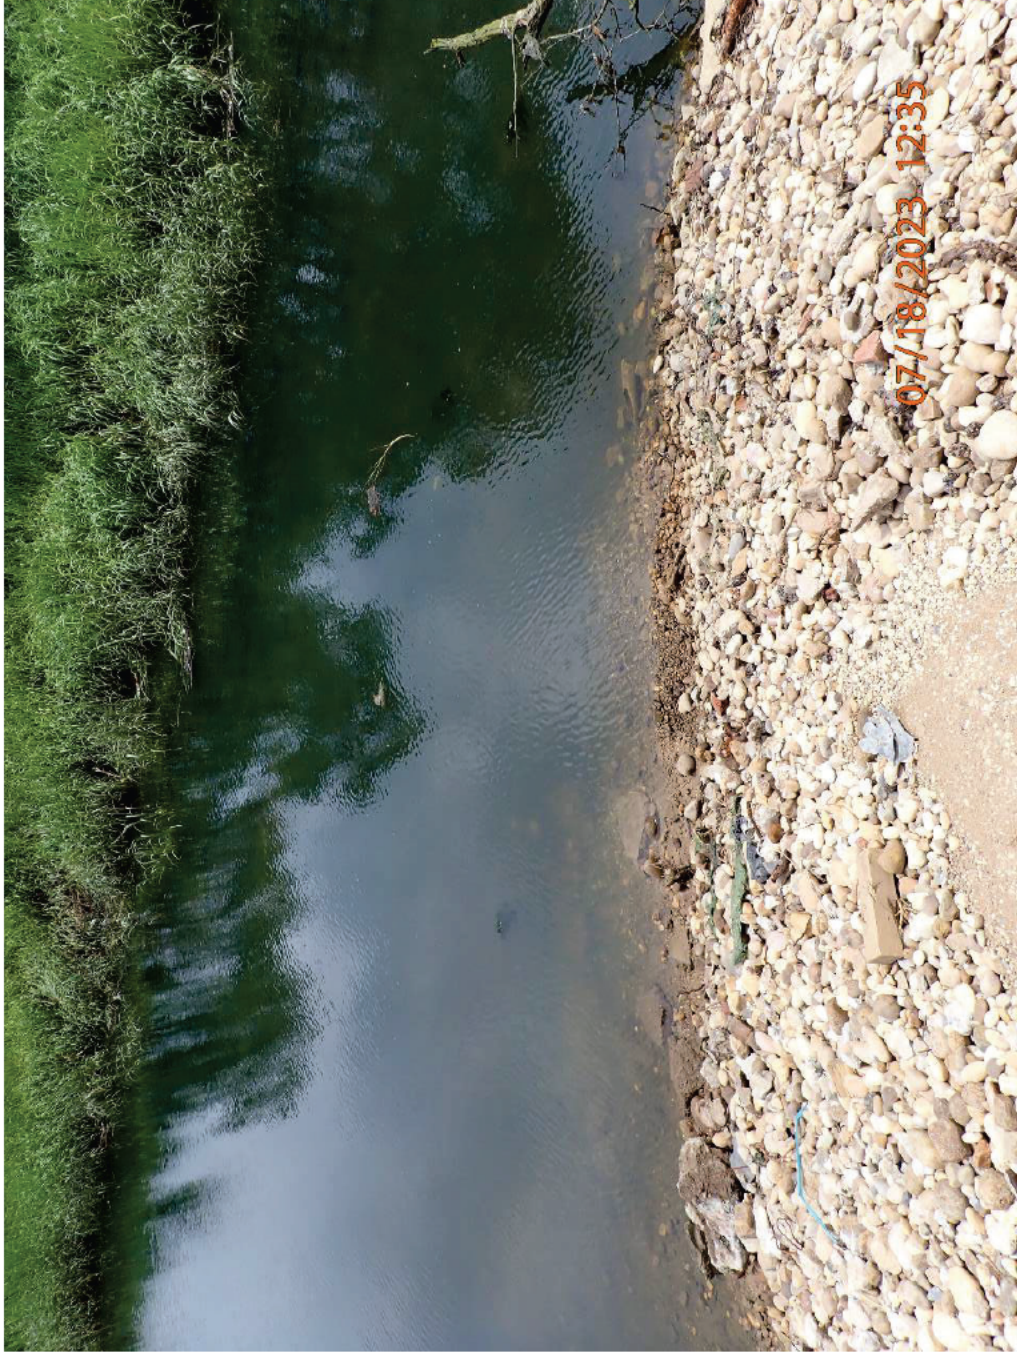
**Date:** 7/18/2023  
**Time:** 12:35 PM  
**Photographer:** S. Andreescu  
**Photo ID:** 16 – P7180122

(5/7) Panorama of fill in Hook  
Creek waters

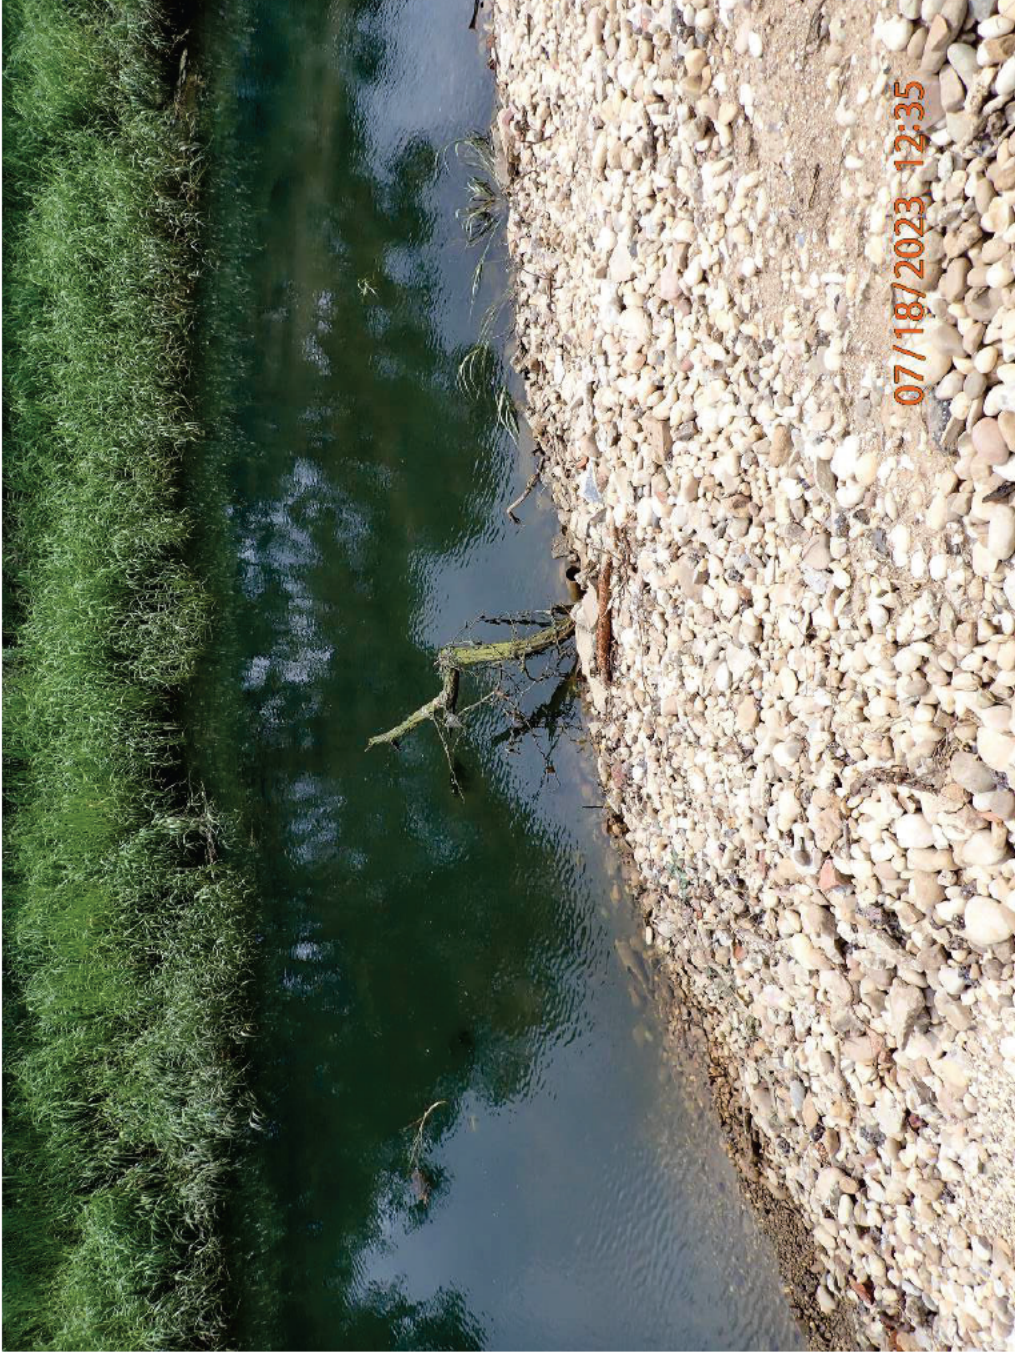
**Date:** 7/18/2023  
**Time:** 12:35 PM  
**Photographer:** S. Andreescu  
**Photo ID:** 17 – P7180123

(6/7) Panorama of fill in Hook  
Creek waters
