## Clean Water Act Section 404: Site Visit/Case Development

| Site Name | Mastro Ready Mix, Inc | | | | |

EPA CWA 404 Inspection Photolog  
Mastro Ready Mix, Inc.

July 18, 2023

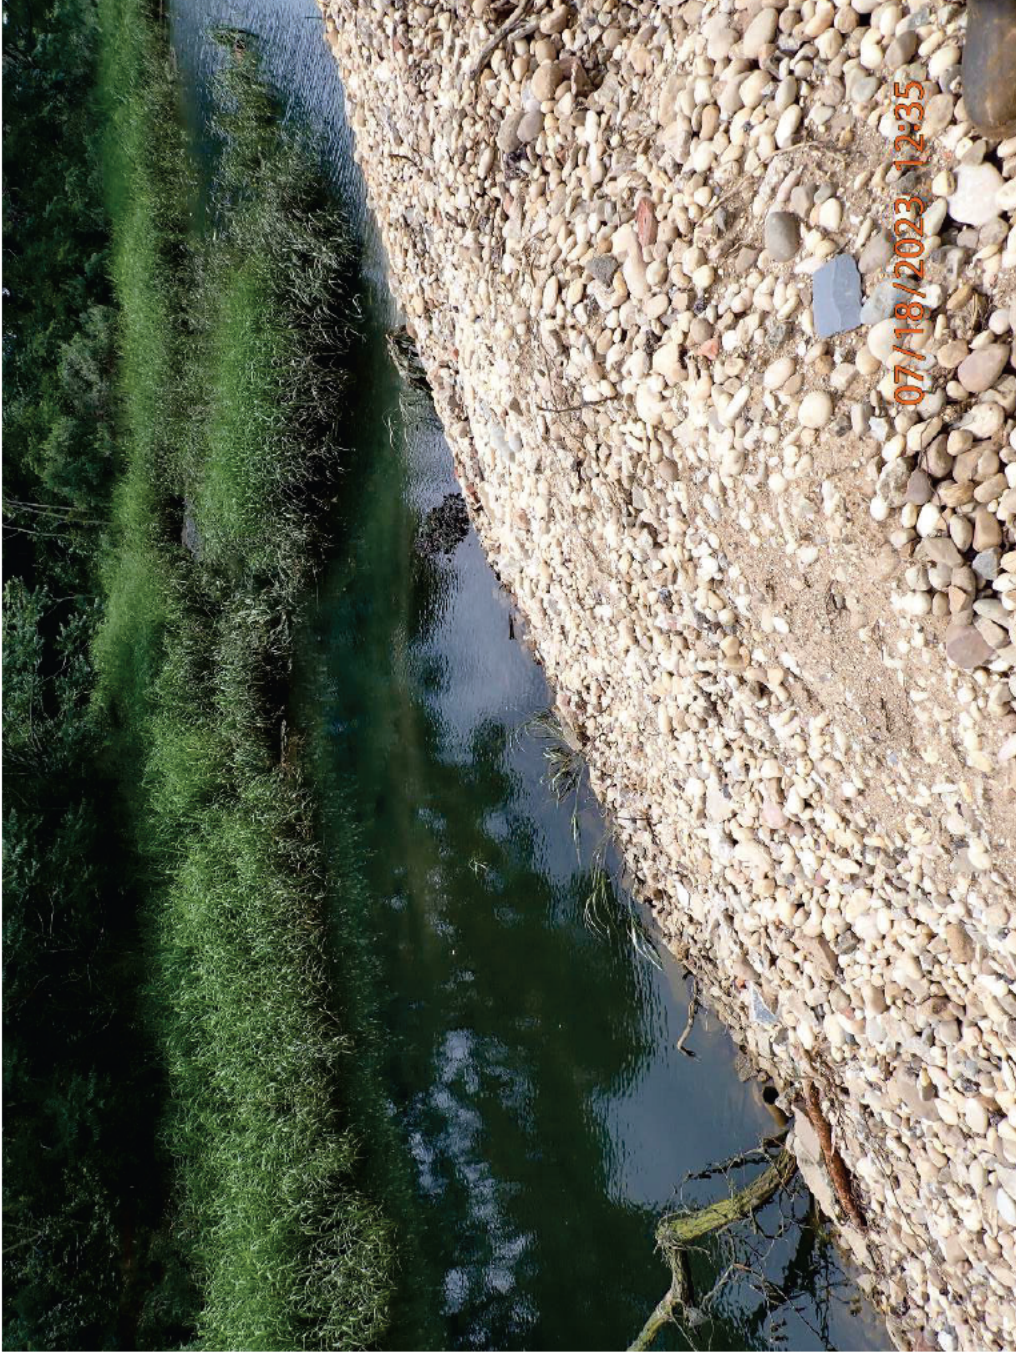
**Date:** 7/18/2023  
**Time:** 12:35 PM  
**Photographer:** S. Andreescu  
**Photo ID:** 18 – P7180124

(7/7) Panorama of fill in Hook  
Creek waters

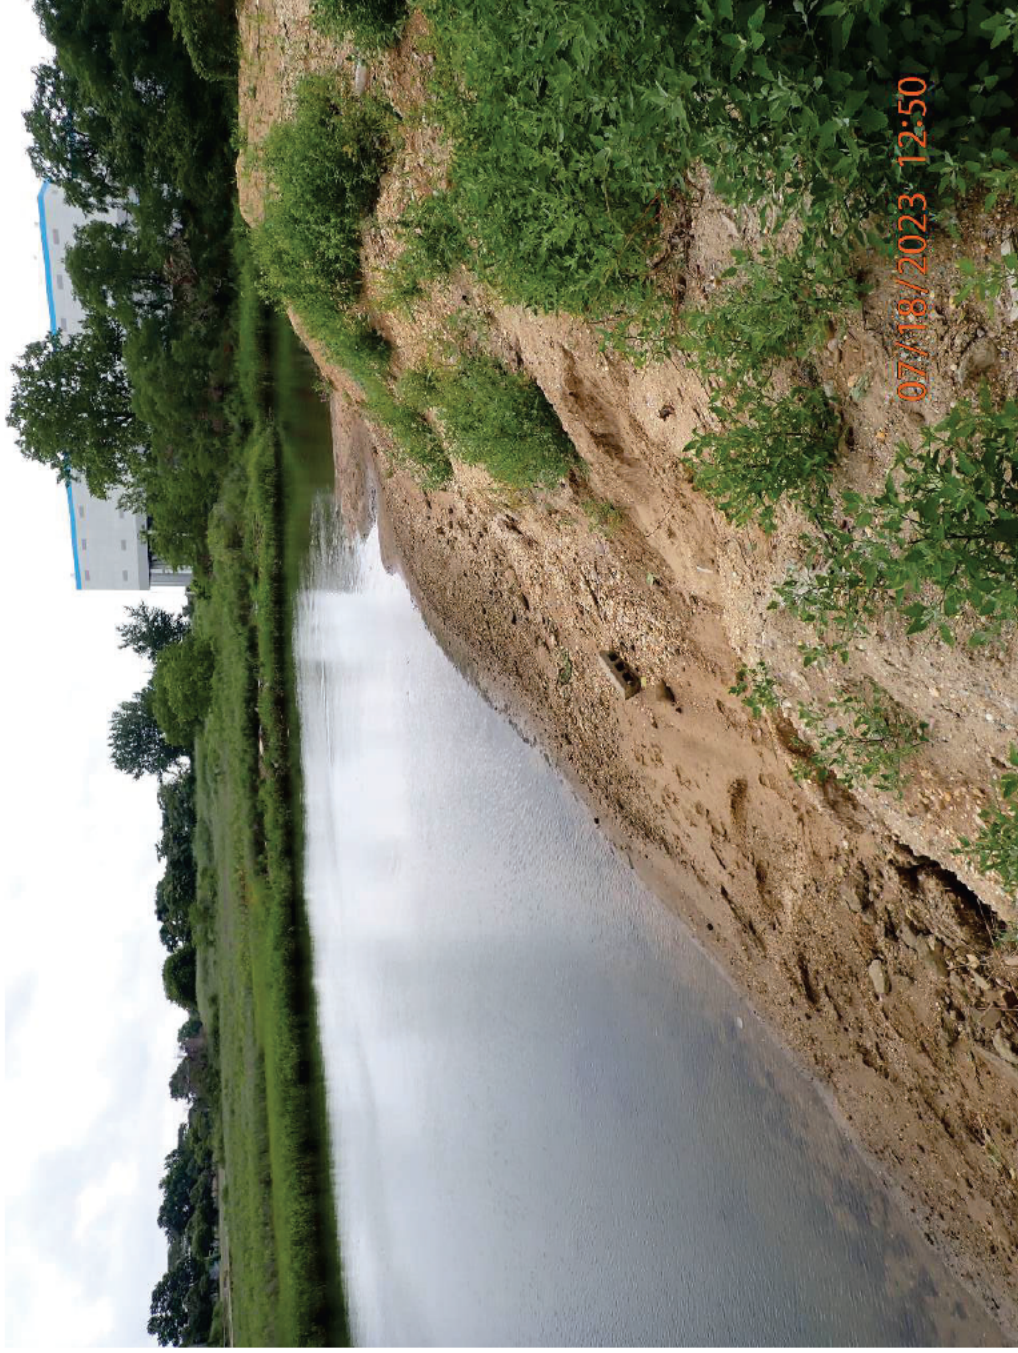
**Date:** 7/18/2023  
**Time:** 12:50 PM  
**Photographer:** S. Andreescu  
**Photo ID:** 19 – P7180125

Gravel and sand fill material in  
Hook Creek waters

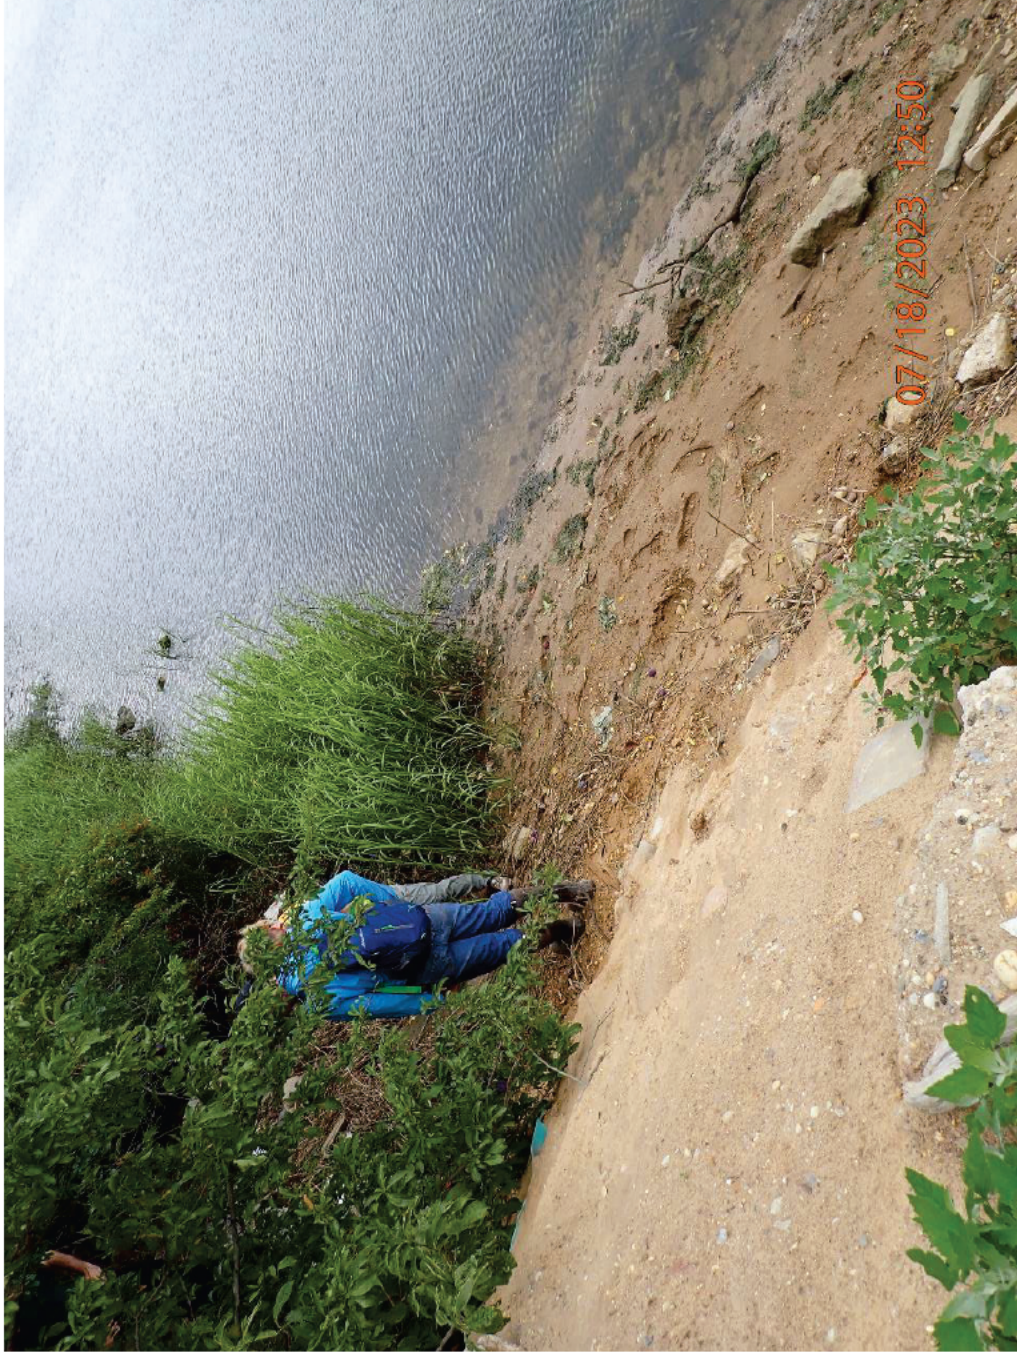
**Date:** 7/18/2023  
**Time:** 12:50 PM  
**Photographer:** S. Andreescu  
**Photo ID:** 20 – P7180126

Gravel and sand fill material in  
Hook Creek waters; limit of  
disturbance

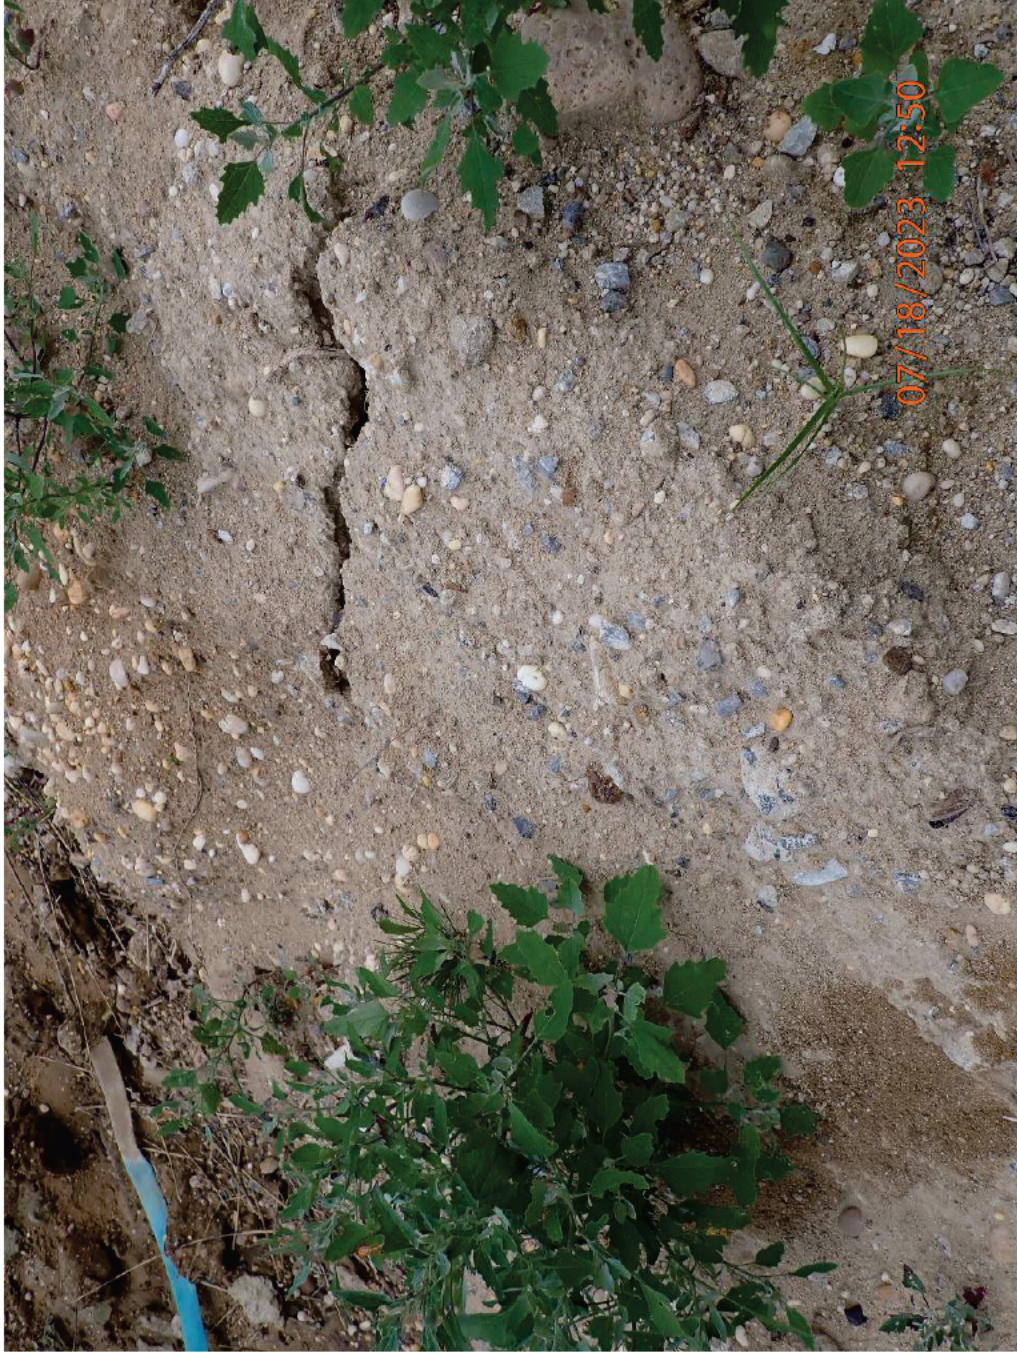
**Date:** 7/18/2023  
**Time:** 12:50 PM  
**Photographer:** S. Andreescu  
**Photo ID:** 21 – P7180127

Gravel and sand fill material

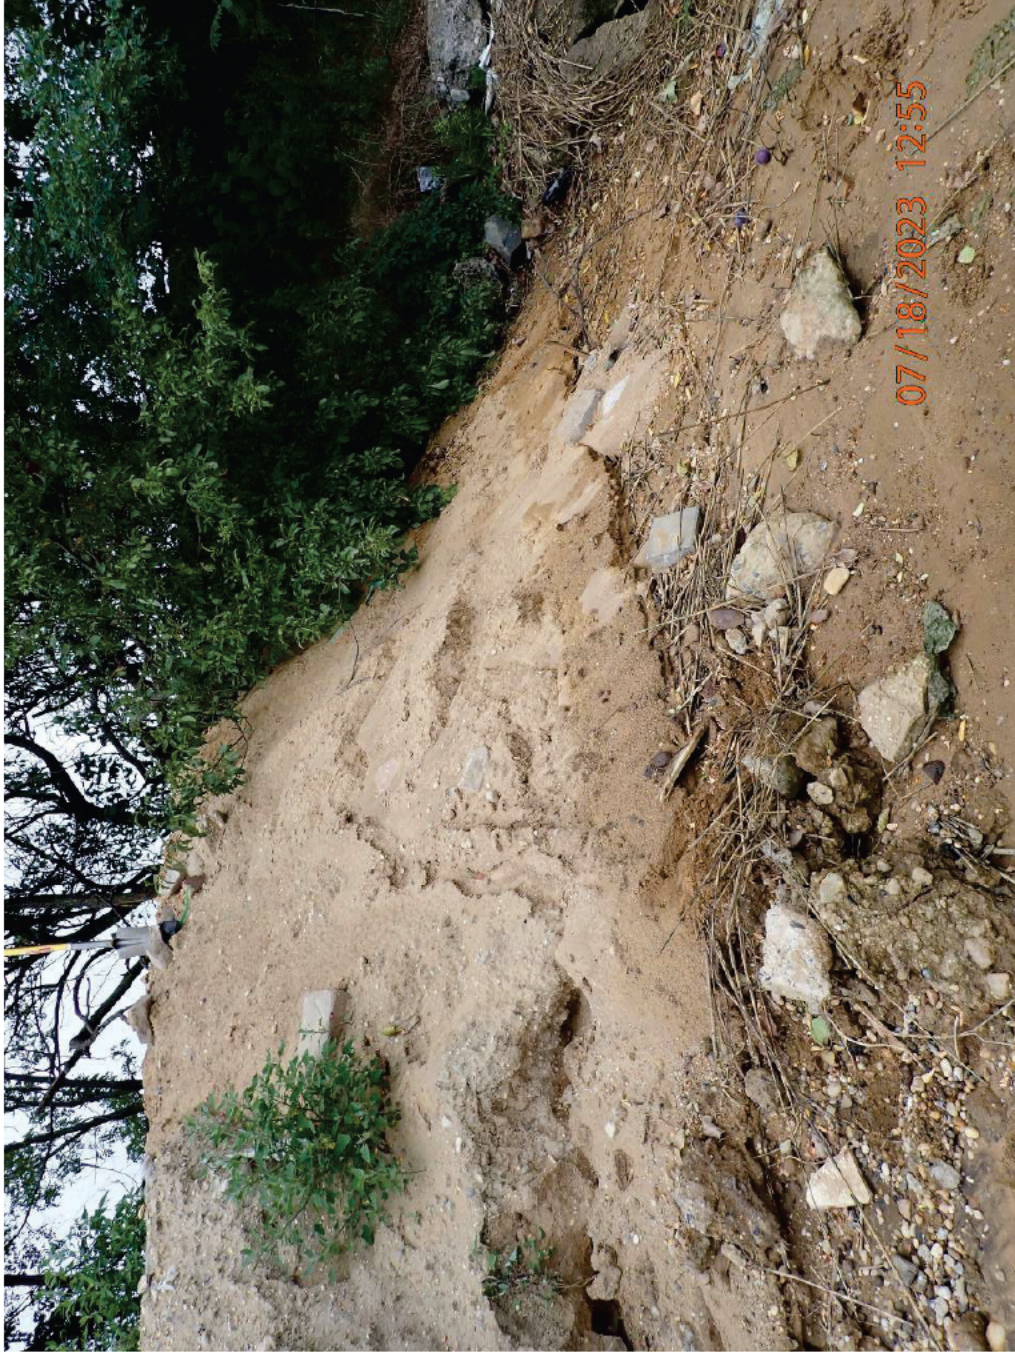
**Date:** 7/18/2023  
**Time:** 12:55 PM  
**Photographer:** S. Andreescu  
**Photo ID:** 22 – P7180128

(1/5) Panorama from near base  
of fill slope

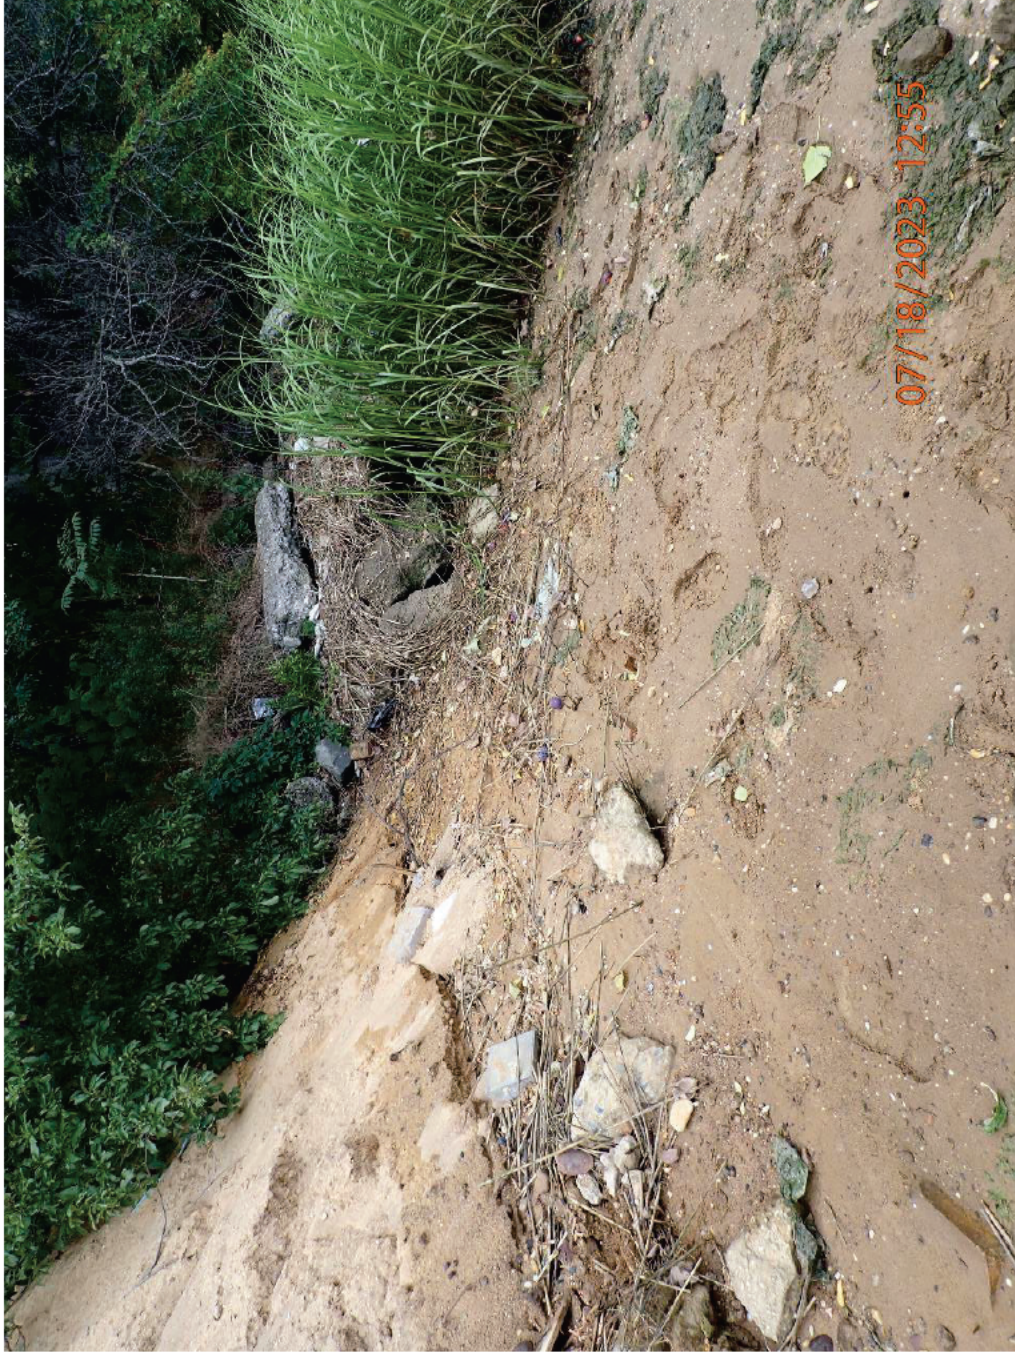
**Date:** 7/18/2023  
**Time:** 12:55 PM  
**Photographer:** S. Andreescu  
**Photo ID:** 23 – P7180129

(2/5) Panorama from near base  
of fill slope

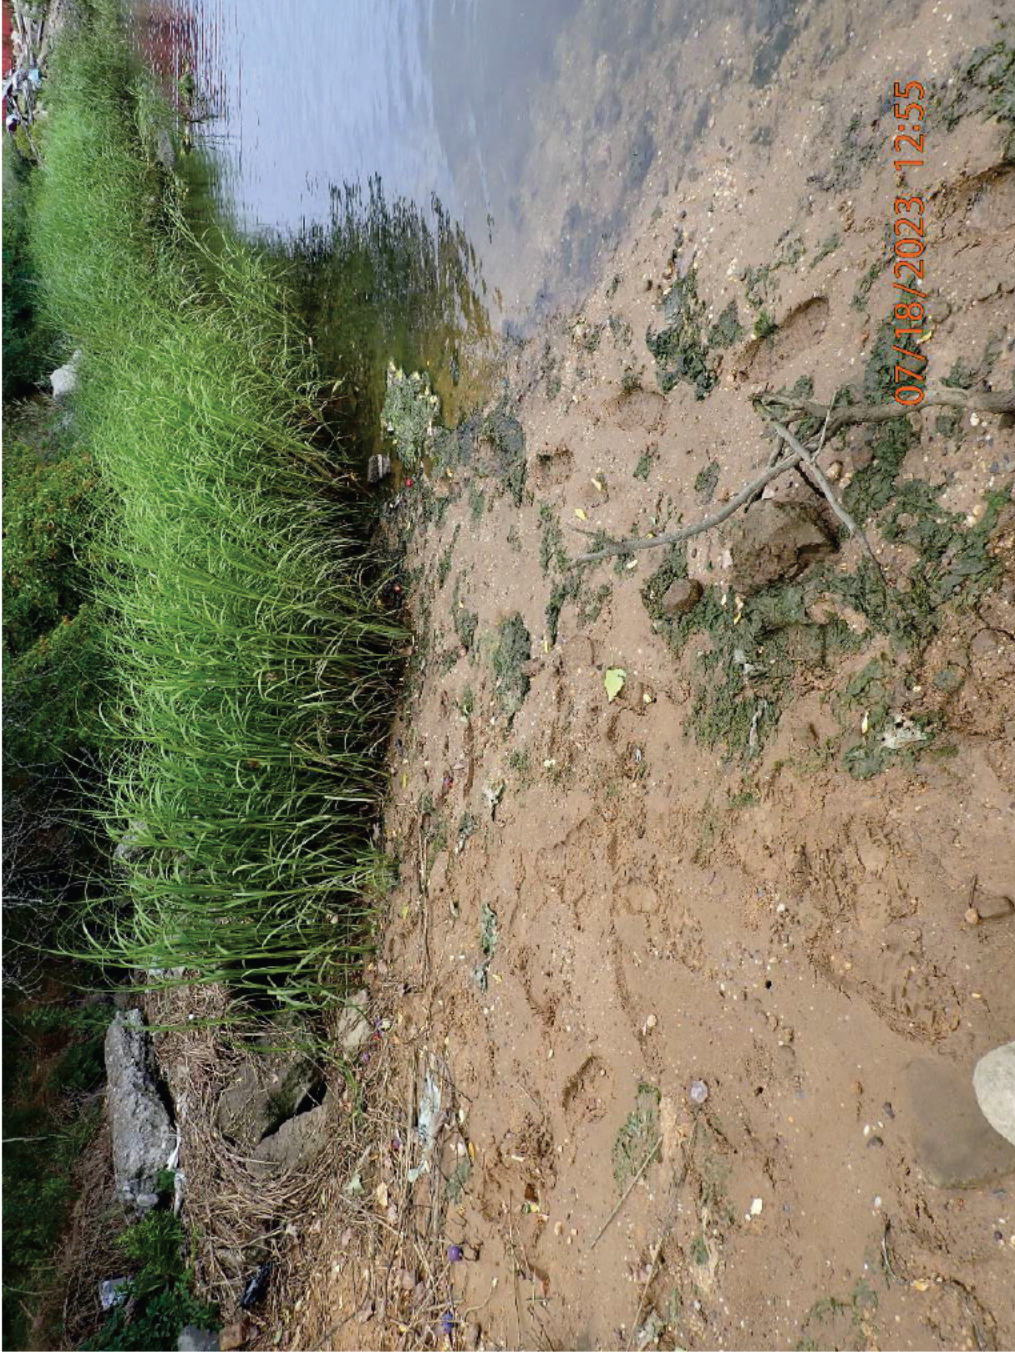
**Date:** 7/18/2023  
**Time:** 12:55 PM  
**Photographer:** S. Andreescu  
**Photo ID:** 24 – P7180130

(3/5) Panorama from near base  
of fill slope

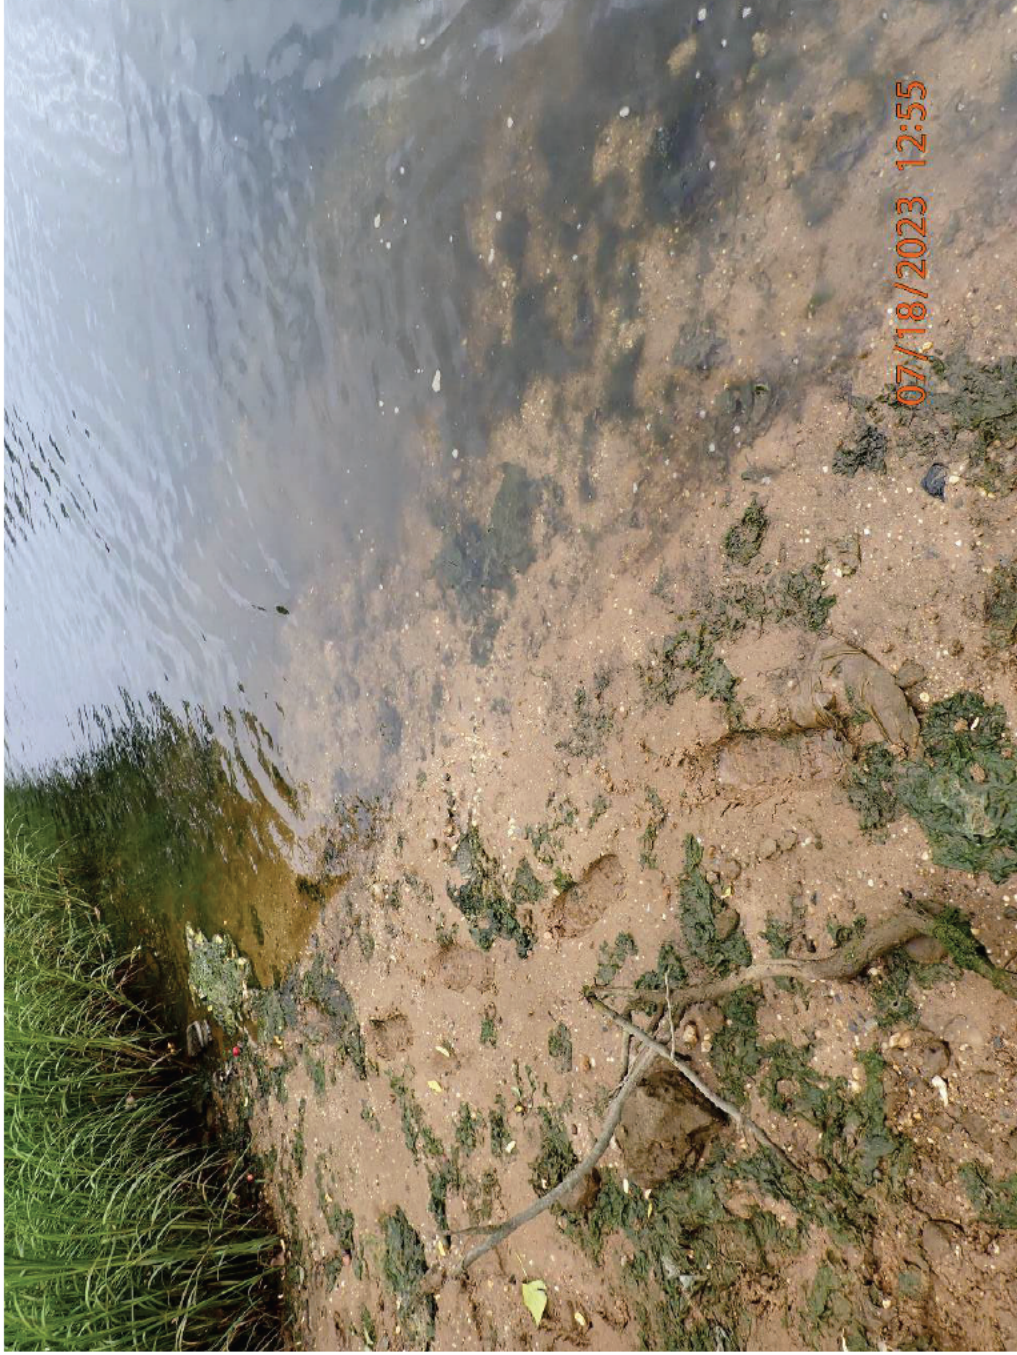
**Date:** 7/18/2023  
**Time:** 12:55 PM  
**Photographer:** S. Andreescu  
**Photo ID:** 25 – P7180131

(4/5) Panorama from near base  
of fill slope

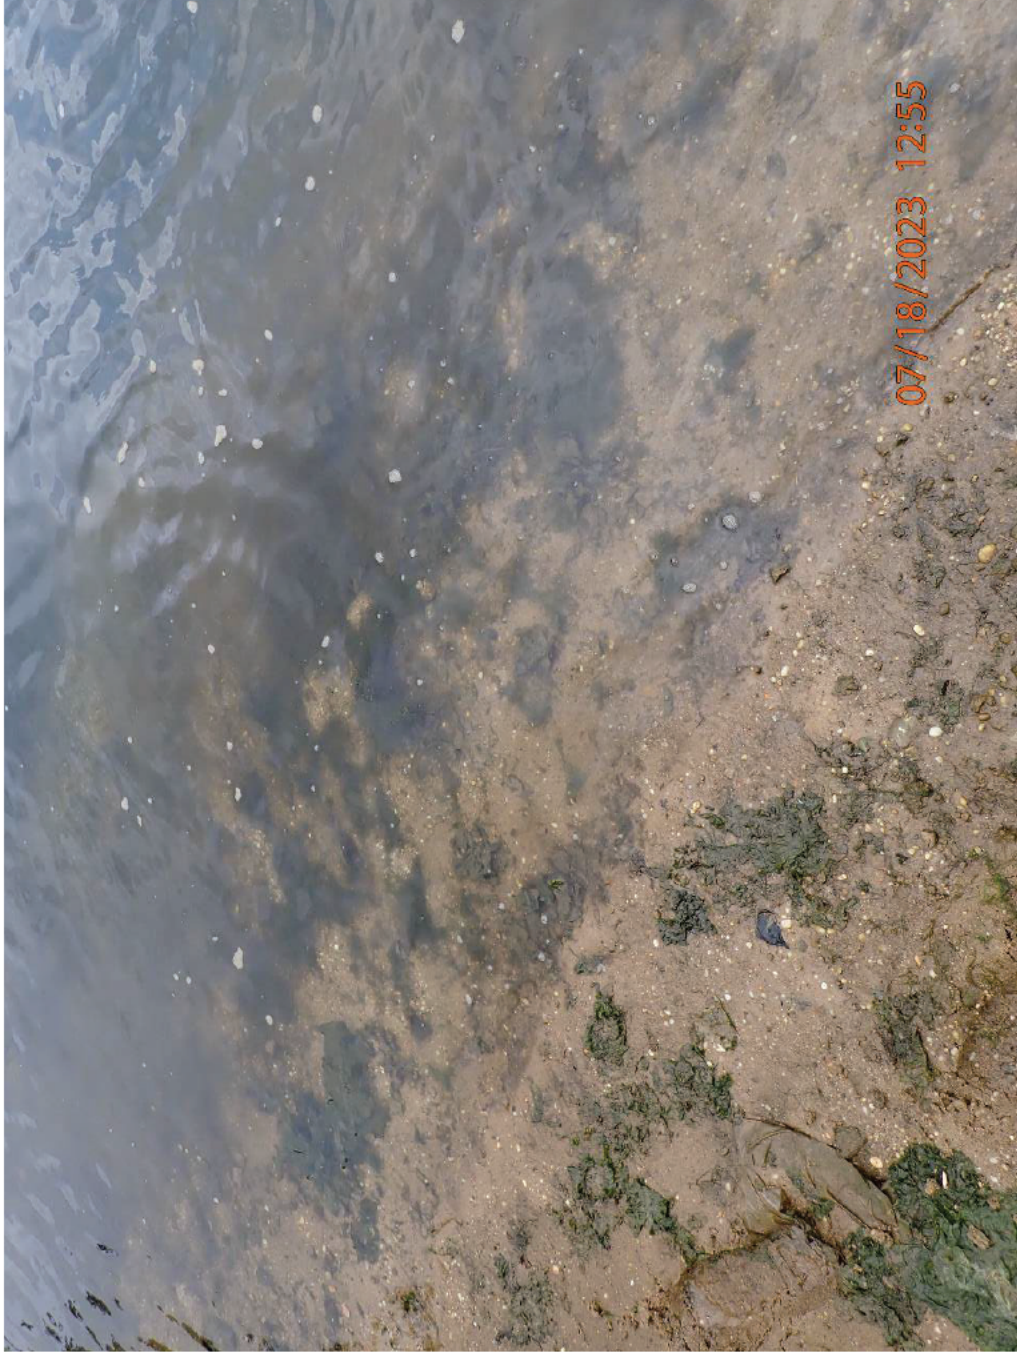
**Date:** 7/18/2023  
**Time:** 12:55 PM  
**Photographer:** S. Andreescu  
**Photo ID:** 26 – P7180132

(5/5) Panorama from near base  
of fill slope

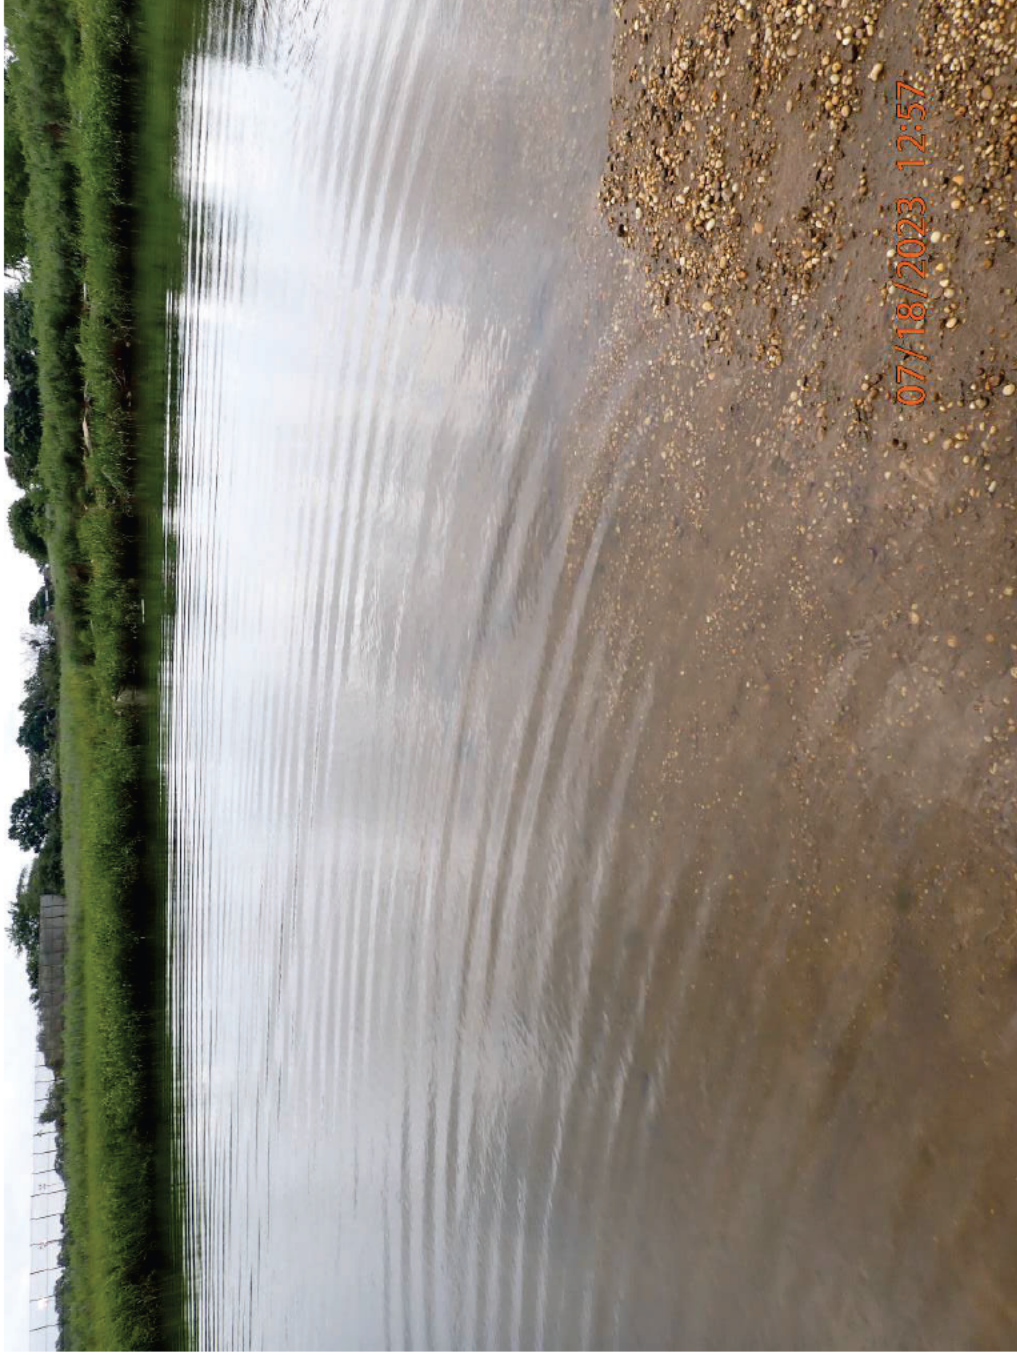
**Date:** 7/18/2023  
**Time:** 12:57 PM  
**Photographer:** S. Andreescu  
**Photo ID:** 27 – P7180133

(1/5) Panorama from edge of  
Hook Creek waters

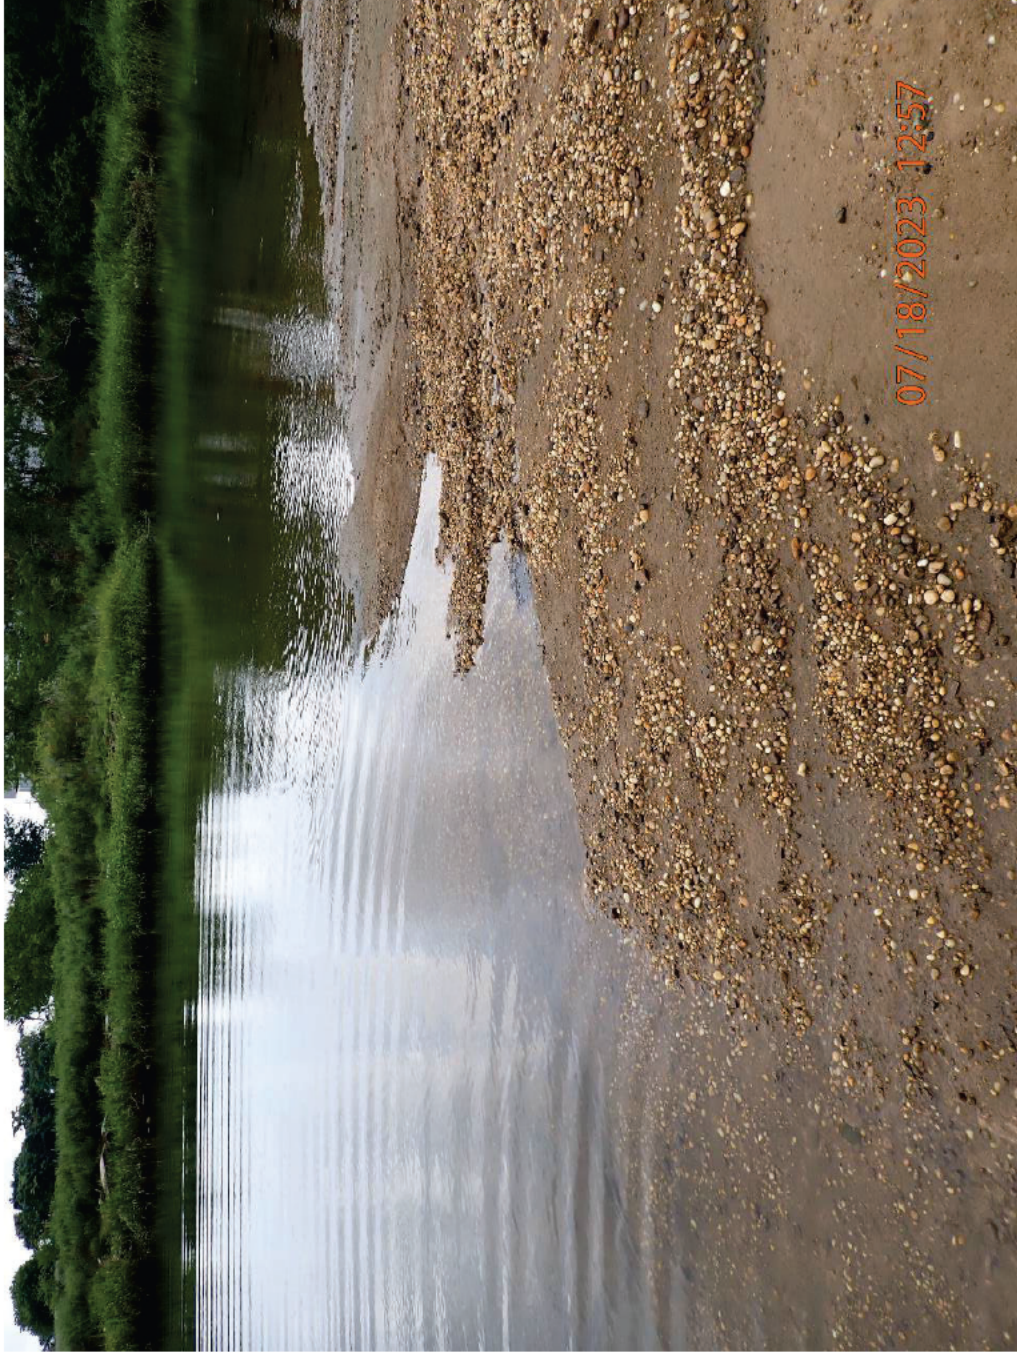
**Date:** 7/18/2023  
**Time:** 12:57 PM  
**Photographer:** S. Andreescu  
**Photo ID:** 28 – P7180134

(2/5) Panorama from edge of  
Hook Creek waters

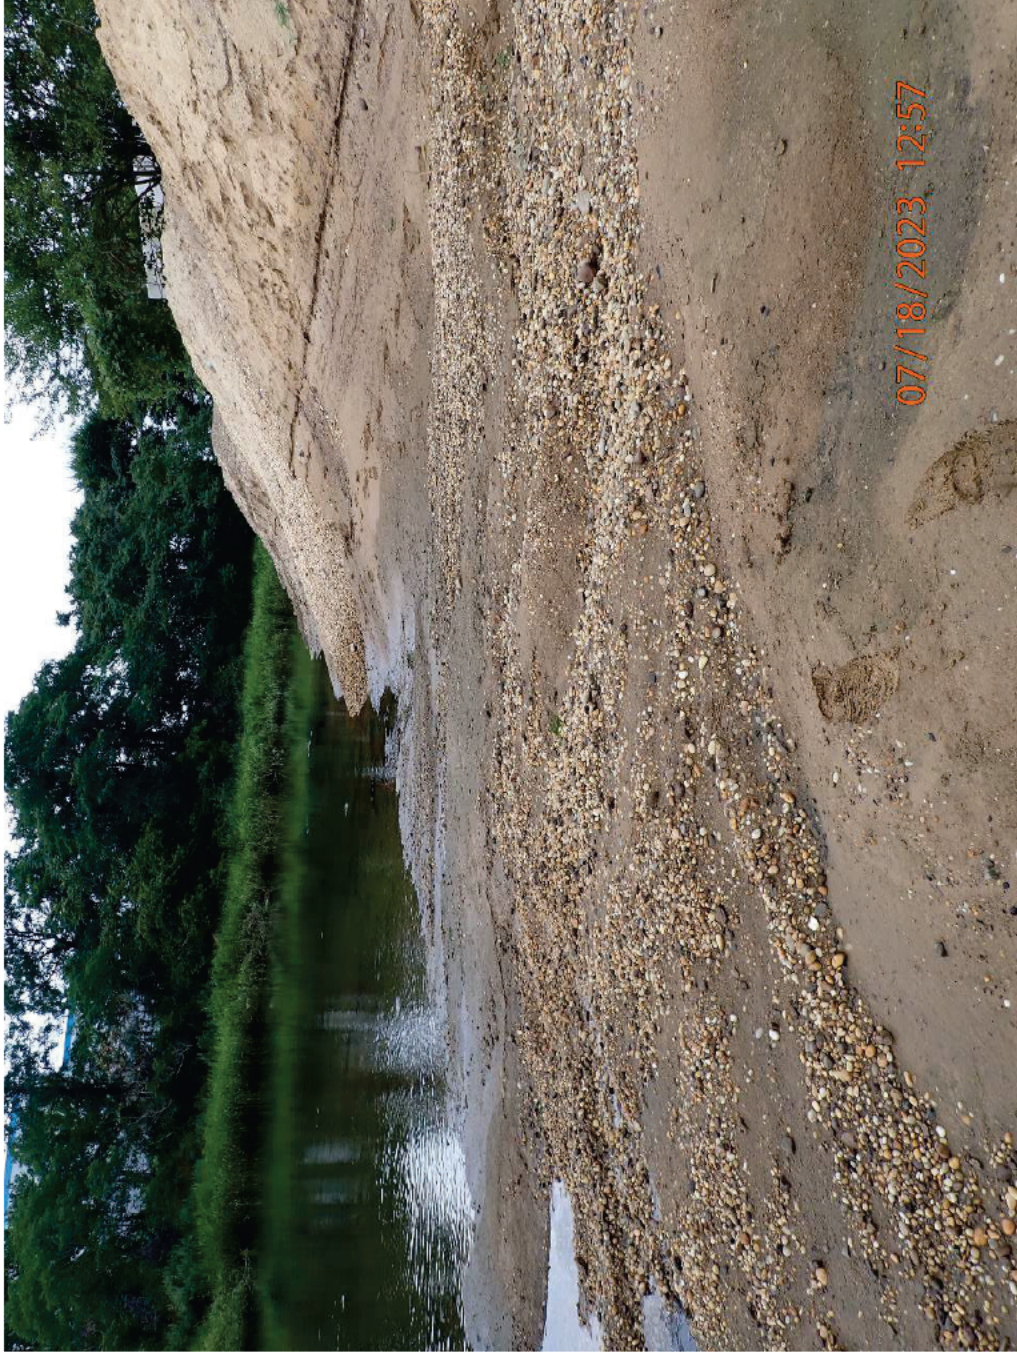
**Date:** 7/18/2023  
**Time:** 12:57 PM  
**Photographer:** S. Andreescu  
**Photo ID:** 29 – P7180135

(3/5) Panorama from edge of  
Hook Creek waters

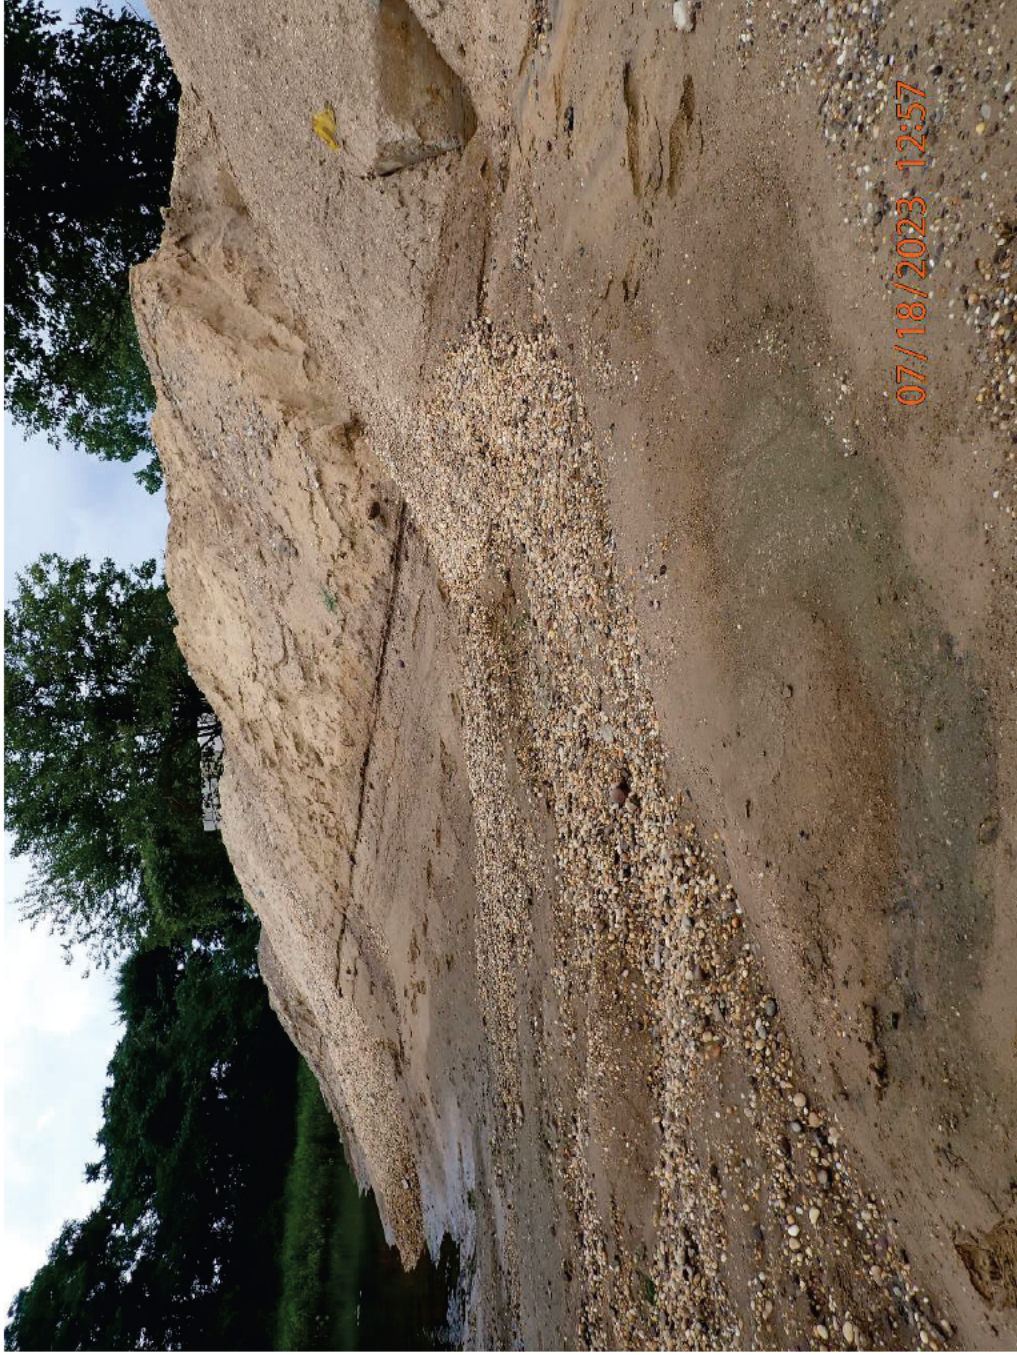
**Date:** 7/18/2023  
**Time:** 12:57 PM  
**Photographer:** S. Andreescu  
**Photo ID:** 30 – P7180136

(4/5) Panorama from edge of  
Hook Creek waters

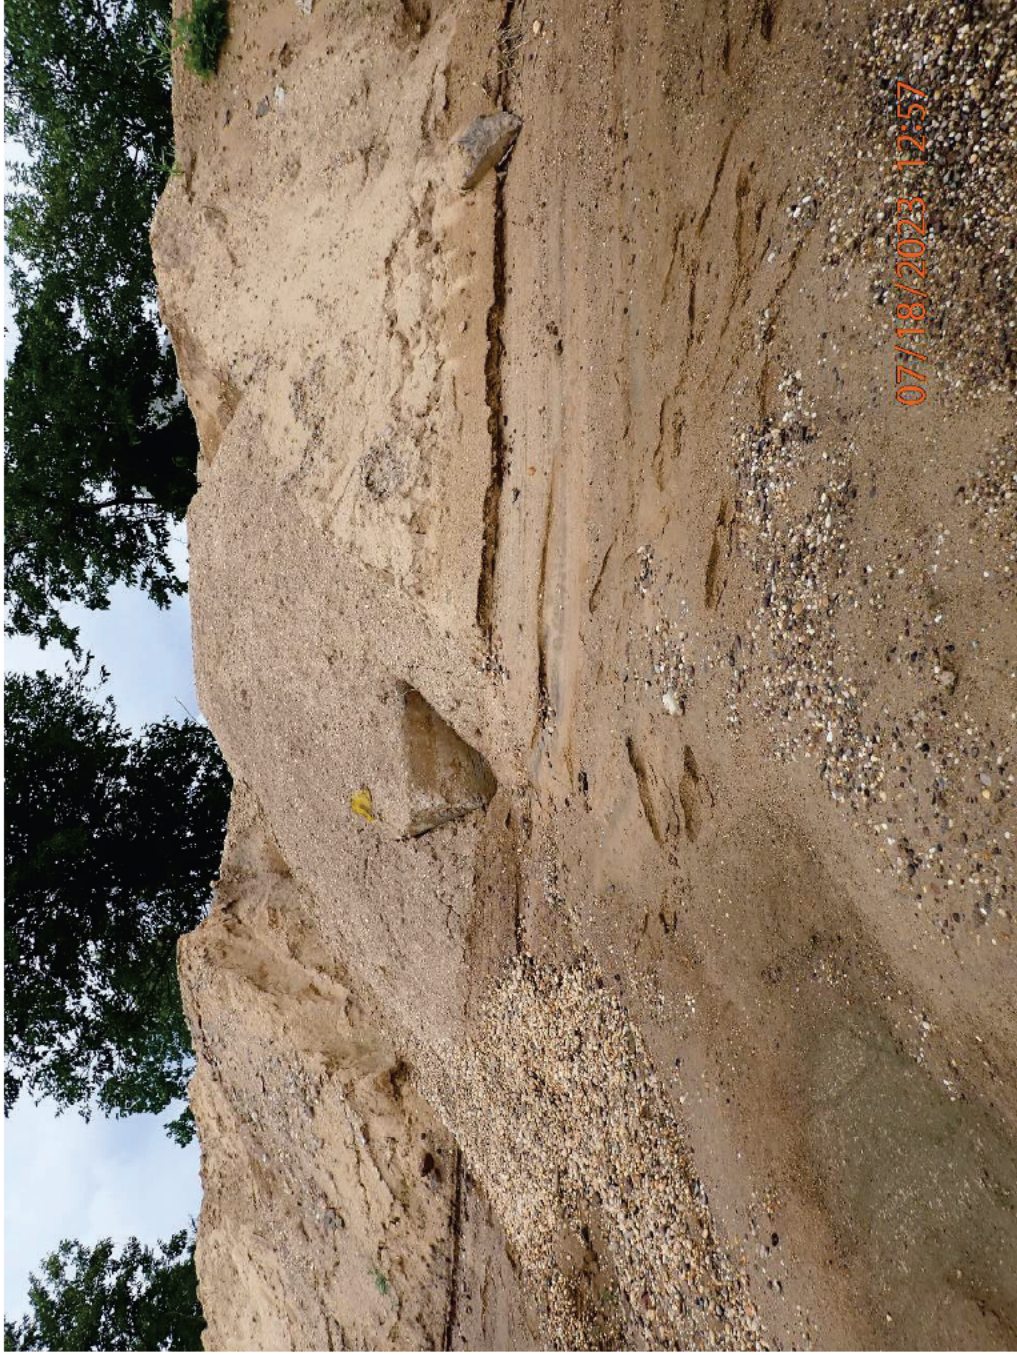
**Description:**  
(5/5) Panorama from edge of  
Hook Creek waters
