**Region 6 - Enforcement & Compliance Assurance Division**  
**INSPECTION REPORT**

| Company Name: | <b>Calgary Energy, LLC</b> | |
| Facility Name: | <b>Tidal Osage 1 Lease</b> | |
| Identification/Permit Number: | OKU000893 | |

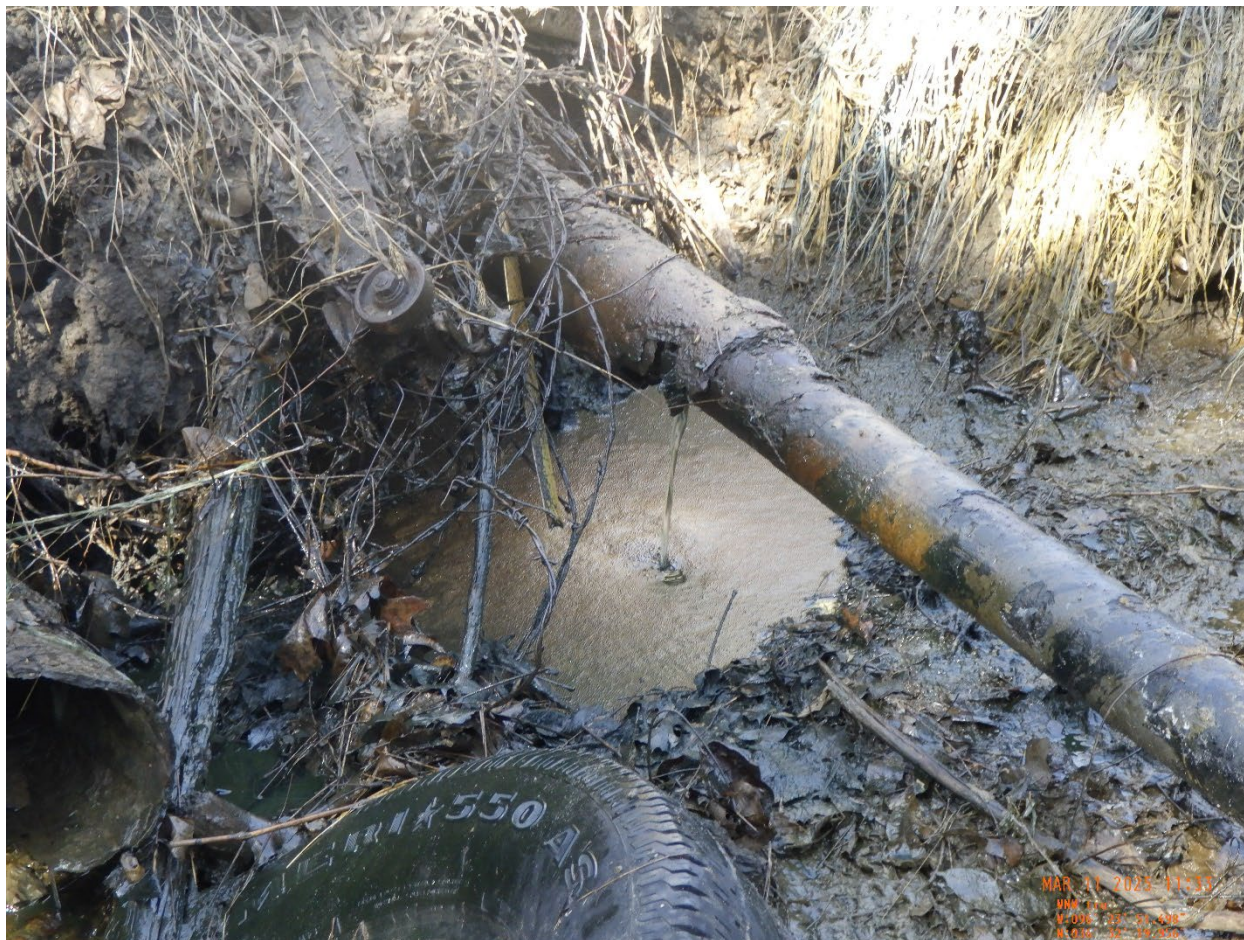
Photo No. 1

I observed the Release Point of the spill which was a 3-inch steel flowline which ruptured due to corrosion. See photo No. 1. For additional GPS location information and photo metadata, please see Appendix 1 (photo log) attached to this report.

**Description:** This was the release point of the spill, a 3" steel line which failed due to corrosion.

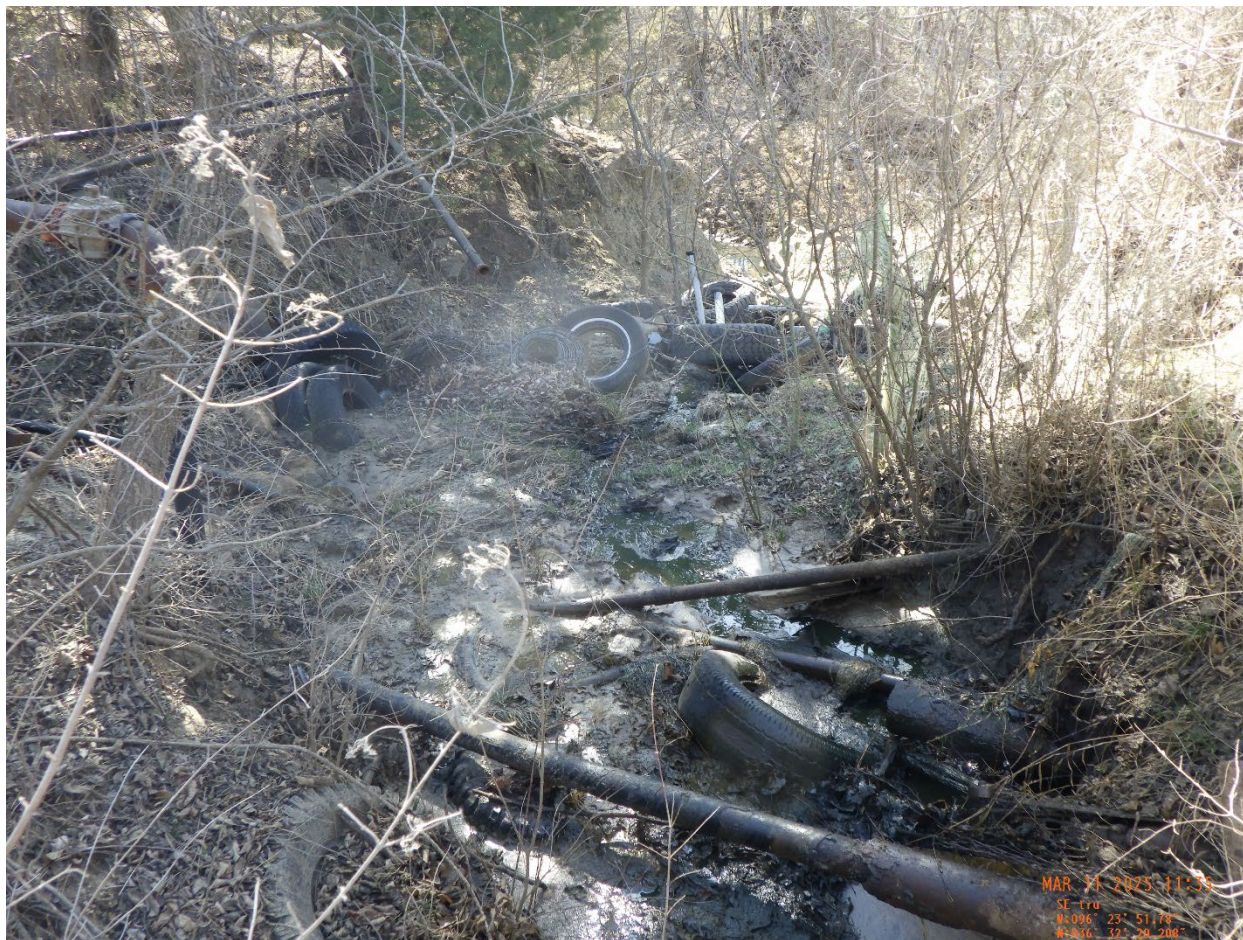
Photo No. 2

I observed the overland flowpath of the spill. Beginning at the release point, spill impacts migrated southeast approximately 50 feet along a drainage feature, toward an unnamed tributary of Little Hominy Creek. See photo No. 2.

**Description:** This was a view from the release point toward the SE, along the flowpath toward an unnamed tributary of Little Hominy Creek.

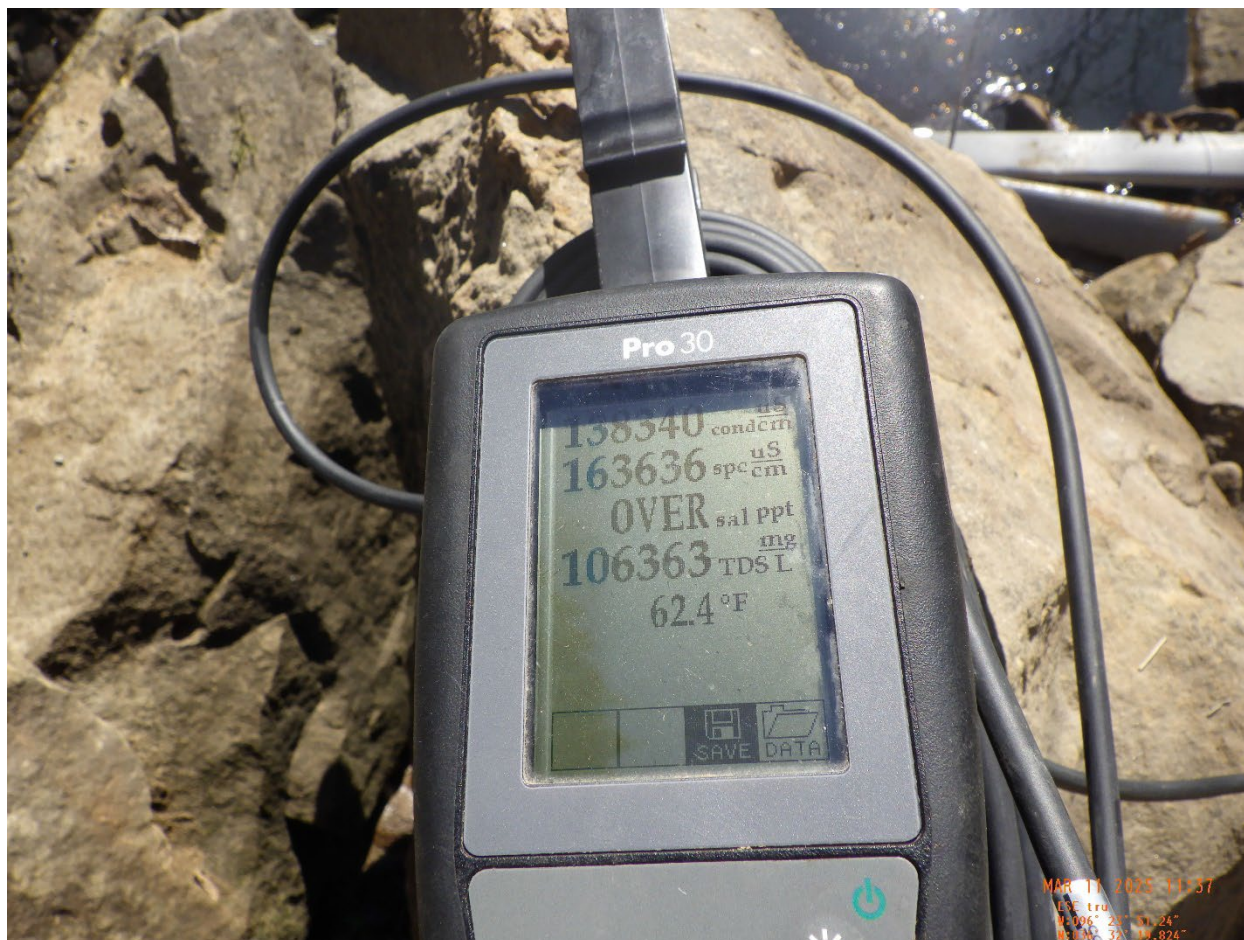
Photo No. 3

I observed the Point of Entry into the unnamed tributary. At this same location I observed a TDS field reading of 106,363 mg/L, this was the highest TDS level observed during the inspection. At this same location, I also observed crude oil floating in the main channel of the impacted tributary. See photos No. 3 & 4.

**Description:** This was a TDS field reading of 106,363 mg/L which was observed in the unnamed tributary of Little Hominy Creek. This was the highest TDS observed during the inspection.

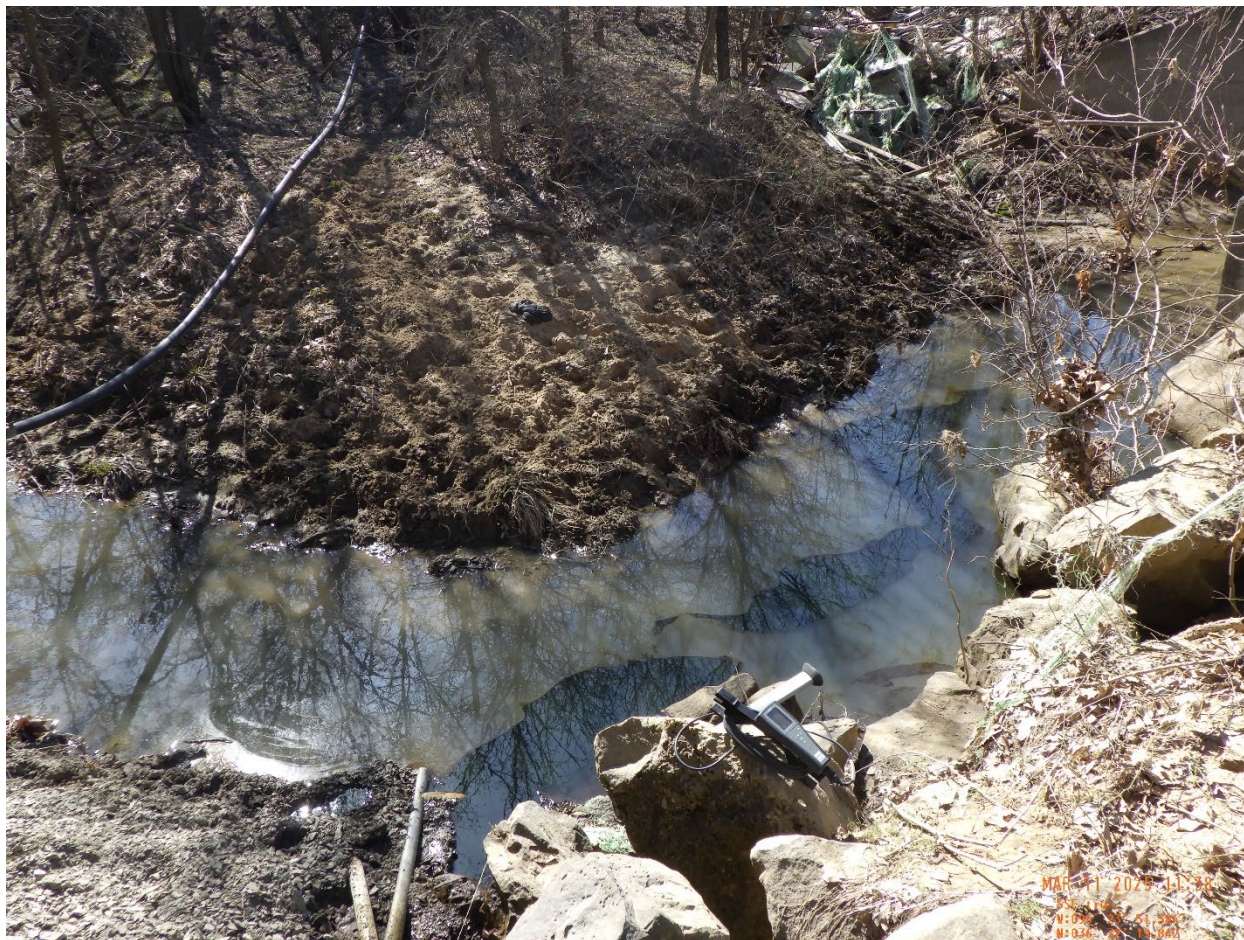
Photo No. 4

**Description:** This was the Point of Entry into the unnamed tributary of Little Hominy Creek. This is the location where the TDS field reading from photo No. 3 was observed. Oil is also present at this location.

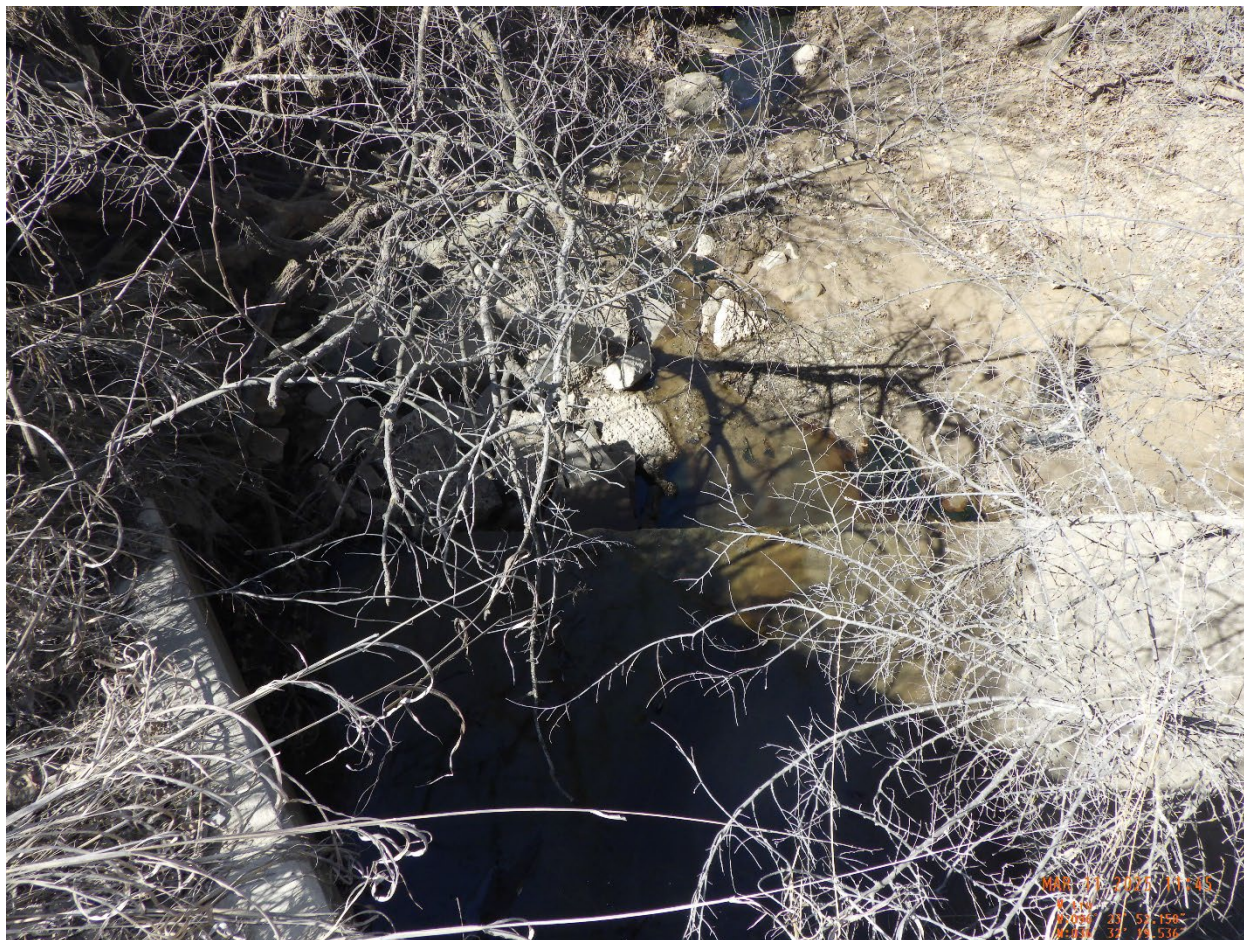
Photo No. 5

On the west side of county road 5305, I observed oil which had passed through the cement culvert under the road. I also observed the unnamed tributary continuing toward the west, which was fully covered with oil at the time of the inspection. See photos No. 5 & 6.

**Description:** This was oil and saltwater observed on the west side of the county road culvert along the impacted, unnamed tributary.

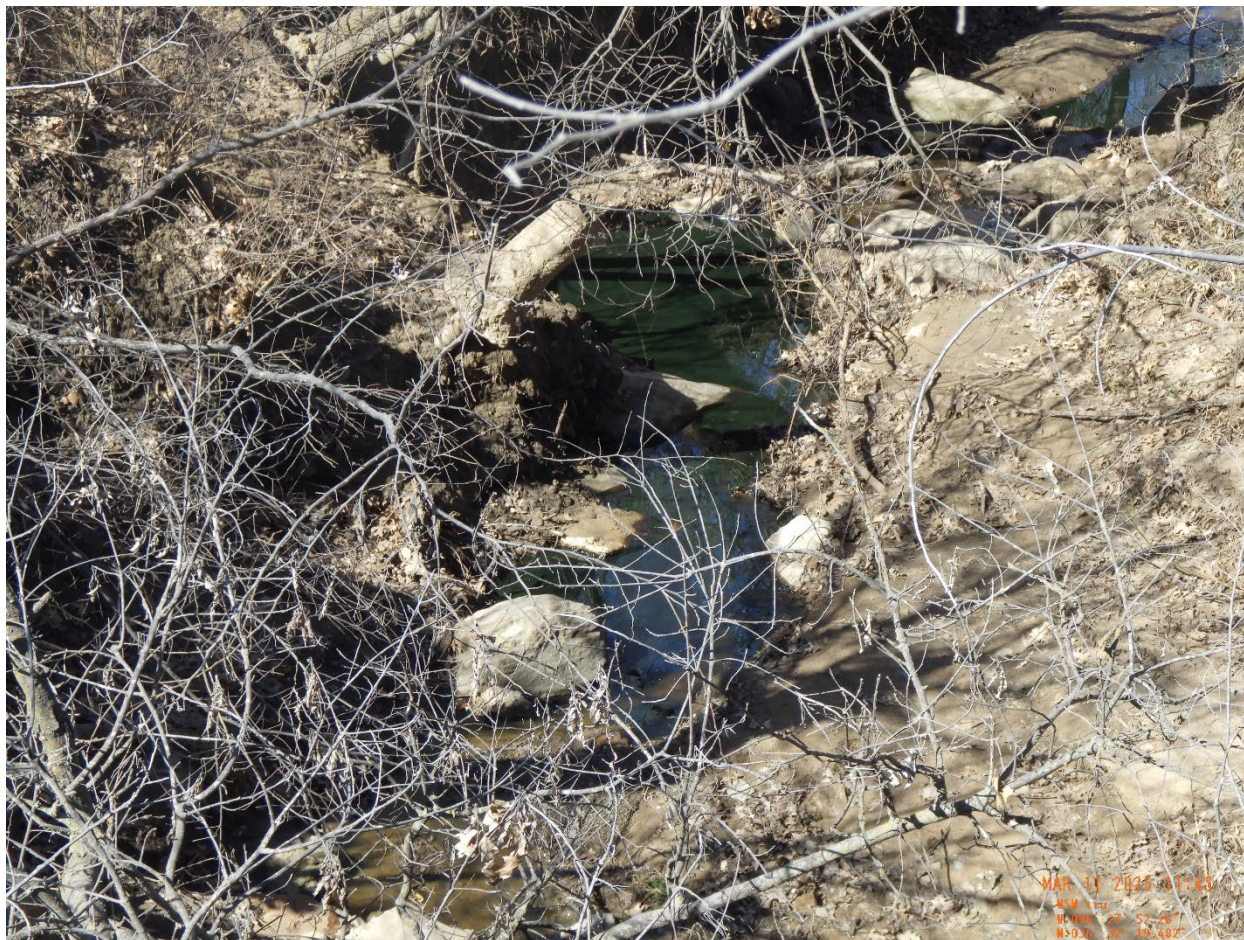
Photo No. 6

**Description:** This was oil along the unnamed tributary, with a view to the west. This photo was captured while standing in the county road atop the culvert from photo No. 5.

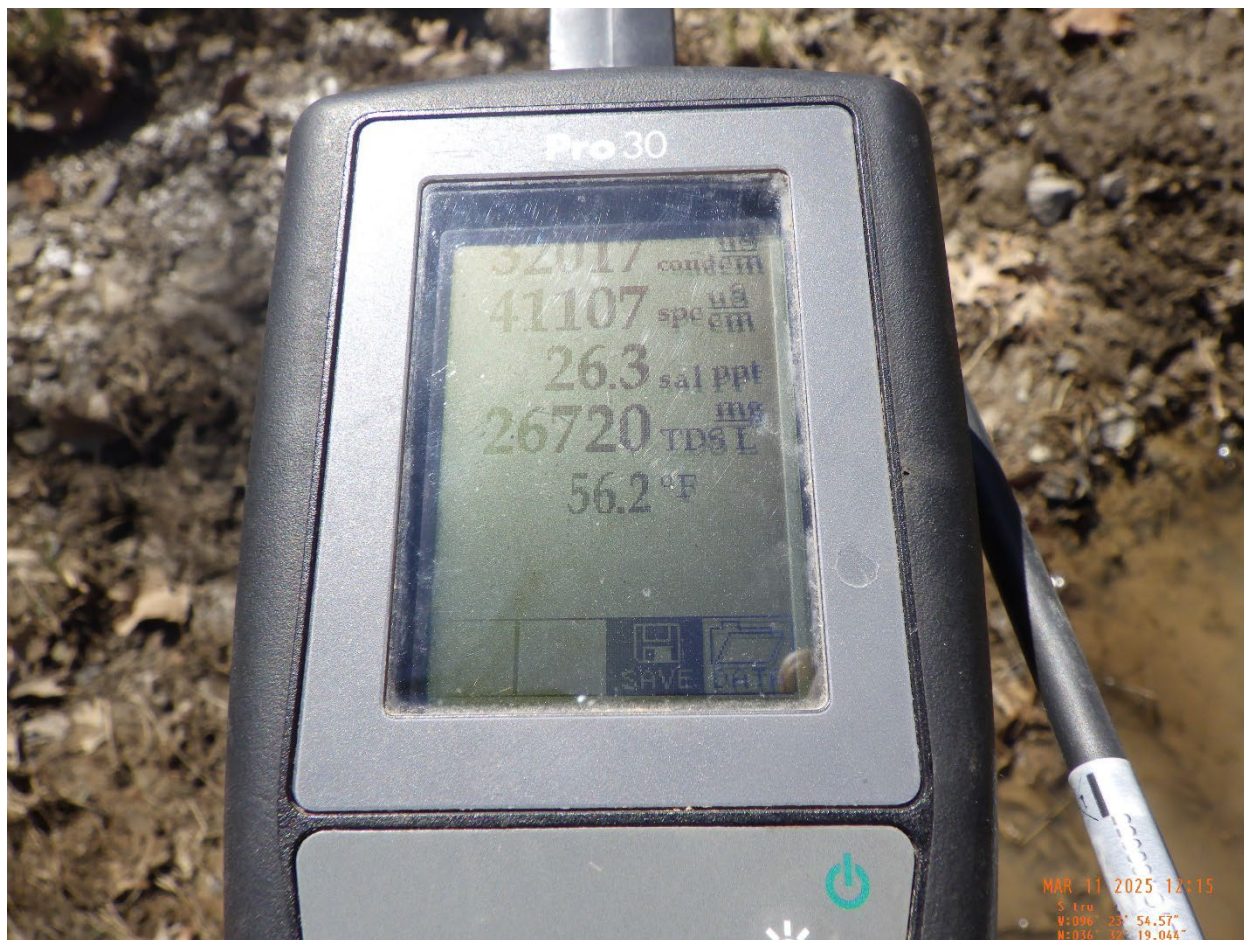
Photo No. 7

Below (south) the confluence of the impacted tributary and Little Hominy Creek, in the main channel of Little Hominy Creek, I observed a TDS field reading of 26,702 mg/L. This was the highest TDS level

observed in Little Hominy Creek during the inspection. See photo No. 7. This TDS observation and all others throughout the inspection were observed using the EPA issued, properly calibrated, YSI Pro 30 conductivity meter.

**Description:** This was a TDS field reading of 26,720 mg/L taken in the main channel of Little Hominy Creek approximately 50 feet downstream from the POE into Little Hominy Creek. This reading was taken from the bottom of the creek channel. TDS was not observed at the confluence of the unnamed tributary and Little Hominy Creek due to steep, unstable banks along the two waterways.

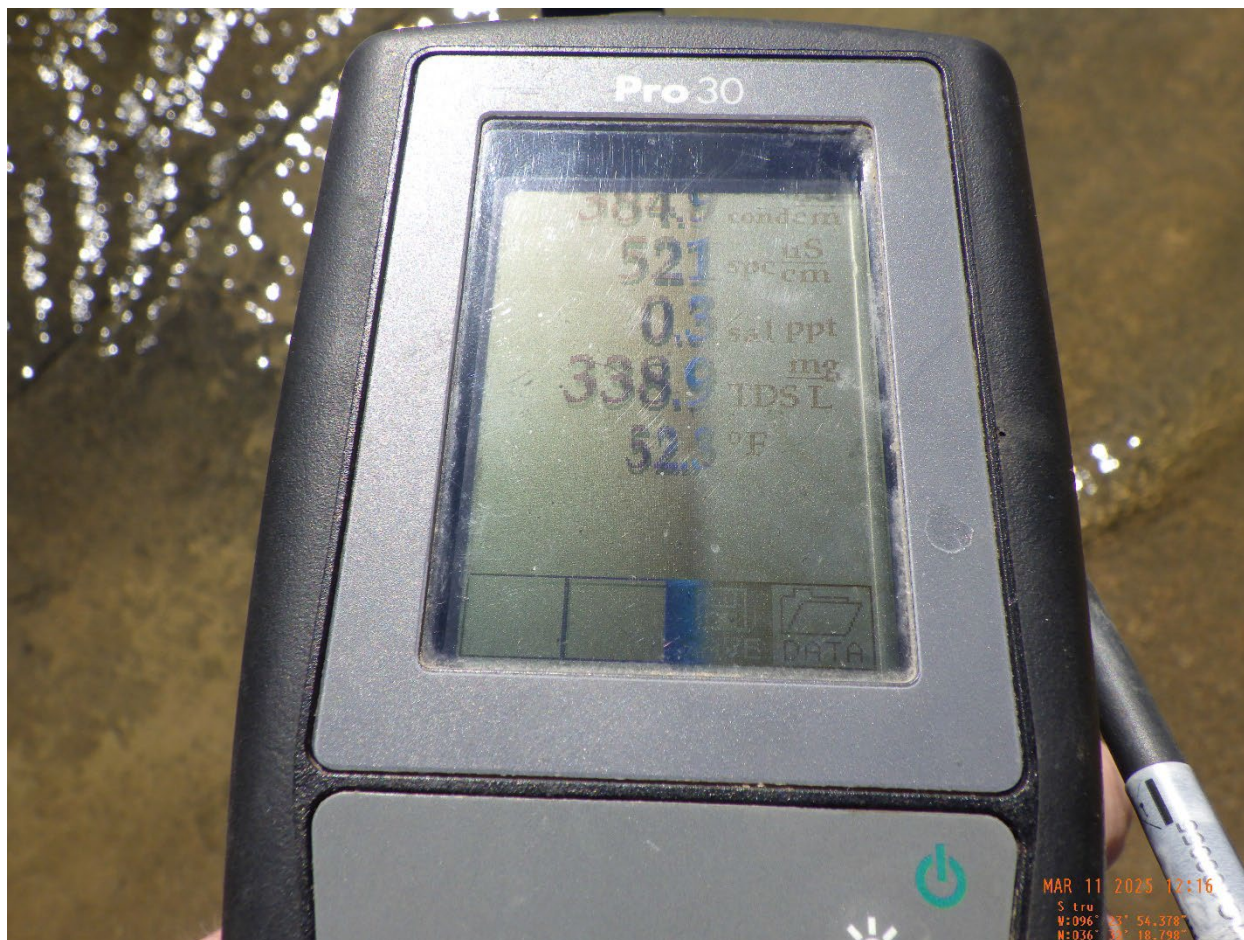
Photo No. 8

At a cement low water bridge crossing Little Hominy Creek, I observed a TDS field reading of 338.9 mg/L in the water overflowing the bridge. At the same location, I observed a floating, oil absorbent containment boom which had been placed to prevent further downstream migration of crude oil. See photos No. 8 & 9.

**Description:** This was a TDS field reading of 338.9 mg/L taken at the cement low water crossing, approximately 50 feet downstream from the POE into Little Hominy Creek. This reading was observed in the water overflowing the bridge.

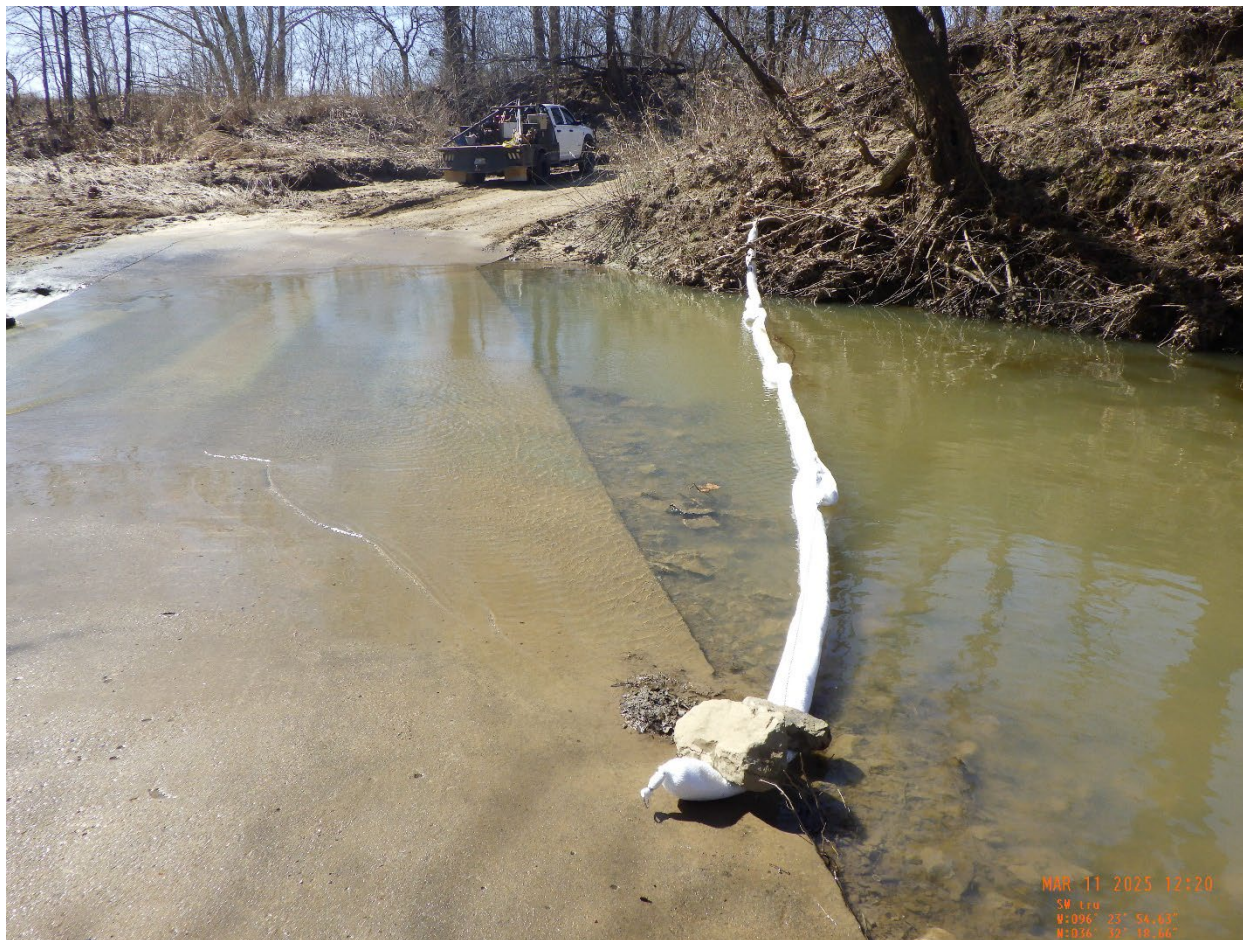
Photo No. 9

**Description:** This was the location of the TDS observation in photo No. 8. This was also the second floating, oil absorbent boom observed during the inspection.

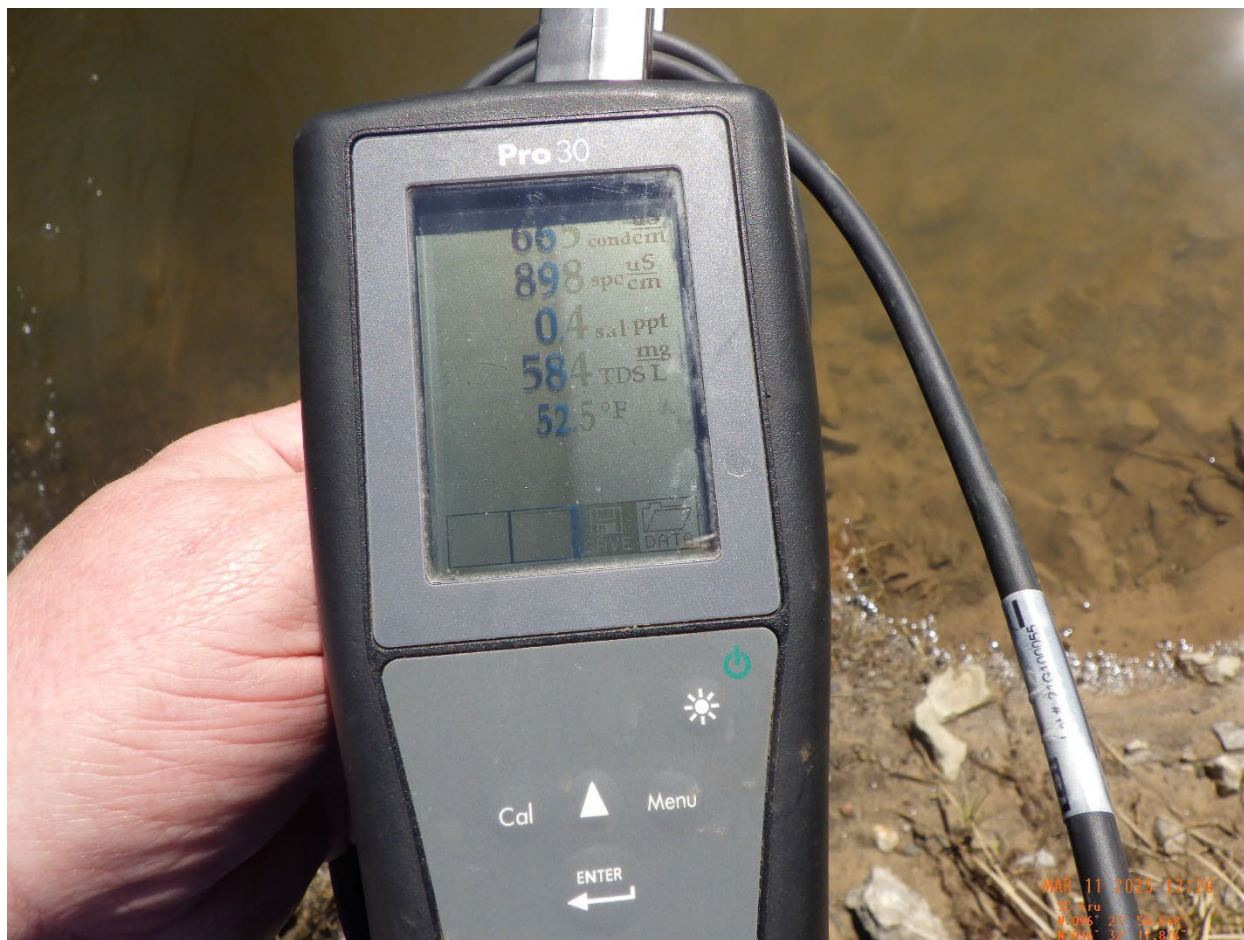
Photo No. 10

Immediately downstream from the low water bridge, I observed a TDS field reading of 584 mg/L. See photo No. 10.

**Description:** This was a TDS field reading of 584 mg/L, observed in the main channel of Little Hominy Creek immediately downstream from the cement low water crossing from photo No. 9.

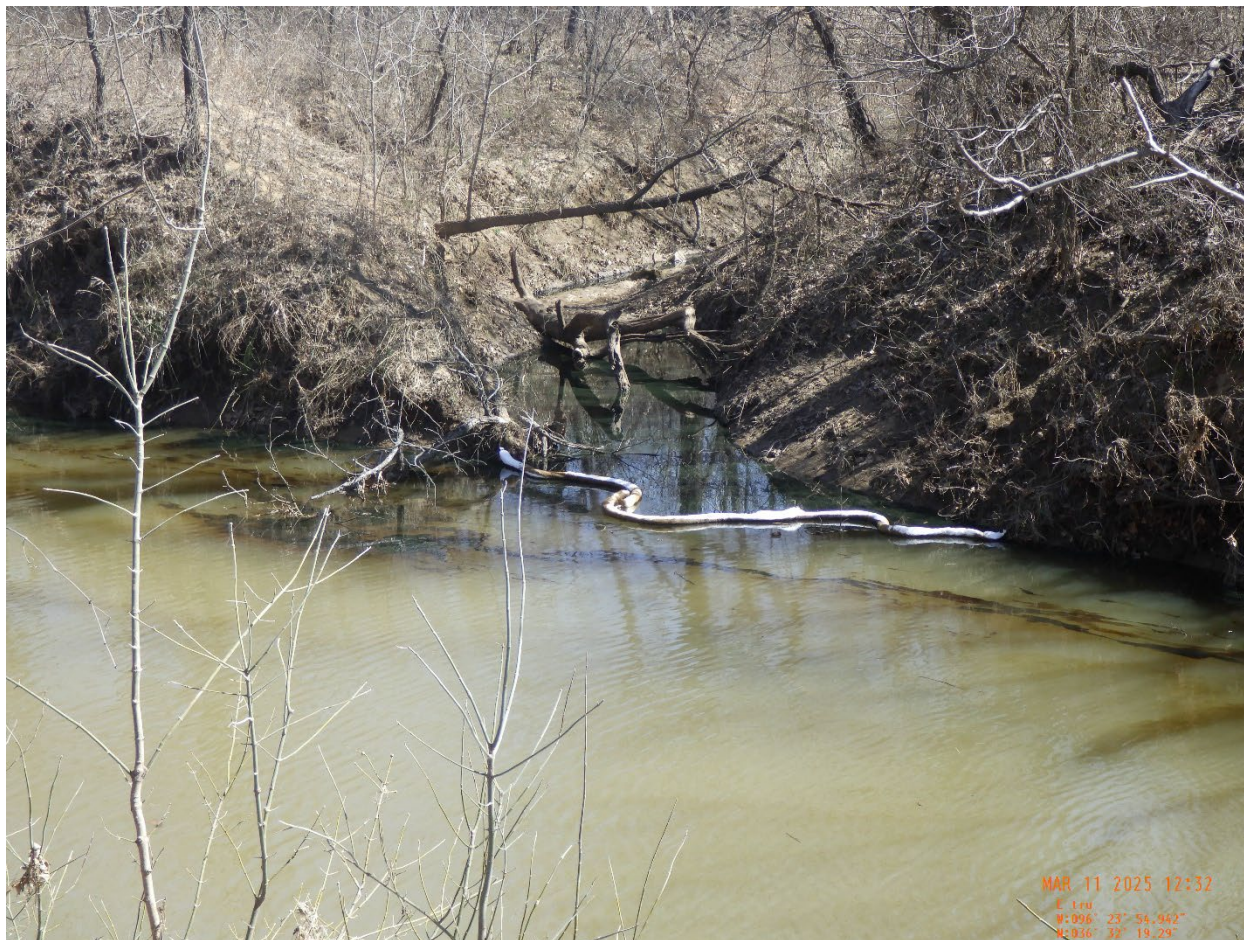
Photo No. 11

From the west bank of Little Hominy Creek, I observed the confluence of the unnamed tributary and Little Hominy Creek. At the time of the inspection a floating oil absorbent containment boom was installed to capture crude oil coming into Little Hominy Creek. Oil was floating on the unnamed tributary and Little Hominy Creek at this location. See photo No. 11.

**Description:** This was a photo of the POE into Little Hominy Creek. This was also the location of the first floating, oil absorbent boom used to contain the floating oil. Oil was floating on Little Hominy Creek and the unnamed tributary at the time of the inspection.

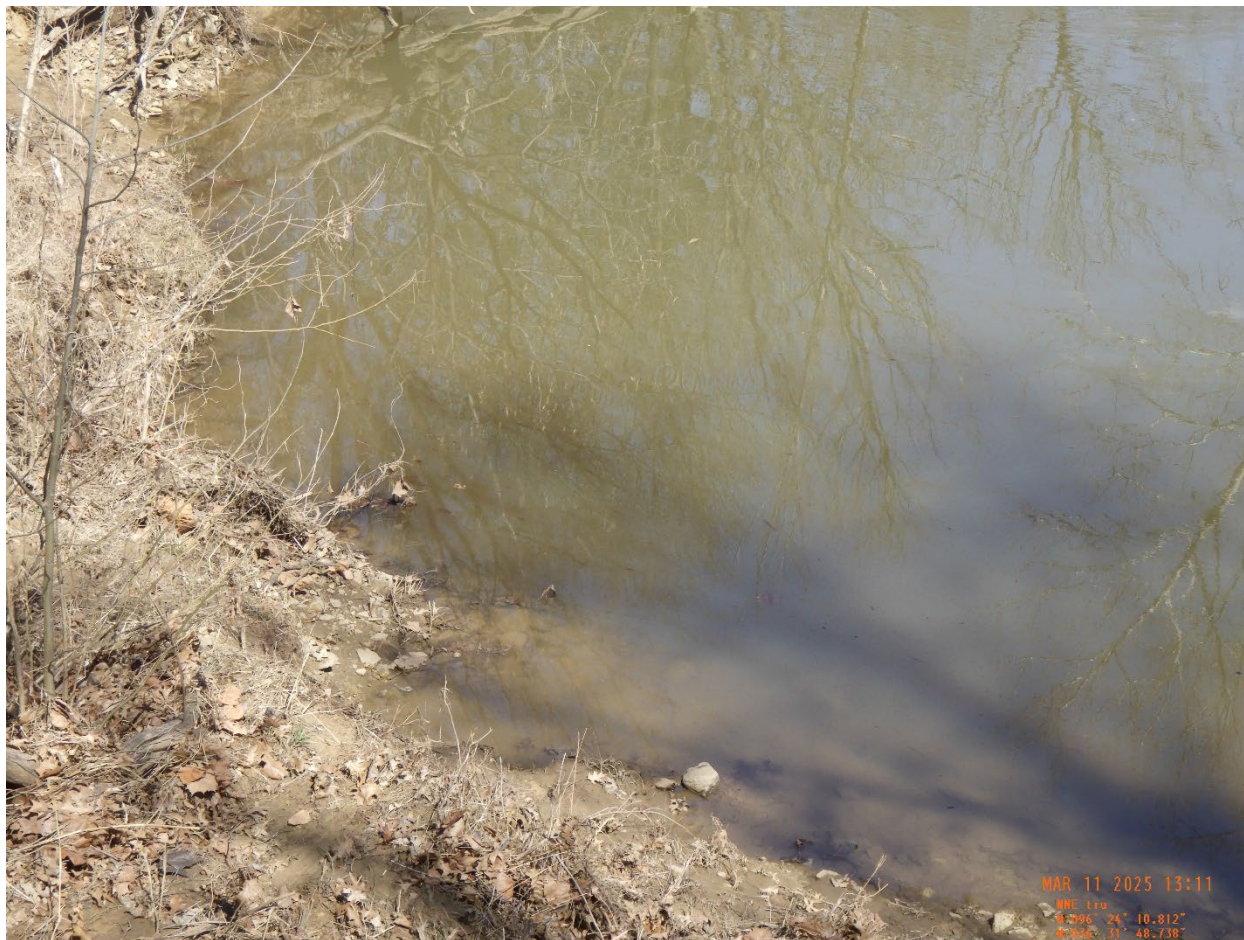
Photo No. 12

I observed the end of spill impacts, which was oil and oil sheen floating on the waters of Little Hominy Creek, this observation was approximately 1.55 miles downstream from the POE, if following the main channel of the creek. At the time of the inspection, there was no containment measures in place to prevent downstream migration of spill impacts. From the end of spill impacts, I observed the upstream and downstream view of Little Hominy Creek, capturing the bed and bank features of the waterway. See photos No. 12, 13 & 14.

**Description:** This was the end of spill impacts at the time of the inspection. Oil and oil sheen was present on the water at this location.

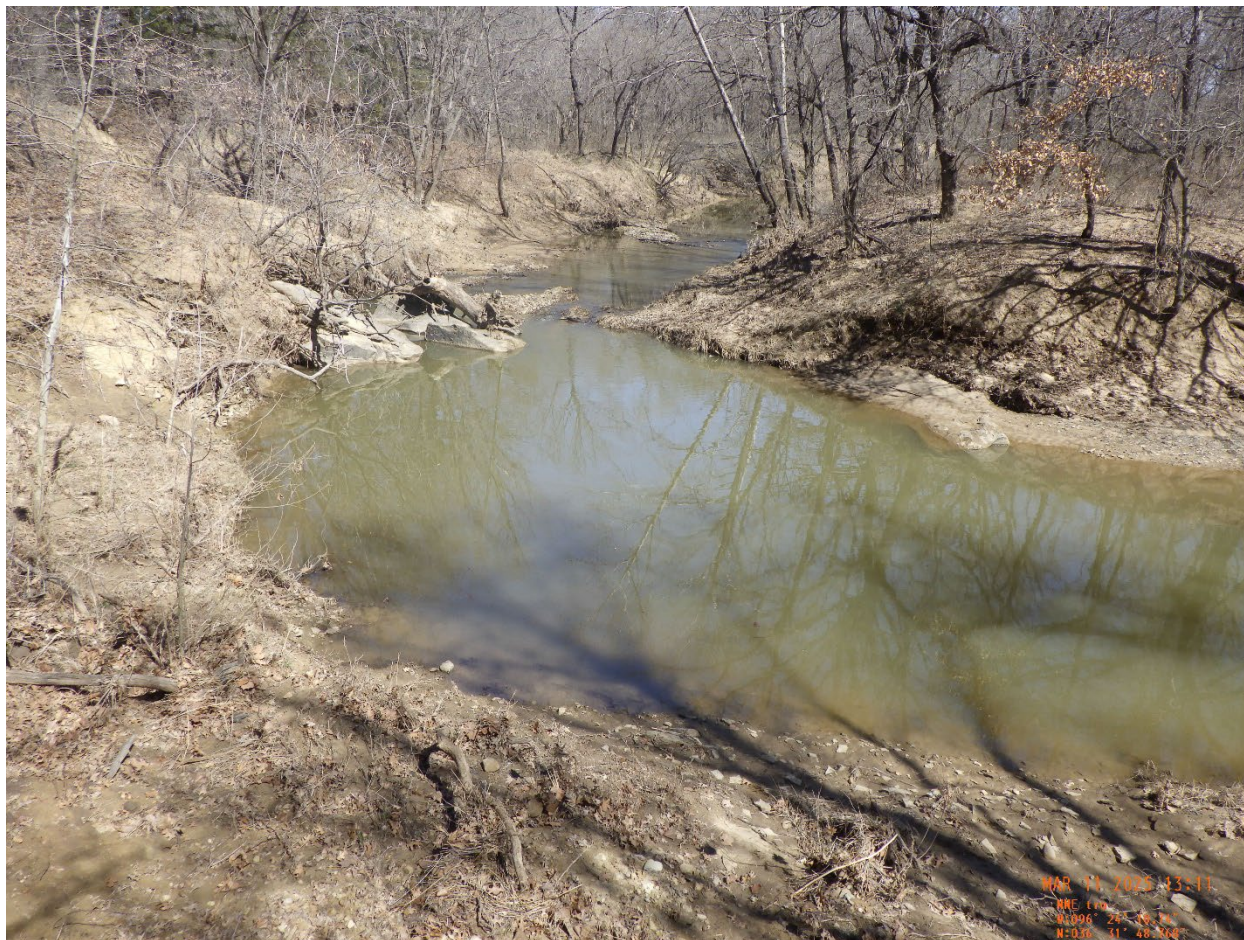
Photo No. 13

**Description:** This was an upstream/NNE view along Little Hominy Creek from the last observed spill impacts during the inspection. At the time of the inspection there was no containment measures preventing downstream migration of oil.

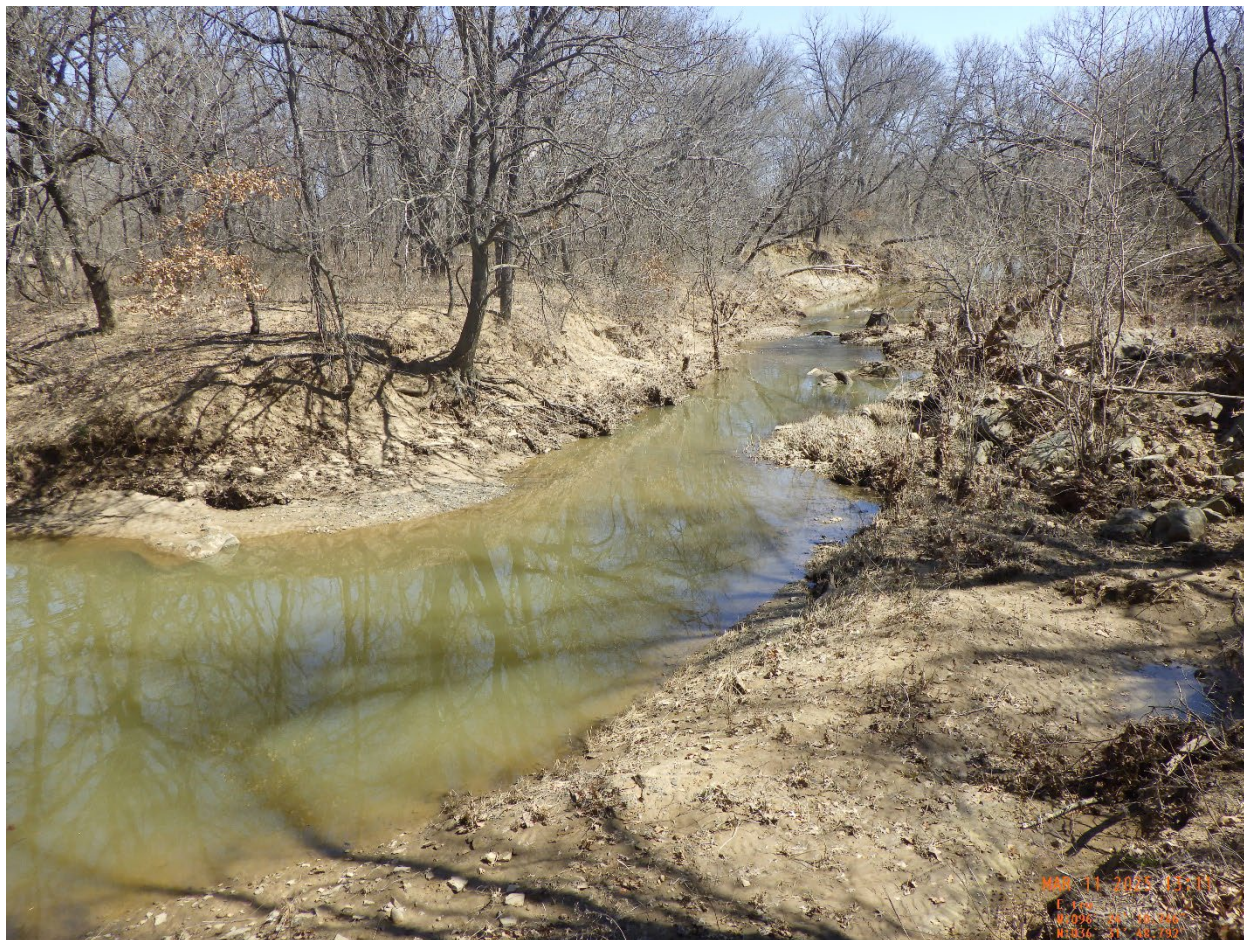
Photo No. 14

**Description:** This was a downstream/east view along Little Hominy Creek from the last observed spill impacts during the inspection. At the time of the inspection there was no containment measures preventing downstream migration of oil.

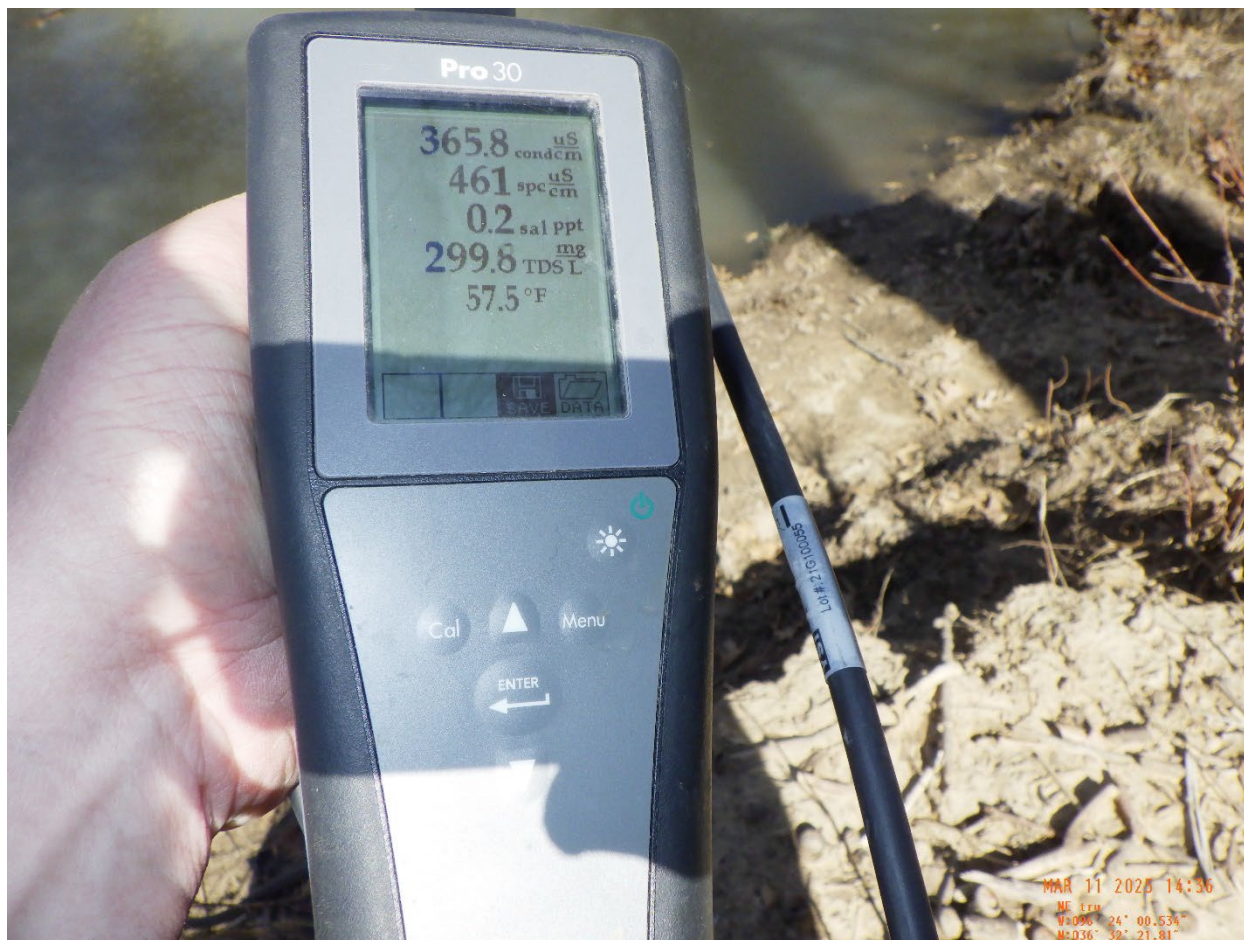
Photo No. 15

I observed a “background” TDS field reading of 299.8 mg/L. This measurement was observed upstream from the POE in the main channel of Little Hominy Creek where spill impacts could not reach. See Photo No. 15.

**Description:** This was a TDS field reading of 299.8 mg/L observed upstream from the POE. This TDS reading should be used when considering background TDS levels in Little Hominy Creek.
