**Well Inspection**  
**Osage DNR / Environmental Protection Agency**  
**1201 Elm Street, Suite 500**  
**Dallas, Texas 75270**

| <b>Operator Info</b> | Contango Resources, LLC<br>1717 South Boulder, Suite 900<br>Tulsa, OK 74119<br>Phone: 918-392-3396 | <b>Inventory ID</b> | OS3927000 | | |
| <b>Location</b> | NW 09 24N 07E | <b>Status</b> | Active | <b>Well Type</b> | Enhanced Recovery |

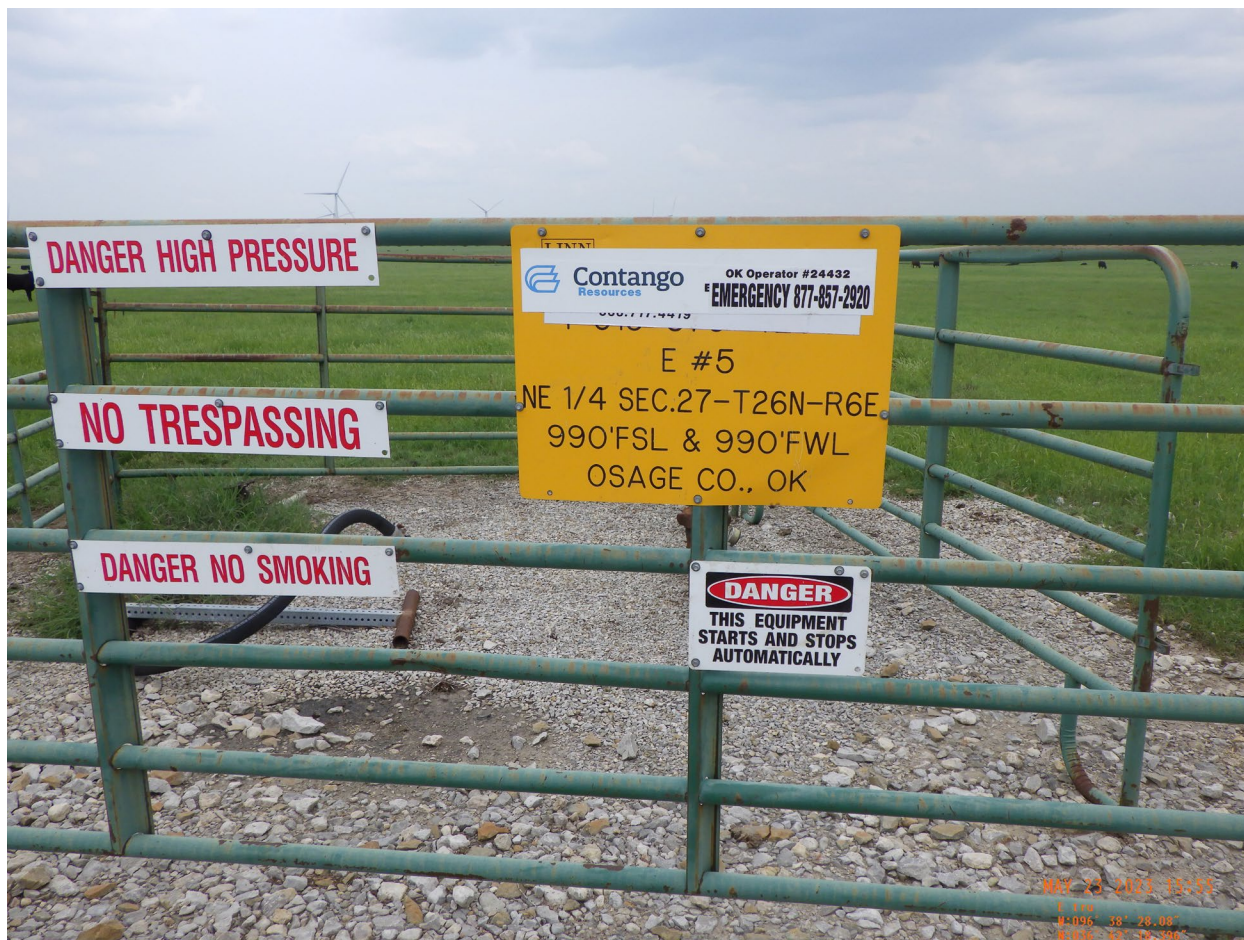
Photo No. 1

Description: This was the injection well OS3927000 at the time of the inspection.

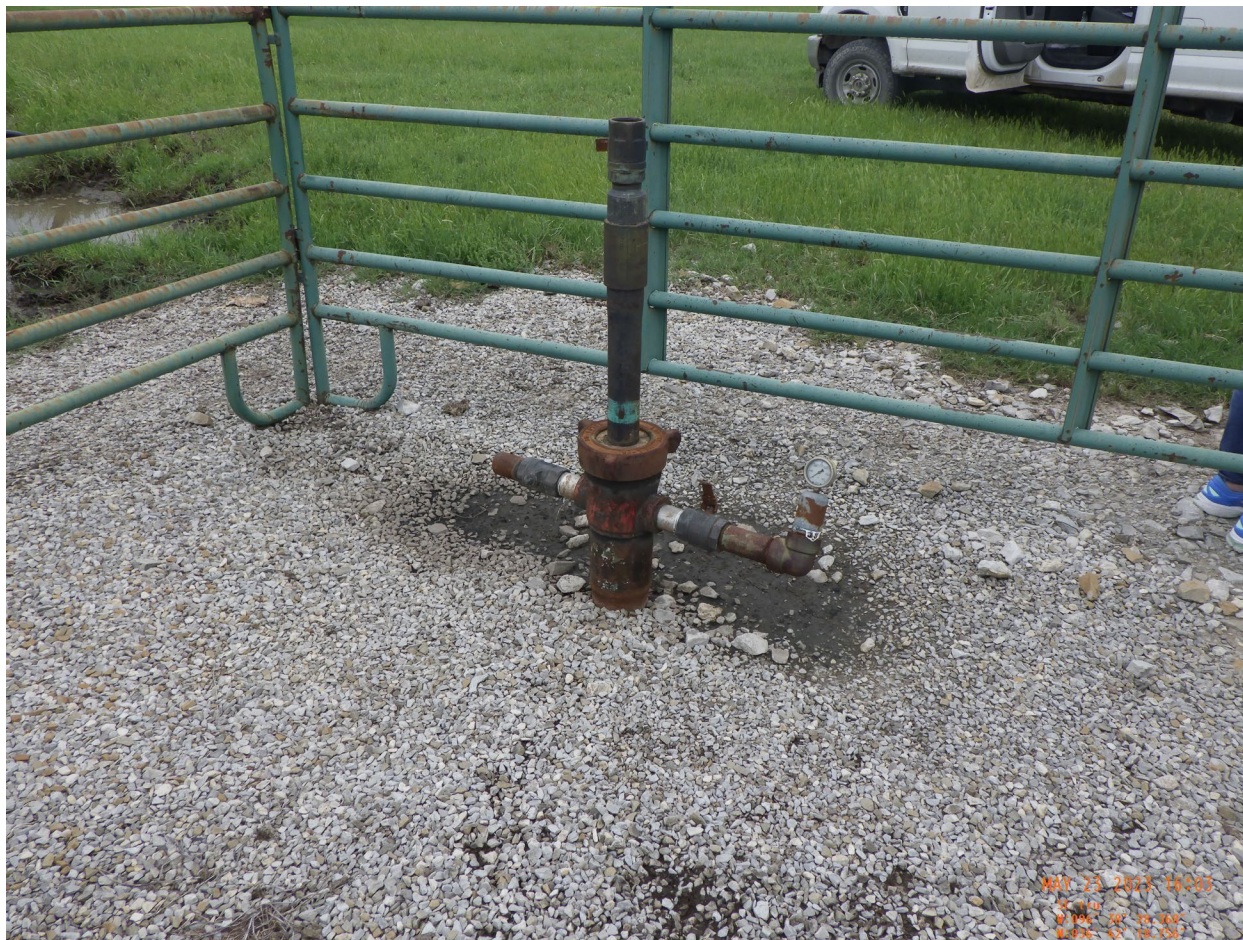
Photo No. 2

**Description:** This was the injection well OS3927000 at the time of the inspection. The well was disconnected at the time of the inspection.
