**NPDES Stormwater Reconnaissance Inspection  
Industrial Facility**

**VEGA BAJA SOLID WASTE MUNICIPAL LANDFILL**  
Road PR-668 Int., Cibuco Ward, Vega Baja, PR 00694  
Coordinates: 18.478408°N, 66.359097°W (Decimal)

**NPDES MSGP ID: PRR053137**

**Inspection Date: April 7, 2022**

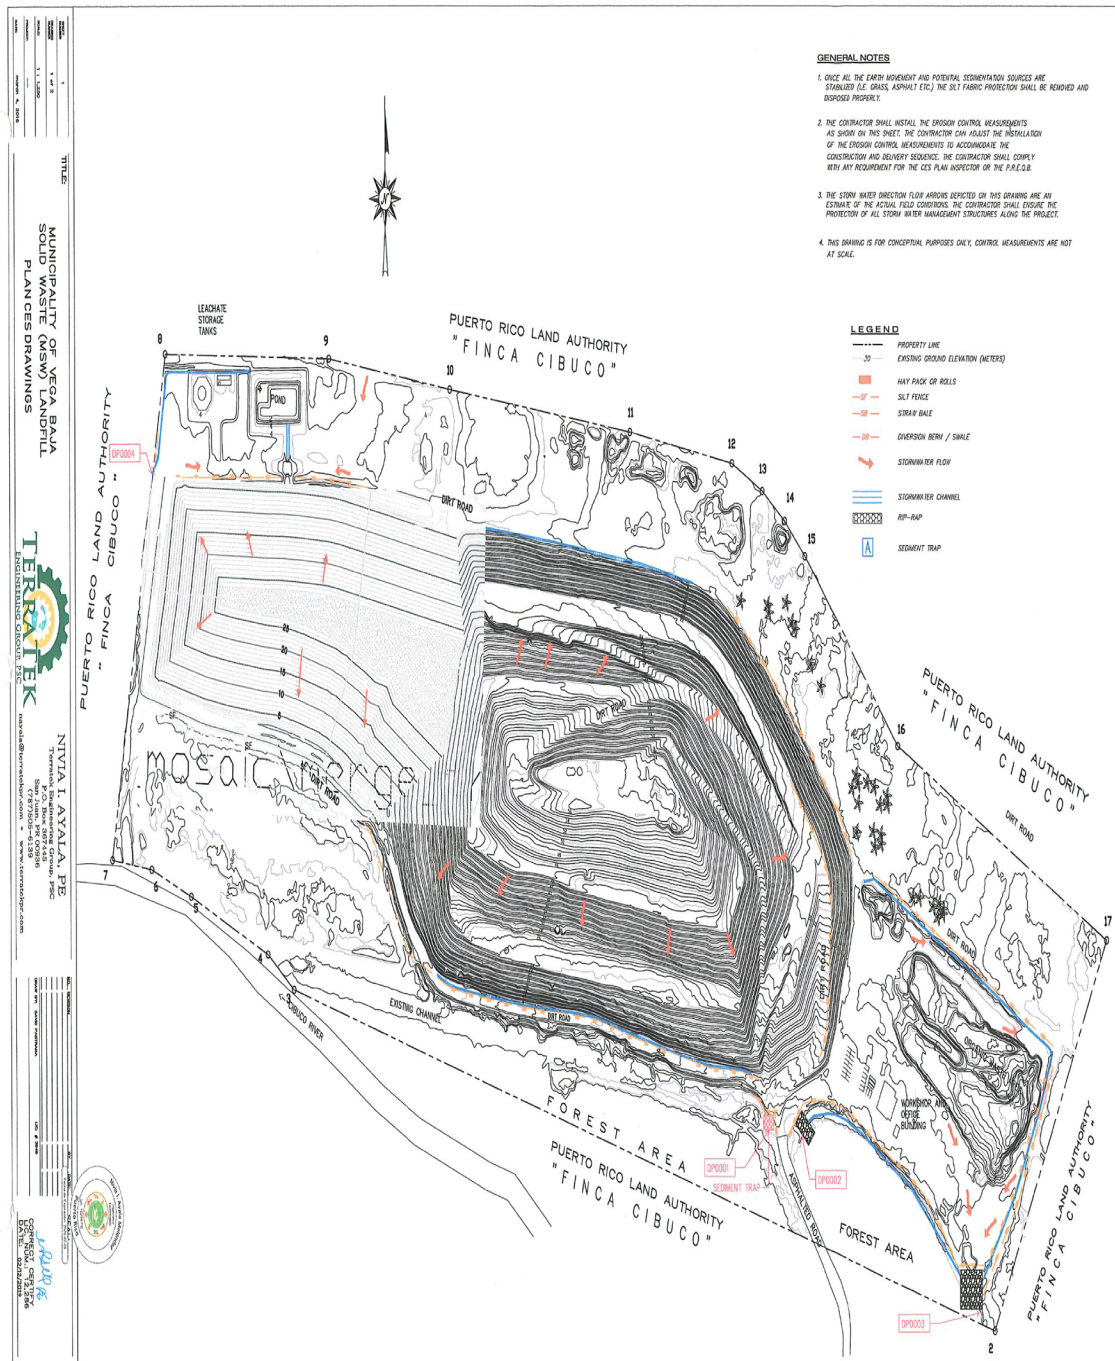
### Figure 1

The storm water runoff from the drainage areas associated with Outfall 004 flow from the west and the northwest sides of the Landfill into a drainage channel located northwest of the Landfill, which in turn flows and discharges into the Cibuco River. Silt fences and synthetic hay bales were installed. **Figure 1** (next page) depicts a site map of the area where the Landfill is located and flow schematic of the Facility. **Image 2** (page 7) depicts the hydrographic area near the Facility and the location of Cibuco River.

- f. The EPA Inspector identified 4 permitted discharge points, as described in Part 3 (*Description of the Stormwater Collection and Discharge System*) of this Inspection Report. Refer to Figure 1, above.
