## Clean Water Act Section 404: Site Visit/Case Development

| Site Name | Kelly Branch | | | | | | |

| Inspection Purpose | Initial site visit | | |

Inspection Photographic Log  
Evarts, Kentucky  
May 7, 2024

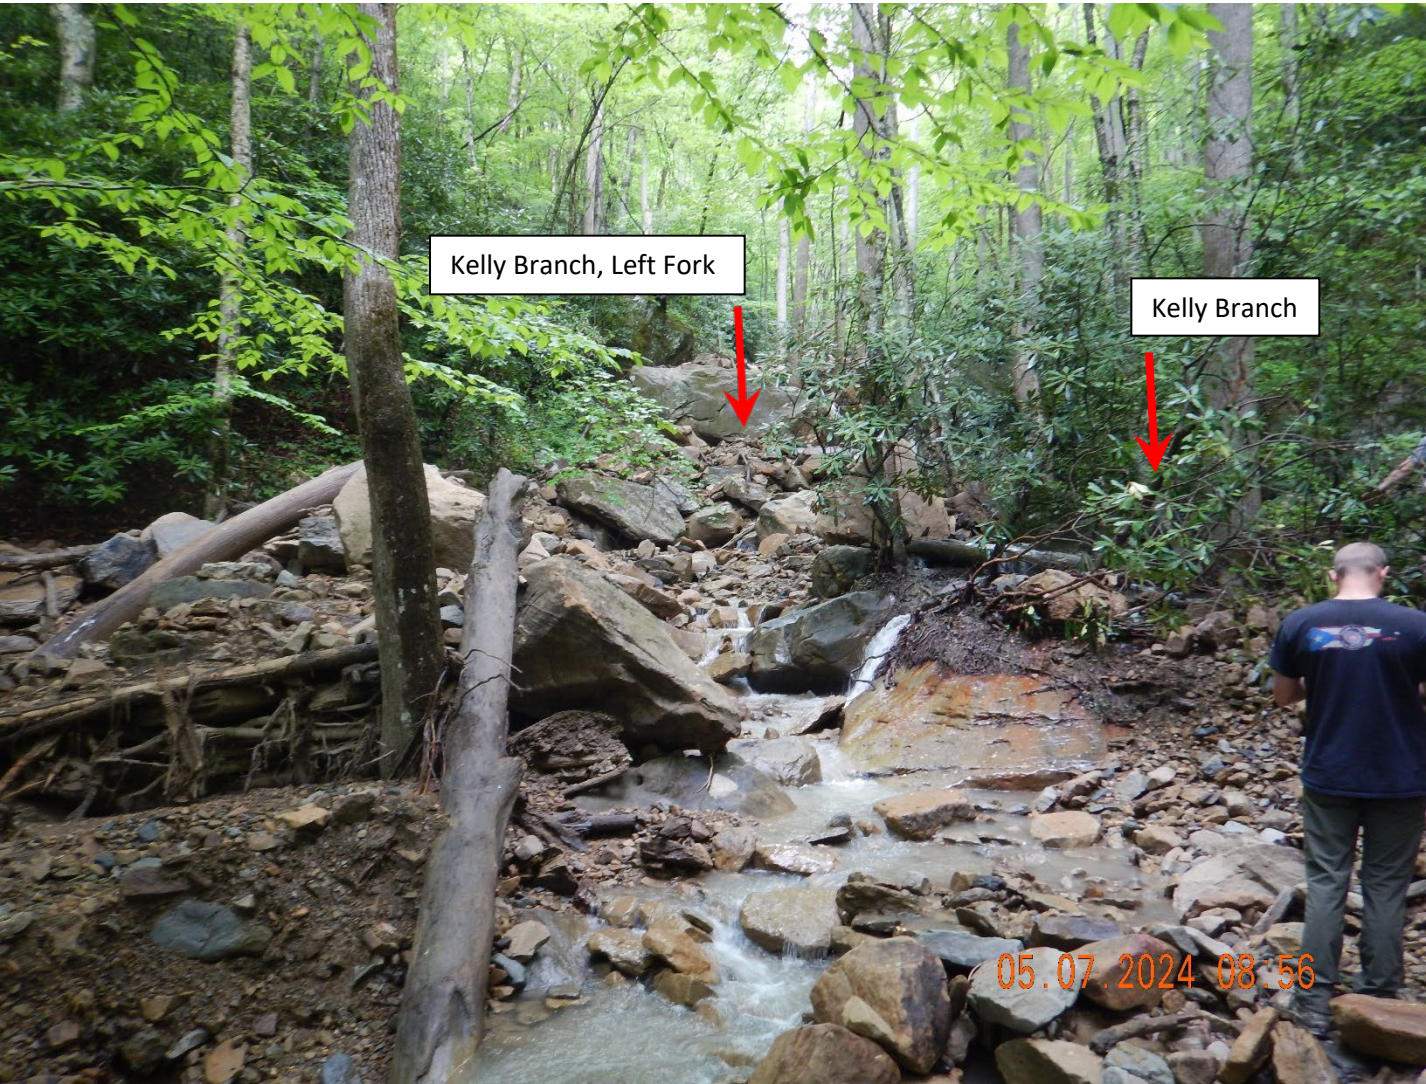
| Title | Photo 7 |

| Description | Kelly Branch facing upstream. Left Fork straight ahead and mainstem of Kelly Branch coming in from the right. |

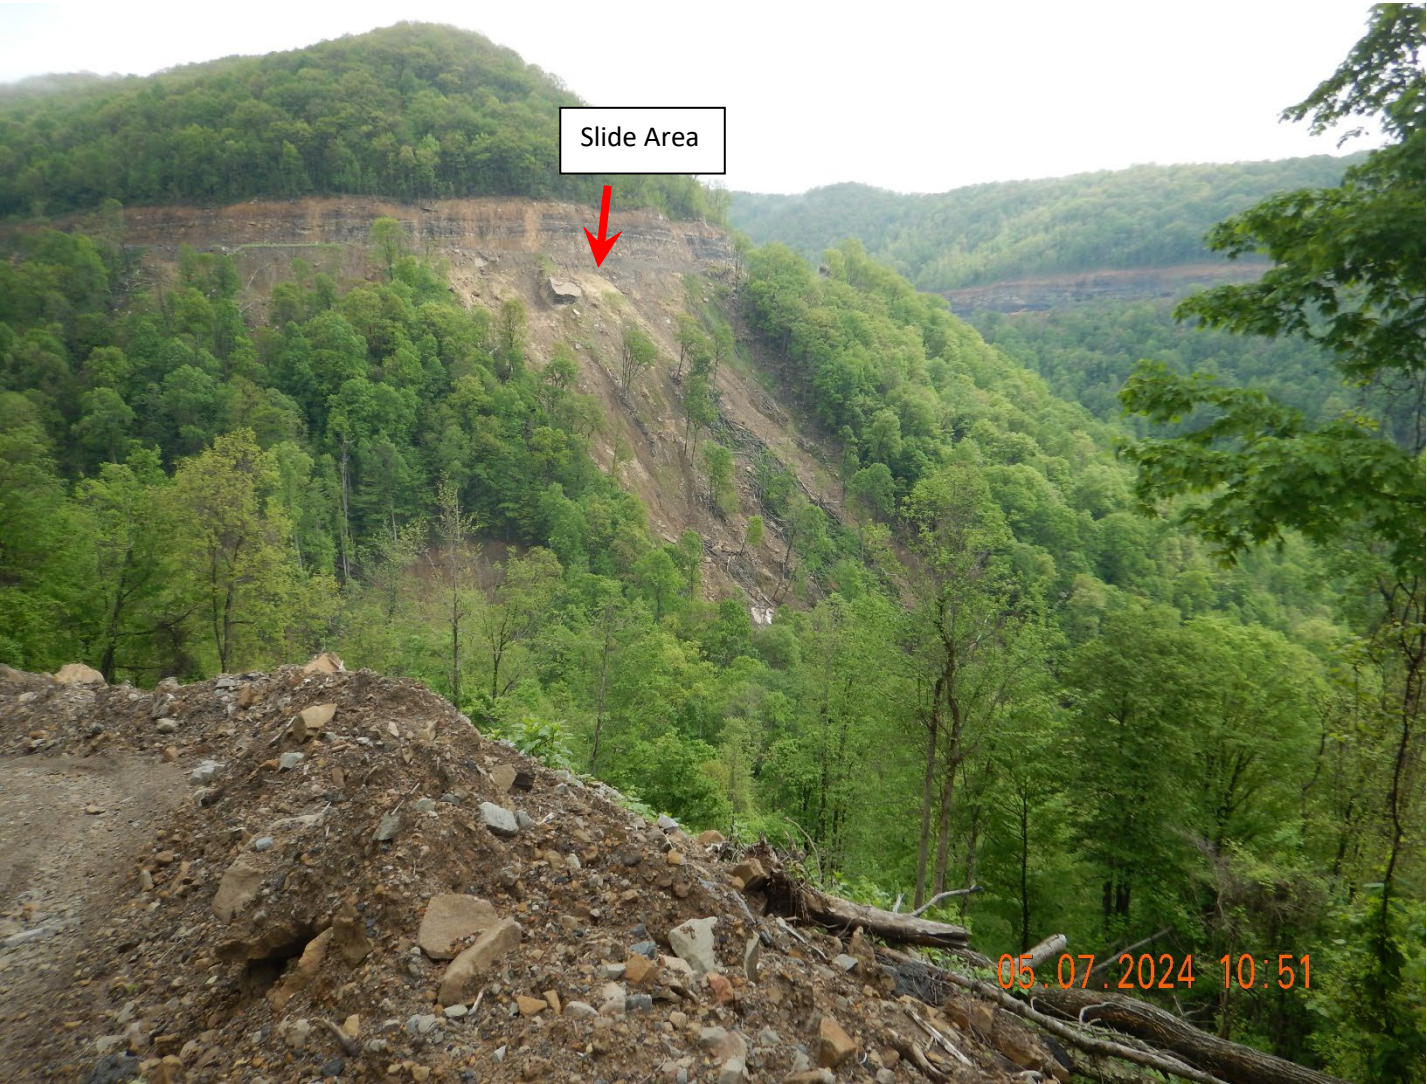
| Title | Photo 9 |

| Multiple landslides occurred on the Site during the mining operation. One slide area impacted the left fork and mainstem of Kelly Branch. Kelly Branch is a tributary of Clover Fork. The Site is located approximately 2.5 miles due east of Closplint, Kentucky (see Attachment A). | | | |

| Description | Photograph of slide area that went into the left fork of Kelly Branch. Photo taken from Pond 8 access road. |
