**CWA COMPLIANCE EVALUATION INSPECTION REPORT
U.S. ENVIRONMENTAL PROTECTION AGENCY, REGION 5**

Purpose: Compliance Evaluation Inspection

Simler's Winding Acres Farm
3017 South Van Brocklin Road
Freeport, Illinois
Stephenson County
42.256066, -89.702072

Date of Inspection: September 24, 2020

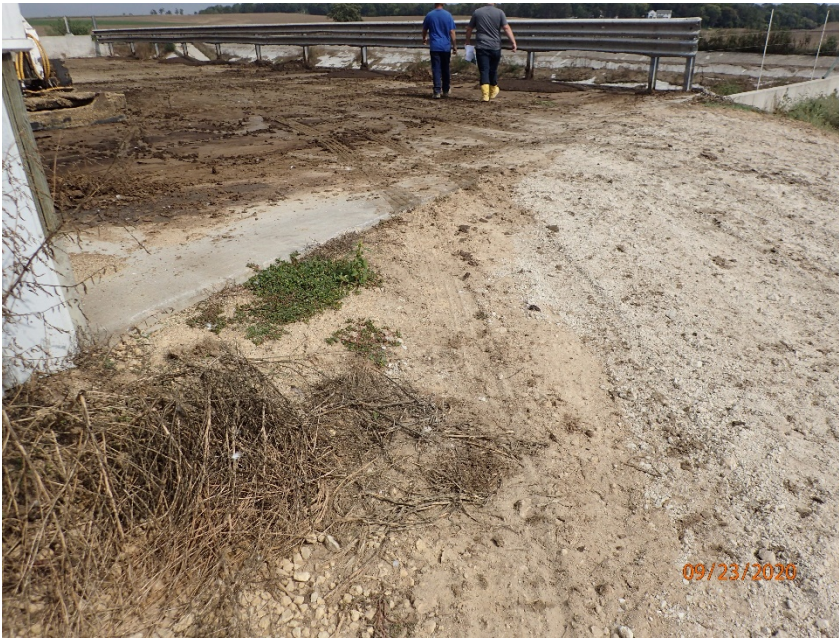
8: P9230008

Description: Manure pushout area on the east side of the Big Barn. Note the mountable curb to prevent runoff from leaving the area. Big Pit in the distance beyond the guardrail.

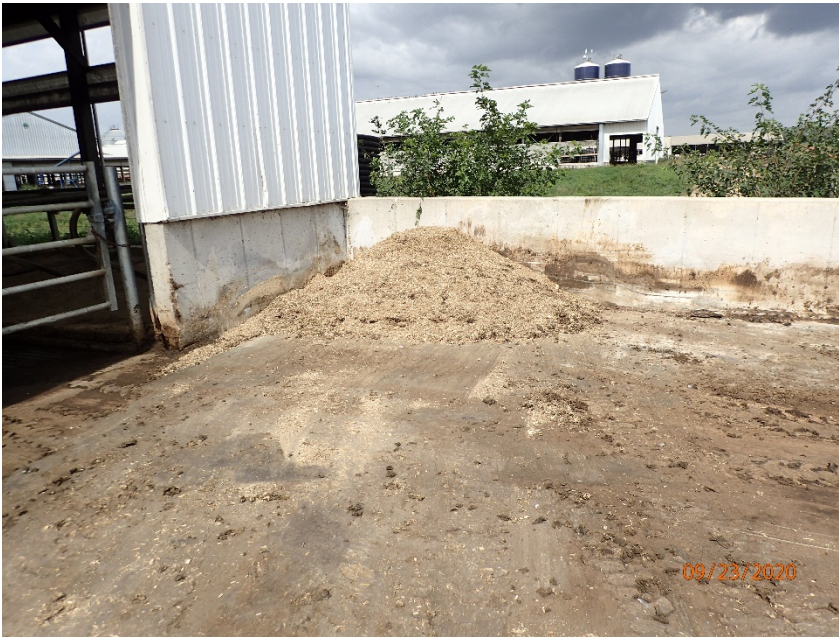
10: P9230010

Description: New mortality compost pile located in northwest corner of Big Barn manure pushout area.

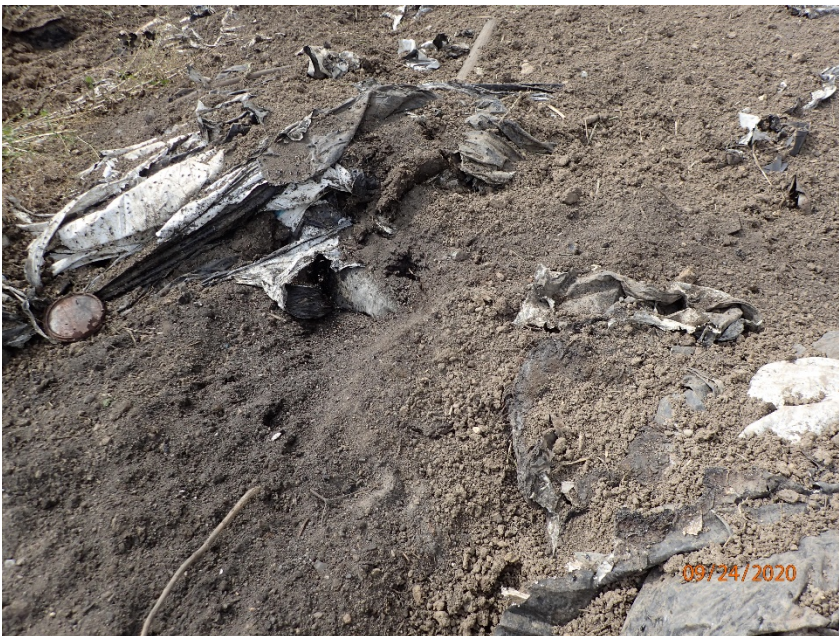
11: P9240011

1. Leachate from the North Silage Pad was observed leaving the pad.
2. Partially decomposed mortalities were observed in the filled area south of the Big Pit.
3. The Little Pit had a leak in the northeast corner.

Description: Recently filled area south of the Big Pit. Note presence of waste plastic silage bags and there was an exposed partially composted mortality.

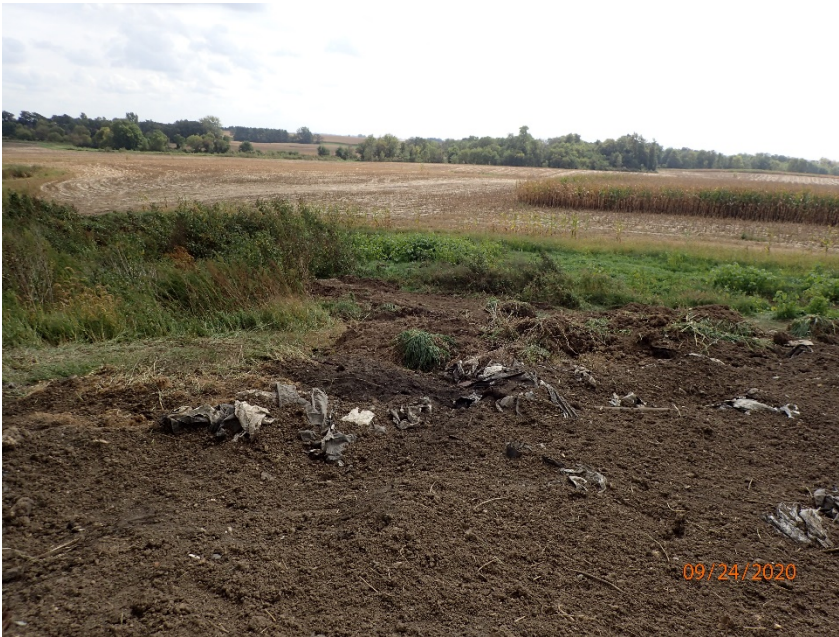
12: P9240012

Description: Recently filled area south of the Big Pit. Note presence of waste plastic silage bags and there was an exposed partially composted mortality.

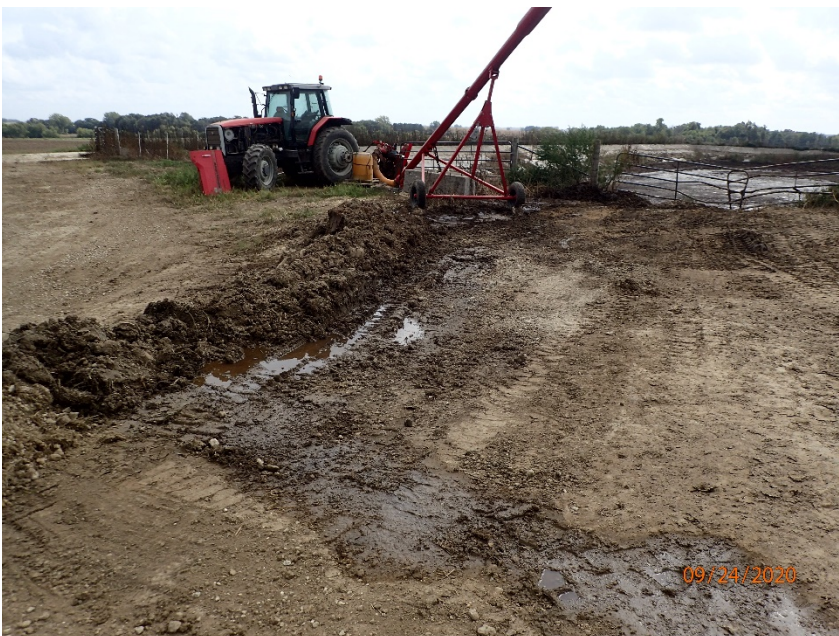
15: P9240015

Description: Berm built to contain and direct leak from the Little Pit to the Big Pit.

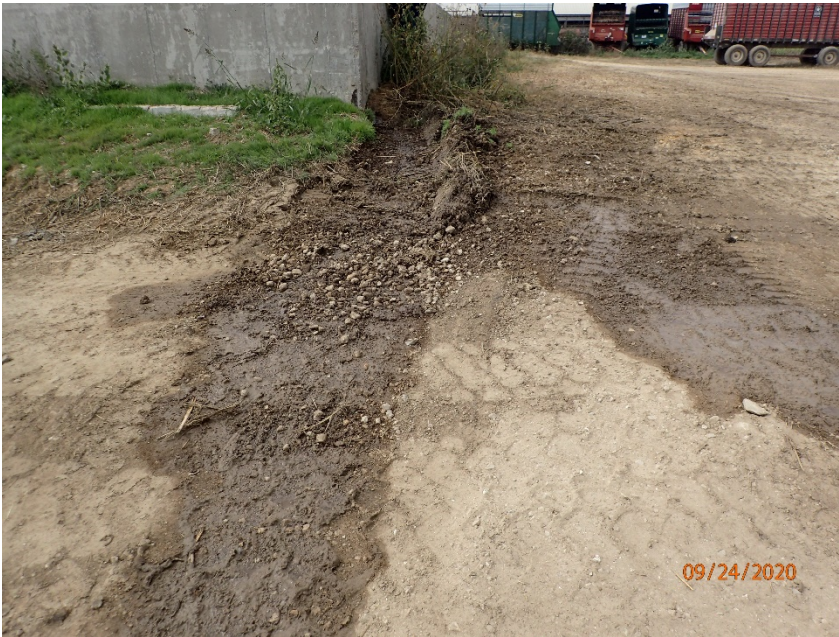
16: P9240016

Description: Leak from the Little Pit.

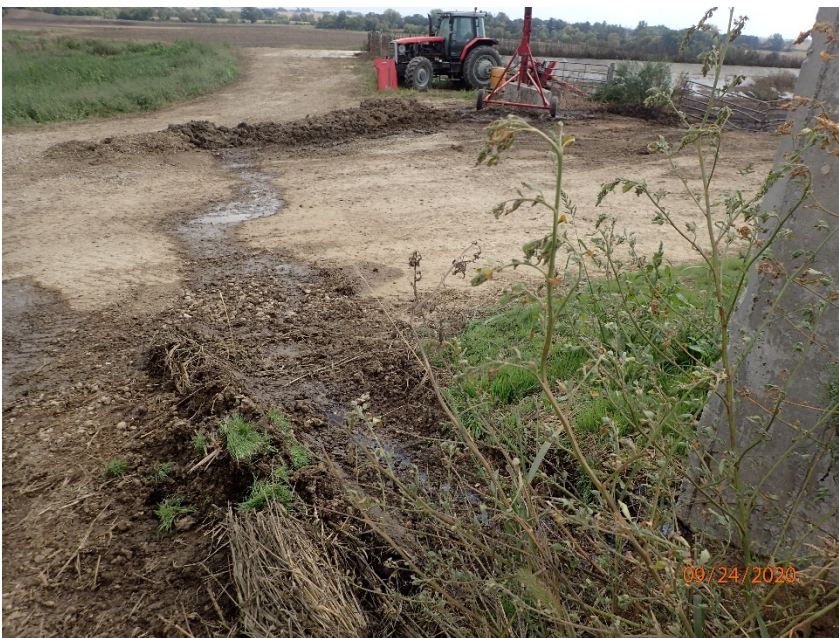
17: P9240017

Description: Flow path of leak from the Little Pit along the berm toward the Big Pit.

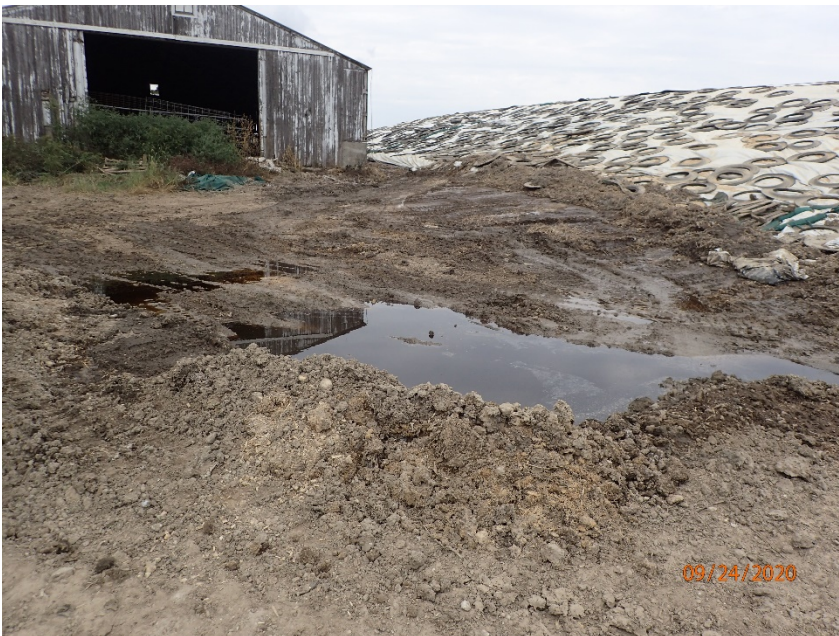
25: P9240025

The Inspectors continued North and observed the Beef Barn (photo 24) and then observed, between the Beef Barn and the Steer Lot, silage leachate that appeared to have leaked from the North Silage Pad (photo 25). It appeared that the Operator had formed berms to collect the leachate. The Operator stated that due to unusually wet silage he had been collecting and scraping the leachate daily. He stated that this was the first year they had encountered that problem and intended to return to putting up their silage drier the following year.

Description: Silage leachate from the North Silage Pad being collected behind a berm between the Beef Barn and the Steer Lot.

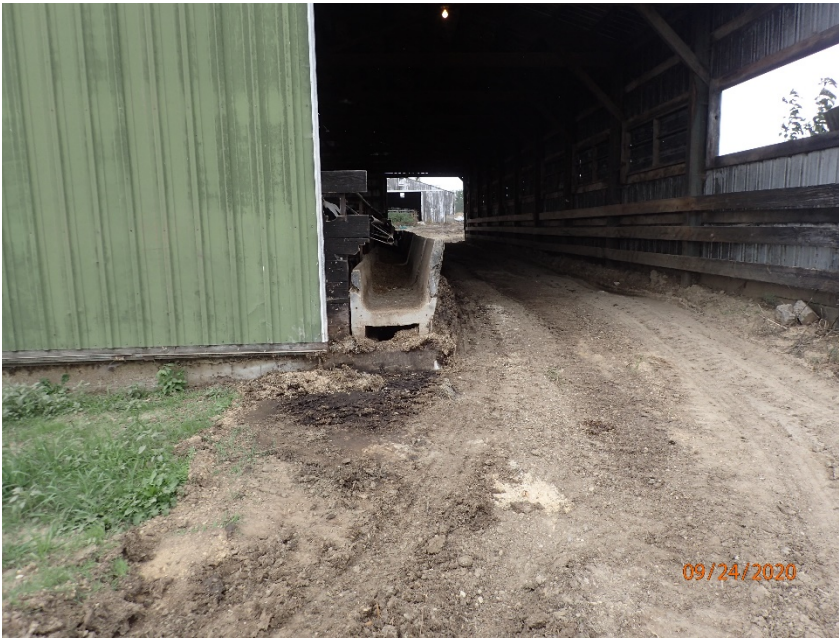
34: P9240034

The Inspectors then walked back east and north past the east end of the Beef Barn. The Inspectors noted to the Operator that the open end of the feed trough allowed any runoff

Description: Looking into the east end of the Beef Barn. Feed trough does not have containment on the end and feed and process wastewater can leave the trough.

from the feed trough to flow out of the building (photo 34). The Operator stated that he could cover the end of the trough to ensure that nothing flowed out of the building.

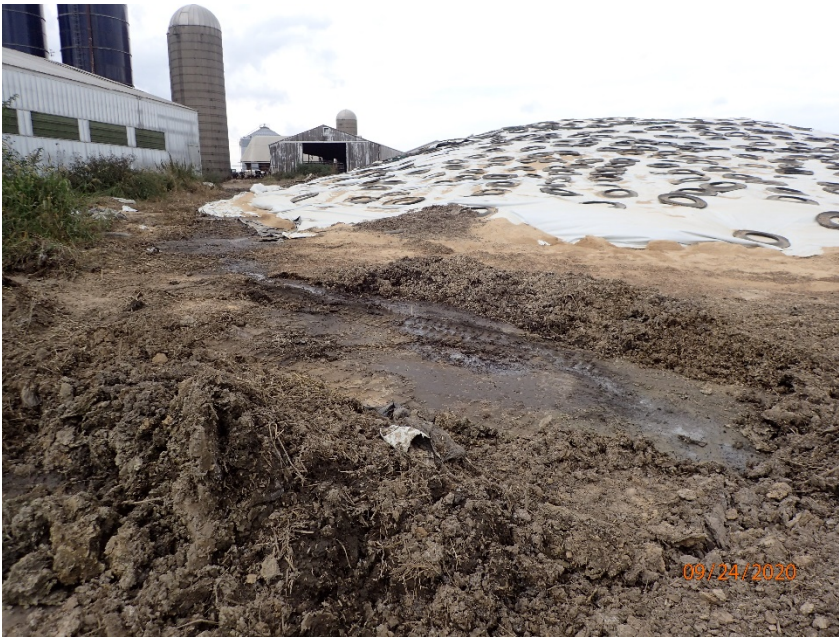
35: P9240035

The Inspectors walked north pasted the east end of the North Silage Pad and observed further leachate and collection berms (photos 35 and 36). The Inspectors informed the Operator that the leachate is considered process wastewater and that he should ensure that it did not discharge to a waterway. The Operator stated that he thought he could build a double berm to ensure that no leachate left the site until they could use the feed on the silage pad.

Description: Looking west at the east end of the North Silage Pad. Note the silage leachate being collected by the berm.

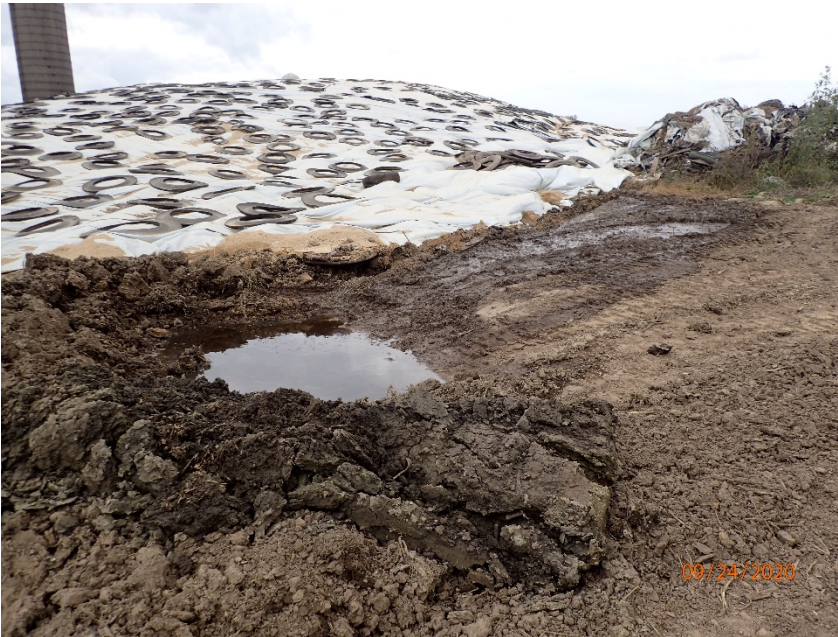
36: P9240036

Description: Looking west at the east end of the North Silage Pad. Note the silage leachate being collected by the berm.

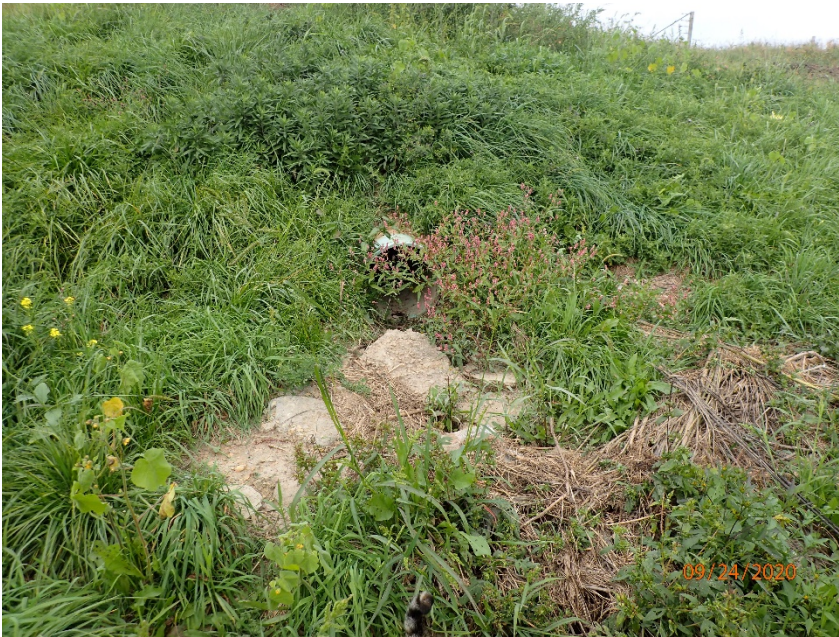
46: P9240046

The Inspectors walked back around the south side of the Big Barn and observed an outlet pipe on the hillslope southeast of the Big Barn (photo 46). The Operator stated that this pipe was the outlet for the inlets seen on the northside of the Big Barn as well as an inlet in the grassed area east of the Milking Parlor. The Inspectors walked to the grassed area east of the Milking Parlor and observed an outlet in the northwest corner of the grassed area (photo 47) which the Operator stated was from a drain on the northside of the Milking Parlor and an inlet in the southeast corner (photo 48) which the operator stated conveyed flow to the outlet seen southeast of the Big Barn (photo 46).

Description: Outlet of the surface inlets shown in Photos 42-45.
