## NPDES Inspection Report – Wastewater Treatment Facility

| Facility Location Information | |
|---|---|
| Site/Facility Name & Location:<br>Enemy Swim Wastewater Treatment Facility<br>Lake Traverse Reservation, South Dakota<br>Lat/Long: 45°25'18.0"N 97°17'40.0"W | Email Report to:<br>John Cloud, III, Program Manager<br>Lake Traverse Utility Commission<br><a href="mailto:johncloud@swu.com">johncloud@swu.com</a> |

**Facility Name:** Waste Management Denver Arapahoe Disposal Site (DADS) Landfill

**Facility Name:** Front Range Landfill

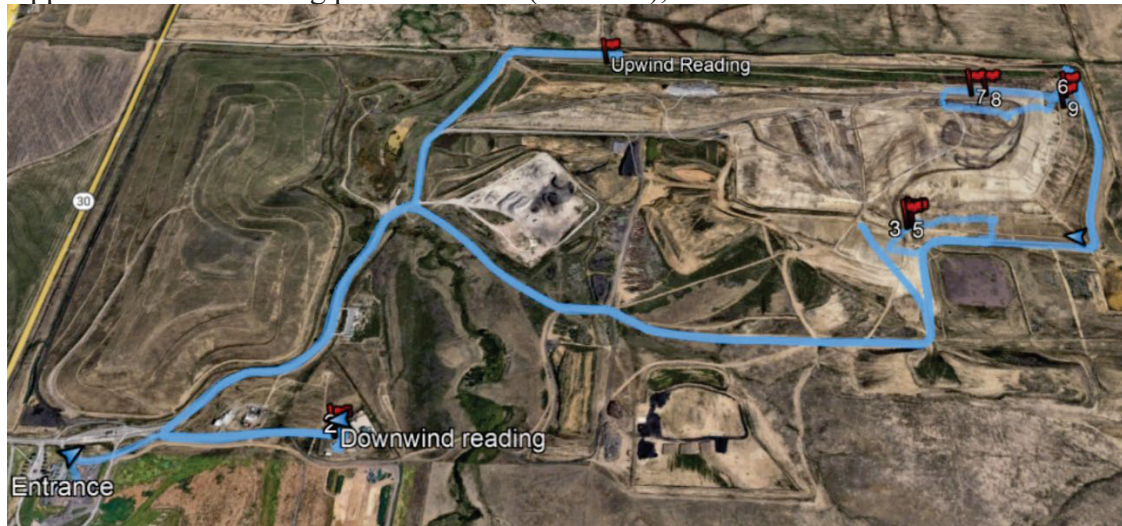
SEM hit locations plotted over satellite imagery from June 7, 2015 as depicted on Google Earth. Approximate monitoring paths included (blue line), derived from GPS data.

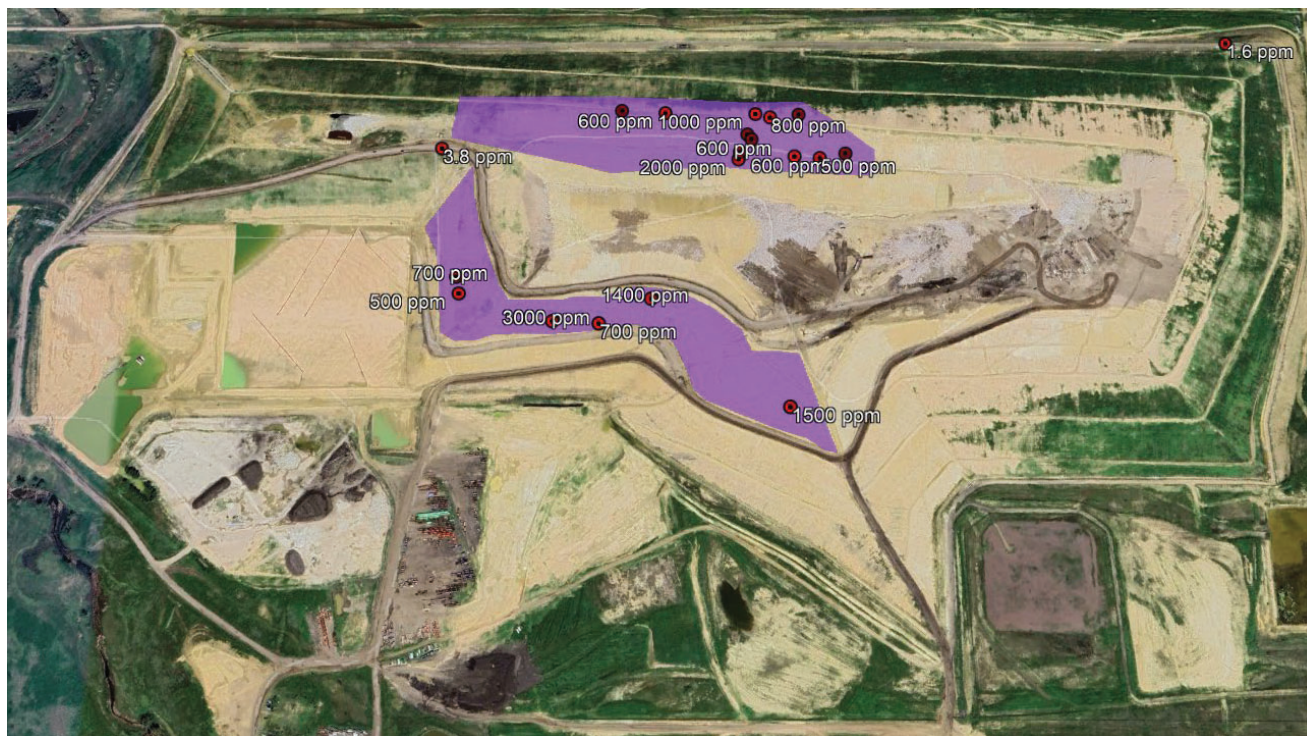
SEM hit locations plotted over satellite imagery from June 9, 2023 as depicted on Google Earth. Approximate monitoring path and monitored areas included (purple highlight), derived from GPS data.

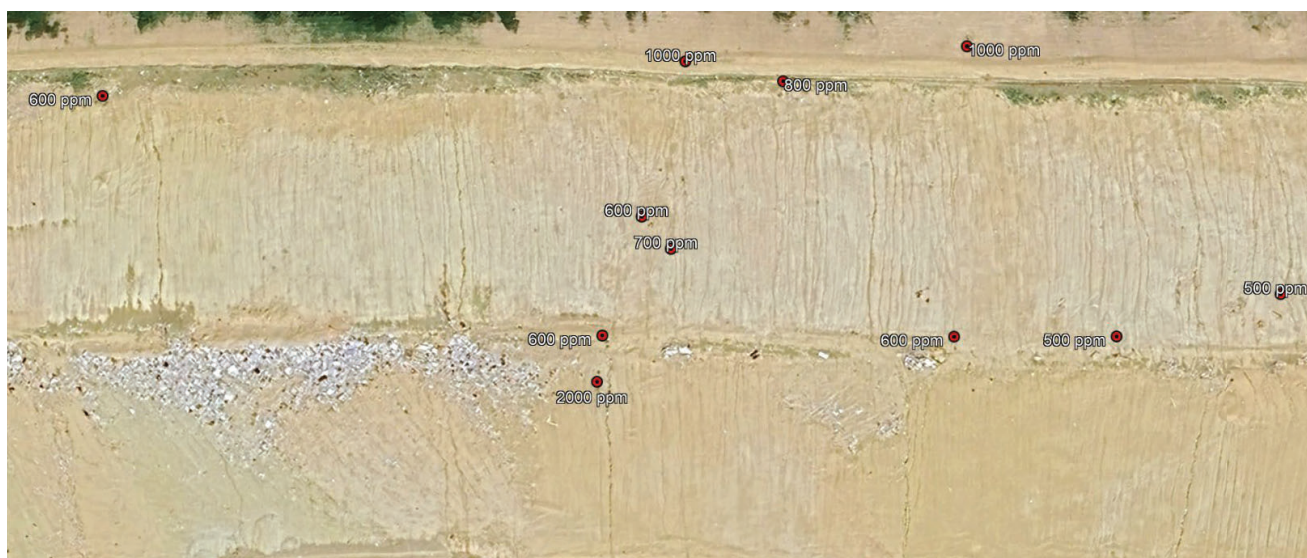
During the inspection, EPA observed a large continuous area on the northern slope with little

to no vegetation and extensive erosion rills. Many of the exceedances on July 20 were discovered in this unvegetated area. DADS personnel communicated that construction activities associated with drilling or repairing wells were recently completed in that area, so there had not been sufficient time to establish new vegetation and erosion was more prevalent due to the lack of vegetation. DADS personnel were aware of the erosion issues and were actively working to address them in the weeks before the inspection.

Google Earth satellite imagery from June 9, 2023, demonstrating extensive erosion rills and sparse vegetation on the northern slope of the landfill near exceedances #11 – #21

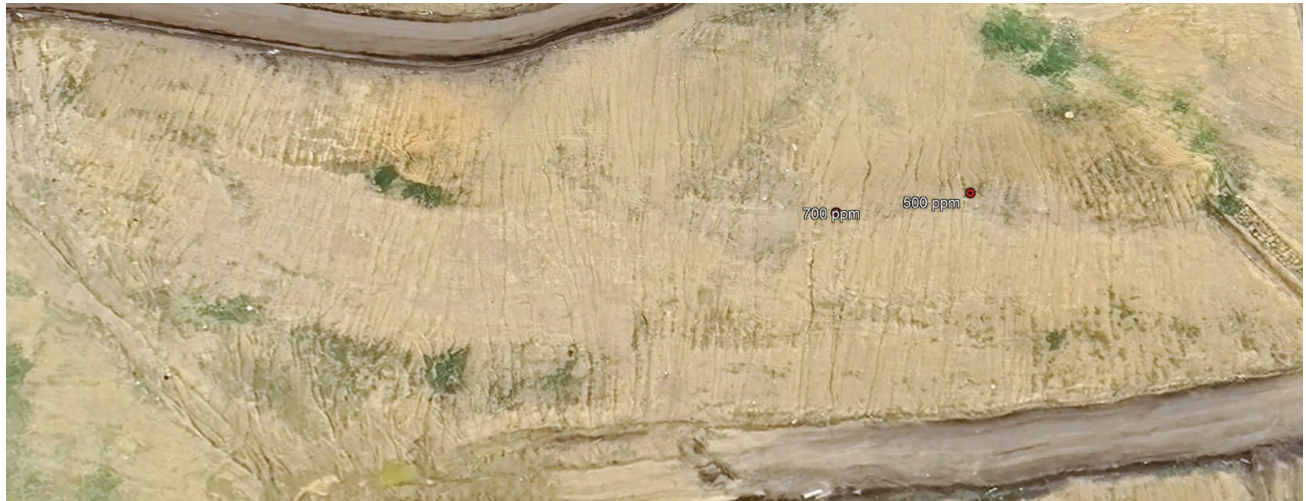
| 22 | 7/20/2023<br>3:53 PM | Surface exceedance recorded in an erosion rill, approximately 3" deep and 1' wide, with unburied waste in the rill. No vegetation noted. | 500 | N<br>39.66273 | W<br>-104.69590 | |

Google Earth satellite imagery from June 9, 2023, demonstrating extensive erosion rills and sparse vegetation on the eastern slope of the landfill near exceedances #22 and #23.

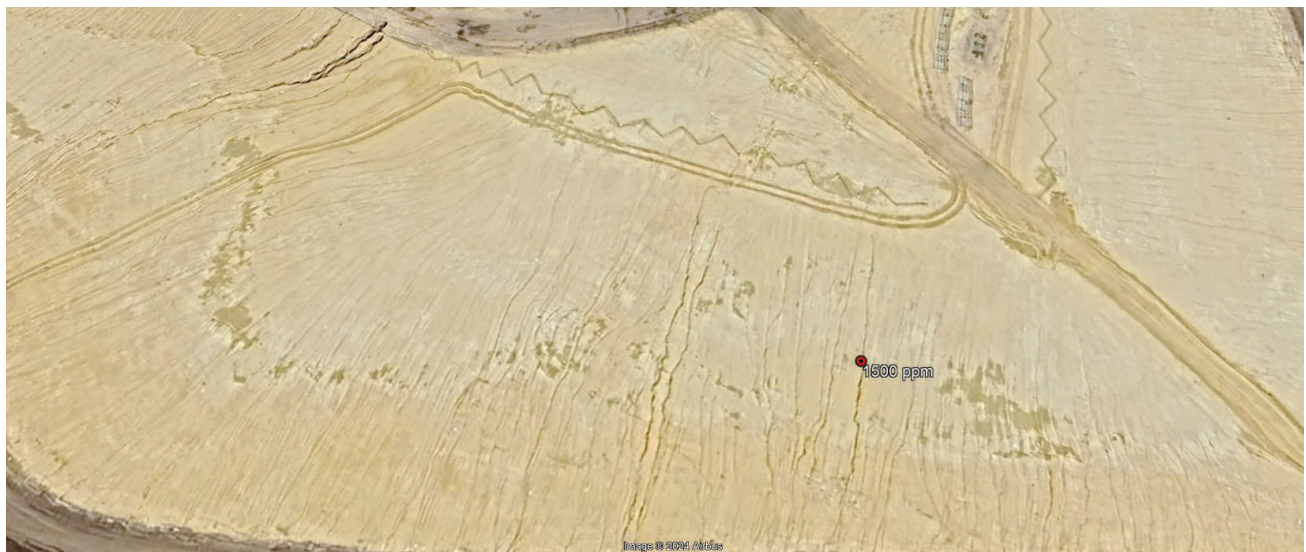
| # | Reading Date/ Time | Well / Location / Description/ Observations | Reading (ppm) | Latitude | Longitude | Media Records |
|---|---|---|---|---|---|---|
| 3 | 7/19/2023<br>3:07 PM | Surface exceedance recorded in an erosion rill approximately 2 feet deep. No vegetation noted. | 1500 | N<br>39.66095 | W<br>-104.68948 | DSCN0027.JPG |

Google Earth satellite imagery from June 9, 2023, demonstrating extensive erosion rills and sparse vegetation on the south-central slope of the landfill near exceedance #3.

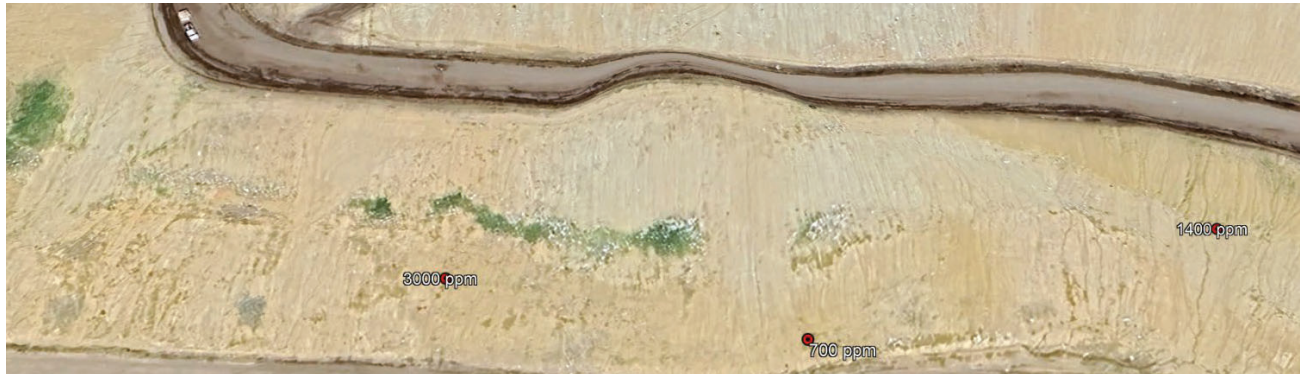
| # | Reading Date/ Time | Well / Location / Description/ Observations | Reading (ppm) | Latitude | Longitude | Media Records |
|---|---|---|---|---|---|---|
| 4 | 7/19/2023<br>3:34 PM | Surface exceedance recorded in a small erosion rill. No vegetation noted. | 1400 | N<br>39.66262 | W<br>-104.69214 | DSCN0028.JPG |
| 5 | 7/19/2023<br>3:56 PM | Penetration exceedance recorded at well 307. No vegetation noted. | 3000 | N<br>39.66227 | W<br>-104.69405 | |
| 6 | 7/19/2023<br>4:06 PM | Penetration exceedance recorded at well 308. No vegetation noted. | 700 | N<br>39.66223 | W<br>-104.69315 | |

Google Earth satellite imagery from June 9, 2023, demonstrating erosion rills and sparse vegetation on the eastern slope of the landfill near exceedances #4 – #6.

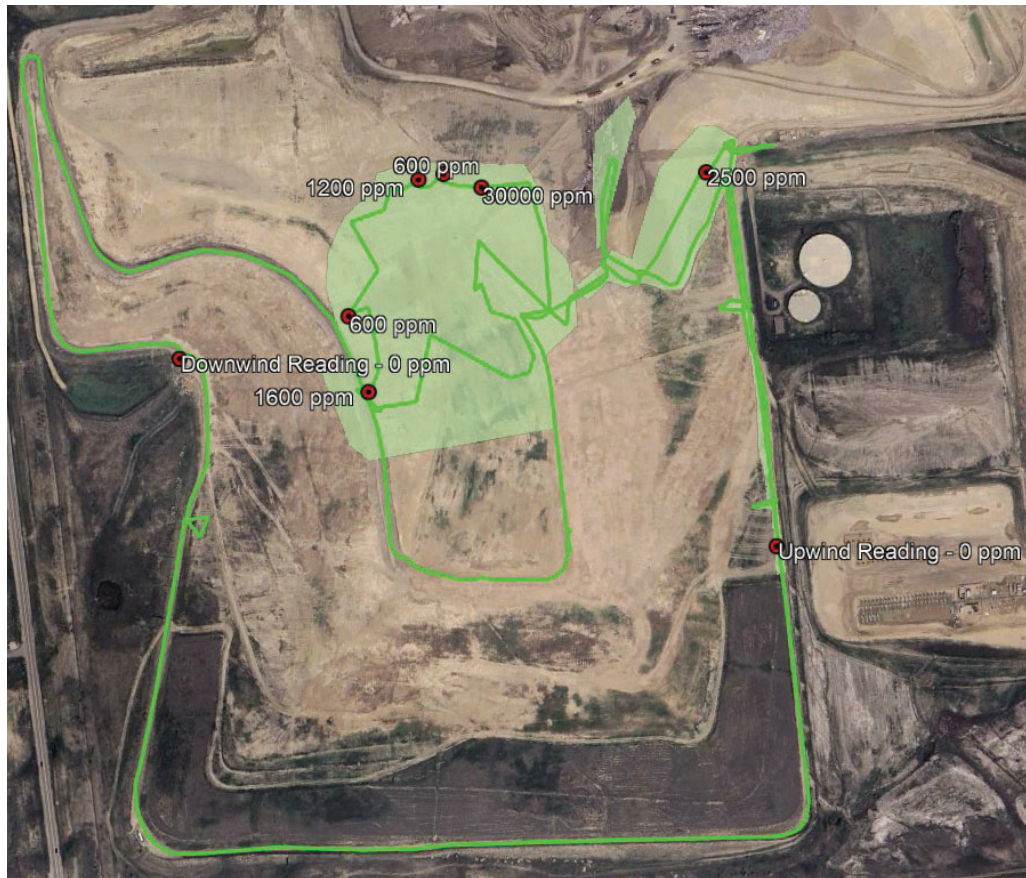
SEM hit locations plotted over satellite imagery from September 4, 2023 as depicted on Google Earth. Approximate monitoring path and monitored areas included (green line and green highlight), derived from GPS data.

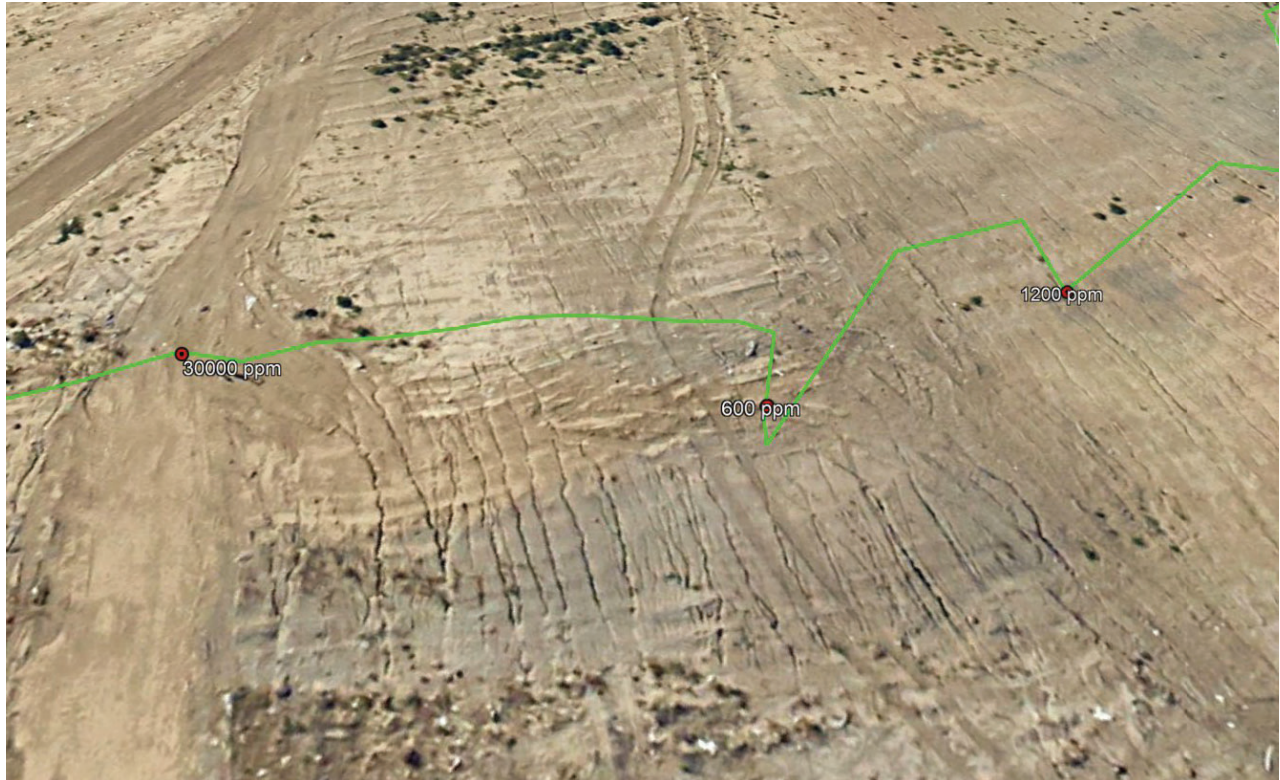
On the landfill slope where exceedances #3 - #5 were recorded, EPA observed a large continuous area with little to no vegetation and some erosion rills. These conditions were also noted near exceedances #6 and #7. Aside from these locations, the landfill cover was generally in good condition, with minimal erosion and well-established vegetation.

| # | Reading Time | Well / Location / Description/ Observations | Reading (ppm) | Conf. Reading (ppm) | Latitude | Longitude | Media Records |
|---|---|---|---|---|---|---|---|
| 3 | 10:23 AM | Well 37 penetration exceedance. Inspectors noted no vegetation and presence of exposed waste. | 12000 | 30000 | N<br>40.02198 | W<br>-105.01184 | IMG_0038.JPG |
| 4 | 10:30 AM | Surface exceedance with elevated methane readings in the general vicinity. No vegetation was noted. | 600 | 600 | N<br>40.02215 | W<br>-105.0123 | IMG_0039.JPG |
| 5 | 10:37 AM | Surface exceedance recorded in a small 6"X6" erosion rill. No vegetation was noted. | 1200 | 750 | N<br>40.02212 | W<br>-105.01262 | IMG_0040.JPG |

Google Earth satellite imagery from September 4, 2023, demonstrating extensive erosion rills and sparse vegetation on the central slope of the landfill near exceedances #3 – #5

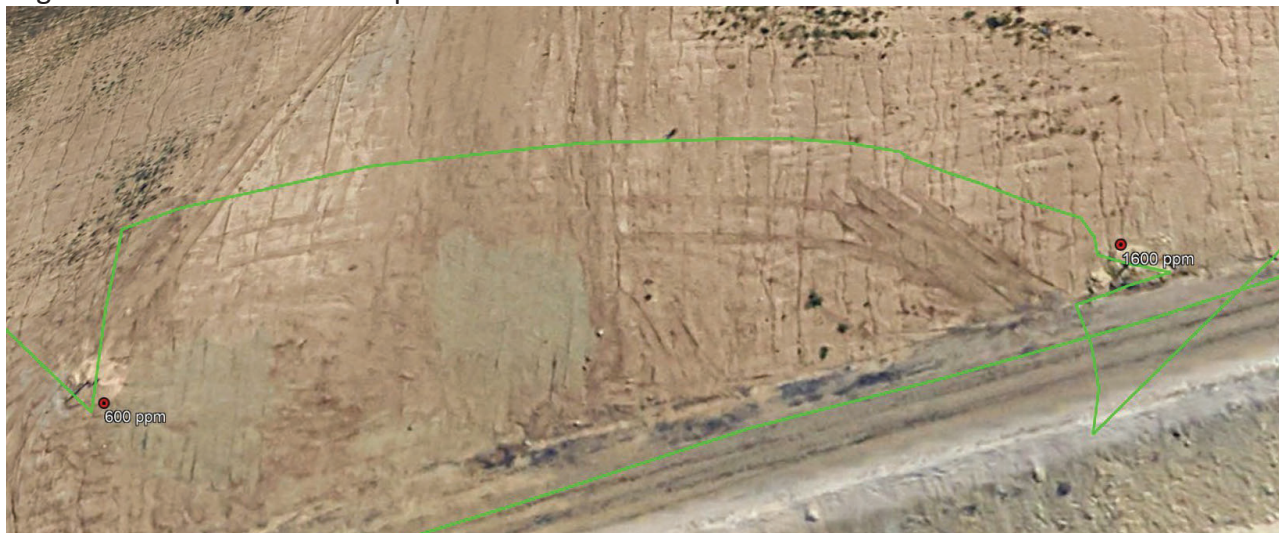
| # | Reading Time | Well / Location / Description/ Observations | Reading (ppm) | Conf. Reading (ppm) | Latitude | Longitude | Media Records |
|---|---|---|---|---|---|---|---|
| 6 | 10:55 AM | Well 31 penetration exceedance. Elevated readings were also recorded in the general vicinity of the well. No vegetation was noted. | 600 | 600 | N<br>40.02086 | W<br>-105.01368 | IMG_0041.JPG |
| 7 | 11:01 AM | Well 29 penetration exceedance, specifically on the extraction well penetration. No vegetation was noted. | 650 | 1600 | N<br>40.02011 | W<br>-105.01353 | IMG_0042.JPG |

Google Earth satellite imagery from September 4, 2023, demonstrating erosion rills and sparse vegetation on the western slope of the landfill near exceedances #6 and #7.

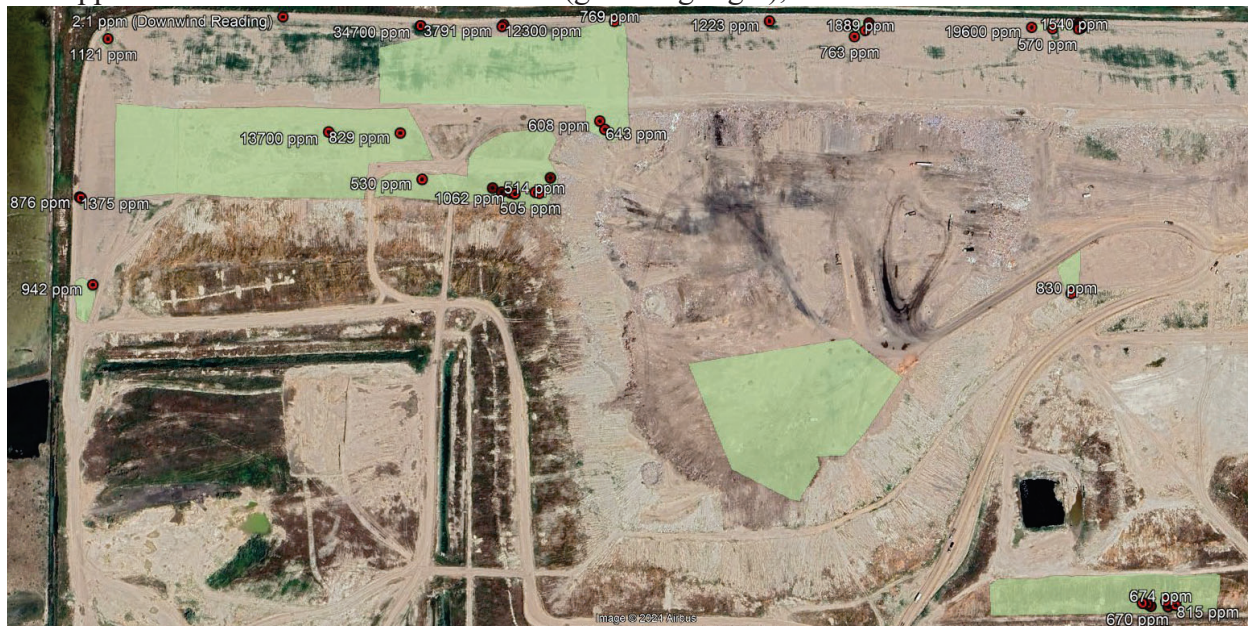
1. SEM hit locations plotted over satellite imagery from May 29, 2023, as depicted on Google Earth. Approximate monitored areas included (green highlight), derived from GPS data.

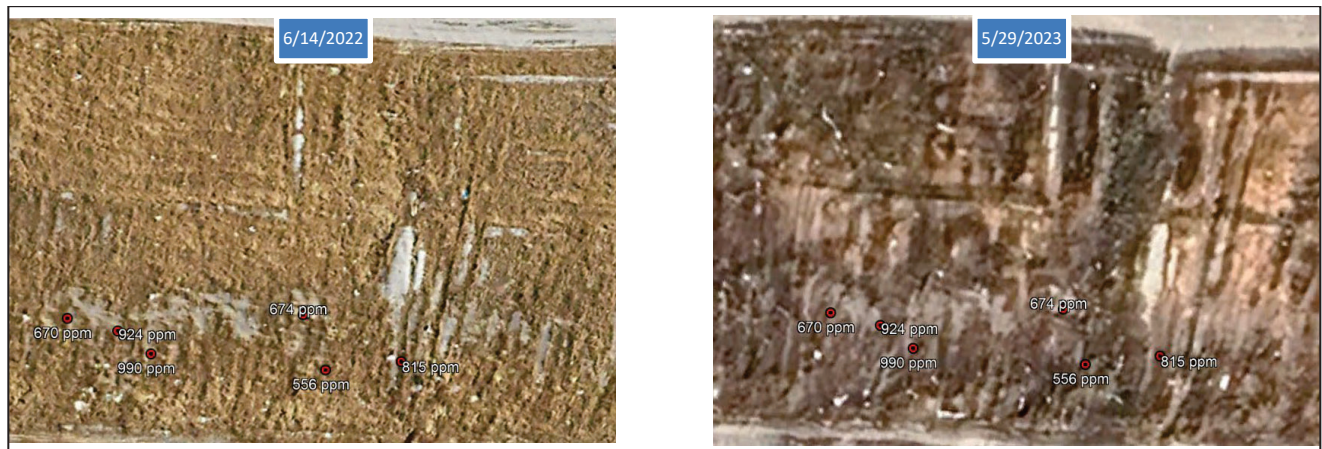
2. Google Earth satellite imagery of exceedances #3 – #8 on the Southeast corner of the landfill, on June 14, 2022, and May 29, 2023, demonstrating persistent erosion rills and vegetation dead spots on the landfill surface.

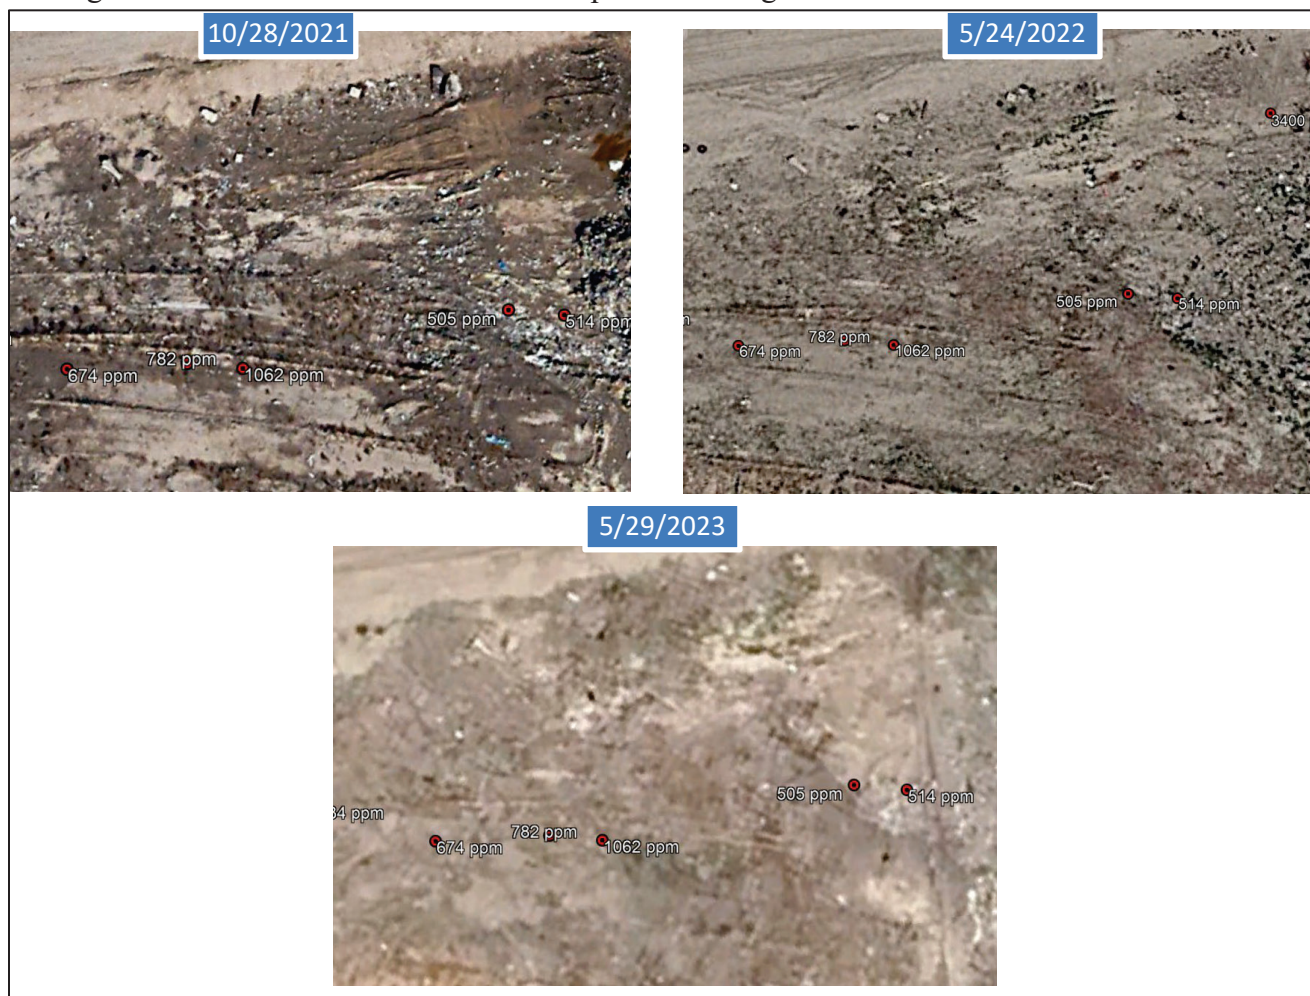
3. Google Earth satellite imagery of exceedances #15 – #21 in the center of the Northwestern cell of the landfill, from October 28, 2021, through May 29, 2023, demonstrating waste placed prior to October 2021 that was unburied and visible during the 2023 EPA inspection, as well as persistent lack of vegetation in the area. This area is also captured in images 64 – 76.

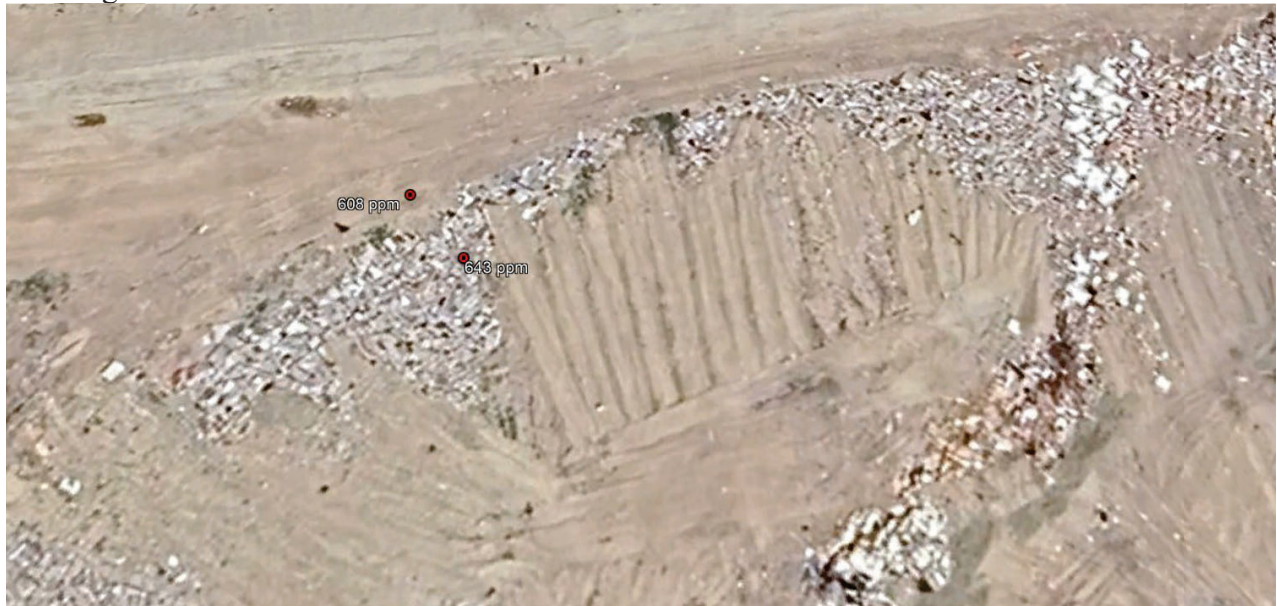
4. Google Earth satellite imagery of exceedances #23 and #24 on the Northeastern area of the landfill on May 29, 2023, demonstrating an extensive swath of unburied waste. This area is also captured in images 78 – 80.

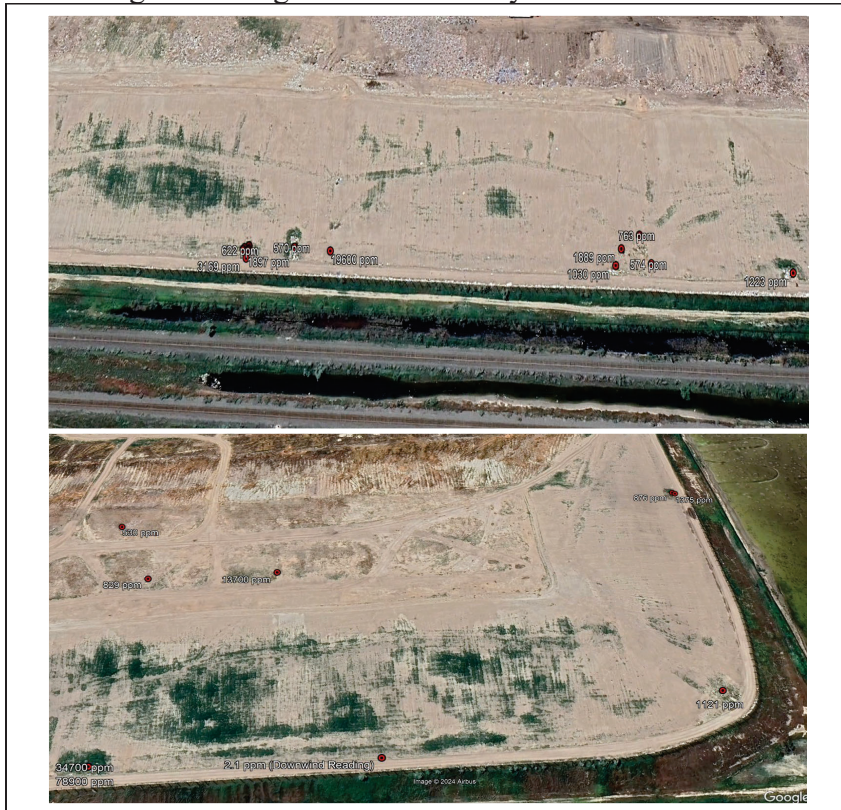
5. Google Earth satellite imagery of exceedances #25 – #45 on the Northwest perimeter of the landfill, on May 29, 2023. The images capture large swaths of unvegetated surface, despite thick vegetation past the fence line and a patch of vegetation on the landfill surface which demonstrate the potential for vegetation to grow in the vicinity.

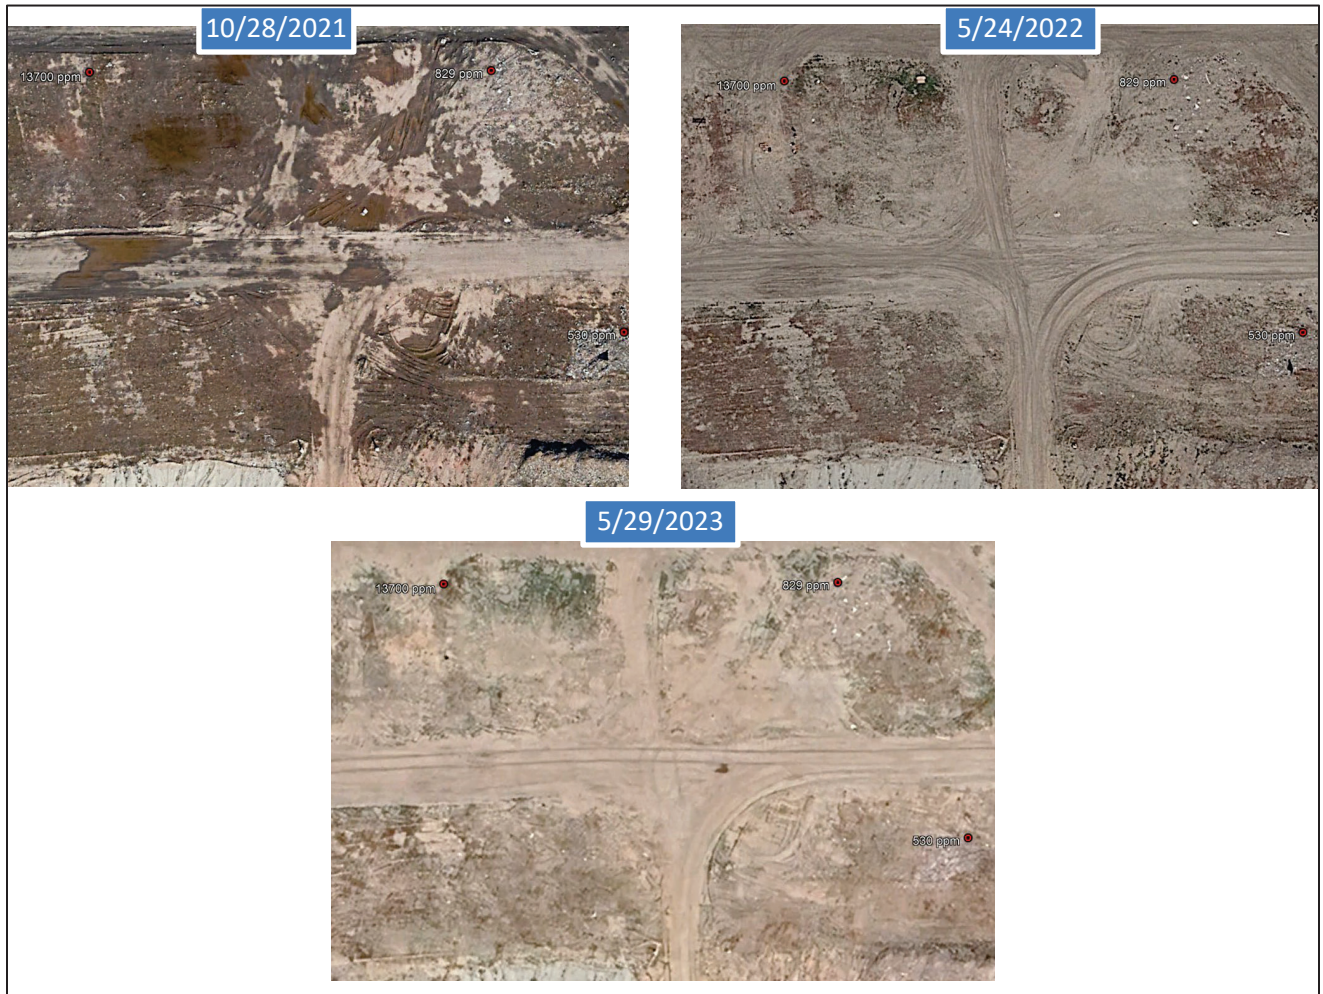
6. Google Earth satellite imagery of exceedances #11, #12, and #22 in the center of the Northwestern cell of the landfill, from October 28, 2021, through May 29, 2023, demonstrating a persistent lack of vegetation in the area. This area is also captured in images 58, 59, 76 and 77.

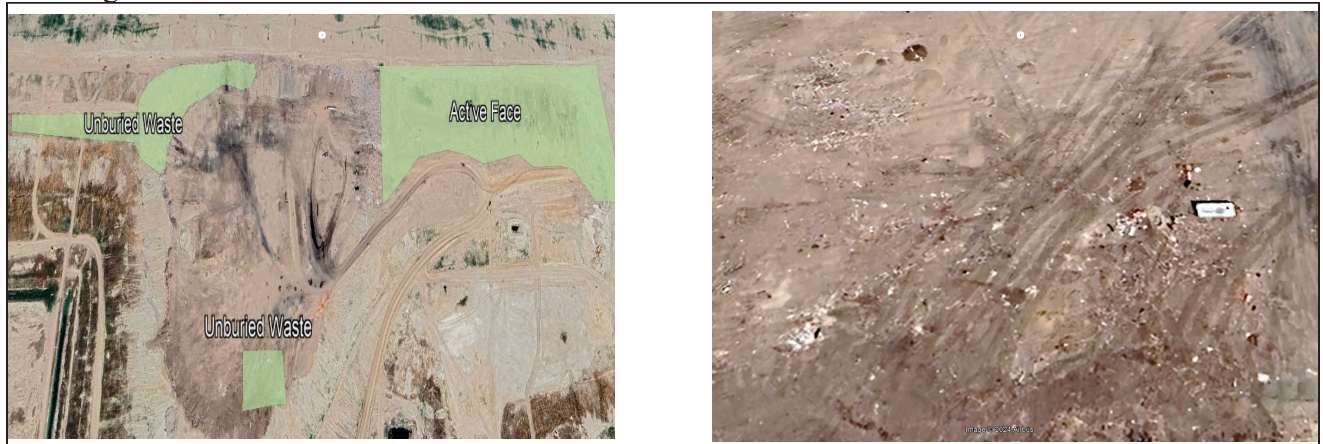
7. Highlighted areas of unburied waste over satellite imagery as seen on Google Earth satellite imagery from May 29, 2023. The second image captures an area of unburied medical waste also captured in images 47 – 57.

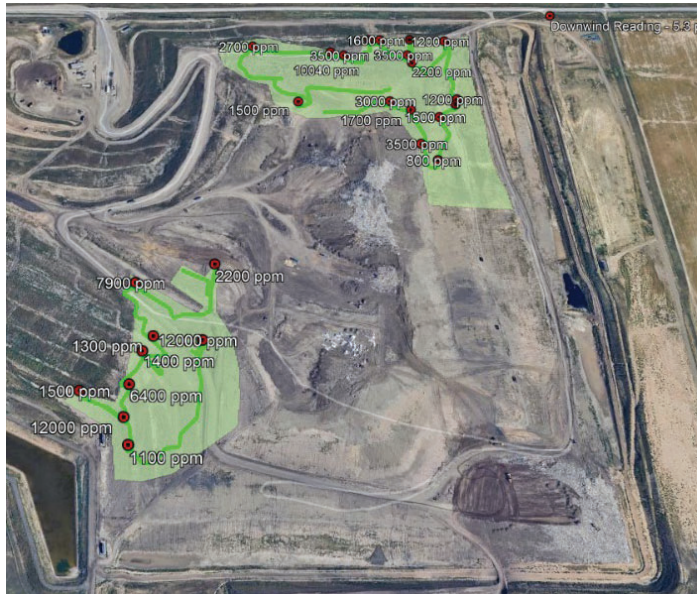
1. SEM hit locations plotted over satellite imagery from September 4, 2023, as depicted on Google Earth. Approximate monitoring path and monitored areas included (green line and green highlight), derived from GPS data.

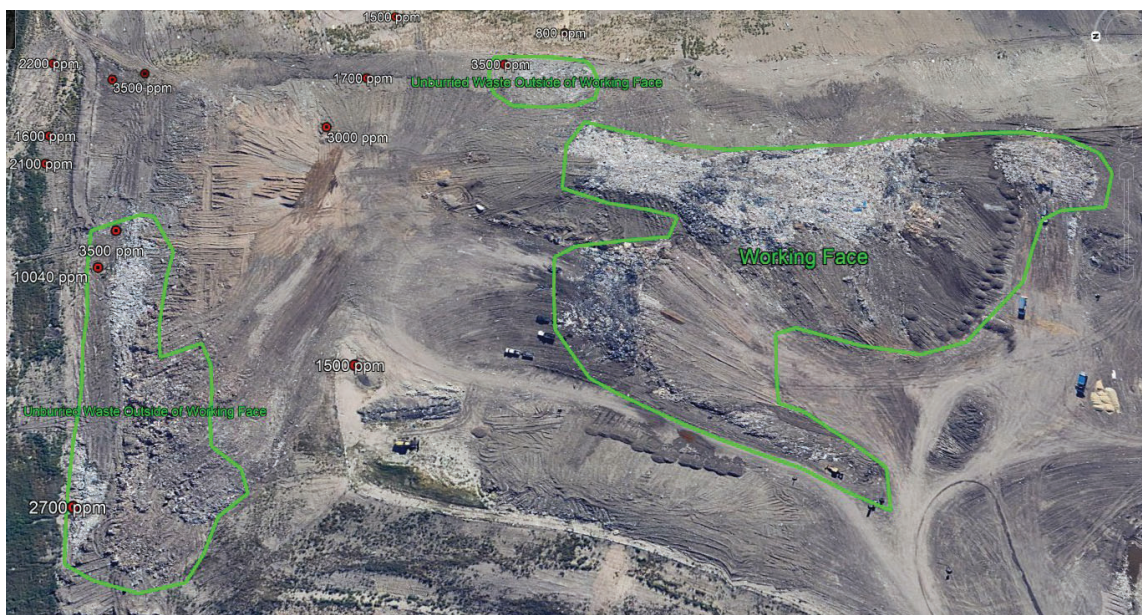
4. Satellite imagery demonstrating exposed waste, separate from the active working face of the landfill, as seen on Google Earth satellite imagery from September 4, 2023. The two smaller green circled areas indicate swaths of unburied waste, as observed by inspectors during the EPA inspection.

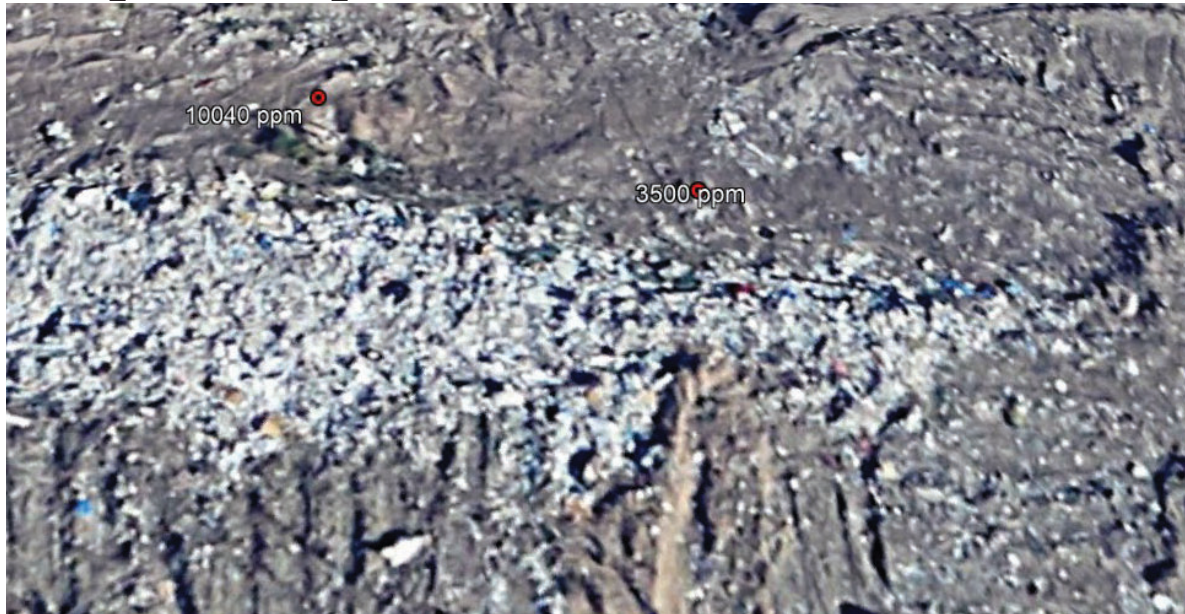
5. Satellite imagery demonstrating exposed waste near exceedances #5 and #6, as seen on Google Earth satellite imagery from September 4, 2023. This area is also captured in IMG\_0002.JPG – IMG\_0005.JPG.

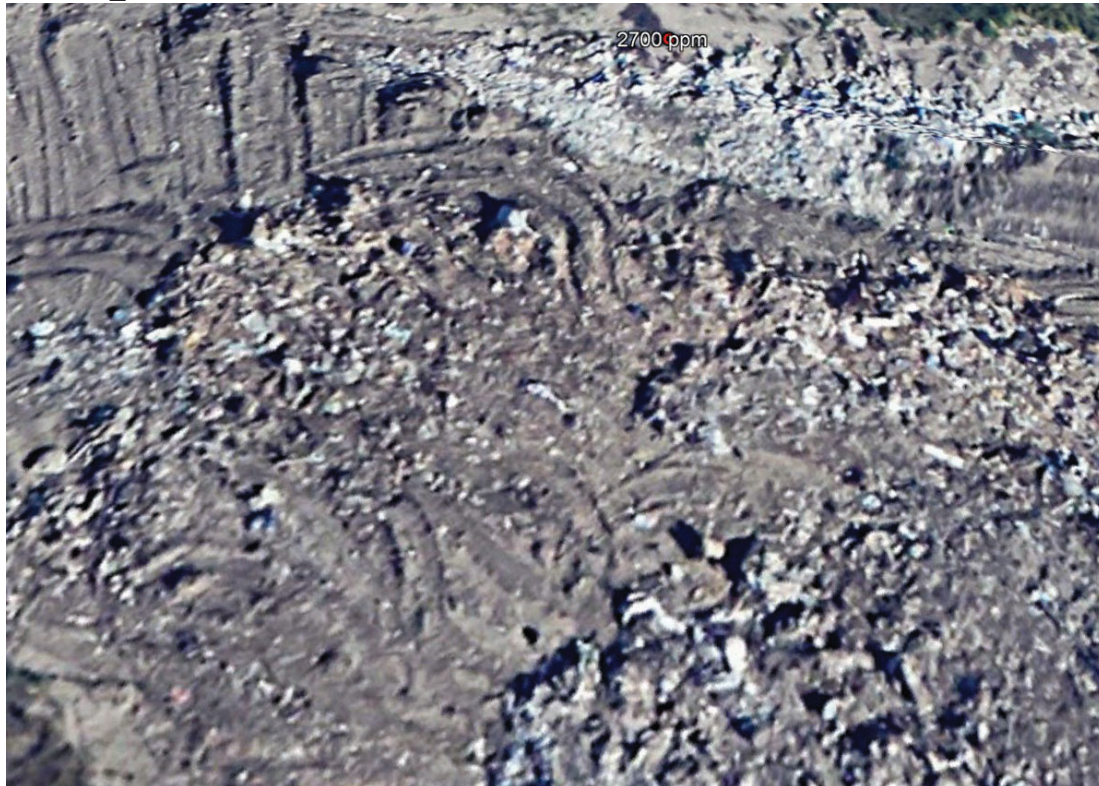
6. Satellite imagery demonstrating exposed waste near exceedance #4, as seen on Google Earth satellite imagery from September 4, 2023. This area is also captured in IMG\_0001.JPG.

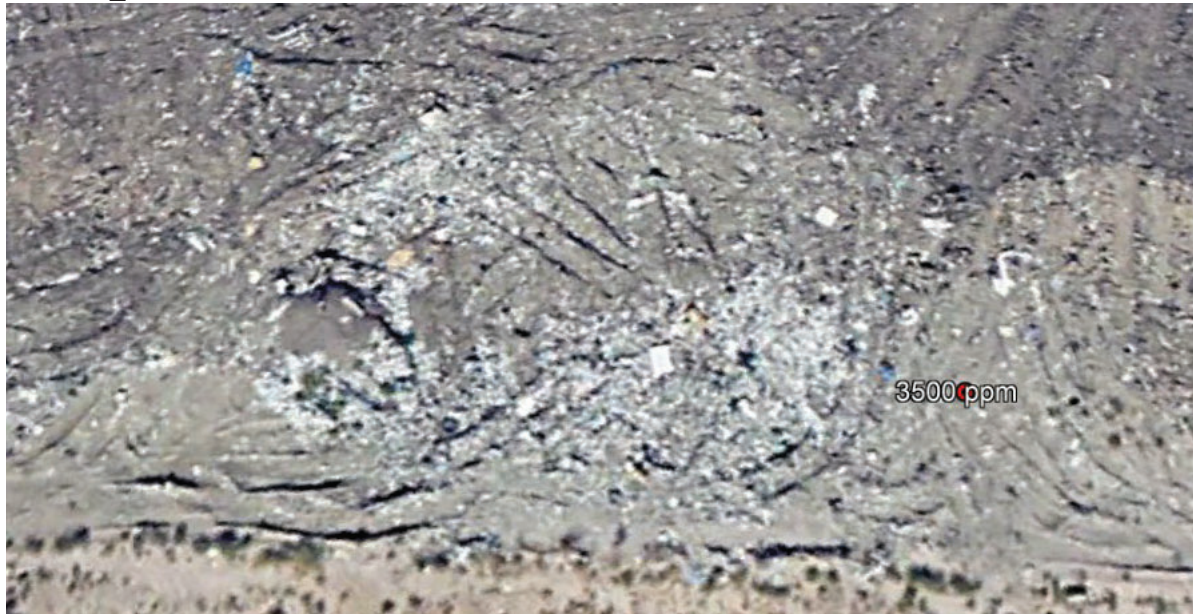
7. Satellite imagery demonstrating exposed waste near exceedance #17, as seen on Google Earth satellite imagery from September 4, 2023. This area is also captured in IMG\_0016.JPG – IMG\_0021.JPG.

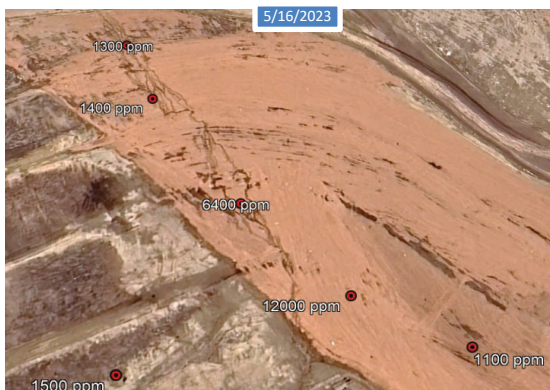
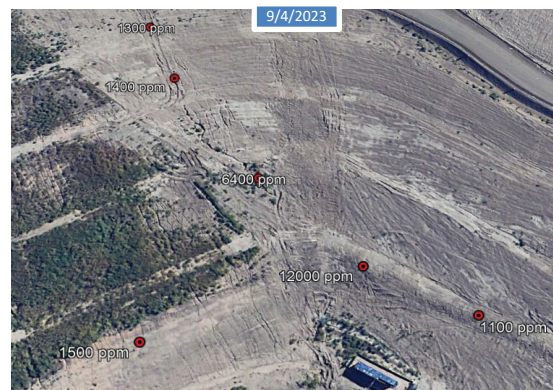
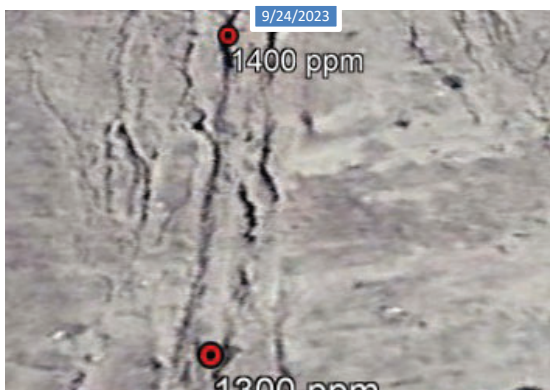
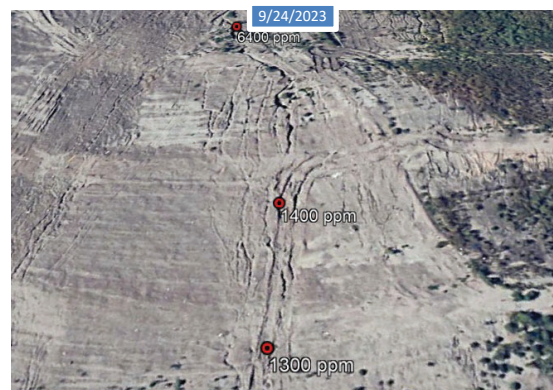
8. Satellite imagery demonstrating a large erosion rill near exceedances #22 - #24, as seen on Google Earth satellite imagery from both May 16 and September 4, 2023.

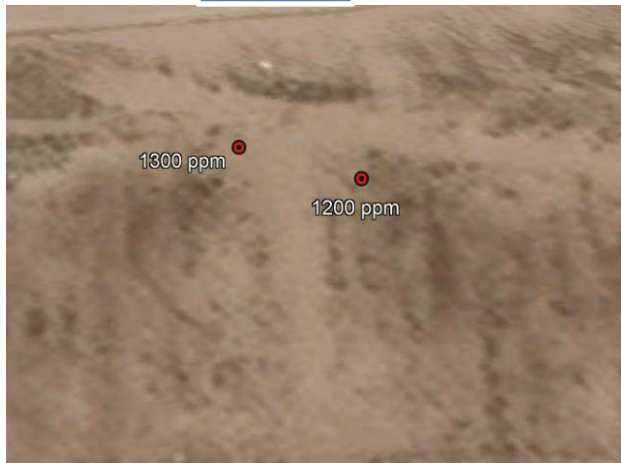
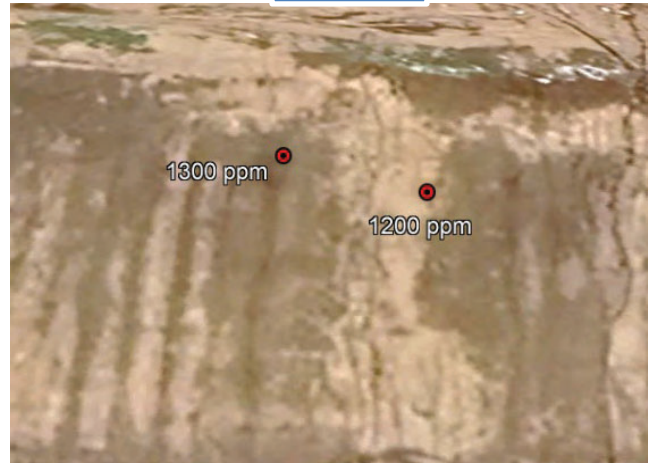
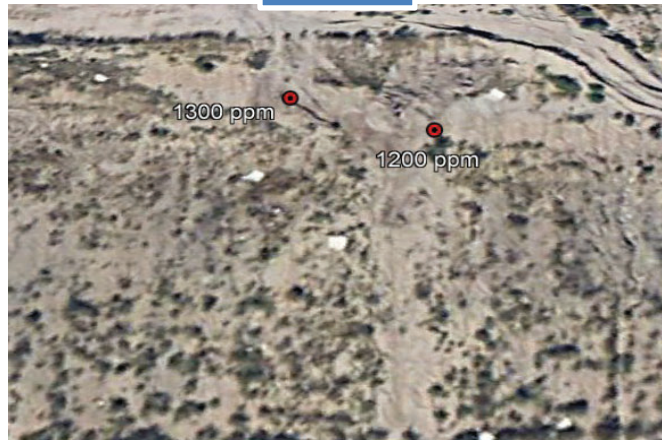
9. Satellite imagery demonstrating persistent sparse vegetation and erosion near exceedances #13 and #14, as seen on Google Earth satellite imagery between July 14, 2022, and September 4, 2023.
